# Vermont Historic Preservation Grants 2025 Application

Historic Name: Putney Town Hall

On the Condition of the Existing Building, &  
Recommendations for Improvements:

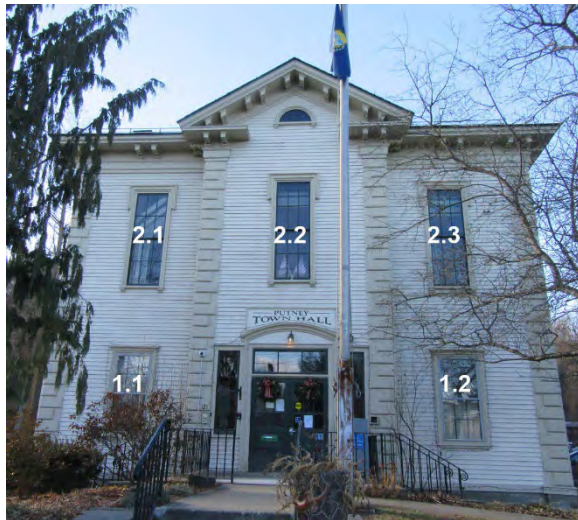
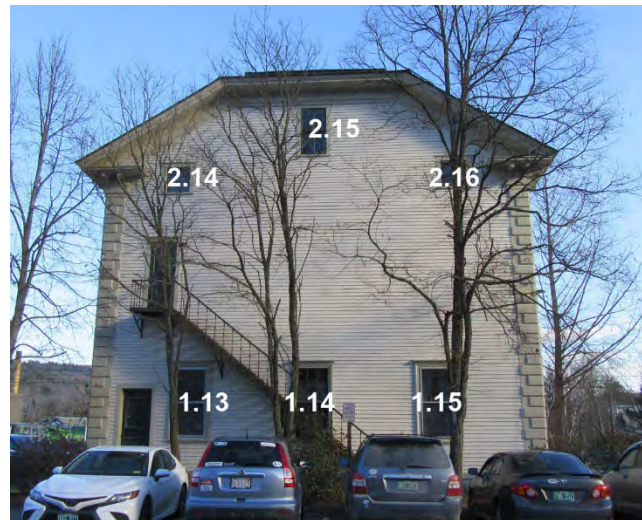
Front (left) and Rear (right)

**Total of 27 original double hung 6/6 windows; (13 monumental & 14 large)  
Plus 3 small windows on rear elevation (stage area)**

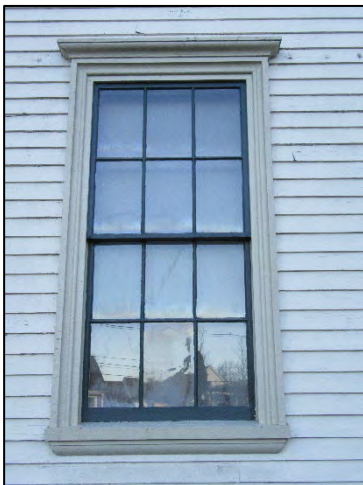
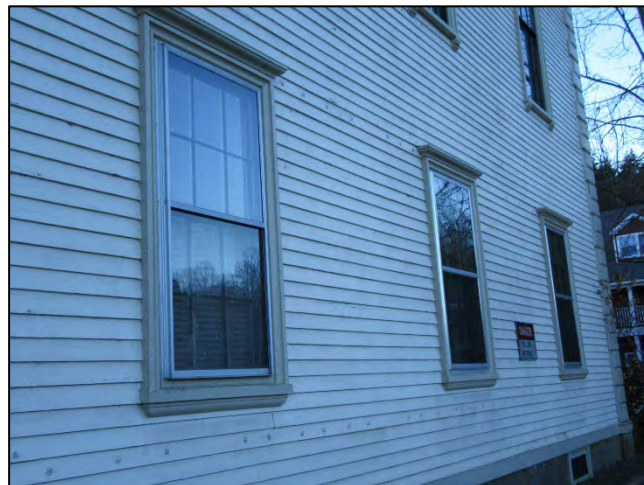
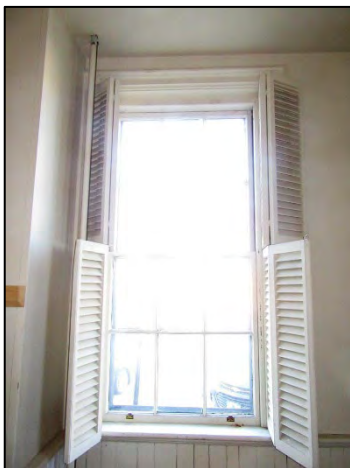
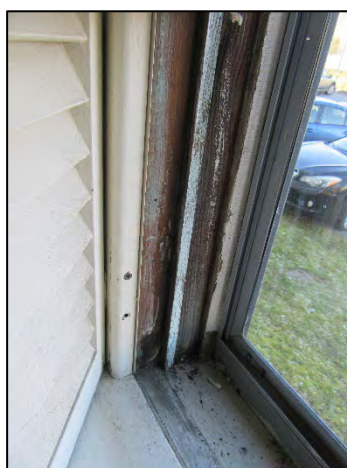
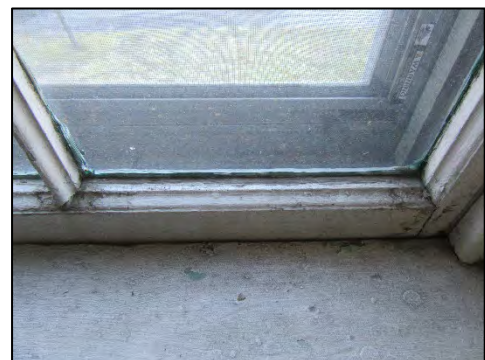
- 1.2 & 1.8 in bathroom – both in good condition and operating smoothly;
- 1.10 in meeting room – sound condition, cord disconnected, some chipped paint
- Exterior exam of windows blocked by vault and by false fireplace – both appear sound but dry with some deteriorated paint

In general, except for the 2 windows now blocked (vault and meeting room) the windows protected by triple track storms are in good condition and need minor tweaking, scraping, re-glazing, maybe some parting beads replaced)

**Typical First floor window views**  
Top left: Window 1.8, Top right: windows 1.10, 1.11, & 1.12; Bottom left: window 1.8 interior; Bottom center: interior

window detail 1.10; Bottom right: Interior window detail 1.2

**I would estimate that on 1<sup>st</sup> floor,**

- **2 windows need full restoration**
- **11 need minor repair, refurbishing**

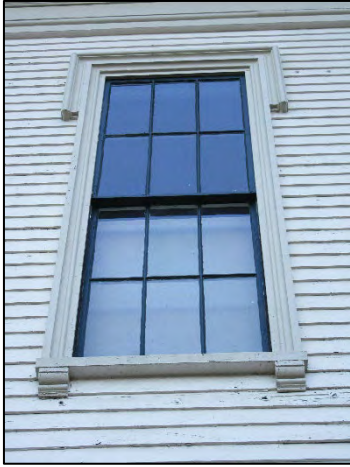
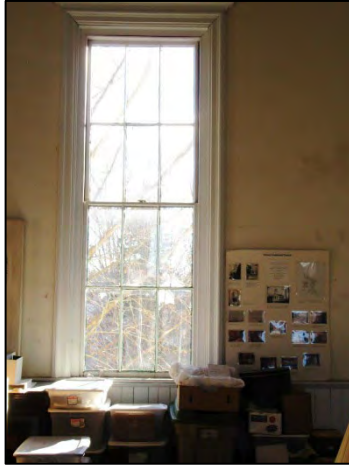
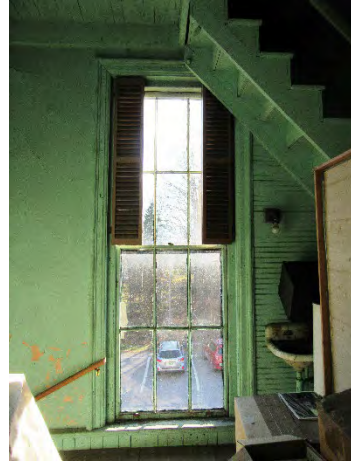
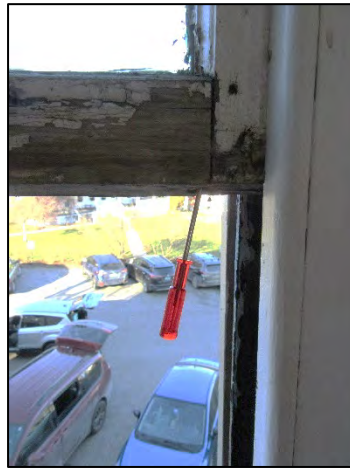
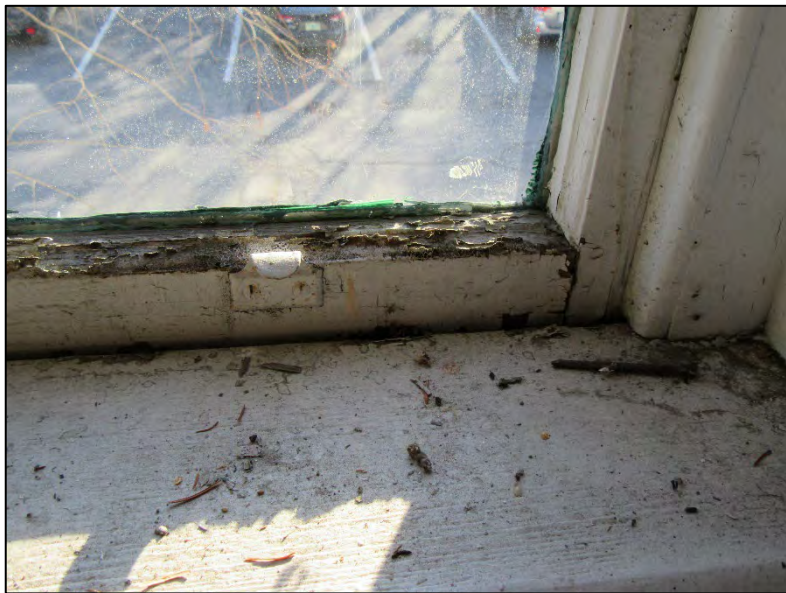
- 2.1 in small south front room – Dry and a bit rough, wobbly, cord there but did not open
- 2.2 in hall – Ok shape, works well but parting bead slightly broken, jams and parting bead need replacing
- 2.4 on stage - Very rough condition, dry, needs several parts replaced
- 2.5 in big room - Very rough condition, dry, needs several parts replaced
- 2.6 & 2.7 in big room – Ok condition, dry, do not open though cords in place
- 2.8 in small south front room – Rough condition, dry, doesn't open
- 2.11 in big room – Dry, and some rot on underside of bottom sash near joint with a ½" gap, operates well
- 2.12 in big room - Ok condition, dry, does not open though cords in place
- 2.13 on stage – Very dry, wobbly does not open
- 2.14 & 2.16 (2'x2', casements) in north & south stage rooms – in rough condition, dry, don't close properly

In general, the monumental (9x3) windows on the second floor, which have not been protected by exterior storms, are in fair to poor condition. They are dry, many do not operate, the majority of the jambs and parting beads need repair or replacement. While the wood of the stiles and rails are generally in fair condition there are spots of rot, there are a few broken panes, and at least two are in very rough condition.

**Typical views of second floor windows**

**Top left: Window 2.9; Top center: interior window 2.11; Top right: interior window 2.4; Bottom left: Interior detail of rot on 2.11; Bottom right: interior detail of dry, deteriorated condition, 2.11**

**I would estimate that on 2nd floor**

- **13 monumental windows need full restoration**
- **3 smaller (stage) windows need full restoration**
