03/29/2024

**STRUCTURAL AND ELECTRICAL ASSESSMENT OF
THE BENNINGTON BATTLE MONUMENT**

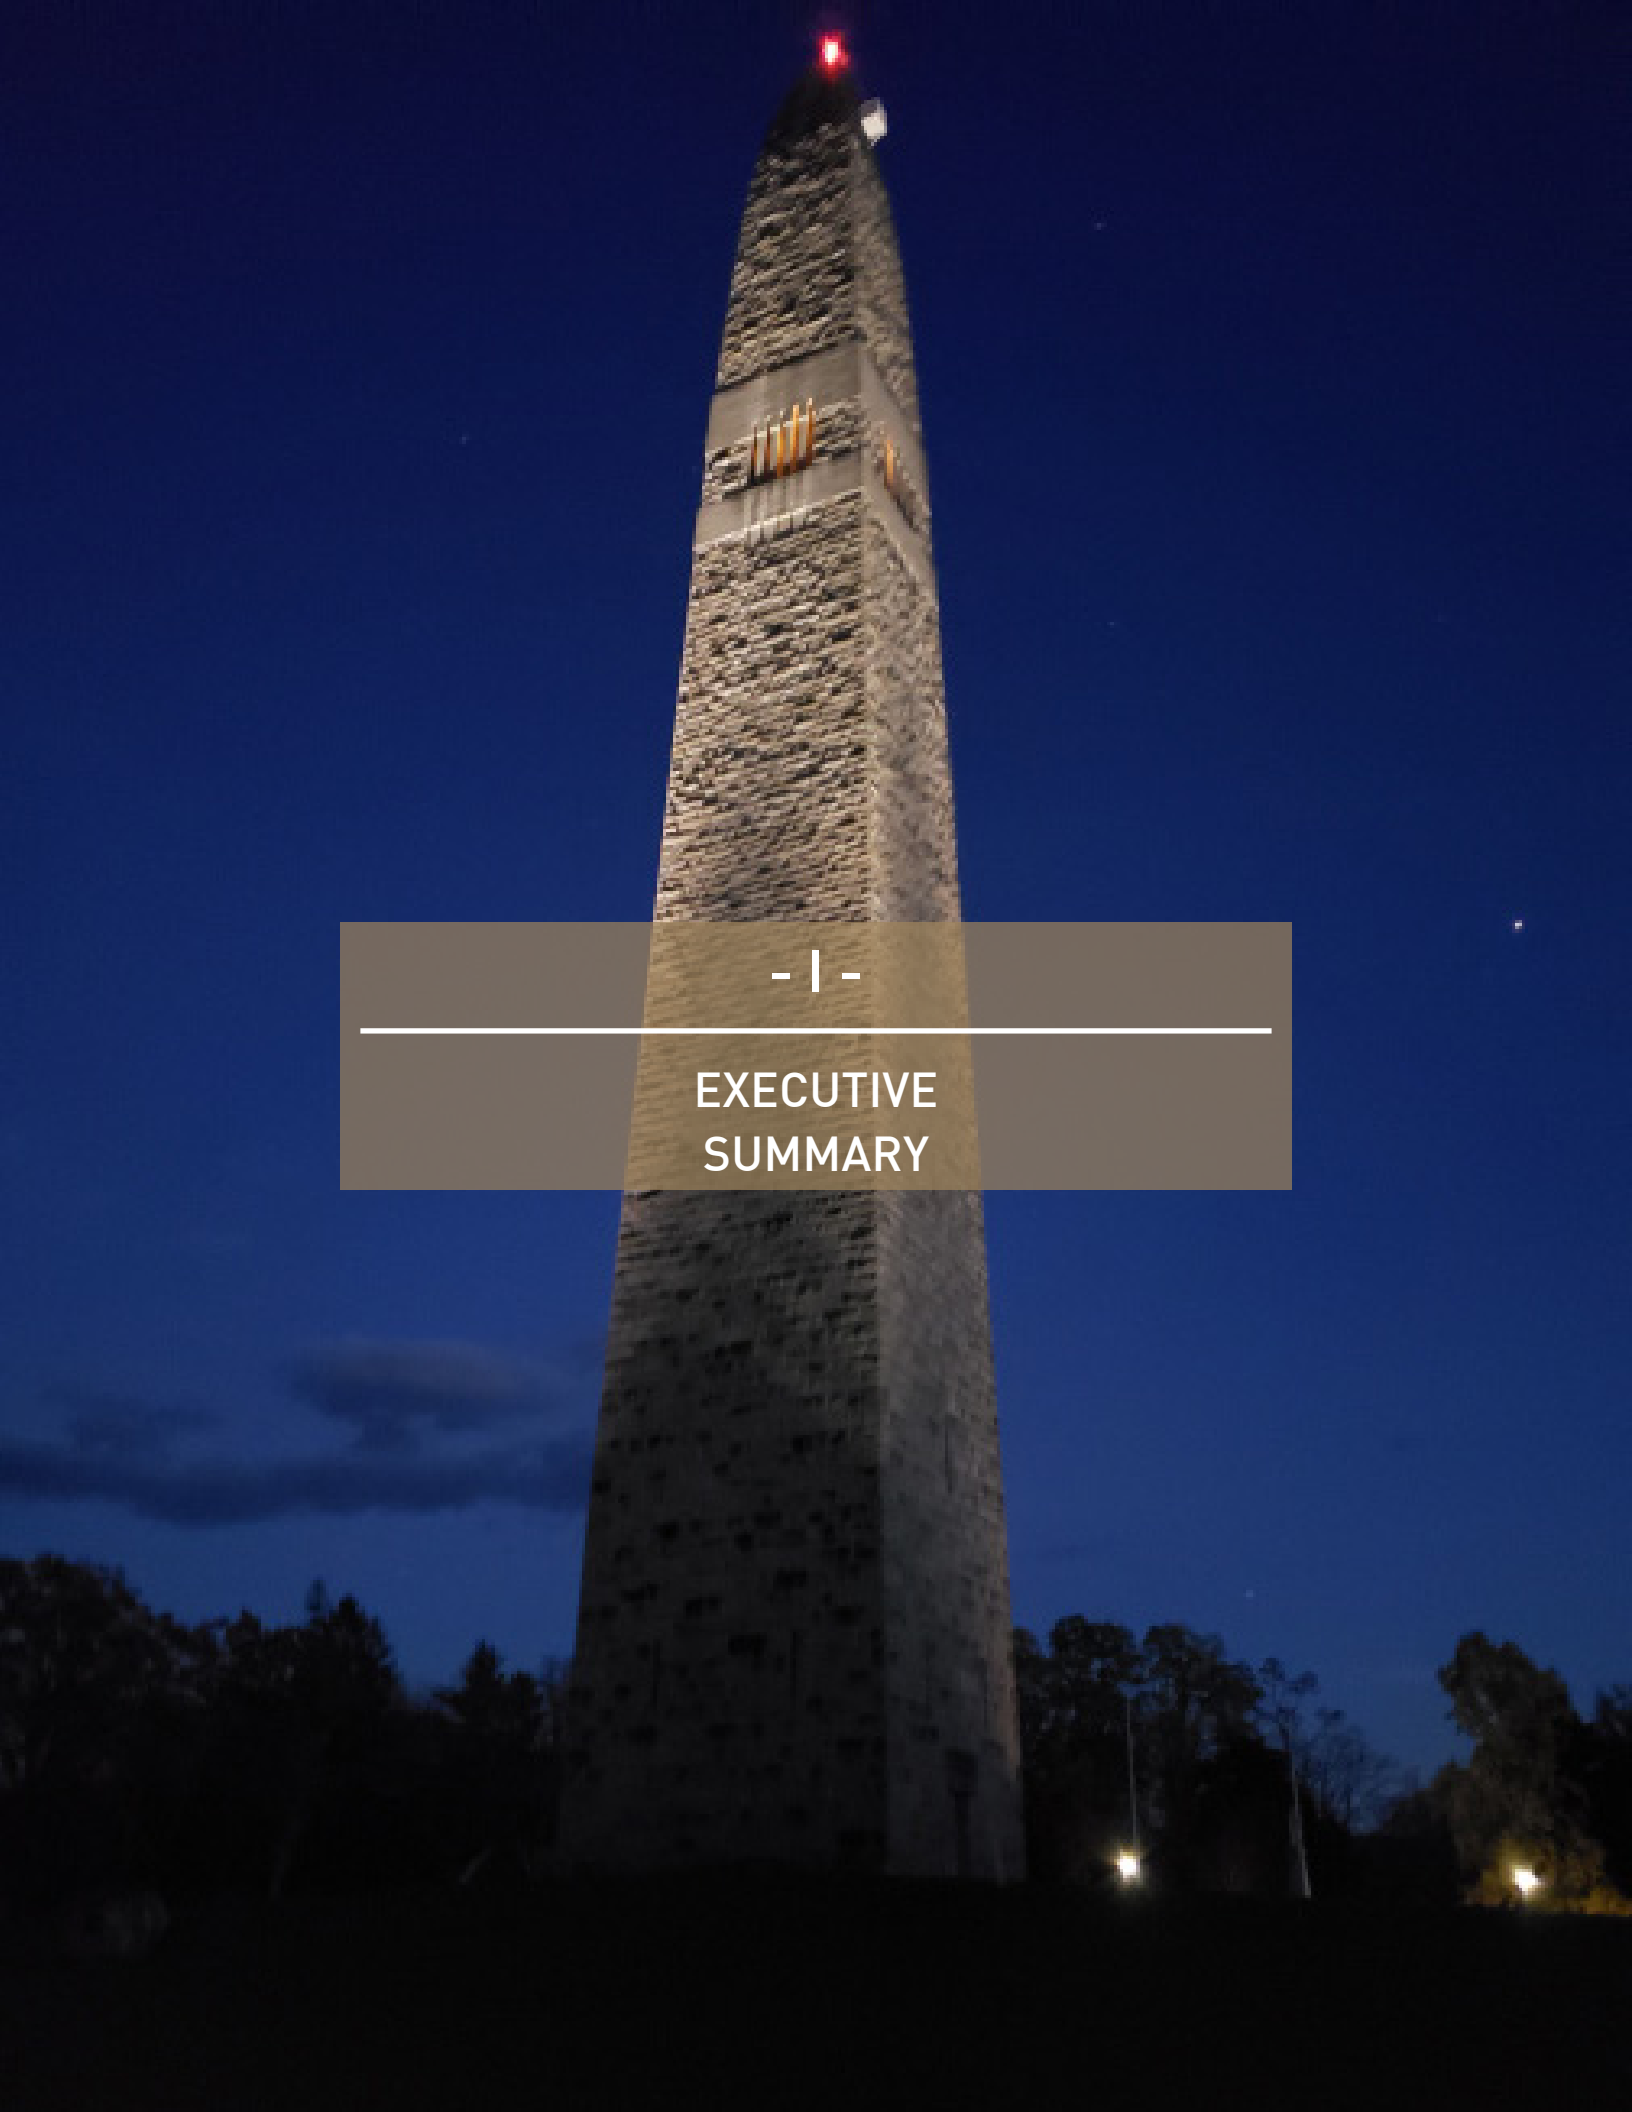
- | -
EXECUTIVE
SUMMARY

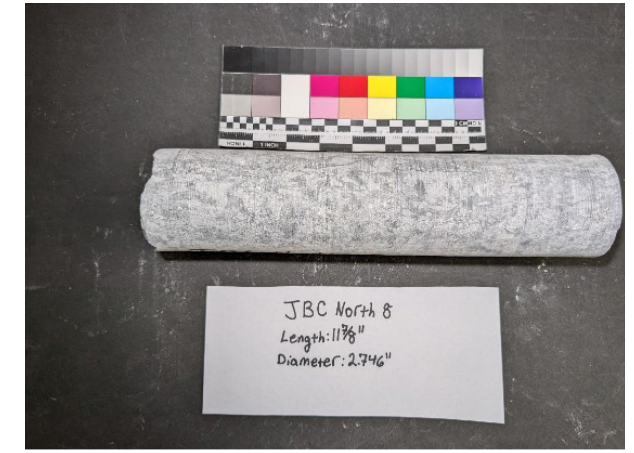
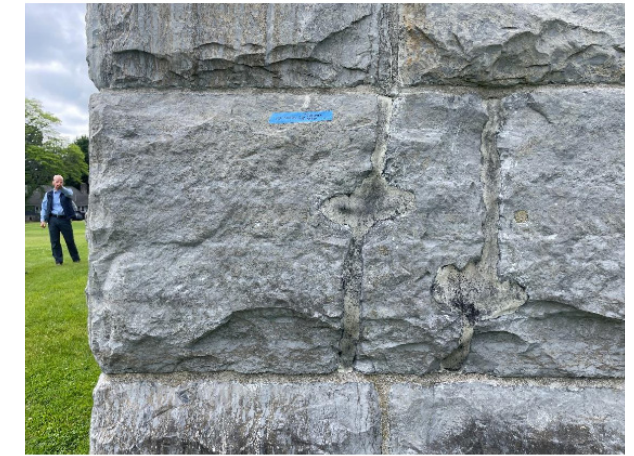
Image 08. Exterior JBC-North-5

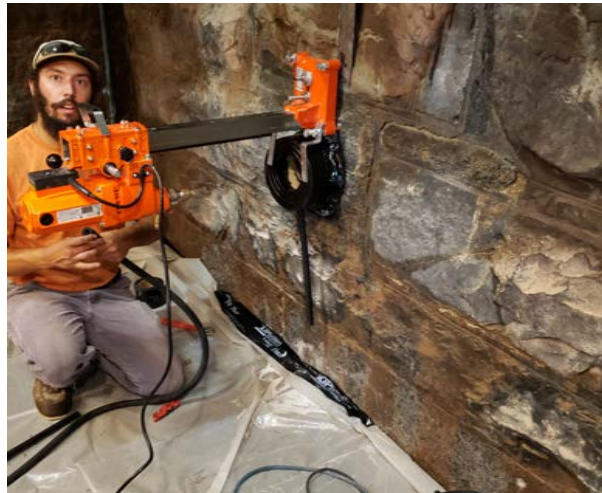
Image 15. Goodman Jack Test. Stevens & Associates 07.17.2023

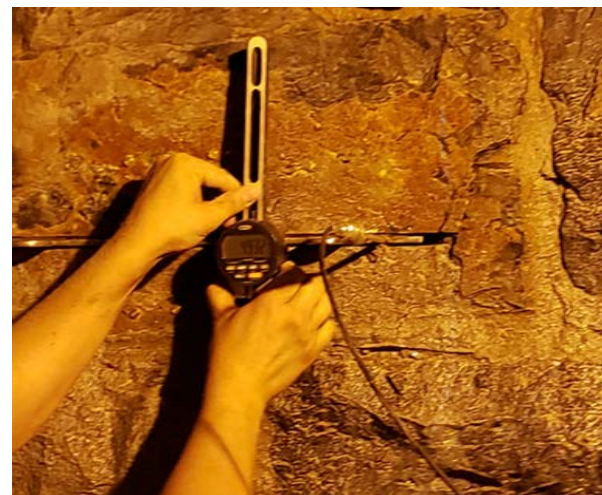
Image 10. Flat Jack Test. Stevens & Associates 07.17.2023

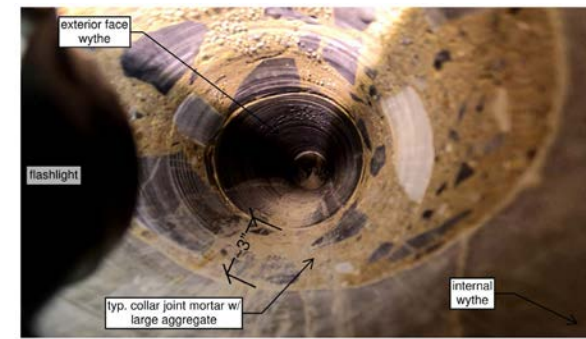
Image 17. CORE-SOUTH after Goodman Jack testing. Atkinson-Noland & Associates

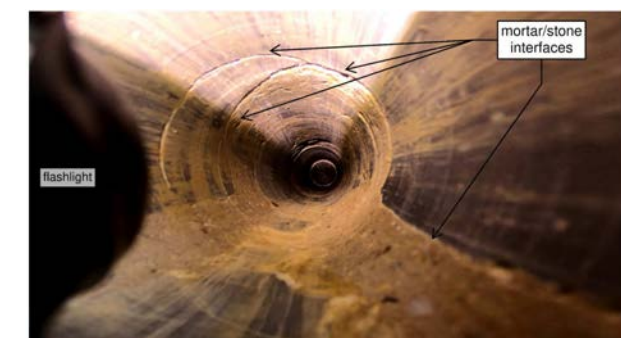
Image 22. Between interior and exterior face wythes, CORE-NORTH. Atkinson-Noland & Associates

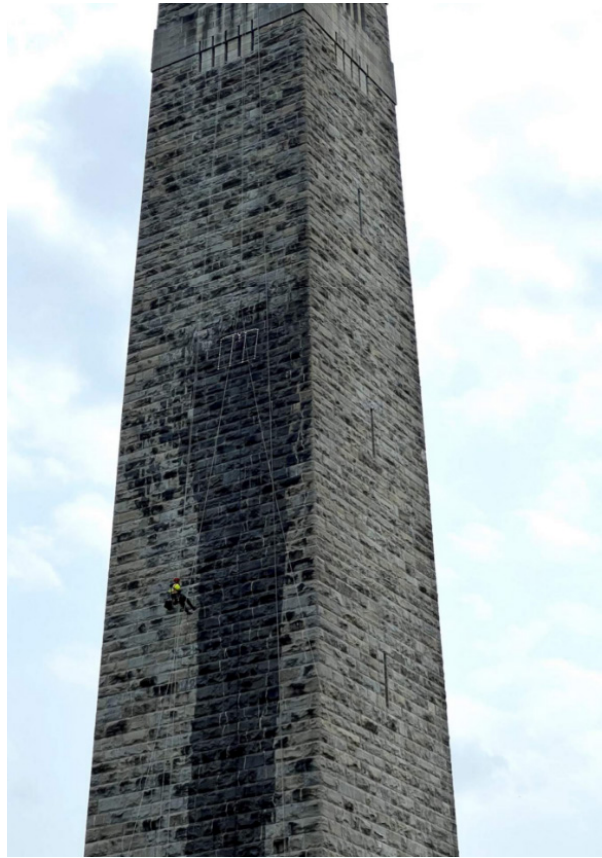
Image 26. North Elevation. Atkinson-Noland & Associates

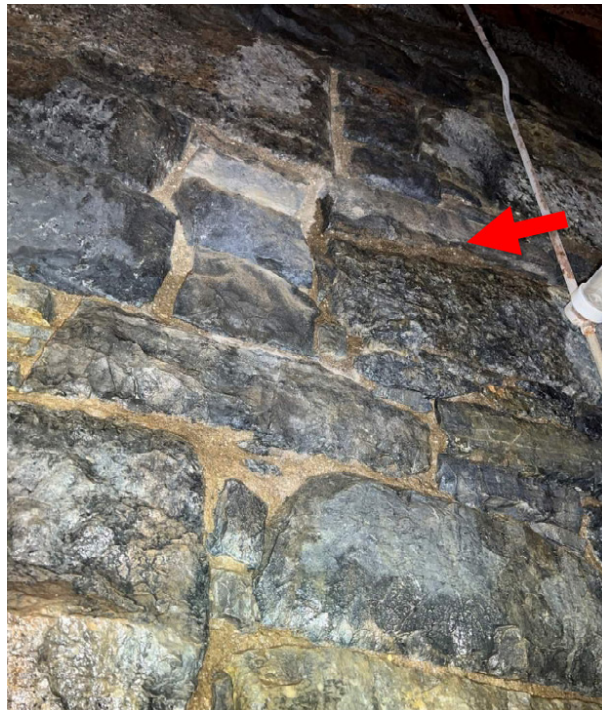
Image 25. Appearance of damp observed at mortar joint below interior stone work. Atkinson-Noland & Associates

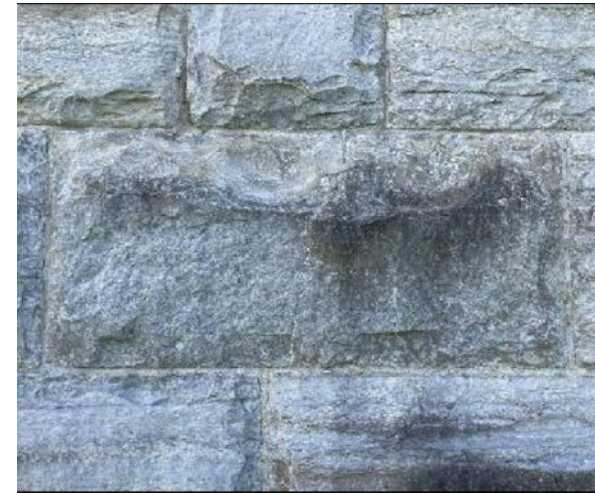
Image 33. Typical exterior condition. *Jablonski*

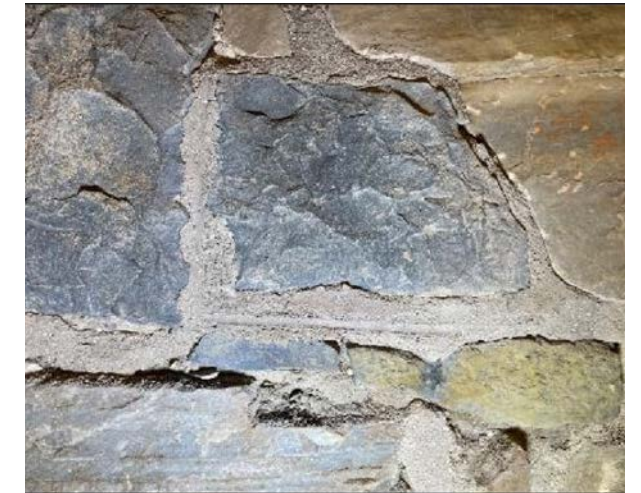
Image 30. Typical interior condition. *Jablonski*

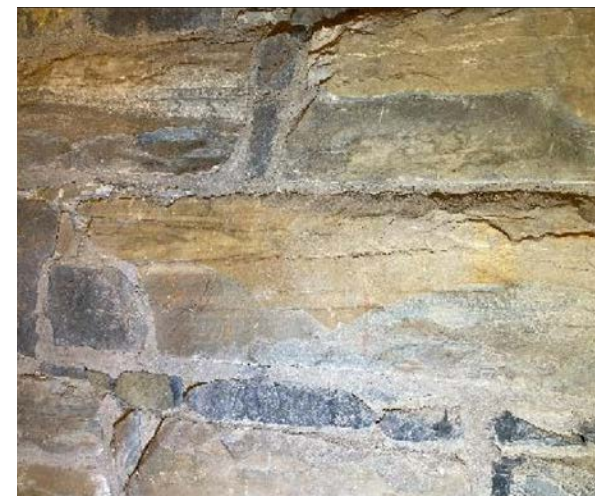
Image 32. Typical interior condition. *Jablonski*

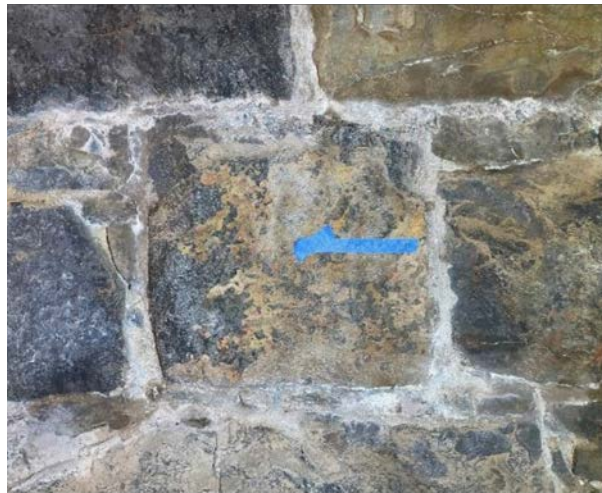
Image 38. Rust-colored crust on the surface of the dark gray stone. *Jablonski*

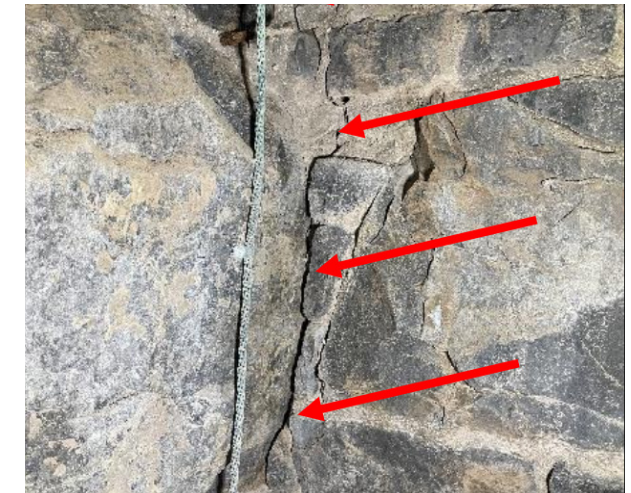
Image 41. Path of separation at the corner. *Jablonski*

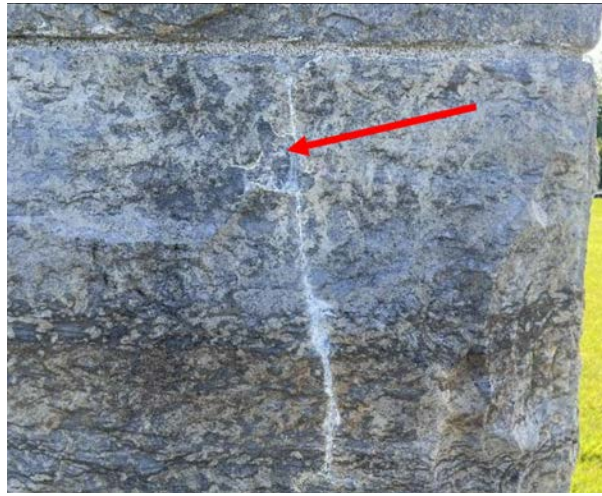
Image 51. Shallow spall. Jablonski

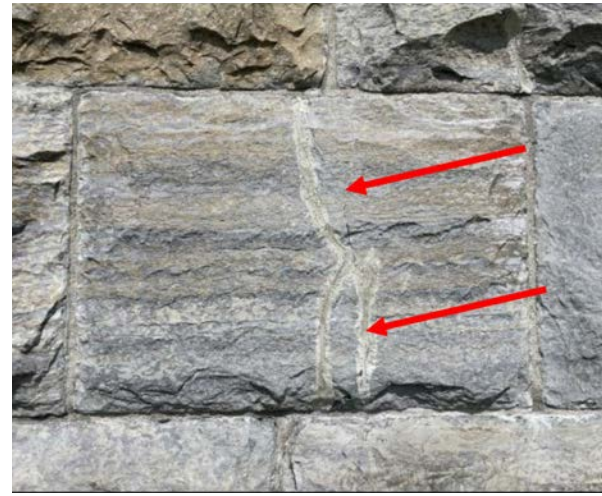
Image 48. Previously repaired crack and hairline crack extending from previous repair. Jablonski

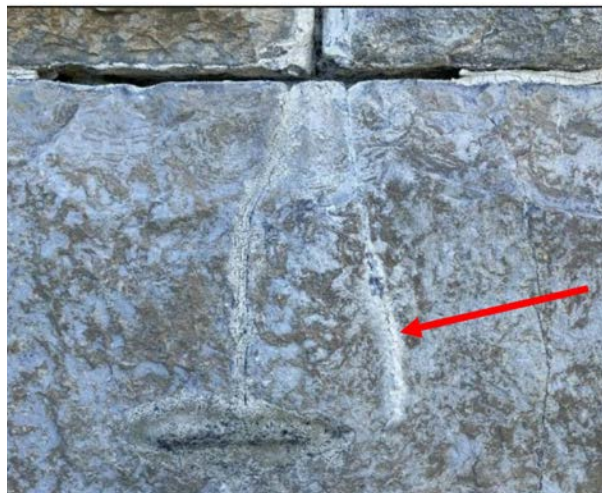
Image 50. White growth along hairline crack. Jablonski

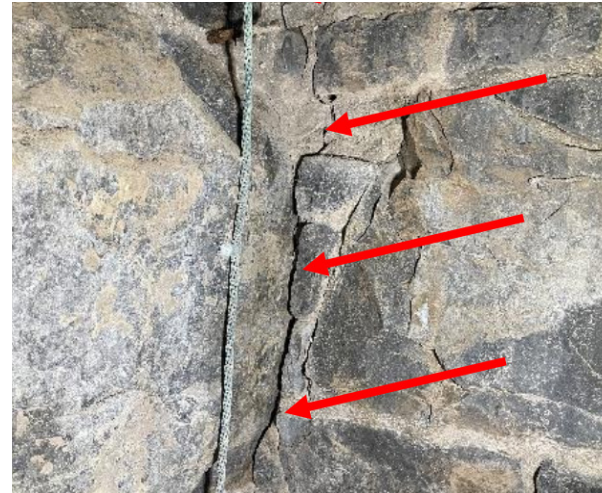
Image 47. Path of separation at the corner. Jablonski

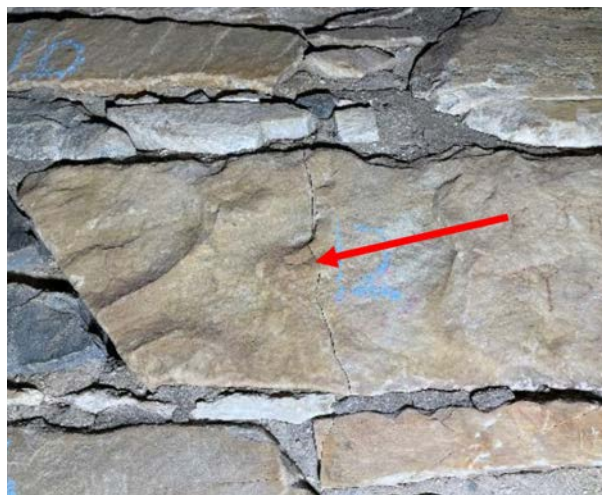
Image 49. Vertical crack. Jablonski

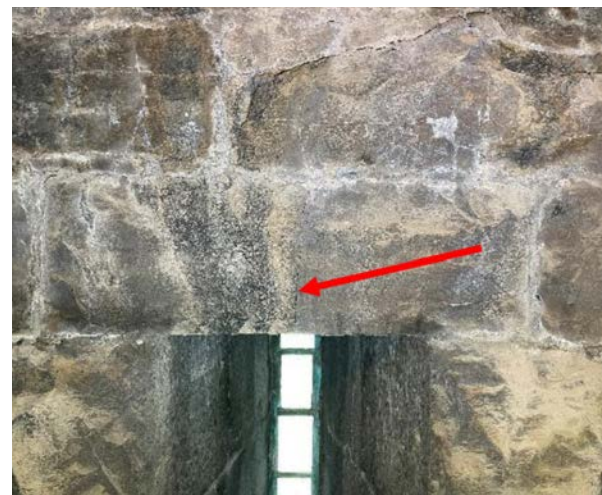
Image 46. Vertical crack running the full height of a window lintel. Jablonski

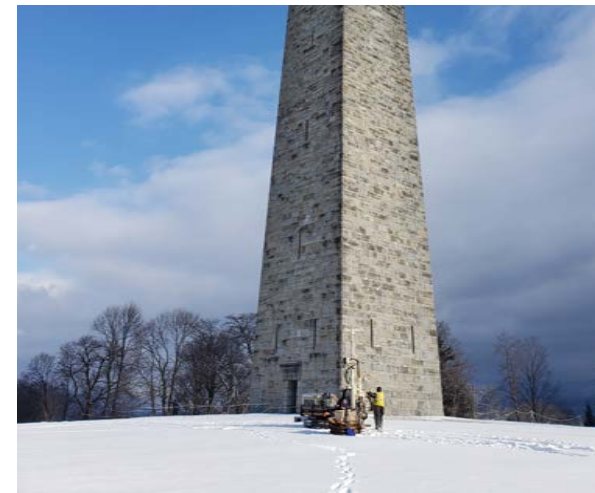
Image 52. Geotech Drilling. Stevens & Associates 01.17.2024

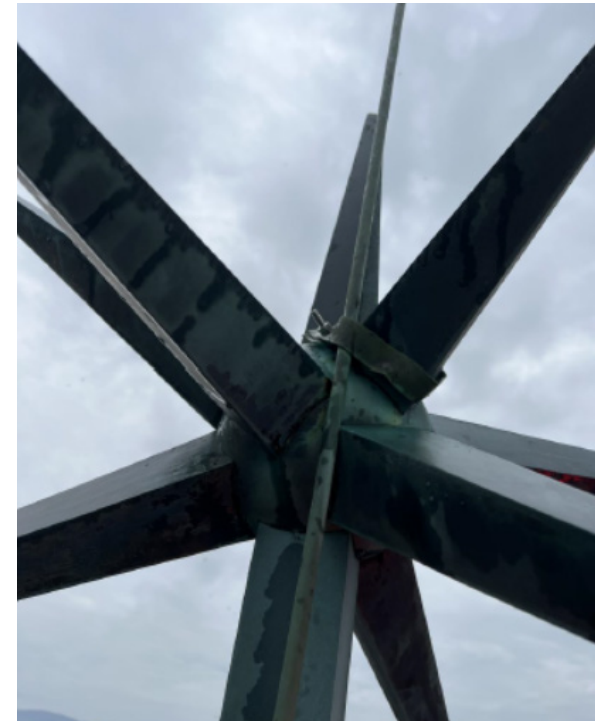
Image 58. 1/2" diameter class II copper air terminal mounted with bolted copper strapping to star finial. *Smokestack Lightning.*

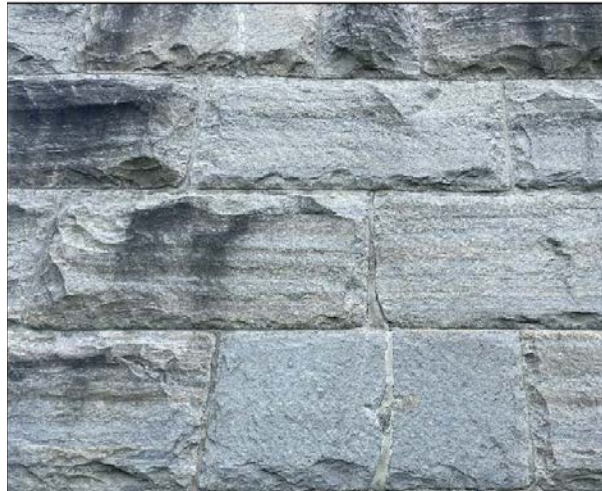
Image 72. Typical exterior rock-faced, coursed Sandy Hill dolomitic limestone ashlar. *Jablonski*

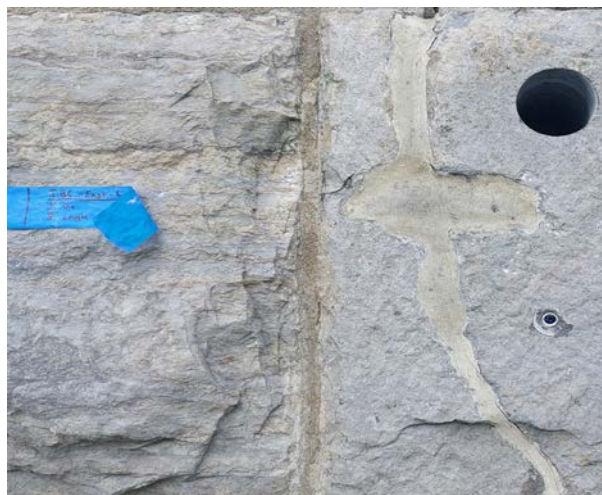
Image 74. Caulk repair and current core hole

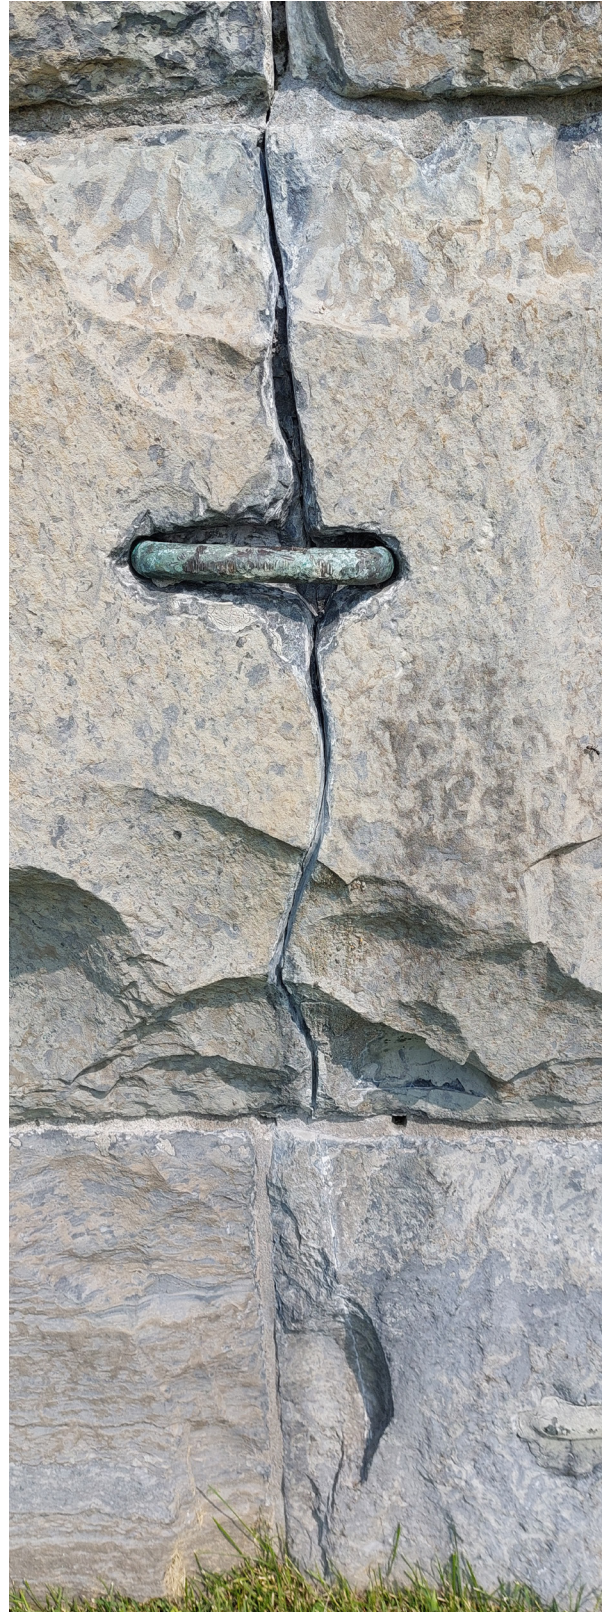
Image 75. Bronze staple condition through crack. *Easton Architects*

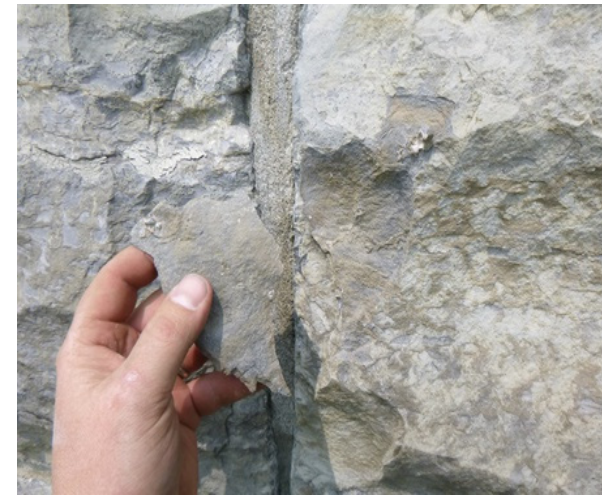
Image 78. Spall removed from the exterior stone masonry. *Vertical Access*

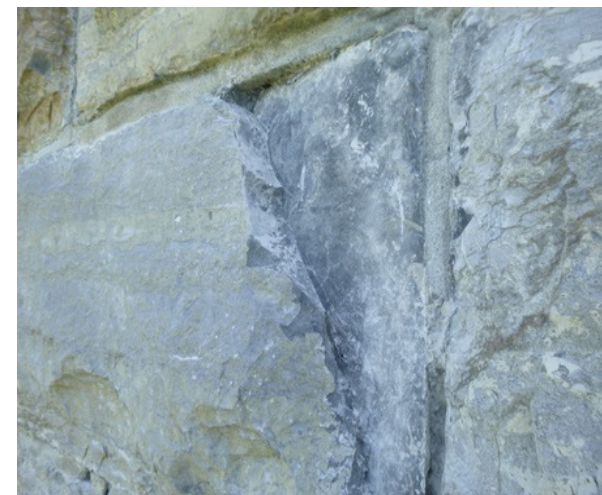
Image 76. Delamination in a stone at the upper portion of the monument. *Vertical Access*

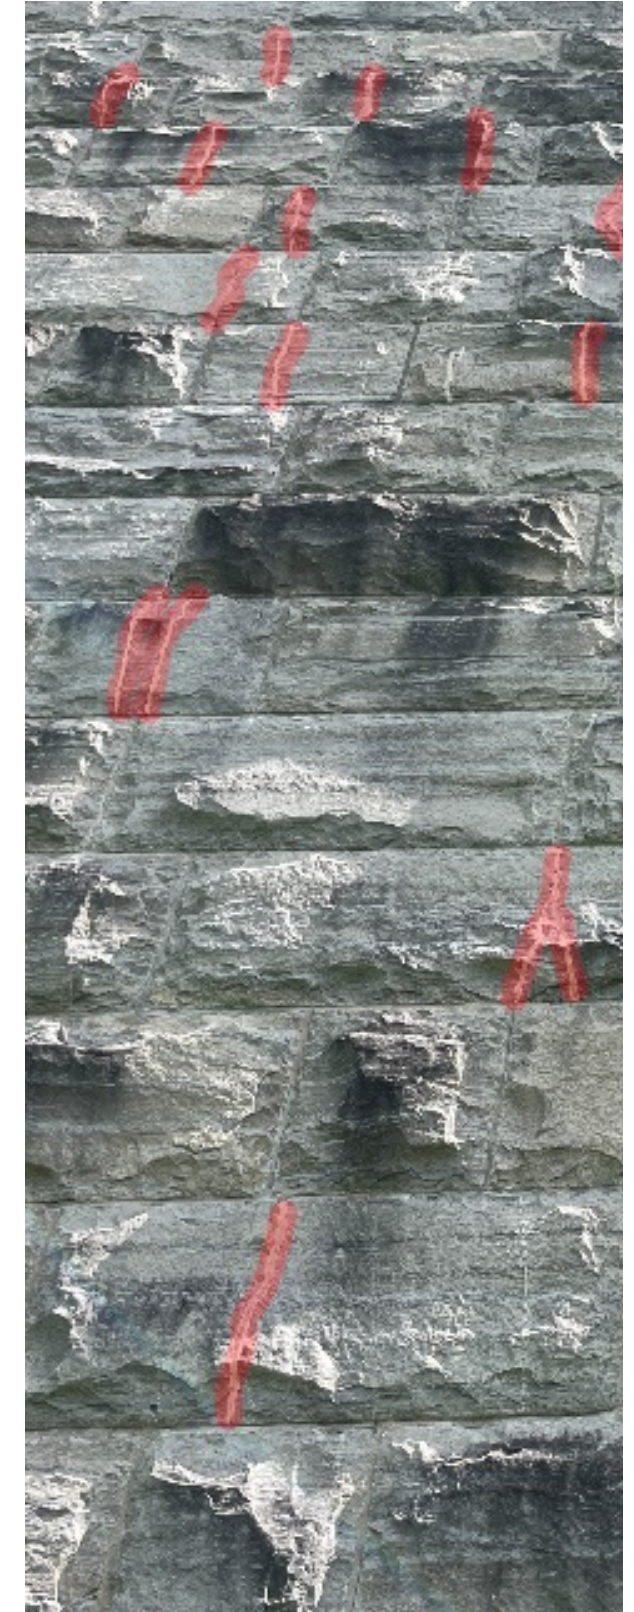
Image 77. Exterior of monument with cracks highlighted in red. Note that most cracks fall below a vertical mortar joint. *JBC.*

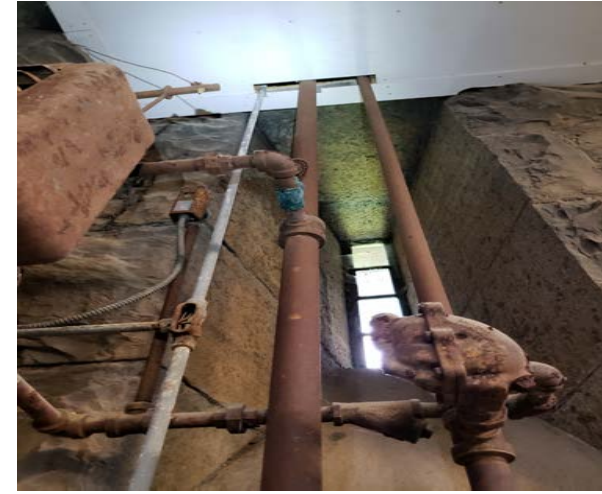
Image 86. Original heating system and piping. *Stevens & Associates*

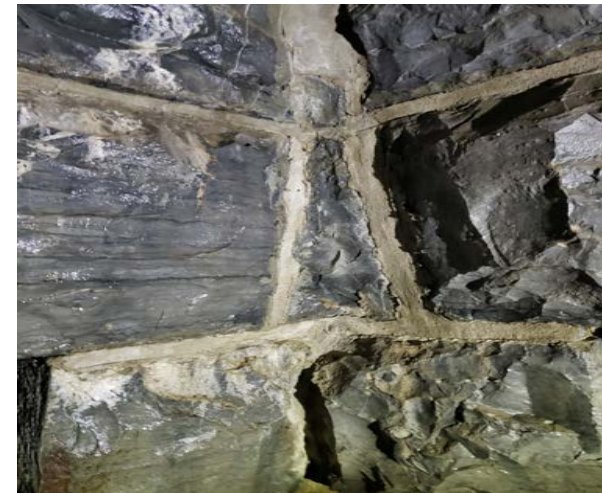
Image 87. Corner condition at top of monument. *Stevens & Associates*

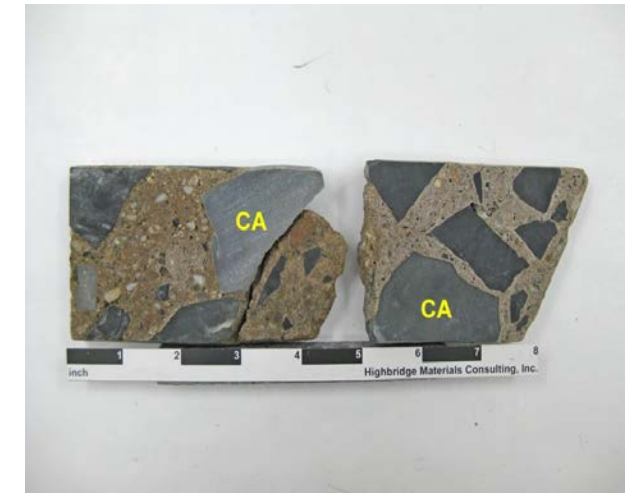
Image 91. Section through sample ANA-South-4 showing large, crushed limestone aggregate in paste of cement. *Jablonski*

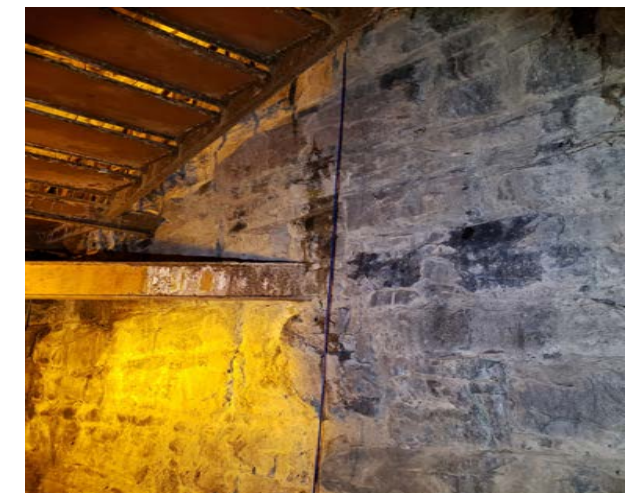
Image 89. Typical condition of stair support meeting masonry. *Stevens & Associates*

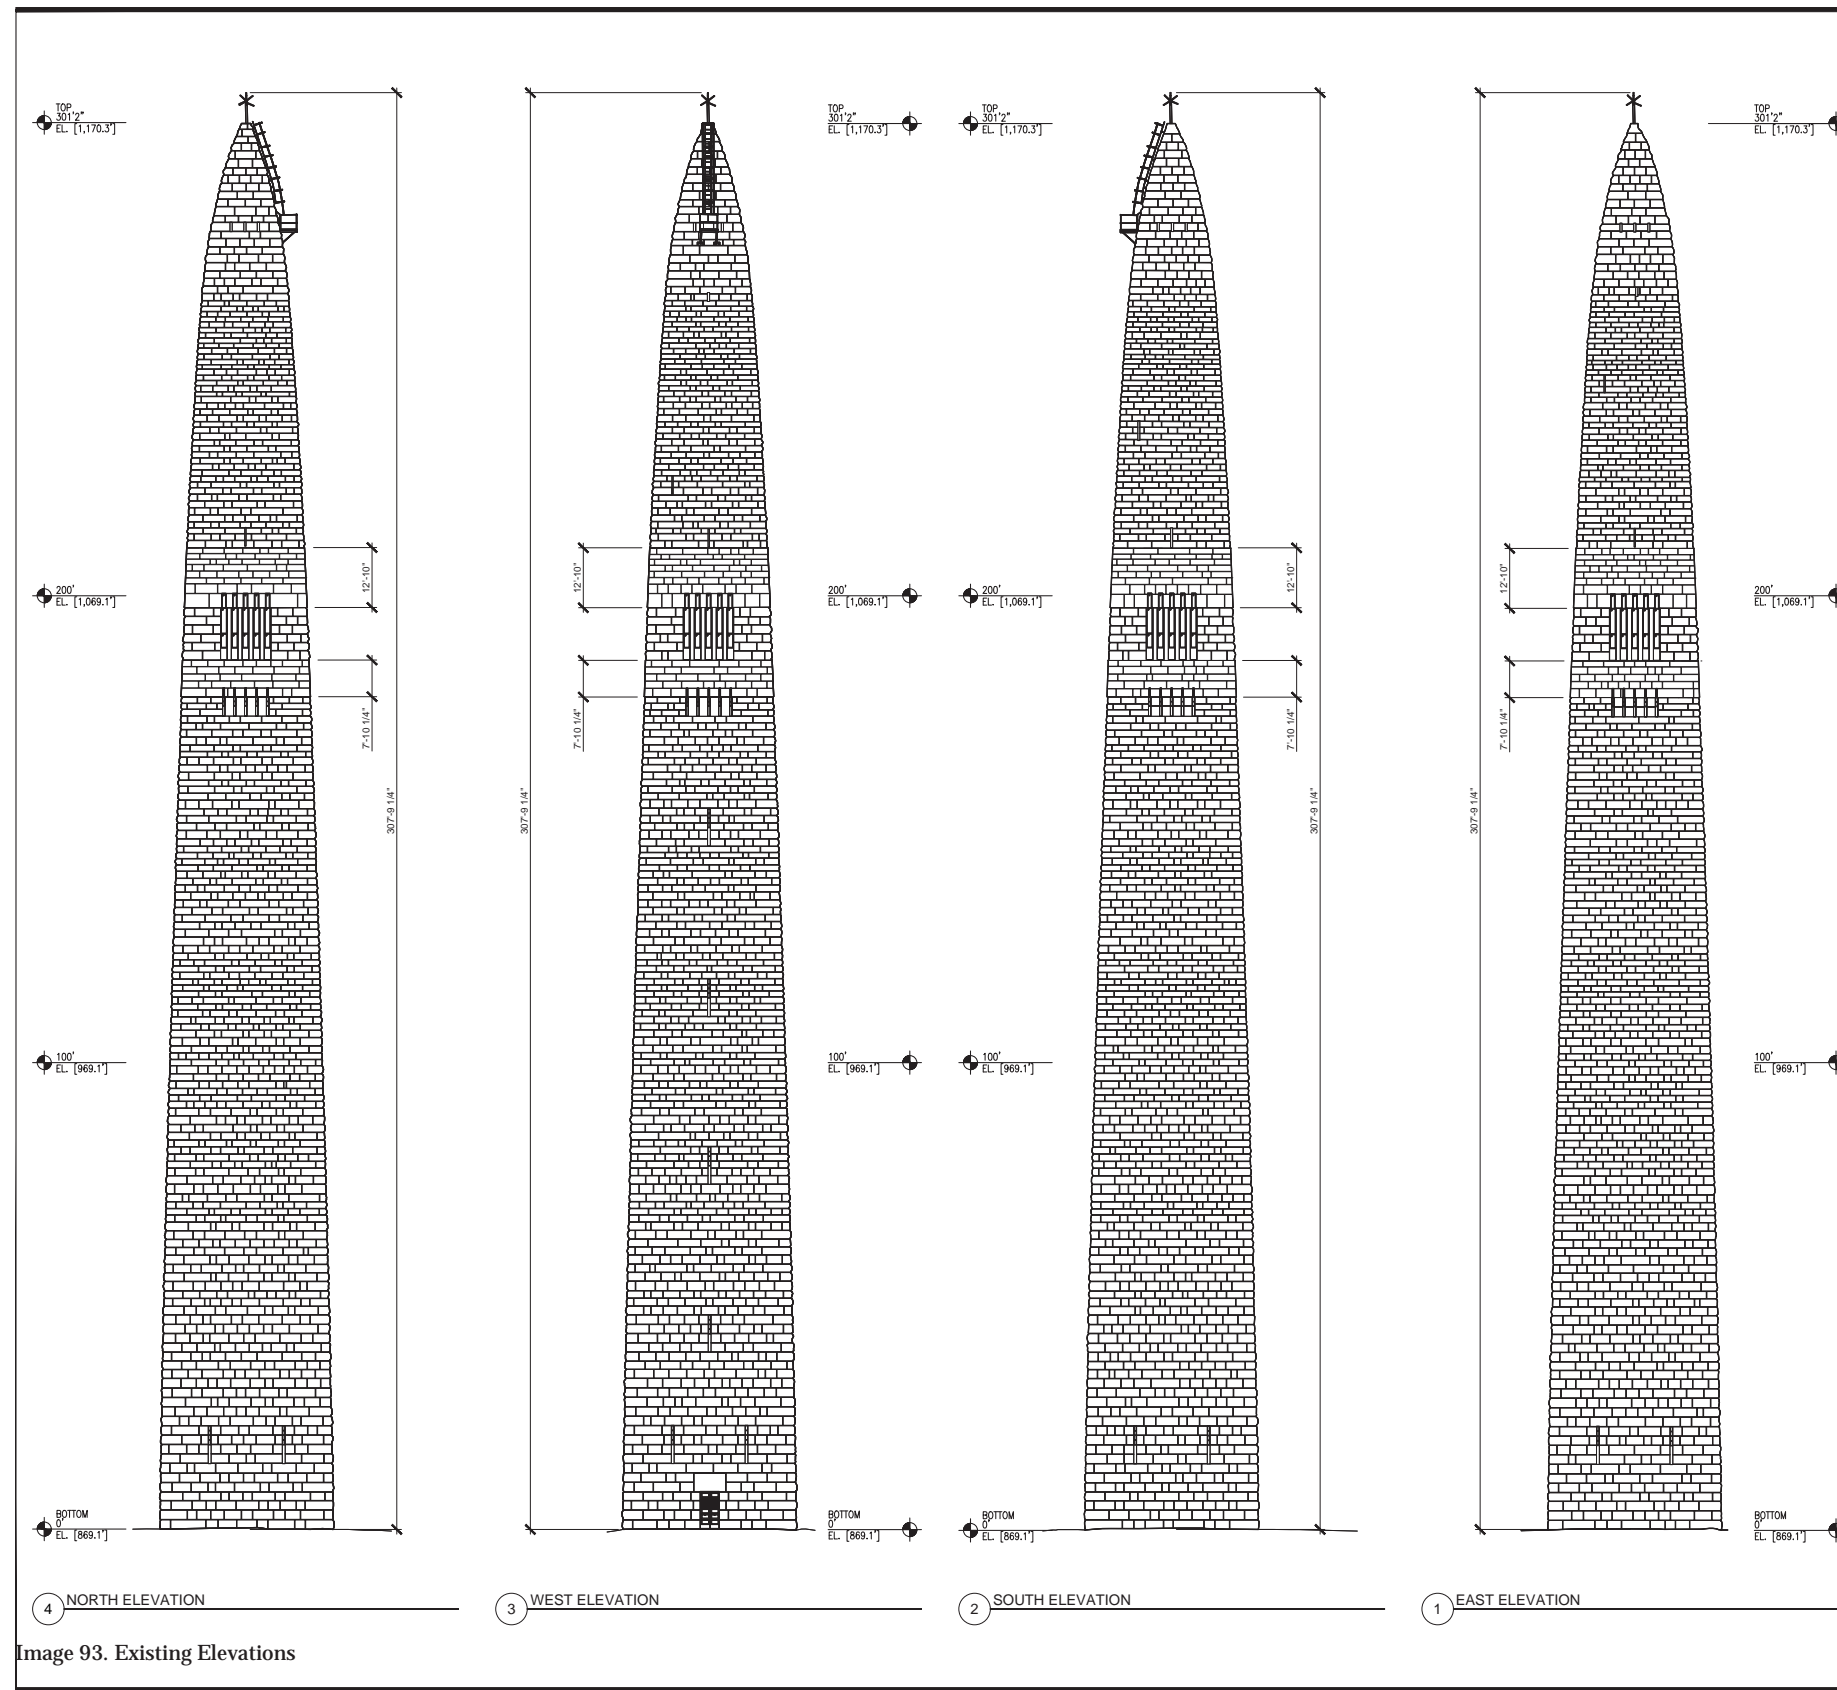
Image 93. Existing Elevations

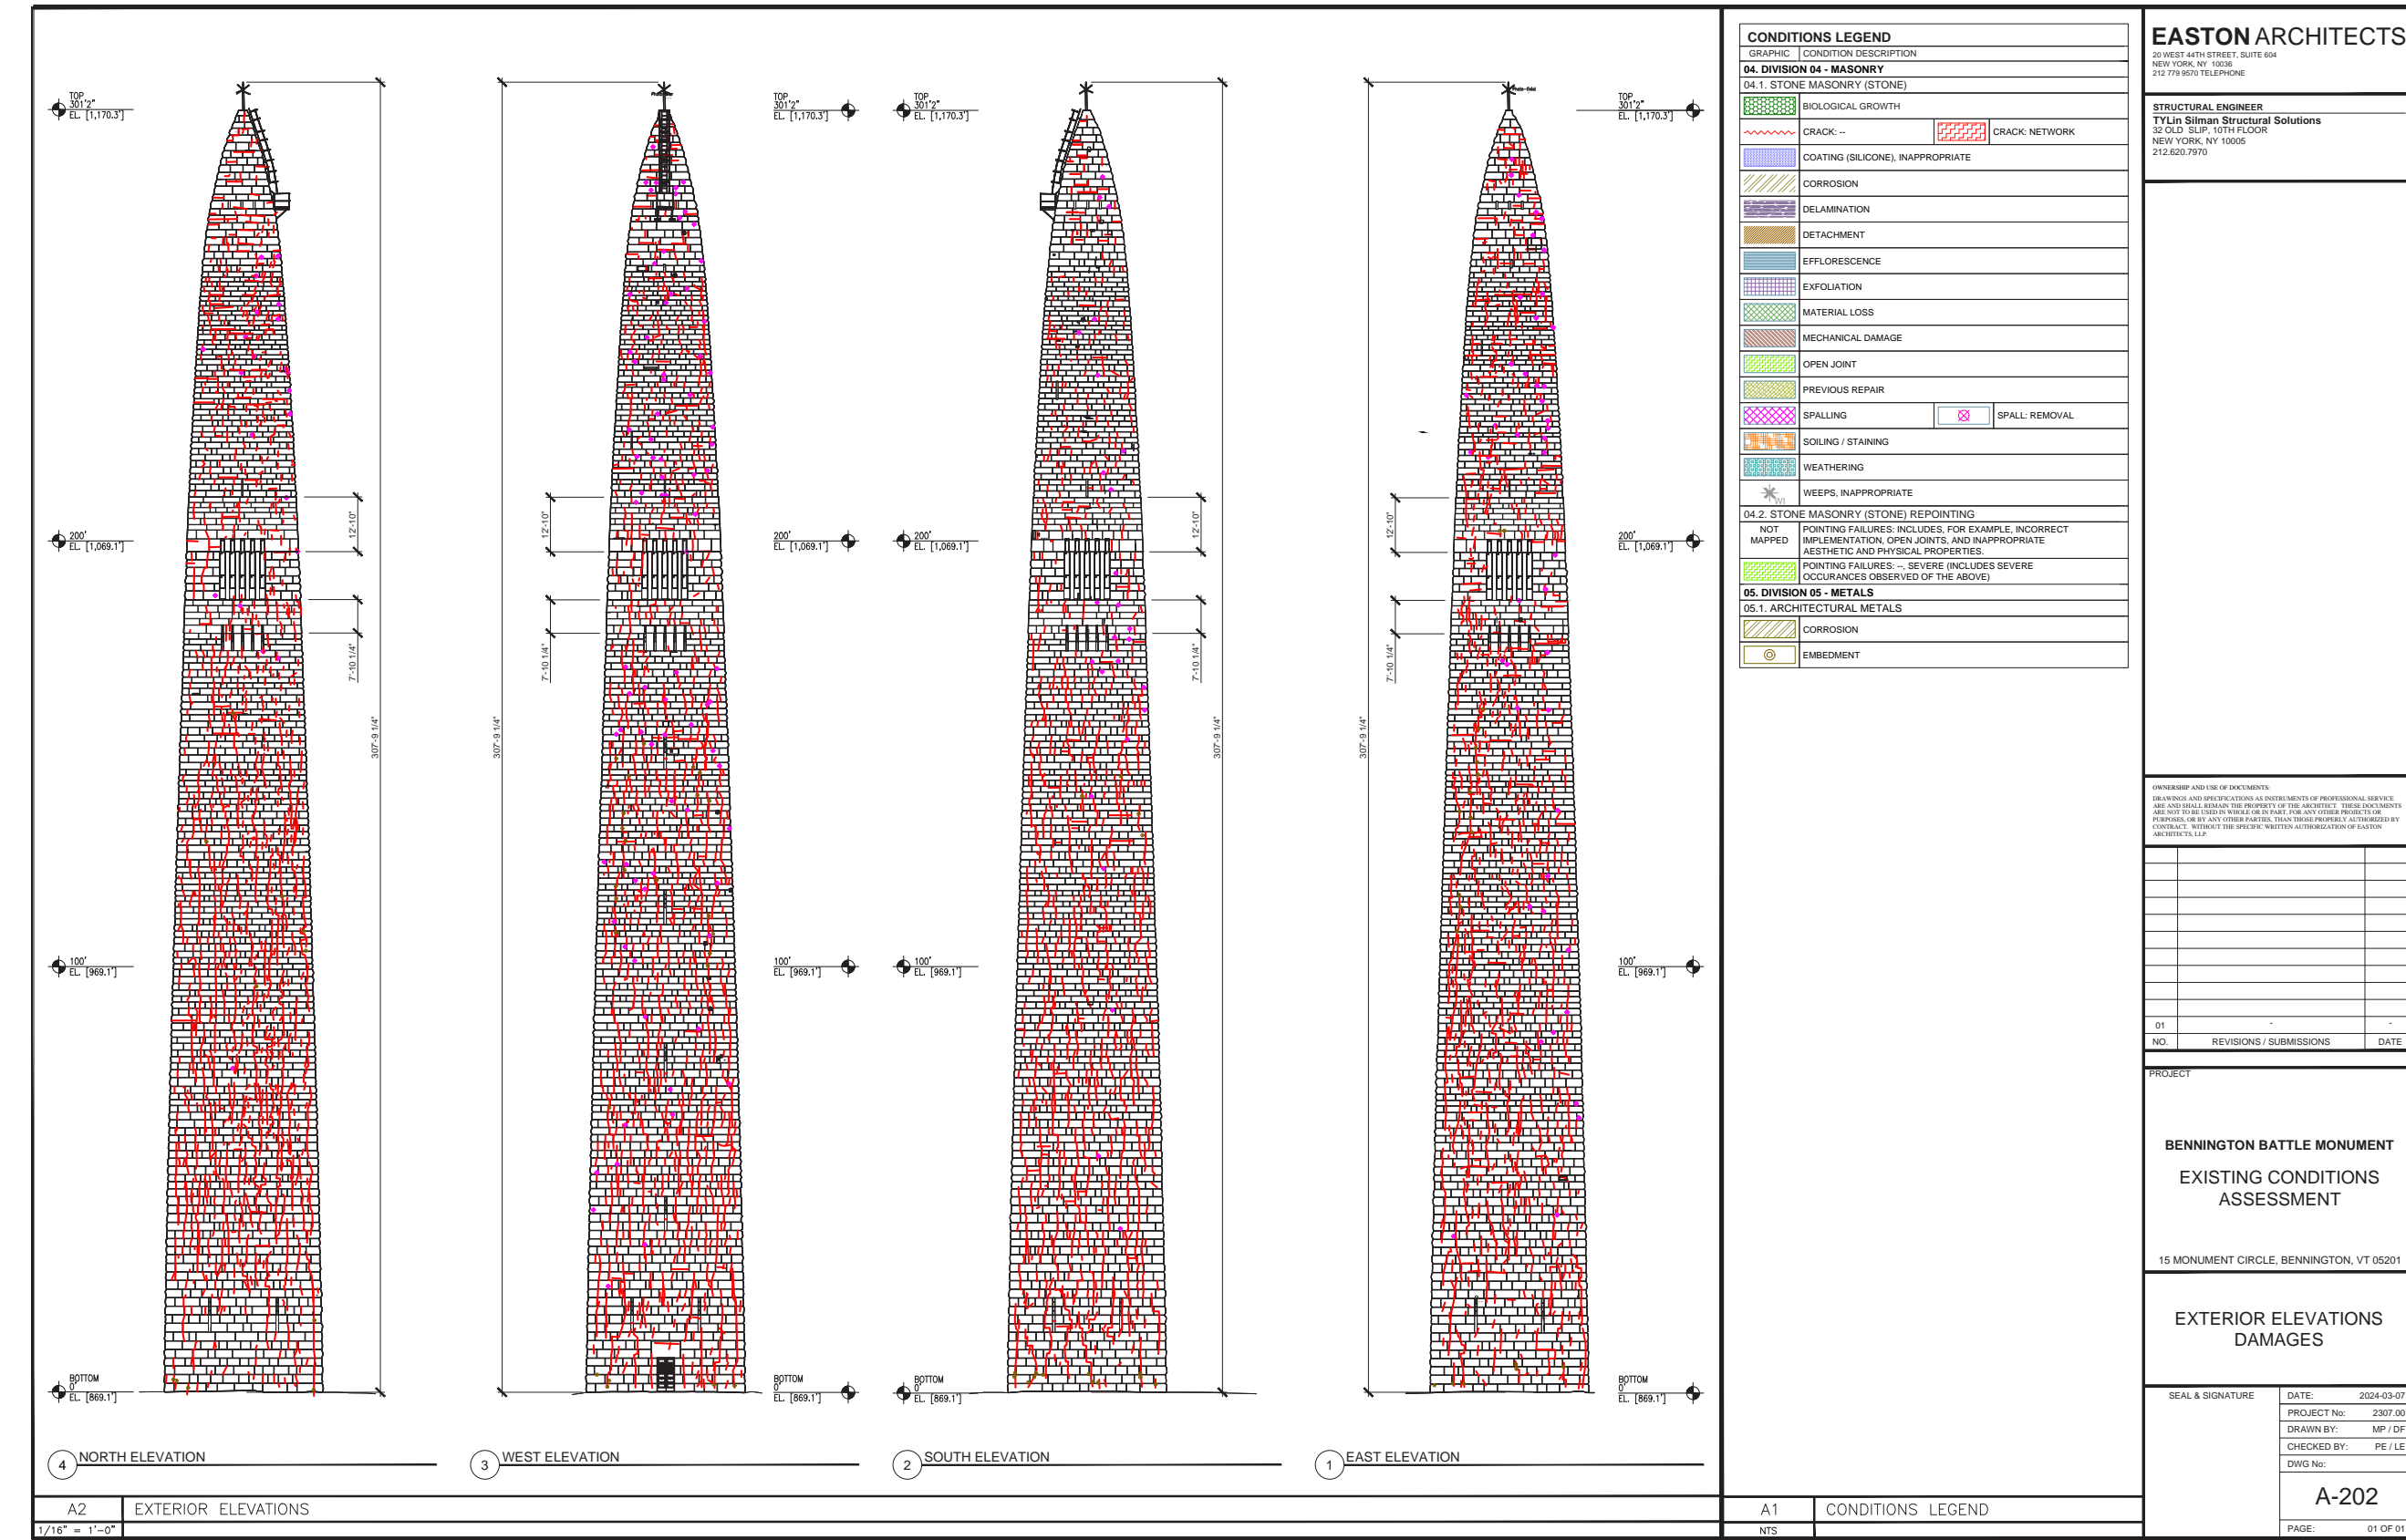
Image 94. Existing Conditions
