03/29/2024

**STRUCTURAL AND ELECTRICAL ASSESSMENT OF
THE BENNINGTON BATTLE MONUMENT**

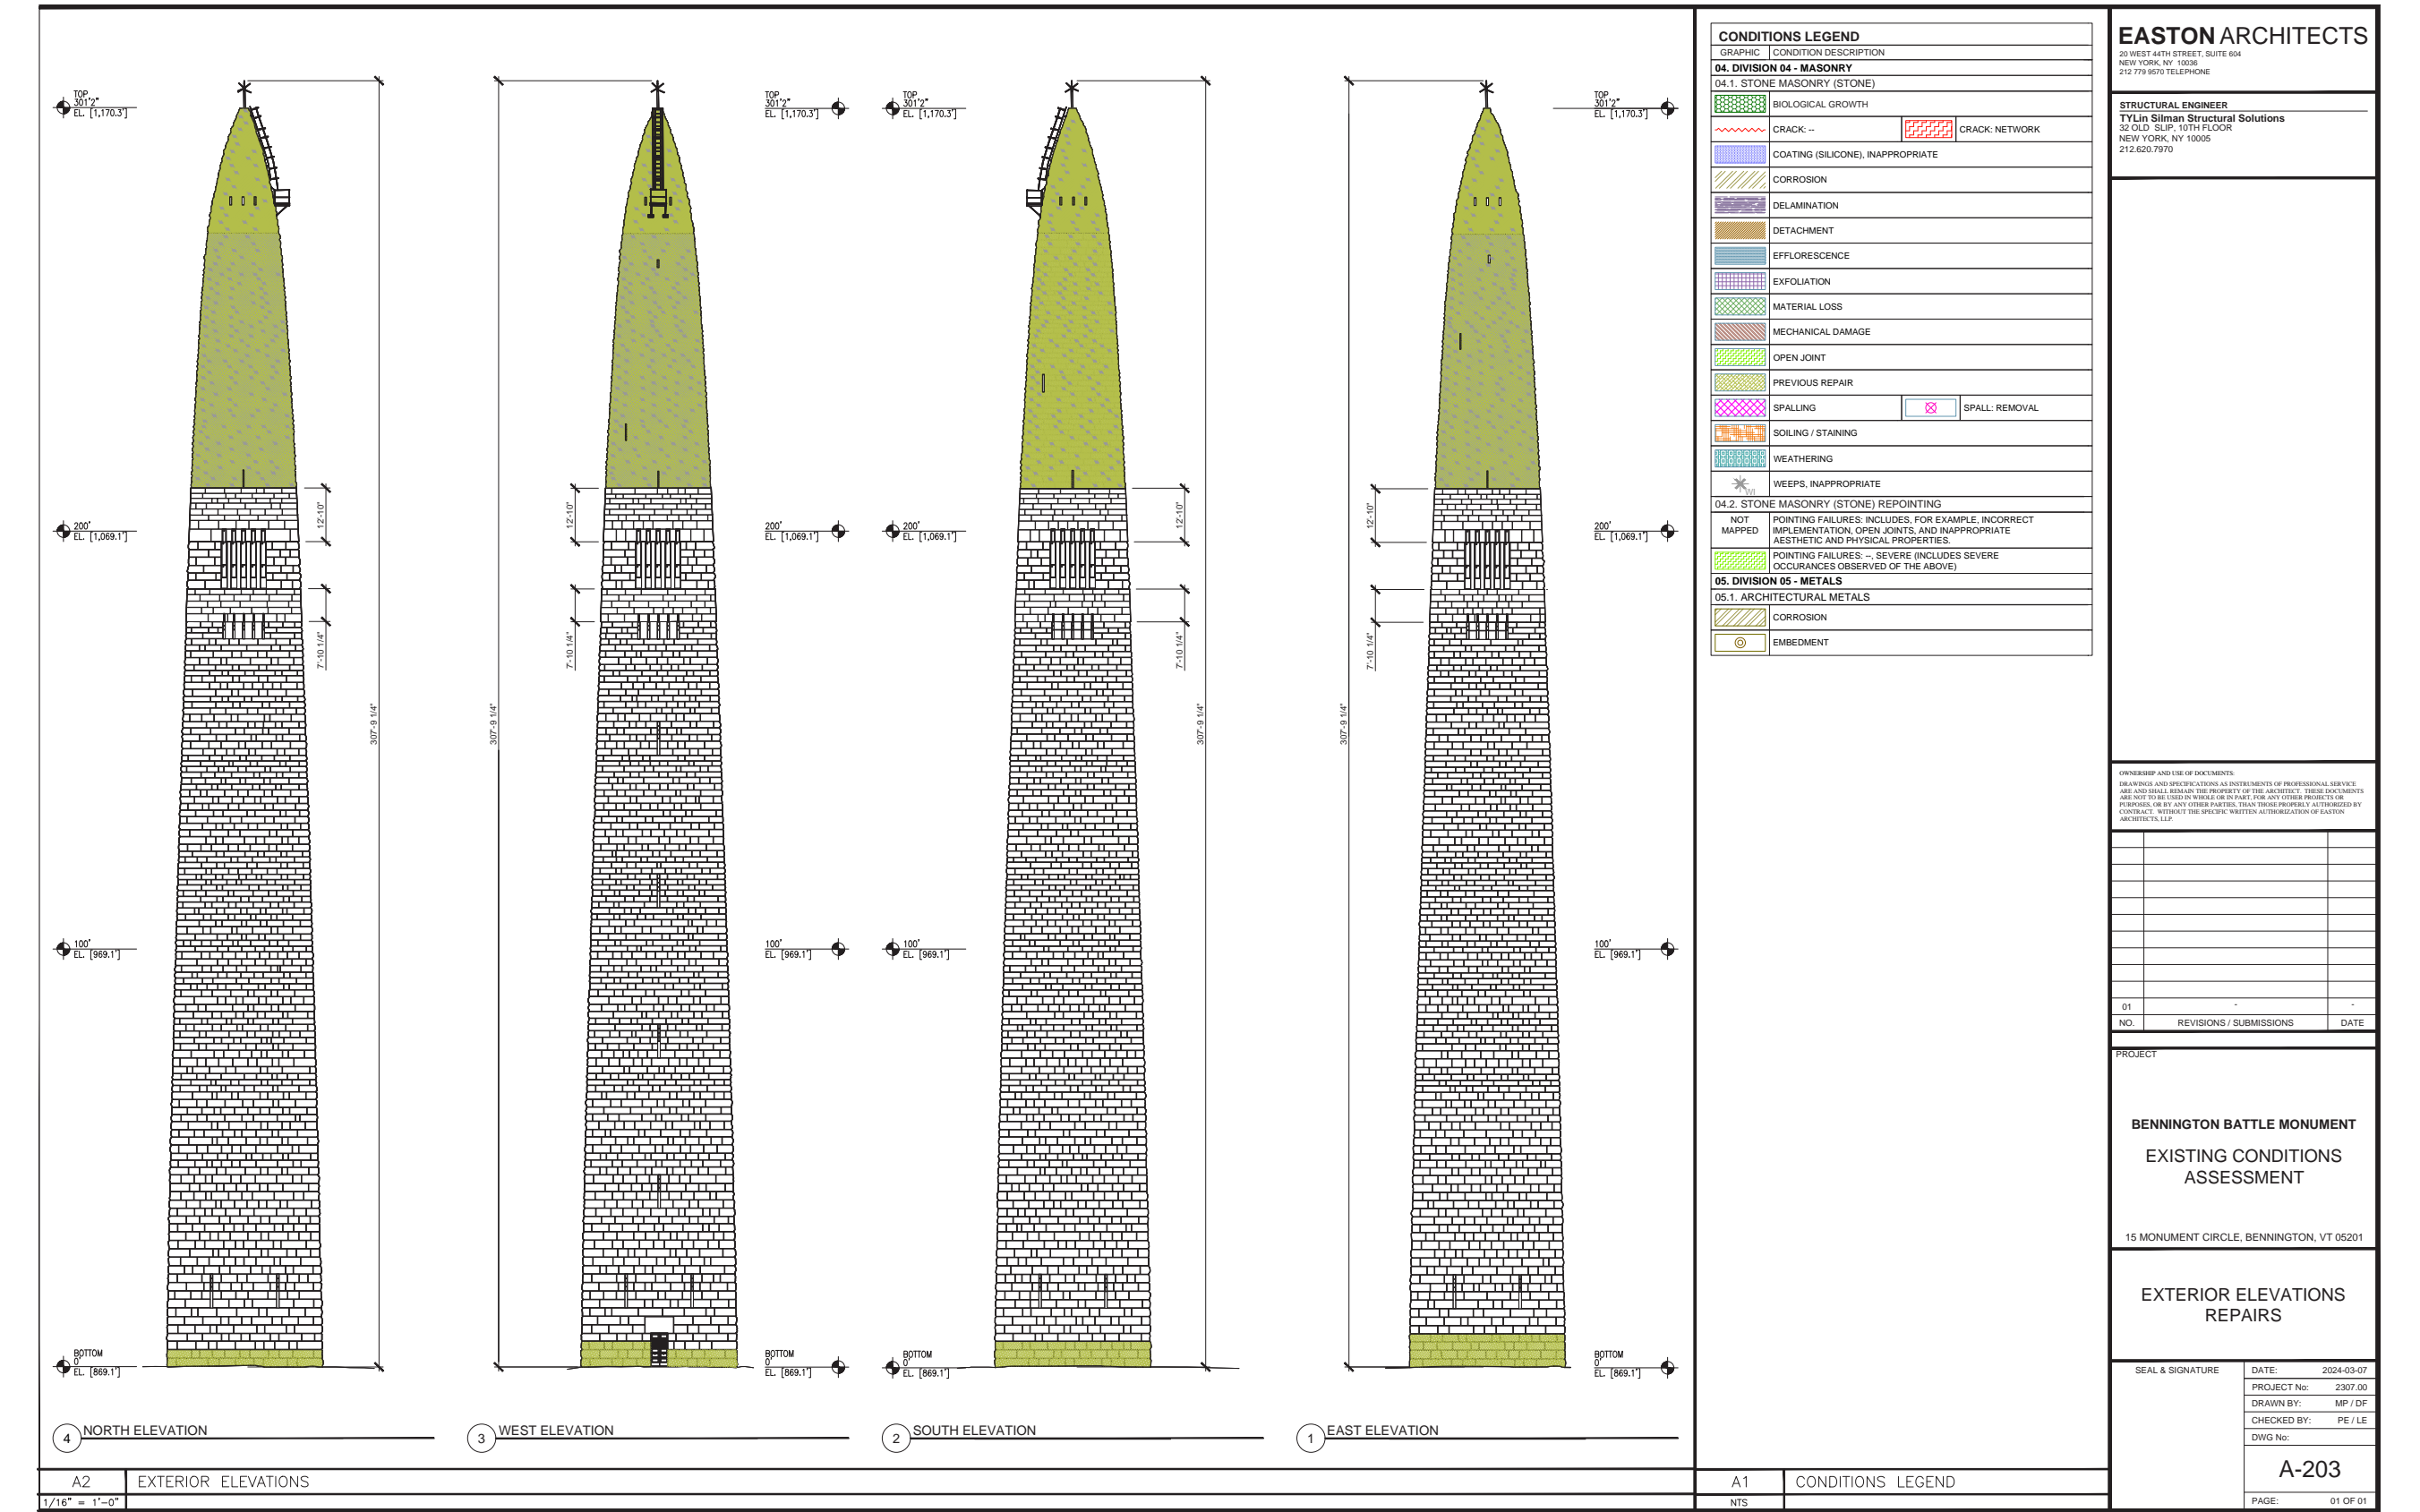
Image 95. Location of Repair Campaigns

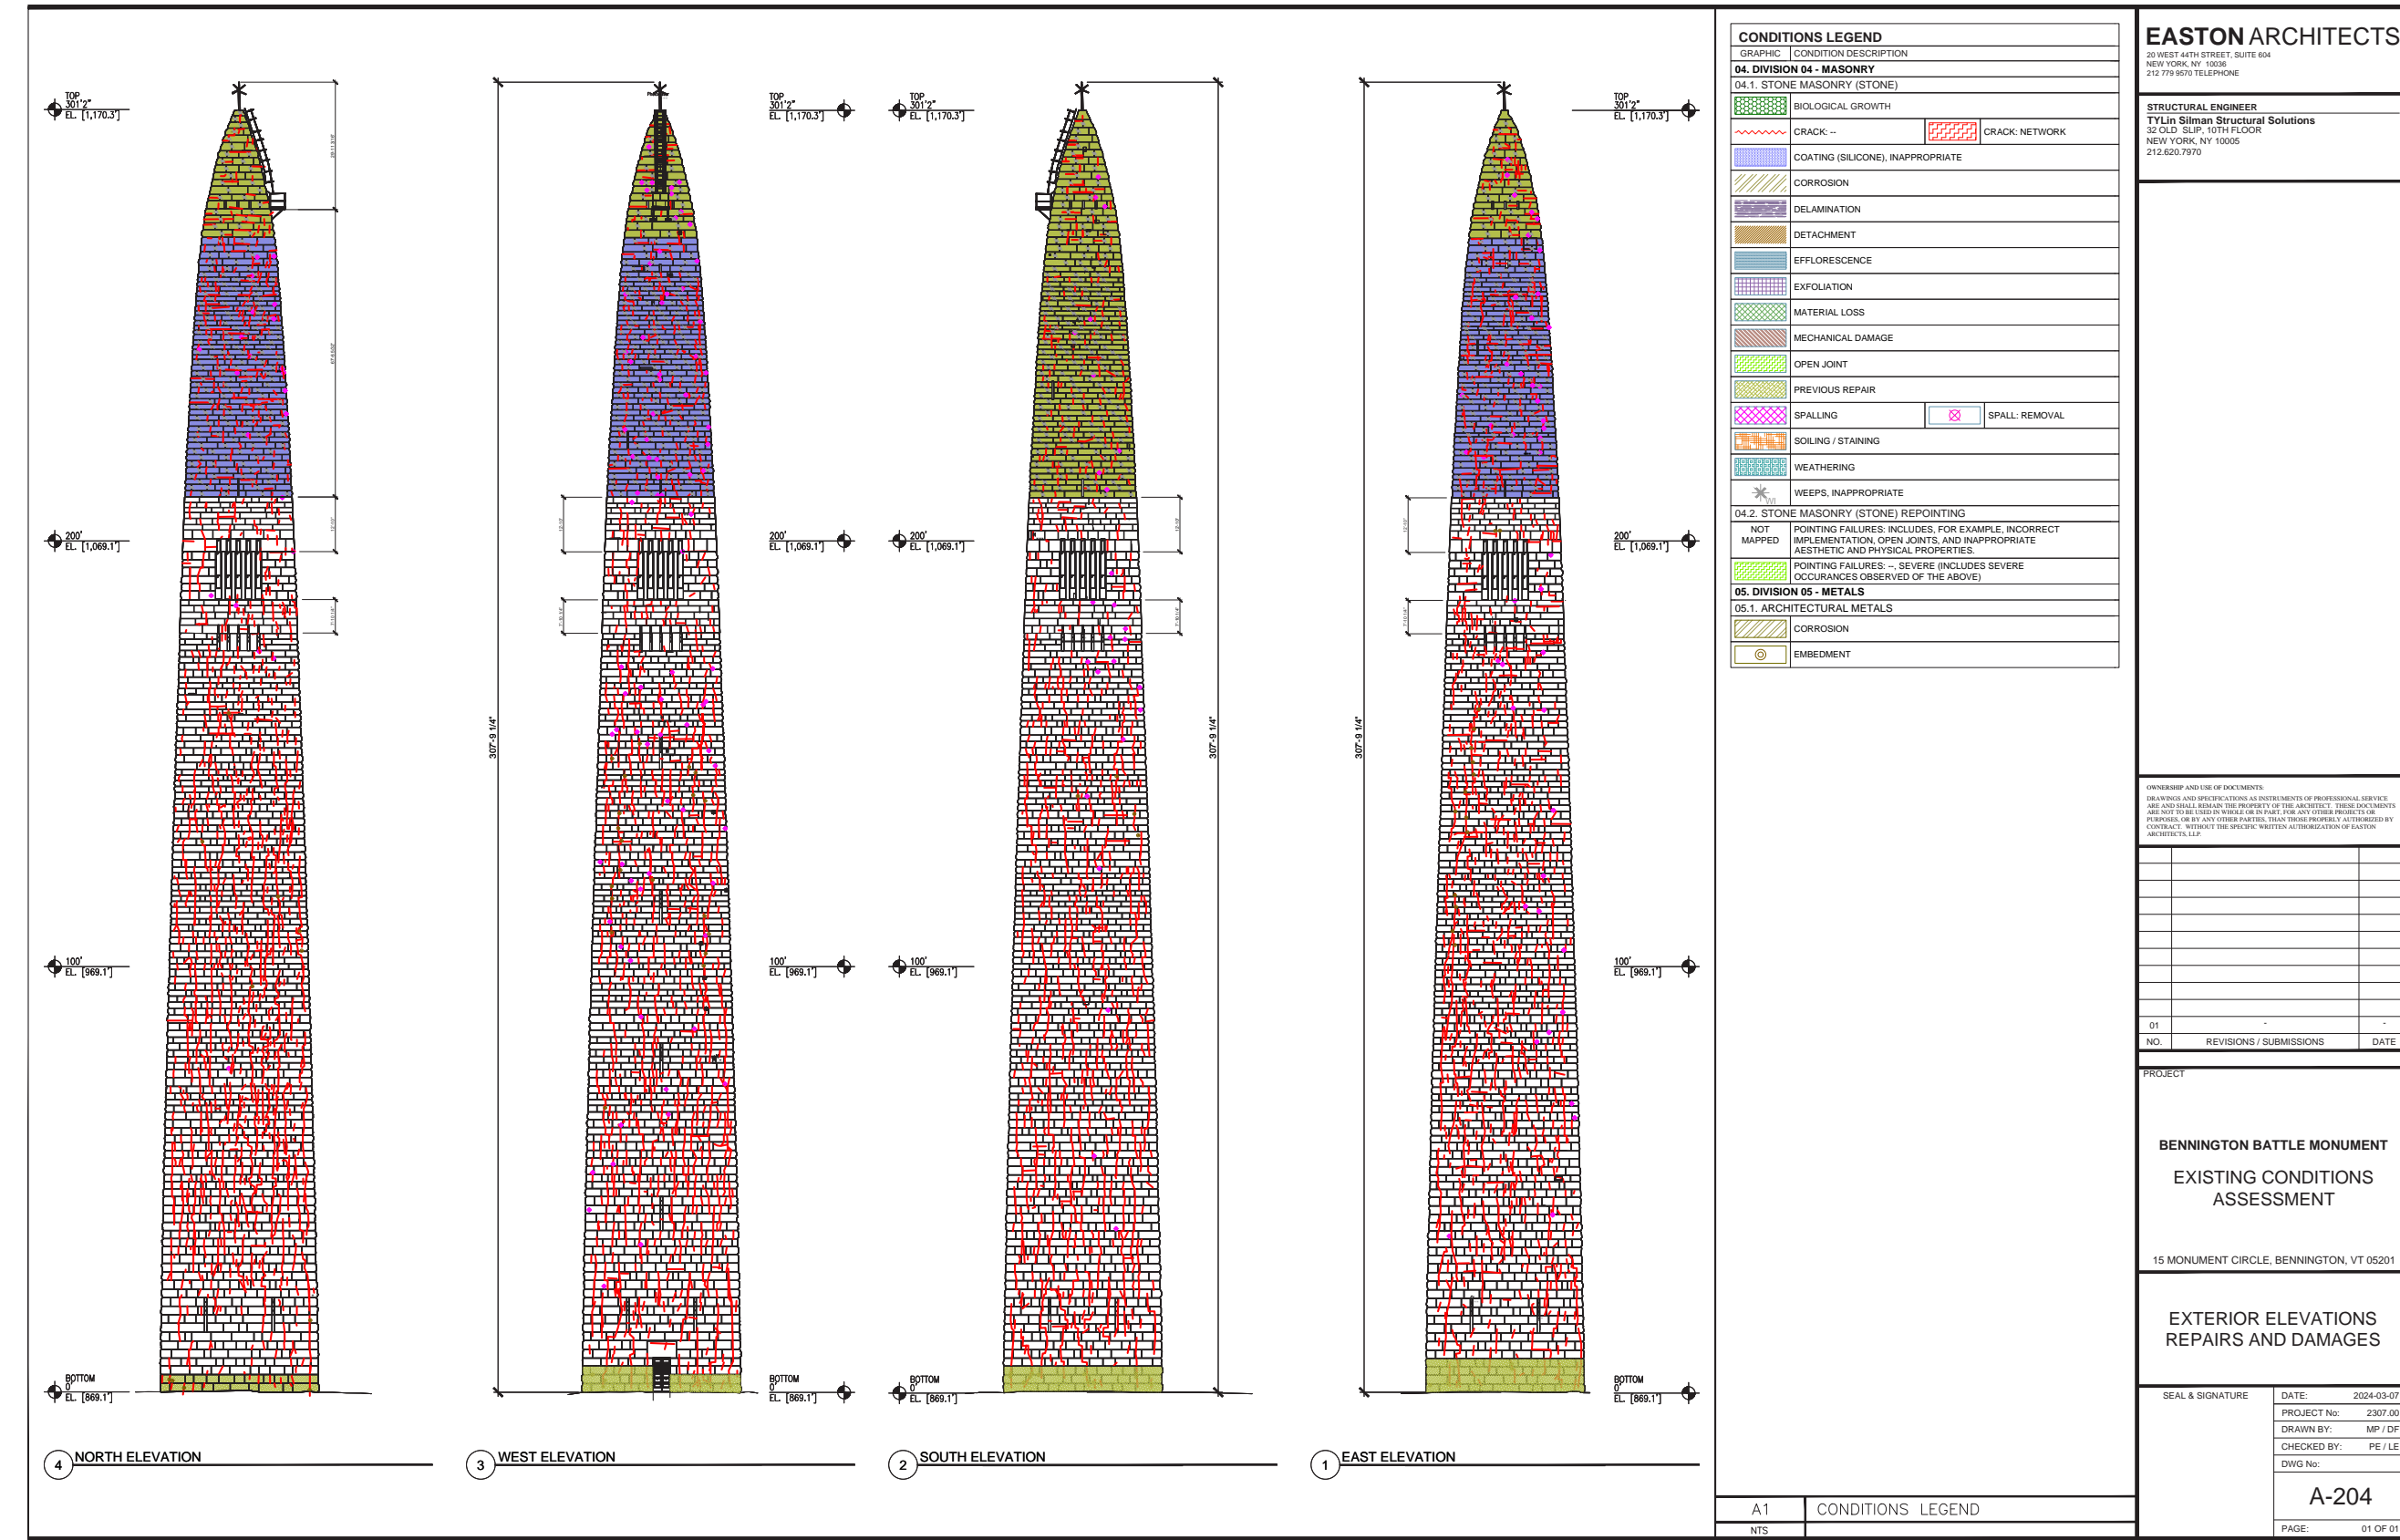
Image 96. Location of Repair Campaigns Overlaid on Conditions

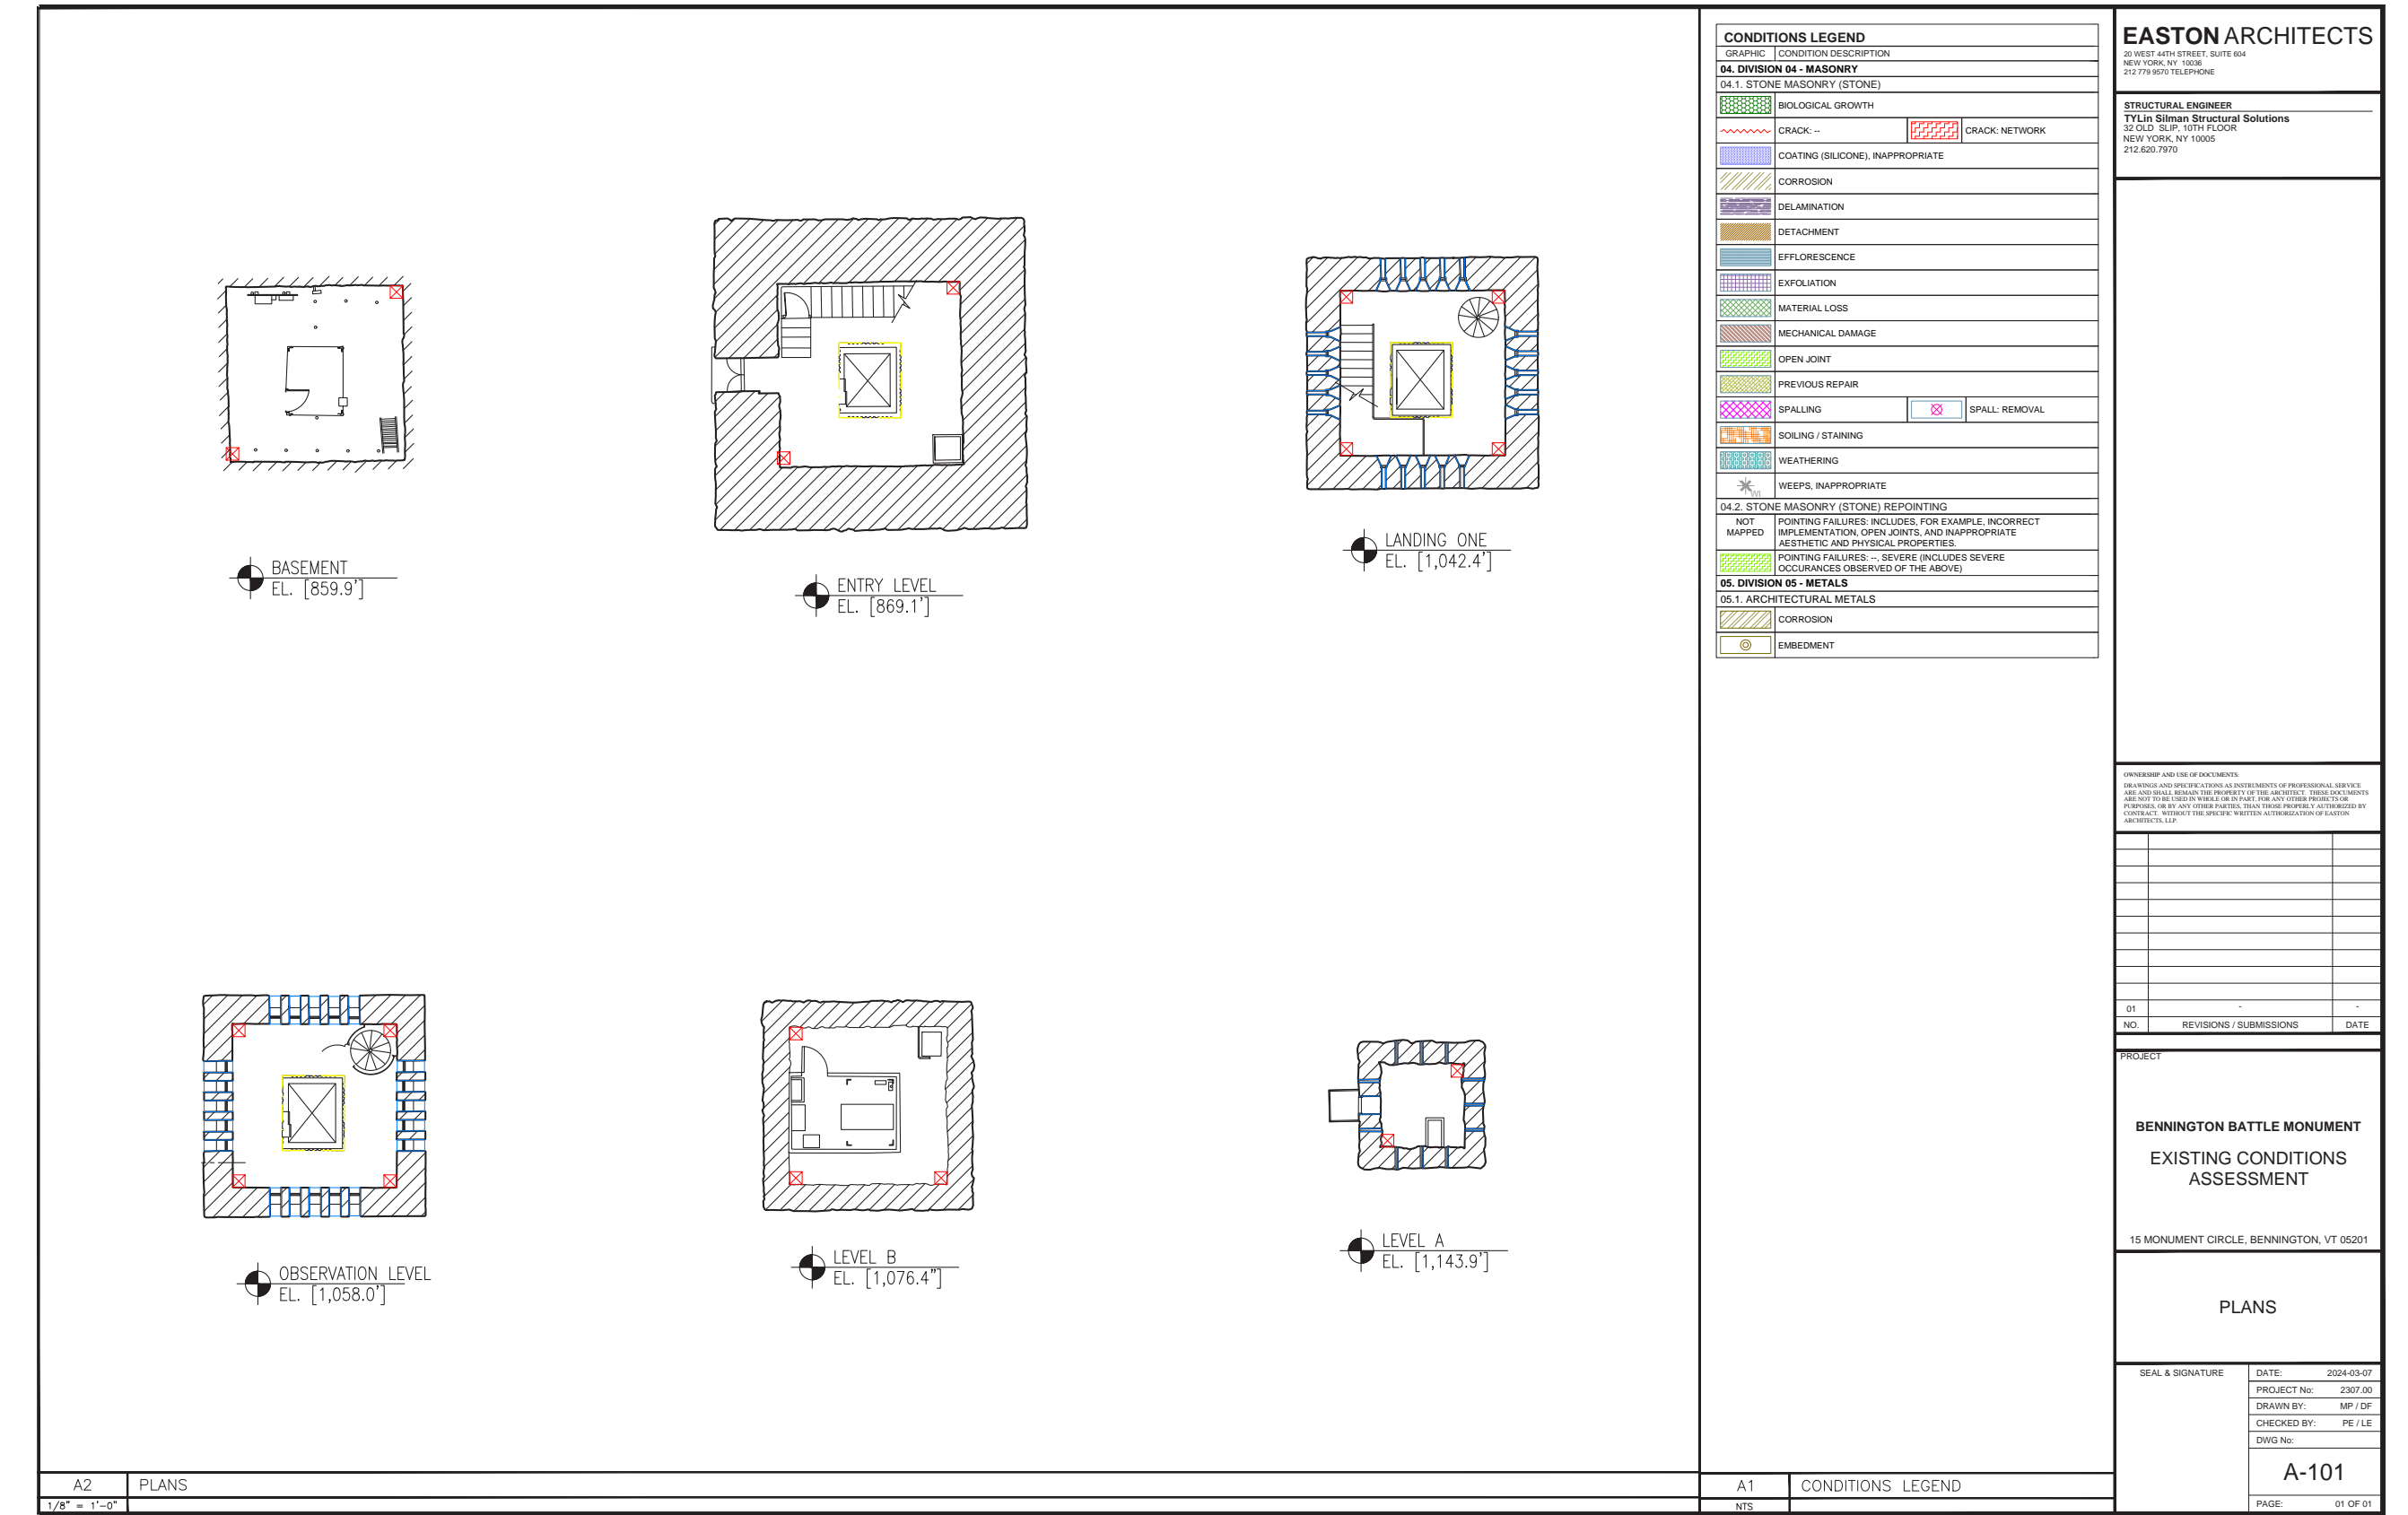
Image 97. Sketch of mechanical intervention location

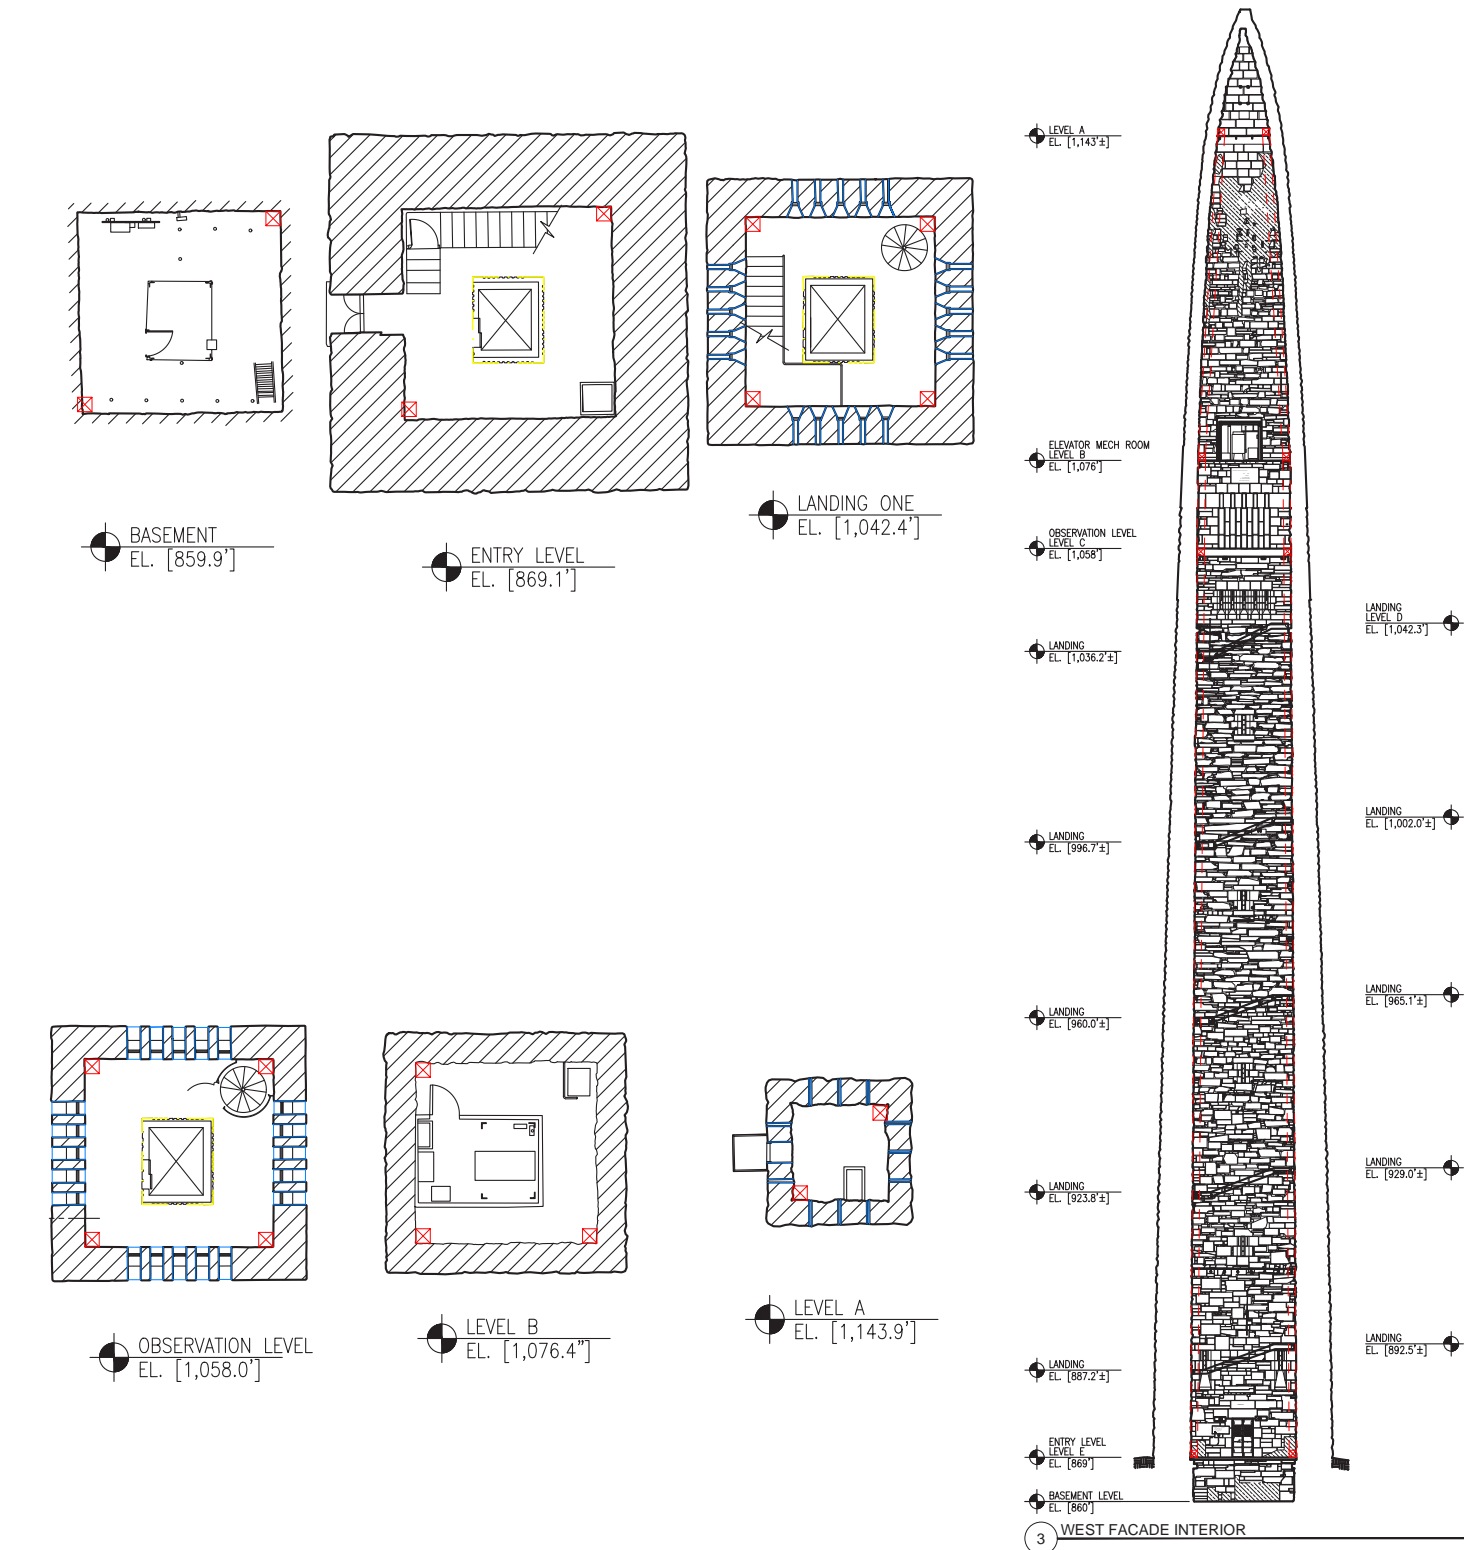
Image 99. Sketch of mechanical intervention location

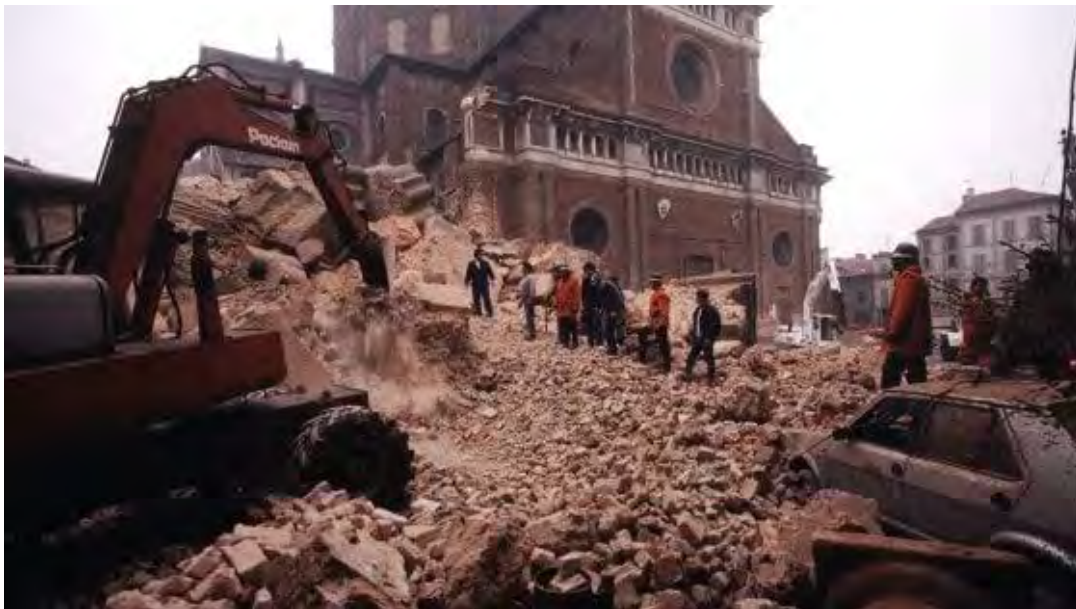
Figure 1 Pavia Tower Collapse [2]

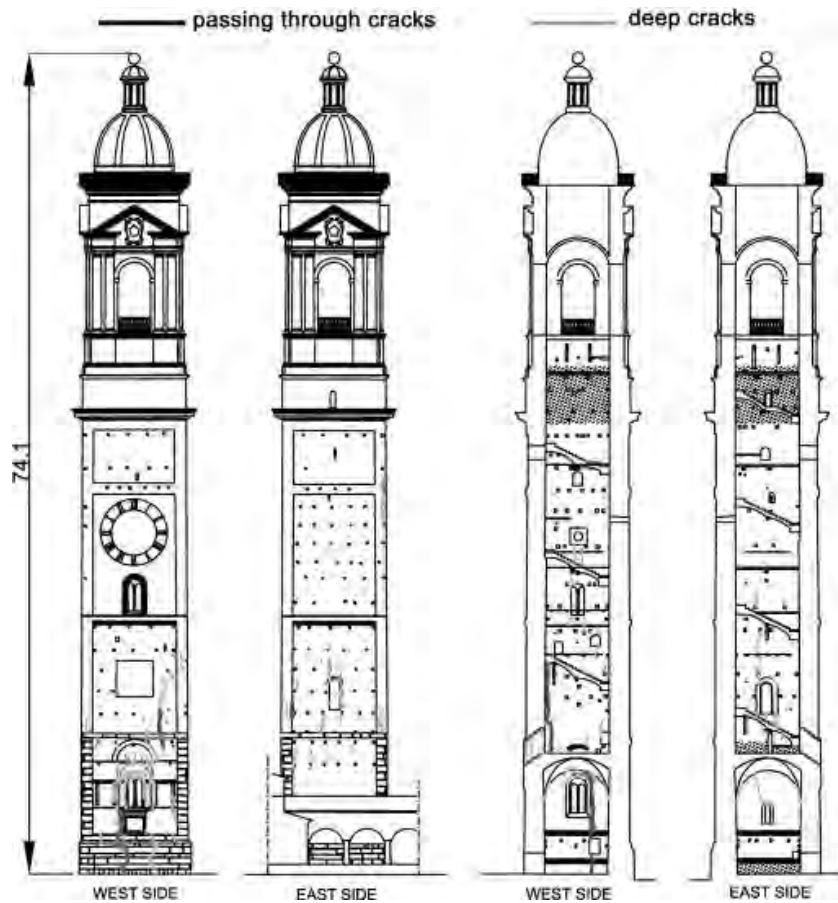
Figure 2 Survey of Cracks in the Bell Tower of the Cathedral of Monza [3]

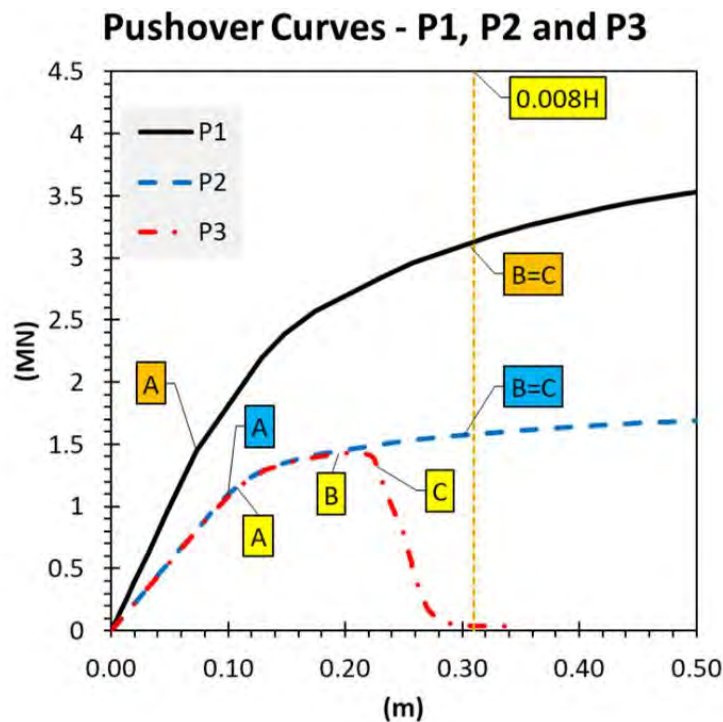
Figure 3 Example of Typical Pushover Curves as a Result of (P1) Inverse Triangular Shape Body Forces, (P2) Concentrated Lateral Load, (P3) Lateral Displacement at Top of a Miscellaneous Tower [6]

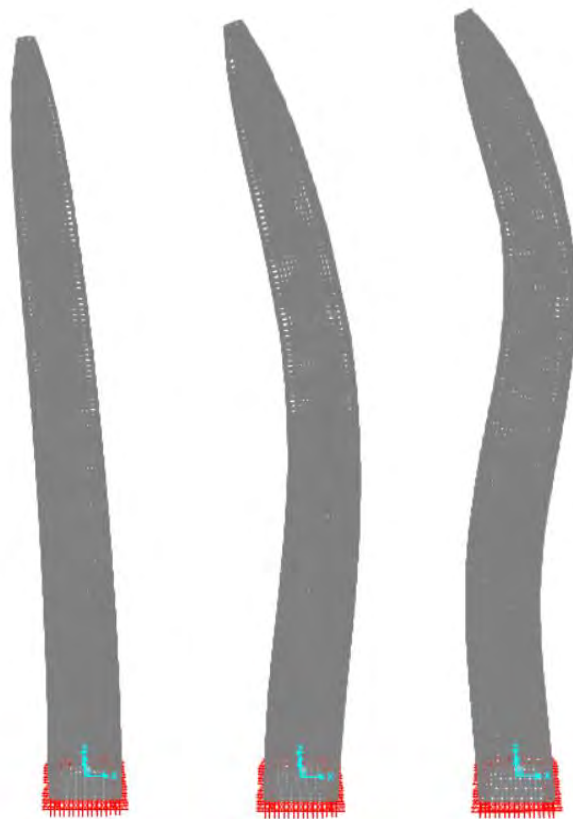
Figure 9 Modal Shapes of Monument Under its First Natural Frequency (Left), Second Natural Frequency (Middle), and Third Natural Frequency (Right) [amplified by a factor of 100]

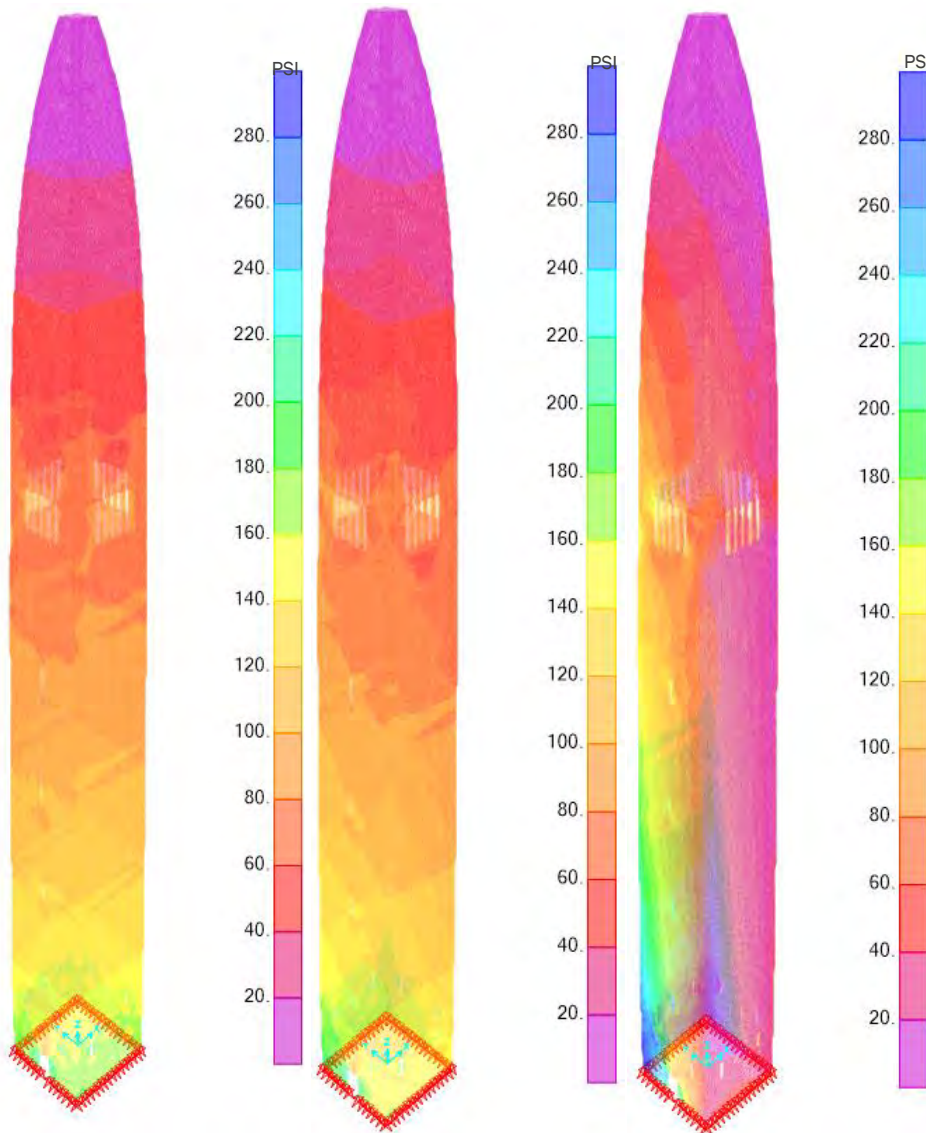
Figure 10 Von Mises Stresses Under Linear Analysis: Self-Weight (Left), Lateral Wind Loads (Middle) and Seismic (Right).

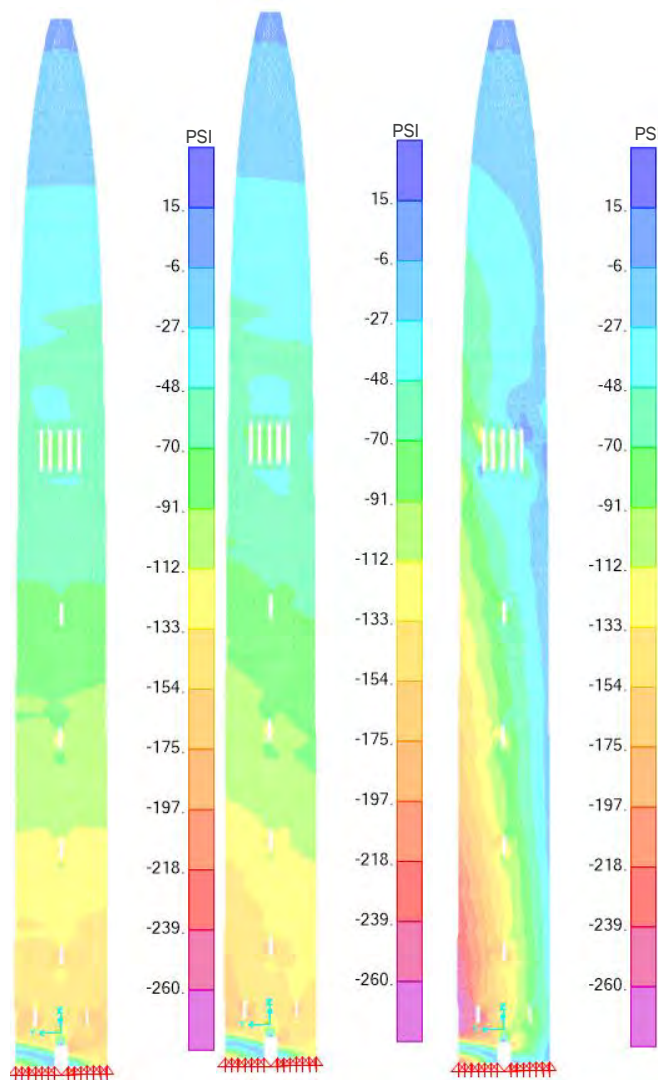
Figure 11 Principal Stresses Under Linear Analysis: Self-Weight (Left), Lateral Wind Loads (Middle) and Seismic (Right)

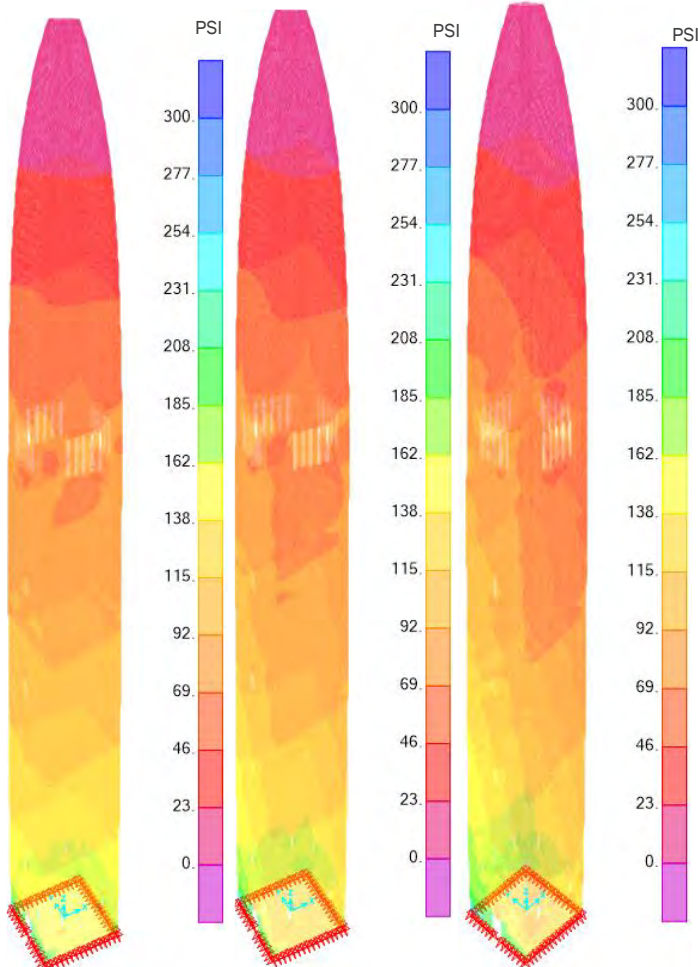
Figure 12 Von Mises Stresses (psi) of Cracked Model with 0.5 Stiffness Modifier Under Dead Loads Only (Left), Dead Loads + Wind Loads (Middle) and Dead Loads +Seismic Loads (Right)

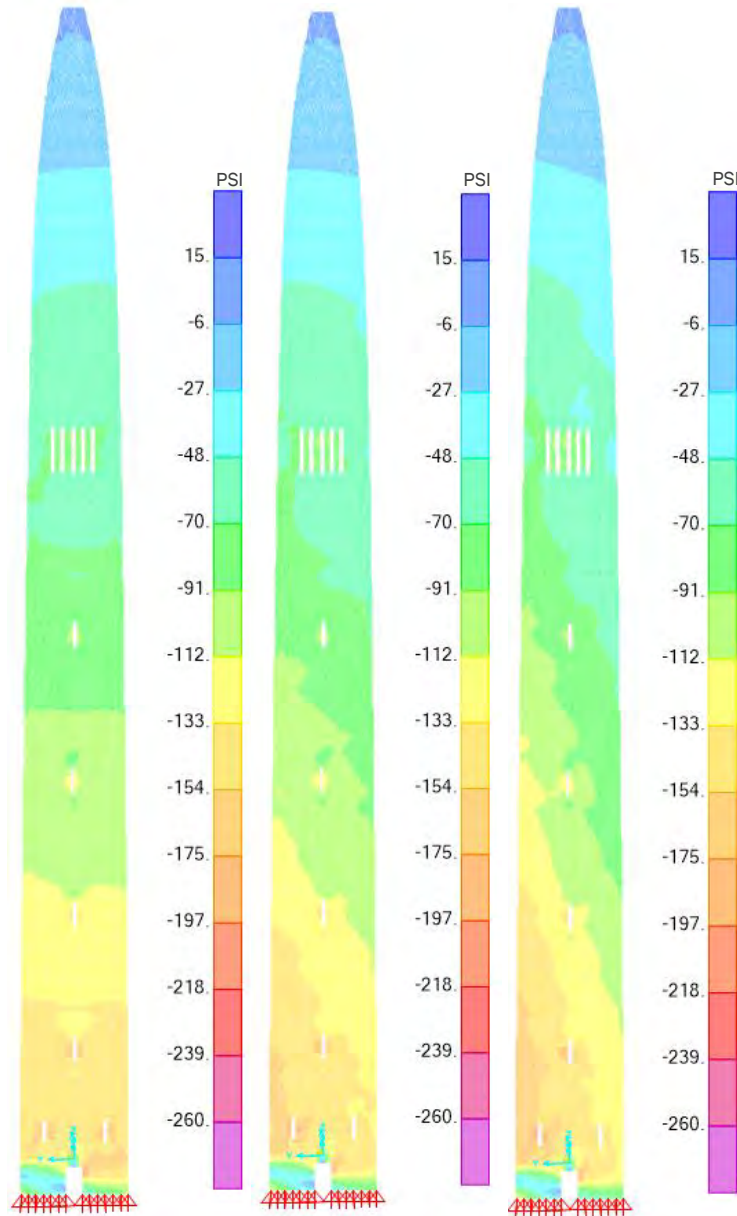
Figure 13 Principal Stress (psi) of Cracked Model with 0.5 Stiffness Modifier Under Dead Loads Only (Left), Dead Loads + Wind Loads (Middle) and Dead Loads + Seismic Loads (Right)

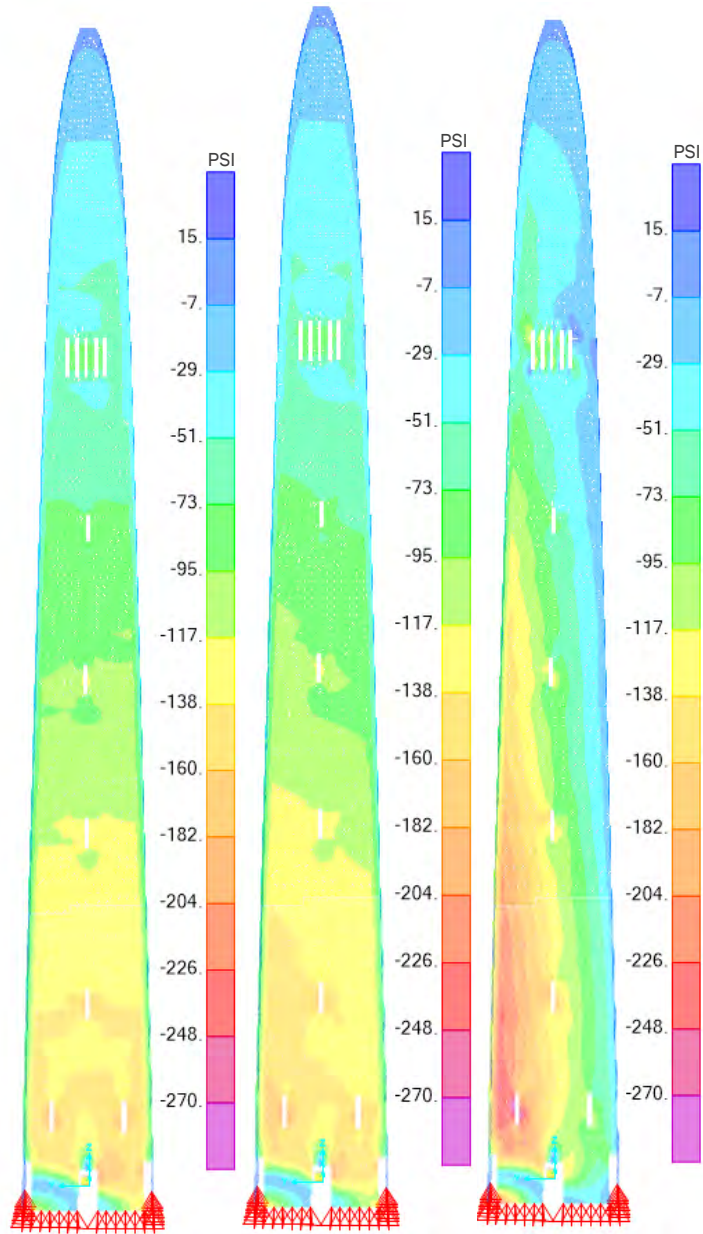
Figure 14 Principal Stress (psi) of Cracked Model with 15 Foot Cracks Under Dead Loads Only (Left), Dead Loads + Wind Loads (Middle) and Dead + Seismic Loads (Right)

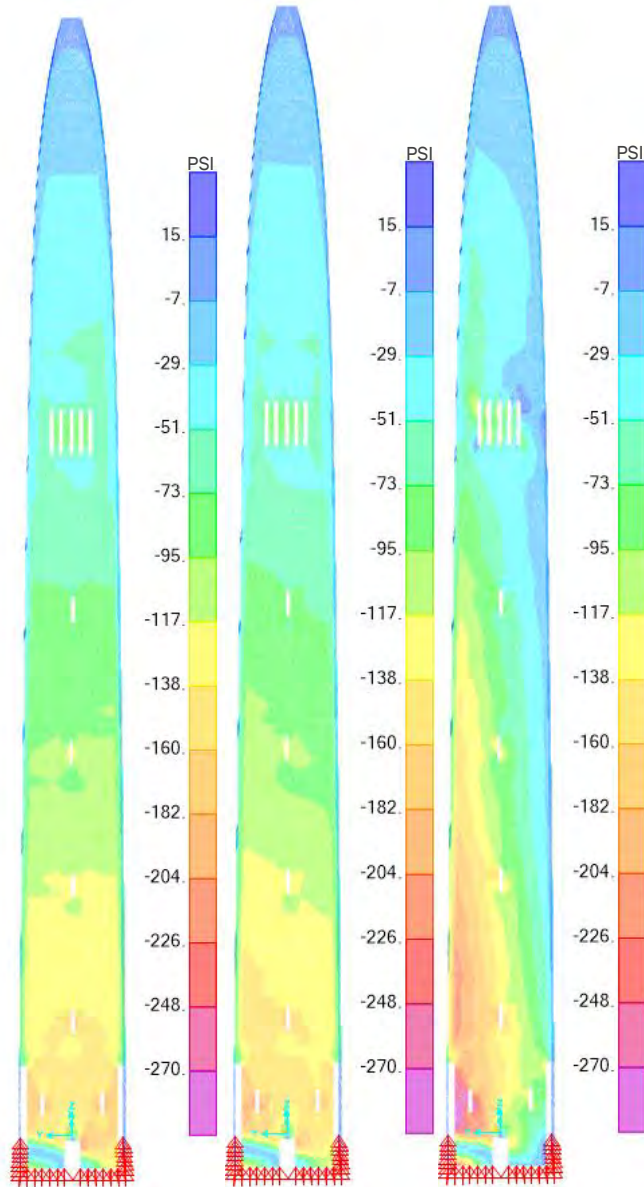
Figure 15 Principal Stress (psi) of Cracked Model with 30 Foot Cracks Under Dead Loads Only (Left), Dead Loads + Wind Loads (Middle) and Dead + Seismic Loads (Right)

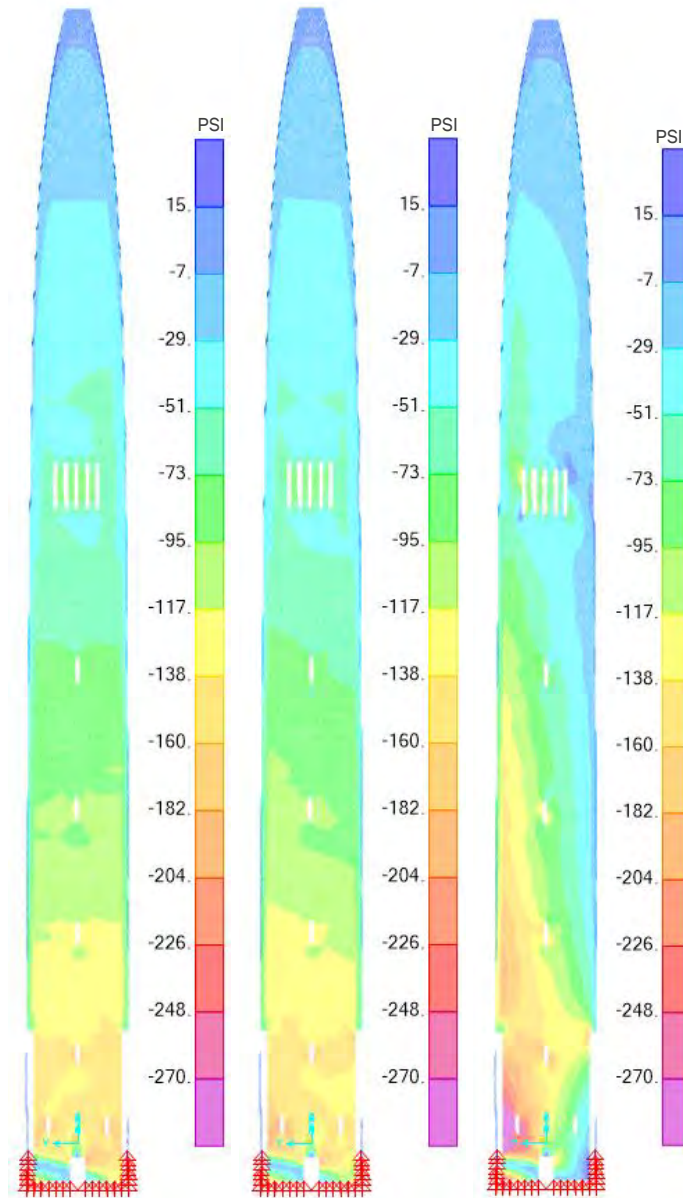
Figure 16 Principal Stress (psi) of Cracked Model with 30 Foot Cracks Under Dead Loads Only (Left), Dead Loads + Wind Loads (Middle) and Dead + Seismic Loads (Right)
