03/29/2024

**STRUCTURAL AND ELECTRICAL ASSESSMENT OF
THE BENNINGTON BATTLE MONUMENT**

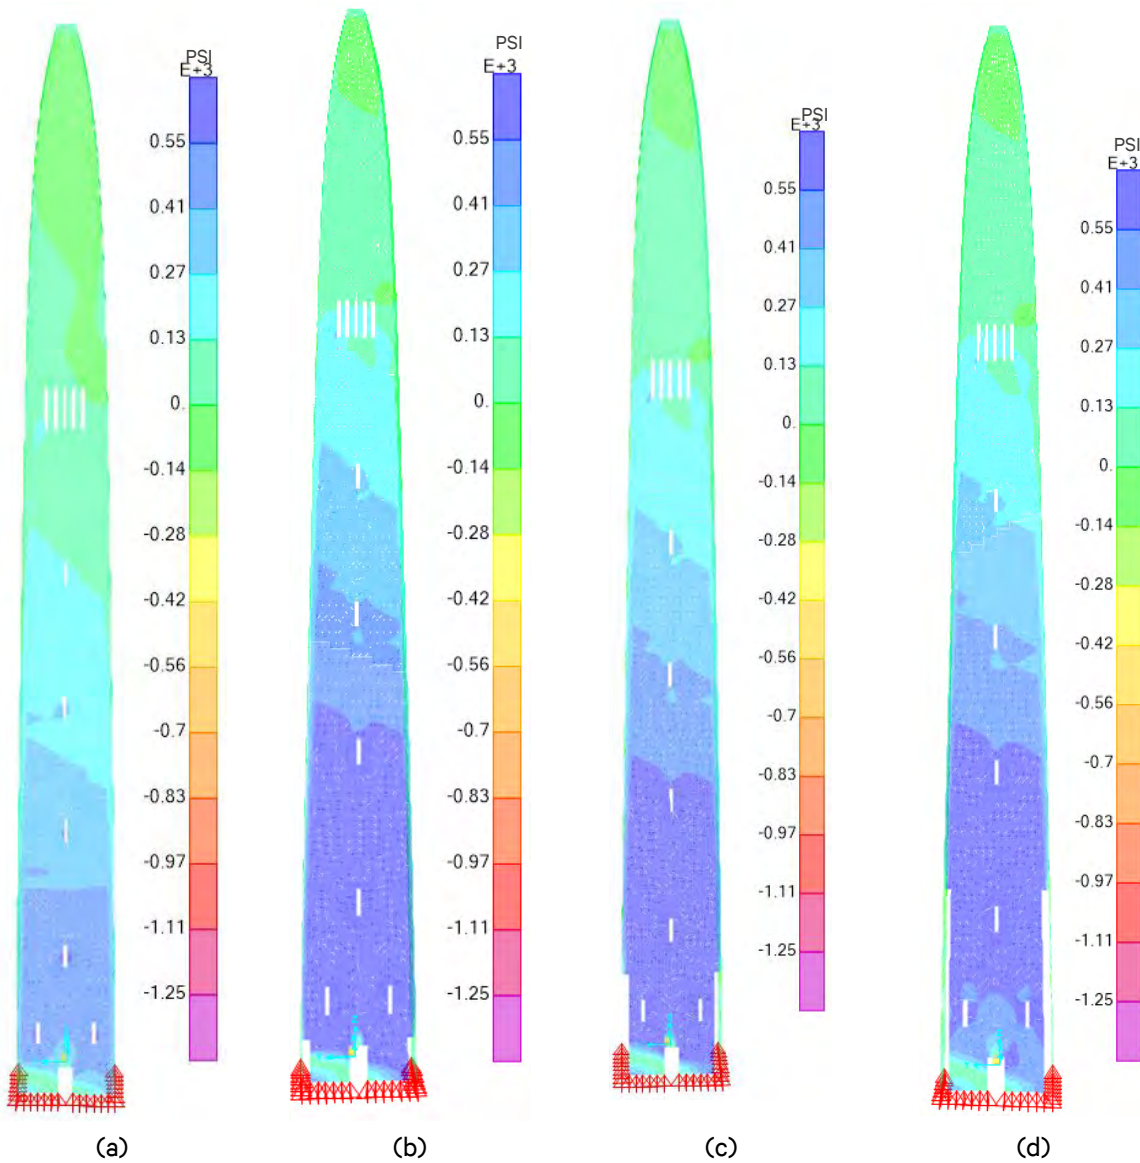
Figure 17 Resultant Pushover Analysis Principal Uplift Stress (psi) at Allowable Displacement: (a) Uncracked Shell Model, (b) 15' Cracks Model, (c) 30' Cracks Model, (d) 50' Cracks Model

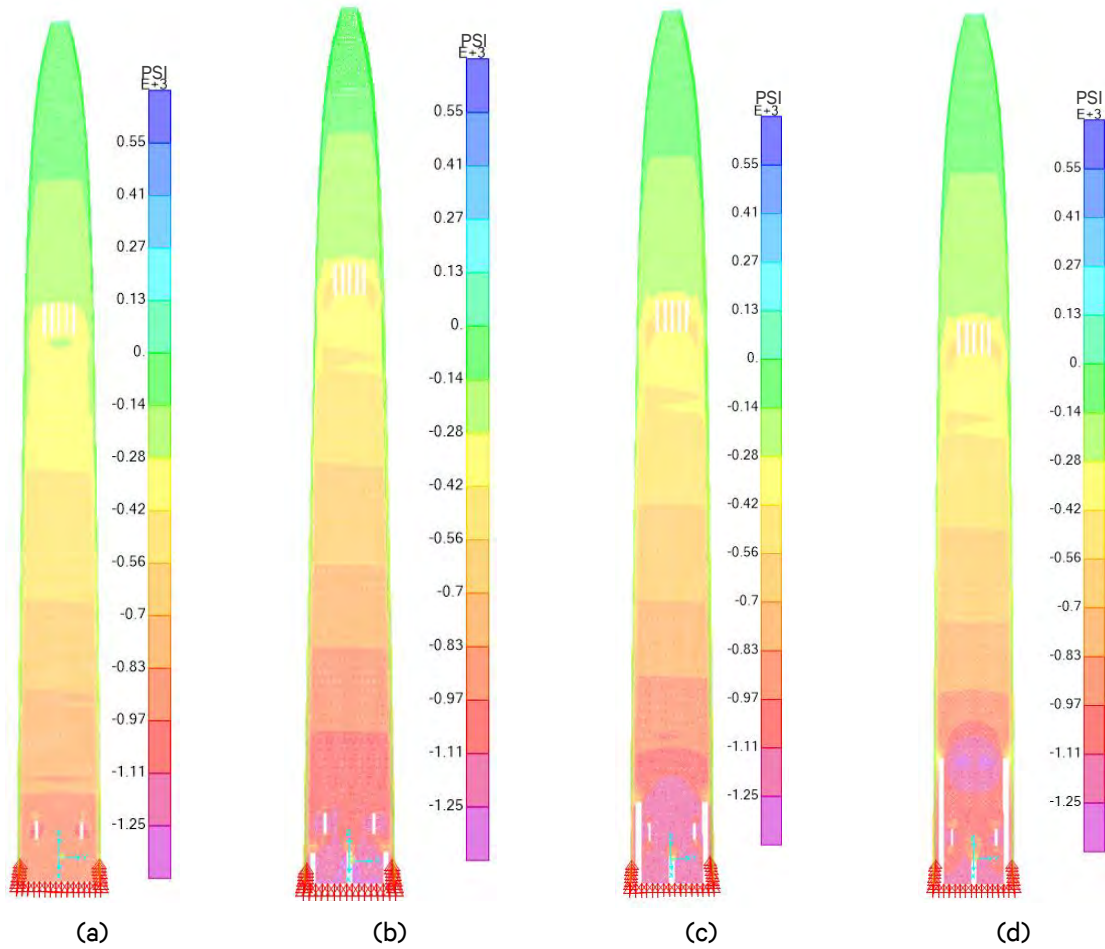
Figure 18 Resultant Pushover Analysis Principal Compressive Stress at Allowable Displacement: (a) Uncracked Shell Model, (b) 15' Cracks Model, (c) 30' Cracks Model, (d) 50' Cracks Model

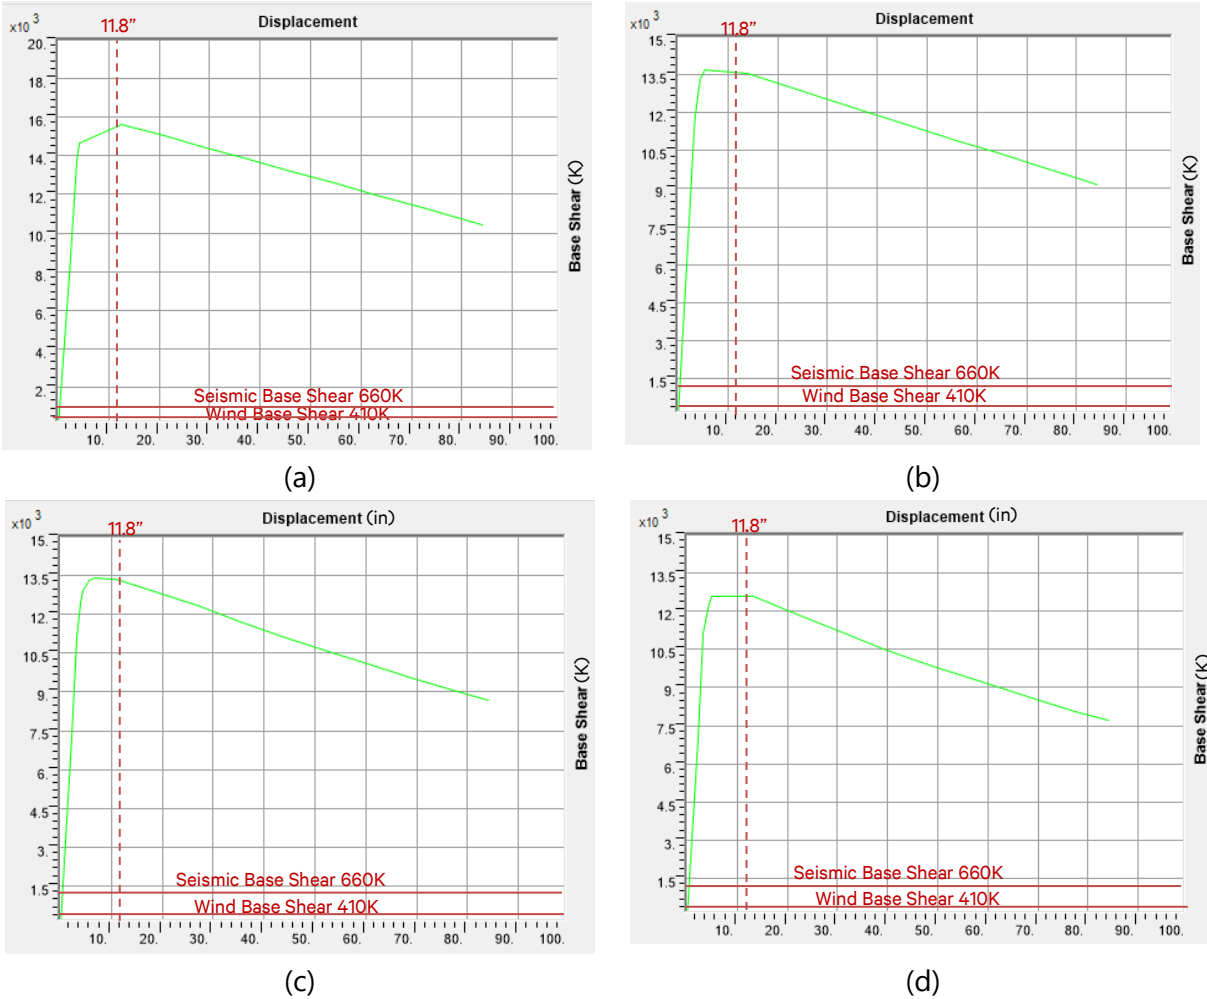
Figure 19 Pushover Curve of: (a) Uncracked Shell Model, (b) 15' Cracked Model, (c) 30' Cracked Model, (d) 50' Cracked Model

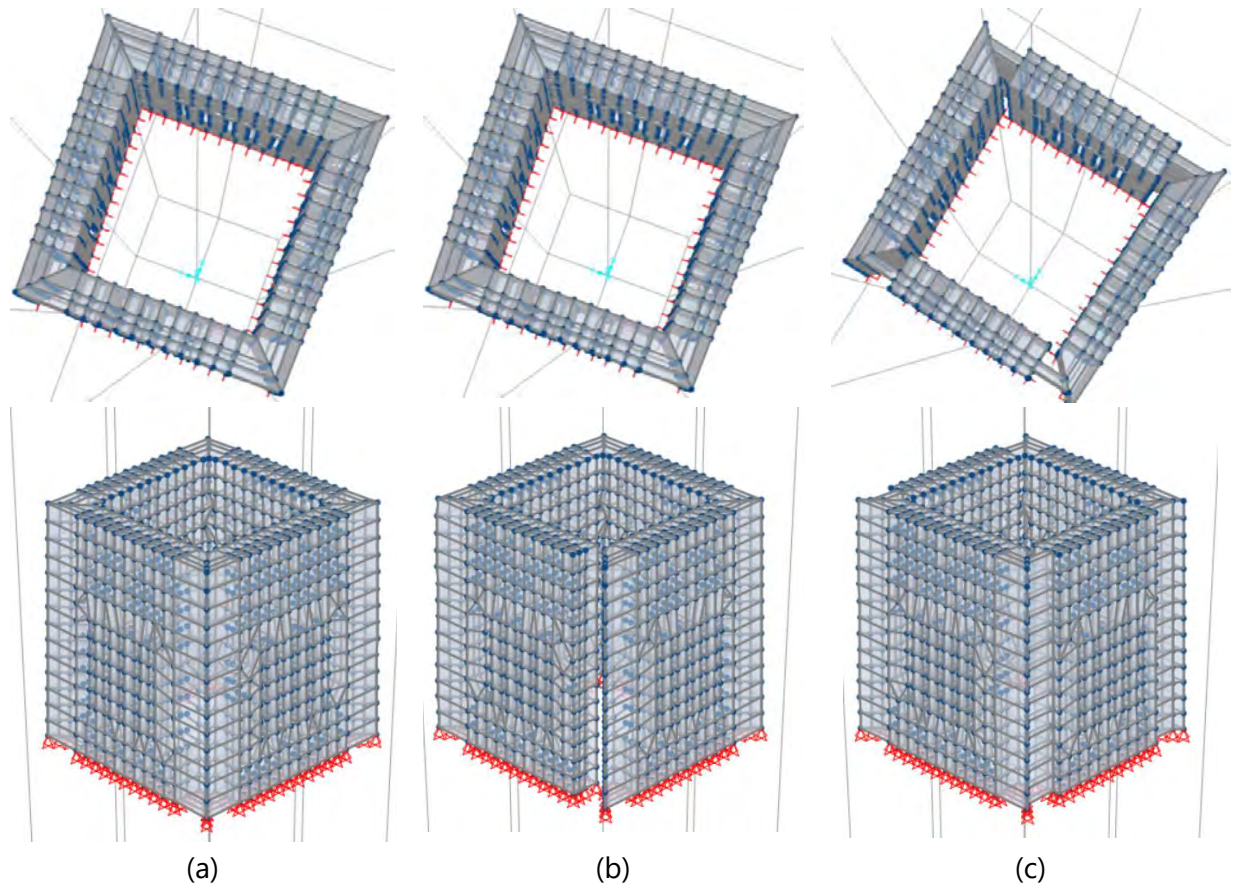
Figure 20 3D Solid Model: (a) Uncracked, (b) Fully Disconnected Corner, (c) Partially Disconnected Corners

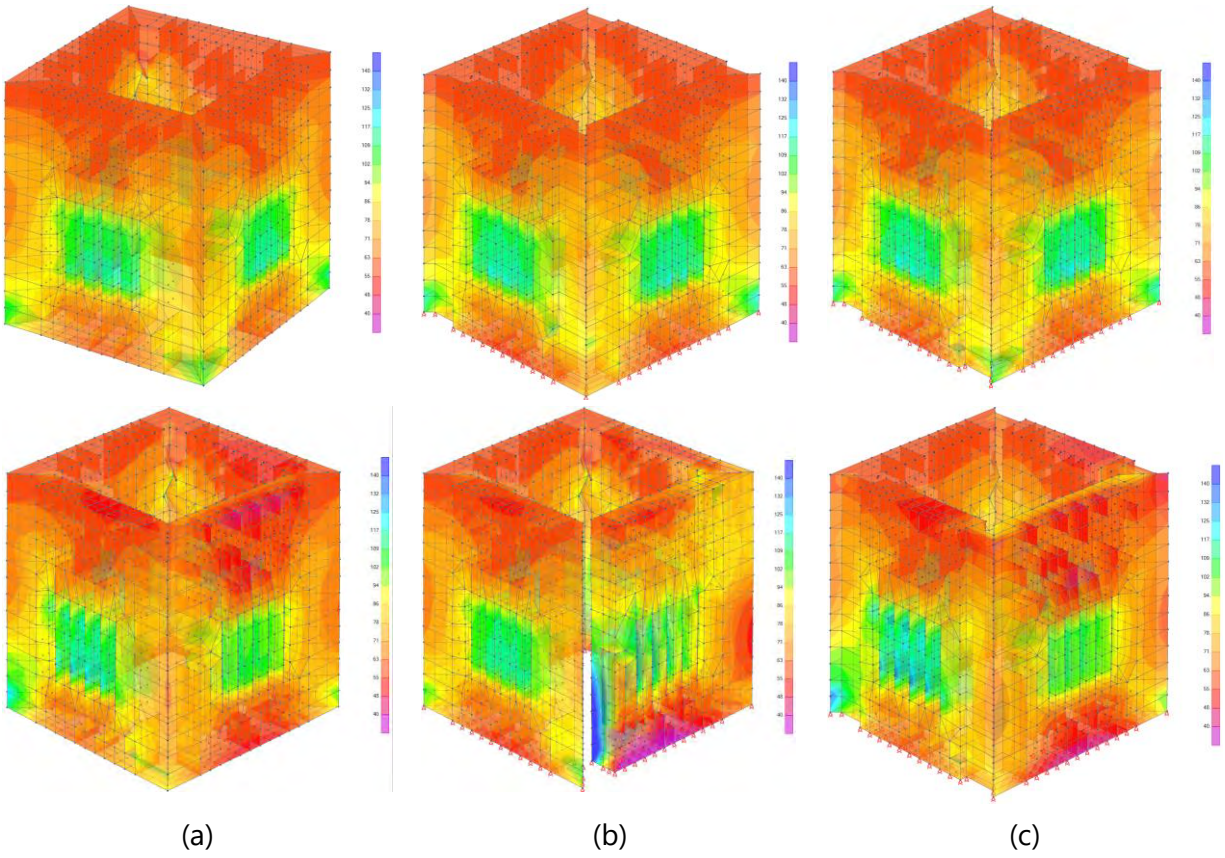
Figure 21 Von Mises Stress from Dead Loads (Top) and Dead Plus Wind Loads (Bottom) in the 3D Solid Model: (a) Uncracked, (b) Fully Disconnected Corner, (c) Partially Disconnected Corners

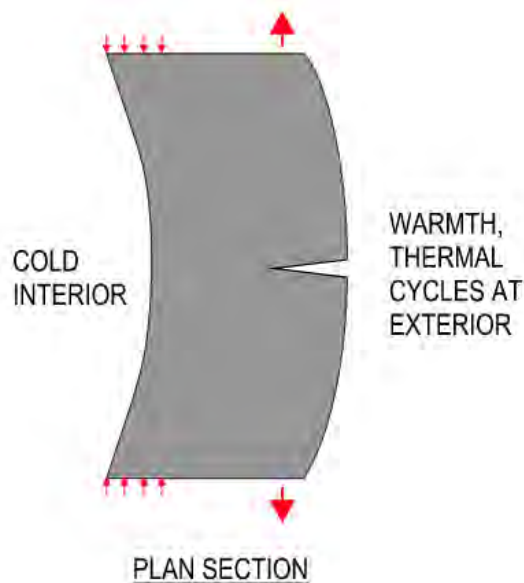
Figure 23. Schematic depiction of the boundary conditions through the masonry in the Monument. The relatively slow changing interior temperatures make the interior masonry act as a restrictive boundary condition to the exterior that experiences greater and faster temperature fluctuations.

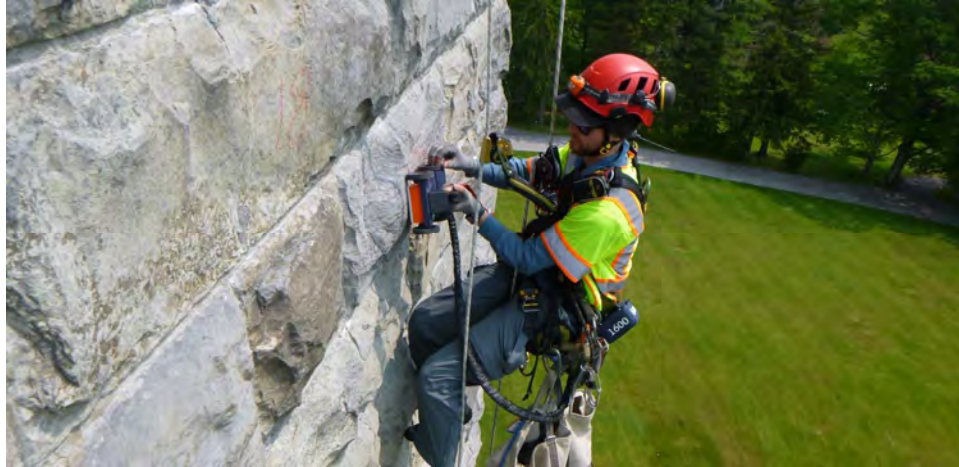
Figure 4. VA technician collecting an SPR scan across a stone course at the exterior of the monument.

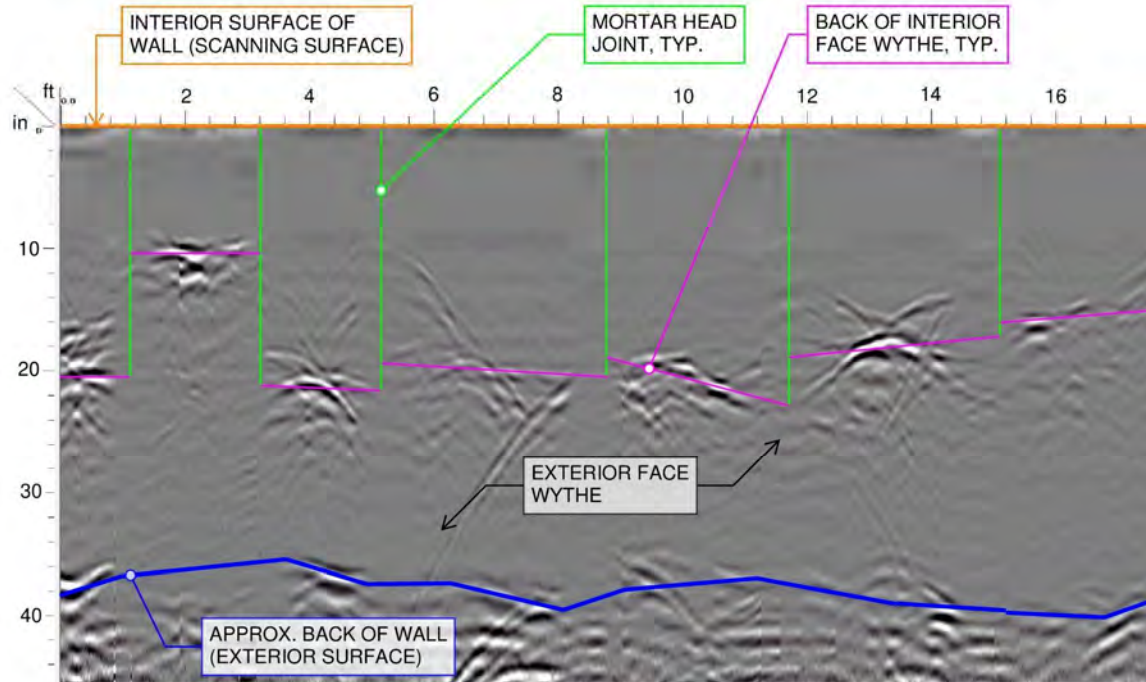
Figure 5. Typical SPR scan collected horizontally at the elevator machine room. Annotations describe elements of the scan.

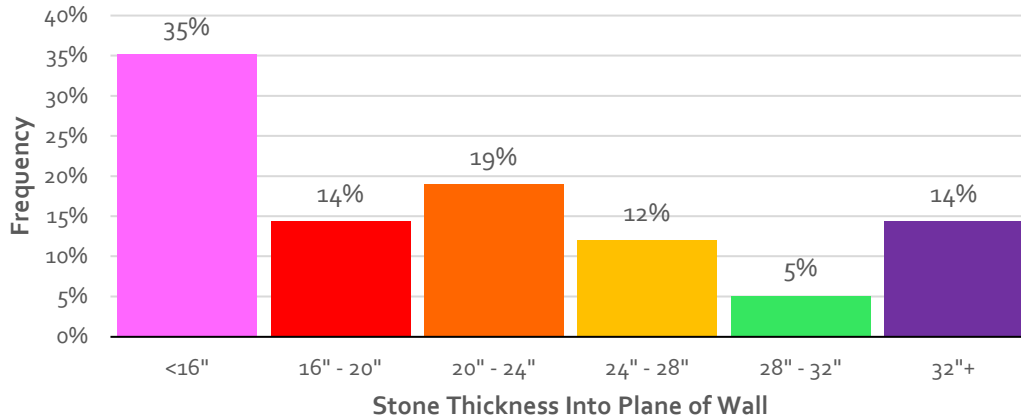
Figure 8. Histogram of interior stone face wythe stone thicknesses. These results are SPR scans collected at monument elevations between ~150' and ~215'. These are Phase II findings intended to represent masonry conditions higher up the monument.

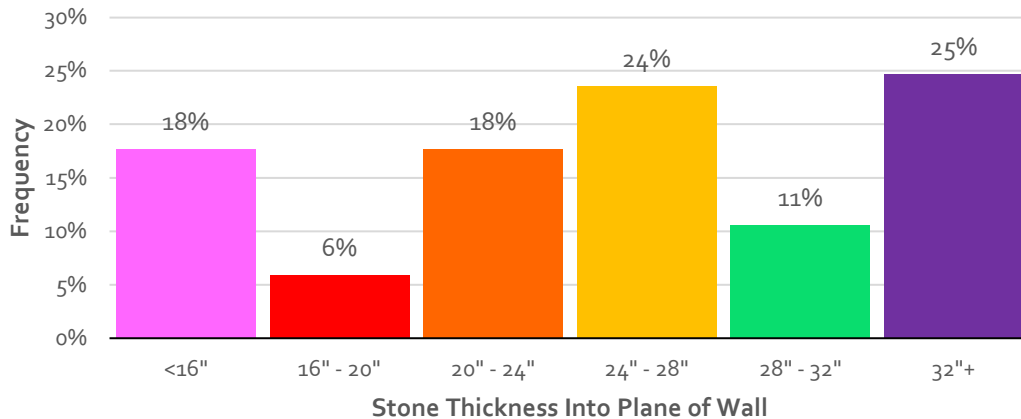
Figure 9. Histogram of interior stone face wythe stone thicknesses. THESE RESULTS ARE FOR THE BOTTOM HALF OF THE MONUMENT AND WERE COLLECTED DURING THE PHASE I NDE WORK.

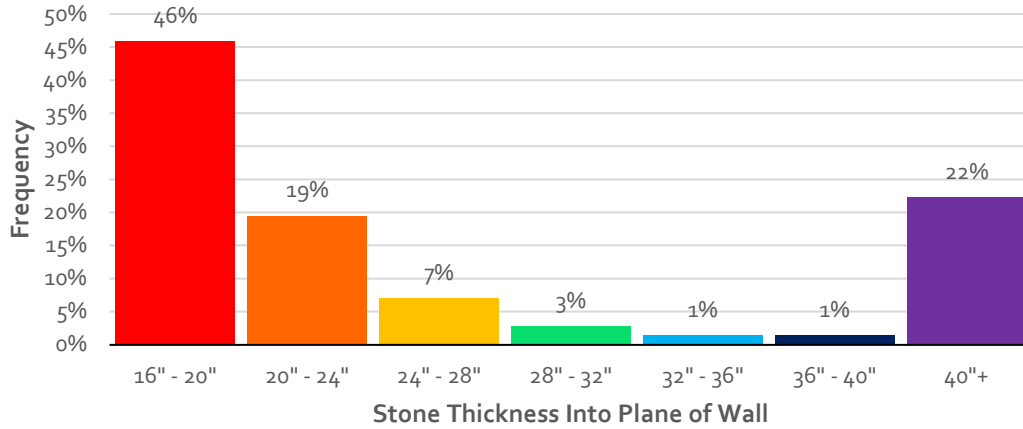
Figure 12. Histogram of exterior stone face wythe stone thicknesses. These results are SPR scans collected at monument elevations of 80-feet and 150-feet. These are Phase II findings intended to represent masonry conditions higher up the monument.

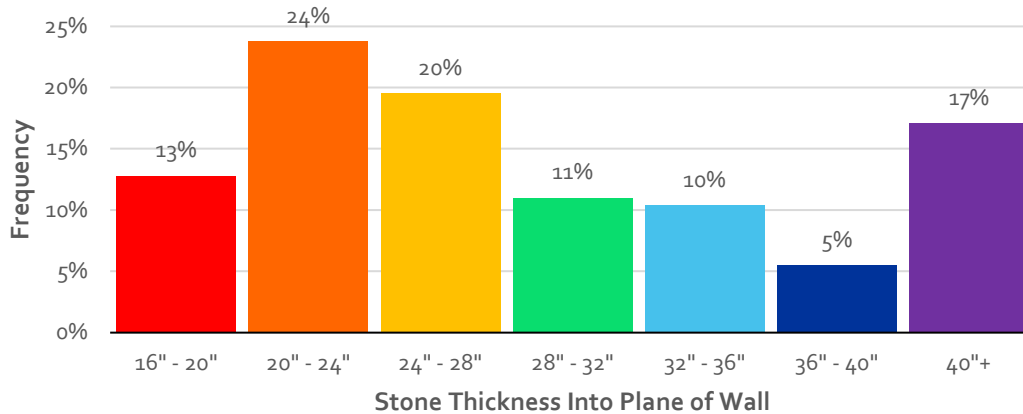
Figure 13. Histogram of exterior stone face wythe stone thicknesses. THESE RESULTS ARE FOR THE BOTTOM FOUR COURSES (APPROX. 8- FEET) OF THE MONUMENT AND WERE COLLECTED DURING THE PHASE I NDE WORK.

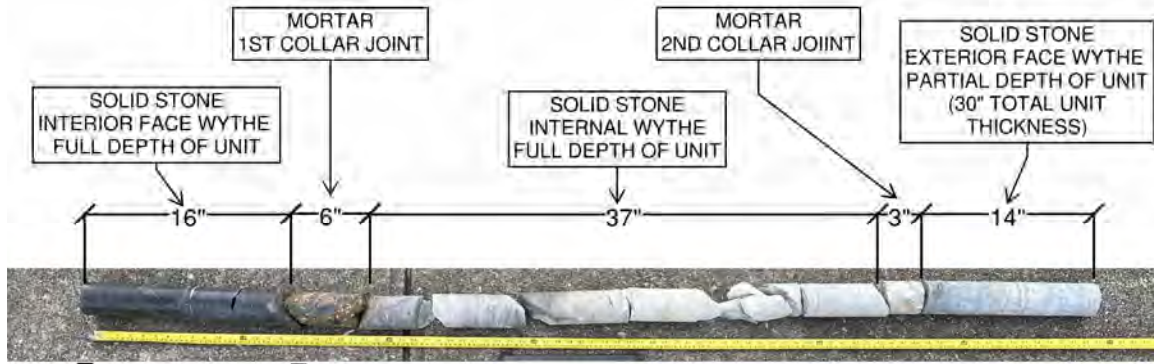
RETAINED FOR LABORATORY TESTING - CORE ID = ANA-SOUTH-4

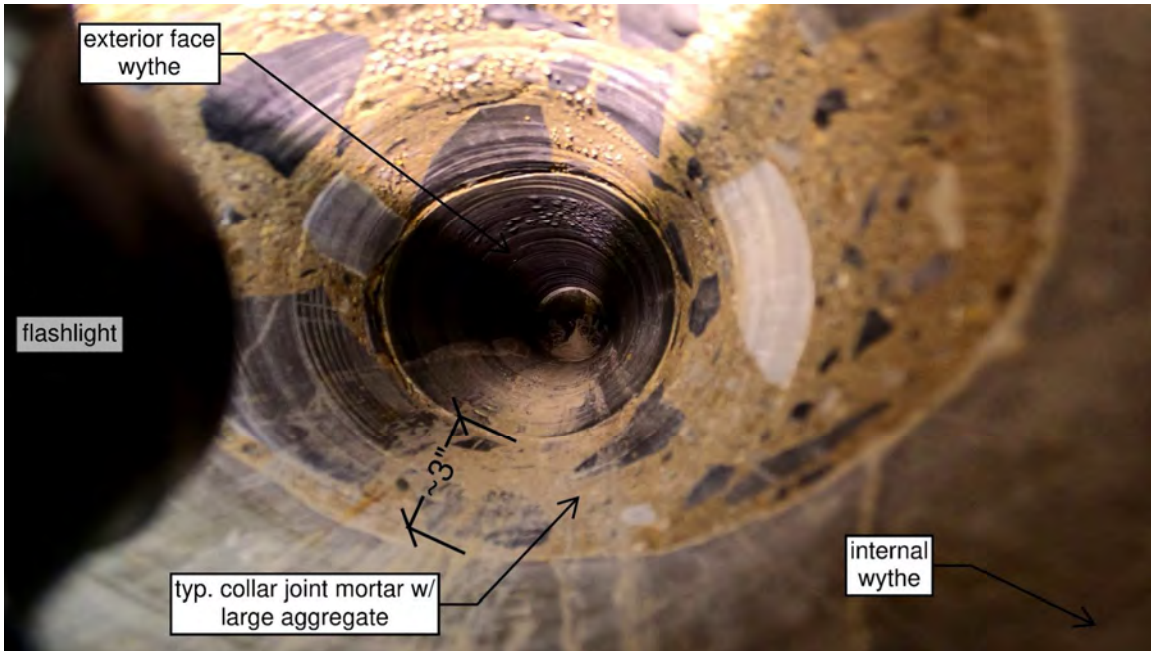
Figure 16. GoPro photo of the 2nd (exterior) collar joint at CORE-SOUTH after the Goodman Jack testing. The collar joint mortar is fully intact and the interface between the two stone wythes and the mortar is solid.

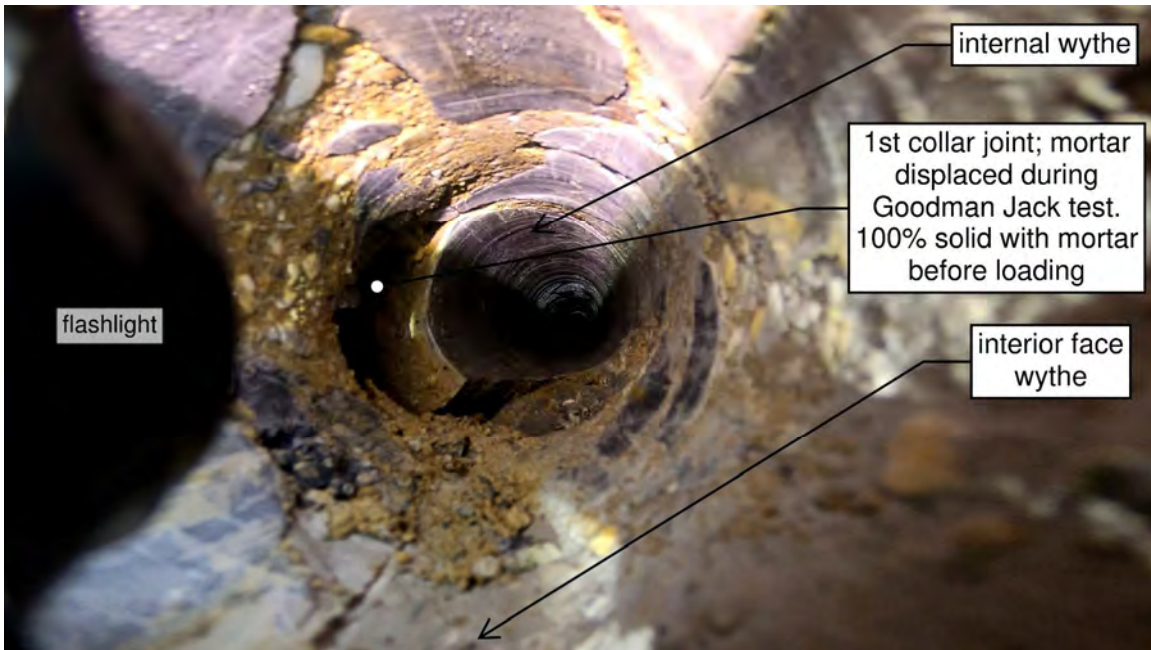
Figure 17. GoPro photo of the 1st (interior) collar joint at CORE-SOUTH after the Goodman Jack testing. The collar joint was previously 100% solid but after testing shows visible distress. This is the location of the Goodman Jack test that resulted in a ruptured membrane as it pressed into the soft mortar and was cut on the stone edge (Goodman Jack test ID: GS17-35).

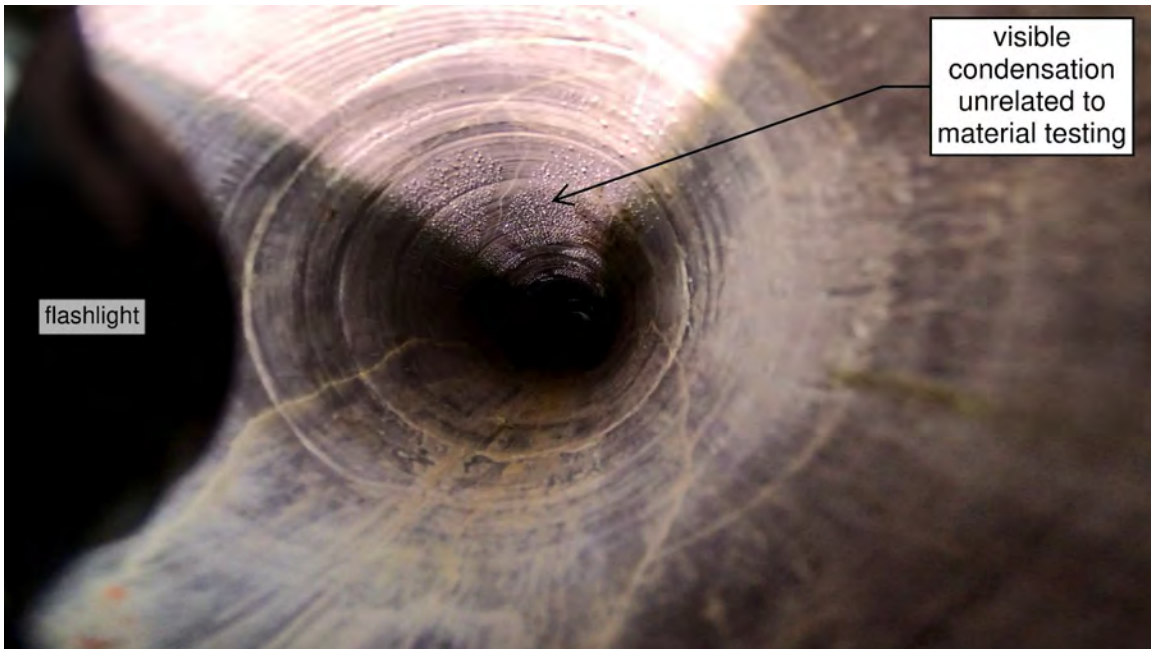
Figure 18. GoPro photo of the internal wythe at CORE-SOUTH after the Goodman Jack testing. The stone is visibly intact. There is visible condensation at the top of the core hole for much of the depth of CORE-SOUTH unrelated to the material testing.

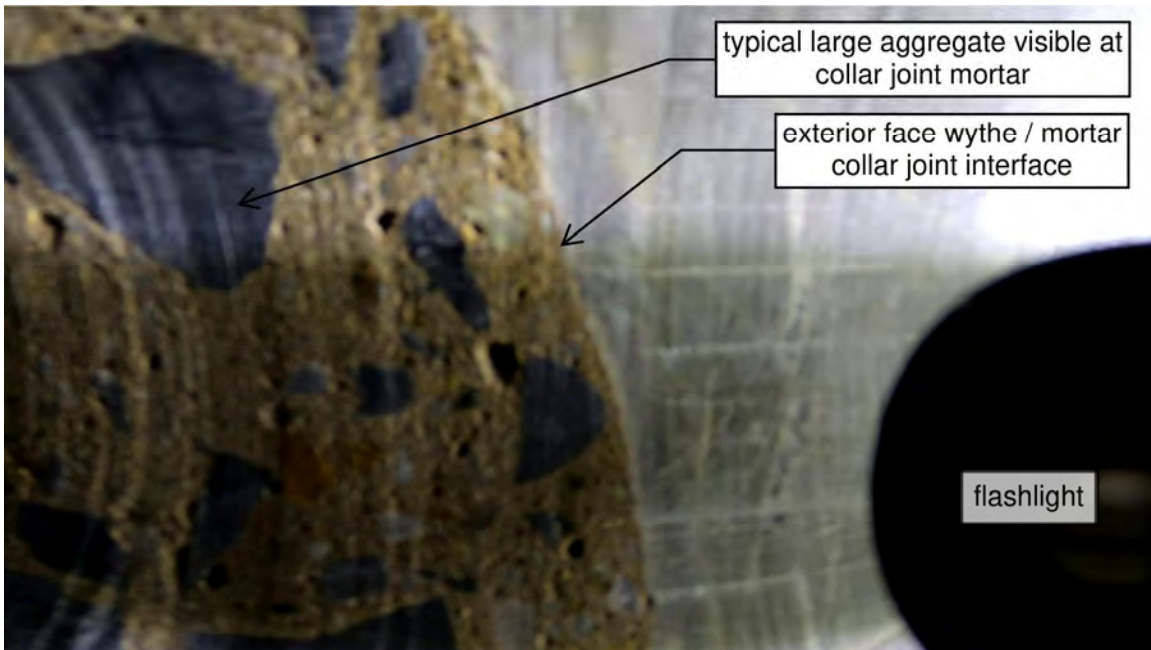
Figure 19. GoPro photo of the 2nd collar joint at CORE-SOUTH before the Goodman Jack testing. The interface between stone and mortar is solid. The large aggregate typically observed at the collar joint mortar is also visible.

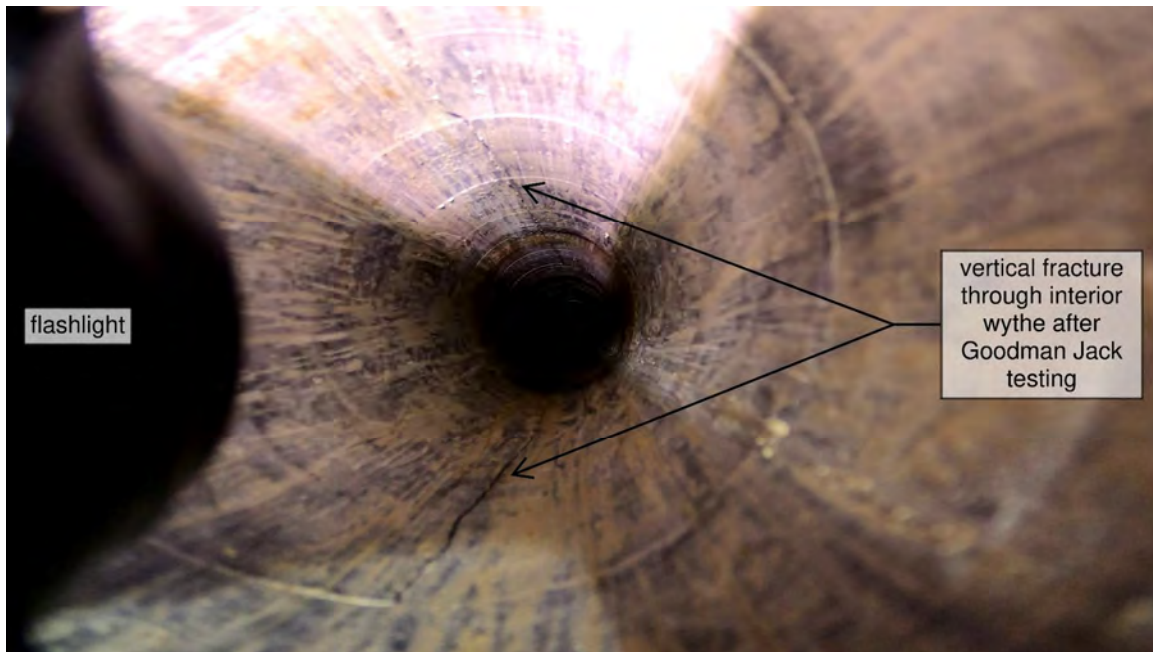
Figure 20. GoPro photo of the interior face wythe at CORE-NORTH after the Goodman Jack testing. The stone was visibly intact before the testing, but loading the masonry resulted in a vertical fracture through the stone unit for the full depth of the unit (16-inches). The fracture is visible at the top and bottom of the core hole in this photo.

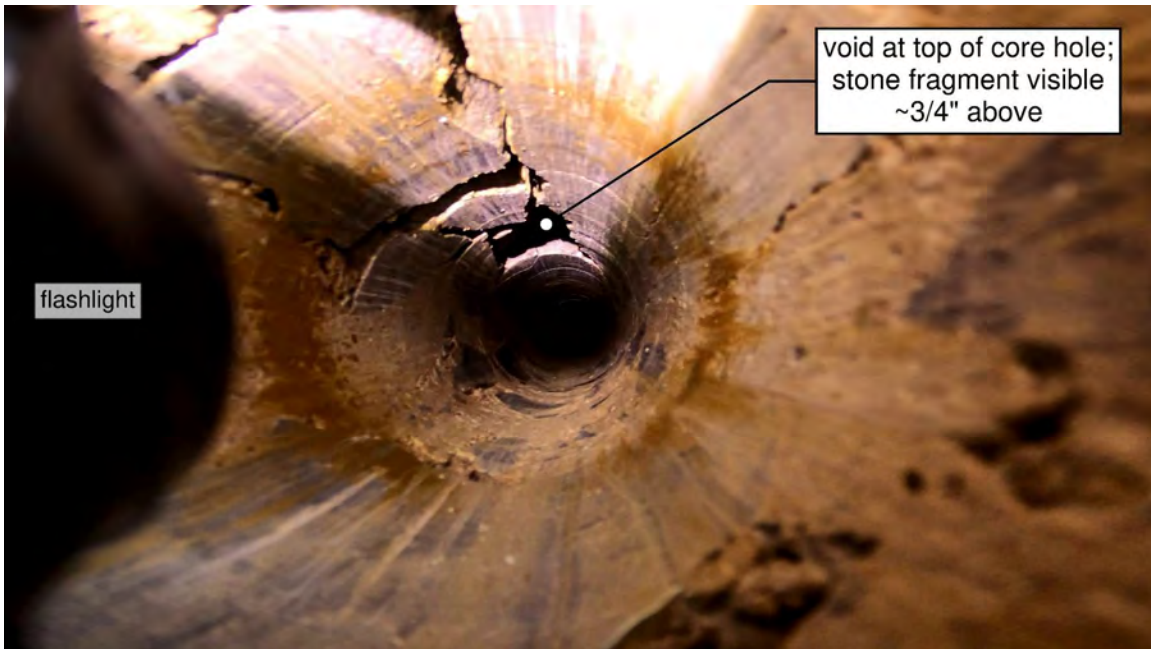
Figure 21. GoPro photo of the masonry between the interior and exterior face wythes (approx. depth of photo = 22" into wall) at CORE-NORTH after the Goodman Jack testing. This portion of the wall was not loaded with the Goodman Jack due to the already present voiding. Figure 22 shows a closer view of the void called out by the annotation in this photo.

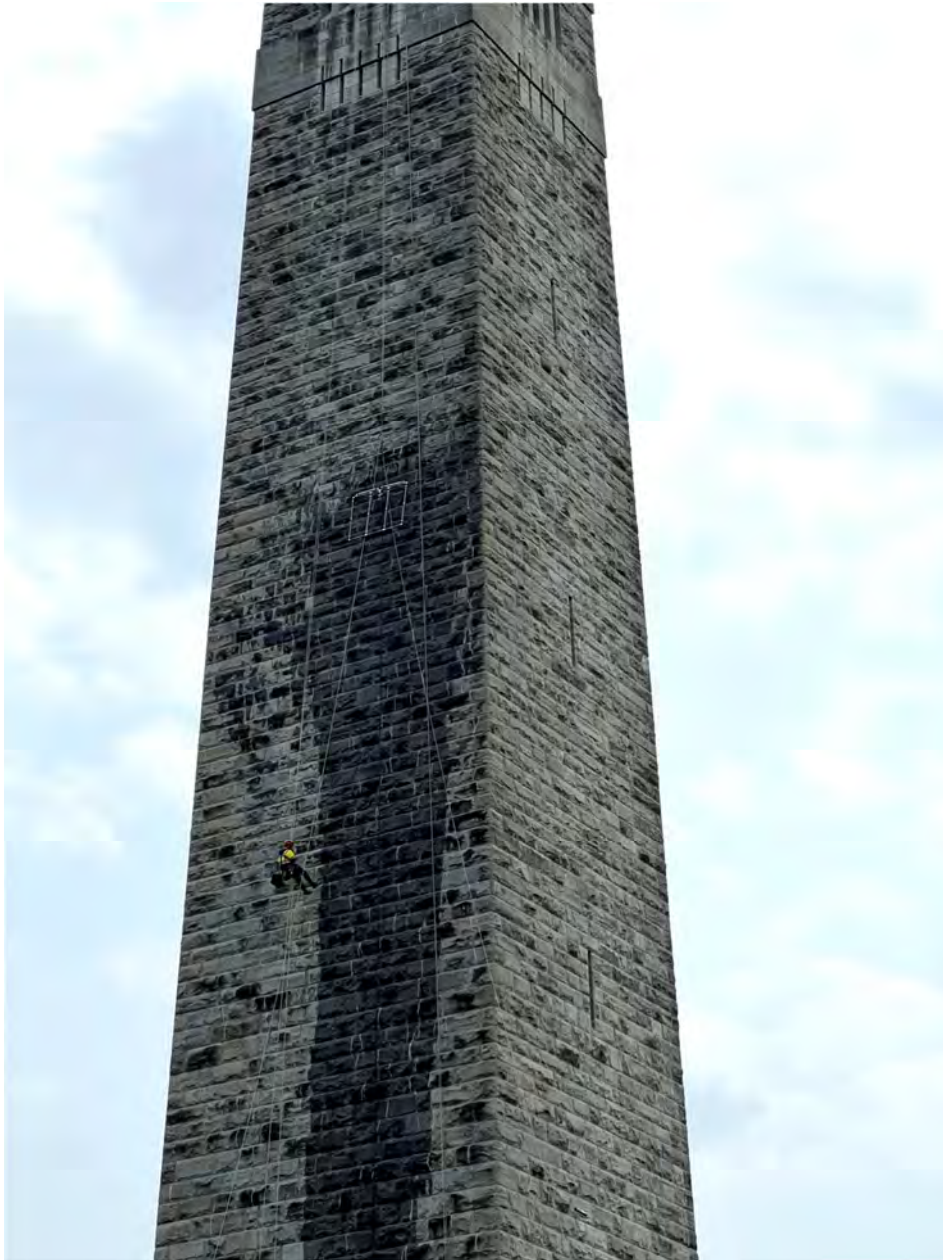
Figure 24. Photo of spray test from exterior – North Elevation.

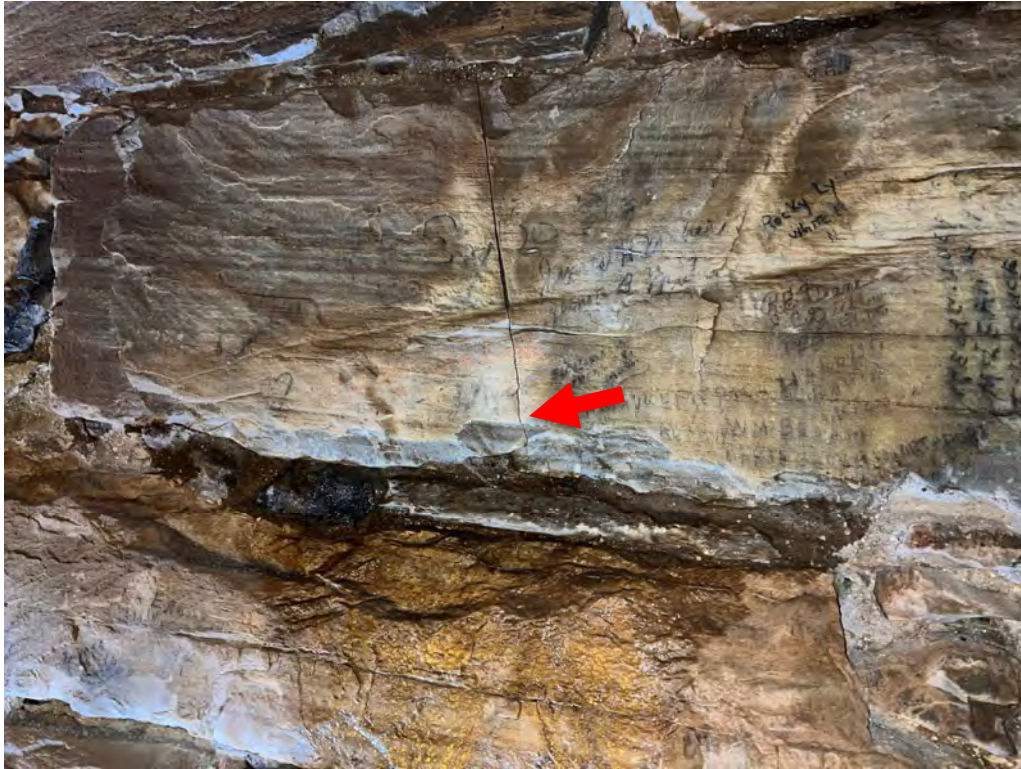
Figure 25. Leak observed as a result of spray testing below crack at interior stone.

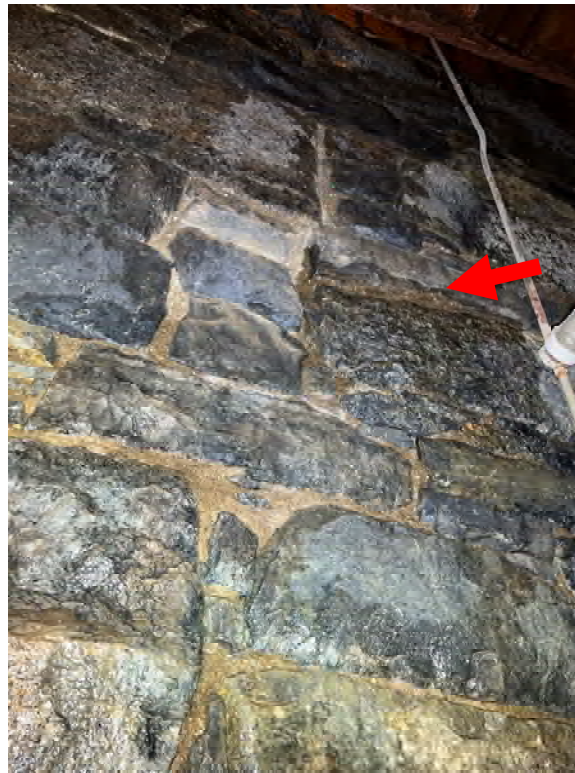
Figure 26. Appearance of damp observed at mortar joint below interior stone work.

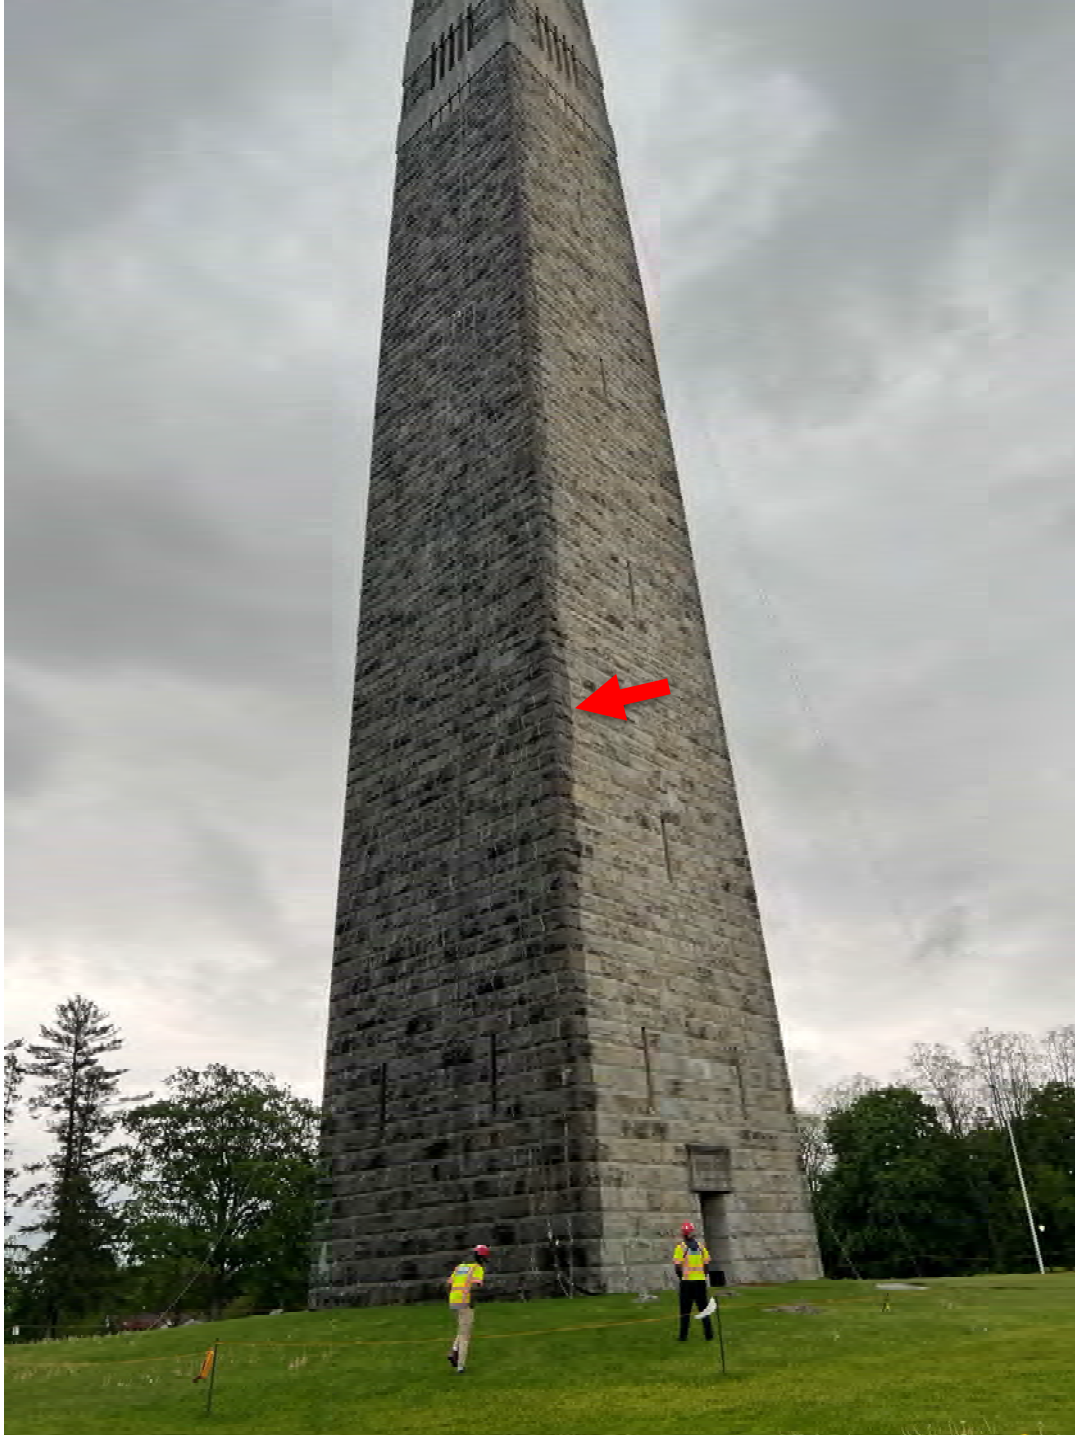
Figure 27. Photo of north wall following rainstorm with the prevailing wind coming directly from the north. The monument largely blocked wind driven rain from the leeward walls, with a small amount of moisture being blown and wrapping around the corners of the monument creating a clear line of moisture approximately half the length of a stone unit to the east and west elevations.

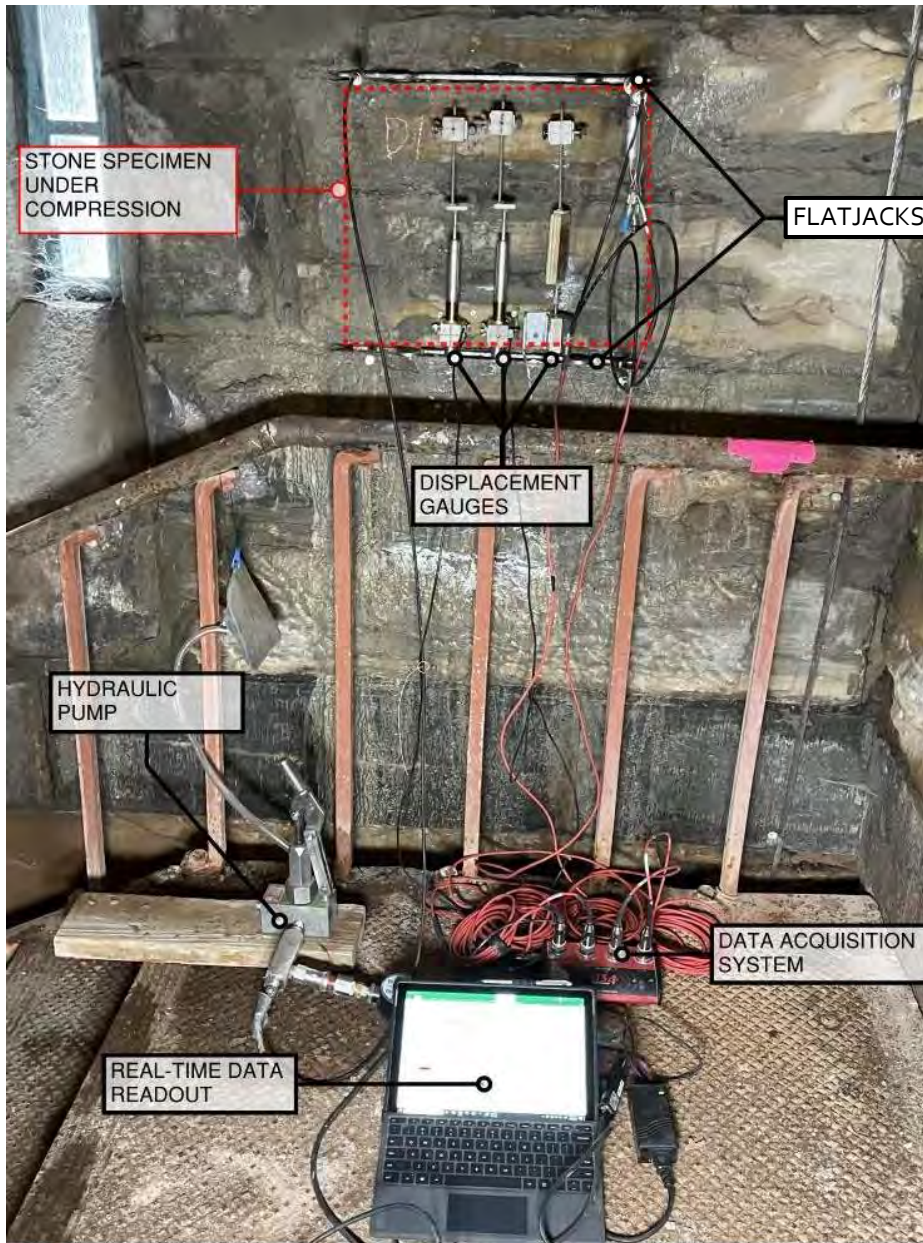
Figure 28. Typical test setup for in-situ deformability tests.

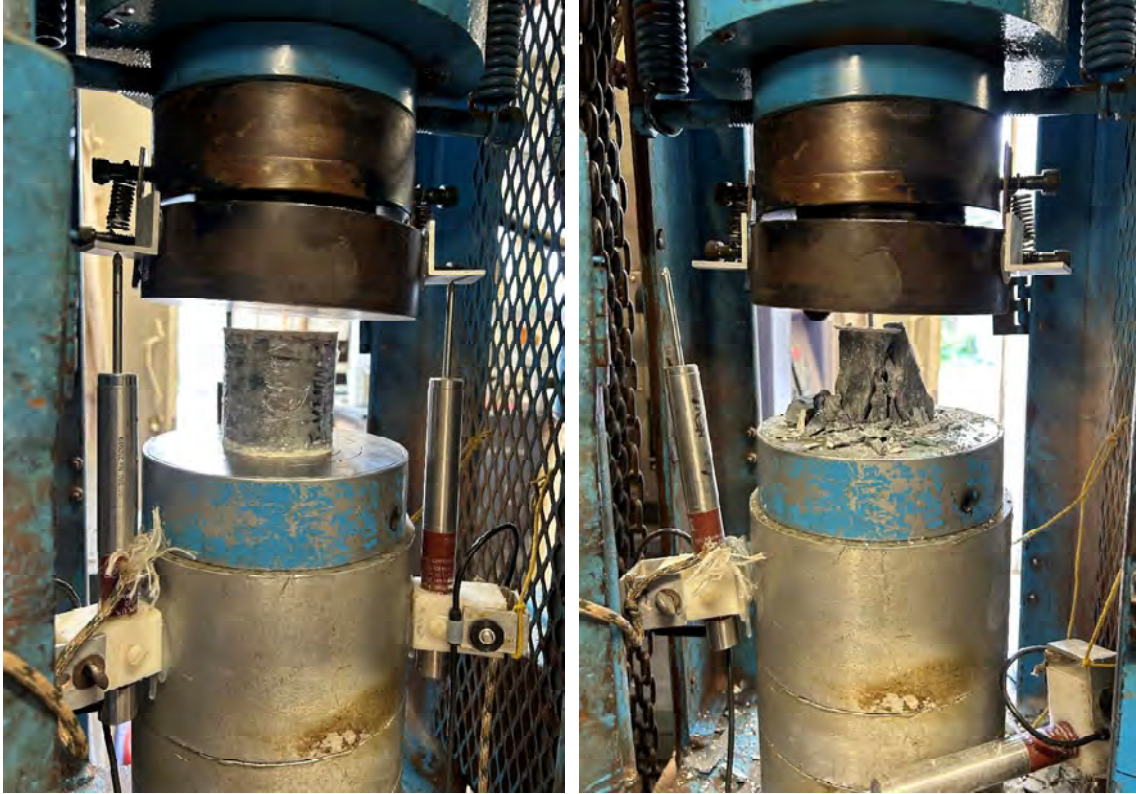
Figure 44. (left) ASTM C170 test setup for a stone specimen before applying load; (right) stone specimen following compressive failure.

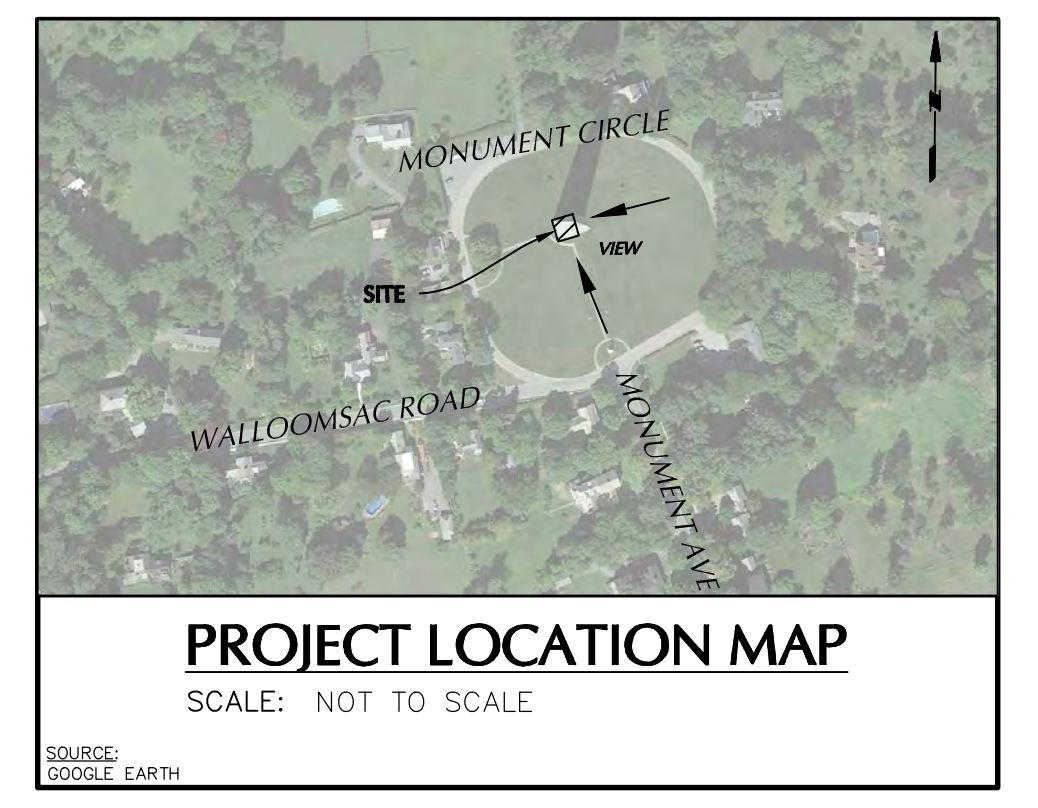
- NOTES:**
- THIS SURVEY IS BASED UPON EXISTING PHYSICAL CONDITIONS FOUND AT THE SUBJECT SITE.
 - INFORMATION SHOWN HEREON HAS BEEN OBTAINED FROM LASER SCAN DATA COLLECTED BY LANGAN ENGINEERING, ENVIRONMENTAL, SURVEYING AND LANDSCAPE ARCHITECTURE, D.P.C., IN FEBRUARY, 2022.
 - ELEVATIONS SHOWN ARE REFERENCED TO THE NORTH AMERICAN VERTICAL DATUM OF 1988.
 - ALL UNITS SHOWN HEREON ARE IN U.S. SURVEY FEET.
 - THIS PLAN NOT VALID UNLESS EMBOSSED OR BLUE INK STAMPED WITH THE SEAL OF THE PROFESSIONAL LAND SURVEYOR.
