03/29/2024

**STRUCTURAL AND ELECTRICAL ASSESSMENT OF
THE BENNINGTON BATTLE MONUMENT**

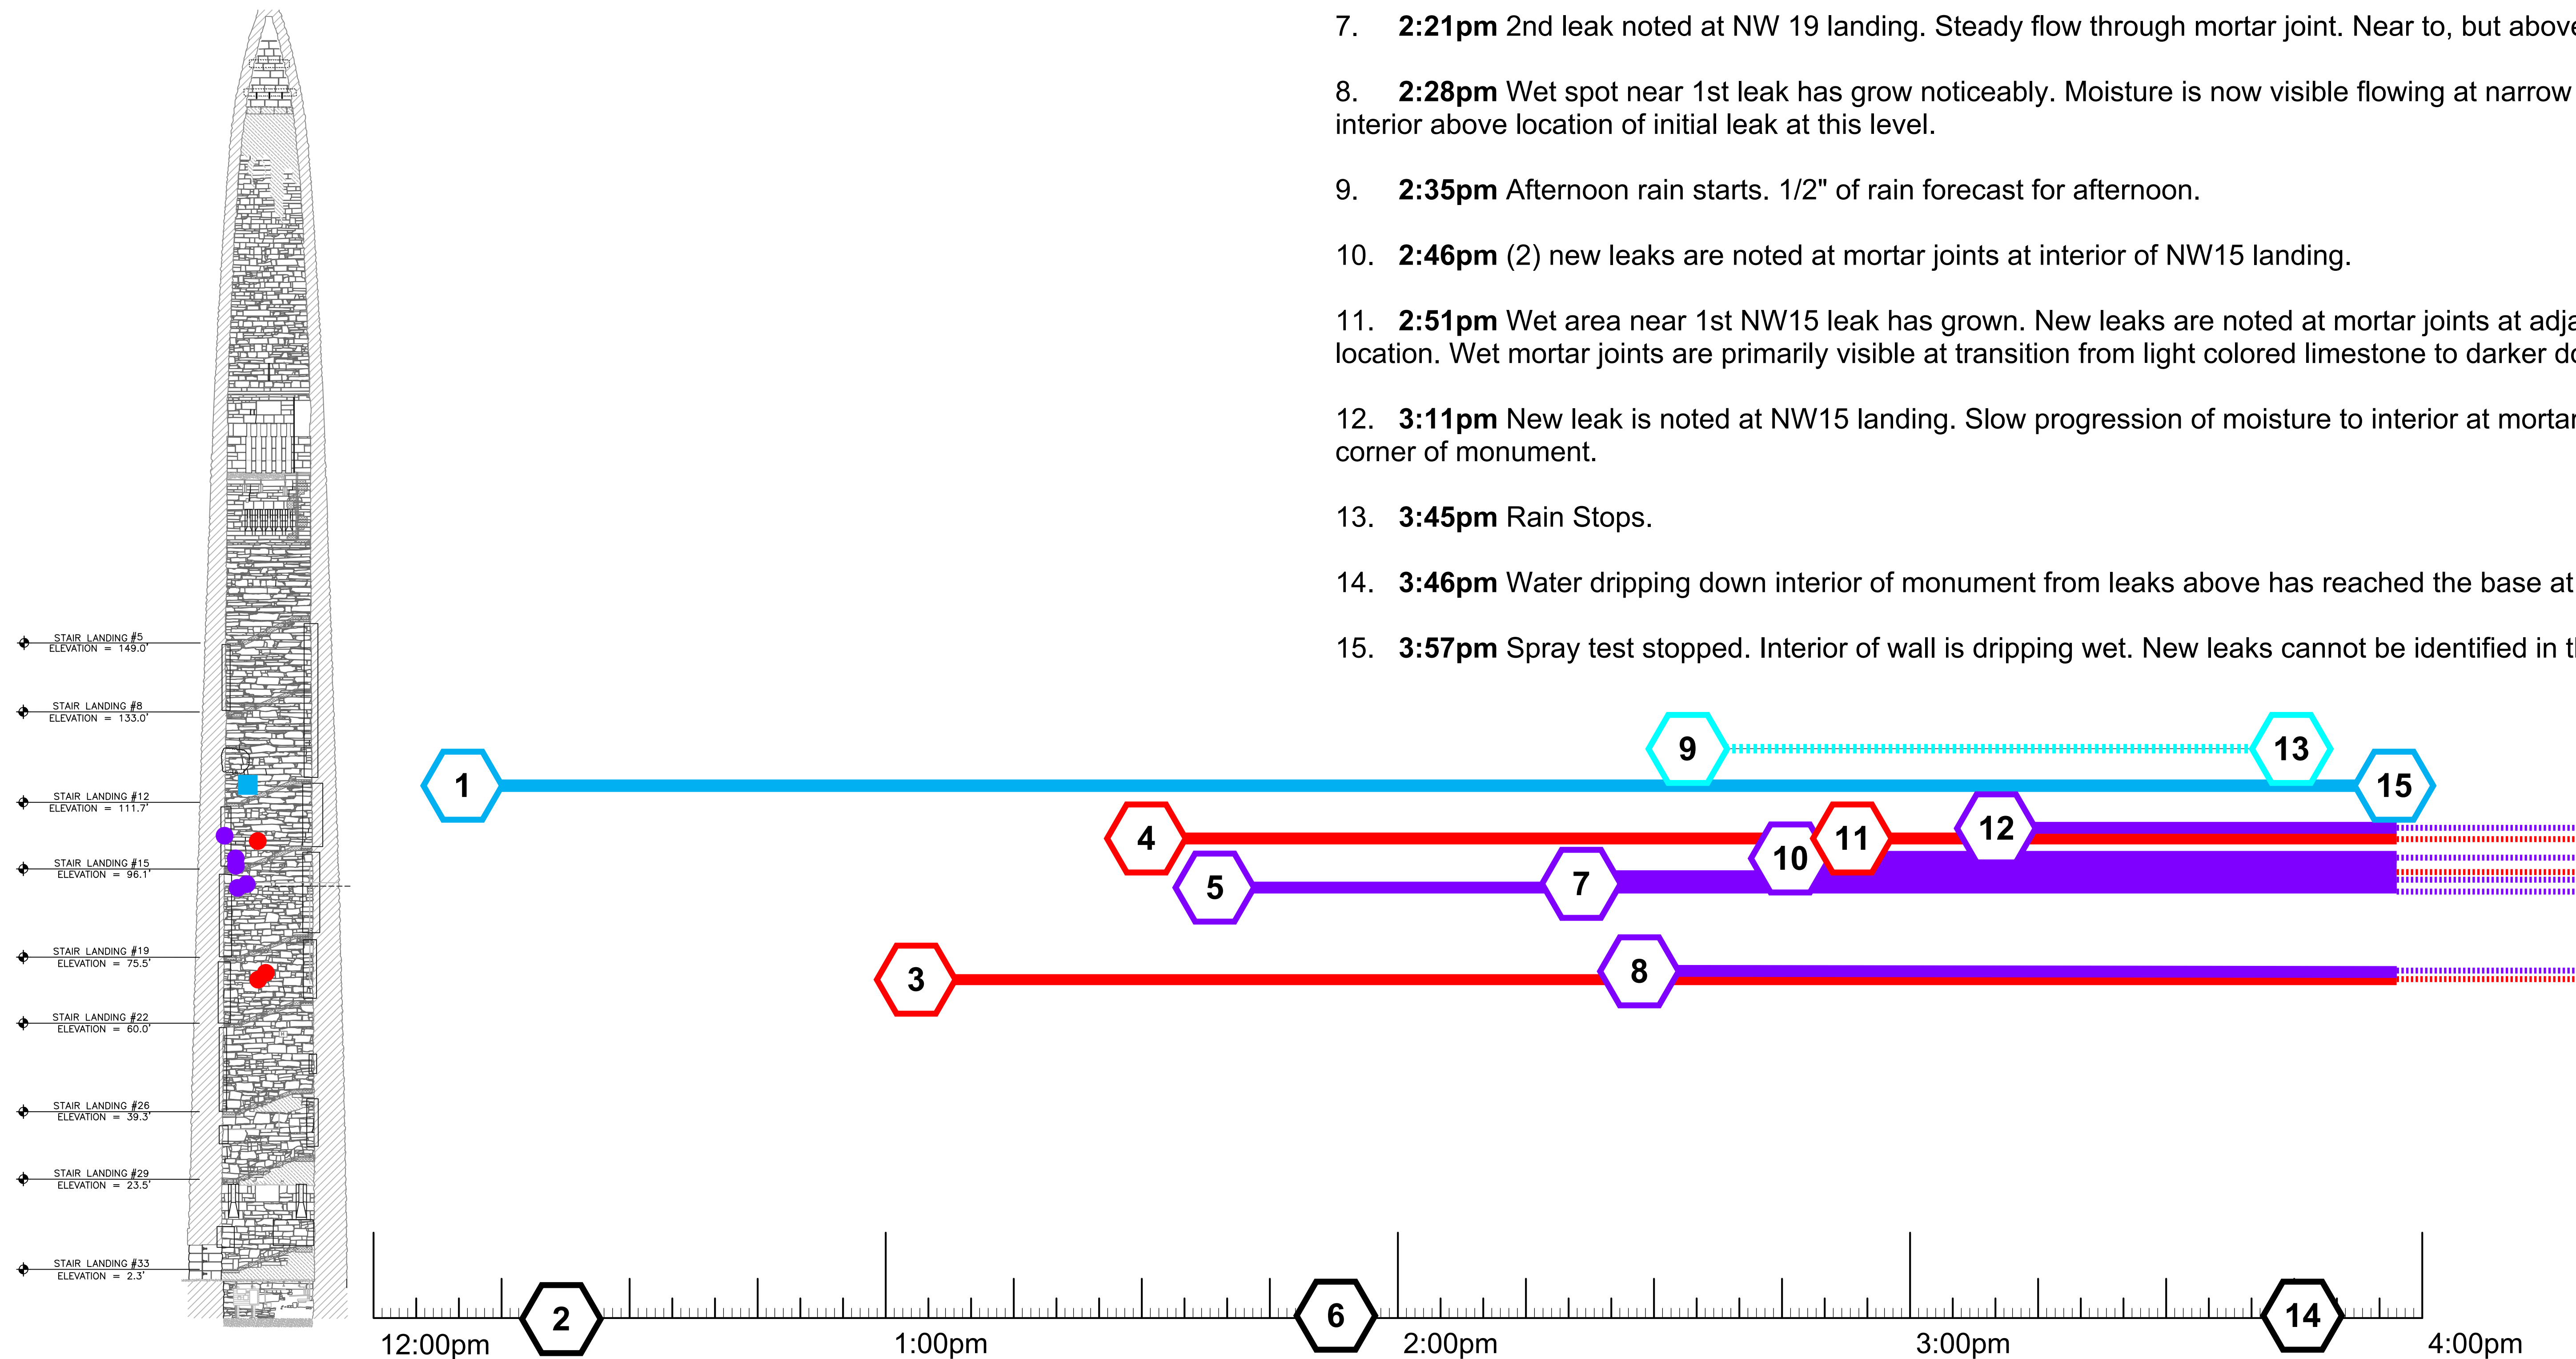
14. **3:46pm** Water dripping down interior of monument from leaks above has reached the base at the interior.
15. **3:57pm** Spray test stopped. Interior of wall is dripping wet. New leaks cannot be identified in the wash from old.

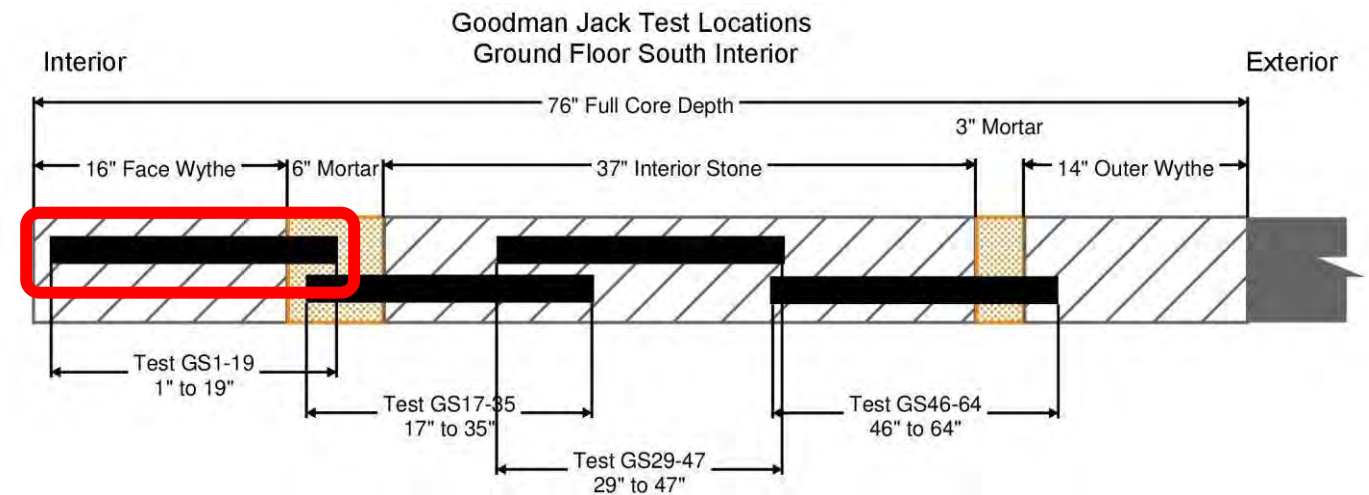
- Typically, two load cycles and two unloading cycles were tested at each Goodman Jack test location, unless there was material failure or equipment failure.

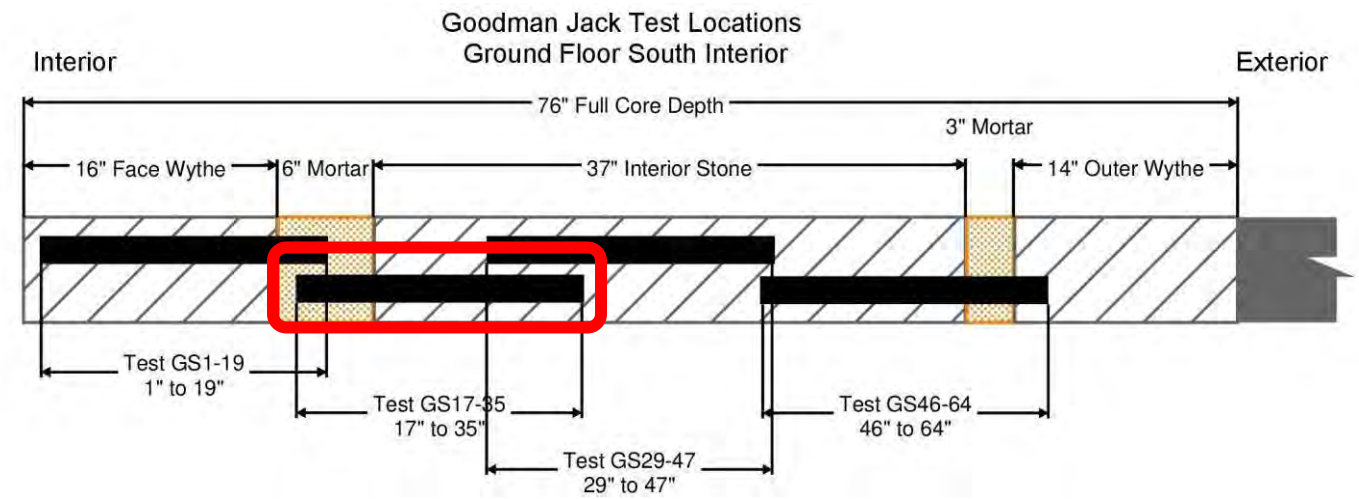
- Typically, two load cycles and two unloading cycles were tested at each Goodman Jack test location, unless there was material failure or equipment failure.

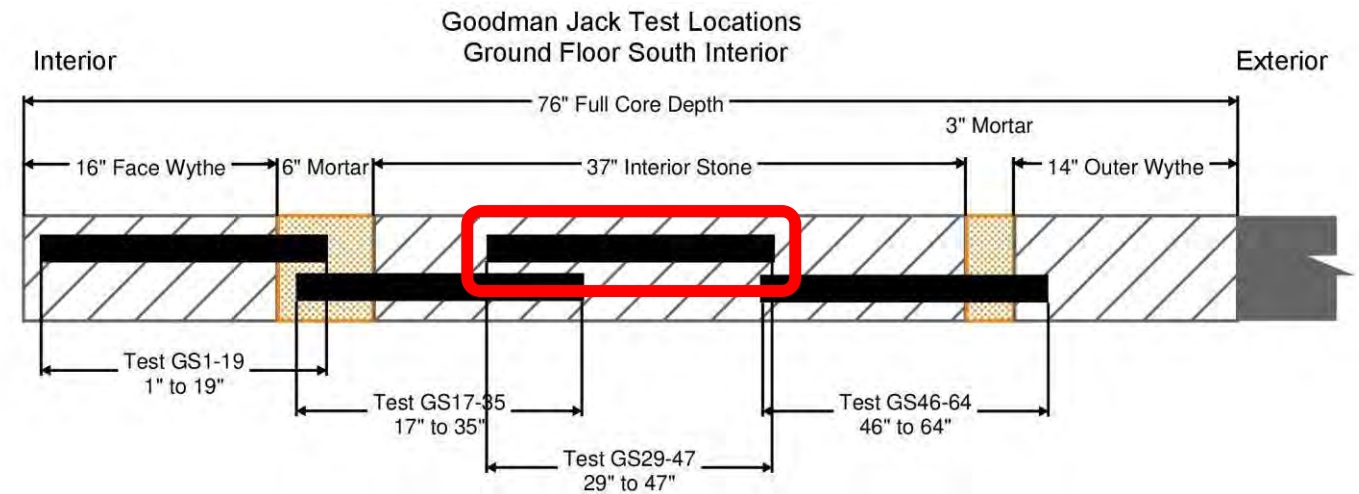
- Typically, two load cycles and two unloading cycles were tested at each Goodman Jack test location, unless there was material failure or equipment failure.

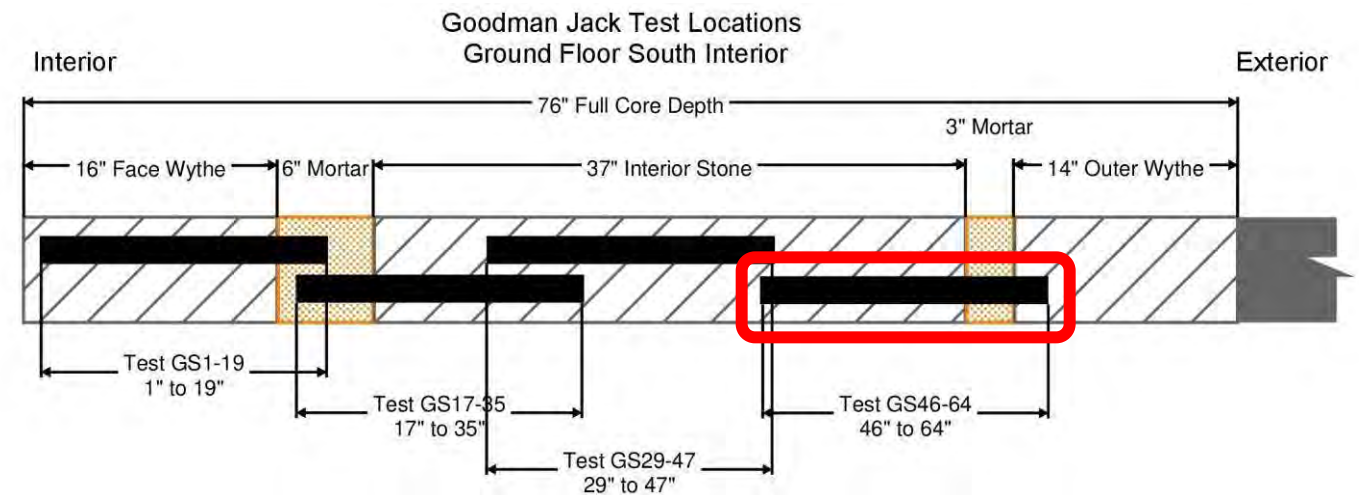
- Typically, two load cycles and two unloading cycles were tested at each Goodman Jack test location, unless there was material failure or equipment failure.

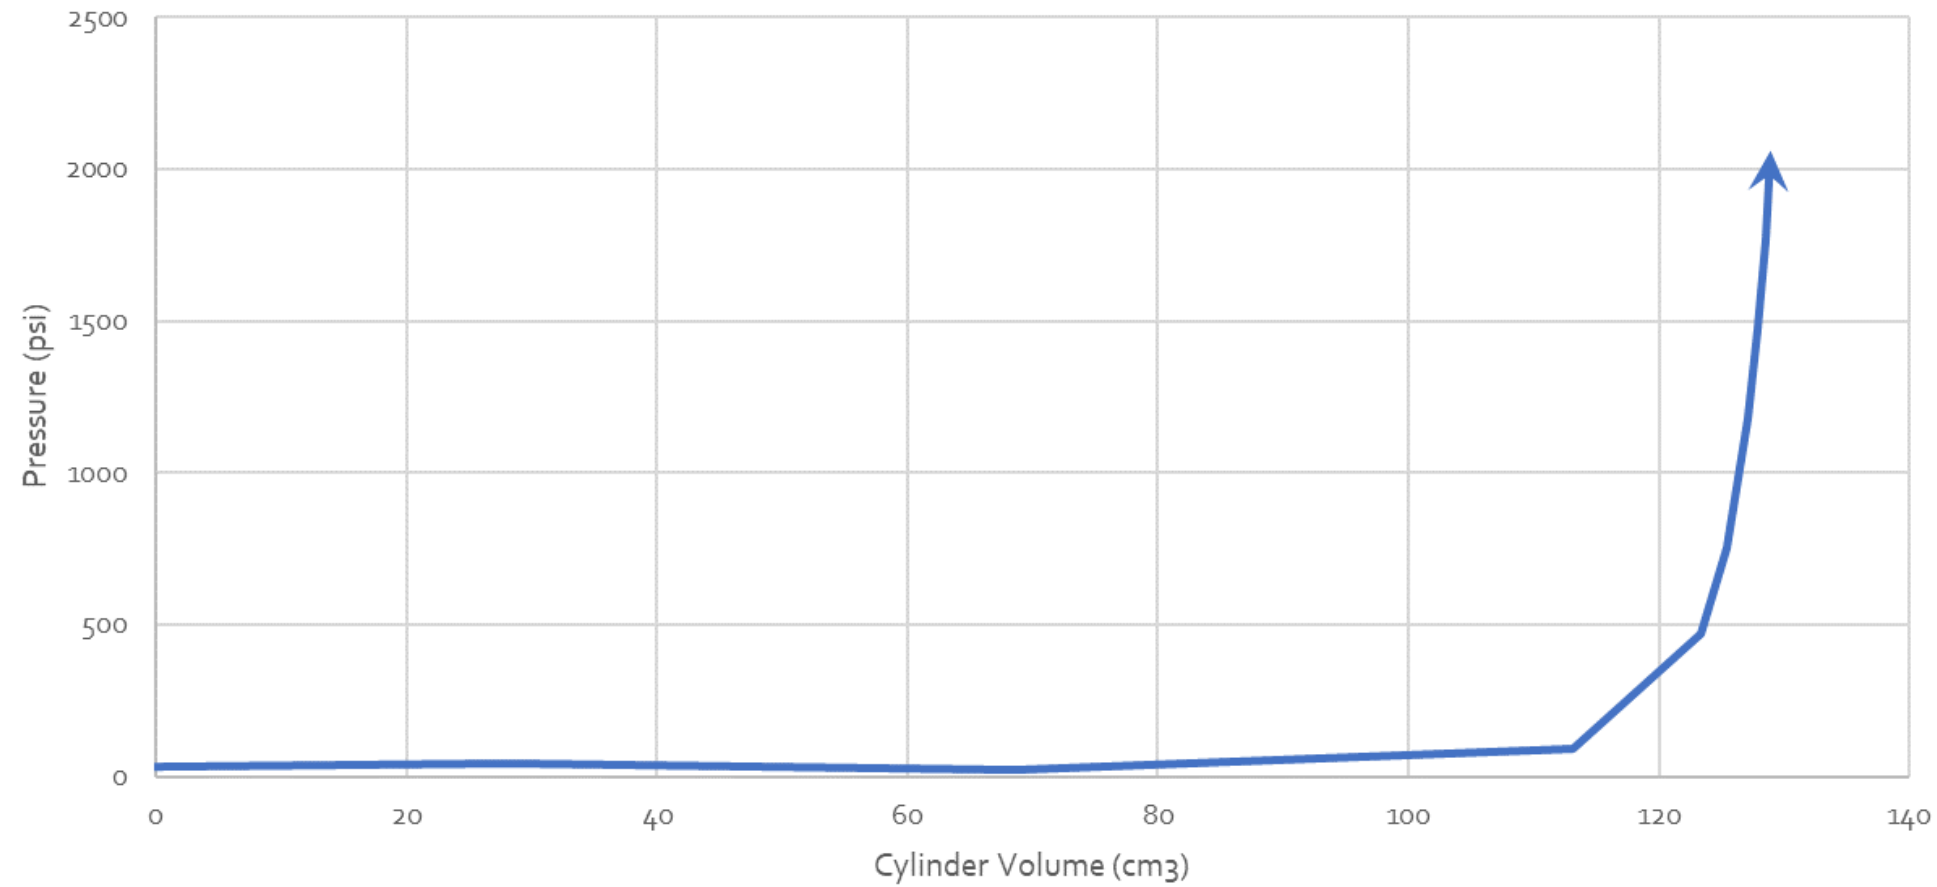
Reason for Stopping Test:
Failure of 18" face wythe observed during Load Cycle 1 and by means of vertical cracks opening for the full depth of the stone unit.

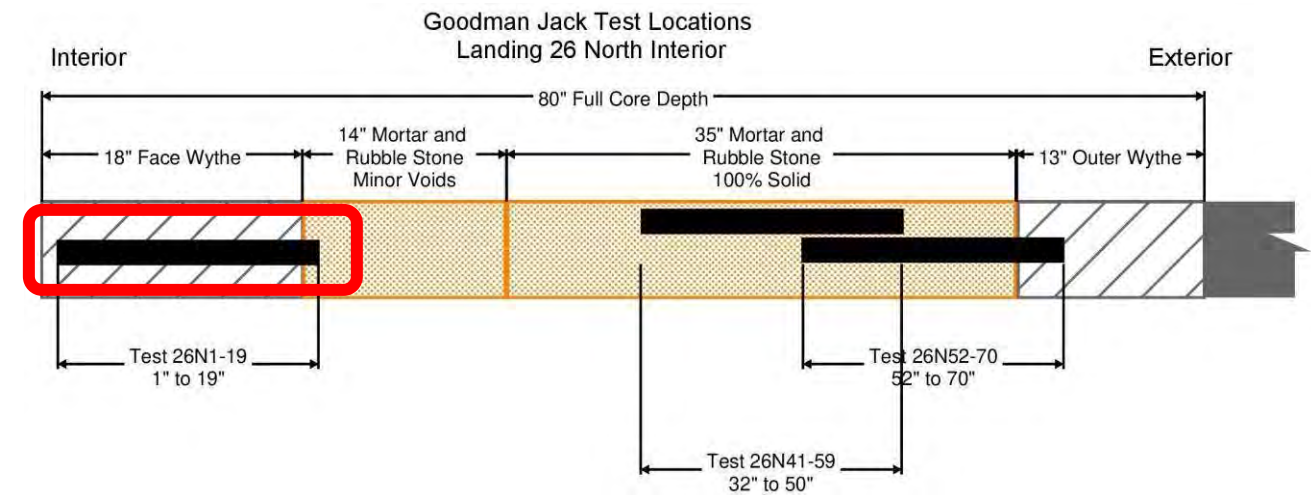
- Typically, two load cycles and two unloading cycles were tested at each Goodman Jack test location, unless there was material failure or equipment failure.

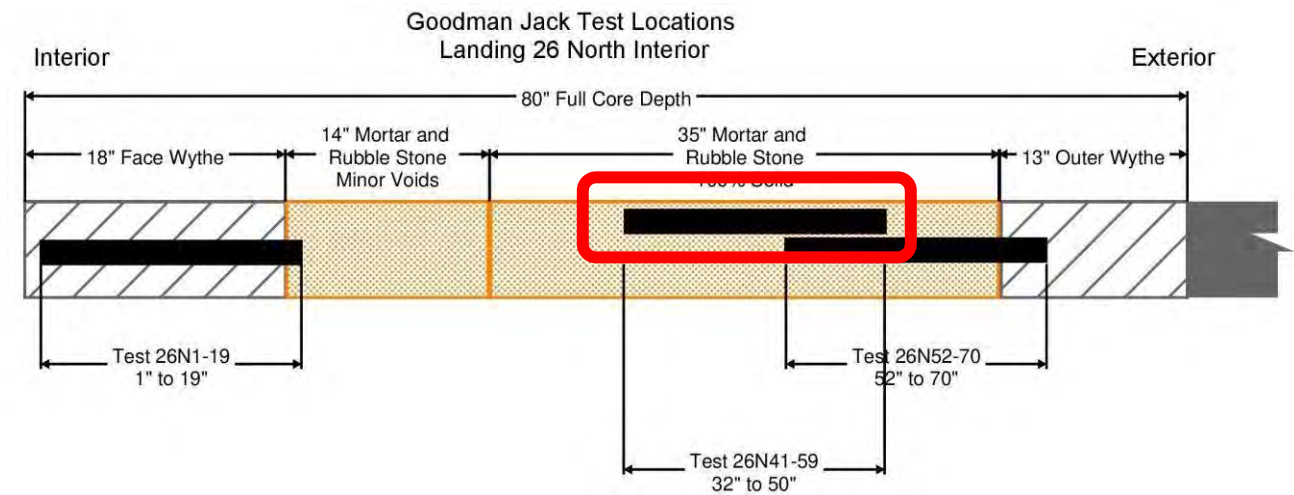
- Typically, two load cycles and two unloading cycles were tested at each Goodman Jack test location, unless there was material failure or equipment failure.

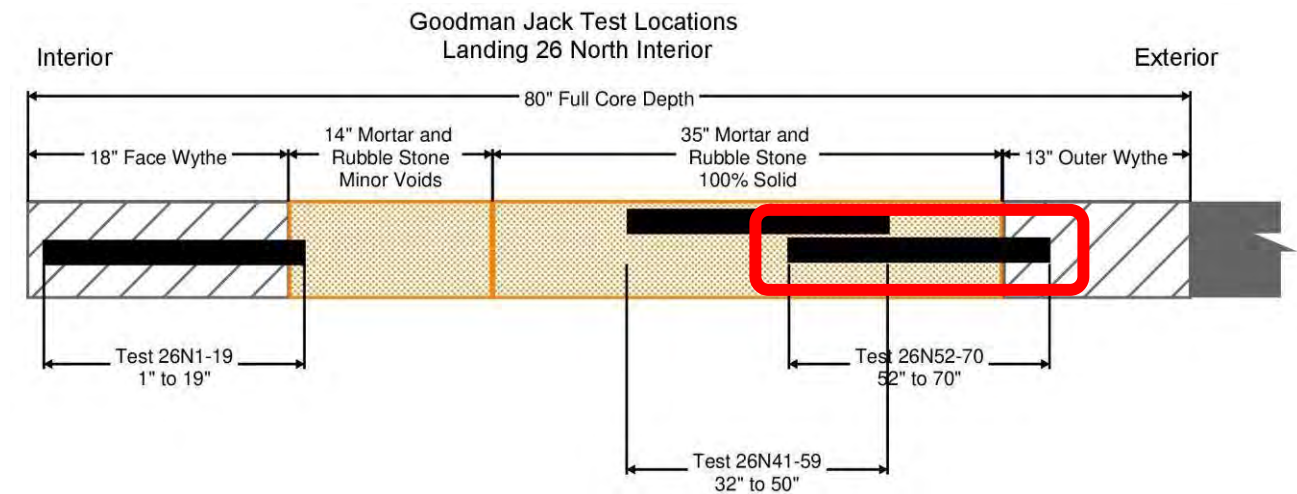
- Typically, two load cycles and two unloading cycles were tested at each Goodman Jack test location, unless there was material failure or equipment failure.

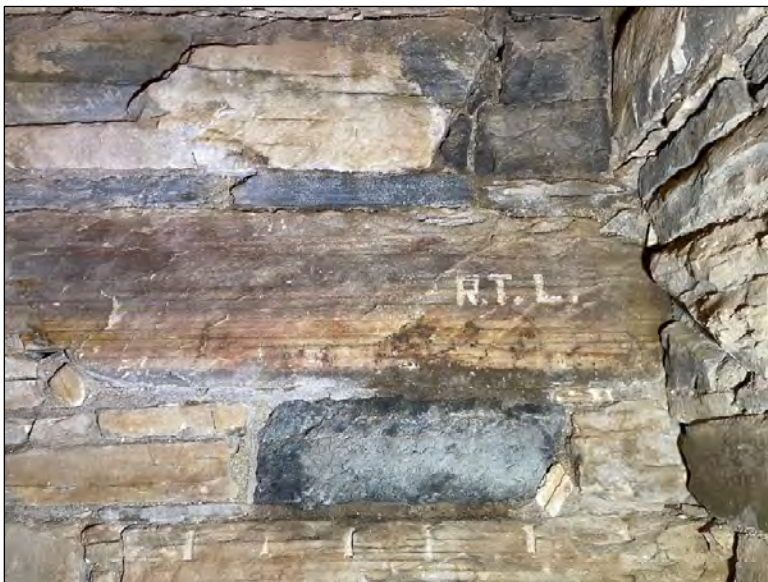
Figure 3. Typical interior coursed rubble masonry. Note color difference between stones.

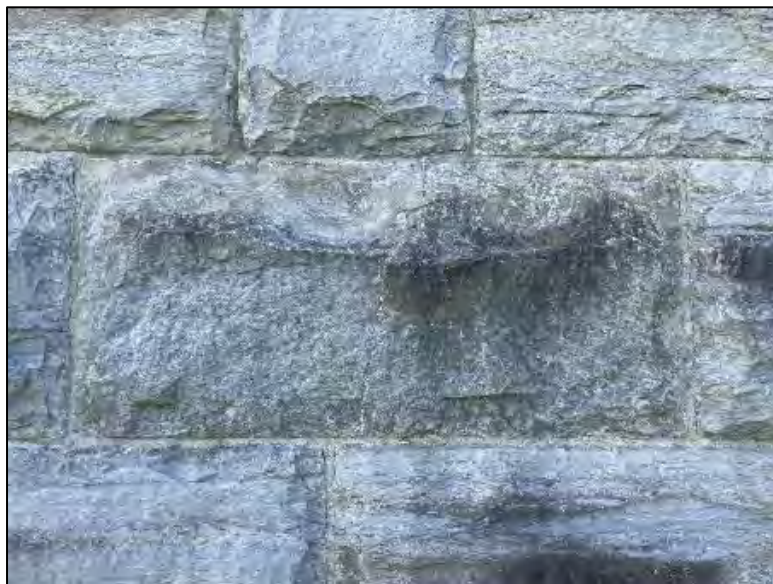
Figure 7. Exterior dolomitic limestone

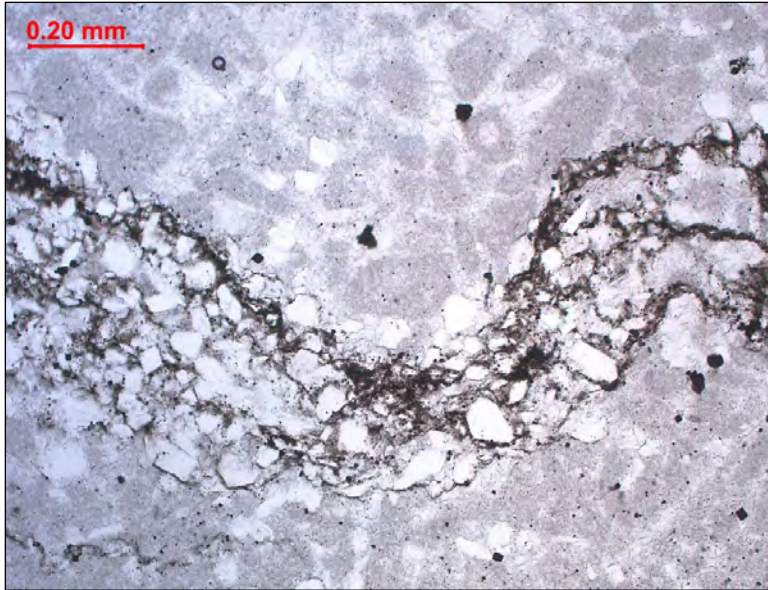
Figure 8. Photomicrograph of a stylolite (wave form running left to right) comprised of mostly quartz and sulfide grains in Sample JBC-East-6 (Plain polarized light, Credit: Highbridge).

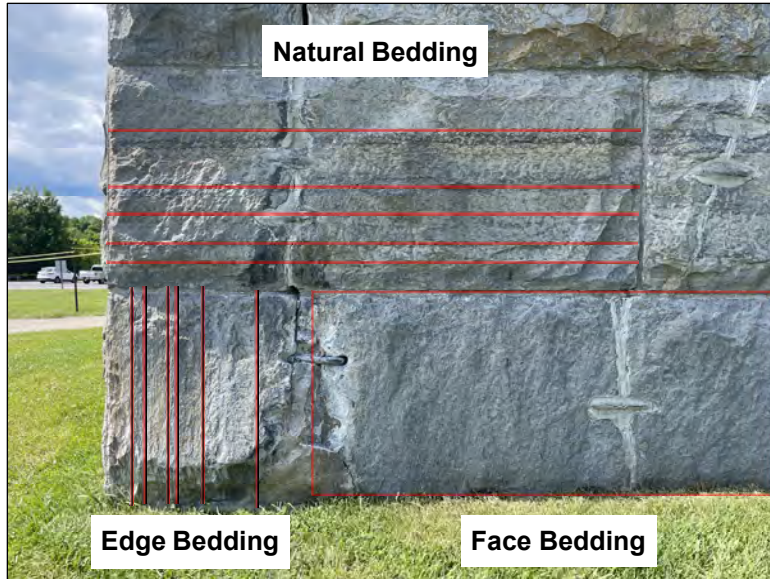
Figure 9. Corner of monument showing stones in three different orientations: natural bedding, face bedding, and edge bedding (bedding planes indicated).

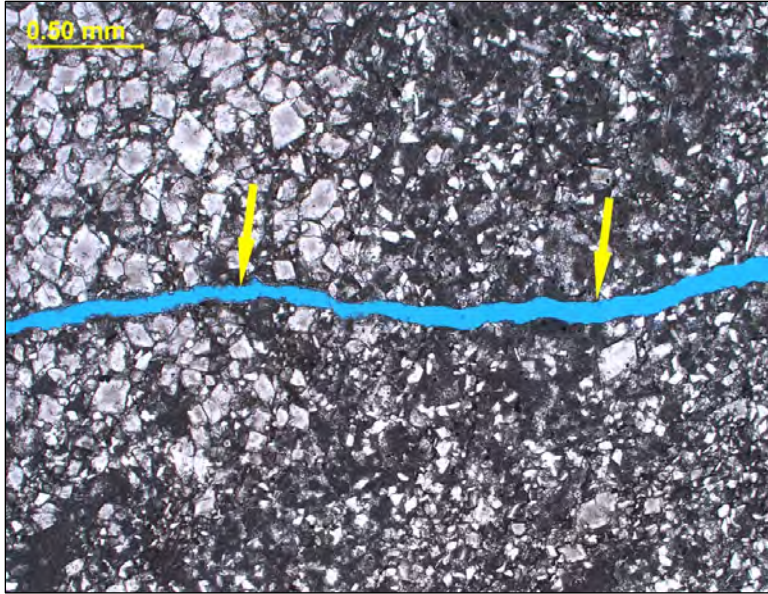
Figure 10. Photomicrograph of a microcrack filled with blue epoxy in Sample JBC-North-5 (Plain polarized light, Credit: Highbridge).

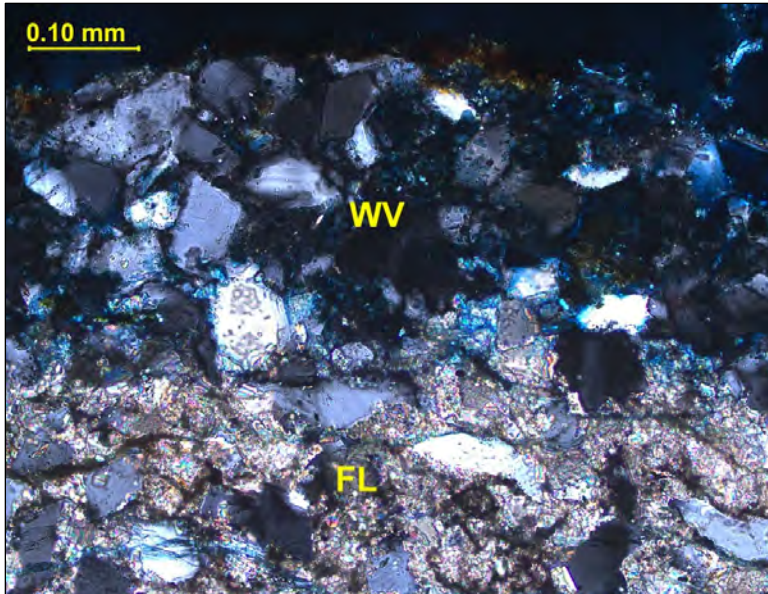
Figure 11. Photomicrograph of a cross-section through the exposed face (oriented to image top) of Sample JBC-East-7, showing carbonate minerals present in the fresh limestone (FL) that have preferentially dissolved within the weathered veneer (WV) leaving voids filled with blue epoxy (Crossed-polarized light, Credit: Highbridge).

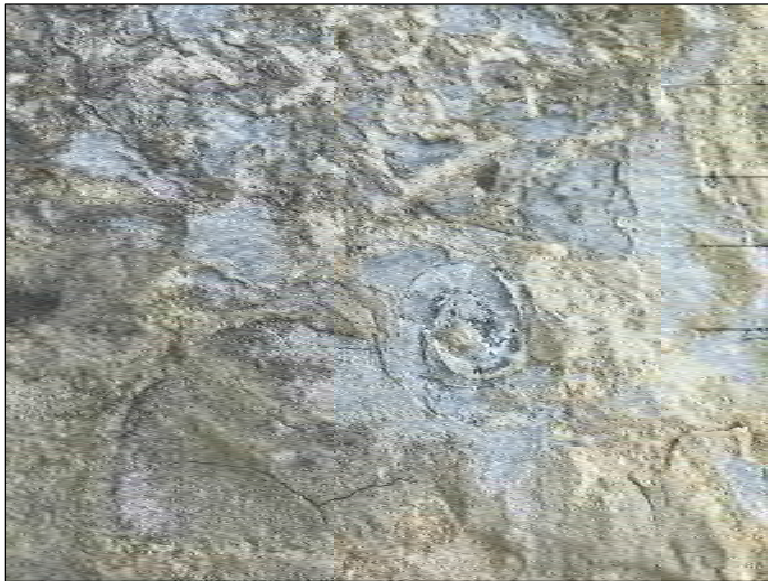
Figure 12. Exterior stone showing an uneven surface texture caused by preferential weathering of acid-soluble carbonate material. A fossilized ammonite, the extinct relative of sea creatures such as the modern nautilus, is visible at image center.

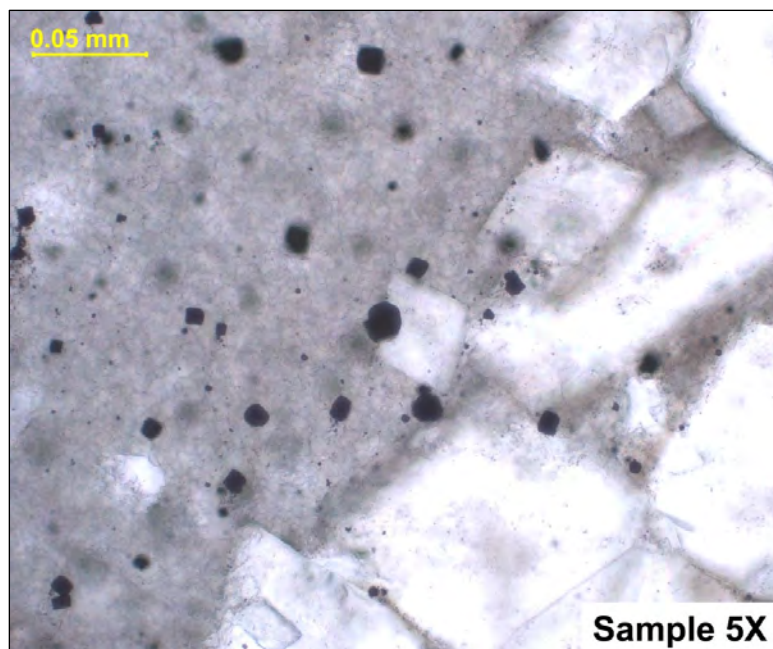
Figure 13. Photomicrograph of dark-colored iron sulfide particles (pyrite) dispersed throughout the matrix in Sample JBC-North-5 (Plane polarized light, Credit: Highbridge).

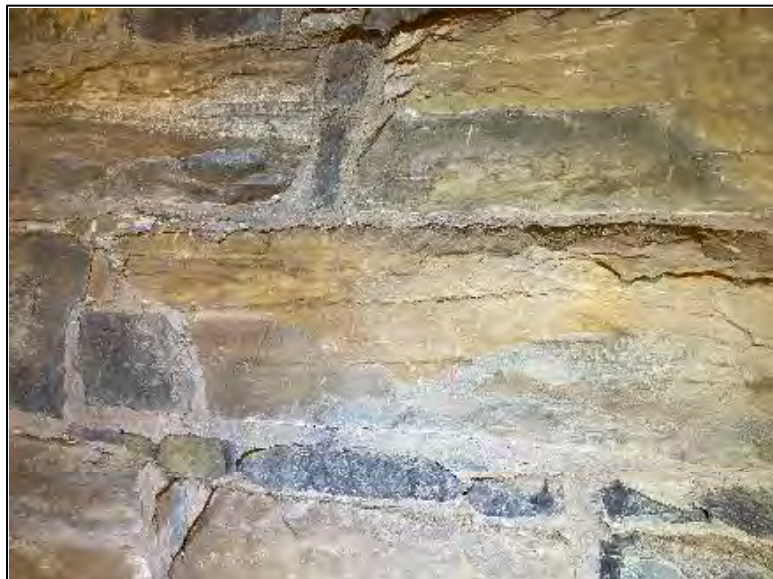
Figure 14. Interior calcitic marble (stone at image center).

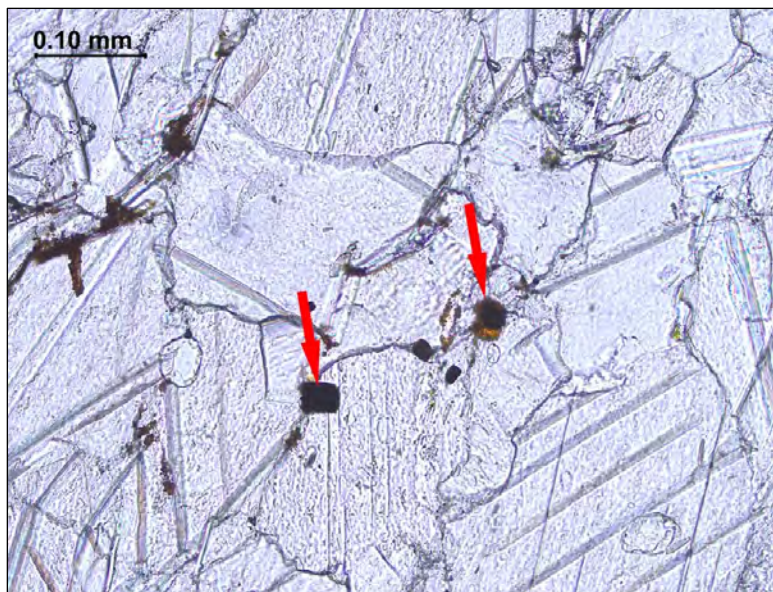
Figure 15. Photomicrograph of Sample JBC-East-2 in plane polarized light showing reddish brown iron oxide particles (indicated) responsible for the diffuse orange veining (Credit: Highbridge).

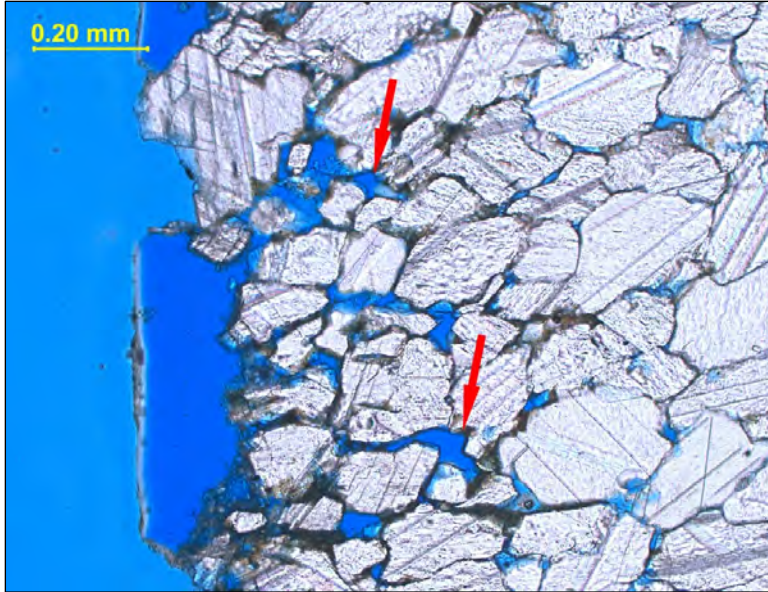
Figure 17. Photomicrograph taken at the outer, exposed surface of Sample JBC-West-1 in plane polarized light, showing open pores (indicted) created by acid dissolution of the constituent calcite grains (Credit: Highbridge).

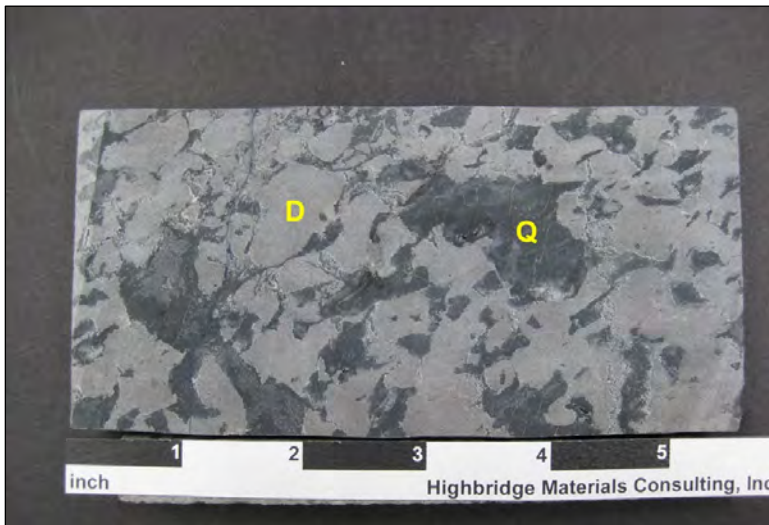
Figure 19. Freshly cut section through breccia showing angular dolostone fragments (D) in a matrix of recrystallized quartz (Q) (Sample JBC-West-4, Credit: Highbridge).

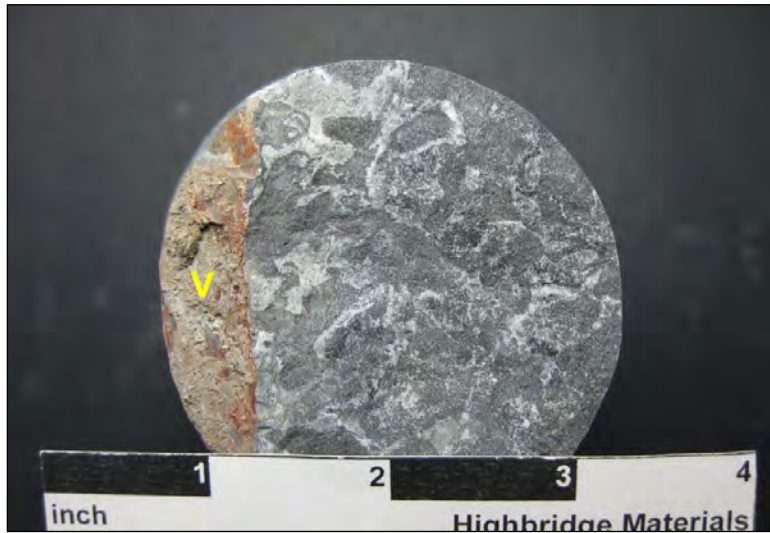
Figure 20. Breccia core showing bisected vein (V) stained reddish brown by iron oxide (Sample JBC-West-4, Credit: Highbridge).

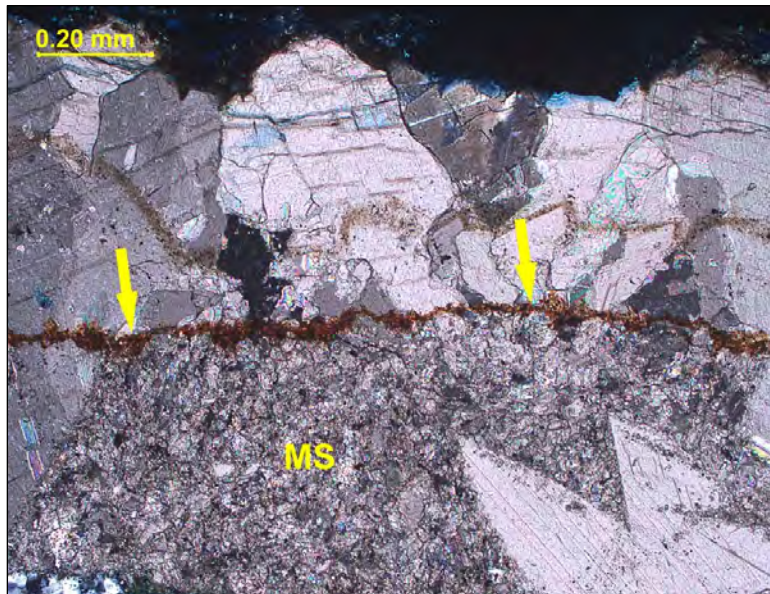
Figure 21. Photomicrograph of a section through a vein showing its reddish-brown iron oxide lining (hematite, indicated) surrounded by dolomite crystals and a sliver of microsparite (MS) that has not been completely replaced by dolomite (Cross-polarized light, Credit: Highbridge).

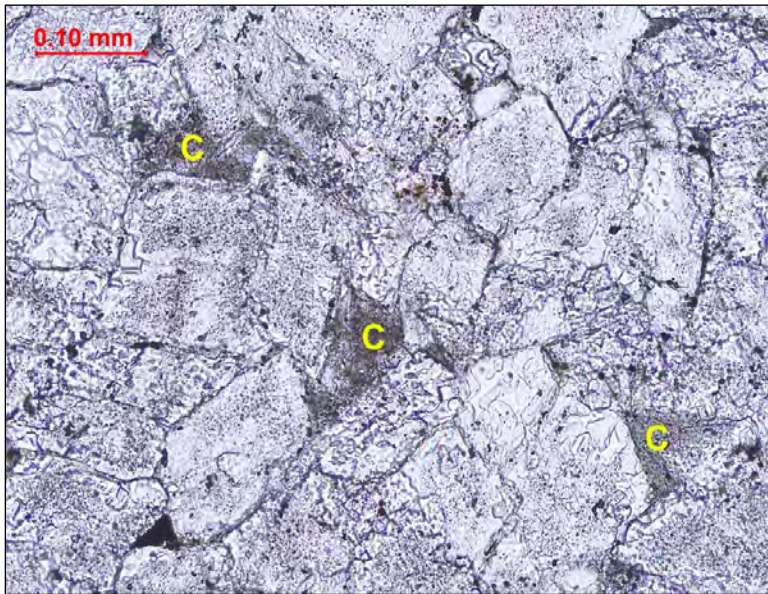
Figure 22. Photomicrograph showing clay filling interstices between dolomite crystals (Plane polarized light, Credit: Highbridge).

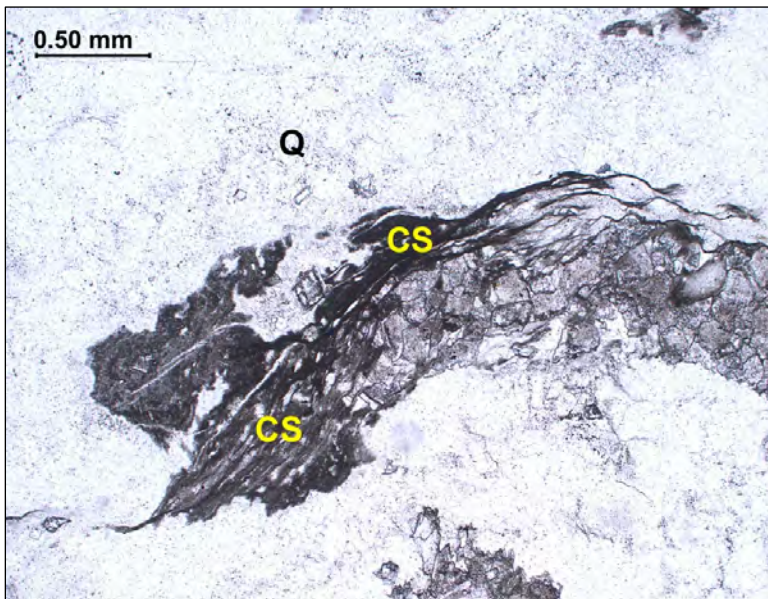
Figure 23. Photomicrograph of clay seam surrounded by quartz (Plane polarized light, Credit: Highbridge).

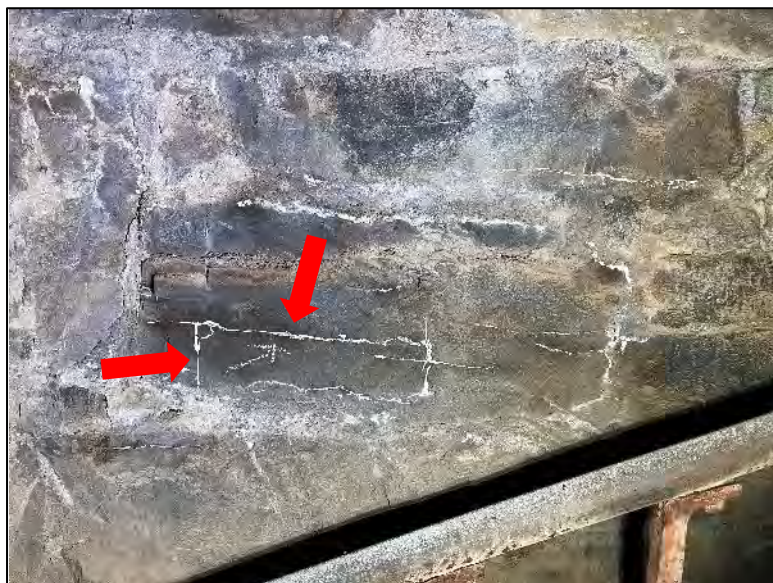
Figure 24. Orthogonal cracks (indicated) in an interior breccia unit. White efflorescence or carbonate deposits occur along the cracks.

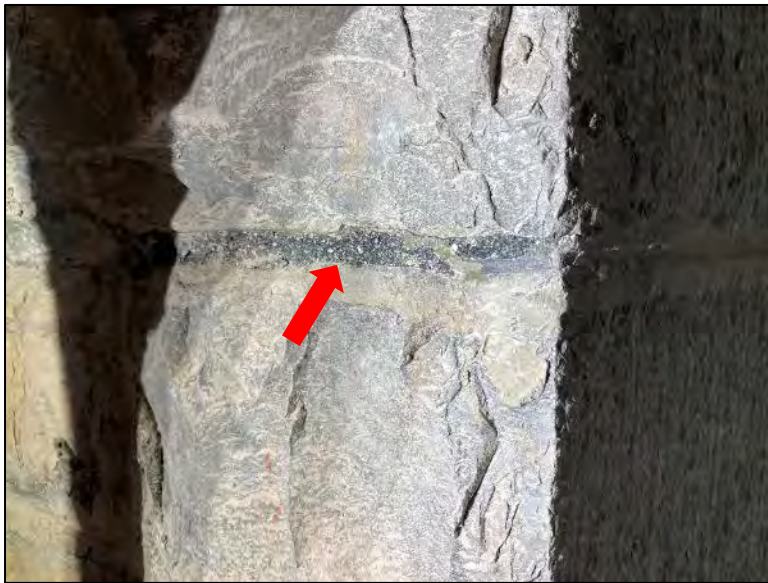
Figure 28. Black-colored pointing mortar (indicated) at interior window return is likely original pointing mortar.

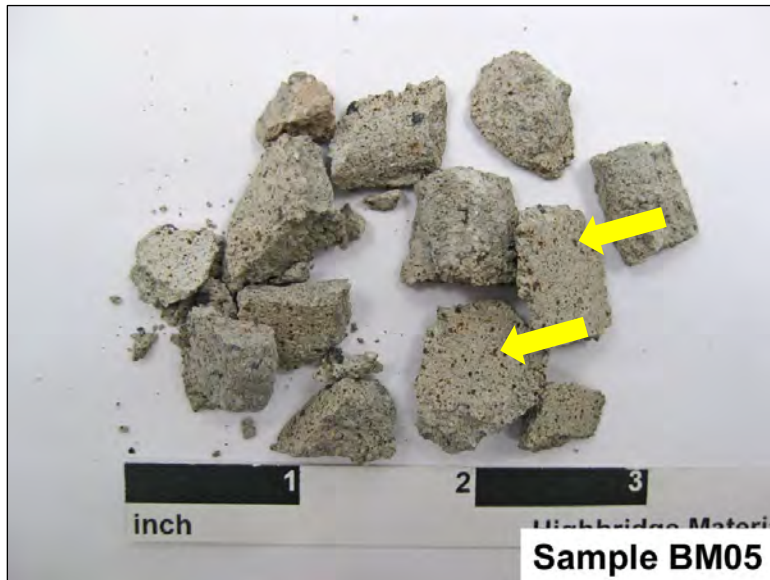
Figure 29. Sample BM-05 with reddish brown iron oxide spots indicated (Credit: Highbridge).

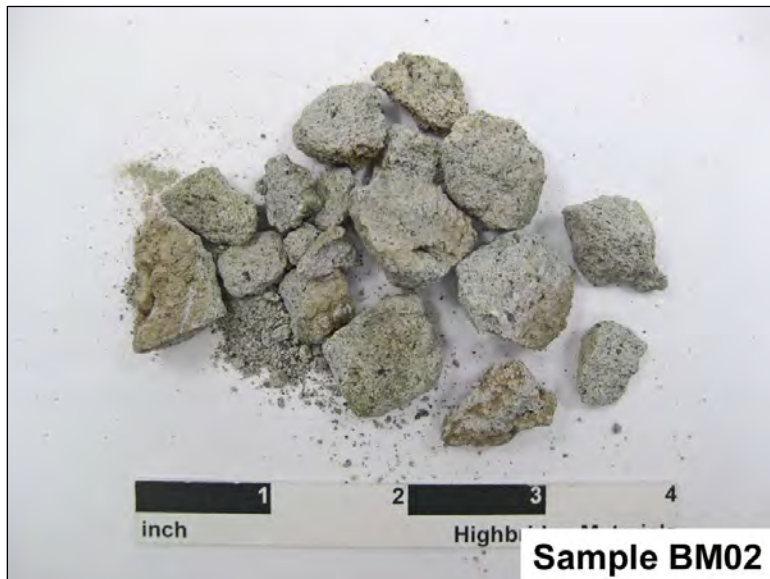
Figure 30. Sample BM-02 (Credit: Highbridge).

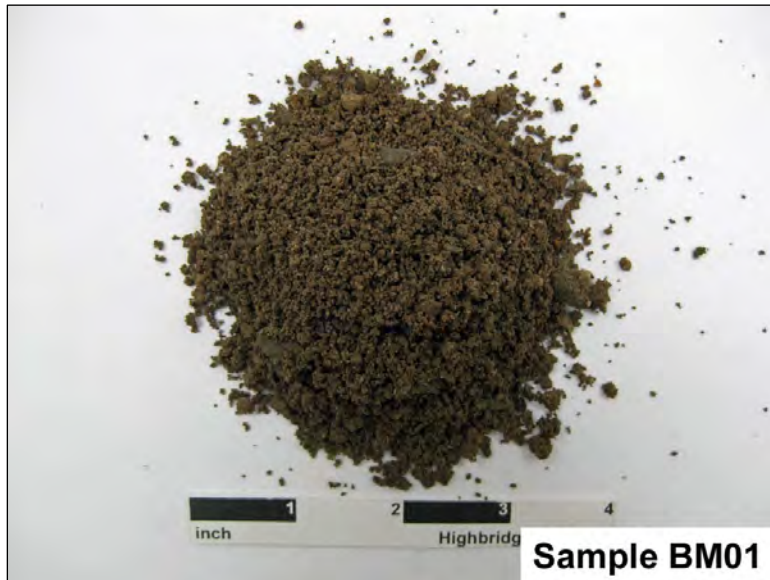
Figure 31. Sample BM-01 showing deteriorated condition of mortar (Credit: Highbridge).

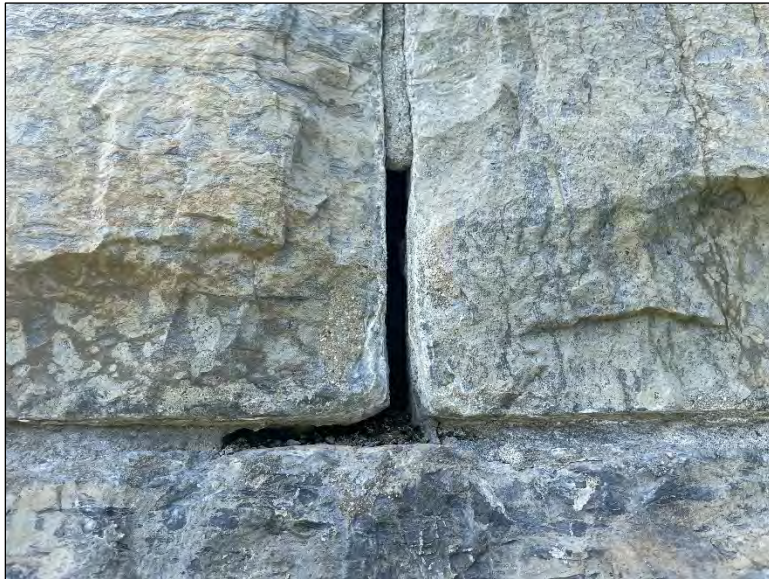
Figure 32. Sampling location for BM-01 (open joint).

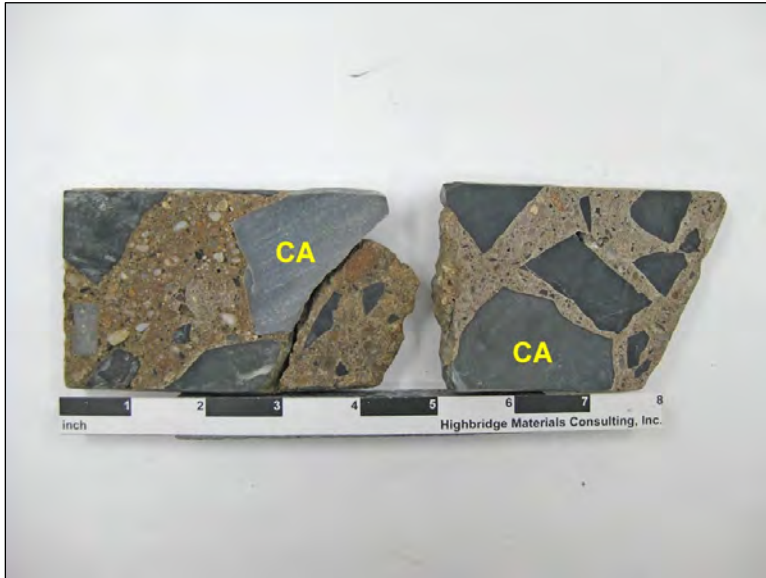
Figure 33. Section through sample ANA-South-4 showing large, crushed limestone aggregate (CA) surrounded by a paste of fine aggregate and cement.

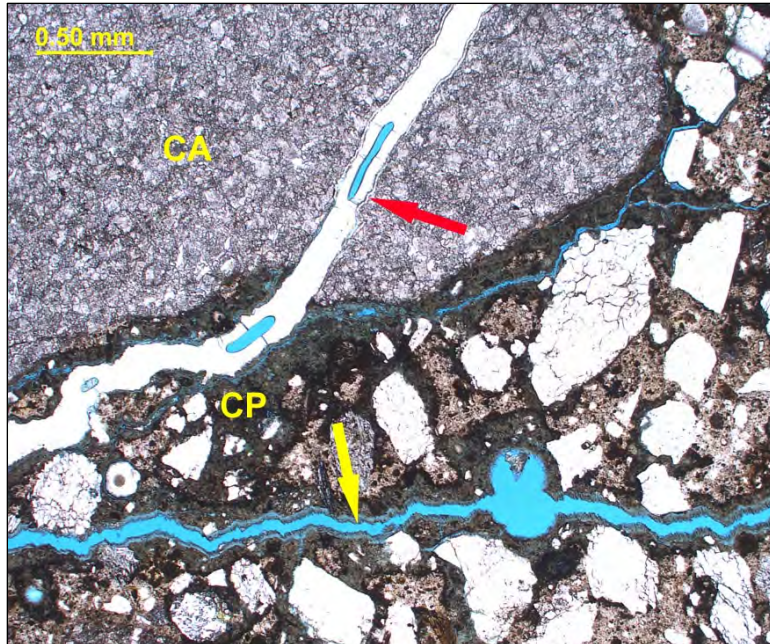
Figure 34. Photomicrograph of sample ANA-South-4 showing a crack (red arrow) transecting a coarse aggregate particle (CA). While this crack is mostly filled with colorless epoxy, a thin veneer of reaction gel lines the crack surfaces. The crack (yellow arrow) extends into the cement paste (CP). (Cross polarized light, Credit: Highbridge.)

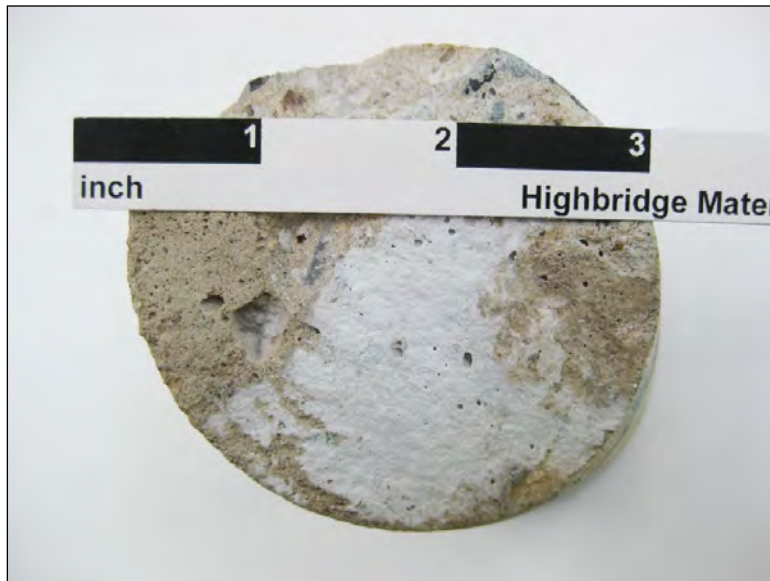
Figure 35. Formed end of core sample ANA-South-4 showing a thin white residue consisting of alkali-aggregate reaction gel.

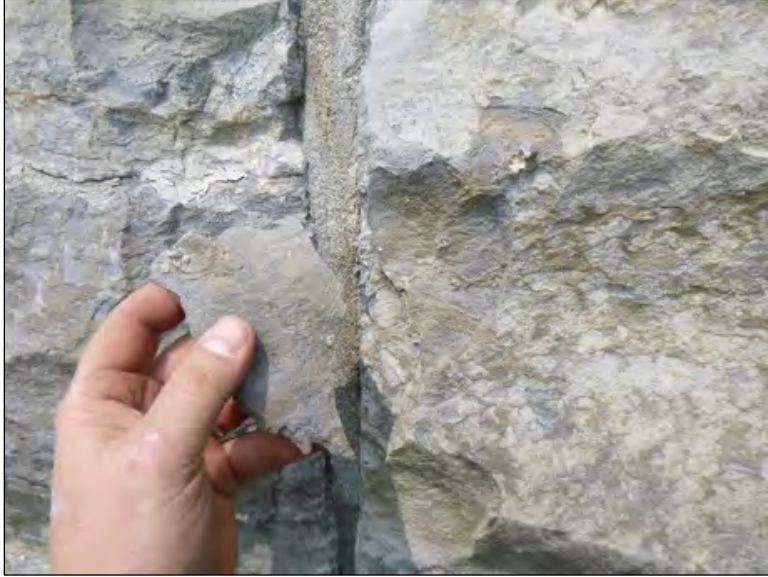
Figure 36. Spall removed from the exterior stone masonry (Credit: Vertical Access).
