03/29/2024

**STRUCTURAL AND ELECTRICAL ASSESSMENT OF
THE BENNINGTON BATTLE MONUMENT**

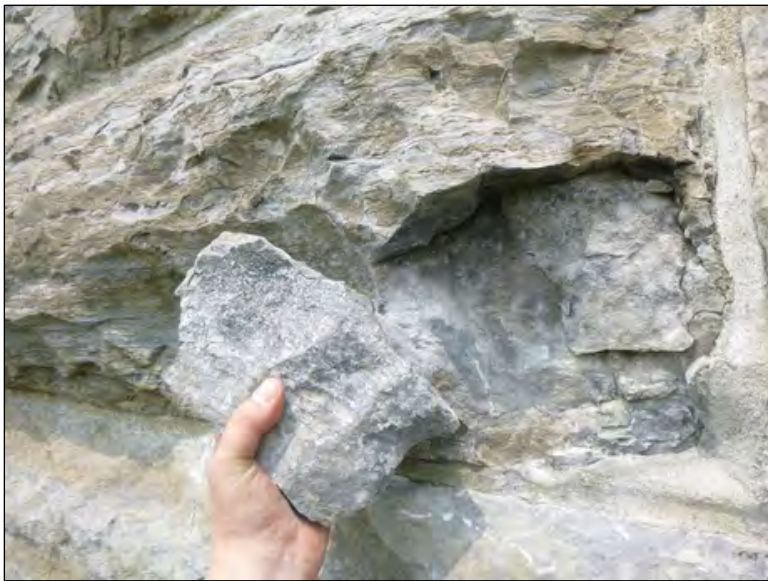
Figure 37. Spall removed from the exterior stone masonry (Credit: Vertical Access).

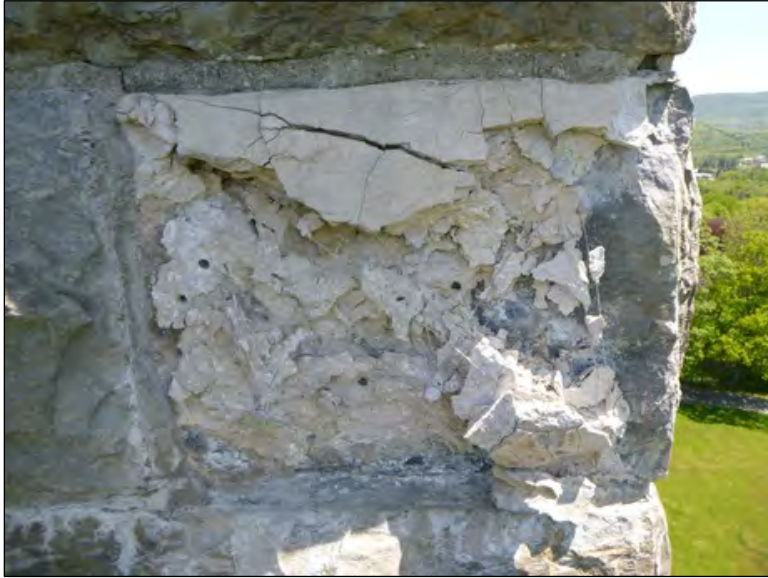
Figure 38. Cracked and spalled cementitious patch repair (Credit: Vertical Access).

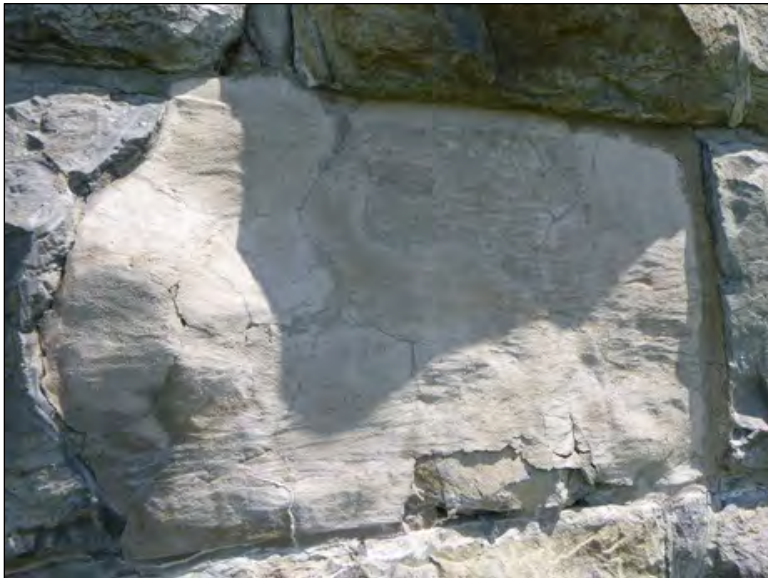
Figure 39. Cracked and failed parge coat applied over the face of a stone (Credit: Vertical Access).

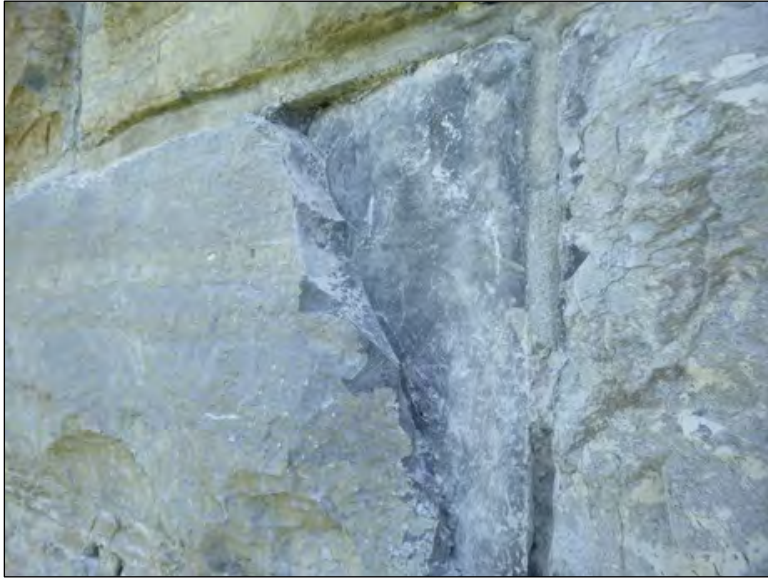
Figure 40. Delamination in a stone at the upper portion of the monument (Credit: Vertical Access).

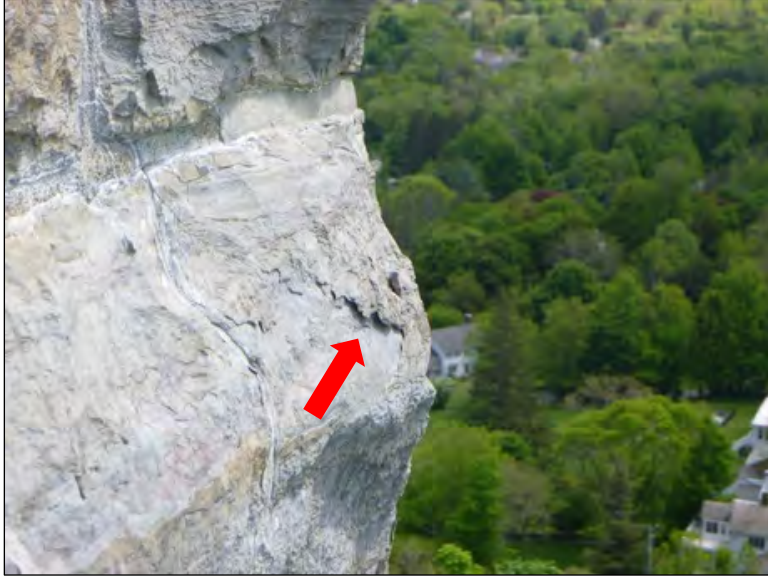
Figure 41. Scaling (indicated) in a stone at the upper portion of the monument (Credit: Vertical Access).

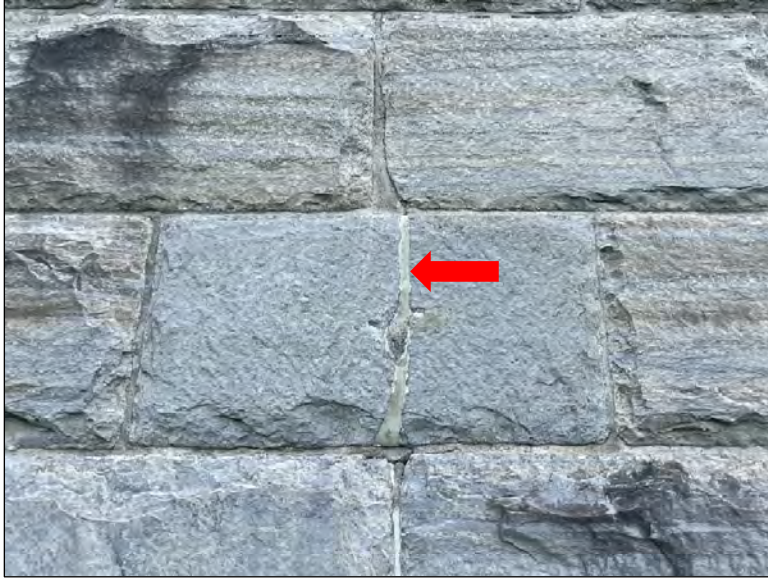
Figure 42. Exterior crack (indicated, repaired with caulk) showing typical vertical orientation and location below mortar joint.

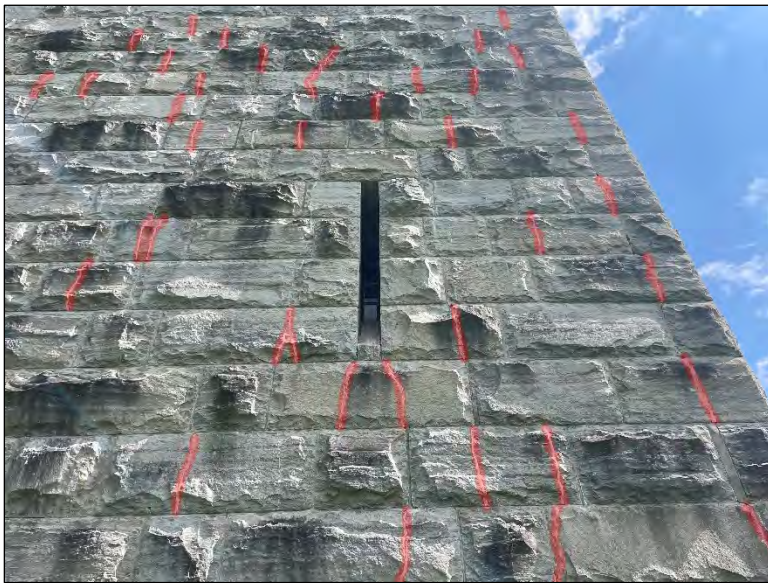
Figure 43. Exterior of monument with cracks highlighted in red. Note that most cracks fall below a vertical mortar joint.

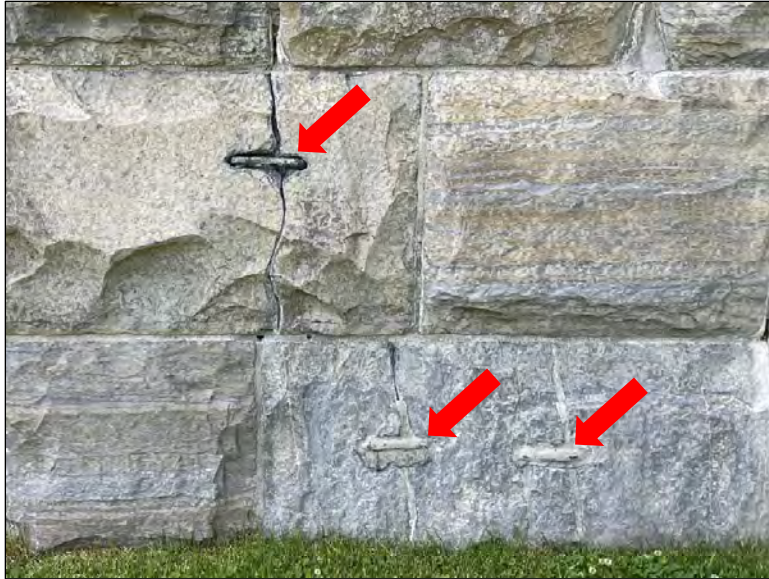
Figure 44. Bronze cramps (indicated) used to stabilize cracks at the base of the monument. Lower cramps have been sealed with elastomeric caulk.

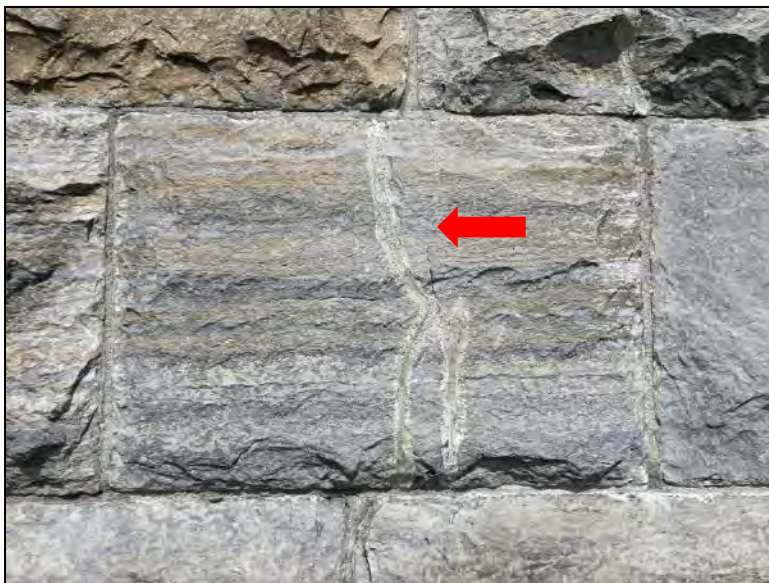
Figure 45. A previously repaired crack with a fresh hairline crack (indicated) extending from the repair.

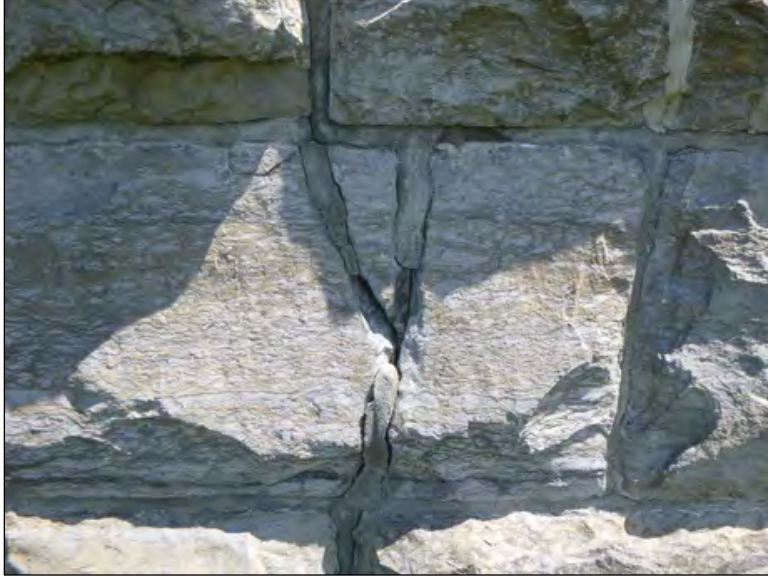
Figure 46. Detached and failed cementitious crack repair (Credit: Vertical Access).

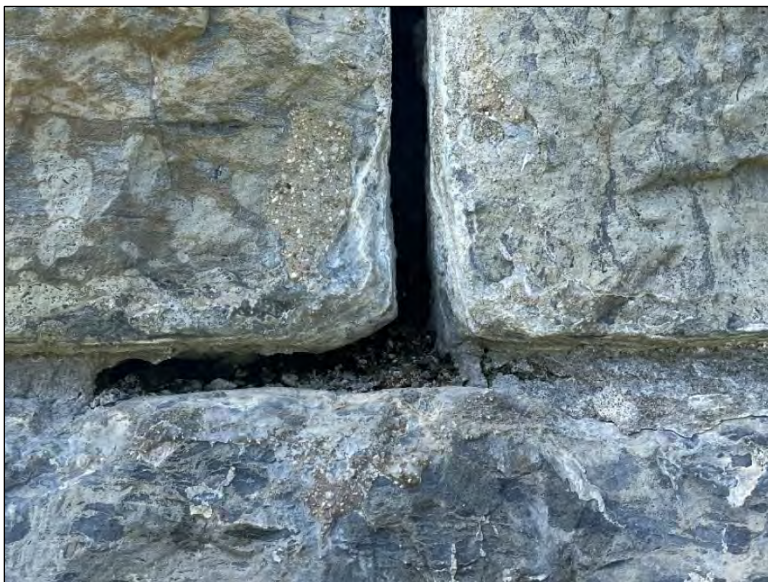
Figure 47. Detail of a typical open joint showing accumulation of crumbly mortar and debris at bottom of joint.

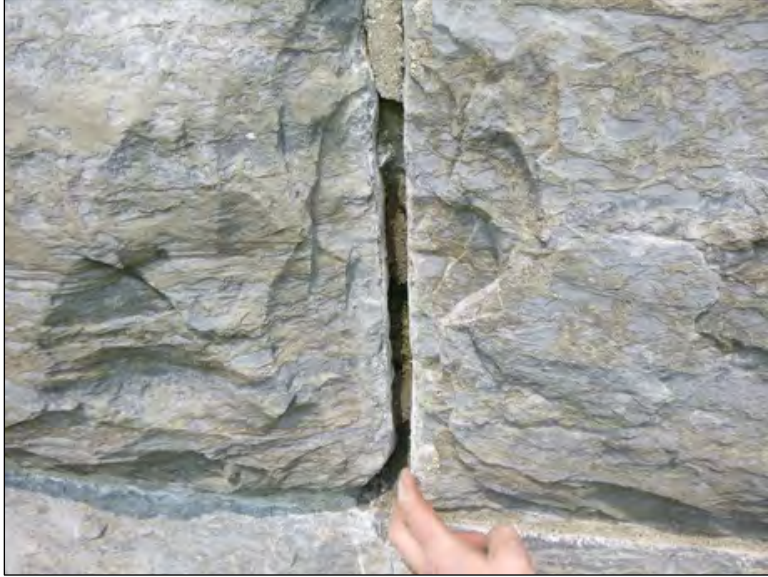
Figure 48. Typical open joint at upper portion of monument. Note mortar at top of joint is deteriorated but remains firmly in place. (Credit: Vertical Access.)

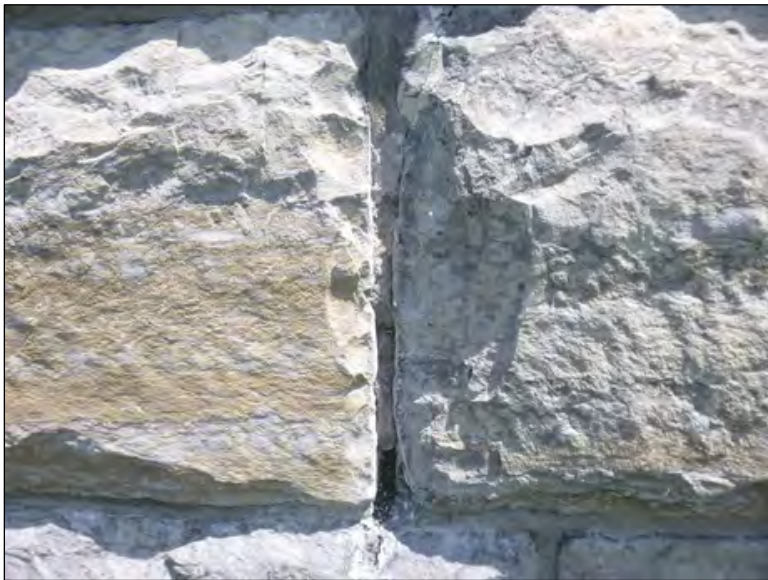
Figure 49. Typical open joint at upper portion of monument. Note mortar at top of joint is deteriorated but remains firmly in place. (Credit: Vertical Access.)

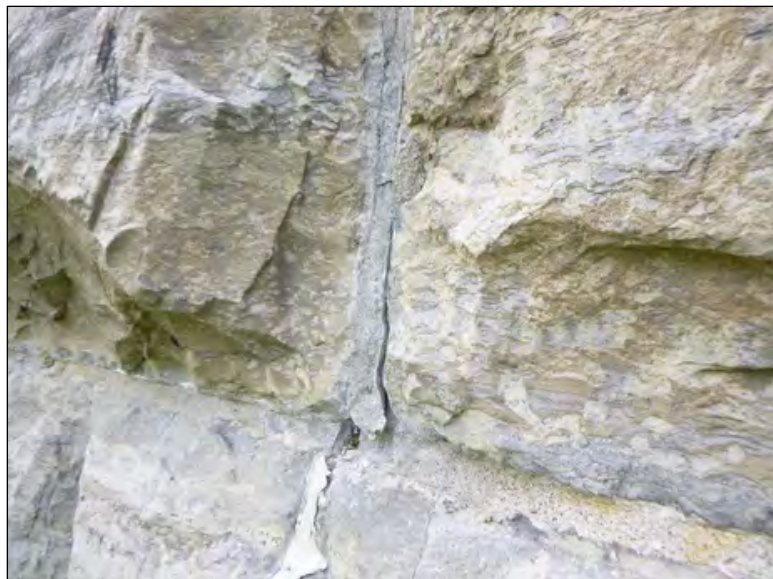
Figure 50. Failed mortar joint at upper portion of monument, possibly resulting from the use of incompatible repointing mortar (Credit: Vertical Access).

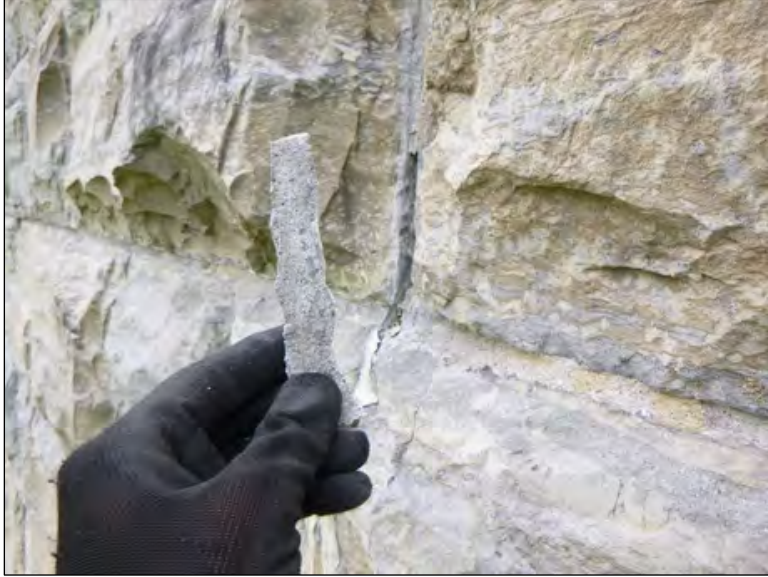
Figure 51. Failed mortar joint at upper portion of monument removed (Credit: Vertical Access).

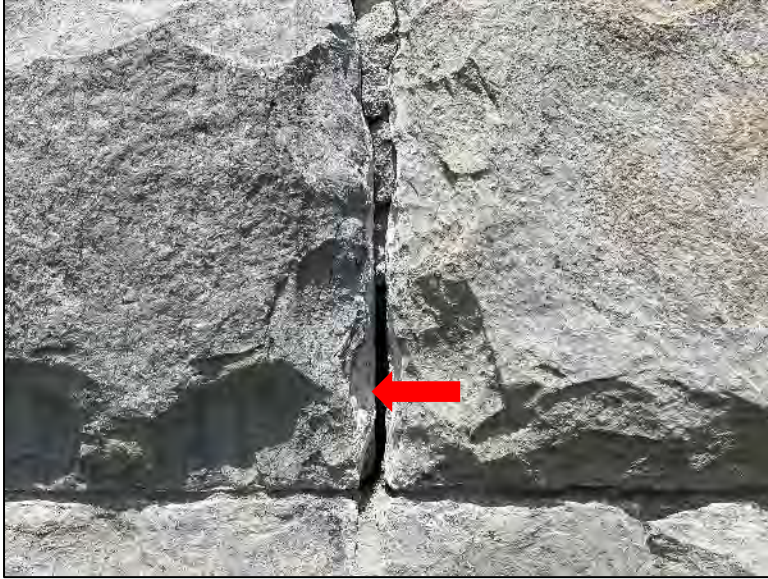
Figure 52. Residue from a previous caulking campaign (indicated) observed below a repointing campaign employing hard, Portland cement-rich mortar that has detached and failed.

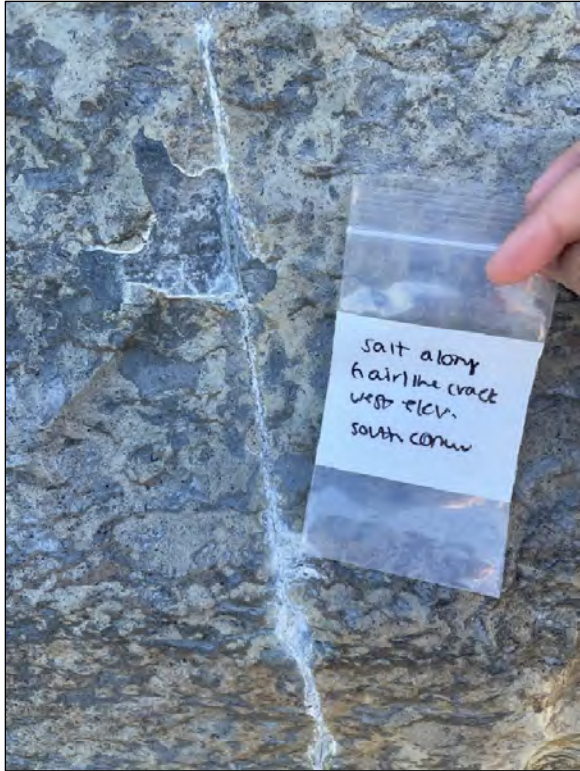
Figure 53. White-colored calcium carbonate deposit along hairline crack.

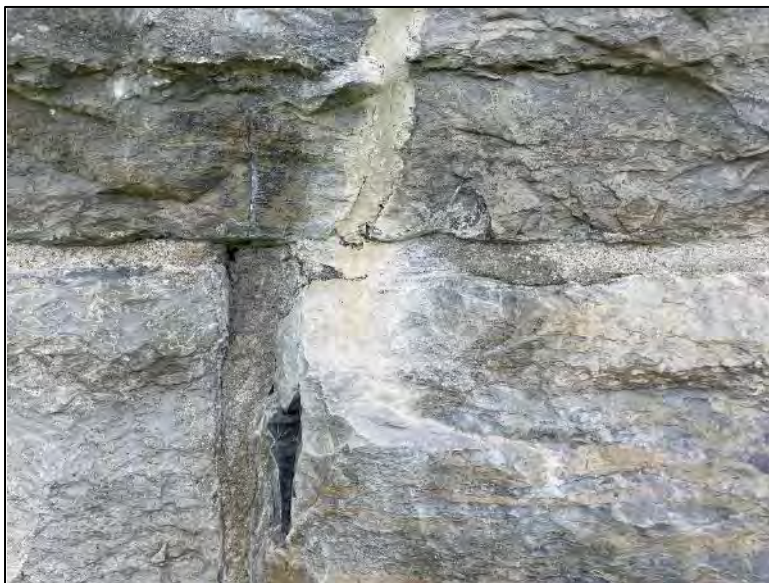
Figure 54. Carbonate deposit (white material) below an epoxy crack repair.

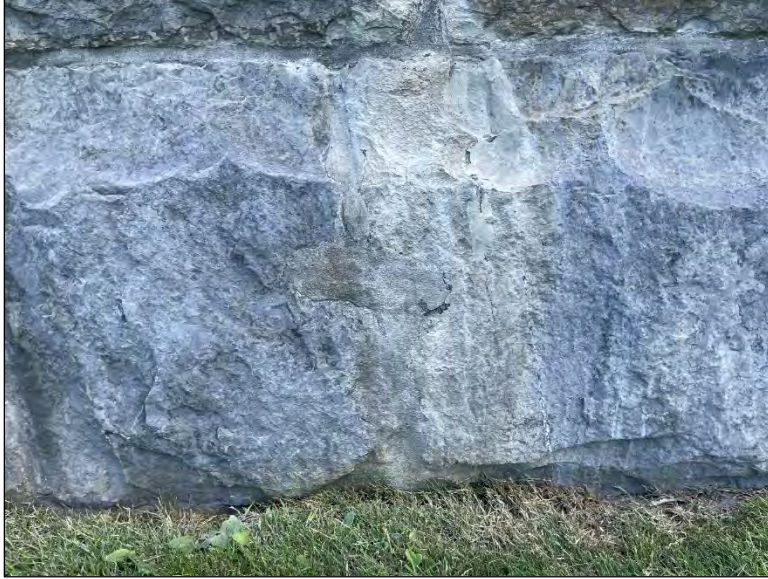
Figure 55. Heavy accumulation of carbonate material leached from a cracked and deteriorated mortar joint.

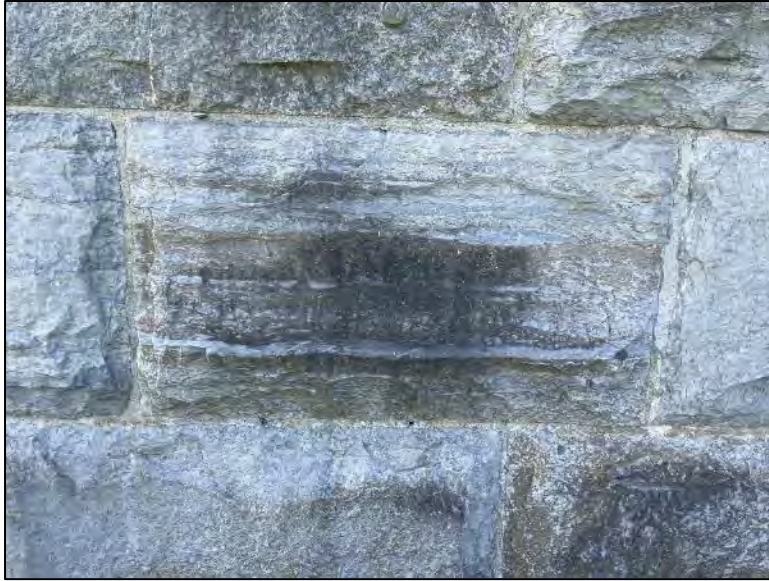
Figure 56. Biological soiling (dark colored material) on surface of an exterior stone.

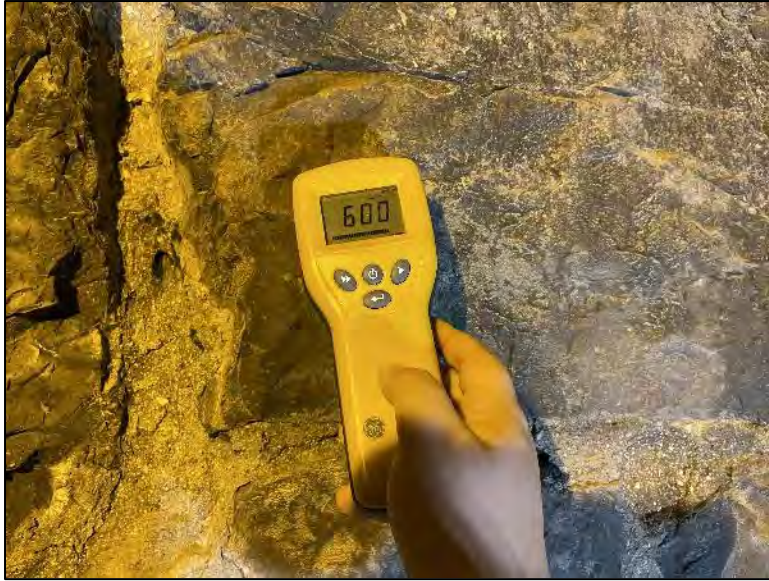
Figure 57. A high, 600 moisture reading taken at the interior stone.

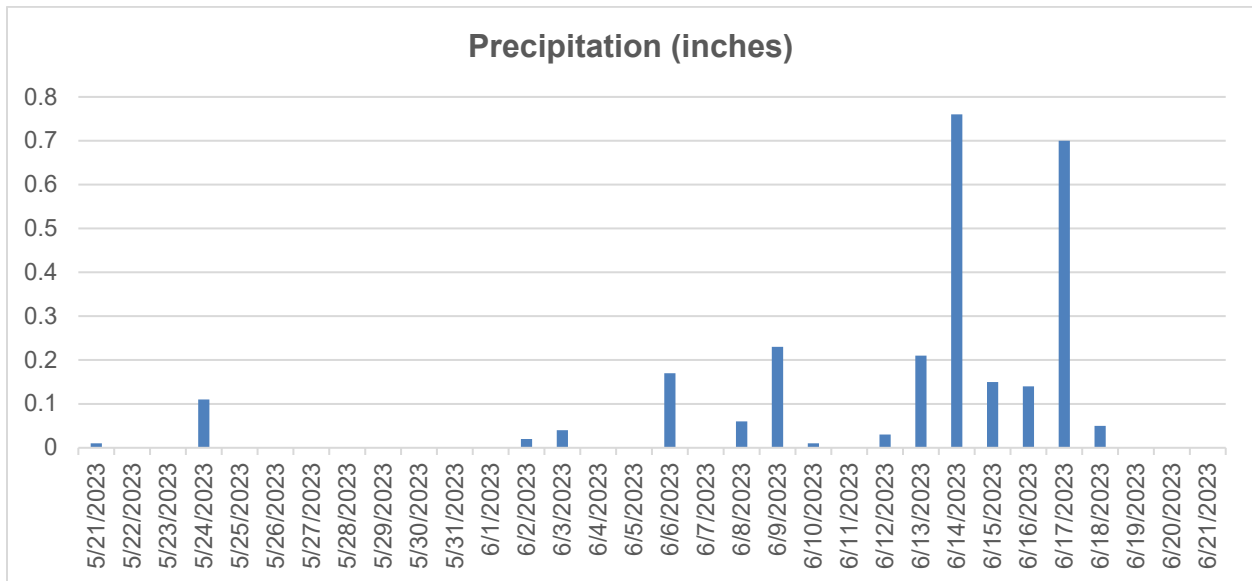
Table 4. Daily precipitation in Bennington for the month preceding moisture measurements on June 21, 2023. (Source: NOWData - NOAA Online Weather Data, Bennington Morse State Park AP Station, <https://www.weather.gov/wrh/climate?wfo=aly>)

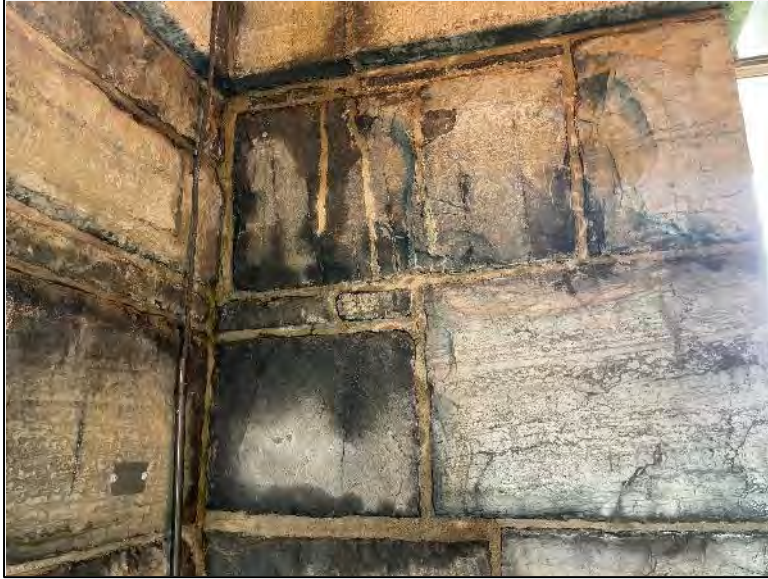
Figure 58. Discoloration due to dampness in the corners of the observation platform.

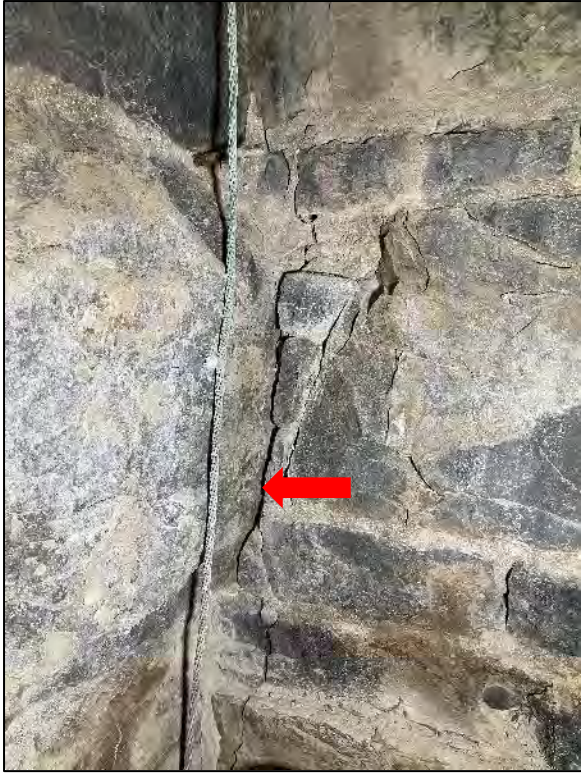
Figure 59. Typical crack (indicated) at interior corner.

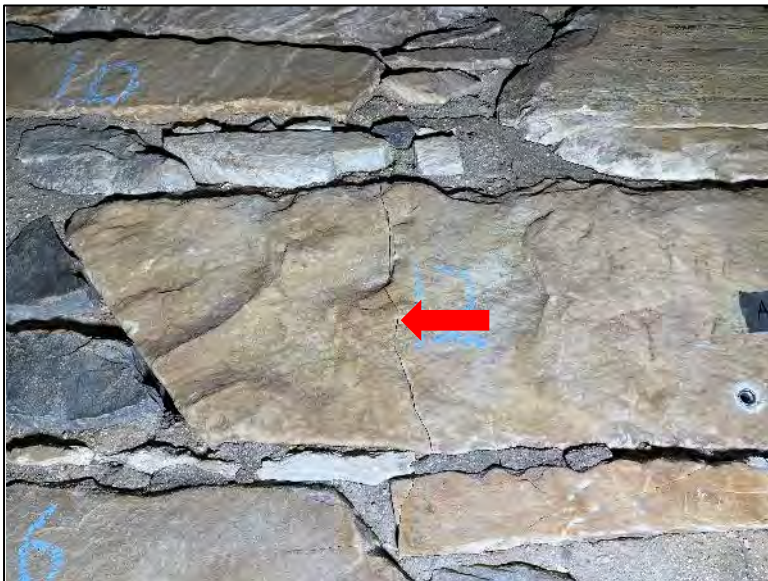
Figure 60. Typical interior vertical crack (indicated) isolated to one stone.

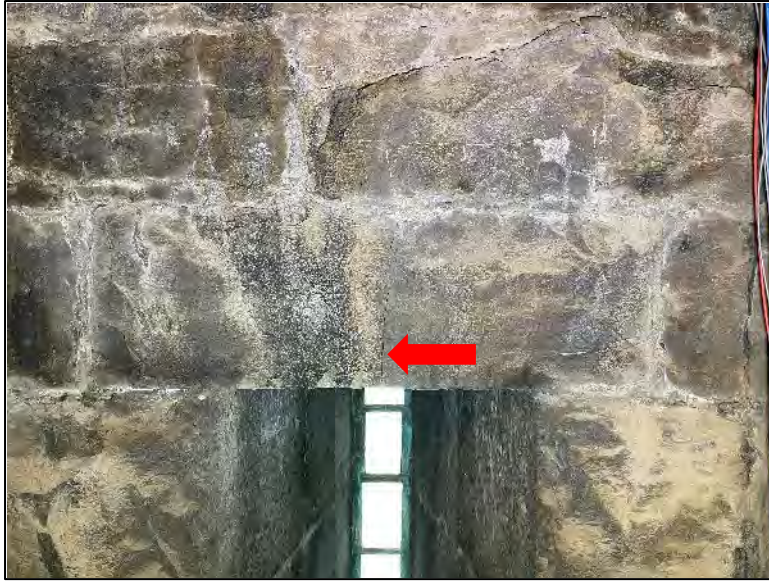
Figure 61. A hairline crack (indicated) through a window lintel resulting from the load of the masonry carried above.

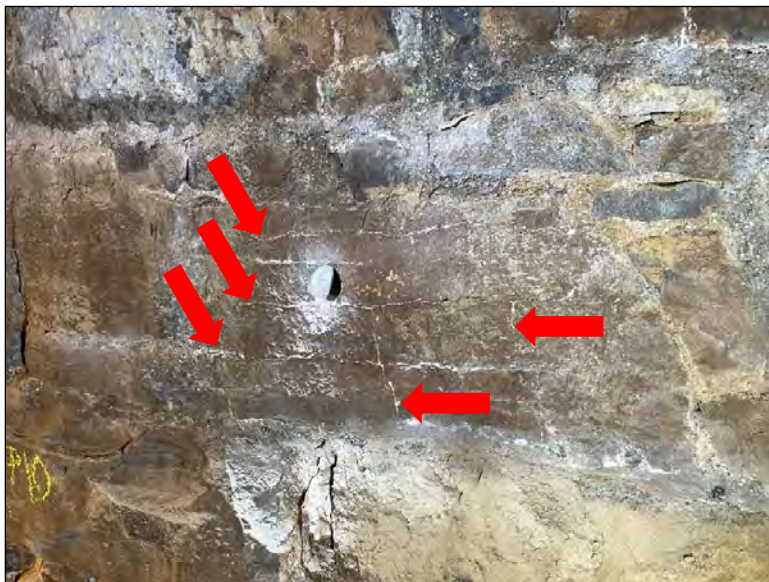
Figure 62. Orthogonal cracks (indicated) in an interior breccia unit.

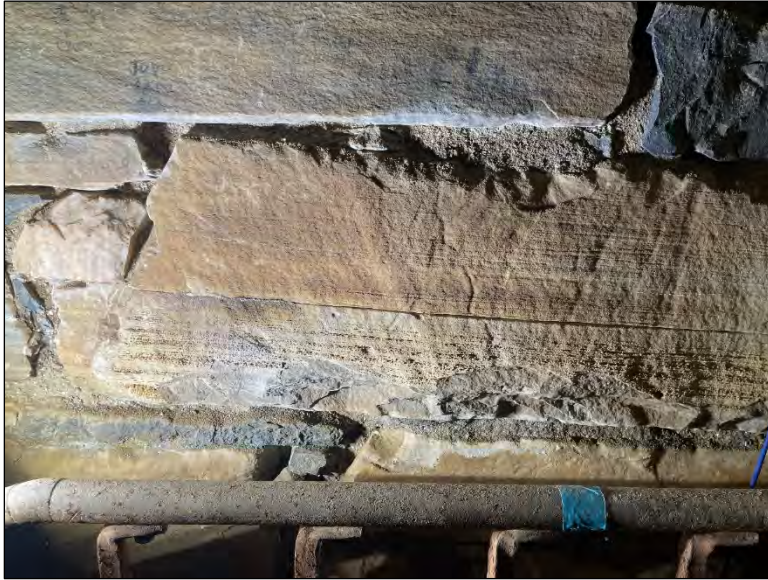
Figure 63. A single, horizontal crack follows the natural foliation of an interior marble unit.

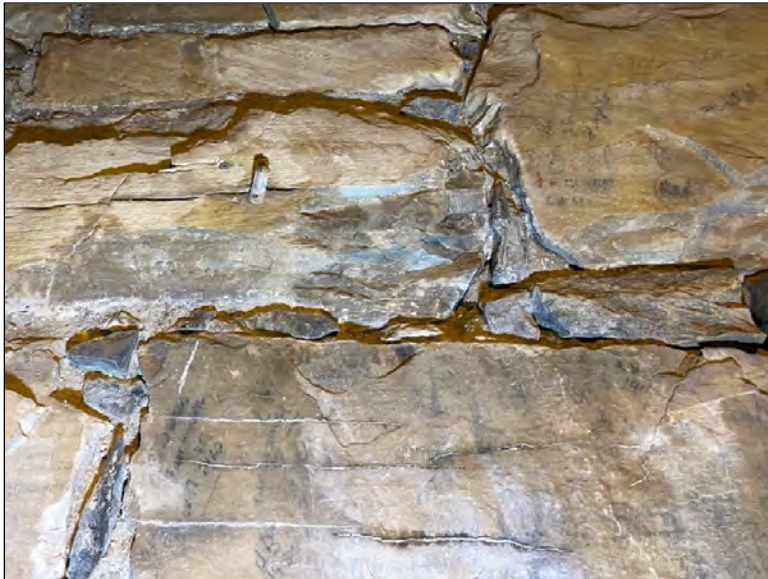
Figure 64. A series of horizontal cracks in an interior marble unit are filled with salts.

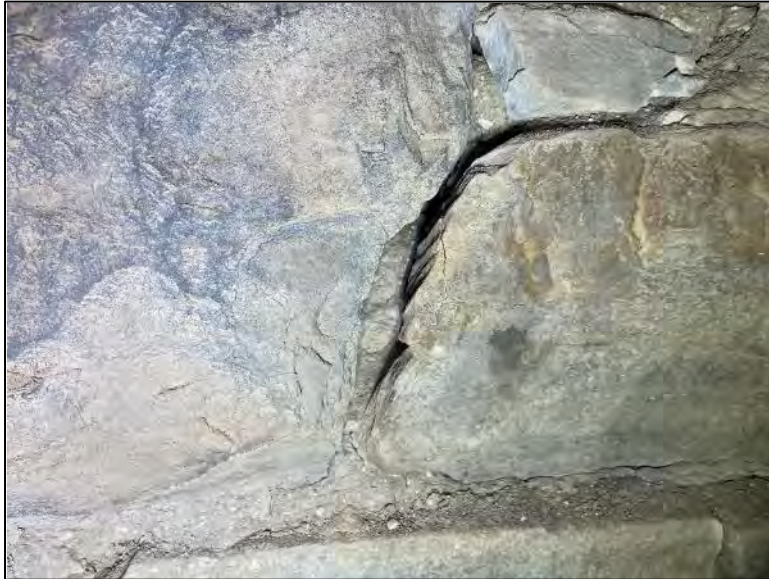
Figure 65. Large void between two interior stones.

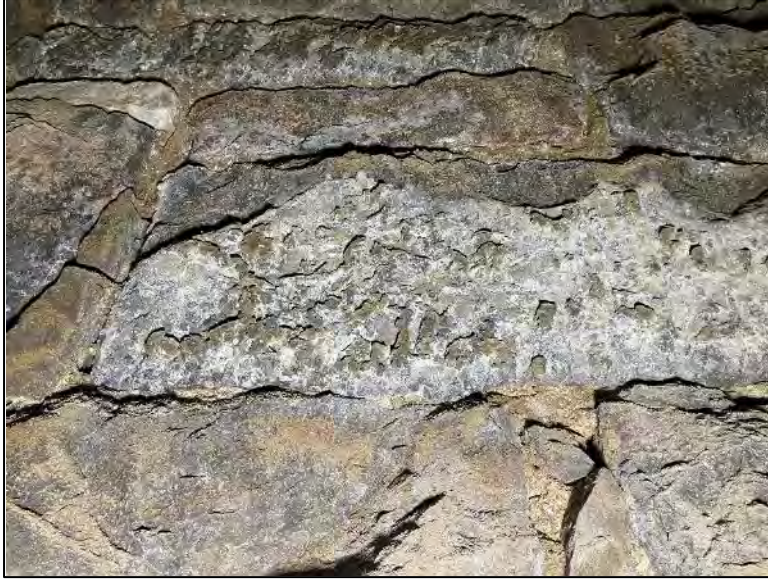
Figure 67. Differential surface loss in the interior breccia.

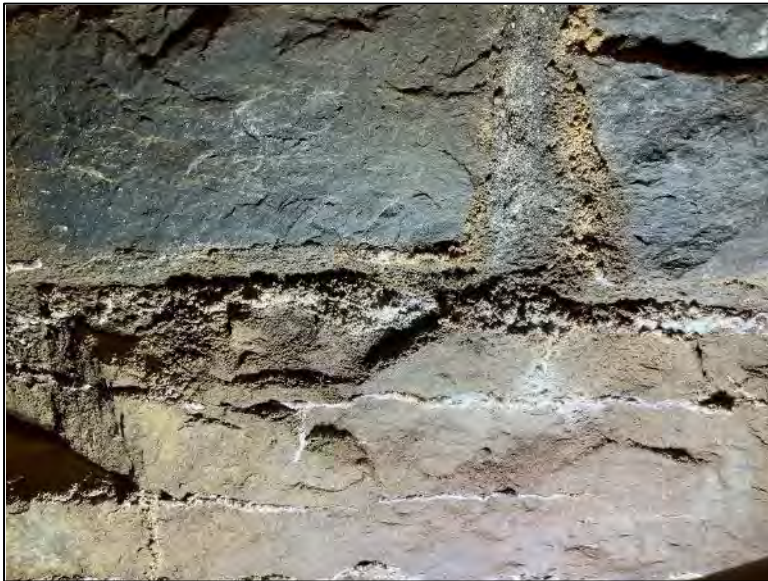
Figure 69. Efflorescence and/or carbonate crusts along cracks and mortar joints.

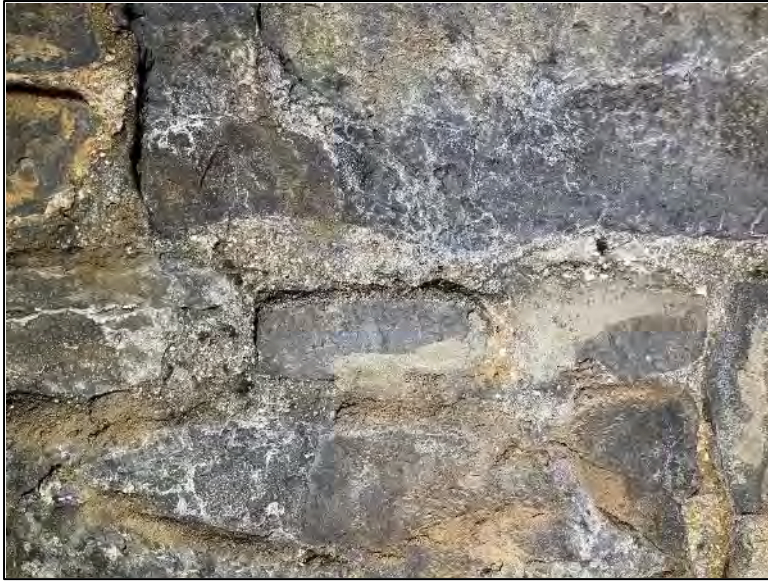
Figure 70. White colored efflorescence on the surface of the stone and mortar joints. Note light brown dust (mortar debris disaggregated by crystallizing salts) accumulating on projections from the stone.

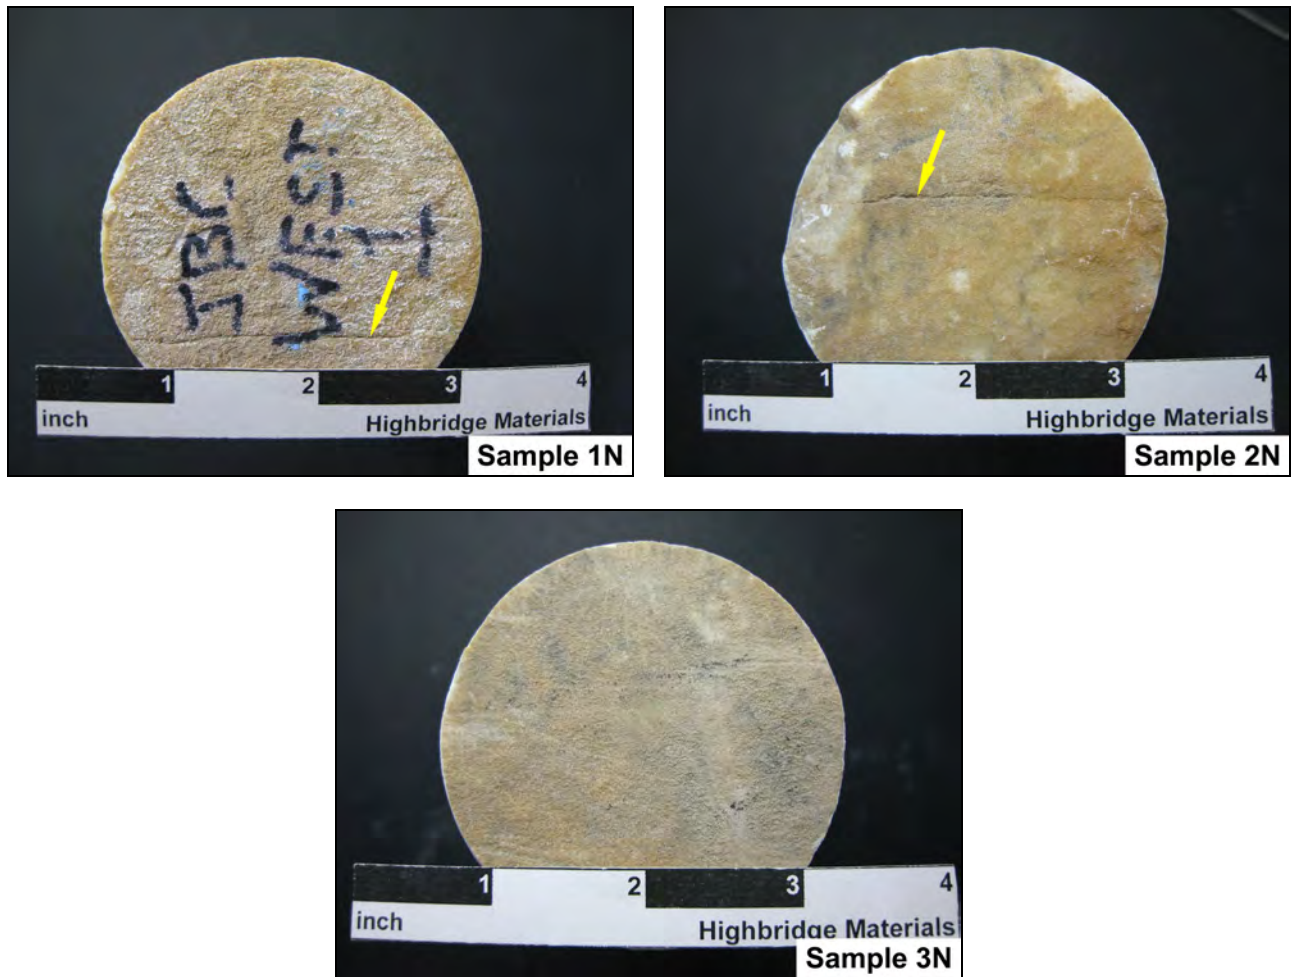
Figure 3: Photographs of the outer cores surfaces. Note that all have an orange-hued discoloration. A few fine cracks intersect the outer surfaces (arrows). These are interpreted to predate the construction.

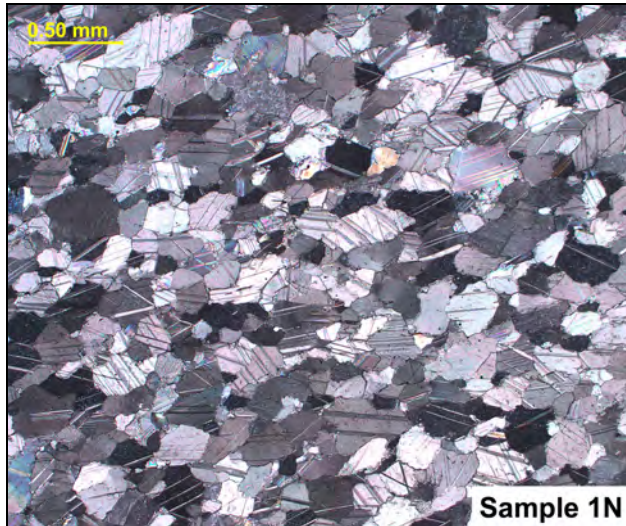
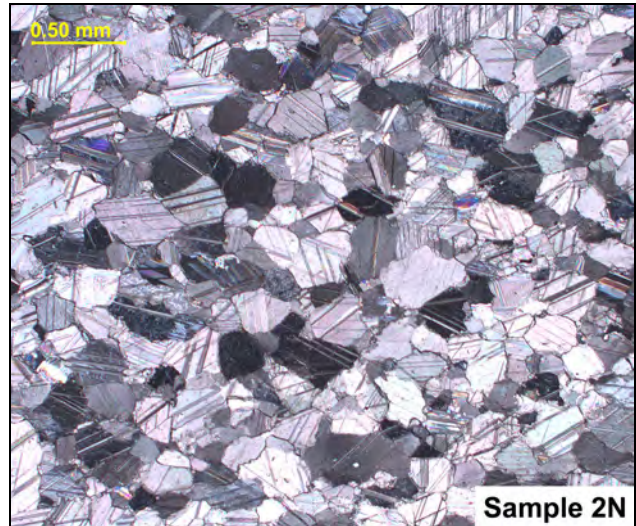
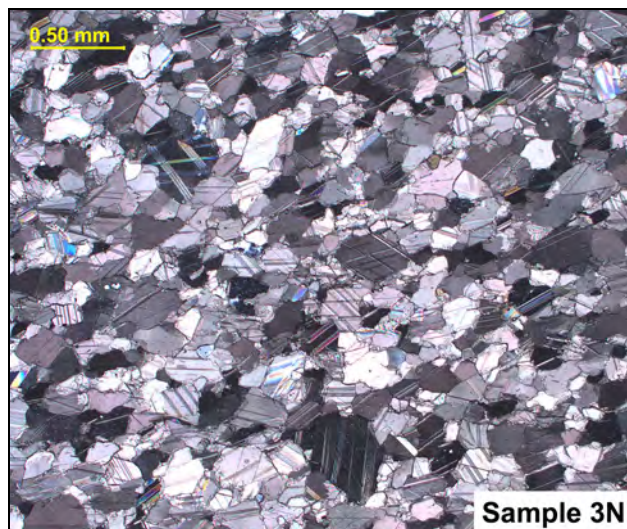
Figure 4: XPL photomicrographs illustrating the mineralogy and microtexture of the marble. The stone consists of a mosaic of calcite crystals. There is a modest grain size variation and a slight grain flattening. Grain boundaries are mostly irregular and interlobate.

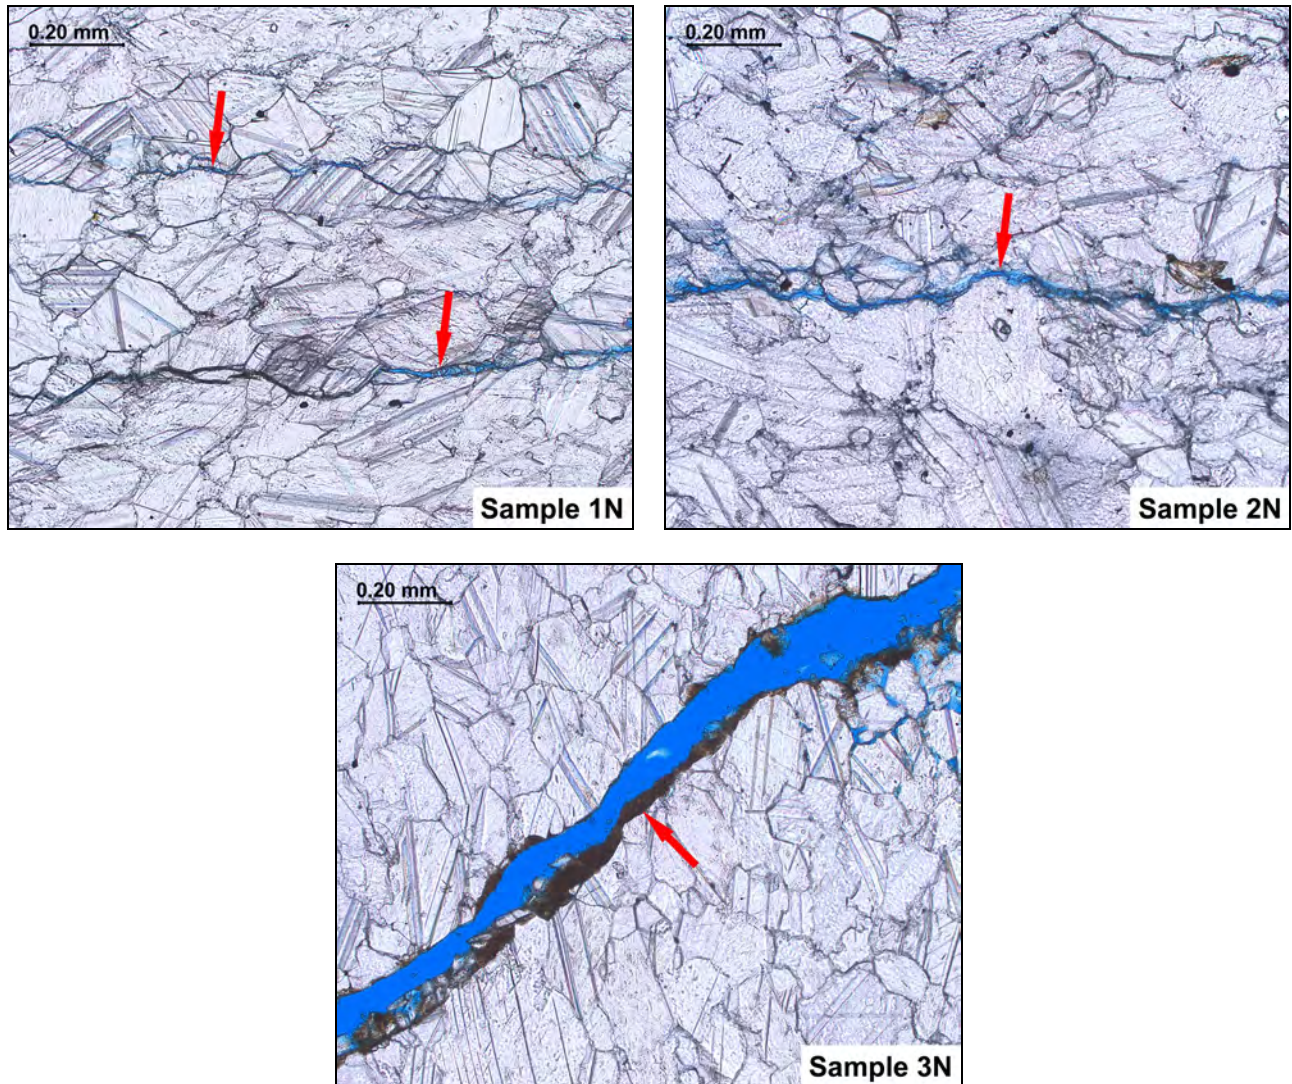
Figure 7: PPL photomicrographs. (Upper images) The arrows indicate fine microcracks that coincide with the veins. These likely predate the construction and relate to the very slight mineralogical and textural differences within these planes. No deleterious salts are identified within the cracks. (Lower image) The arrow indicates the tensile joint in Sample 3N. Note that the joint is lined with a very fine alteration product rich in iron oxide.

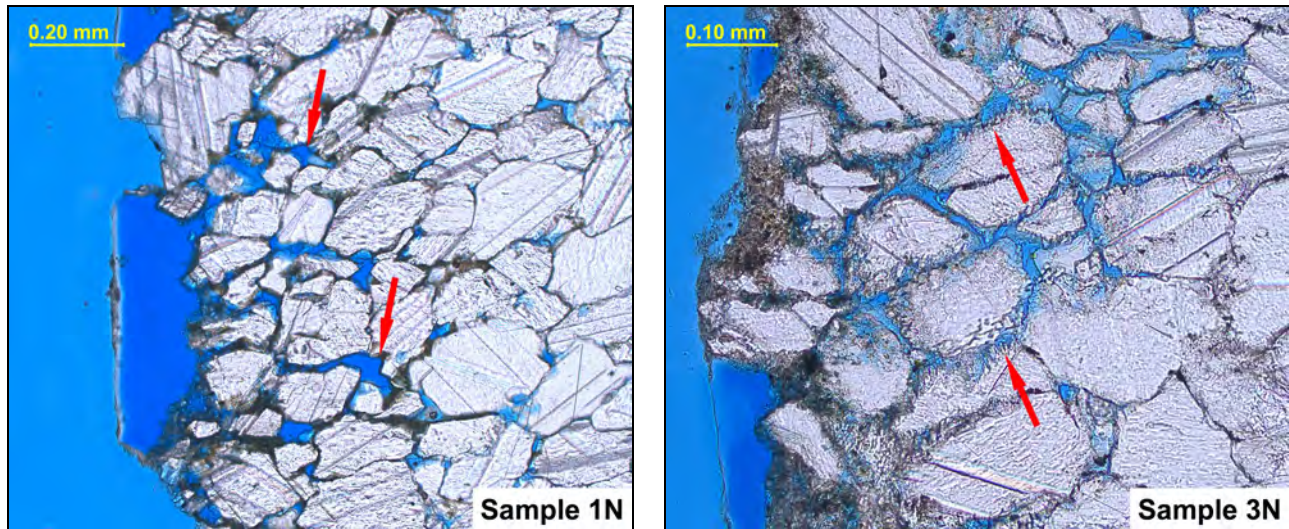
Figure 8: PPL photomicrographs taken at the outer surfaces of Samples 1N and 3N. Note that the images are taken at different magnifications. The arrows indicate pore spaces created through the acidic etching of constituent calcite crystals. The grain corrosion is more uniform in Sample 1N. In Sample 3N, the etching has produced fine jagged comb-like structures.

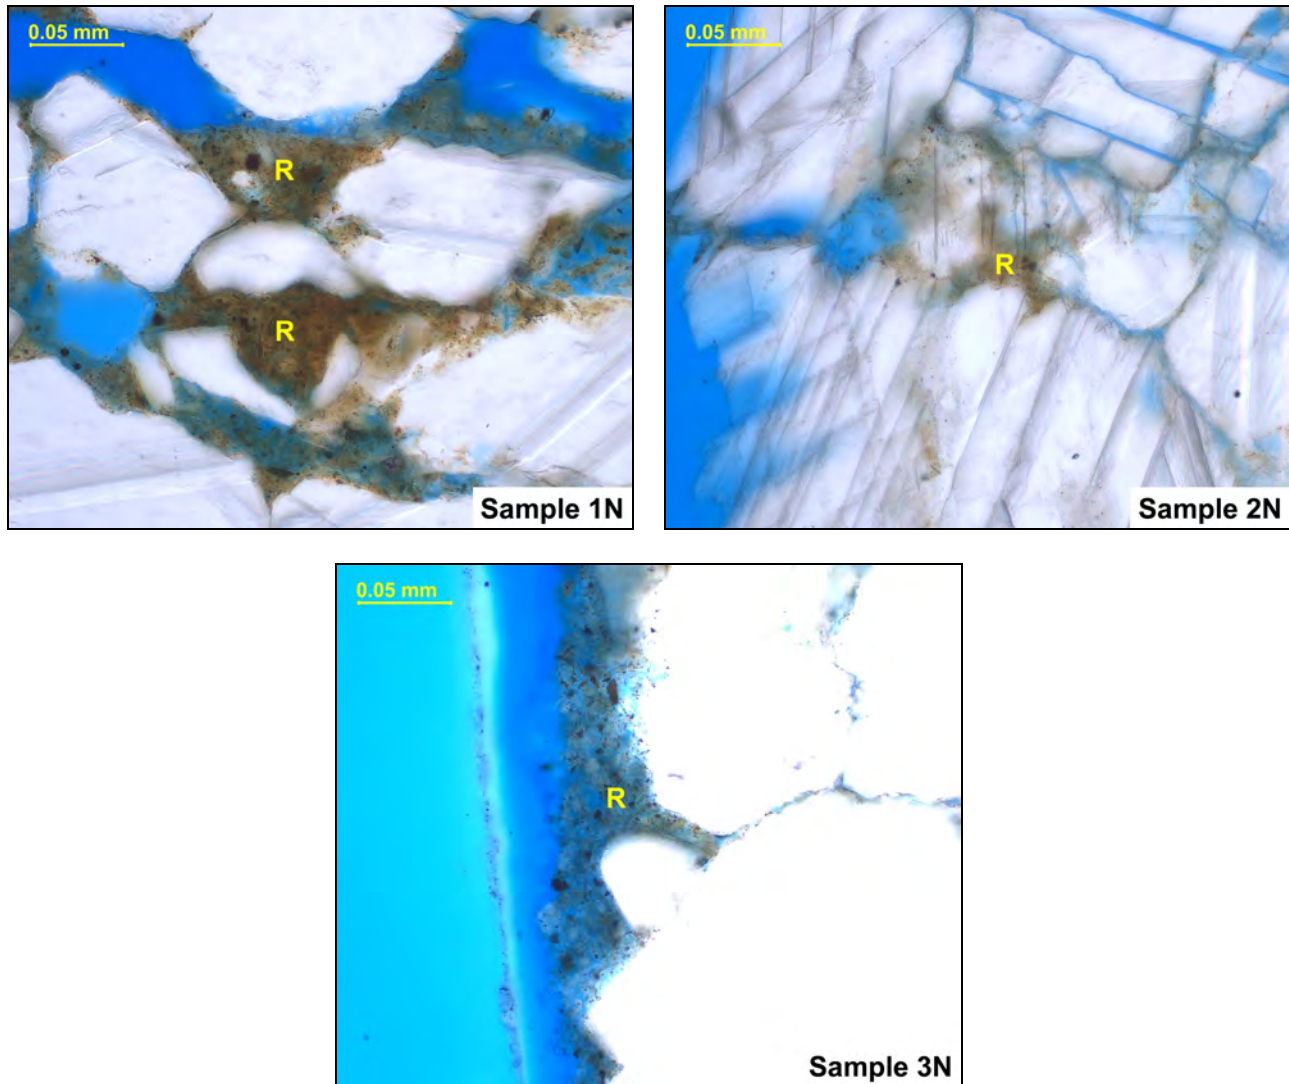
Figure 9: CPL photomicrographs taken at the outer surfaces of all three samples. The outer surface and some subsurface pores are lined with a residue (R) containing ultrafine-grained reddish particulates believed to consist of iron oxides. These residues are interpreted to be responsible for the orange discoloration on each surface. The iron may have been released through the corrosion of the surface calcite.
