03/29/2024

**STRUCTURAL AND ELECTRICAL ASSESSMENT OF
THE BENNINGTON BATTLE MONUMENT**

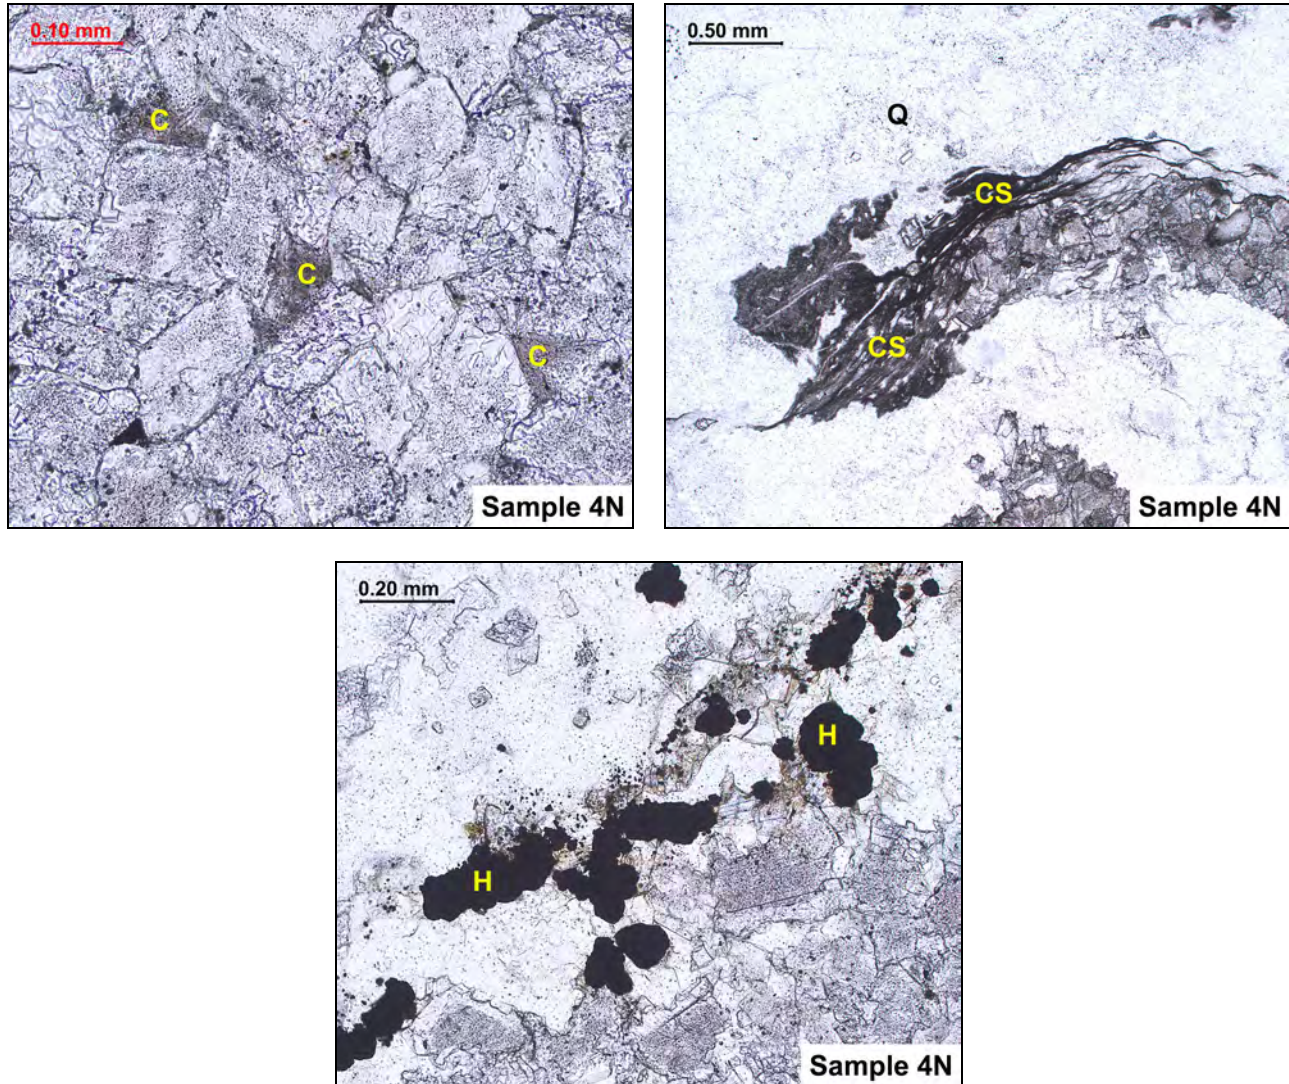
Figure 3: PPL photomicrographs illustrating the lesser constituents of the stone. (Upper left) Carbonaceous clay (C) is often found at the angular interstices between adjacent dolomite crystals. (Upper right) A clay seam (CS) is truncated and embedded in a quartzose region (Q). (Lower) Very fine hematite crystals (H) are a replacement of original pyrite crystals.

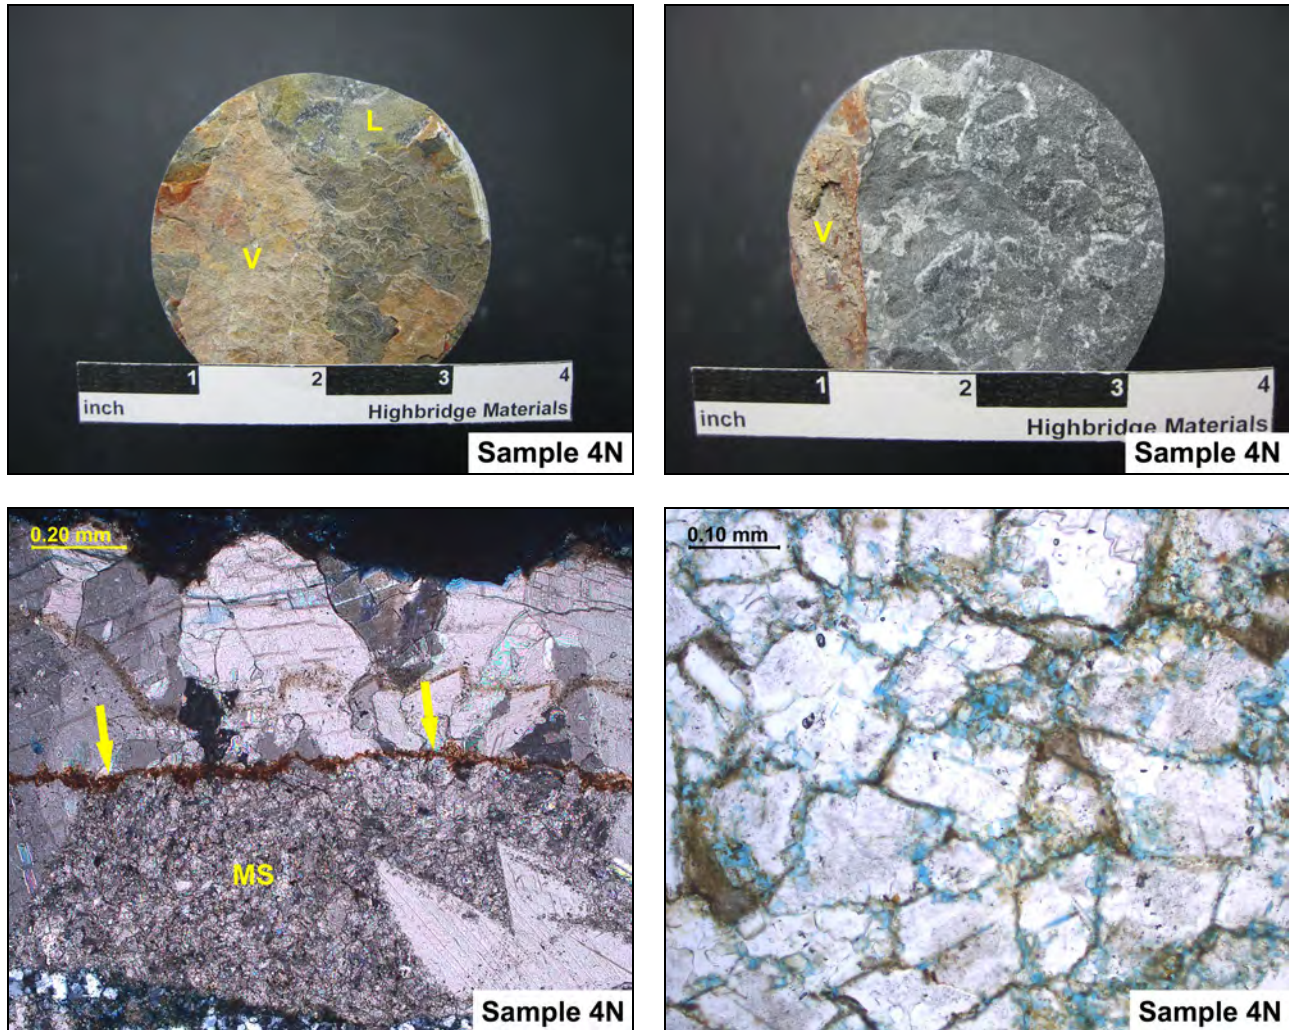
Figure 4: (Upper left) The outer surface of the core is shown. Much of the face is covered by a thin geological vein (V). Beyond the vein, some of the dolostone is yellow in color due to limonite lining the grain boundaries (L). (Upper right) A similar vein is intersected along the rear surface. (Lower left XPL image) The outer vein contains a sliver of microsparite (MS) that is not completely replaced by dolomite. Thin hematite linings (arrows) are responsible for the reddish color seen in hand sample. (Lower right CPL image) This photomicrograph was taken just beyond the outer vein. The bluish color represents pore spaces where there has been some solubilization of the dolomite locally. Note the yellowish brown linings around individual crystals. These contain limonite or iron oxide-hydroxide.

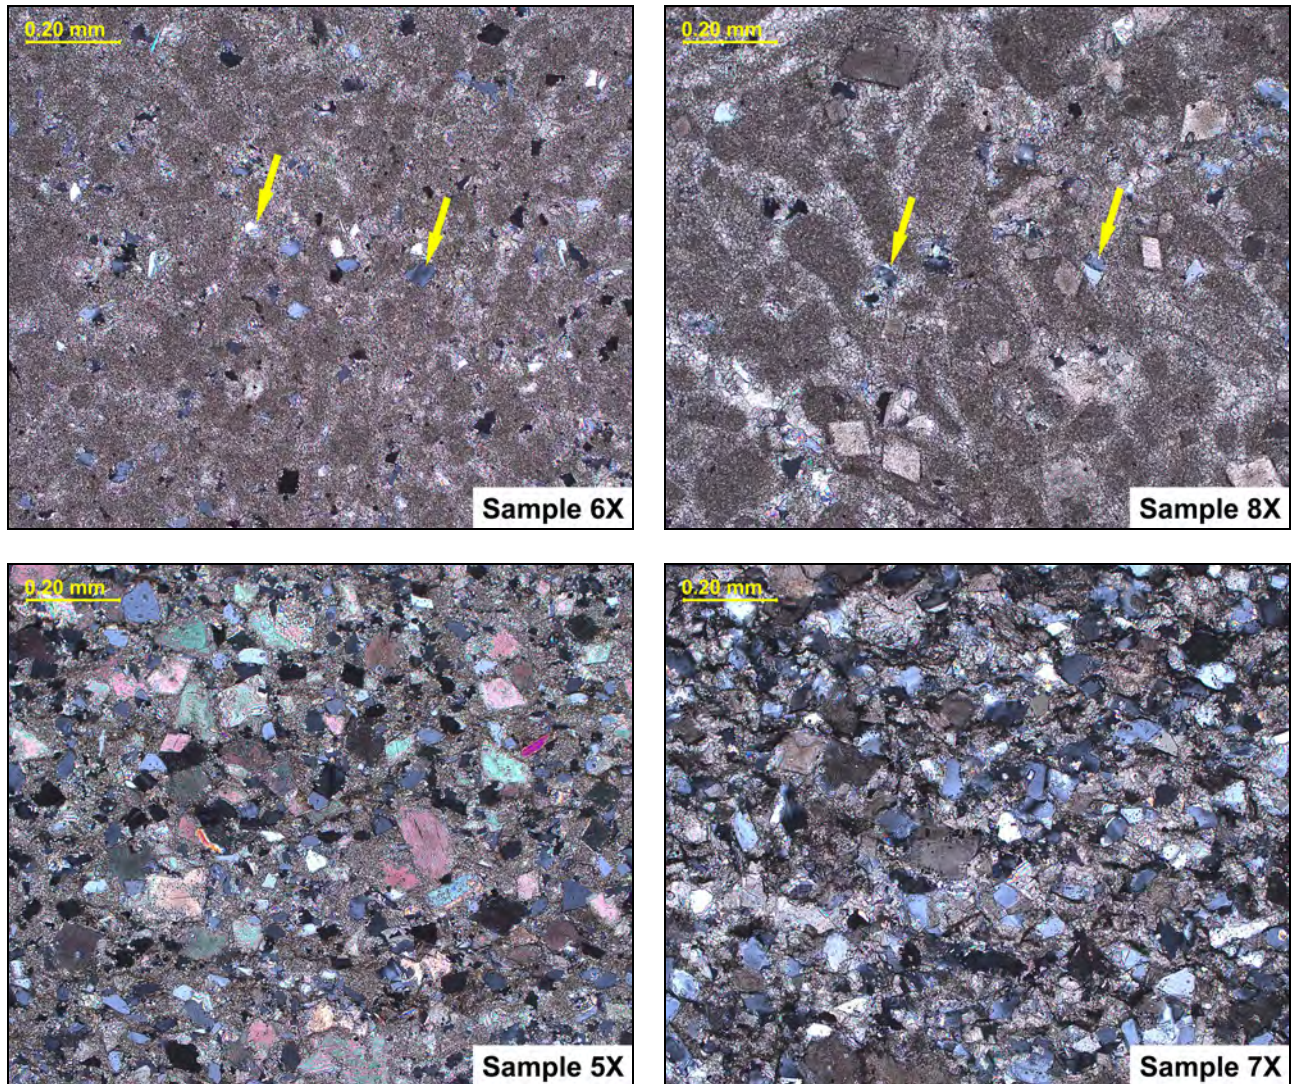
Figure 6: PPL photomicrographs. (Upper images) Fine sediment is distributed throughout all of the stone. The arrows show silt-sized grains of quartz and feldspar in two of the samples. (Lower images) Bands enriched in quartz are found in Samples 5X and 7X. In these images, the quartz and feldspar are represented by the white and gray particulates. The sediment-rich bands are the only planar sedimentary structures discernible in the limestone. Other planar fabrics are structural rather than sedimentary.

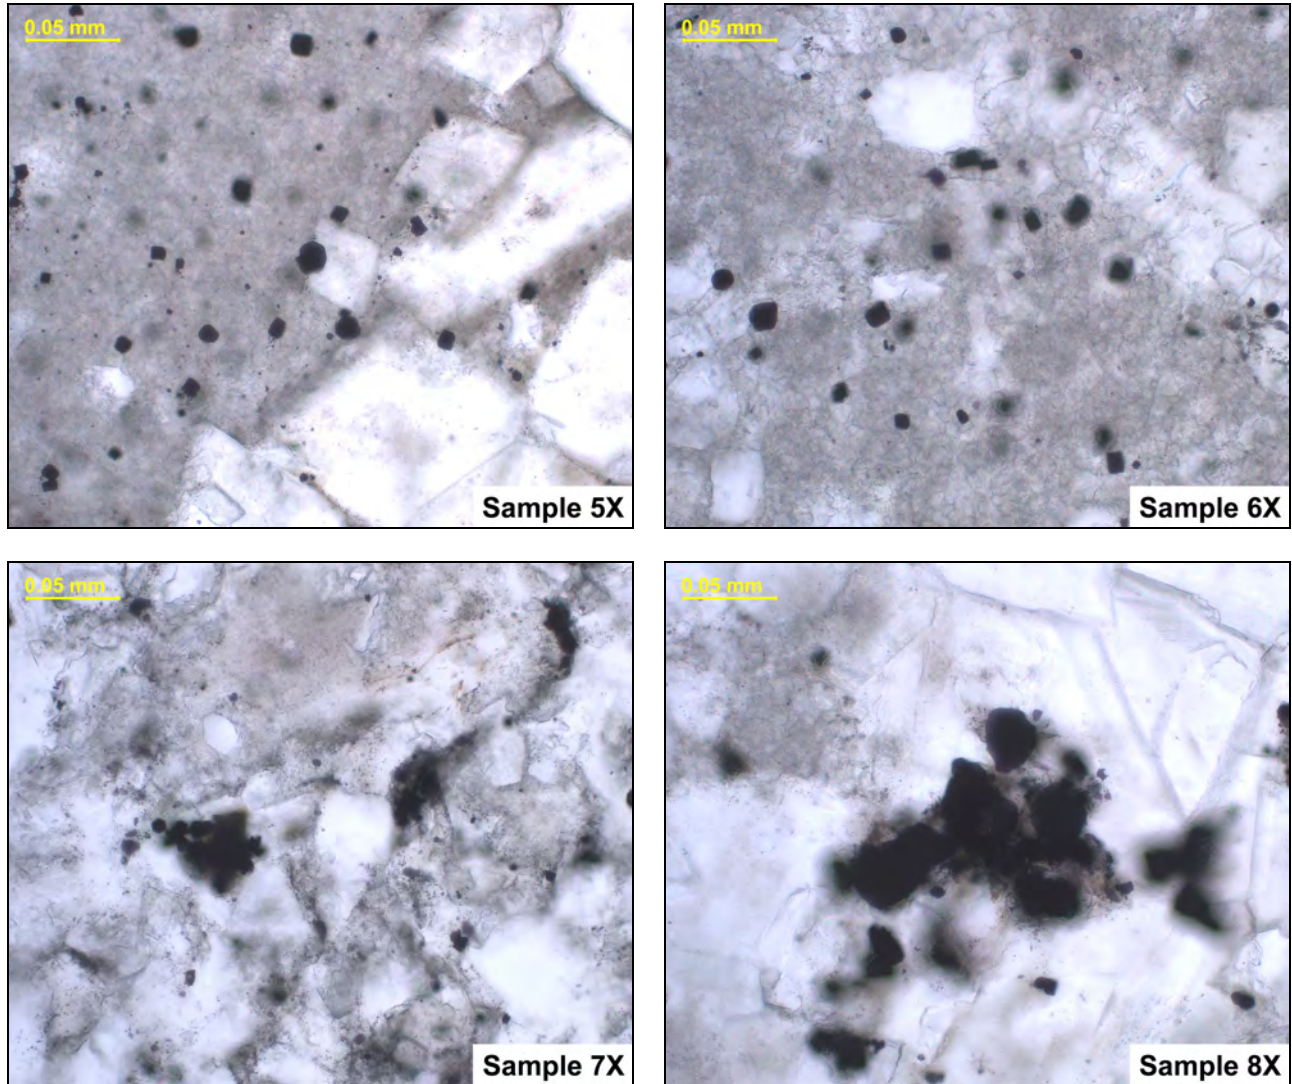
Figure 7: CPL photomicrographs. The black grains are iron sulfides found ubiquitously throughout the stone. Virtually all of the sulfide is fresh and unoxidized. The grains are finer than the thickness of the thin section. In part, this causes the grains to appear blurry.

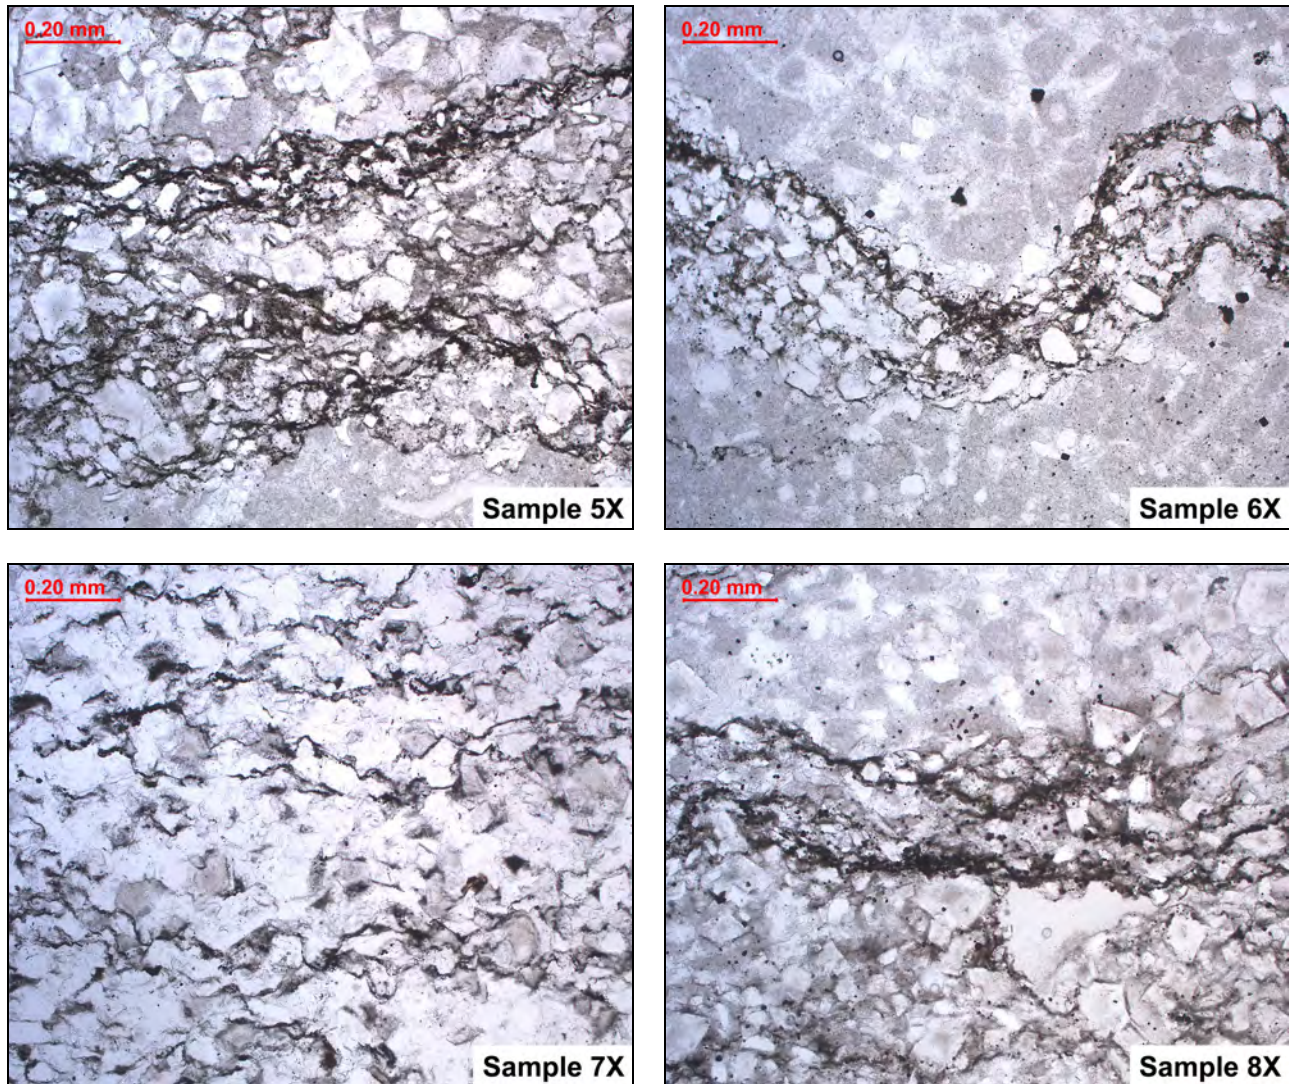
Figure 8: CPL photomicrographs. The dark streaks running left to right in the images are concentrations of quartz and sulfide grains in pressure solution cleavages called stylolites. These are sites along which the carbonate has dissolved under geological pressure leaving behind insoluble materials. While these can sometimes be permeable and represent planes of preferential weakness, all appear tight and indurate in the sample set. Note that there are no continuous stylolites in Sample 7X. All are incipient in this sample.

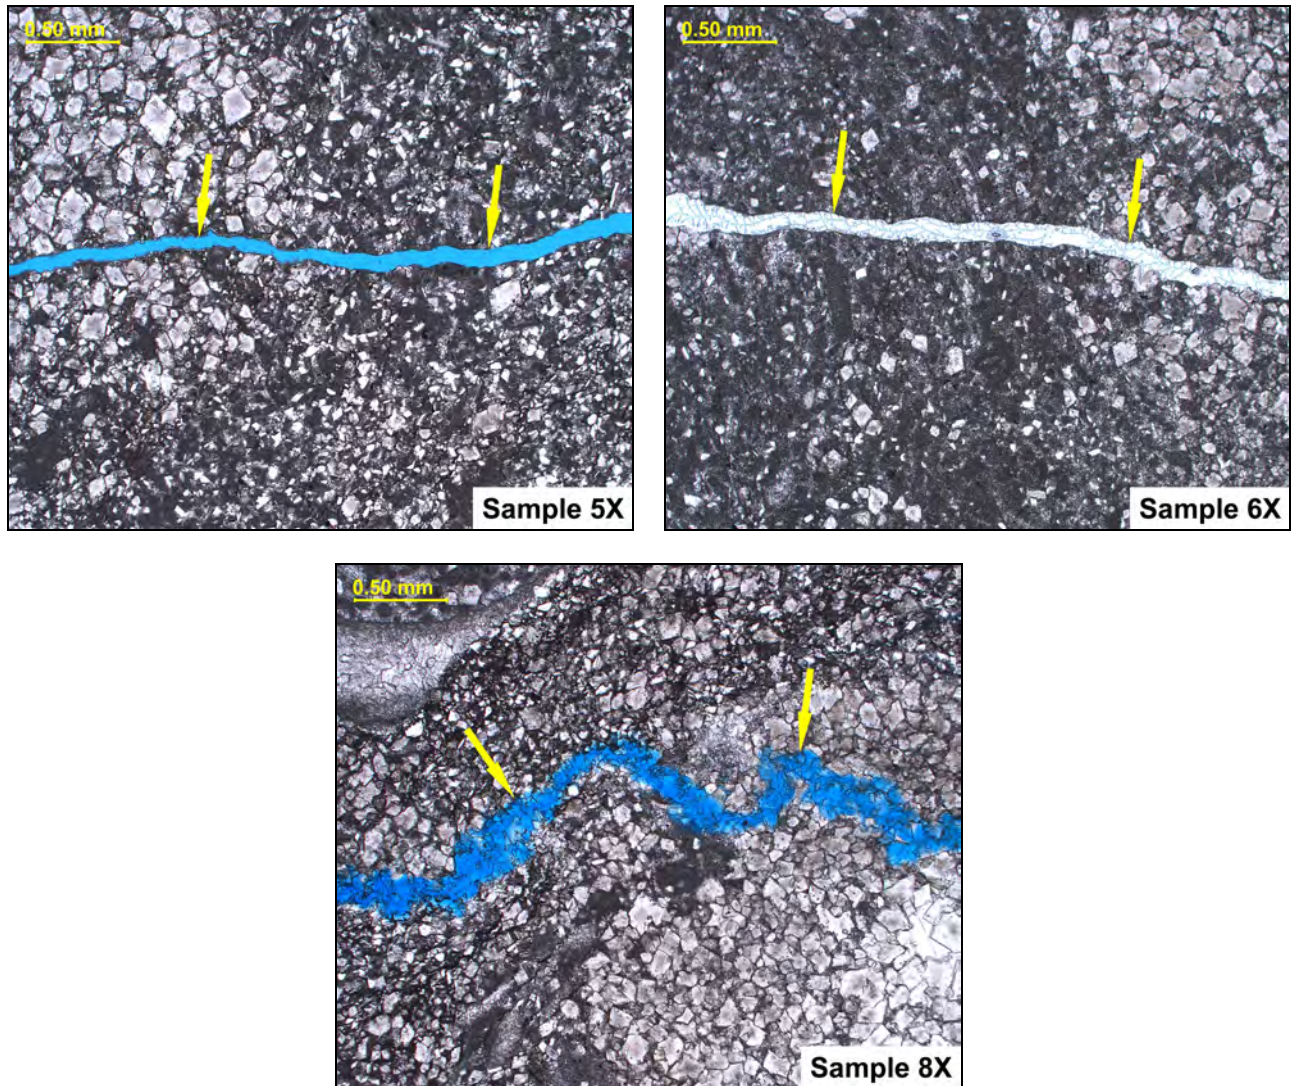
Figure 9: The arrows in these PPL photomicrographs indicate hairline cracks in three of the samples that are interpreted to have formed geologically. Two are filled with a blue-dyed epoxy. The crack in Sample 8X was cut at an oblique angle resulting in a less sharp character in cross section. No dissolution, mineralizations, or subsidiary cracking is found in association with these minor cracks.

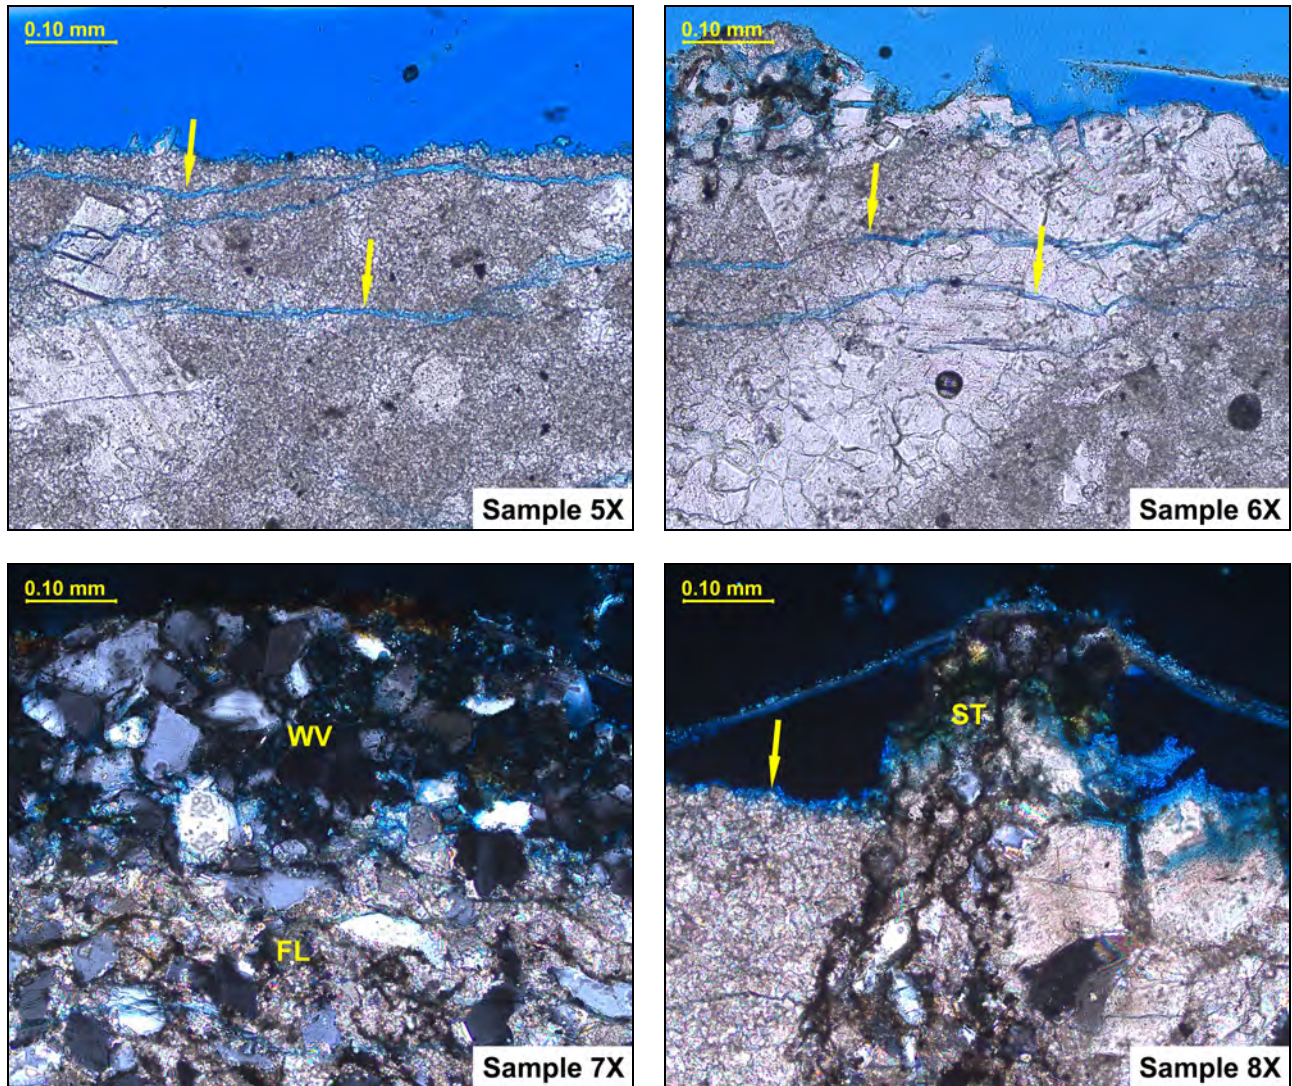
Figure 10: These PPL photomicrographs were taken at the outer surface of each core. The surfaces are oriented toward the top of each image. In the upper two images, the arrows indicate exceptionally minor scaling cracks. At lower left, the carbonate minerals are present in the fresh limestone (FL) of Sample 7X but, have preferentially dissolved within the weathered veneer (WV). Insoluble quartz remains proud along the weathered face. At lower right, a stylolite (ST) remains proud over the weathered-back carbonate (arrow) of Sample 8X. All of the observed weathering in the four samples is considered superficial and innocuous.

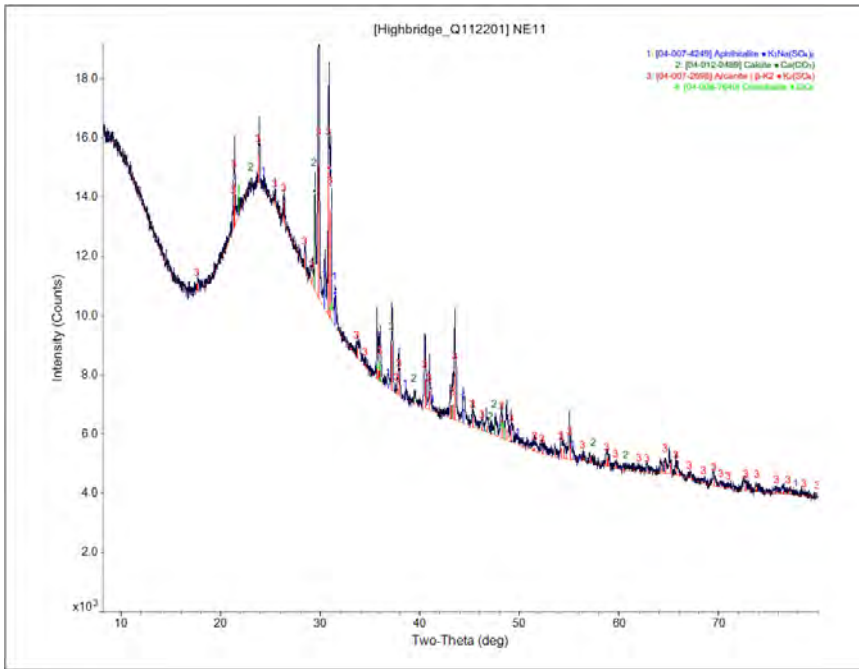
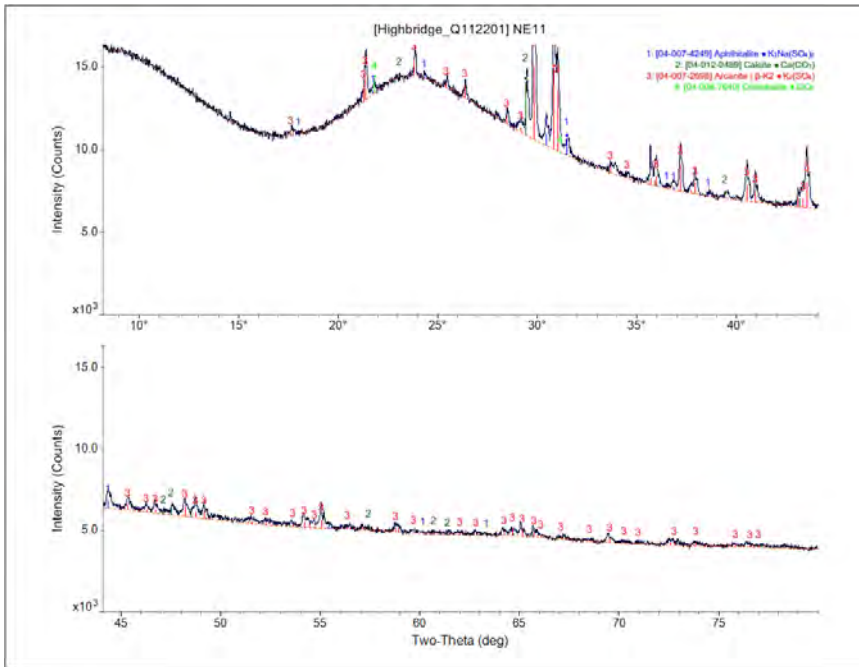
Chart I.2: X-ray diffraction spectrum for Sample NE11. The surface scraping provided by the client was ground and measured "as-found". The full spectrum is shown at top and an exploded view at bottom. Note the broad hump at 2θ between about 20° and 30° . This is indicative of an amorphous material.

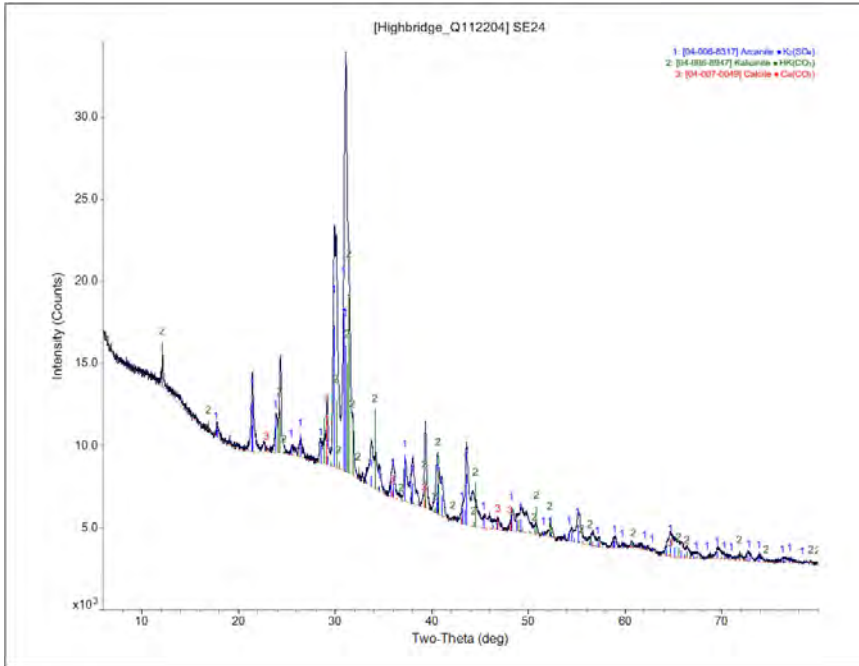
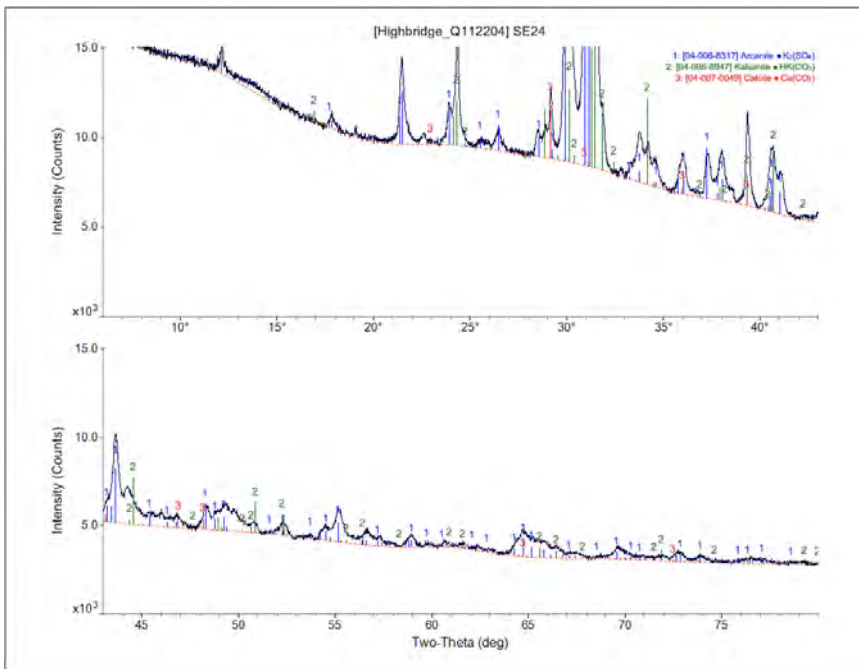
Chart I.3: X-ray diffraction spectrum for Sample SE24. The salts were extracted by water digestion from surface scrapings provided by the client. The full spectrum is shown at top and an exploded view at bottom.

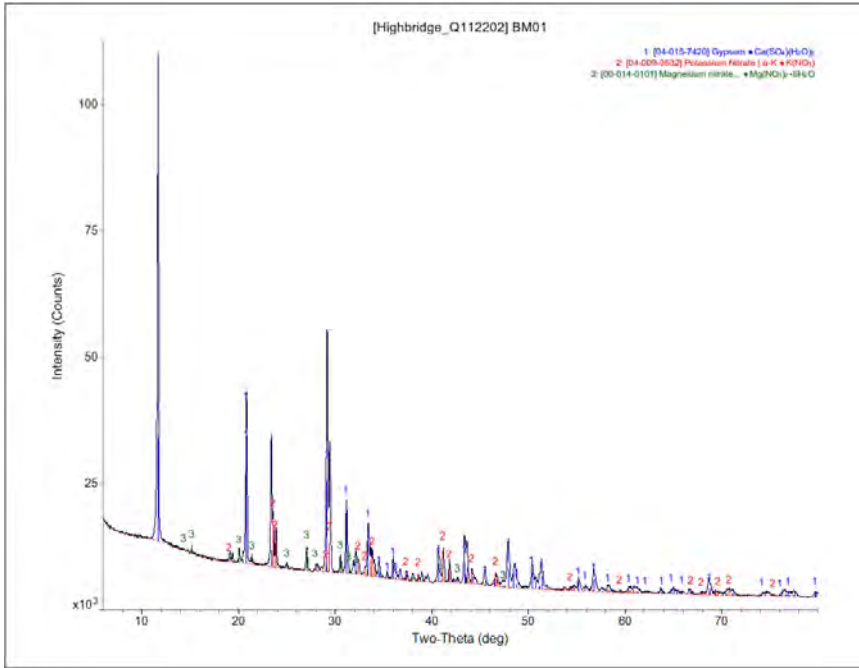
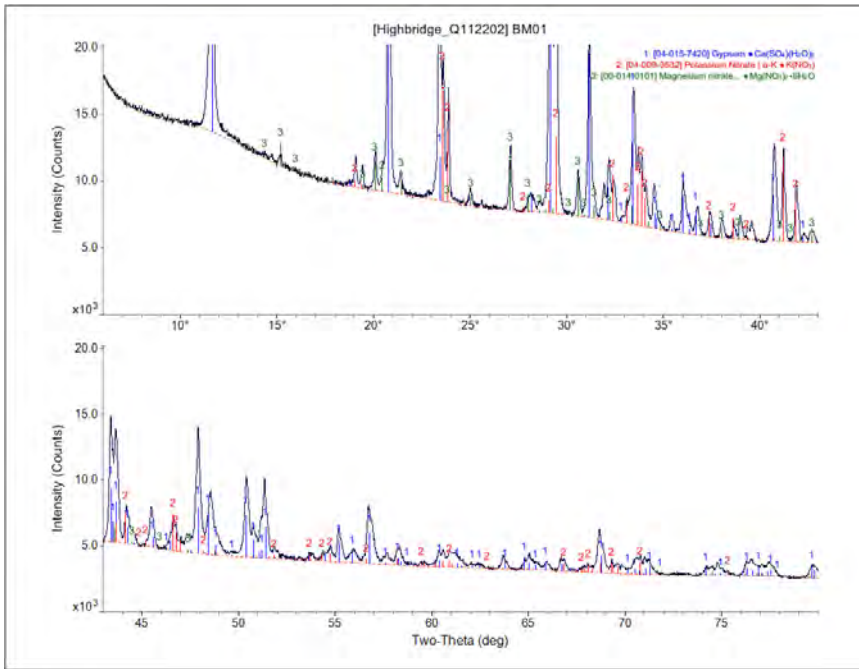
Chart I.6: X-ray diffraction spectrum for Sample BM01. The salts were extracted by water digestion from degraded mortar debris provided by the client. The full spectrum is shown at top and an exploded view at bottom.

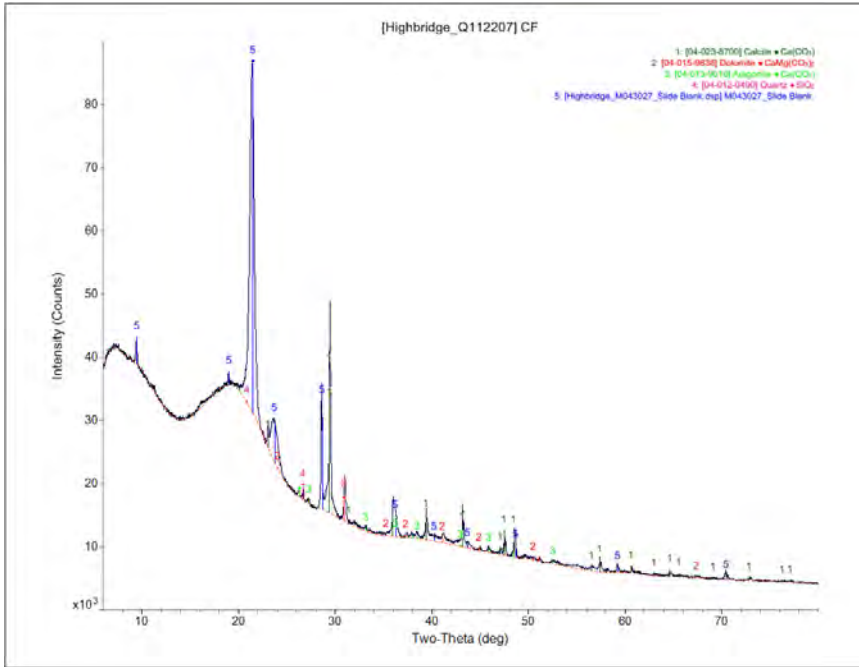
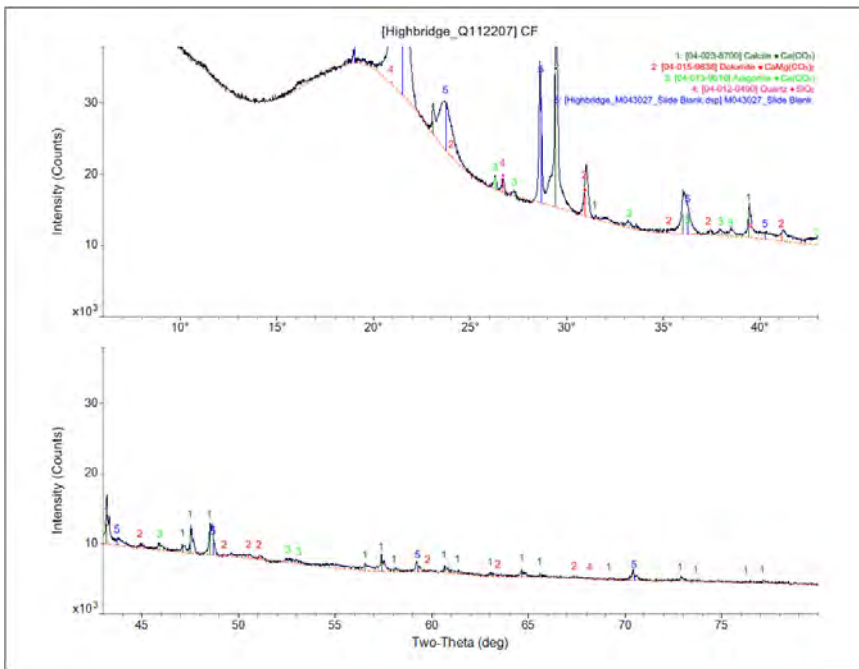
Chart I.7: X-ray diffraction spectrum for Sample CF. The salts were directly transferred from a mineralized veneer present along a formed surface of concrete infill. The full spectrum is shown at top and an exploded view at bottom. Note the broad hump at 2θ centered about 20°. This is indicative of an amorphous material.

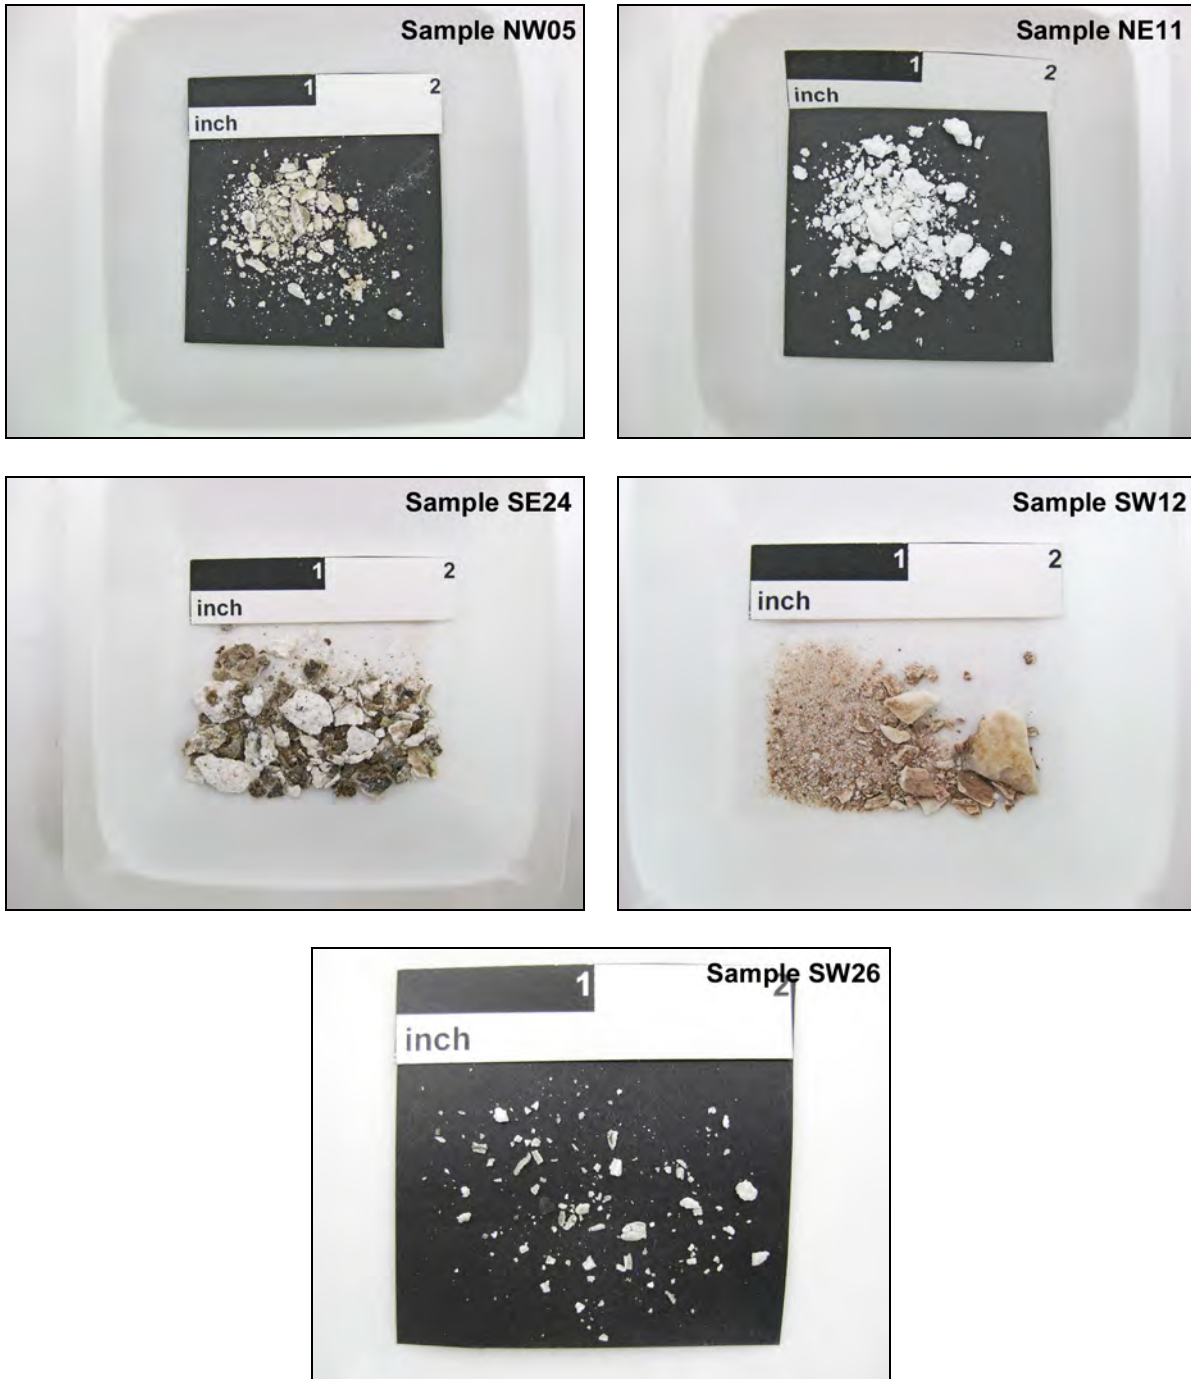
Figure 1: Photographs of the five samples consisting of salt deposits scraped from masonry surfaces by the client and provided to the laboratory for analysis. Four of these were subjected to a water extraction process to concentrate the salt from other debris. Only Sample NE11 was measured in its "as-found" condition.

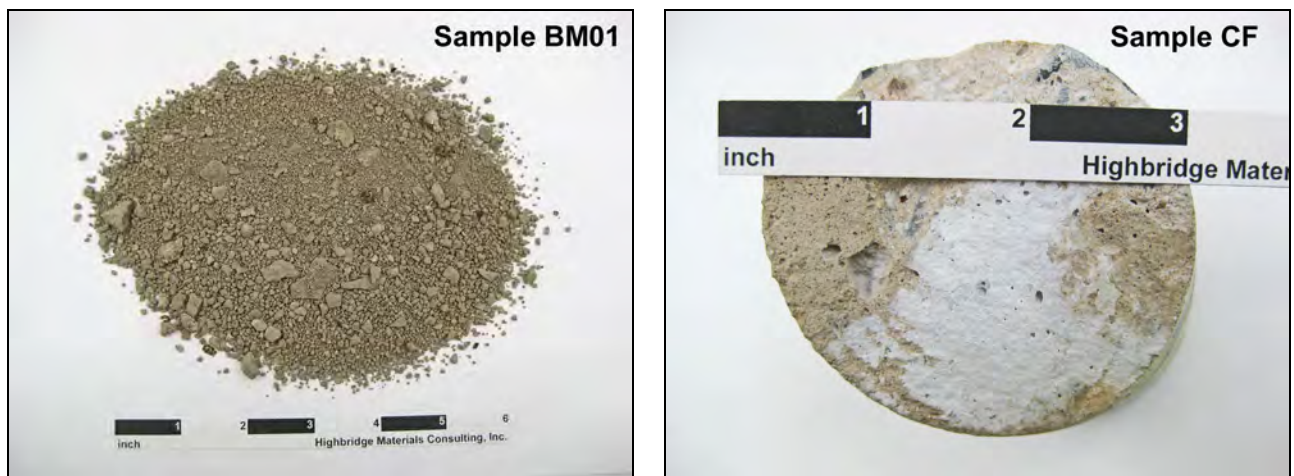
Figure 2: Photographs of Samples BM01 and CF as received. BM01 is a degraded mortar sample from which salts were extracted through water digestion. Sample CF was taken from the formed surface of a concrete infill sample where there was a veneer deposit of secondary salts.

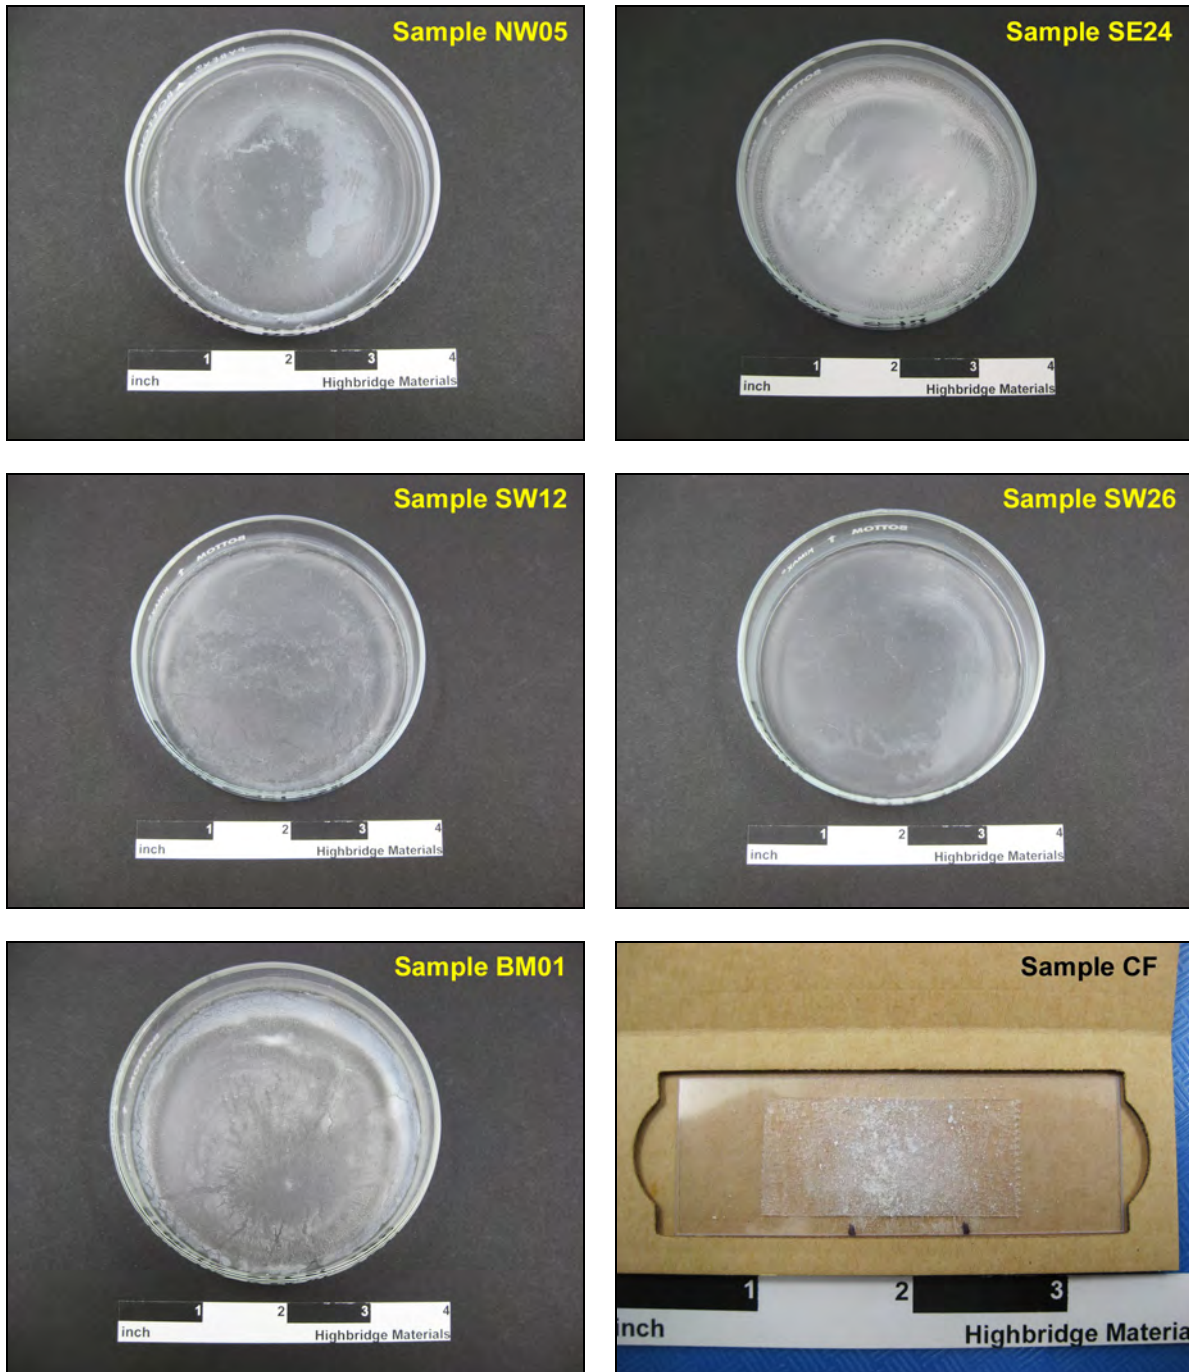
Figure 3: Photographs of the water-extracted salts after redeposition in the petri dishes through evaporation, and the one salt sample transferred on a flexible slide. All were analyzed using XRD. Sample NE11 is not shown here as it was run directly as-found.

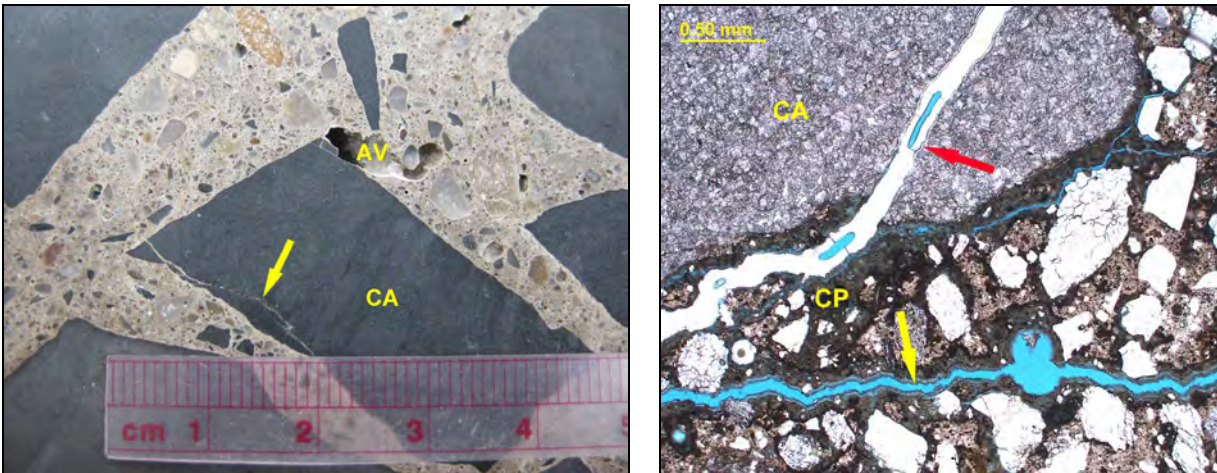
Figure 6: (Left) A close-up is shown of the honed cross section. A coarse aggregate particle (CA) contains a hairline crack (arrow). An adjacent air-void (AV) is thinly lined with some reaction gel. (Right) PPL photomicrograph. A crack (red arrow) transects a coarse aggregate particle (CA). This crack opened in preparation and is now mostly filled with colorless epoxy. Still, a thin veneer of reaction gel lines the crack surfaces. The crack extends into the cement paste (CP). Cracks are also observed transecting the mortar fraction (yellow arrow).

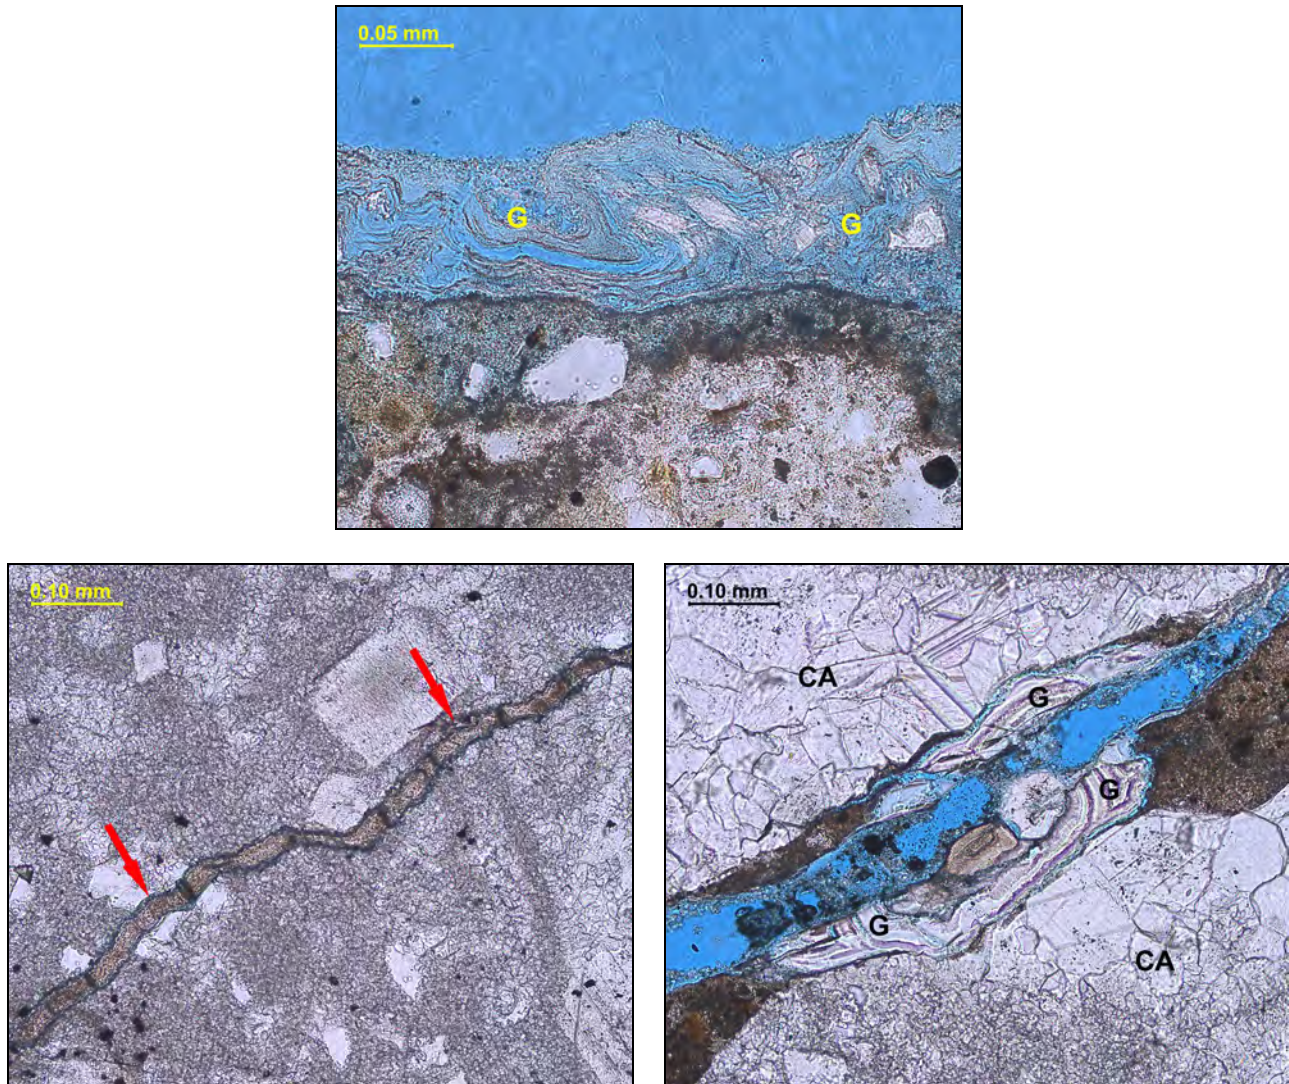
Figure 7: PPL photomicrographs. (Upper image) The white veneer lining the planar formed surface shown in Figure 1 consists mostly of a layered reaction gel (G). (Lower left) The arrows indicate a microcrack within a coarse aggregate grain completely filled with secondary reaction gel. (Lower right) A more open crack within a coarse aggregate grain (CA) contains a deposit of layered gel (G).
