03/29/2024

**STRUCTURAL AND ELECTRICAL ASSESSMENT OF
THE BENNINGTON BATTLE MONUMENT**

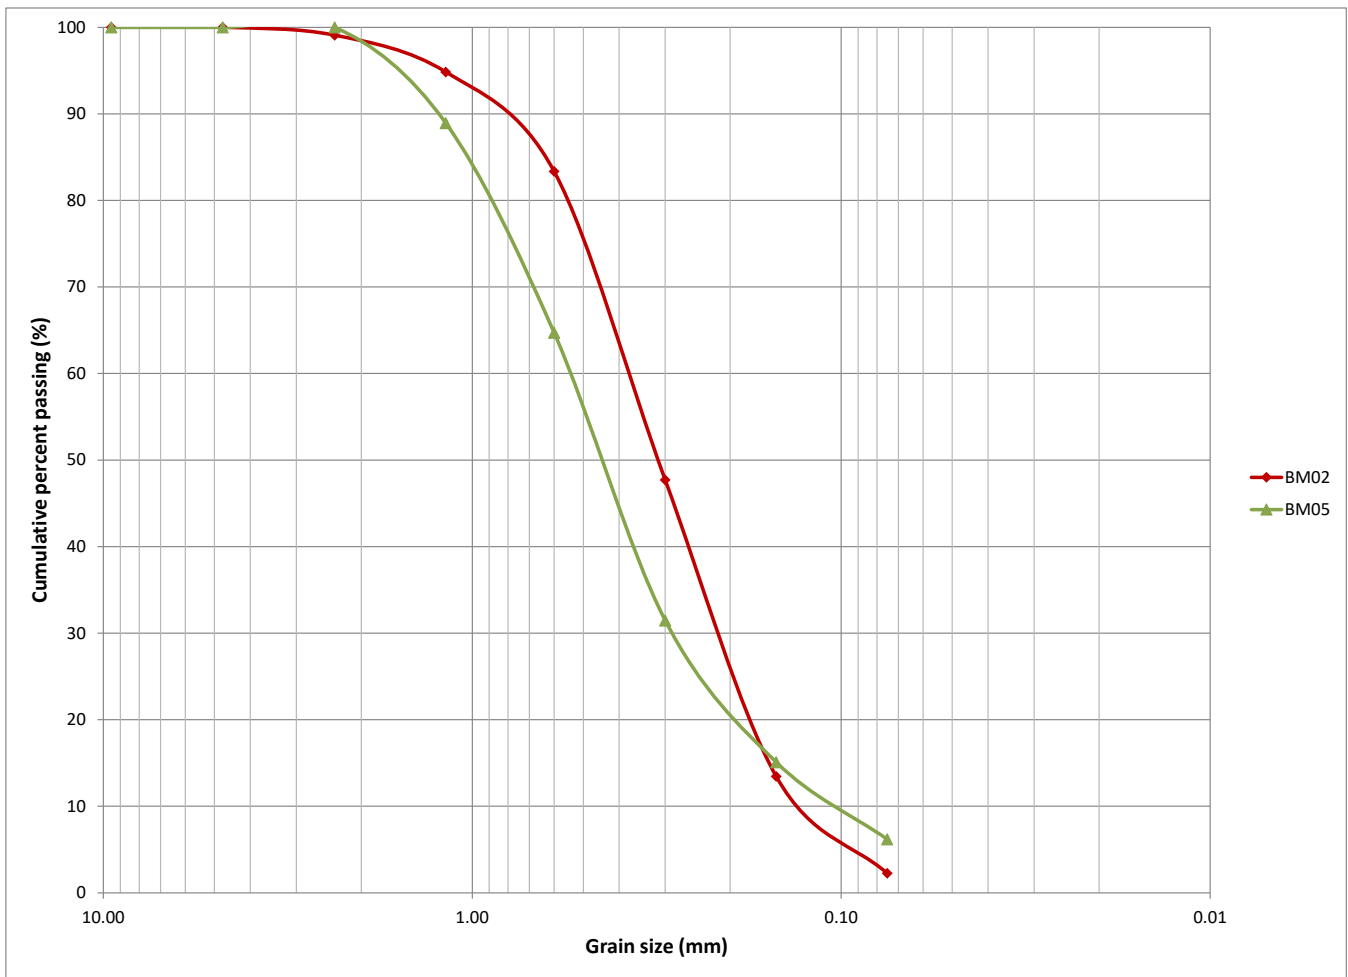
8. Chemical Analysis

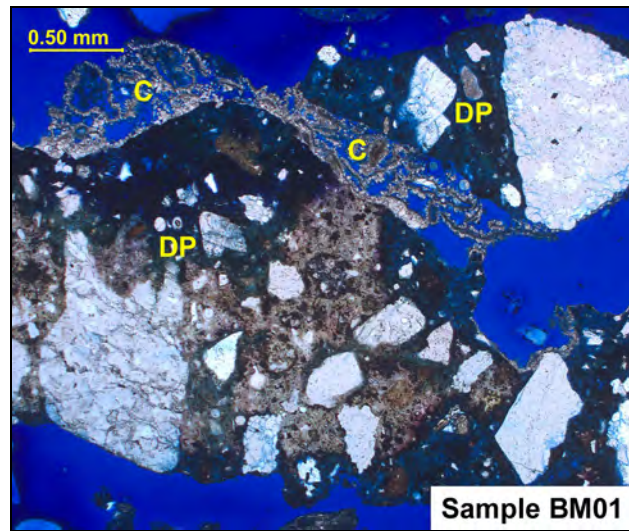
Figure 8: PPL photomicrograph showing the degraded condition of Sample BM01. The sample consists of fine pieces of mortar debris. The few intact fragments consist mostly of decalcified paste (DP), and secondary deposits of calcium carbonate (C) are abundant. These features suggest the mortar has been subject to a high degree of water infiltration.

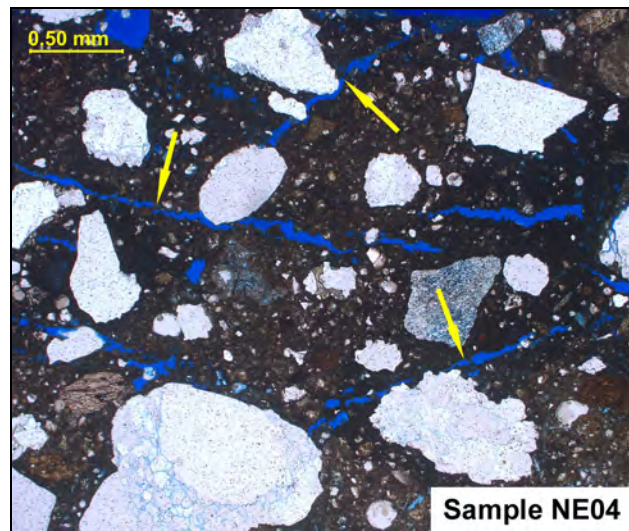
Figure 9: PPL photomicrograph illustrating the splays of ice crystal impressions (arrows) observed in Sample NE04. These indicate that the mortar froze before hardening and suggest the mortar was placed during cold weather.

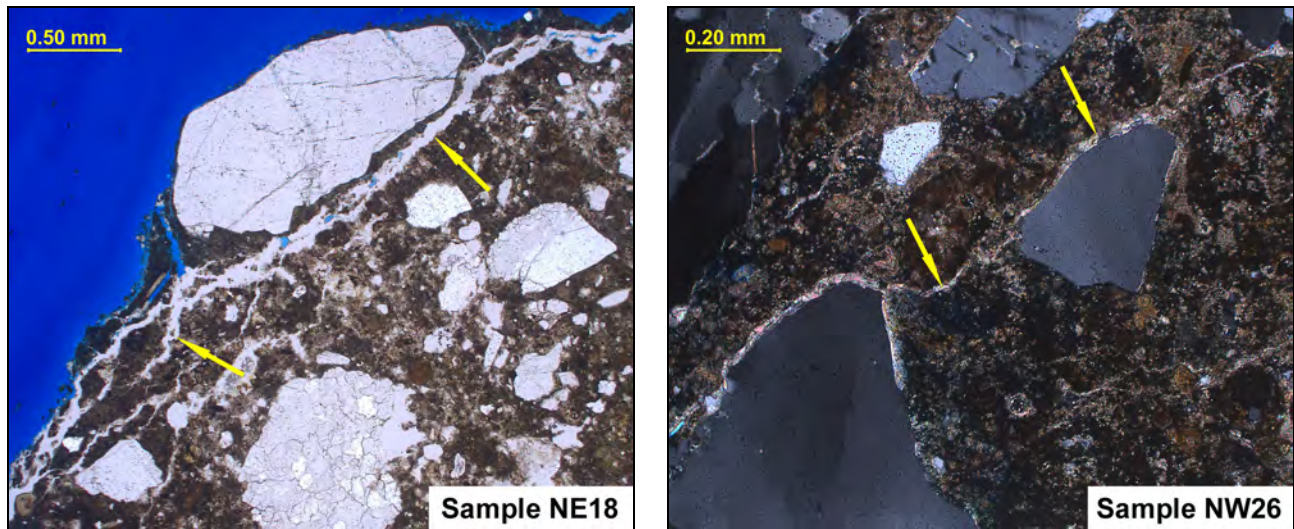
Figure 10: PPL photomicrograph illustrating the fine cracks (arrows) in Samples NE18 and NW26. In Sample NE18, these are filled with an undifferentiated, isotropic salt (potentially chlorides). In Sample NW26, these are often filled with secondary carbonate deposits.

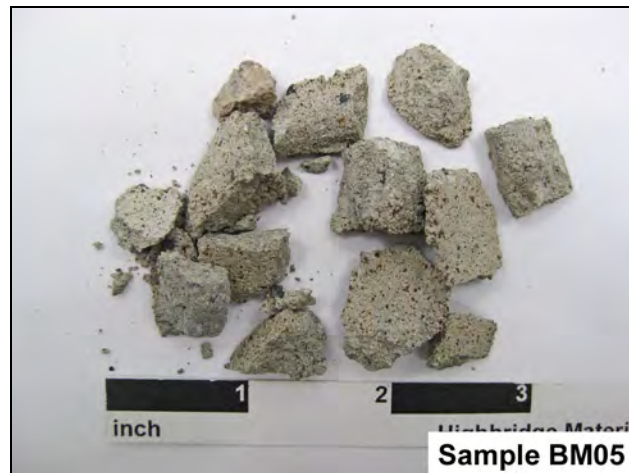
Figure 11: Photograph of Sample BM05 provided to Highbridge for compositional analysis. This is a cement-lime mortar that has a light brownish gray color overall and some fine dark spots due to an iron additive. The mortar is hard and indurate though the paste is somewhat rapidly water-absorptive.

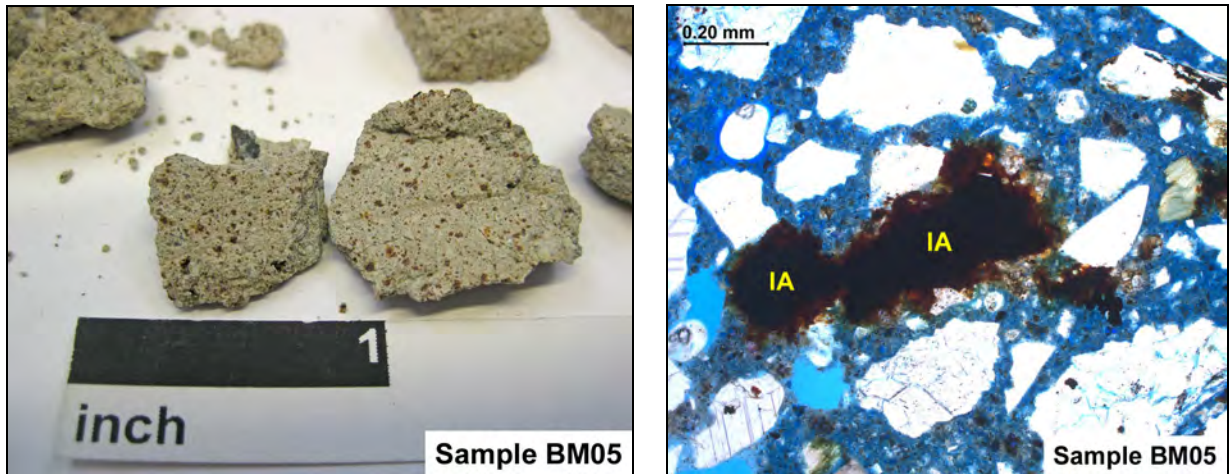
Figure 14: Images illustrating the metallic iron addition within Sample BM05. (Left photograph) The iron particles have oxidized producing fine rust spot, as viewed here on the tooled surface of the mortar. (Right CPL photomicrograph) The iron additive (IA) was added as sand-sized particles from which iron oxides have now emanated into the surrounding binder paste.

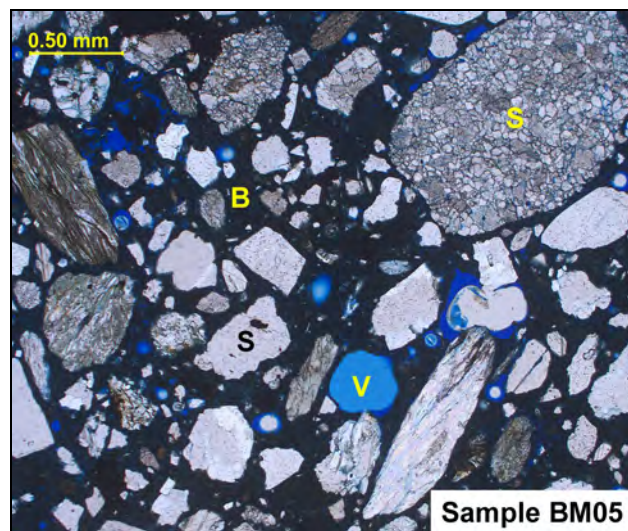
Figure 15: PPL photomicrograph illustrating the microtexture of the mortar in Sample BM05. The binder matrix (B) has a moderately high microporosity, as indicated by the absorption of the blue-dyed epoxy used in the sample preparation. The sand (S) is somewhat sharp-textured, broadly-graded, and evenly distributed. The mortar was well consolidated and air-voids (V) are not excessive.

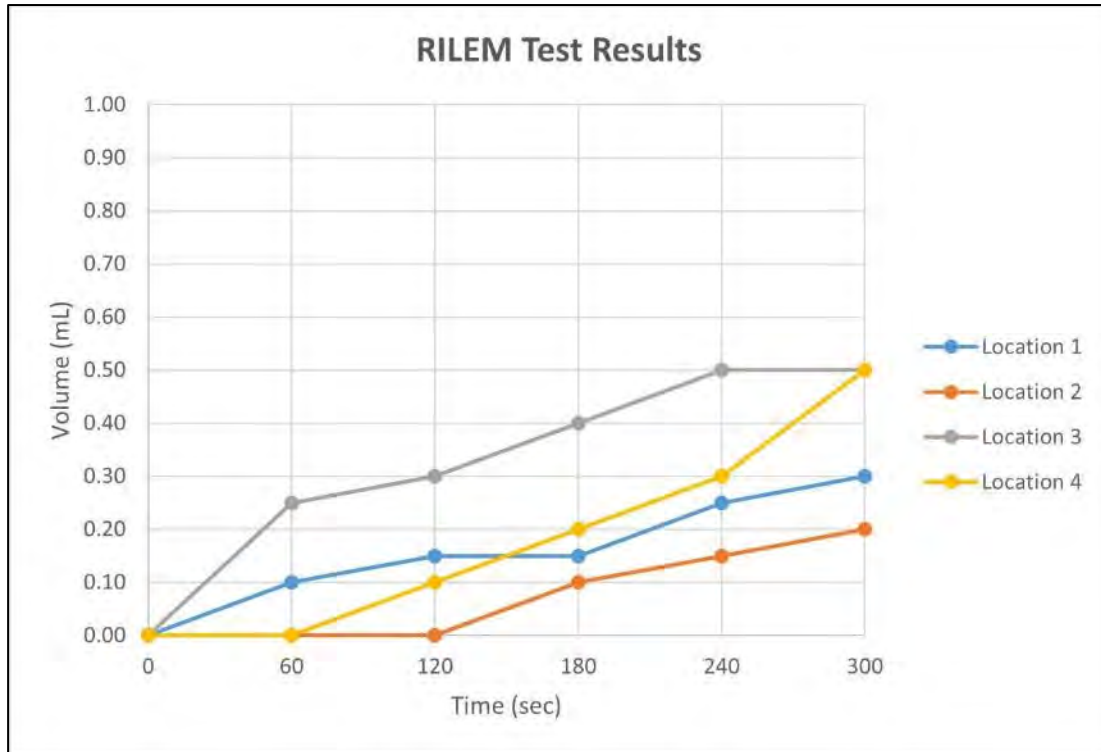
The exterior testing locations absorbed 1 ml or less of water over five minutes. The testing apparatuses were left on the stone units while other work was being performed for close to two hours with less than 2 ml of water absorption.

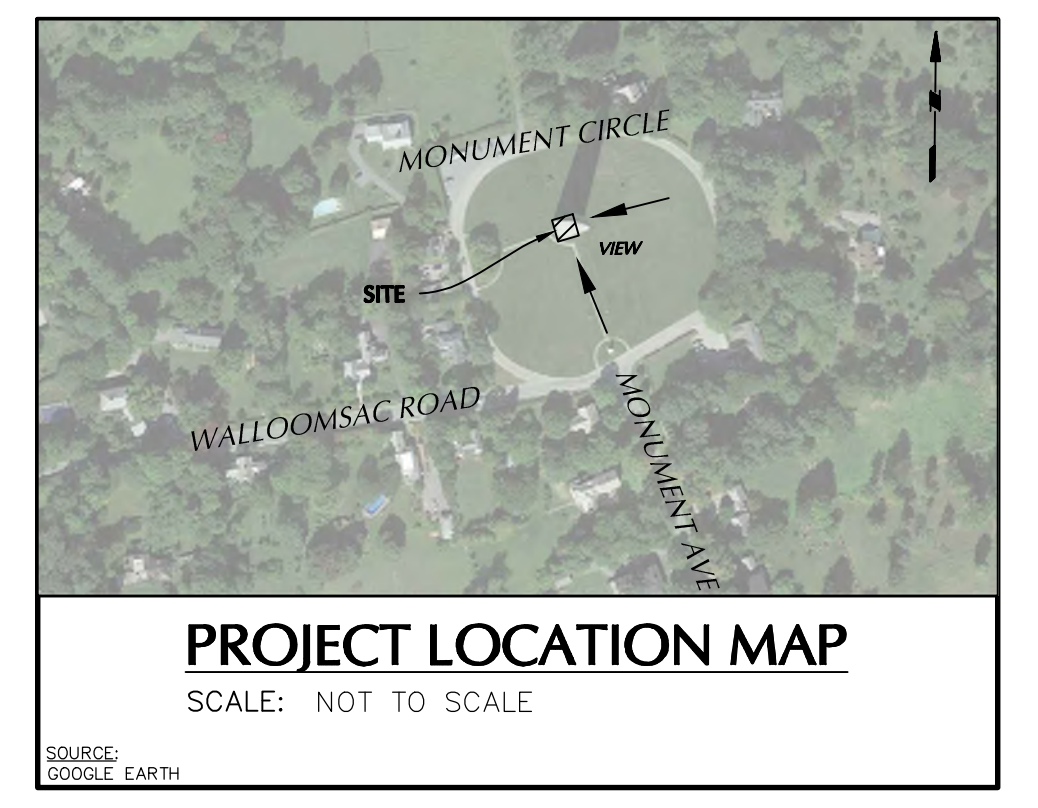
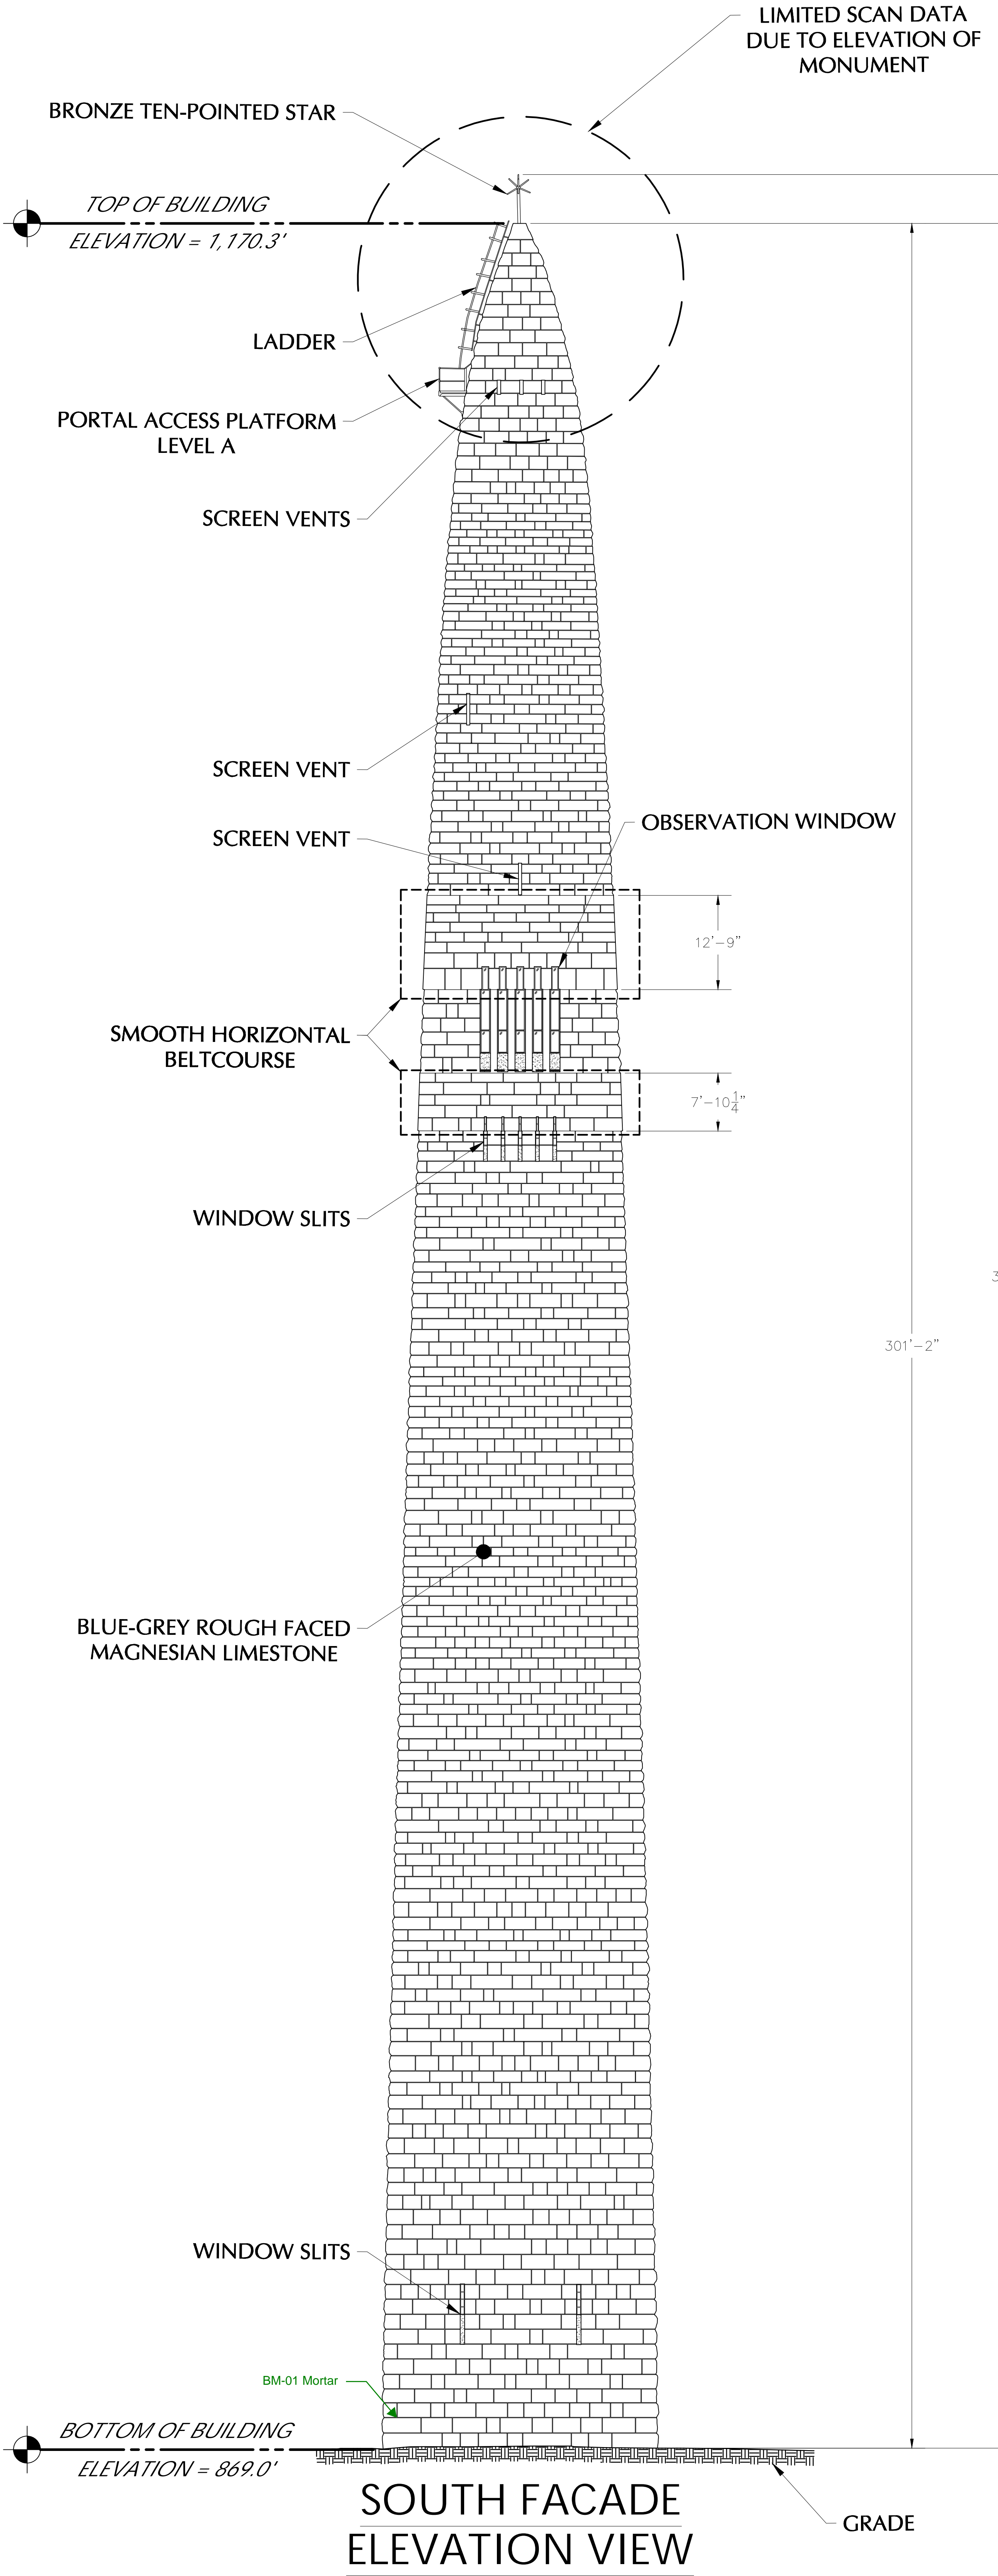
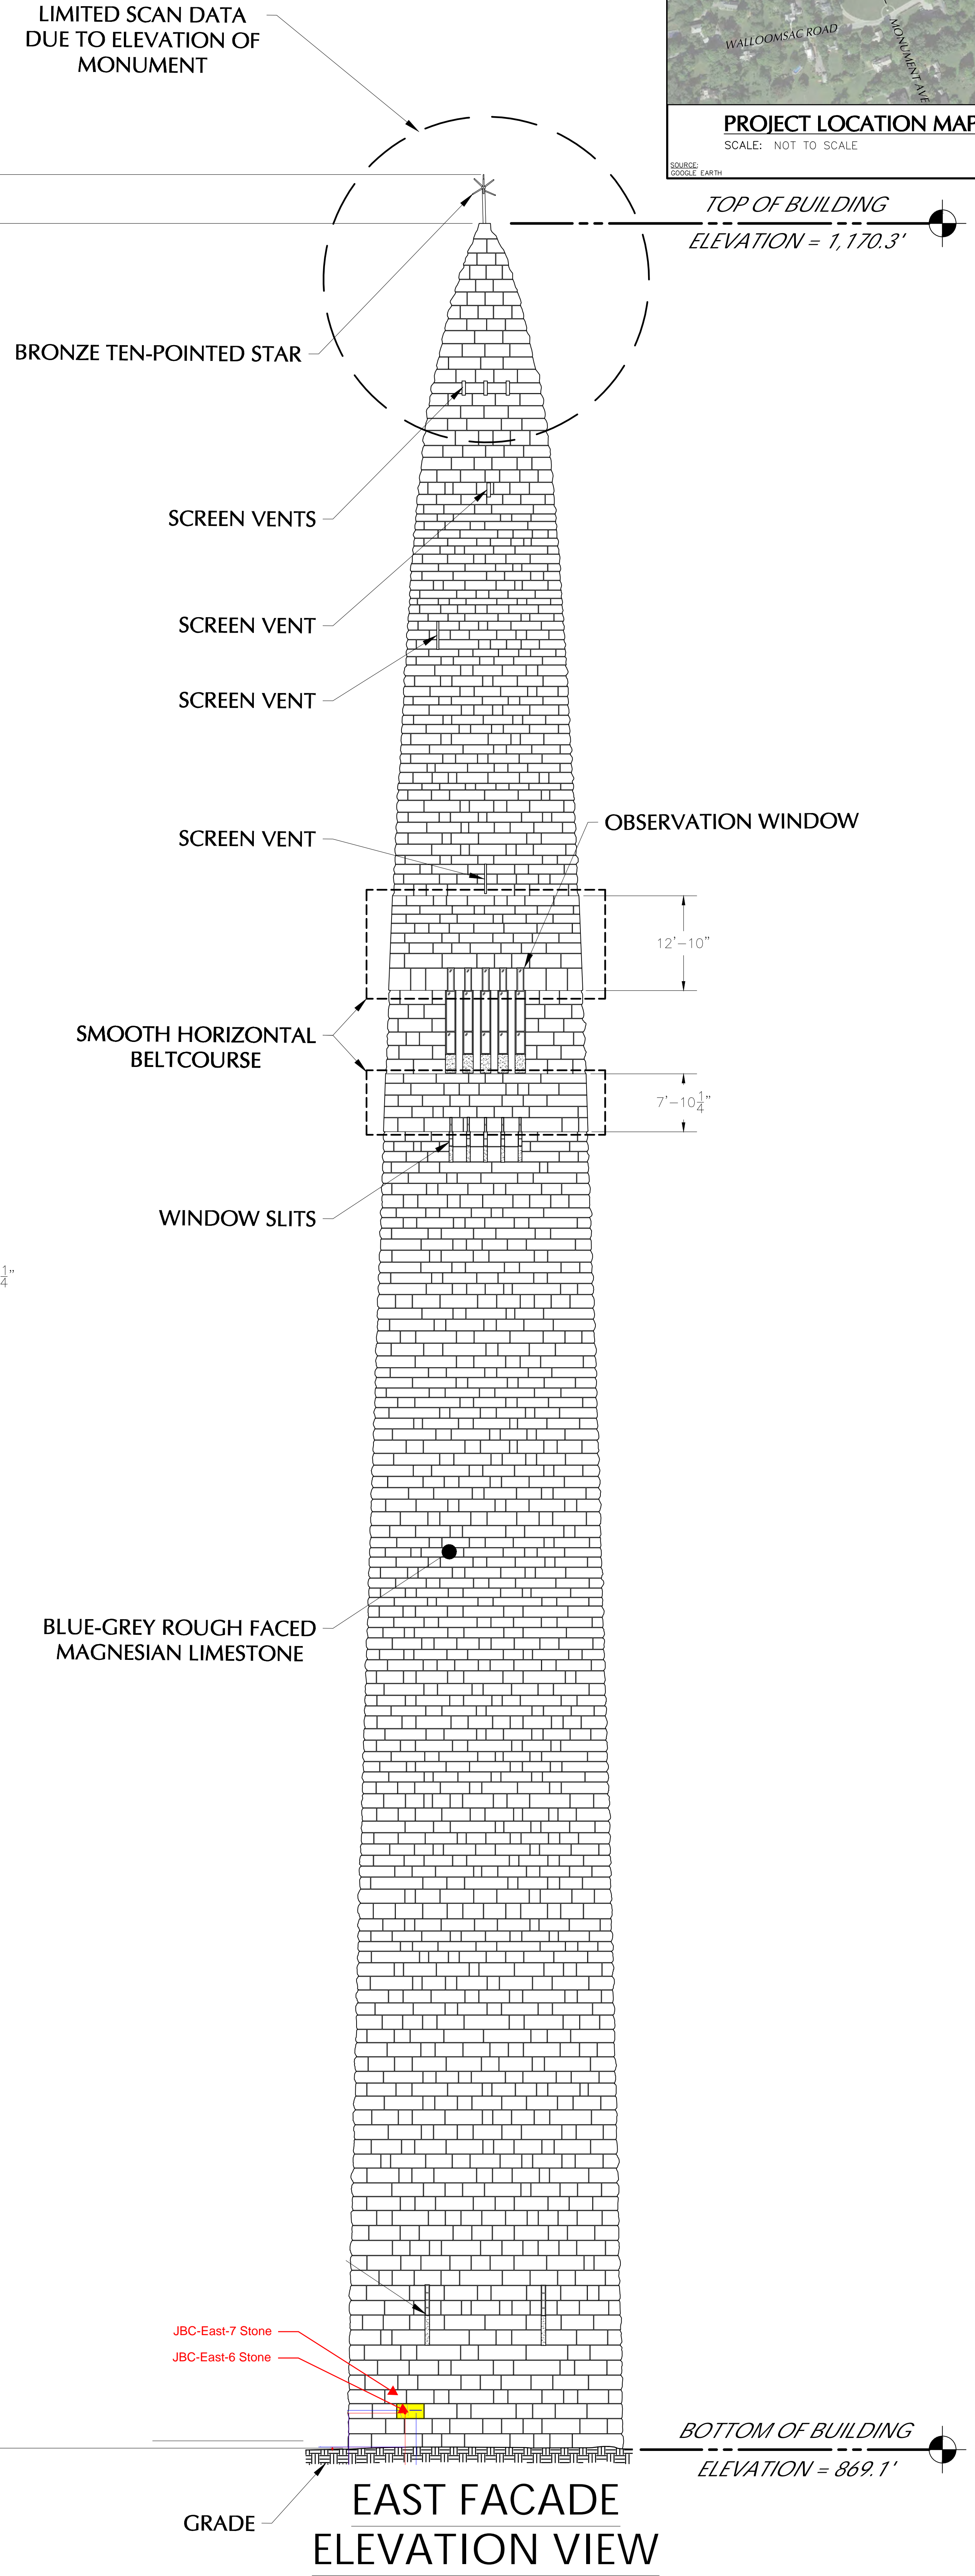
SAMPLING LOCATION PLAN

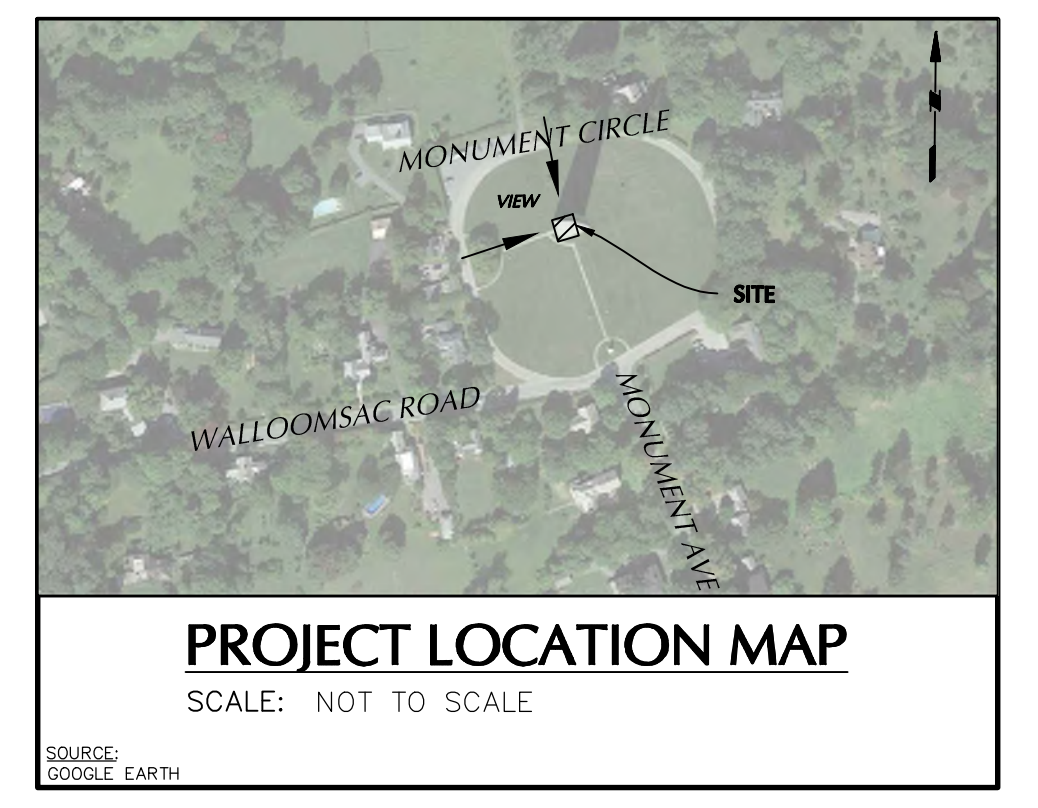
- NOTES:**
1. THIS SURVEY IS BASED UPON EXISTING PHYSICAL CONDITIONS FOUND AT THE SUBJECT SITE.
 2. INFORMATION SHOWN HEREON HAS BEEN OBTAINED FROM LASER SCAN DATA COLLECTED BY LANGAN ENGINEERING, ENVIRONMENTAL, SURVEYING AND LANDSCAPE ARCHITECTURE, D.P.C., IN FEBRUARY, 2022.
 3. ELEVATIONS SHOWN ARE REFERENCED TO THE NORTH AMERICAN VERTICAL DATUM OF 1988.
 4. ALL UNITS SHOWN HEREON ARE IN U.S. SURVEY FEET.
 5. THIS PLAN NOT VALID UNLESS EMBOSSED OR BLUE INK STAMPED WITH THE SEAL OF THE PROFESSIONAL LAND SURVEYOR.

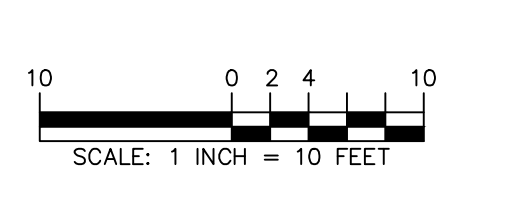
LANGAN Langan Engineering and Environmental Services, Inc. 21 Penn Plaza, 960 West 31st Street, 8th Floor New York, NY 10001 T: 212.479.5400 F: 212.479.5444 www.langan.com Project BENNINGTON BATTLE MONUMENT 15 MONUMENT CIRCLE BENNINGTON, VT BENNINGTON COUNTY VERMONT Drawing Title ELEVATION PLAN INTERIOR (NORTH & WEST) Project No. 170724001 Date 05/11/2022 Drawn By JFR Checked By PDF Drawing No. EL-03 Sheet 003 of 004

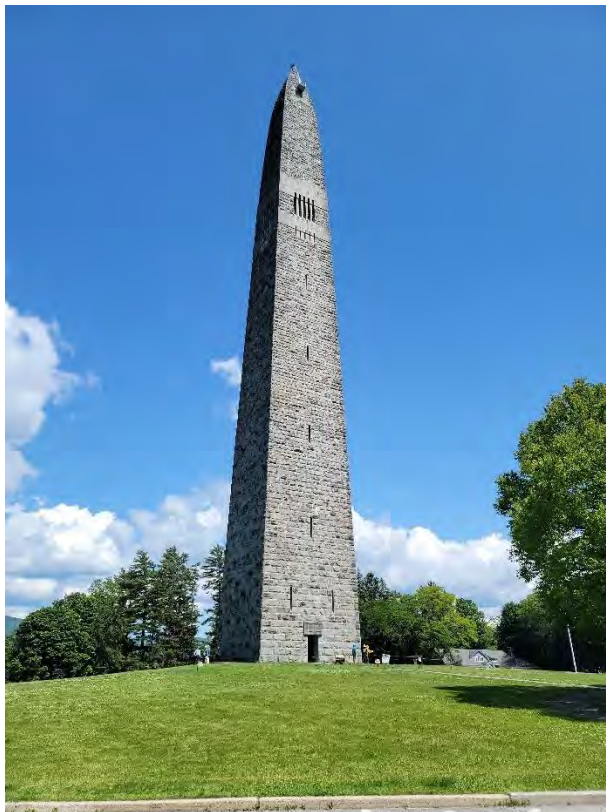
**CONDITION ASSESSMENT AND TREATMENT RECOMMENDATIONS
FOR
ENVIRONMENTAL CONDITIONS INSIDE MONUMENT**

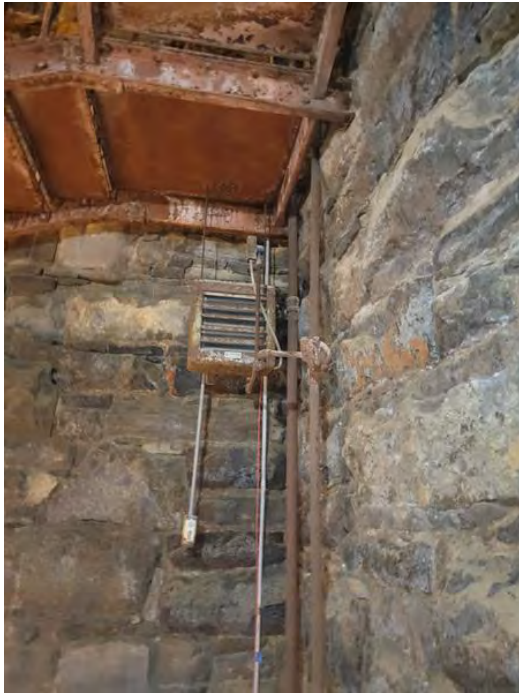
Figure 1. Remnants of abandoned heating system in monument

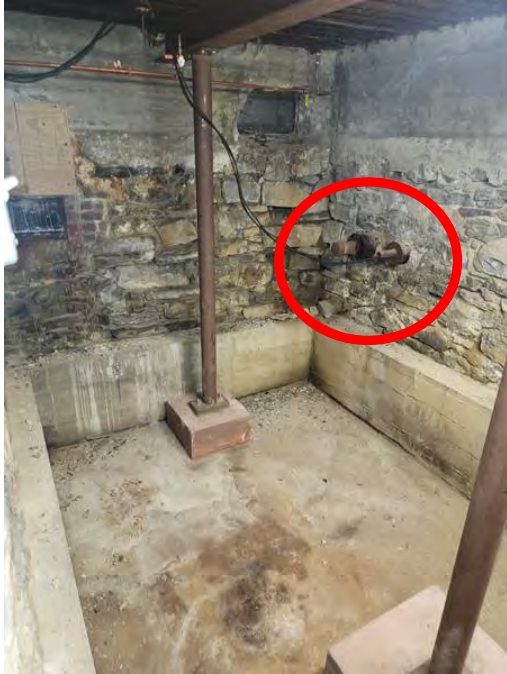
Figure 2. Former boiler room in visitor's center. Note piping cut and capped

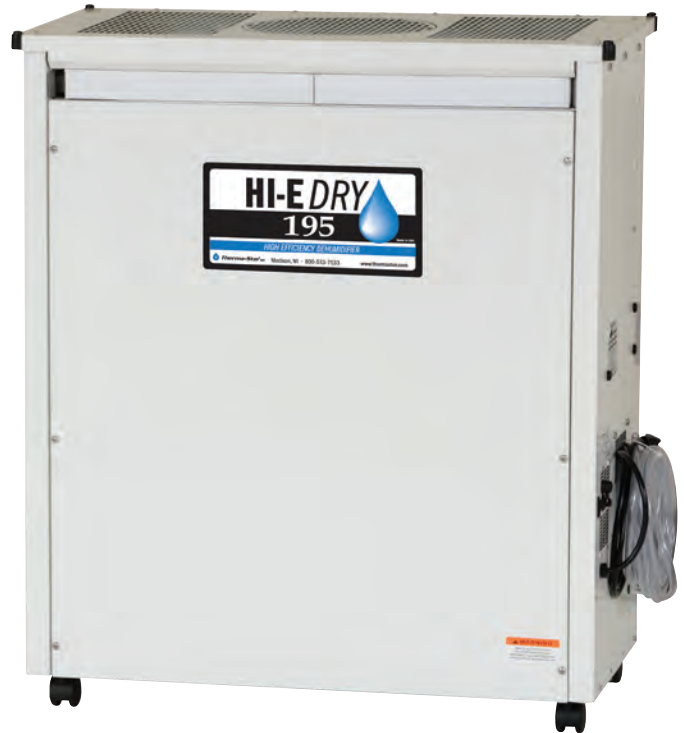
The Hi-E DRY 195 high efficiency dehumidifier utilizes refrigeration to cool the incoming air stream below its dew point as it passes through the dehumidification (evaporator) coil. This cooling results in the removal of moisture (latent heat) and reduction in temperature (sensible heat). The cooled and dried air is used to pre-cool the incoming air stream resulting in up to a 200 percent increase in overall efficiency. After the pre-cooling stage the processed air is reheated by passing through the condenser coil. The latent heat removed by the evaporator coil is returned to the air stream at this stage as sensible heat, resulting in an overall temperature increase from the incoming air.

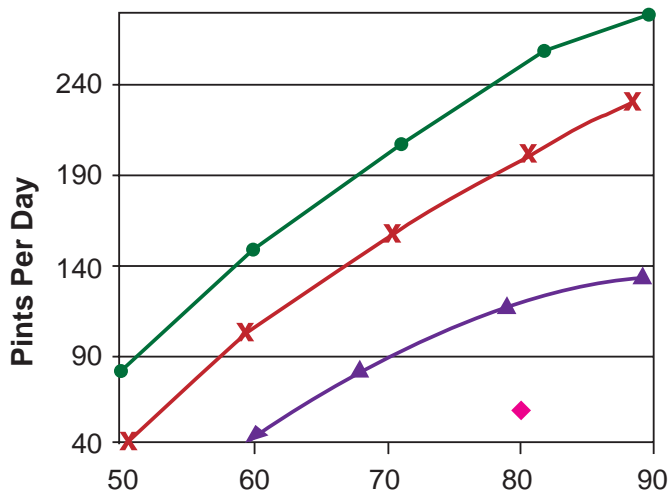
Minimum Performance at Set Conditions

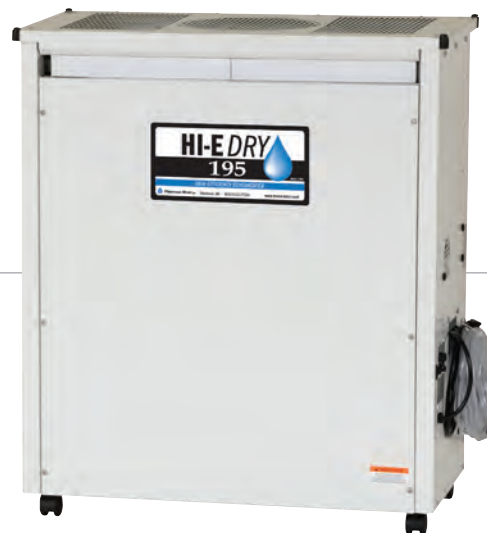
Date: 12 January, 2024

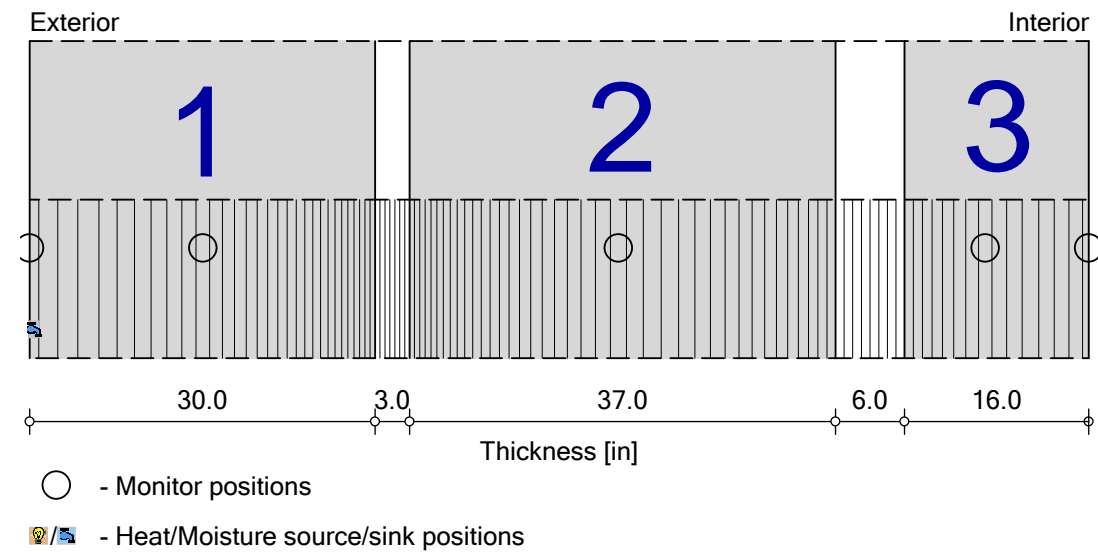
Exterior (left side) Albany, NY
 Interior (right side) 55° F with fluctuation of 25° F; and 72% RH with a 50% amplitude
 Moisture Source Exterior Limestone Layer - 1% (ANSI/ASHRAE standard 160)

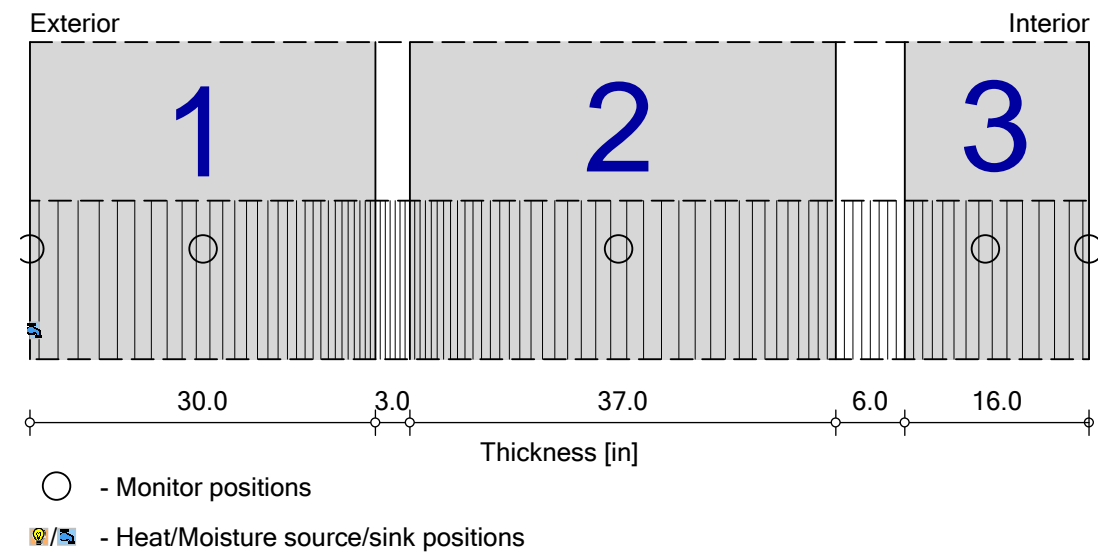
Exterior (left side) Albany, NY
 Interior (right side) 55° F with fluctuation of 25° F; and 72% RH with a 50% amplitude
 Moisture Source Exterior Limestone Layer - 1% (ANSI/ASHRAE standard 160)

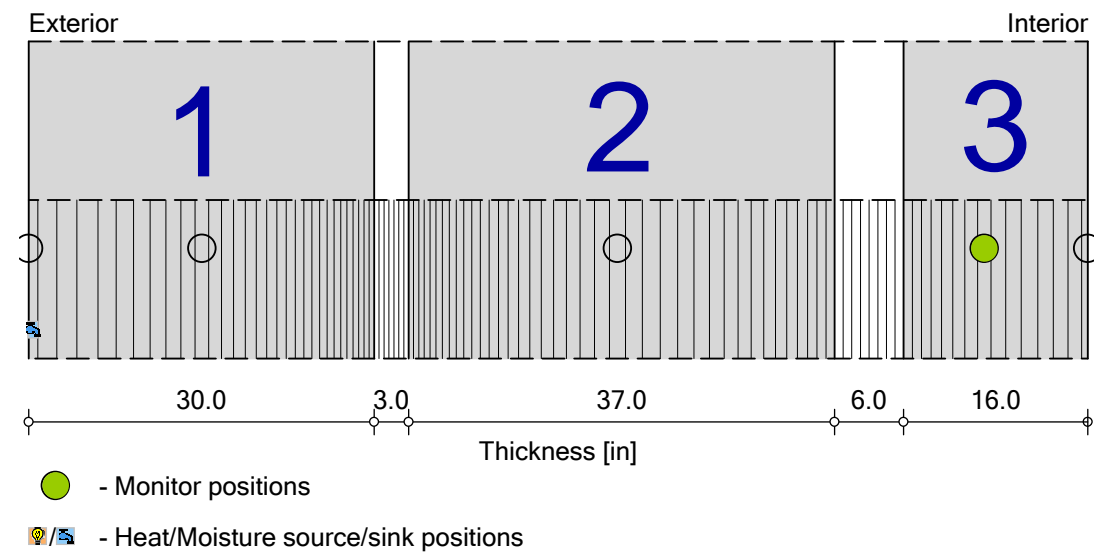
Exterior (left side) Albany, NY
 Interior (right side) 55° F with fluctuation of 25° F; and 72% RH with a 50% amplitude
 Moisture Source Exterior Limestone Layer - 1% (ANSI/ASHRAE standard 160)

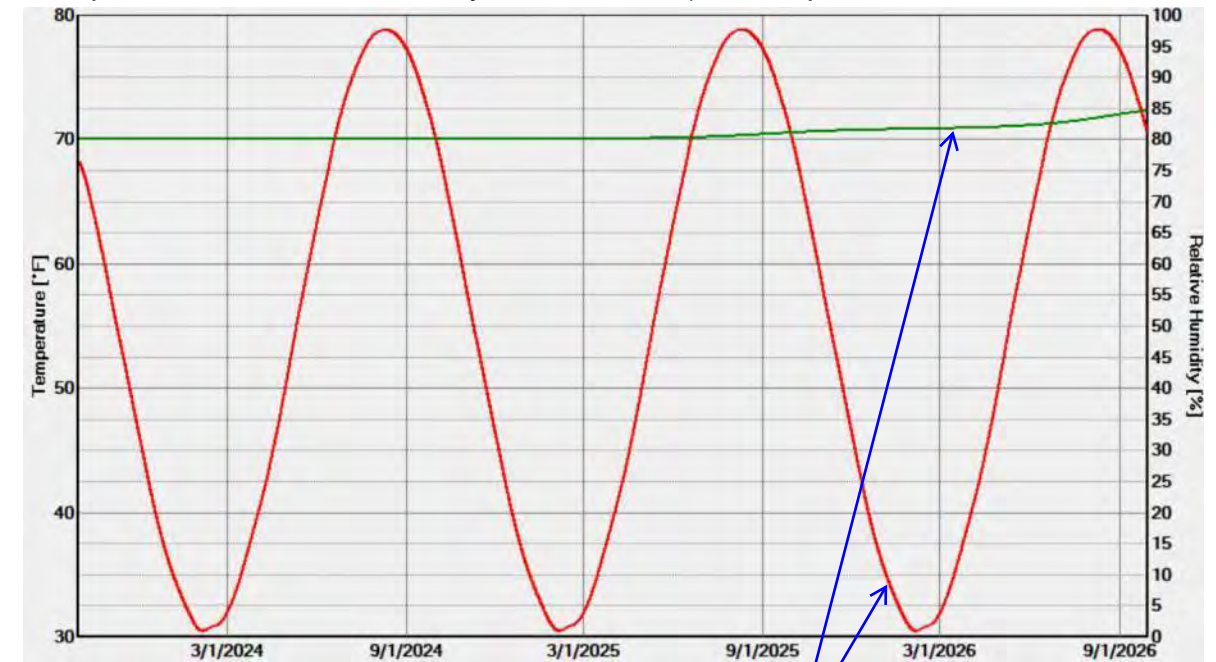
Temperature fluctuates seasonally; Relative Humidity (RH) trends upward during the 3-year period

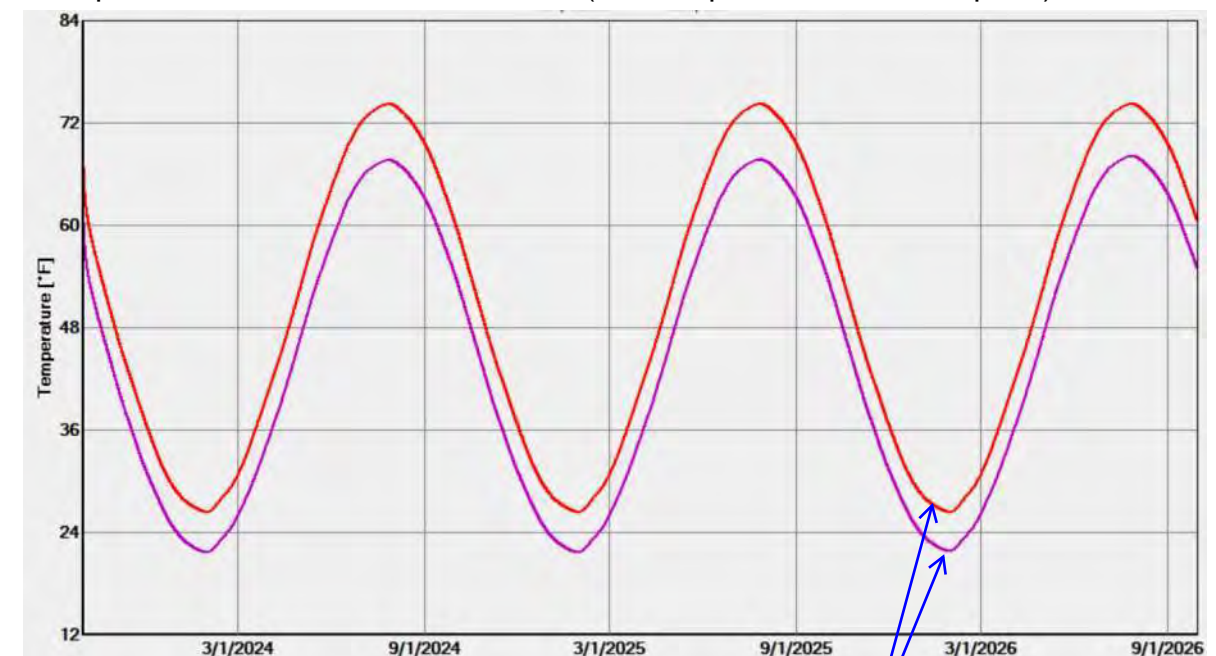
Temperature fluctuates seasonally; Temperature and Dew Point do not intersect (signifies low condensation risk)

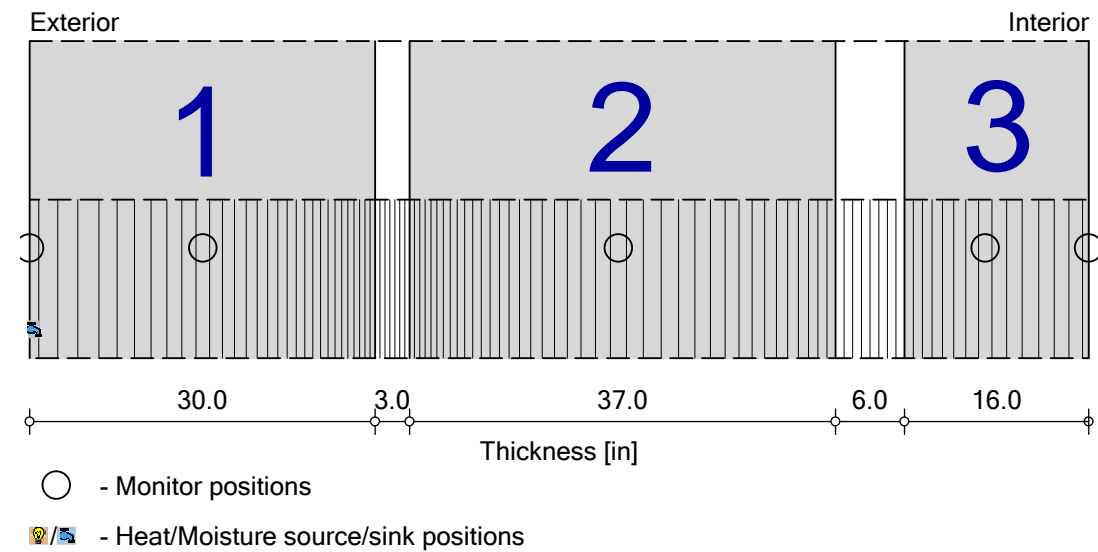
Exterior (left side) Albany, NY
 Interior (right side) 55° F with fluctuation of 25° F; and 72% RH with a 50% amplitude
 Moisture Source Exterior Limestone Layer - 1% (ANSI/ASHRAE standard 160)

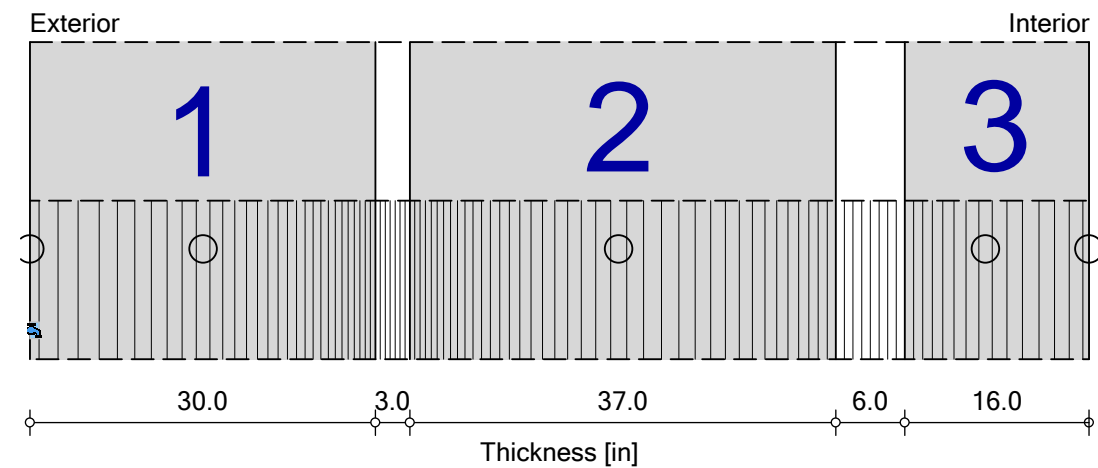
○ - Monitor positions
 - Heat/Moisture source/sink positions

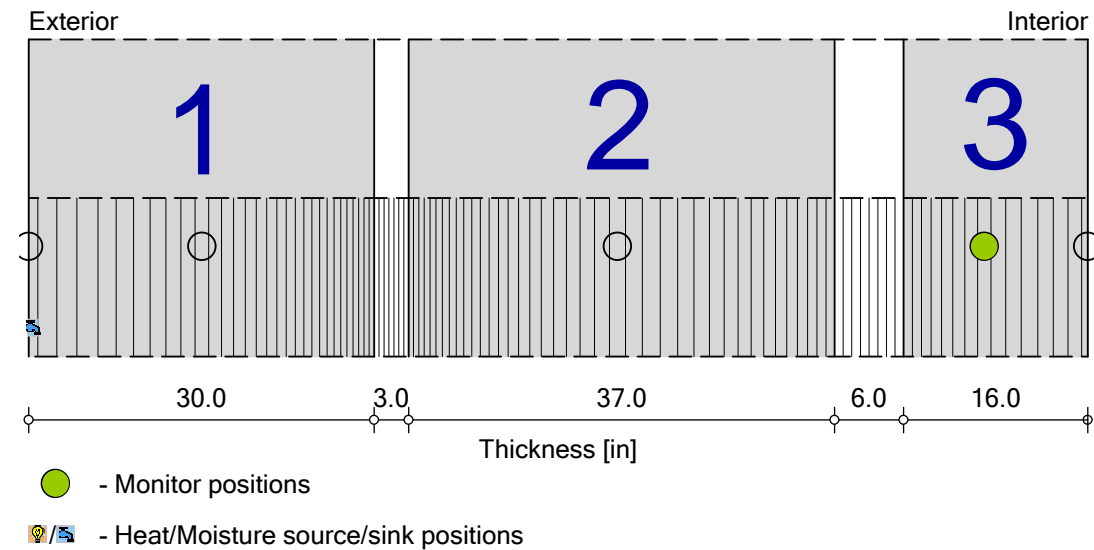
Exterior (left side) Albany, NY
 Interior (right side) 55° F with fluctuation of 25° F; and 72% RH with a 50% amplitude
 Moisture Source Exterior Limestone Layer - 1% (ANSI/ASHRAE standard 160)

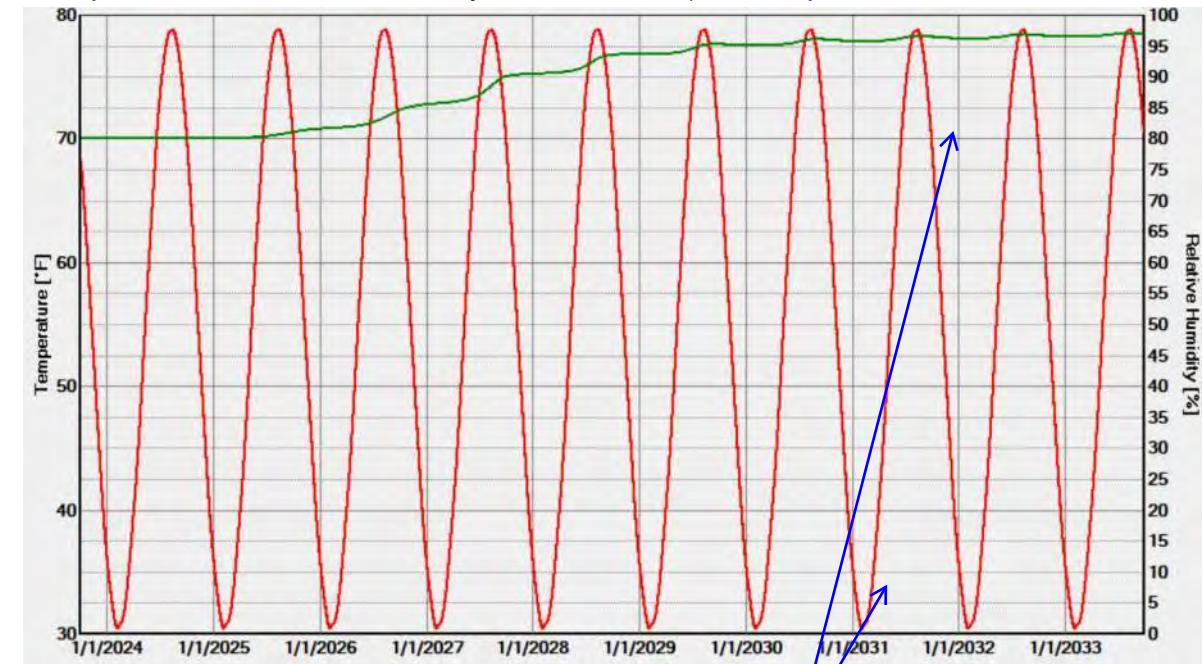
Temperature fluctuates seasonally; Relative Humidity (RH) trends upward during the 10-year period

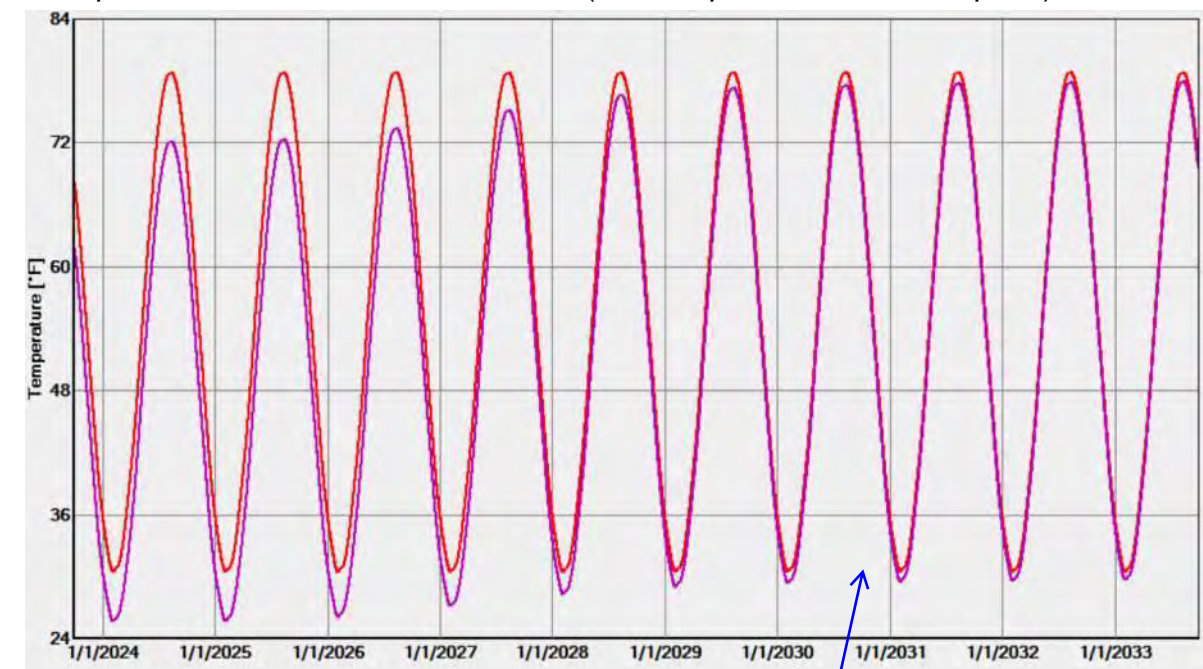
Temperature fluctuates seasonally; Temperature and Dew Point do not intersect, but graphs begin to intersect after six years (signifies condensation risk)

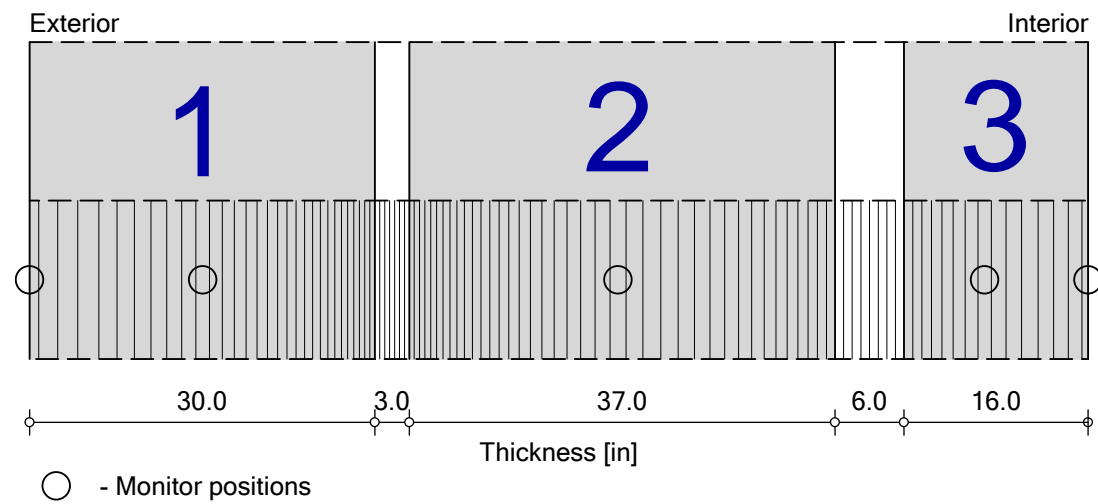
Exterior (left side) Albany, NY
 Interior (right side) 55° F with fluctuation of 25° F; and 60% RH with a 20% amplitude
