03/29/2024

**STRUCTURAL AND ELECTRICAL ASSESSMENT OF
THE BENNINGTON BATTLE MONUMENT**

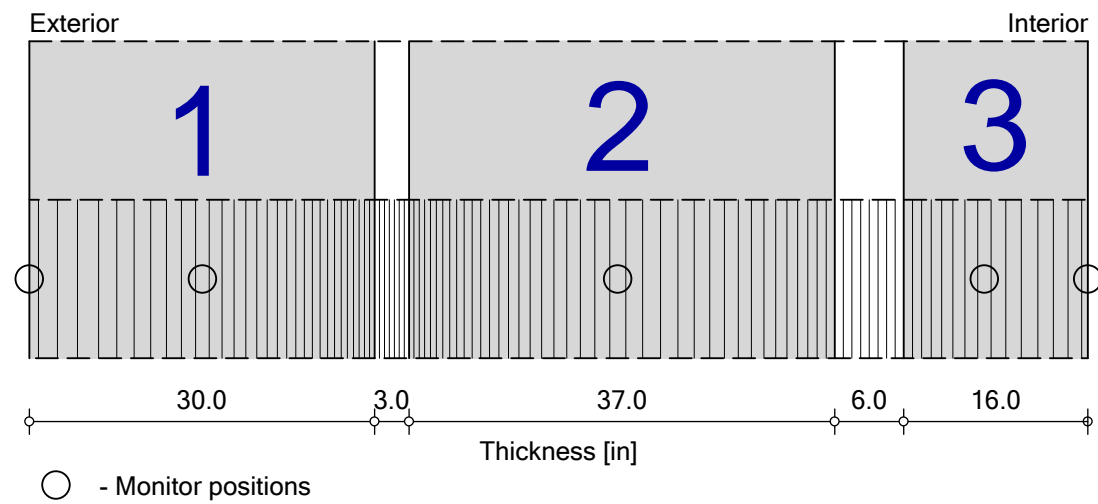
Exterior (left side) Albany, NY
 Interior (right side) 55° F with fluctuation of 25° F; and 60% RH with a 20% amplitude

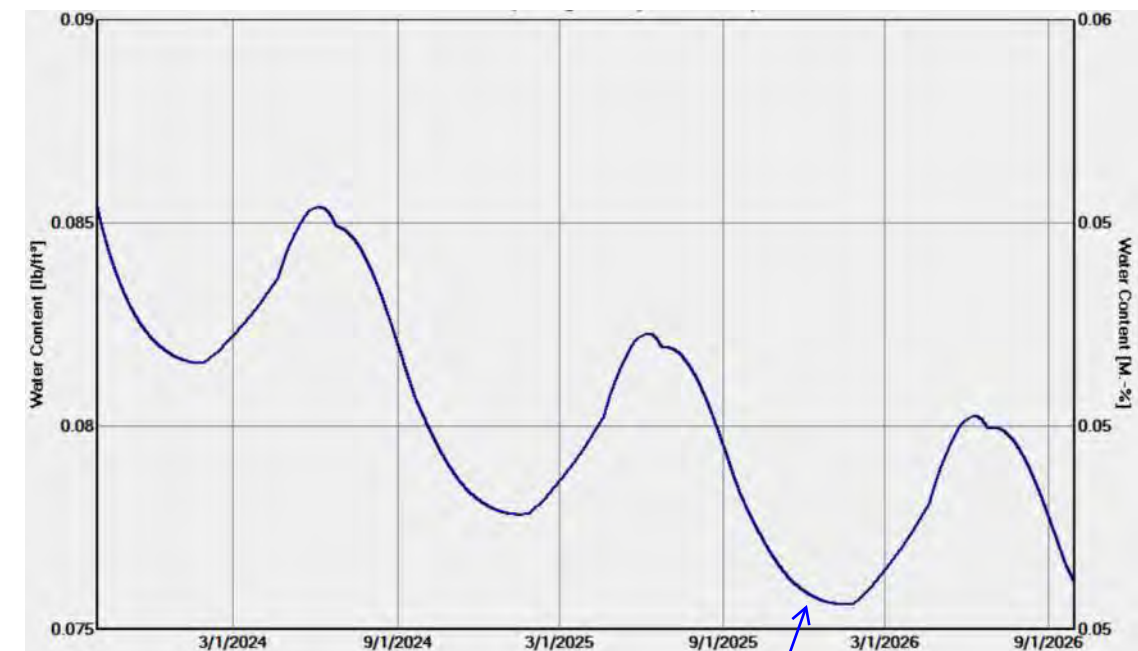
Water content at the interior layer fluctuates seasonally, with decreasing moisture during the 3-year period

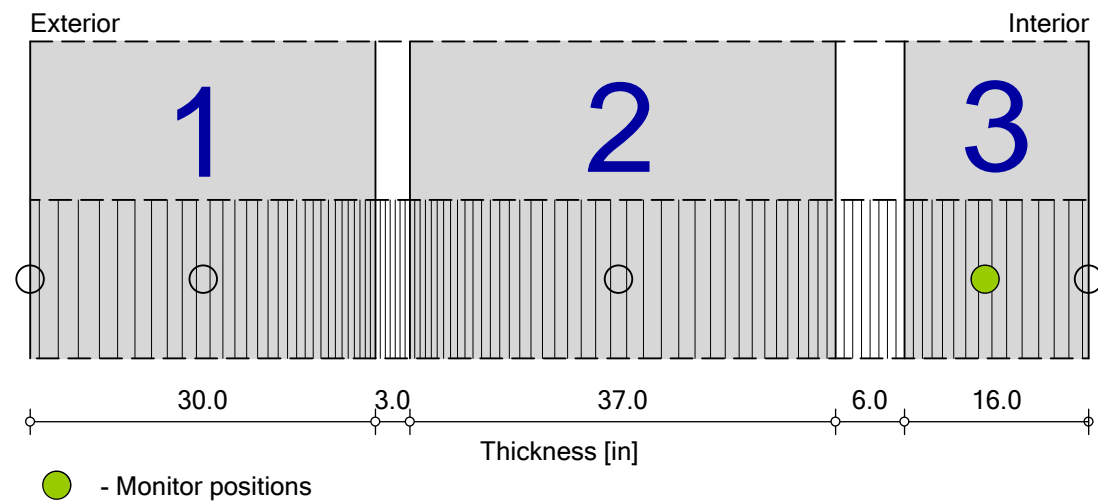
Exterior (left side) Albany, NY
 Interior (right side) 55° F with fluctuation of 25° F; and 60% RH with a 20% amplitude

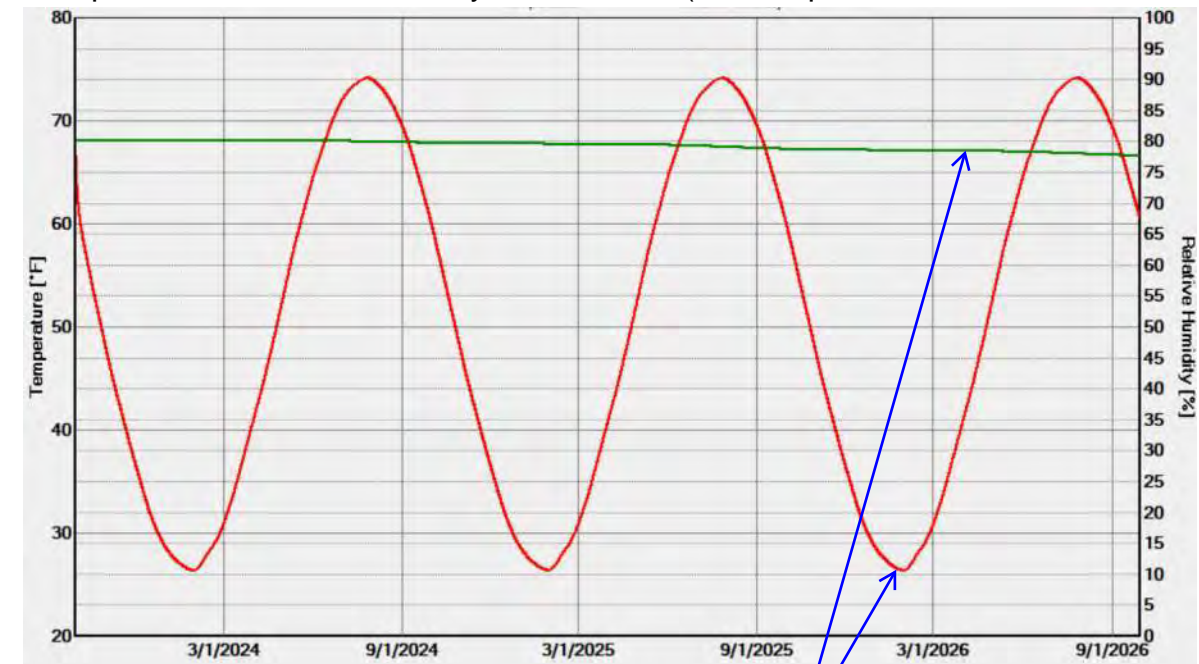
Temperature fluctuates seasonally; Relative Humidity (RH) trends downward during the 3-year period

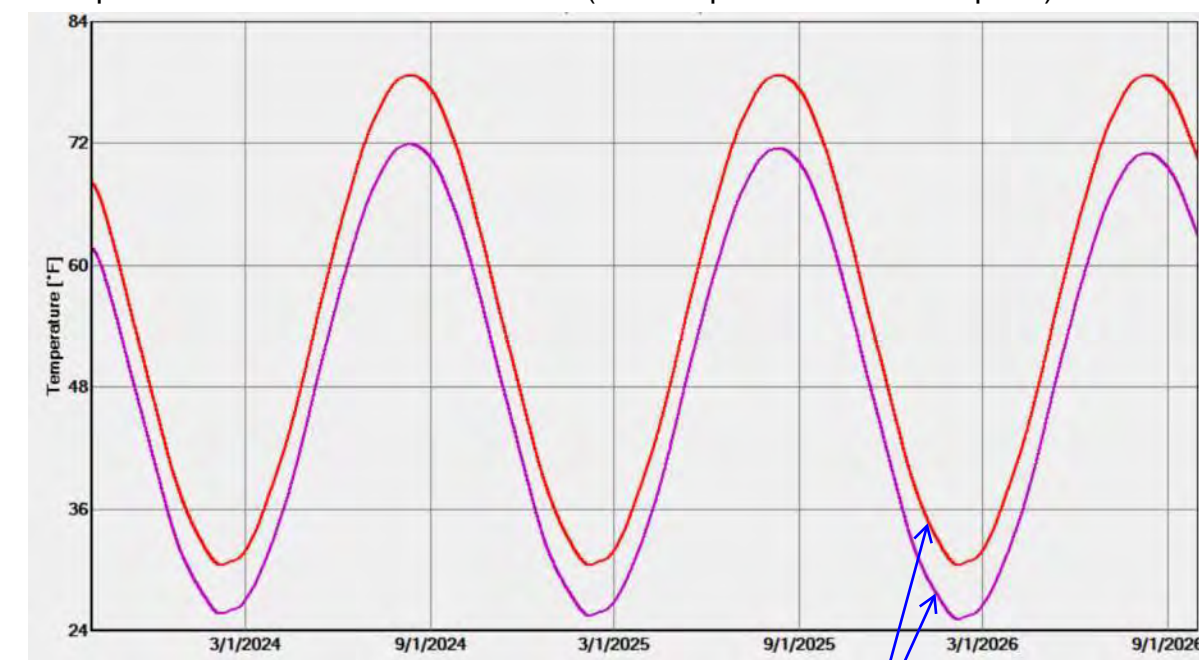
Temperature fluctuates seasonally; Temperature and Dew Point do not intersect (signifies low condensation risk)

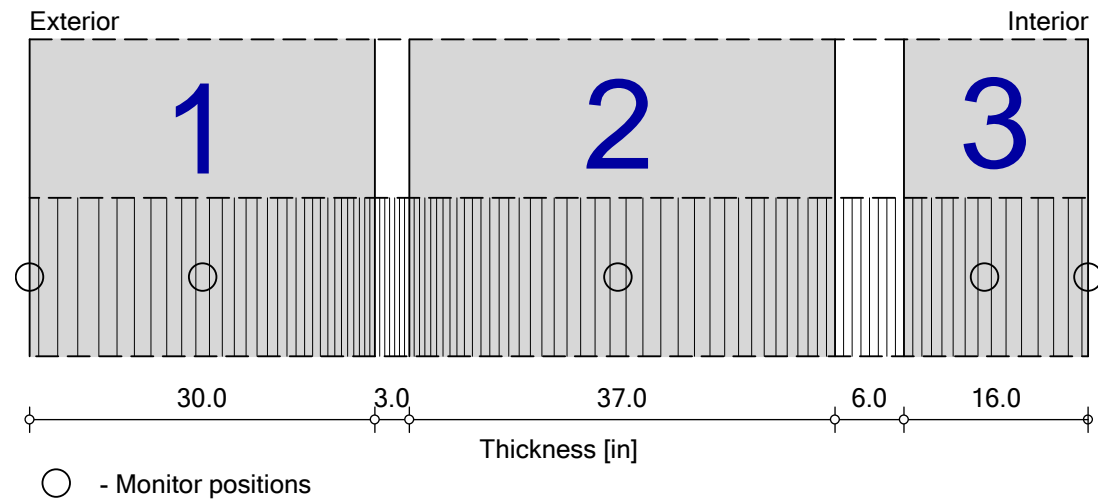
Exterior (left side) Albany, NY
 Interior (right side) 55° F with fluctuation of 25° F; and 60% RH with a 20% amplitude

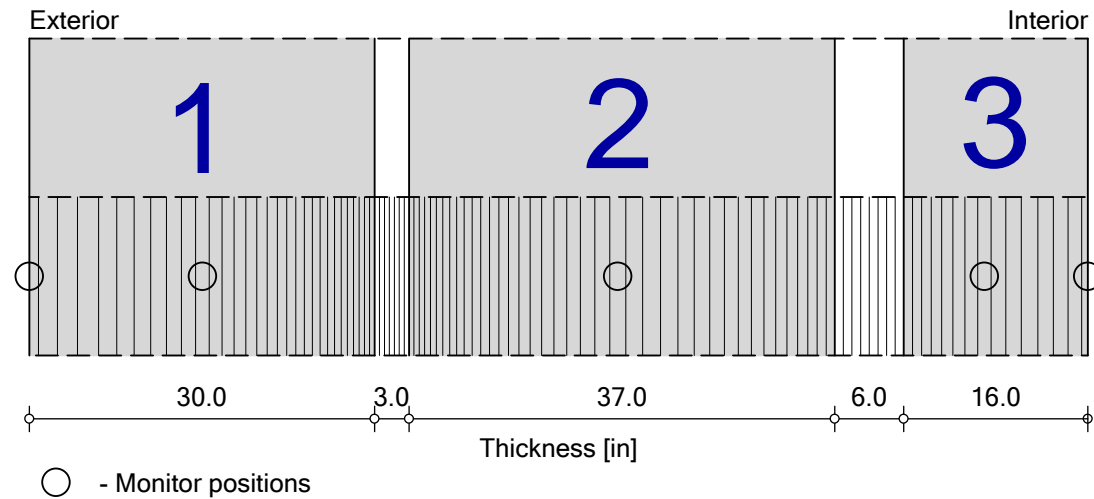
Exterior (left side) Albany, NY
 Interior (right side) 55° F with fluctuation of 25° F; and 60% RH with a 20% amplitude

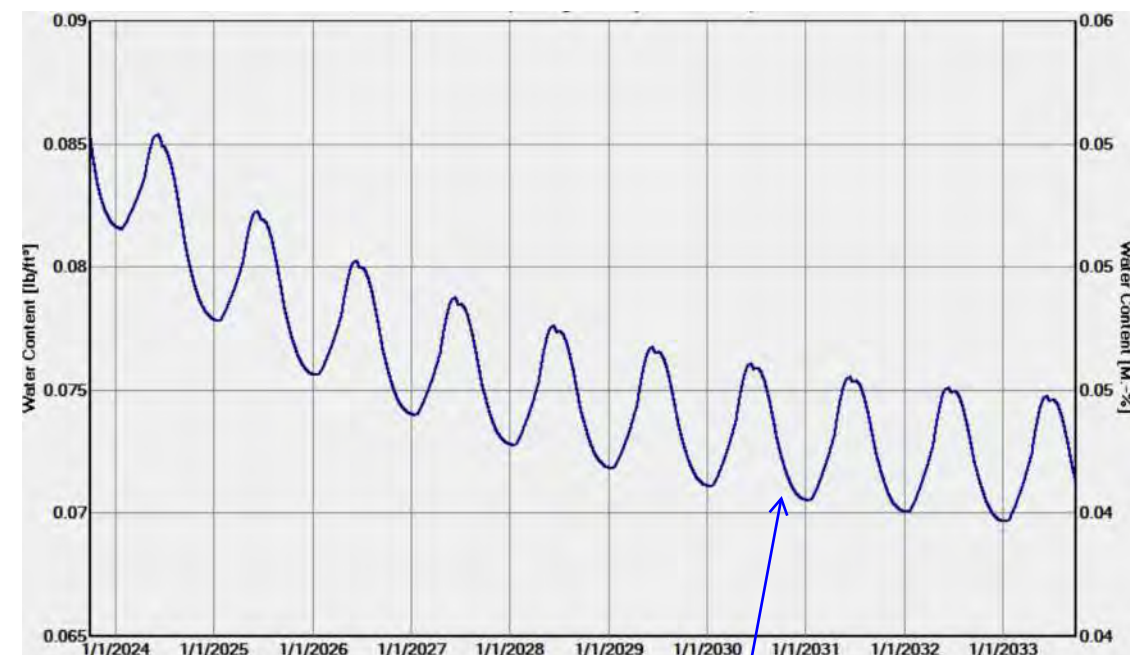
Water content at the interior layer fluctuates seasonally, with decreasing moisture during the 10-year period

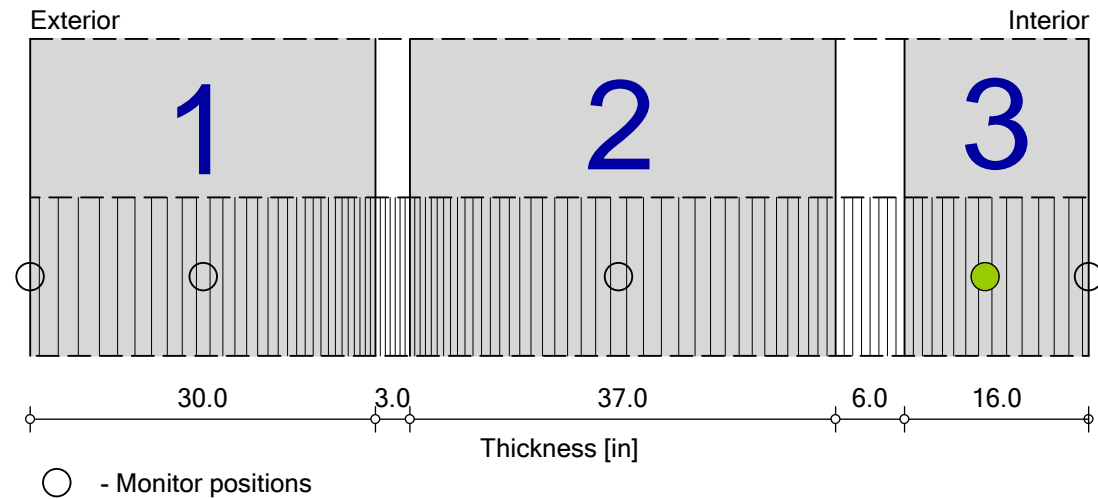
Exterior (left side) Albany, NY
 Interior (right side) 55° F with fluctuation of 25° F; and 60% RH with a 20% amplitude

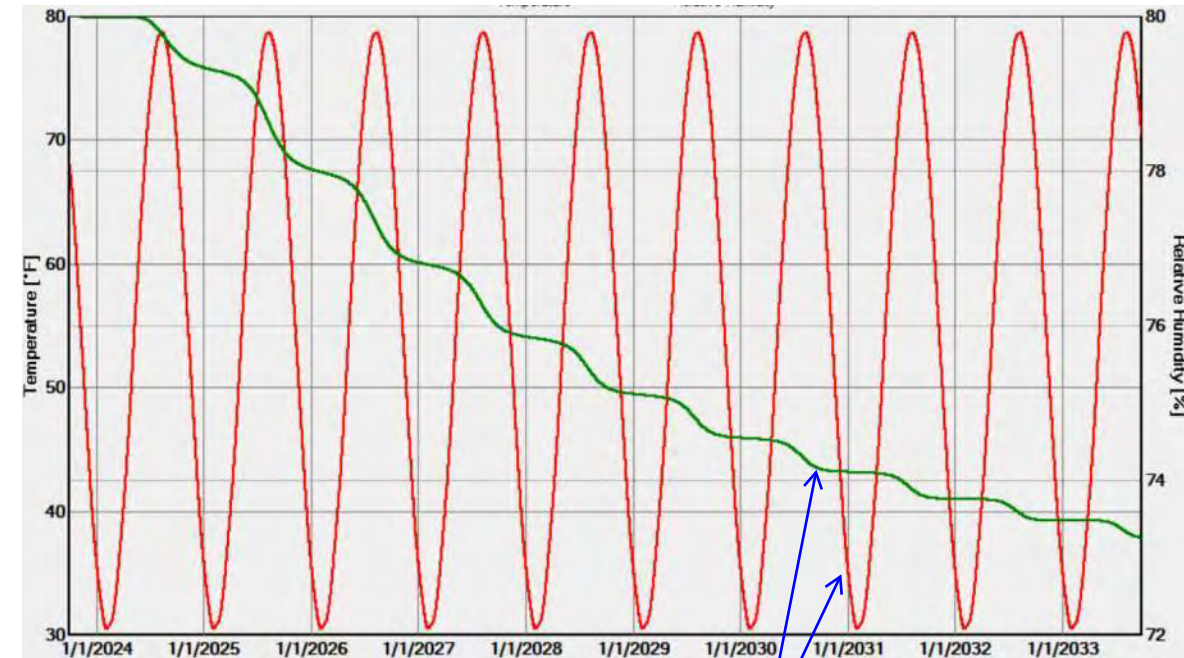
Temperature fluctuates seasonally; Relative Humidity (RH) trends downward during the 10-year period

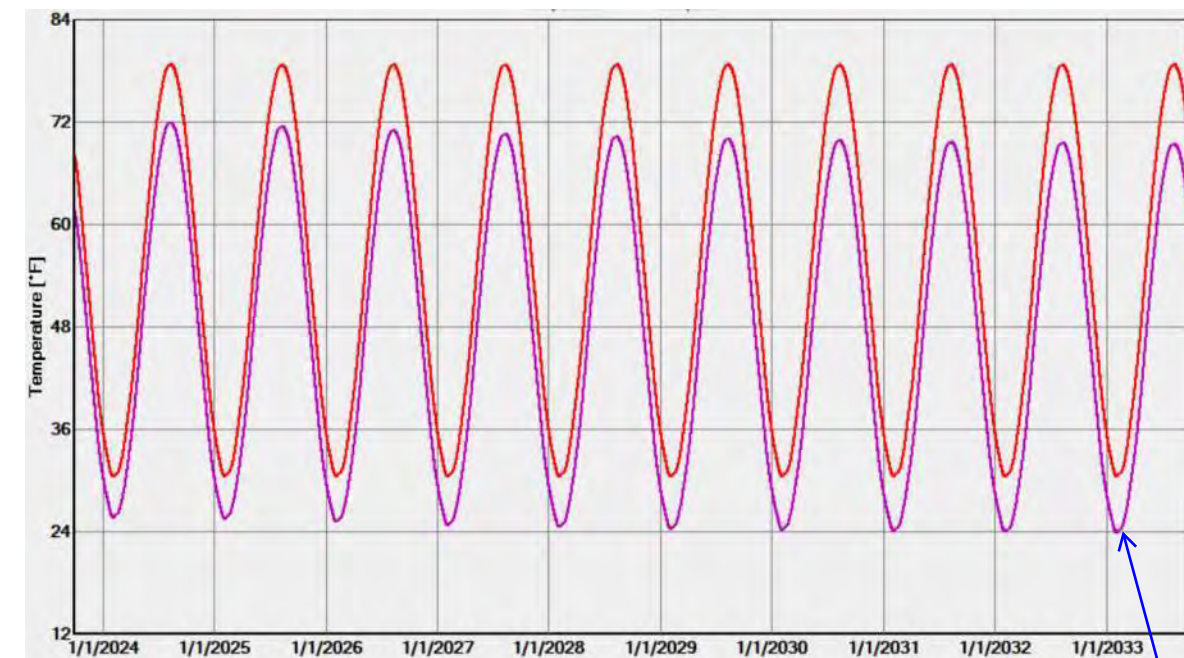
Temperature fluctuates seasonally; Temperature and Dew Point do not intersect; graphs grow further apart during the 10-year period (signifies reduced condensation risk)

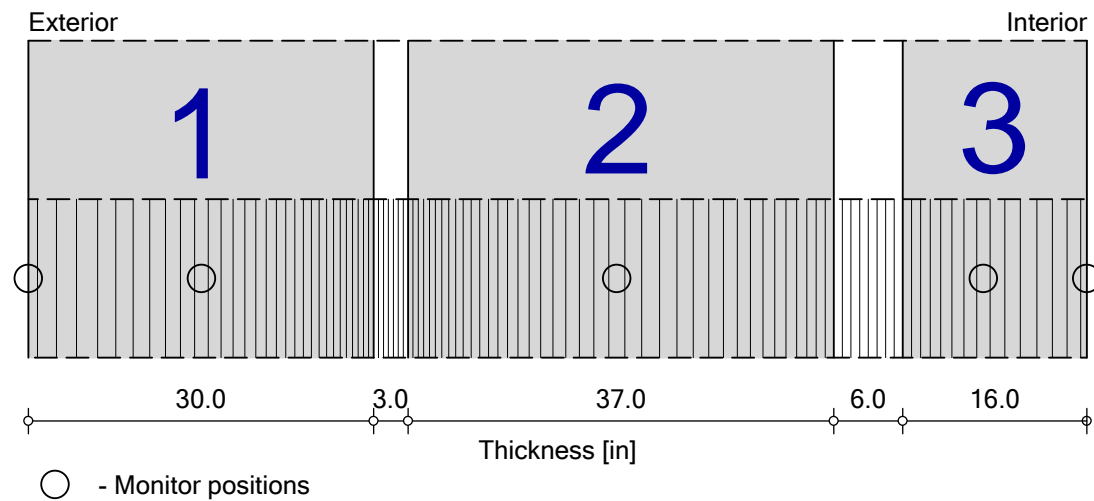
Exterior (left side) Albany, NY
 Interior (right side) 55° F with fluctuation of 25° F; and 72% RH with a 50% amplitude

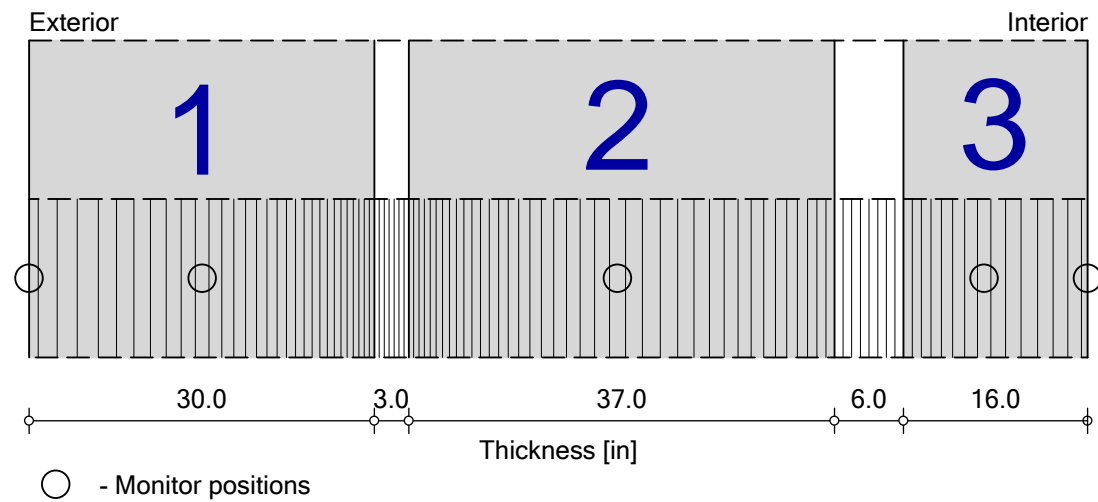
Exterior (left side) Albany, NY
 Interior (right side) 55° F with fluctuation of 25° F; and 72% RH with a 50% amplitude

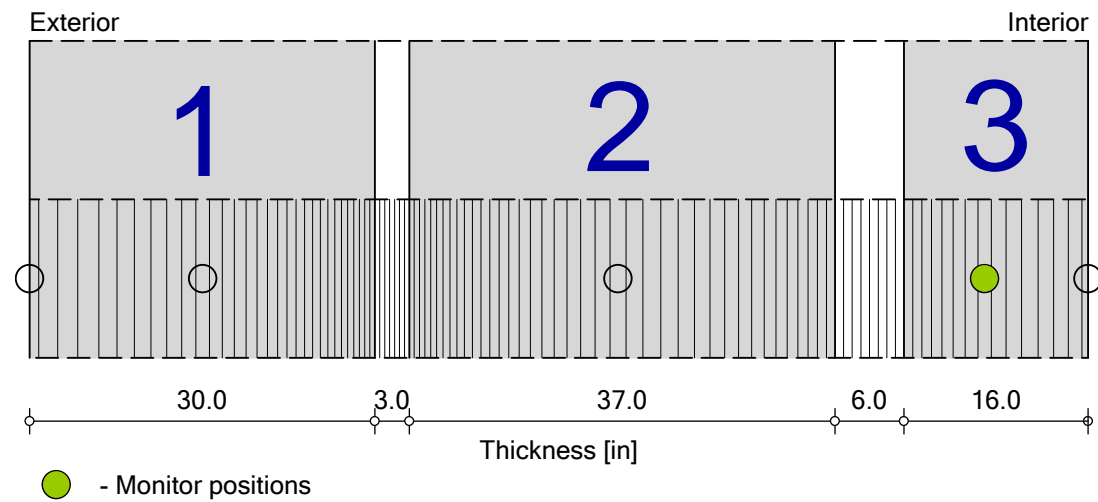
Exterior (left side) Albany, NY
 Interior (right side) 55° F with fluctuation of 25° F; and 72% RH with a 50% amplitude

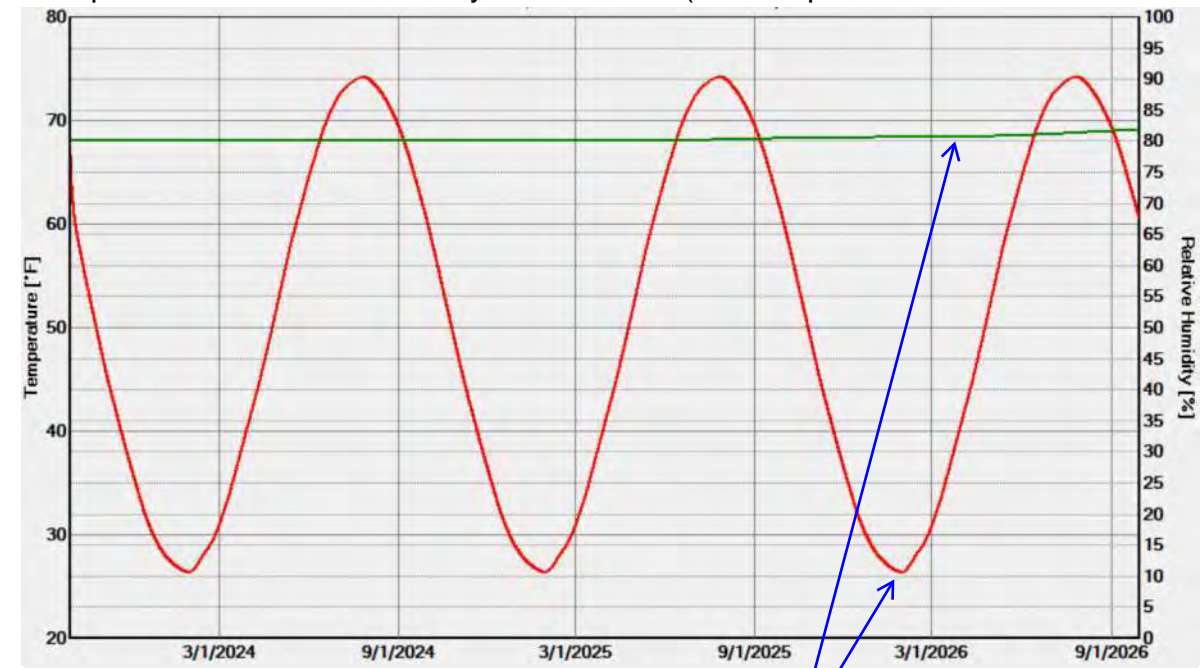
Temperature fluctuates seasonally; Relative Humidity (RH) trends upward during the 3-year period

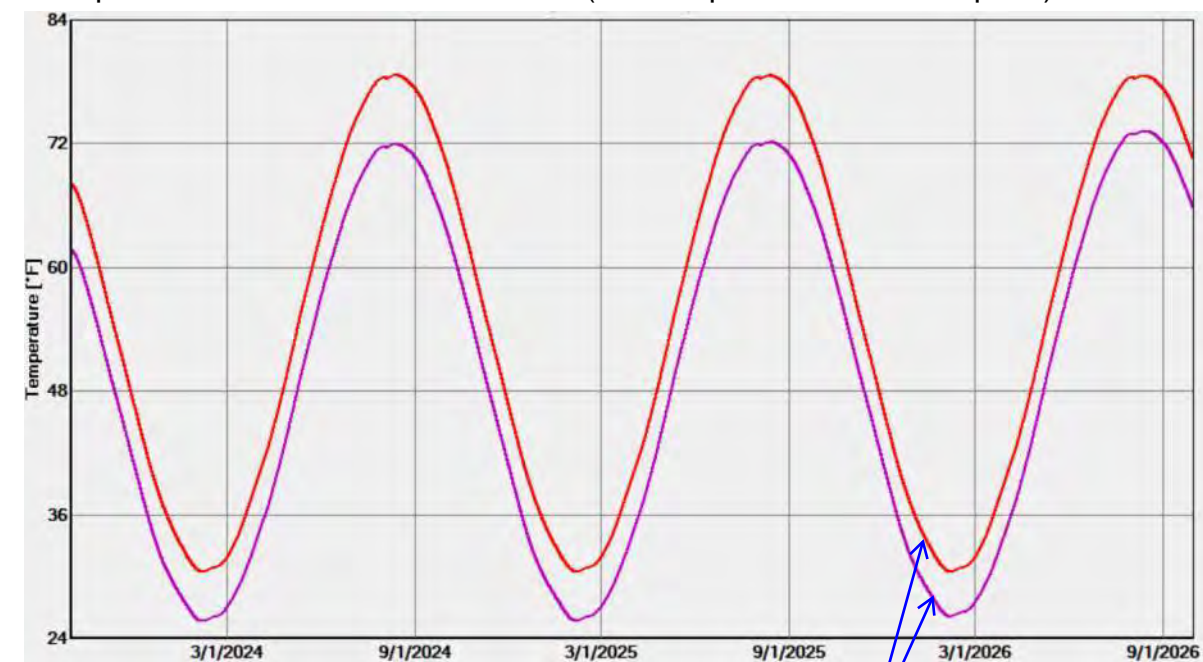
Temperature fluctuates seasonally; Temperature and Dew Point do not intersect (signifies low condensation risk)

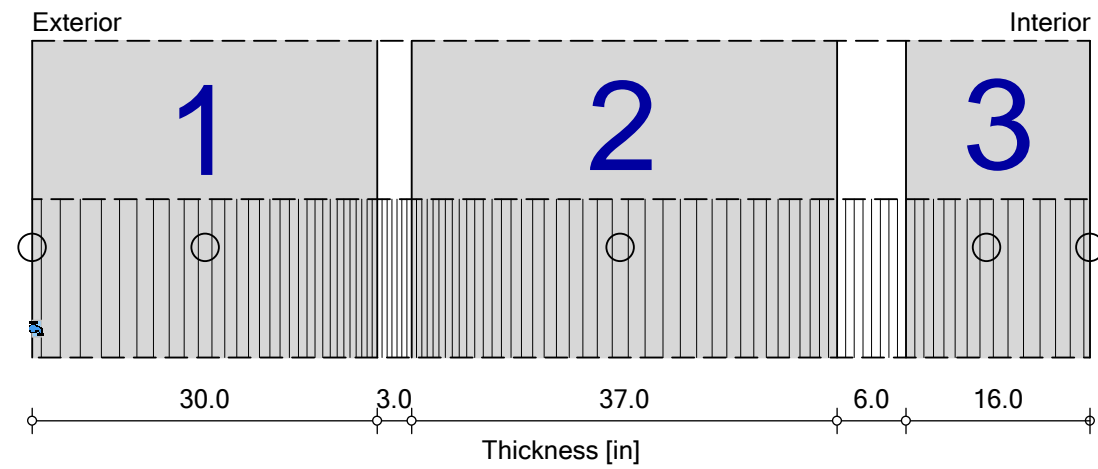
○ - Monitor positions
 - Heat/Moisture source/sink positions

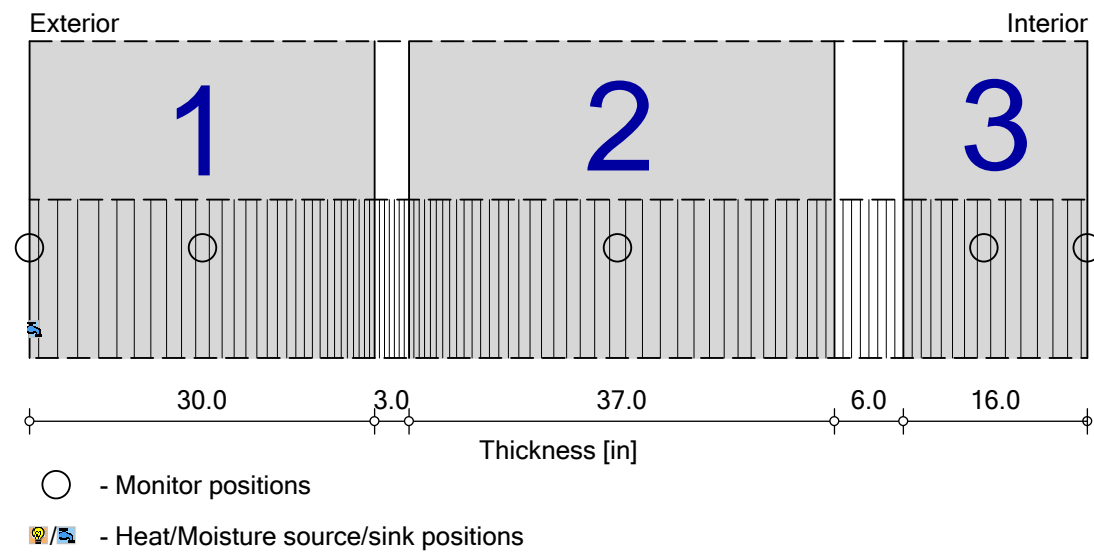
Exterior (left side) Albany, NY
 Interior (right side) 55° F with fluctuation of 25° F; and 72% RH with a 50% amplitude
 Moisture Source **Exterior Limestone Layer - 3%**

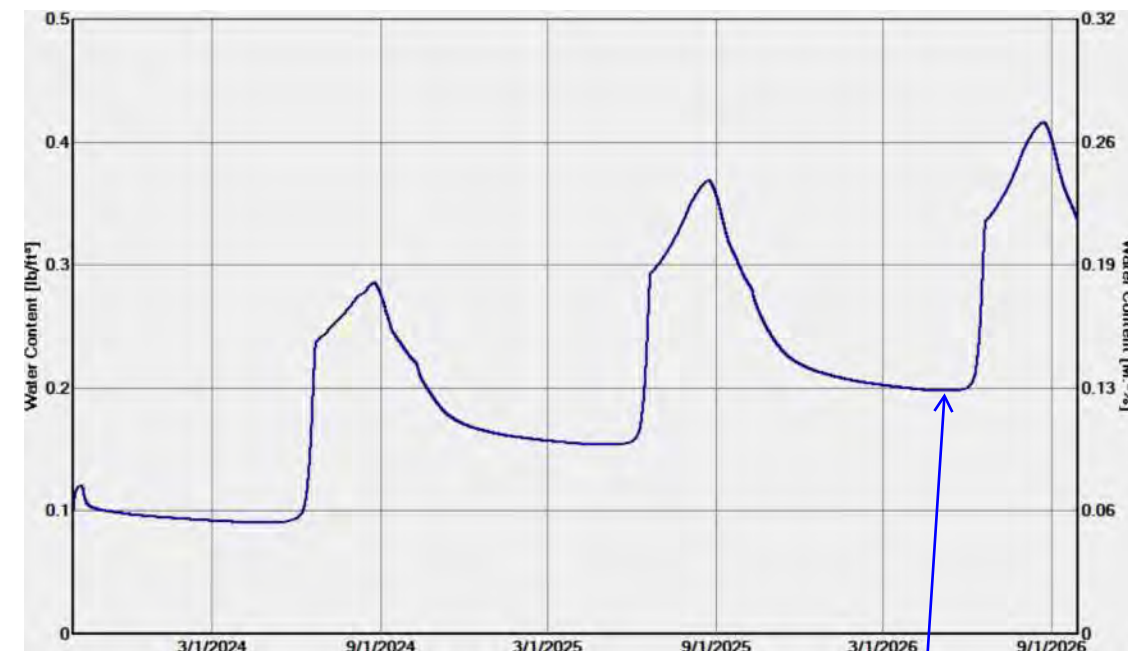
Water content at the interior layer fluctuates seasonally, with increasing moisture during the 3-year period (similar to Existing, Page 4)

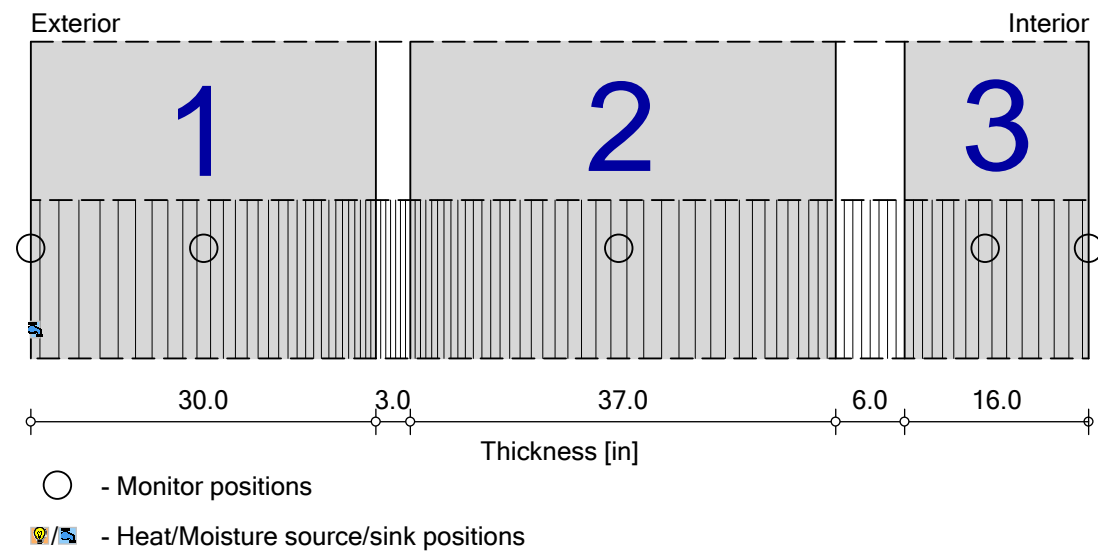
Exterior (left side) Albany, NY
 Interior (right side) **60° F with fluctuation of 20° F**; and 72% RH with a 50% amplitude
 Moisture Source Exterior Limestone Layer - 1% (ANSI/ASHRAE standard 160)

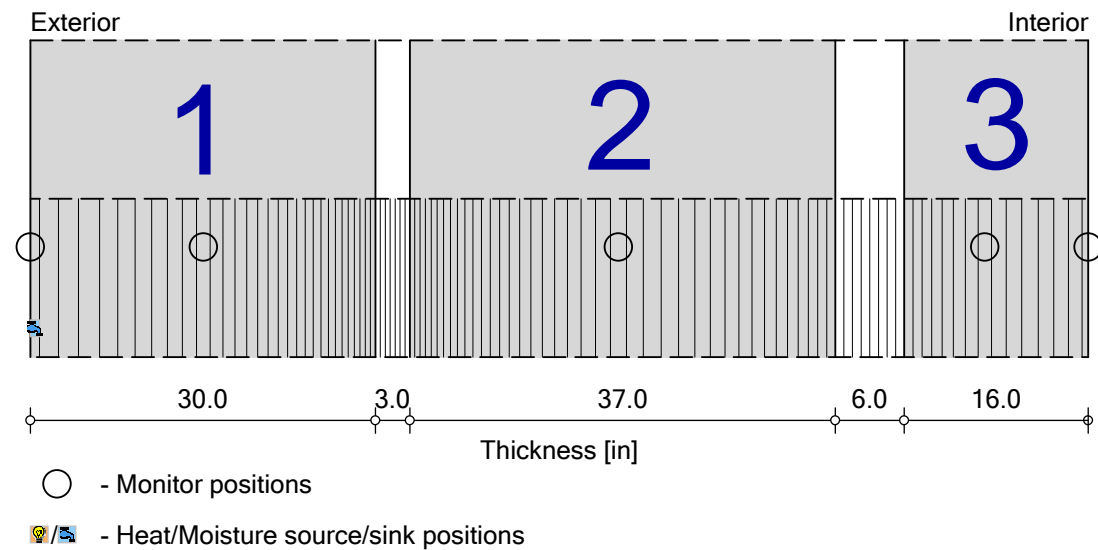
Exterior (left side) Albany, NY
 Interior (right side) **60° F with fluctuation of 20° F**; and 72% RH with a 50% amplitude
 Moisture Source Exterior Limestone Layer - 1% (ANSI/ASHRAE standard 160)

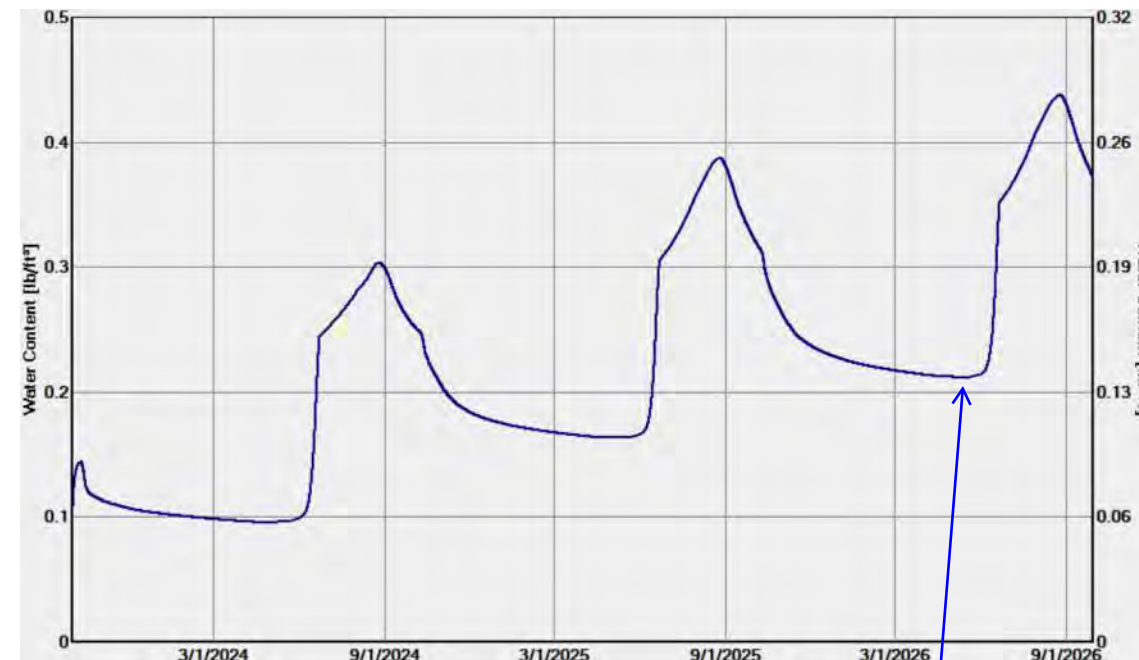
Water content at the interior layer fluctuates seasonally, with increasing moisture during the 3-year period (similar to Existing, Page 4)

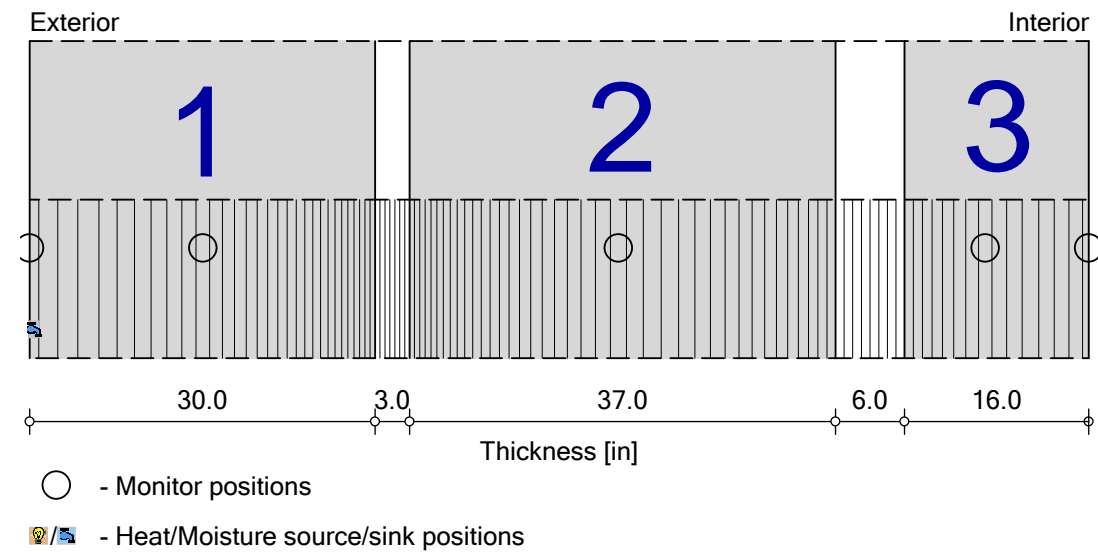
Exterior (left side) Albany, NY
 Interior (right side) 55° F with fluctuation of 25° F; and 72% RH with a 50% amplitude
 Moisture Source Exterior Limestone Layer - 1% (ANSI/ASHRAE standard 160)

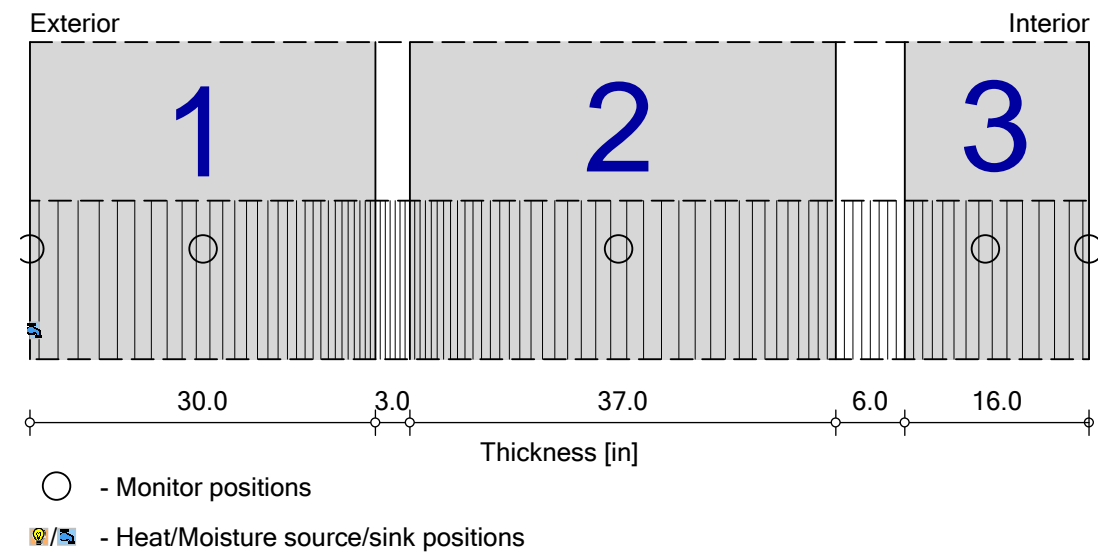
Exterior (left side) Albany, NY
 Interior (right side) 55° F with fluctuation of 25° F; and 72% RH with a 50% amplitude
 Moisture Source Exterior Limestone Layer - 1% (ANSI/ASHRAE standard 160)

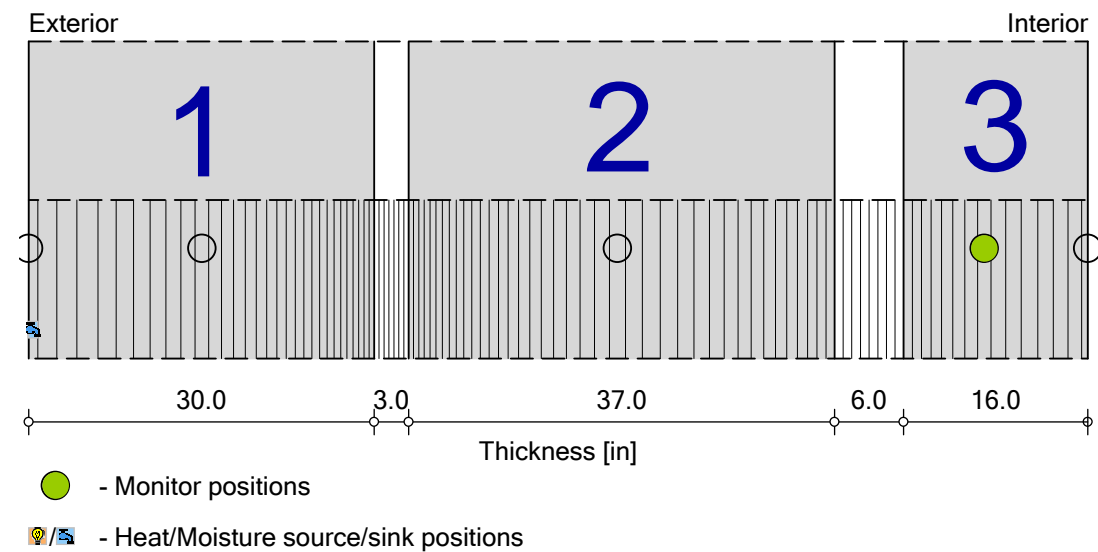
Exterior (left side) Albany, NY
 Interior (right side) 55° F with fluctuation of 25° F; and 72% RH with a 50% amplitude
 Moisture Source Exterior Limestone Layer - 1% (ANSI/ASHRAE standard 160)

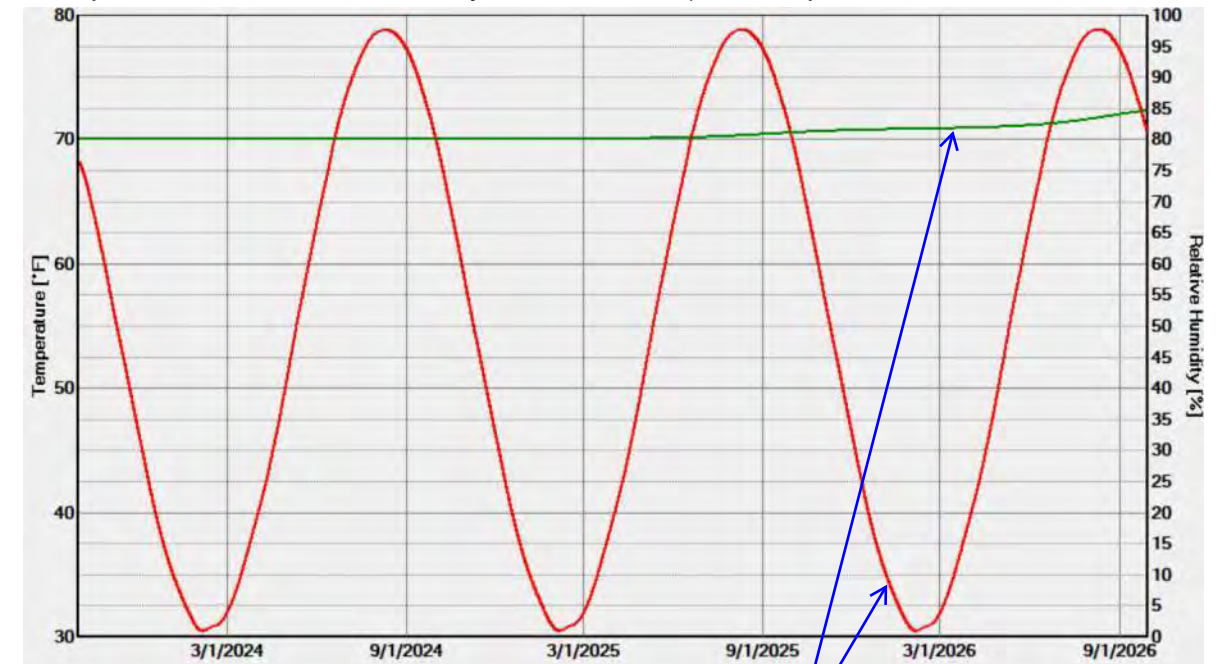
Temperature fluctuates seasonally; Relative Humidity (RH) trends upward during the 3-year period

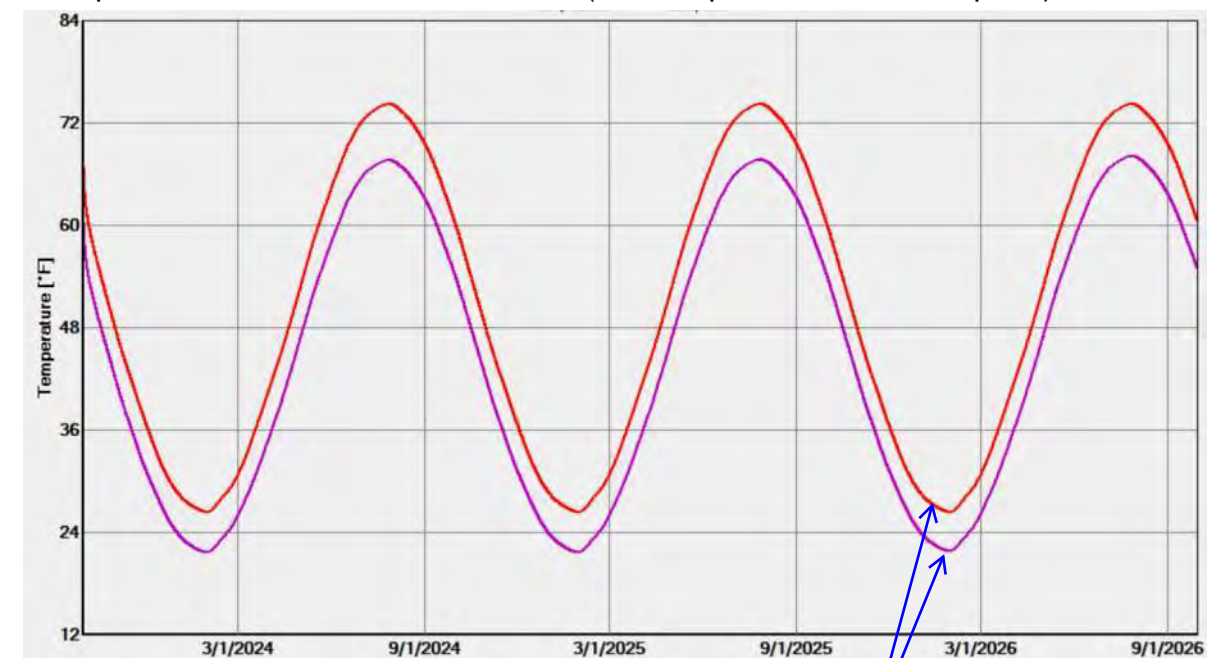
Temperature fluctuates seasonally; Temperature and Dew Point do not intersect (signifies low condensation risk)

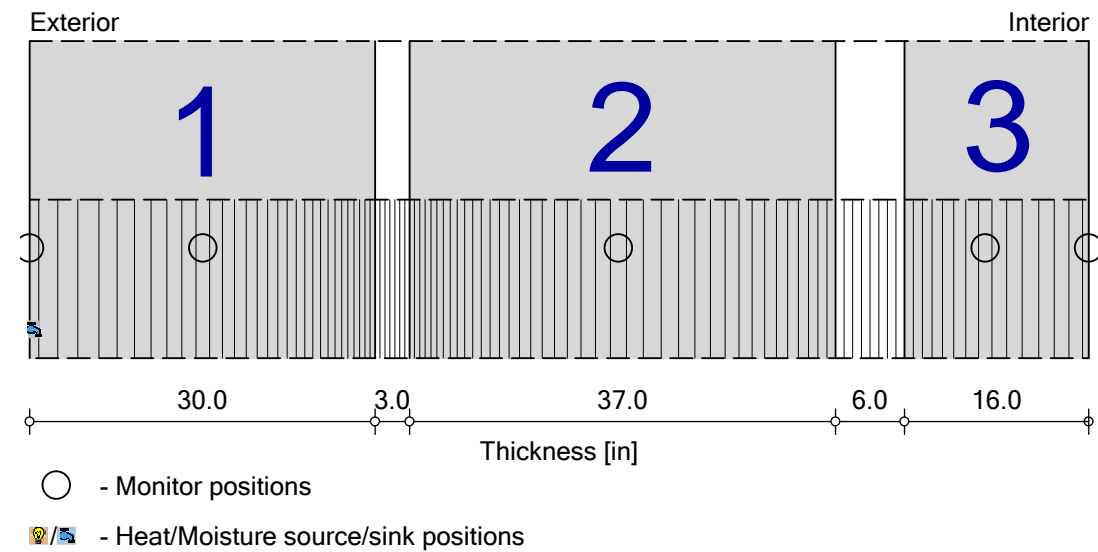
Exterior (left side) Albany, NY
 Interior (right side) 55° F with fluctuation of 25° F; and 72% RH with a 50% amplitude
 Moisture Source Exterior Limestone Layer - 1% (ANSI/ASHRAE standard 160)

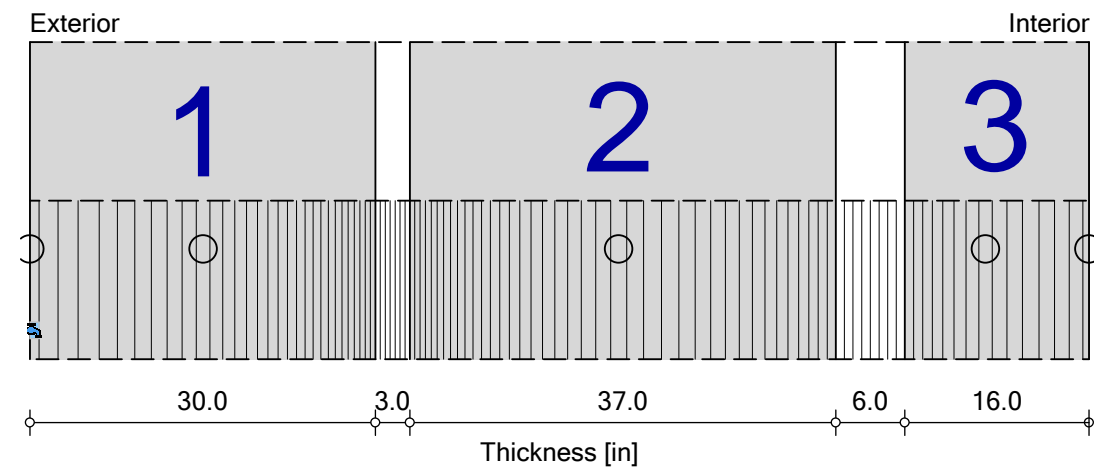
○ - Monitor positions
 - Heat/Moisture source/sink positions

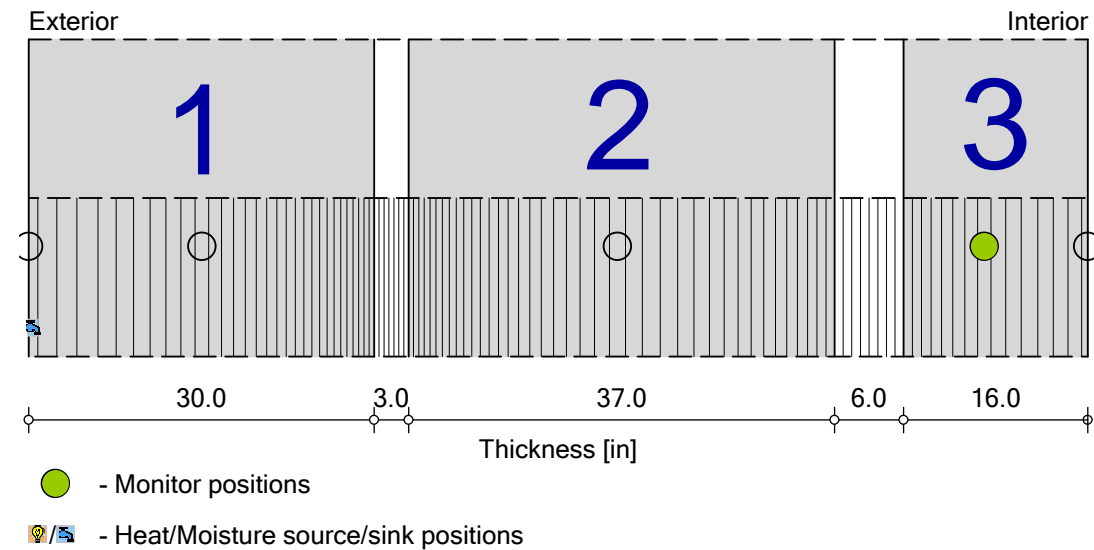
Exterior (left side) Albany, NY
 Interior (right side) 55° F with fluctuation of 25° F; and 72% RH with a 50% amplitude
 Moisture Source Exterior Limestone Layer - 1% (ANSI/ASHRAE standard 160)

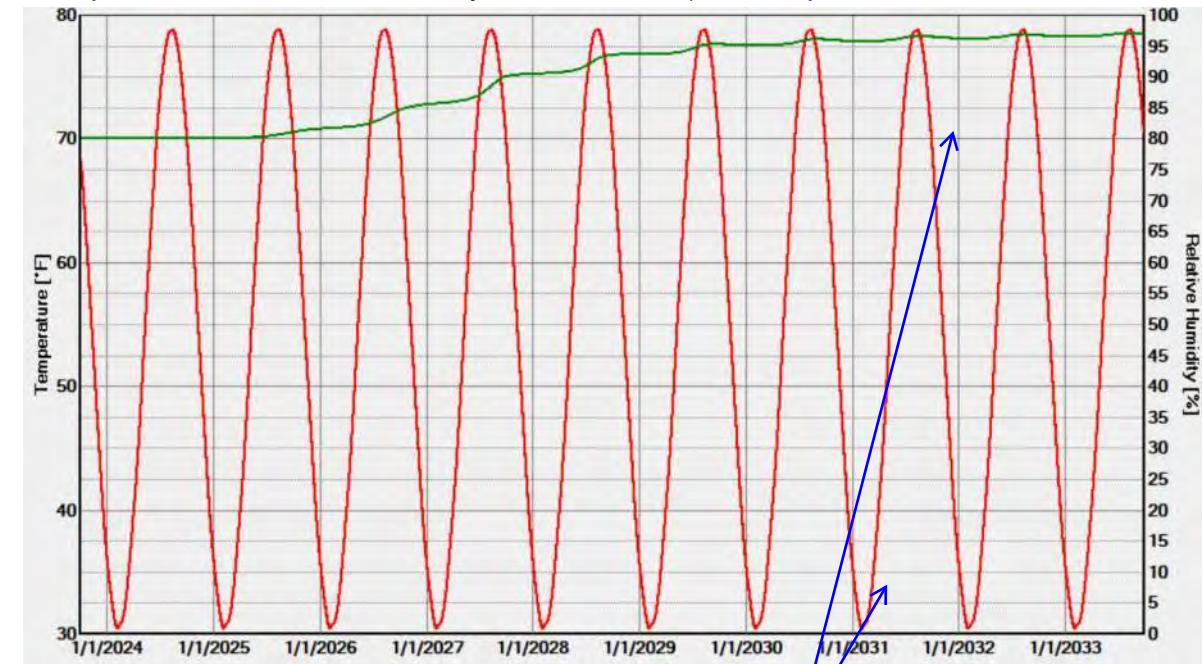
Temperature fluctuates seasonally; Relative Humidity (RH) trends upward during the 10-year period

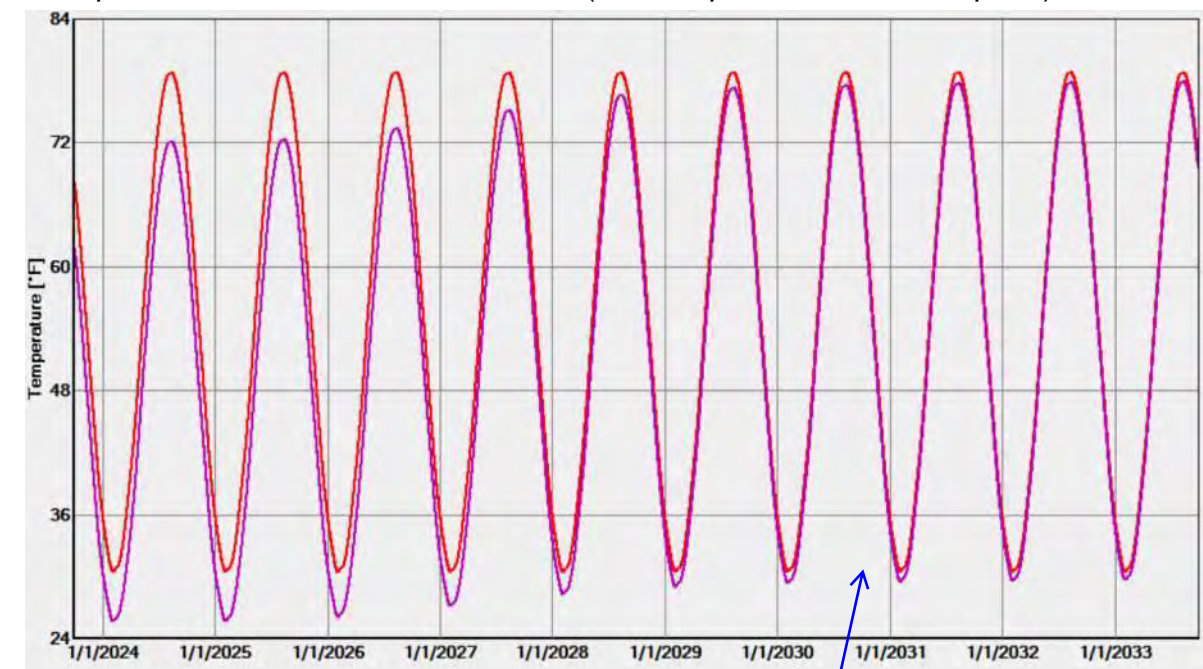
Temperature fluctuates seasonally; Temperature and Dew Point do not intersect, but graphs begin to intersect after six years (signifies condensation risk)

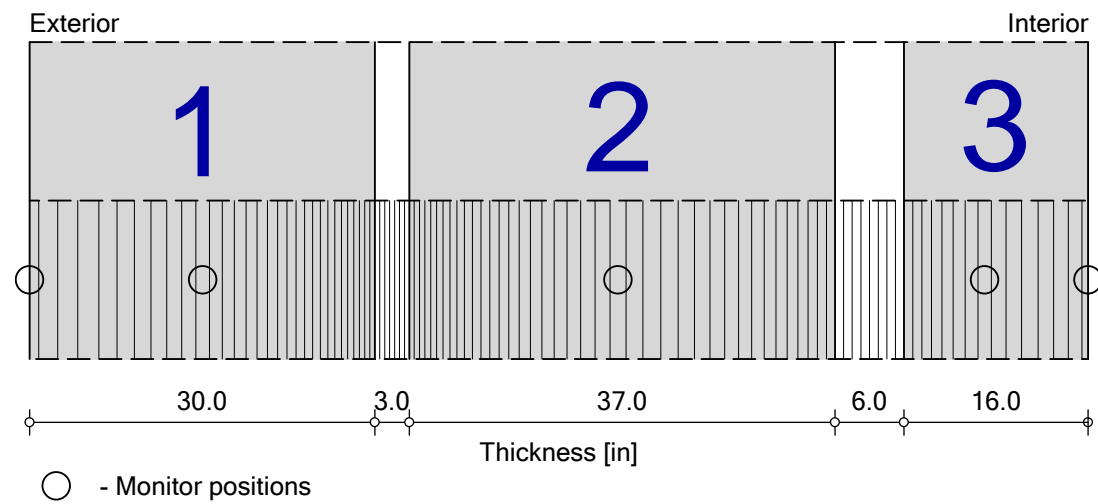
Exterior (left side) Albany, NY
 Interior (right side) 55° F with fluctuation of 25° F; and 60% RH with a 20% amplitude
