03/29/2024

**STRUCTURAL AND ELECTRICAL ASSESSMENT OF
THE BENNINGTON BATTLE MONUMENT**

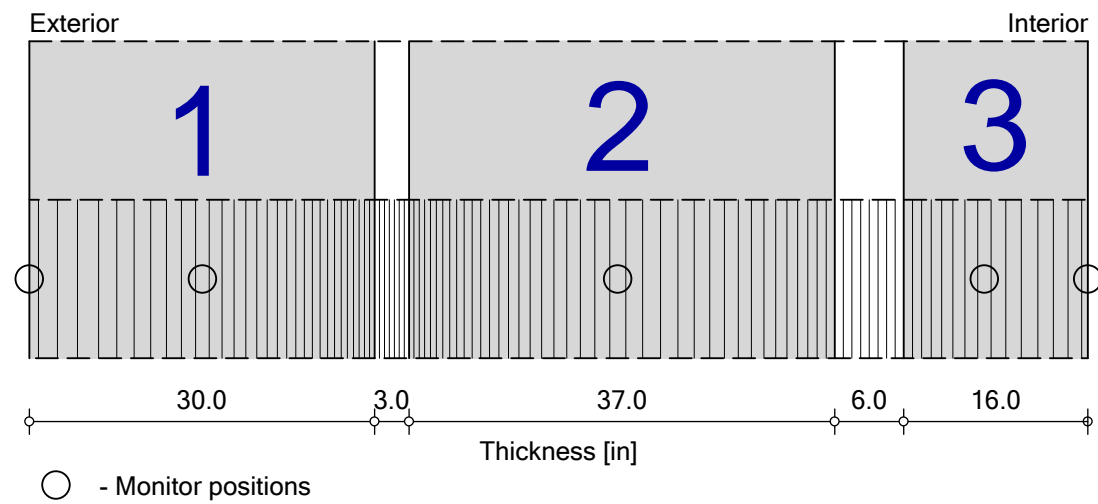
Exterior (left side) Albany, NY
 Interior (right side) 55° F with fluctuation of 25° F; and 60% RH with a 20% amplitude

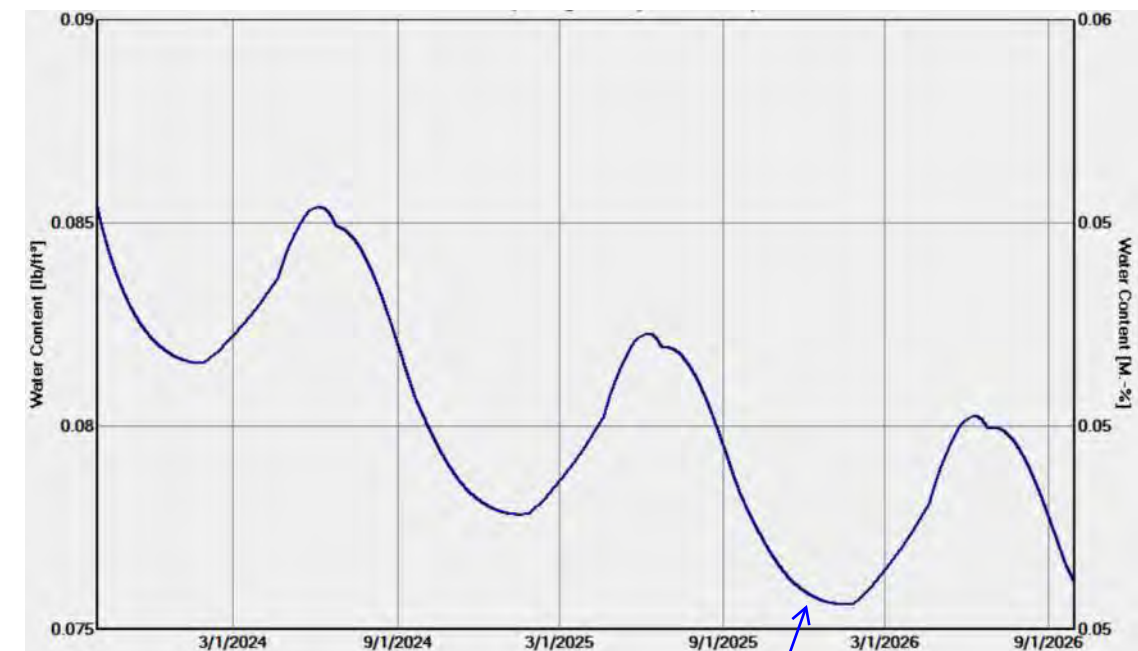
Water content at the interior layer fluctuates seasonally, with decreasing moisture during the 3-year period

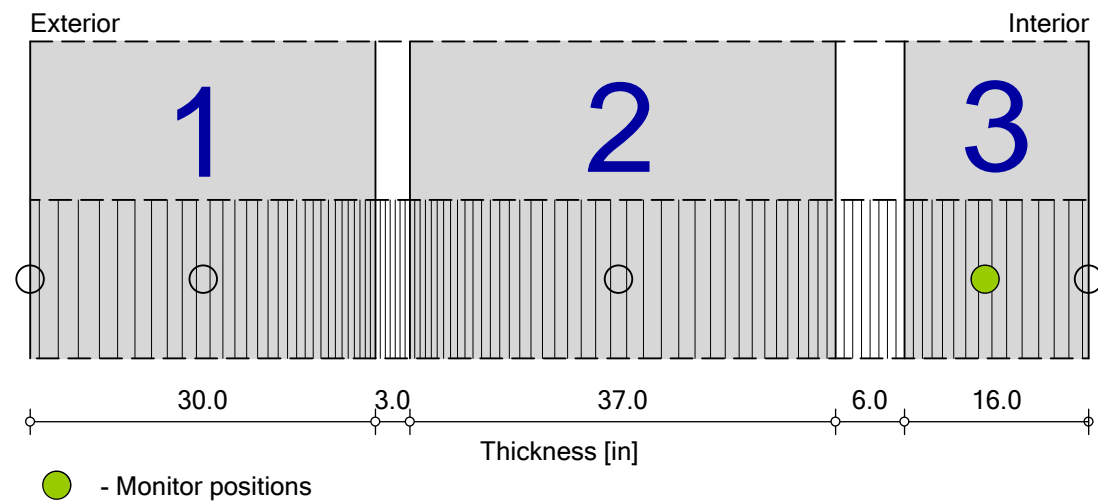
Exterior (left side) Albany, NY
 Interior (right side) 55° F with fluctuation of 25° F; and 60% RH with a 20% amplitude

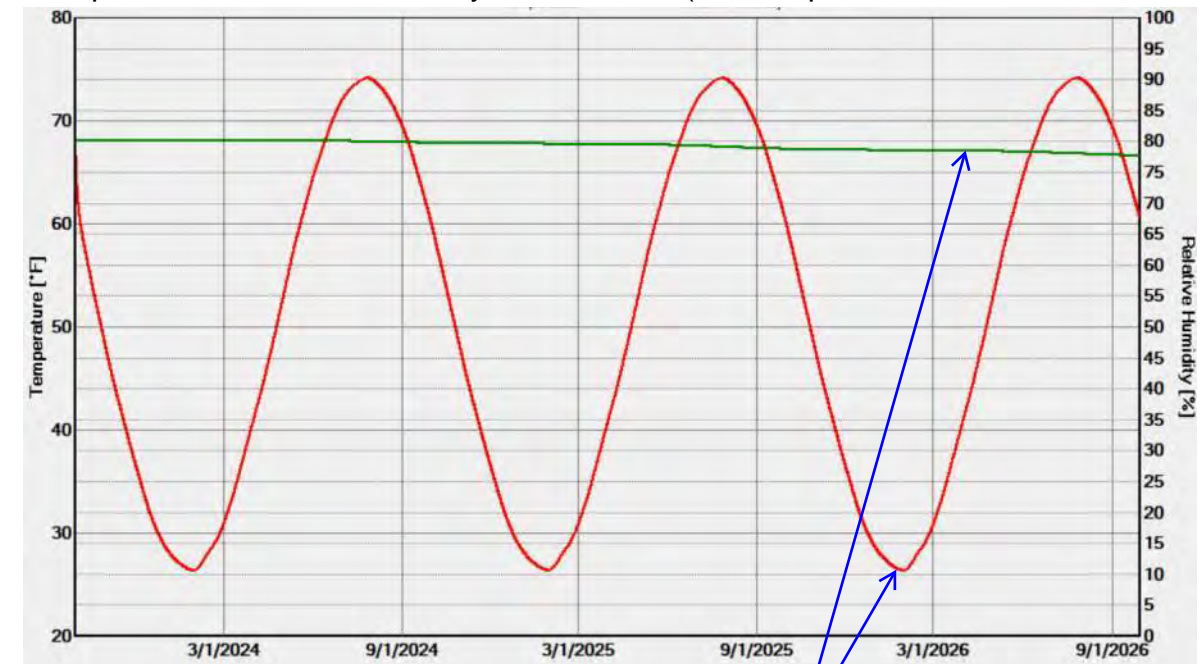
Temperature fluctuates seasonally; Relative Humidity (RH) trends downward during the 3-year period

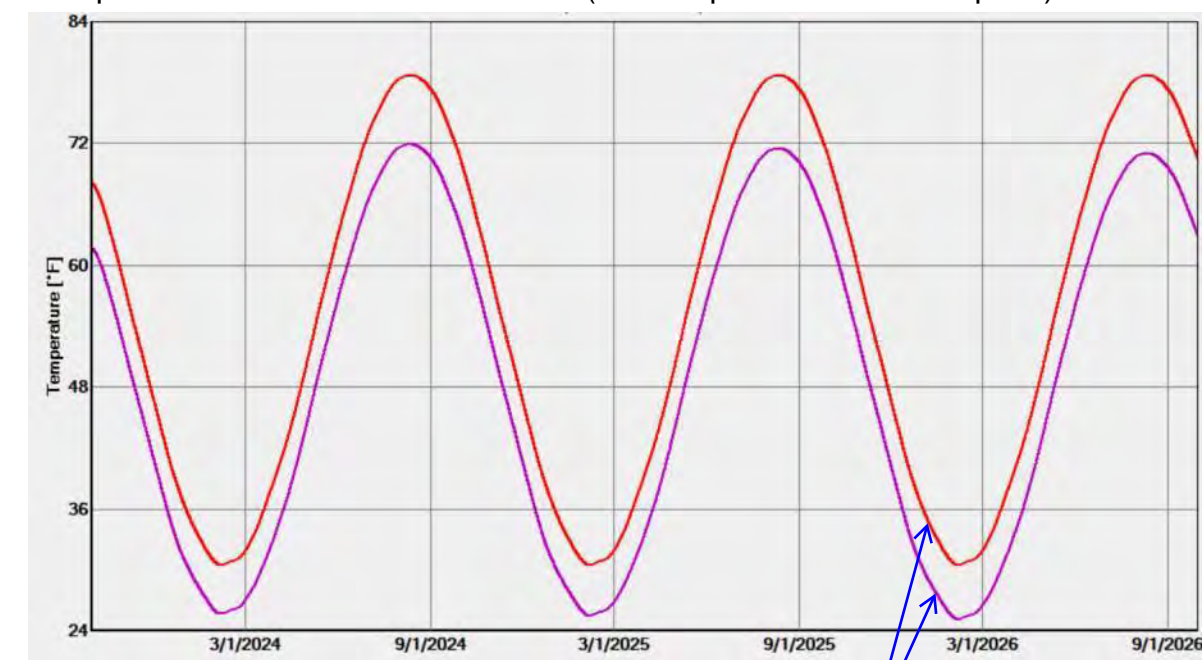
Temperature fluctuates seasonally; Temperature and Dew Point do not intersect (signifies low condensation risk)

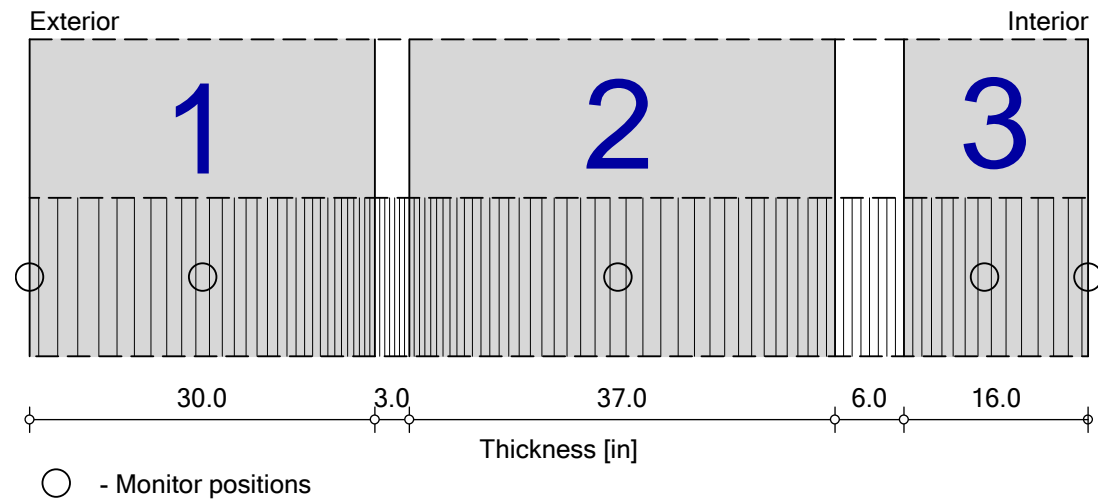
Exterior (left side) Albany, NY
 Interior (right side) 55° F with fluctuation of 25° F; and 60% RH with a 20% amplitude

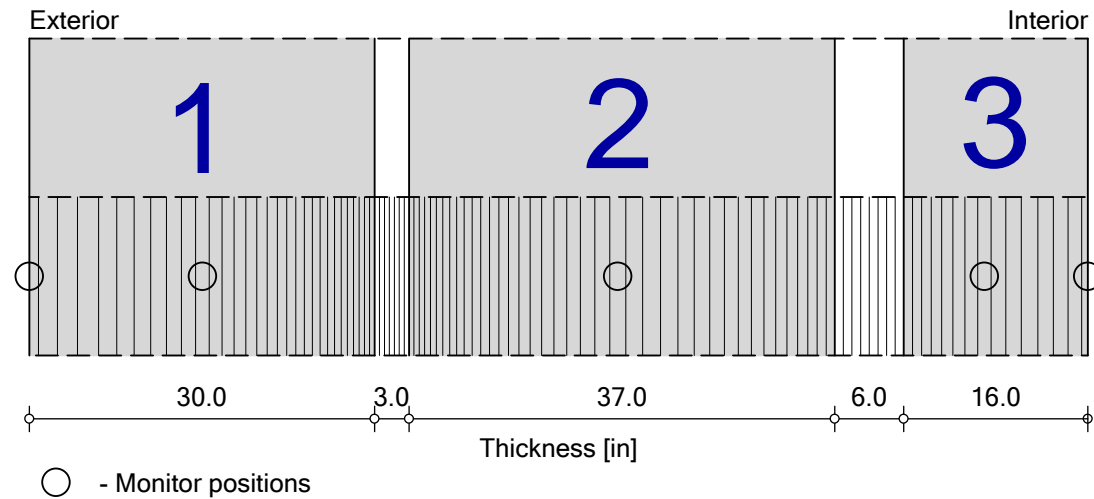
Exterior (left side) Albany, NY
 Interior (right side) 55° F with fluctuation of 25° F; and 60% RH with a 20% amplitude

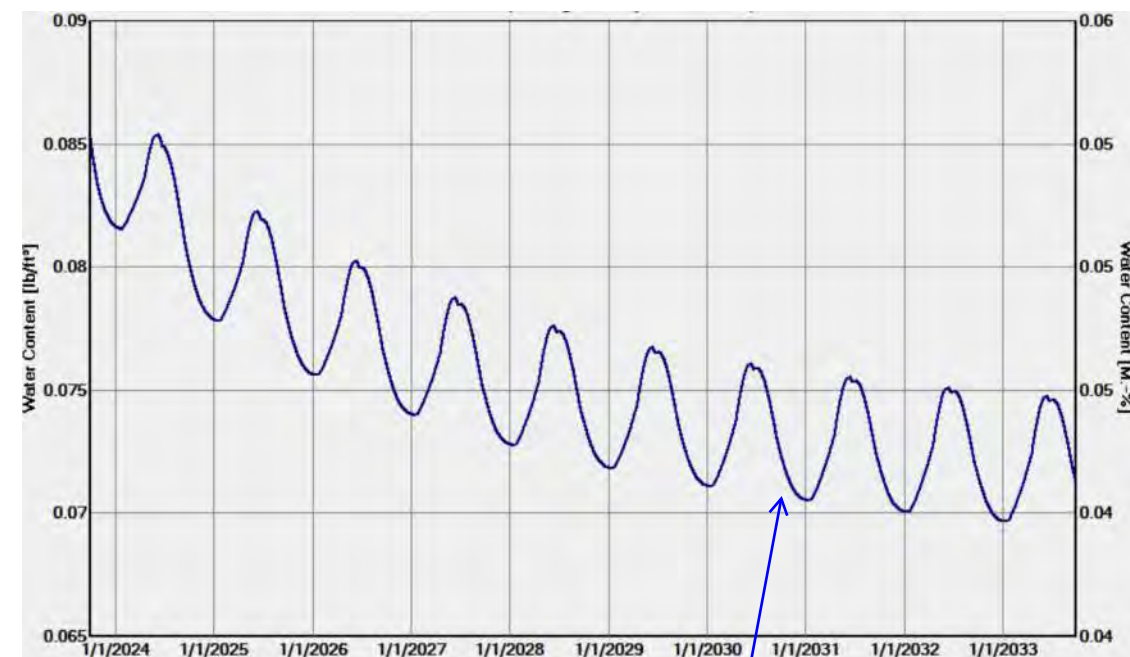
Water content at the interior layer fluctuates seasonally, with decreasing moisture during the 10-year period

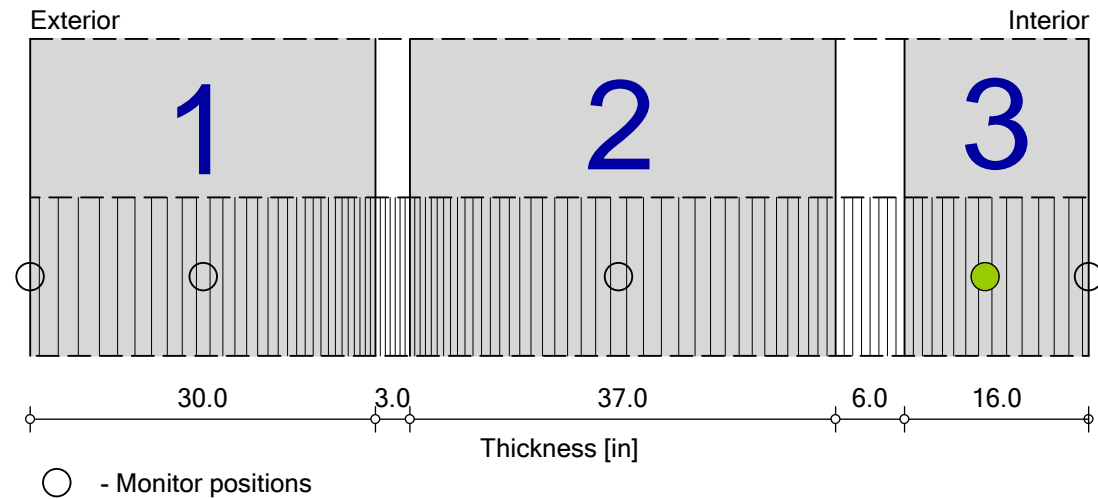
Exterior (left side) Albany, NY
 Interior (right side) 55° F with fluctuation of 25° F; and 60% RH with a 20% amplitude

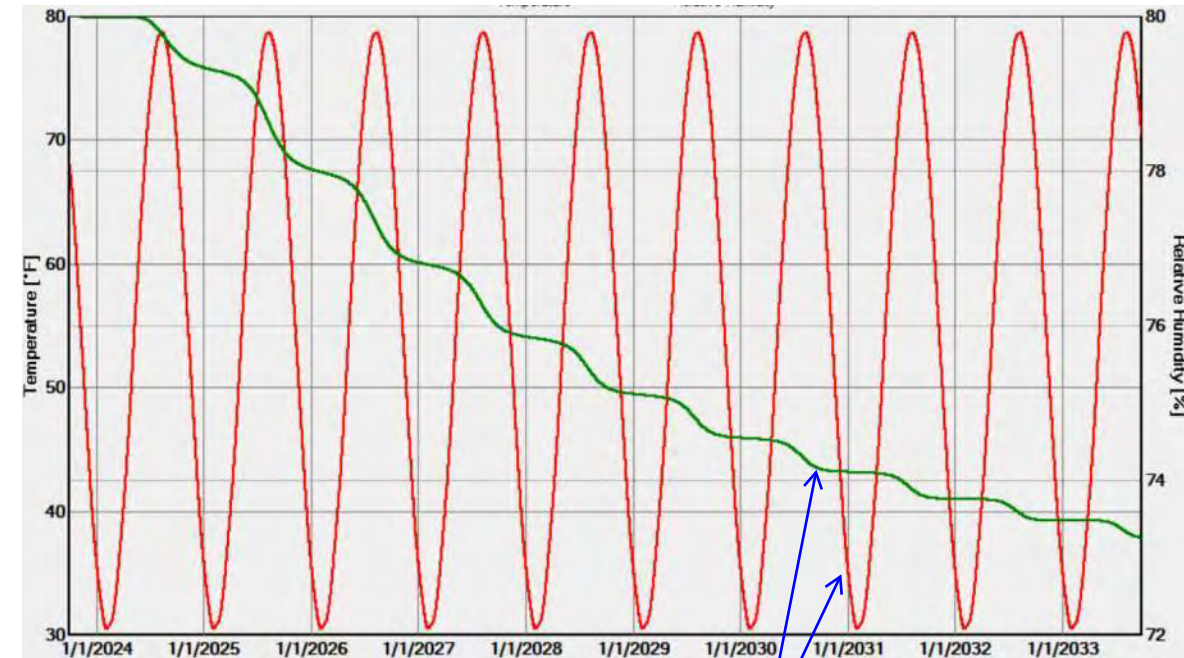
Temperature fluctuates seasonally; Relative Humidity (RH) trends downward during the 10-year period

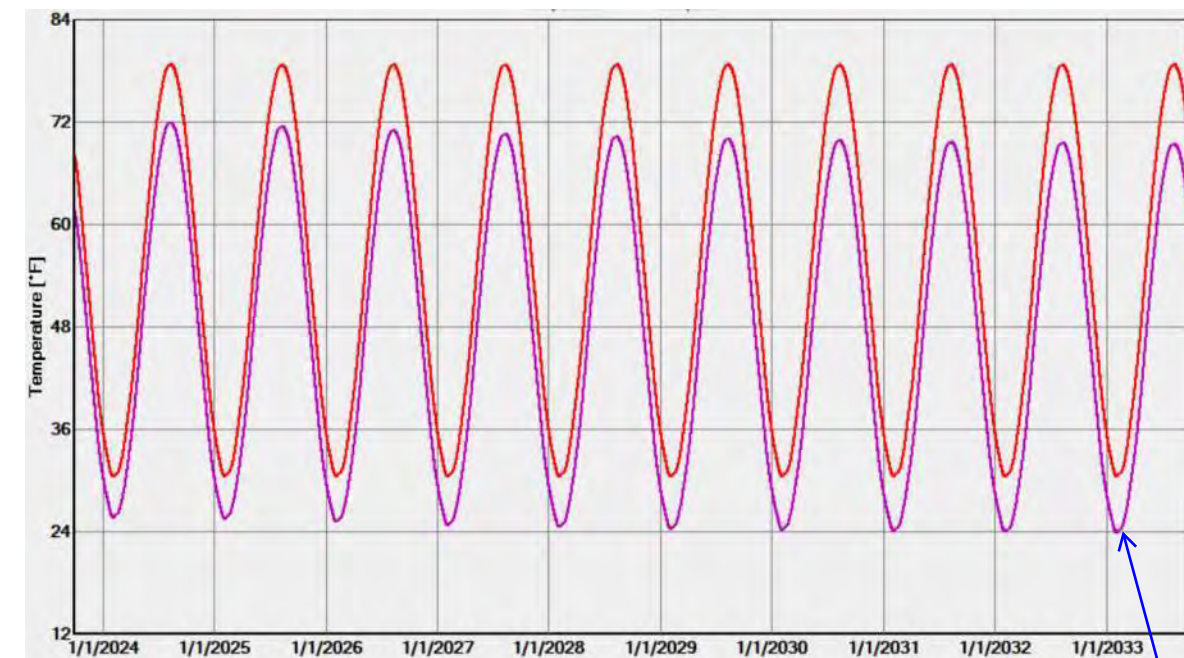
Temperature fluctuates seasonally; Temperature and Dew Point do not intersect; graphs grow further apart during the 10-year period (signifies reduced condensation risk)

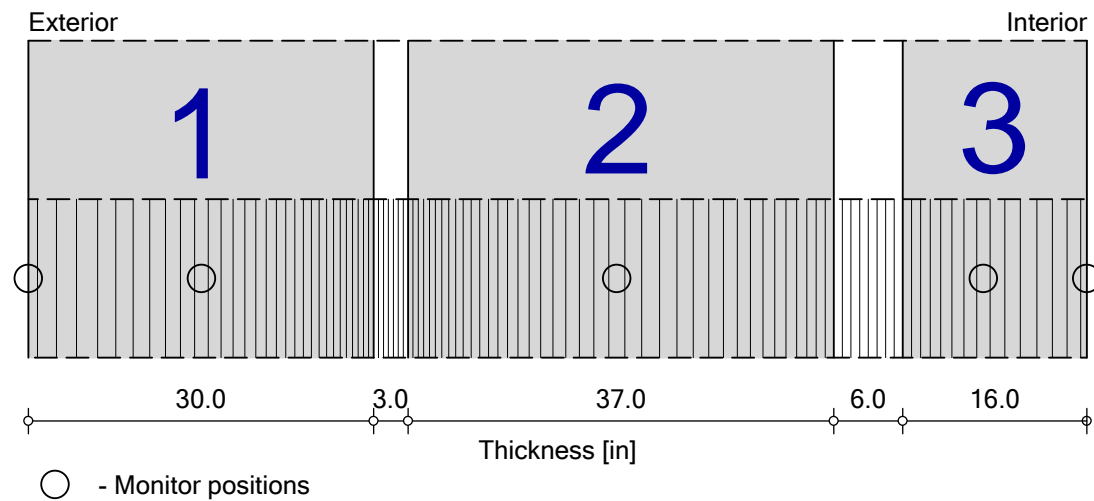
Exterior (left side) Albany, NY
 Interior (right side) 55° F with fluctuation of 25° F; and 72% RH with a 50% amplitude

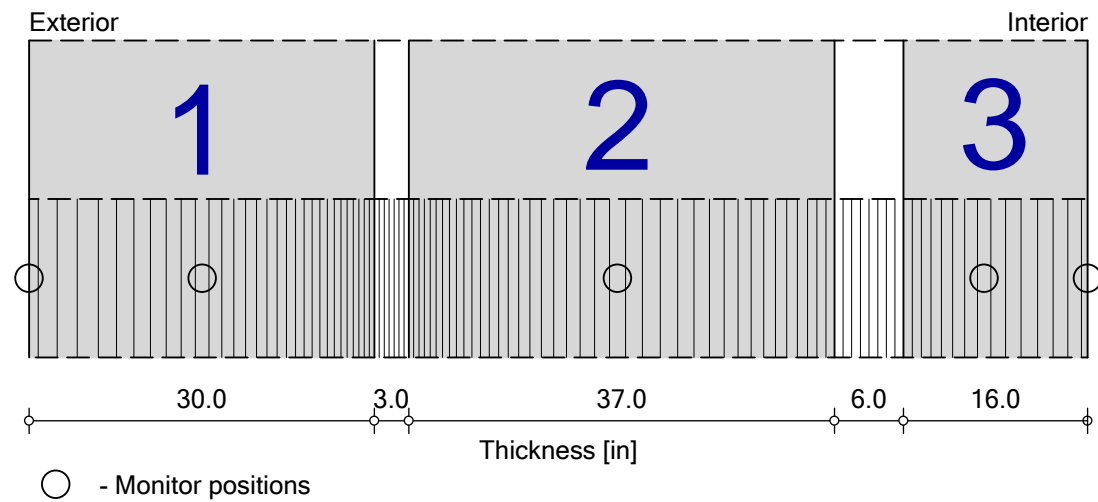
Exterior (left side) Albany, NY
 Interior (right side) 55° F with fluctuation of 25° F; and 72% RH with a 50% amplitude

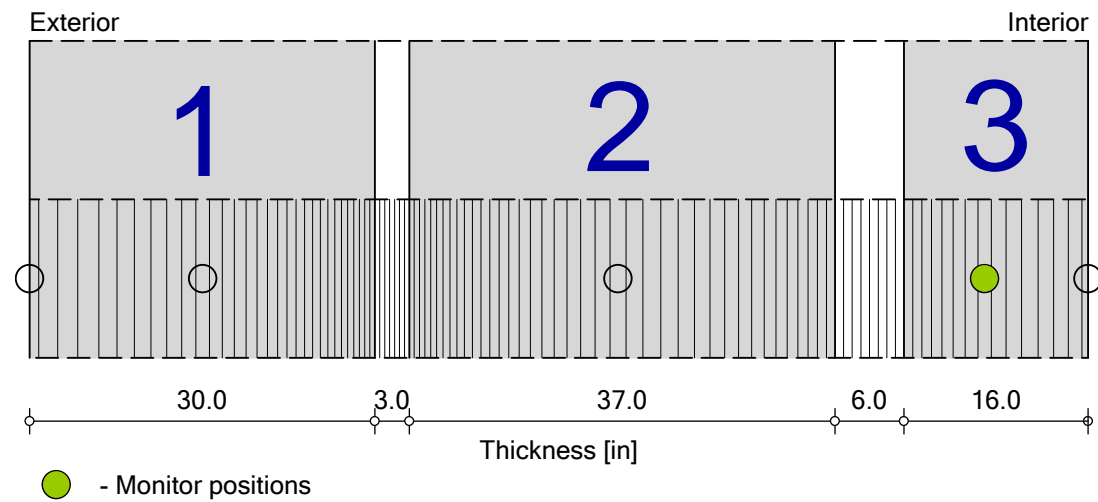
Exterior (left side) Albany, NY
 Interior (right side) 55° F with fluctuation of 25° F; and 72% RH with a 50% amplitude

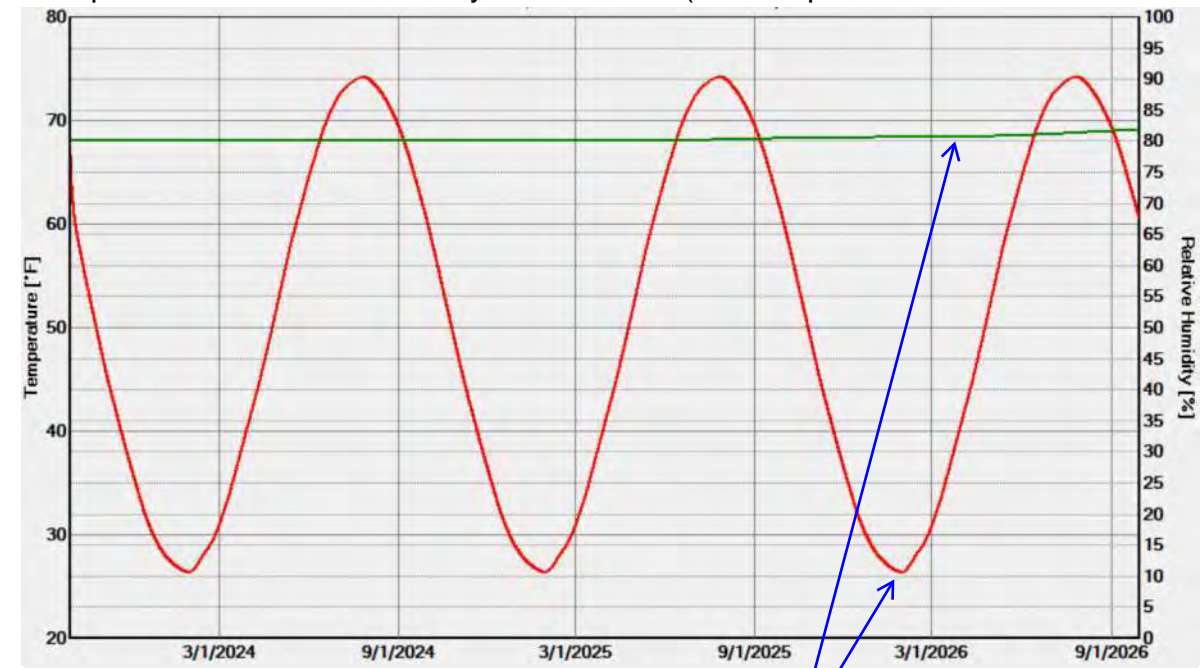
Temperature fluctuates seasonally; Relative Humidity (RH) trends upward during the 3-year period

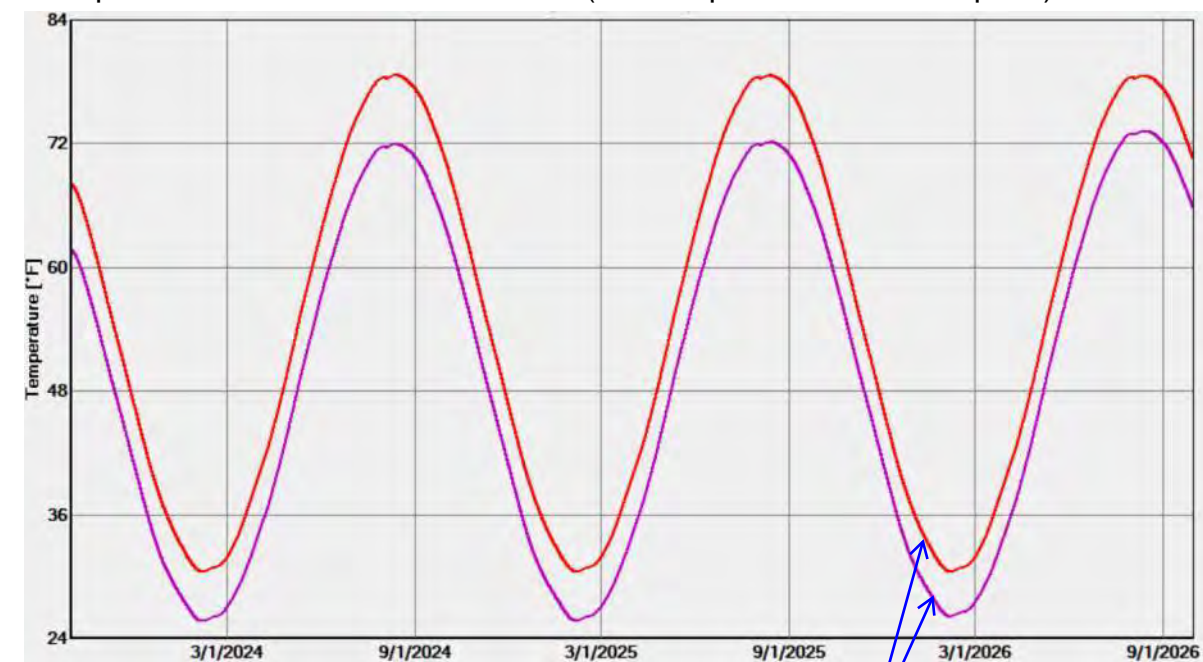
Temperature fluctuates seasonally; Temperature and Dew Point do not intersect (signifies low condensation risk)

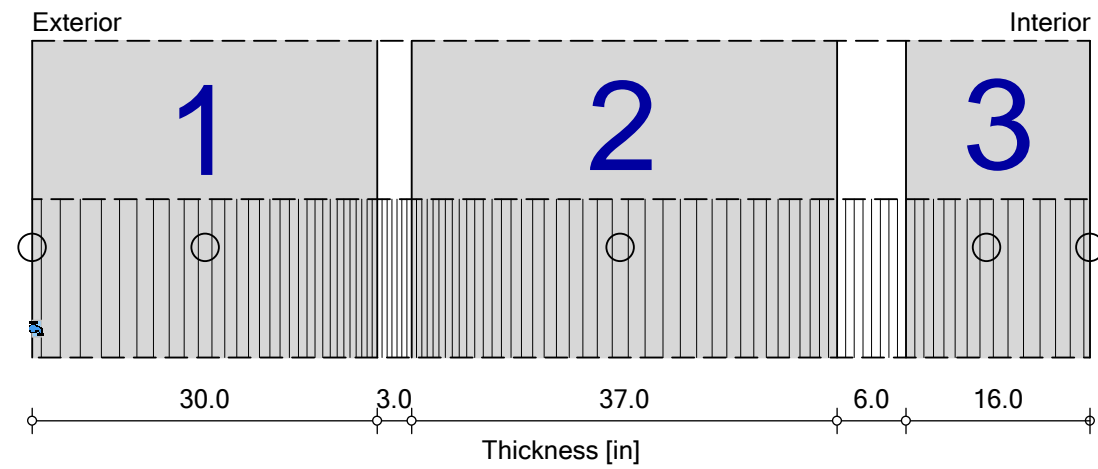
Exterior (left side) Albany, NY
 Interior (right side) 55° F with fluctuation of 25° F; and 72% RH with a 50% amplitude
 Moisture Source **Exterior Limestone Layer - 3%**

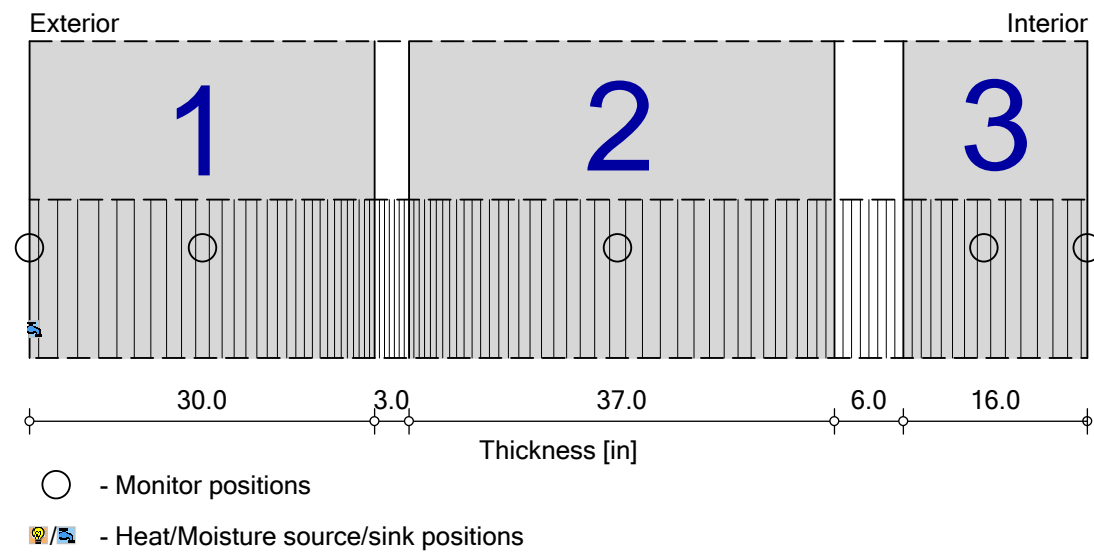
Exterior (left side) Albany, NY
 Interior (right side) 55° F with fluctuation of 25° F; and 72% RH with a 50% amplitude
 Moisture Source **Exterior Limestone Layer - 3%**

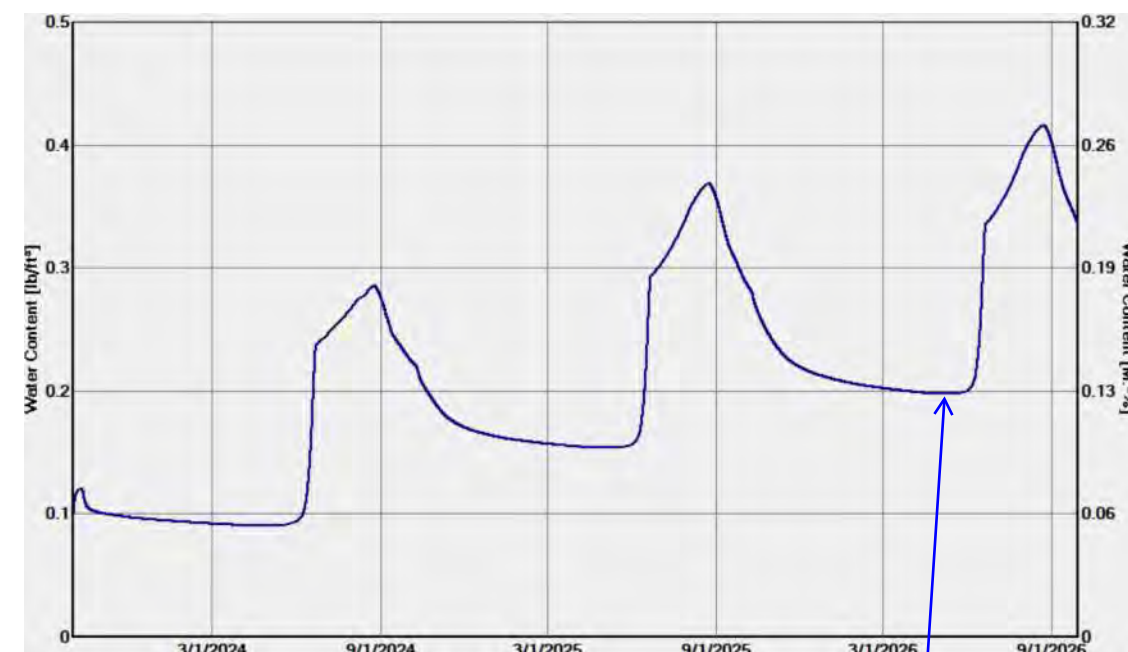
Water content at the interior layer fluctuates seasonally, with increasing moisture during the 3-year period (similar to Existing, Page 4)

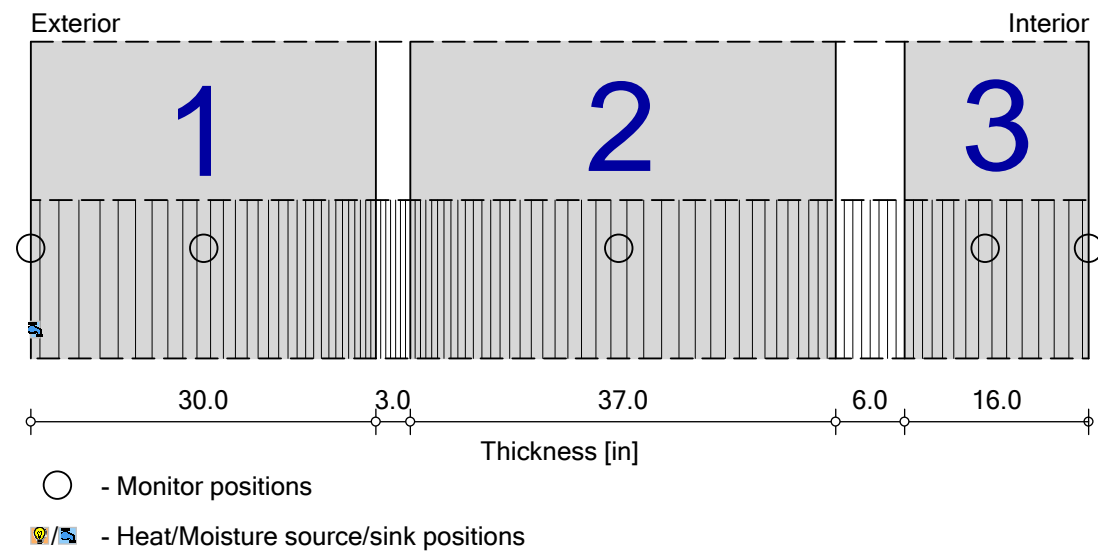
Exterior (left side) Albany, NY
 Interior (right side) **60° F with fluctuation of 20° F**; and 72% RH with a 50% amplitude
 Moisture Source Exterior Limestone Layer - 1% (ANSI/ASHRAE standard 160)

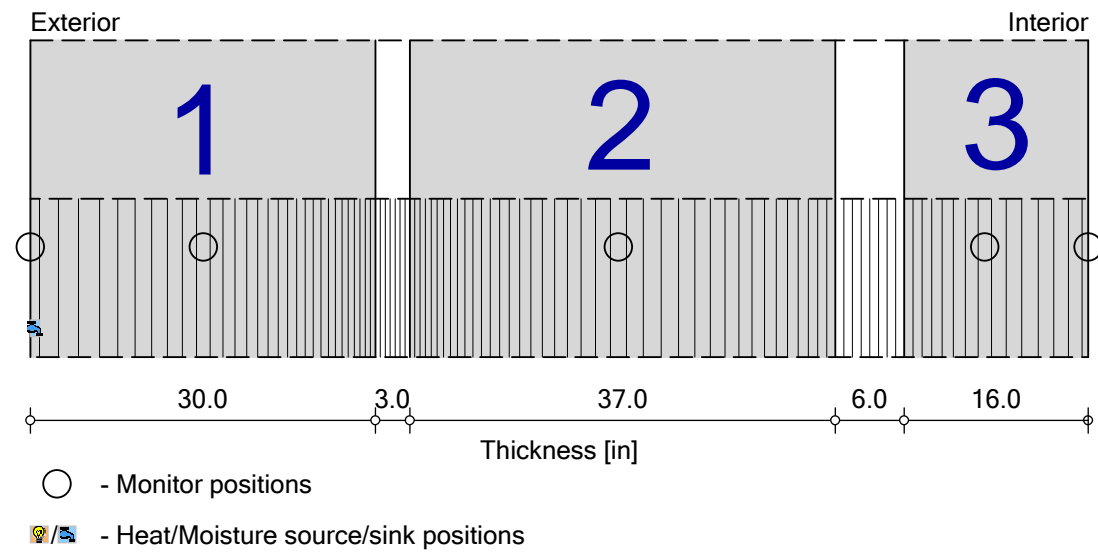
Exterior (left side) Albany, NY
 Interior (right side) **60° F with fluctuation of 20° F**; and 72% RH with a 50% amplitude
 Moisture Source Exterior Limestone Layer - 1% (ANSI/ASHRAE standard 160)

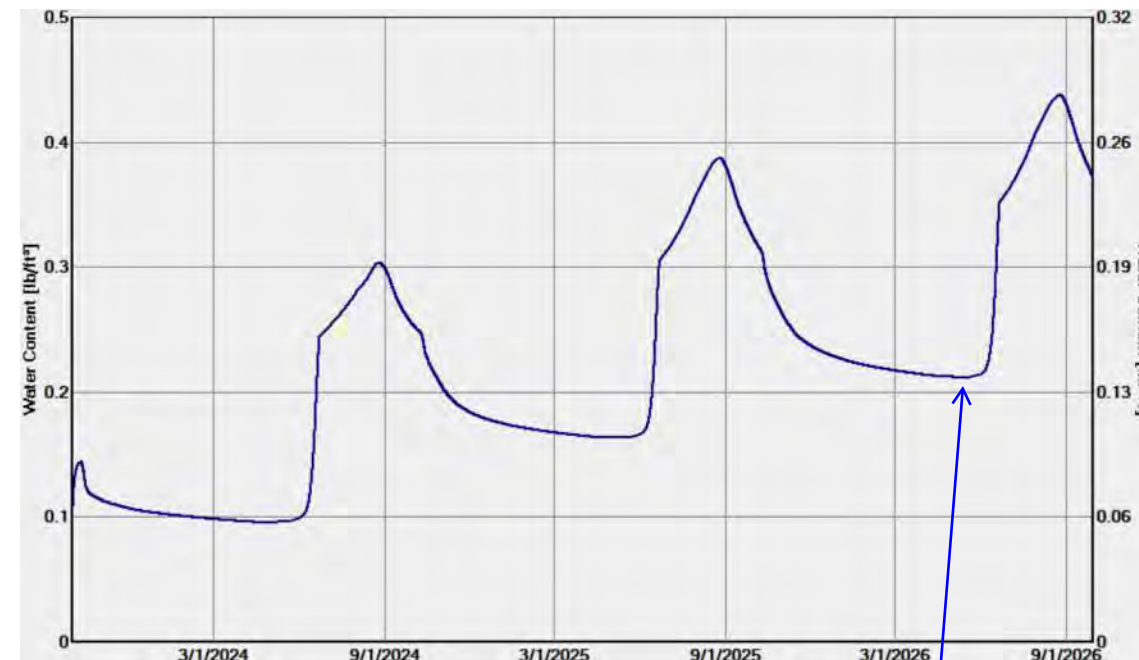
Water content at the interior layer fluctuates seasonally, with increasing moisture during the 3-year period (similar to Existing, Page 4)

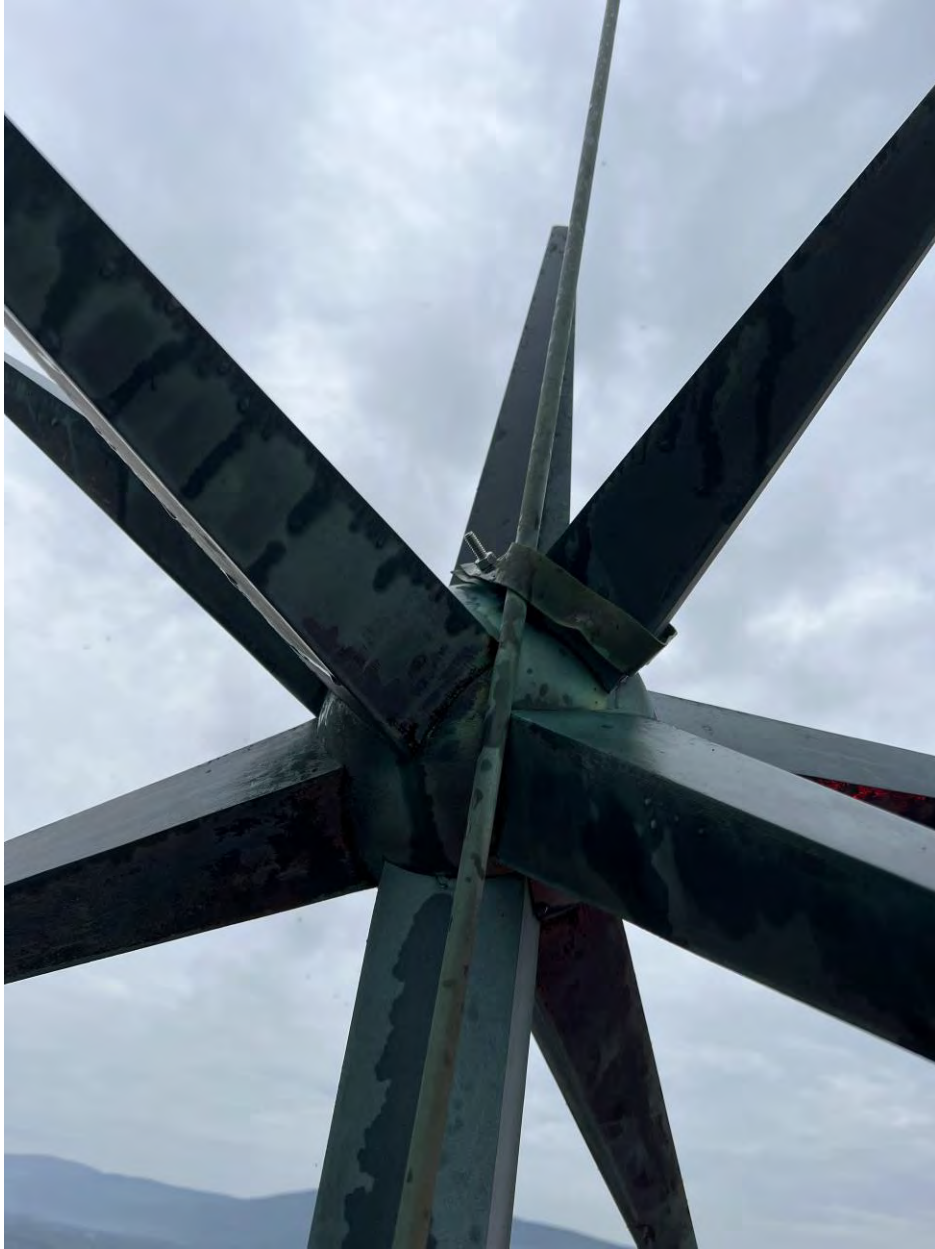
Image 1. ½” diameter class II copper air terminal mounted with bolted copper strapping to star finial. This report recommends a full-size bond between the finial and the air terminal. The strapping currently provides this bond but it is difficult to determine if there is adequate surface area for the connection.

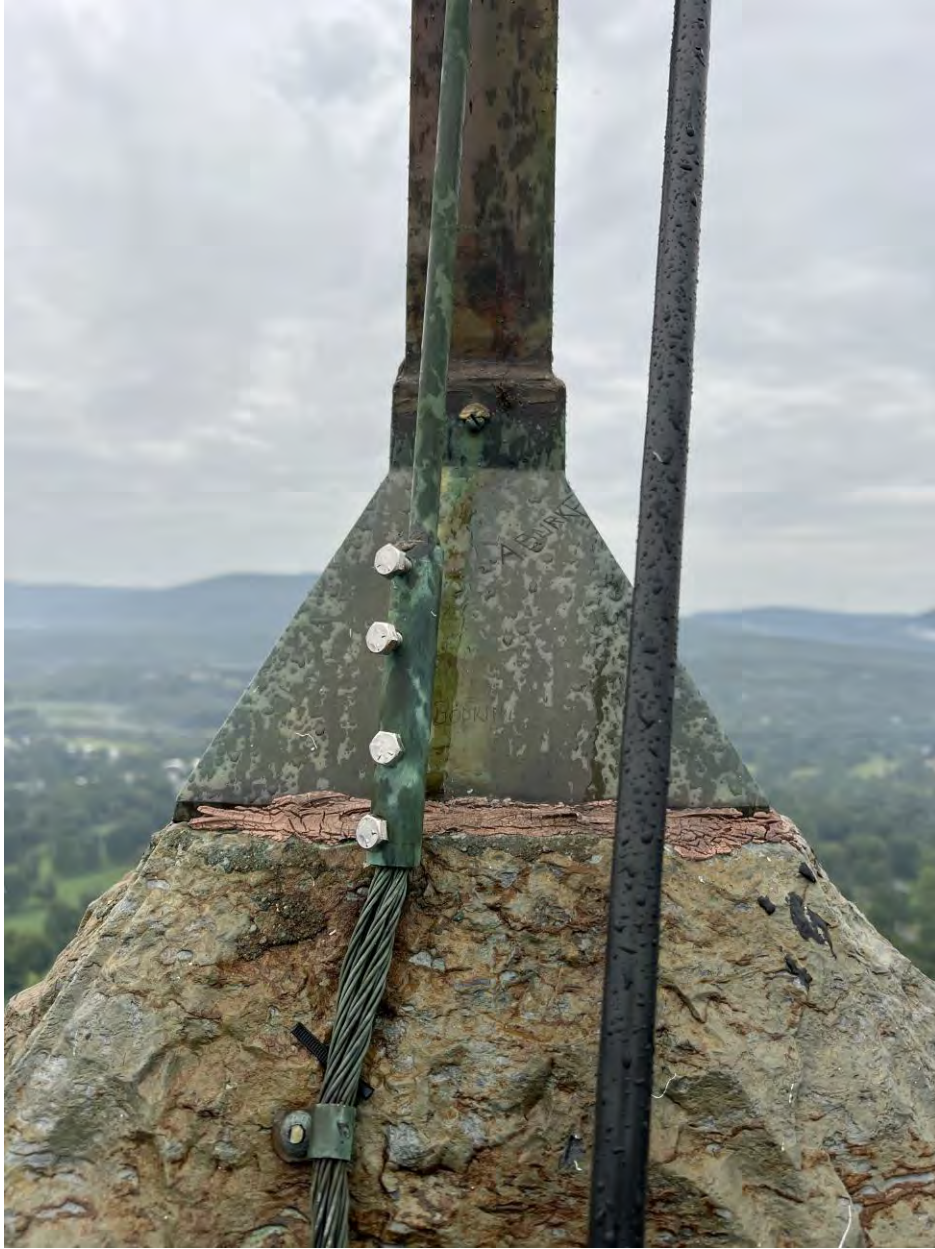
Image 2. Bolted connection from air terminal to class II copper lightning conductor.

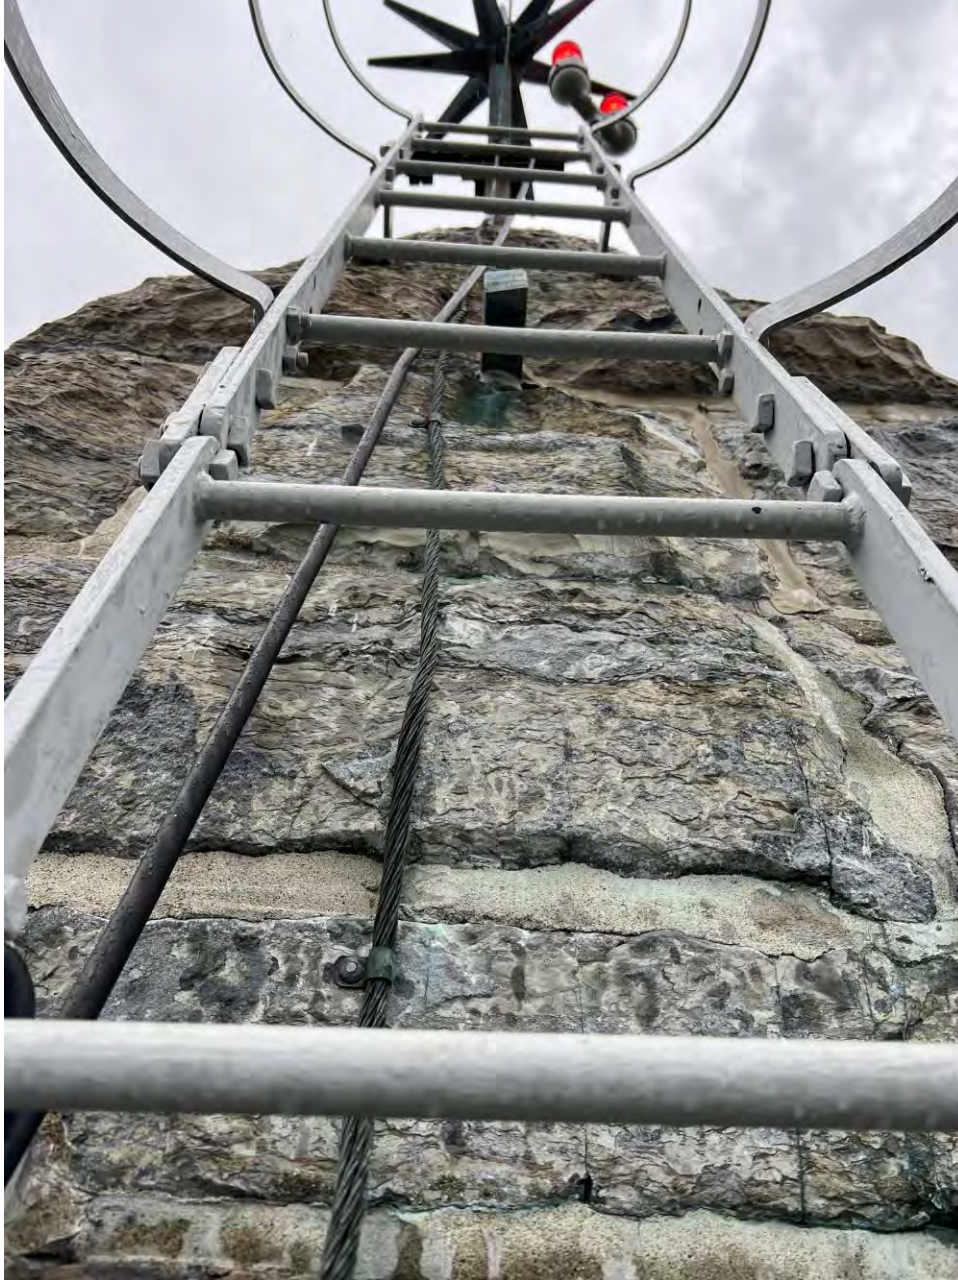
Image 3. The access ladder is directly over the main lightning conductor and is bonded to the lightning protection system at the base of the ladder through a thru bolt into the tower. This report recommends bonding the ladder at the top as well as at the bottom. Also, the platform below the ladder is not bonded into the lightning protection system. This report recommends that the platform be bonded into the system as well.

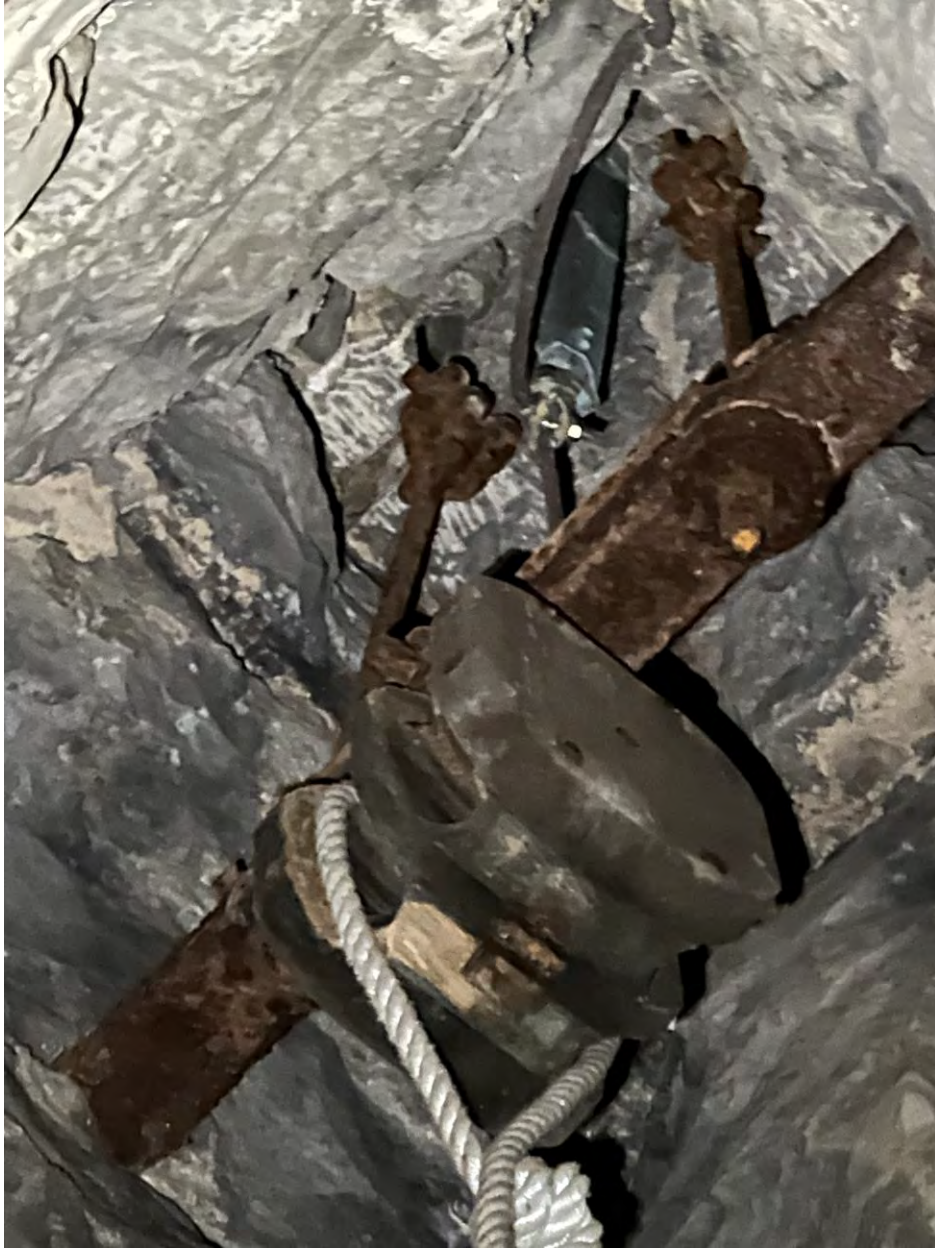
Image 4. Bolted connection to interior of finial mounting hardware. From this connection the conductors travel through the monument on the interior of the Northwest and Southeast corners.

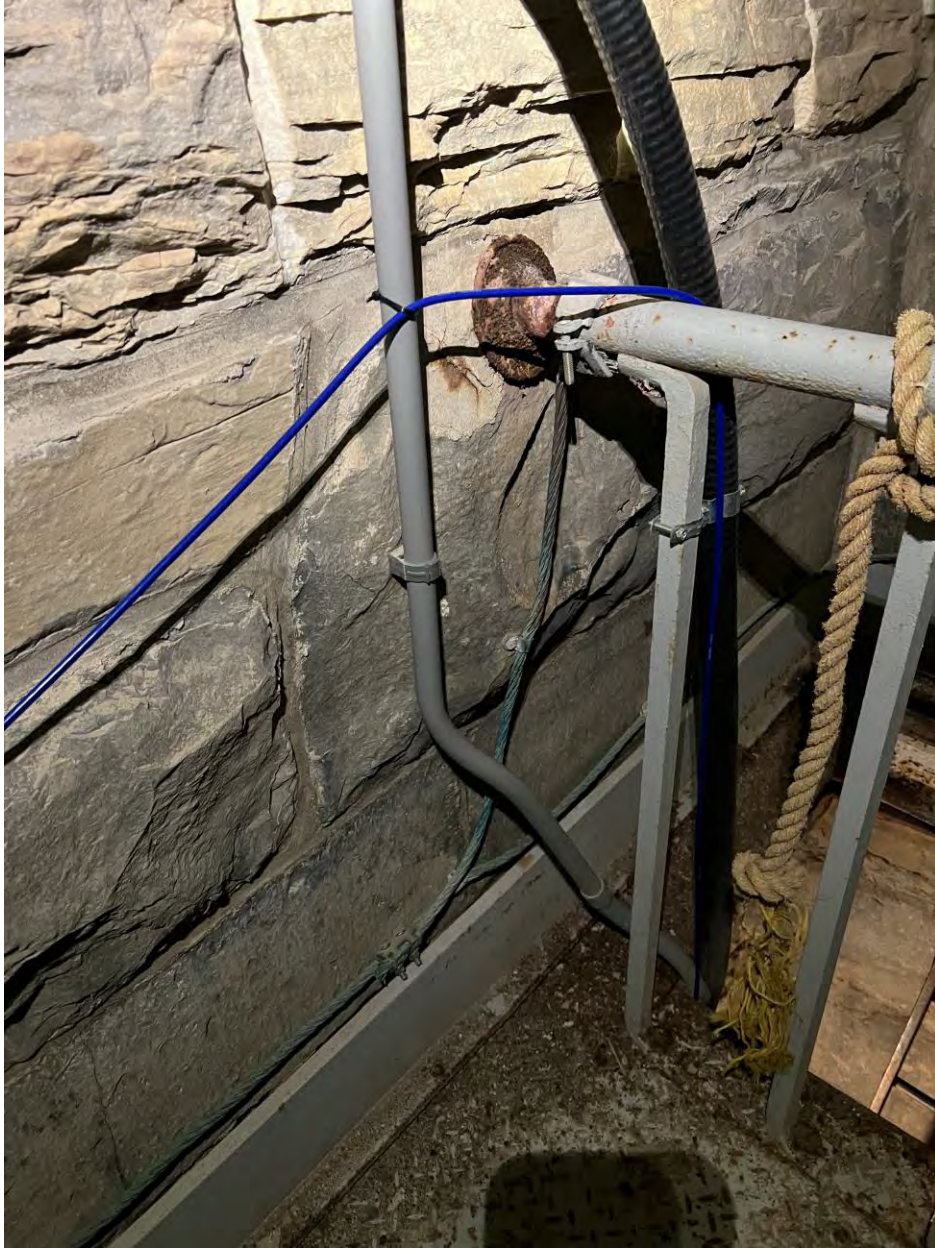
Image 5. The patinaed copper wire runs horizontally and connects the 2 opposite conductors at 4 levels. This intermediate connection is required per NFPA, UL and LPI standards for structures of this height. The bond to the railing is showing some signs of corrosion.

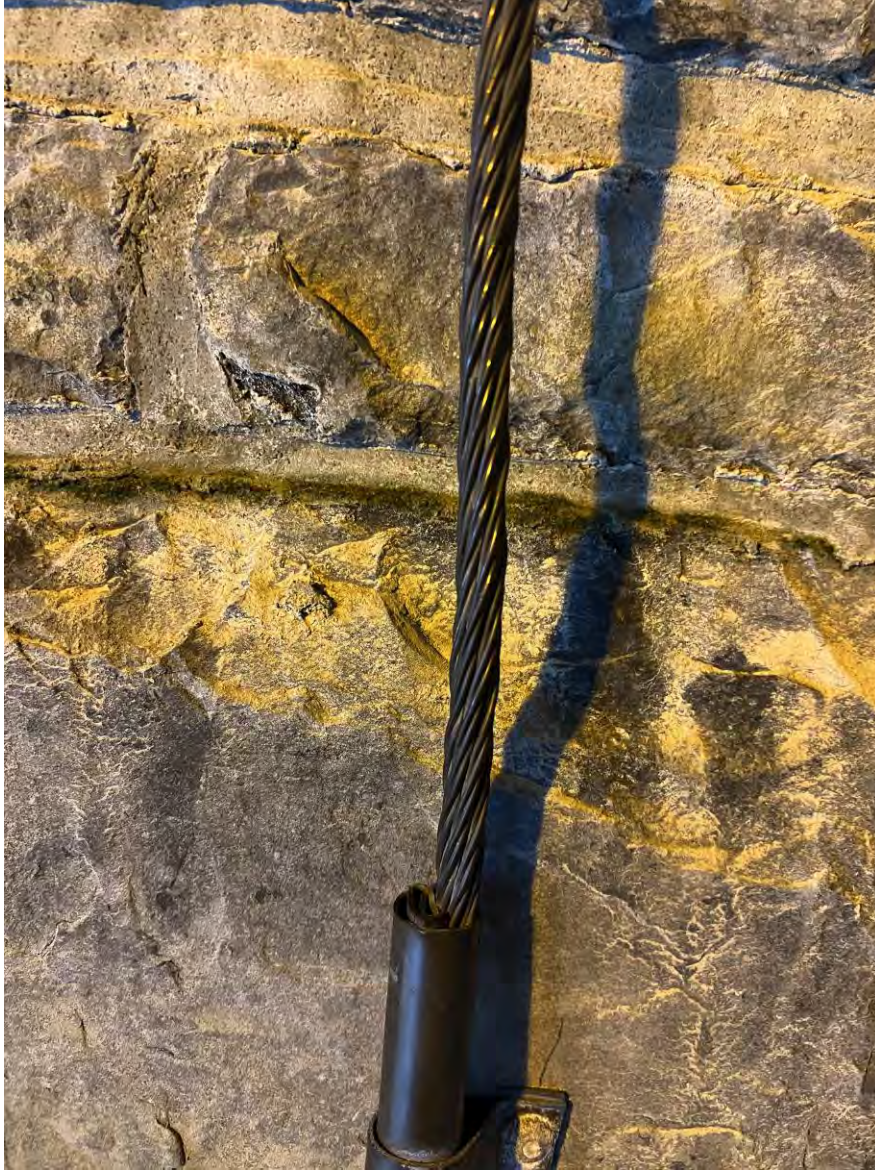
Image 6. At the publicly accessible levels of the monument the conductors are protected by a copper conduit. To keep continuity between the conduit and the conductor a copper wedge is placed into the top of the conduit. This wedge is visible on some of the conduits but not the others. This report recommends confirming or bonding each copper conduit to the lightning protection conductor at the top and bottom of the conductor as required by the lightning protection standards.
