03/29/2024

**STRUCTURAL AND ELECTRICAL ASSESSMENT OF
THE BENNINGTON BATTLE MONUMENT**

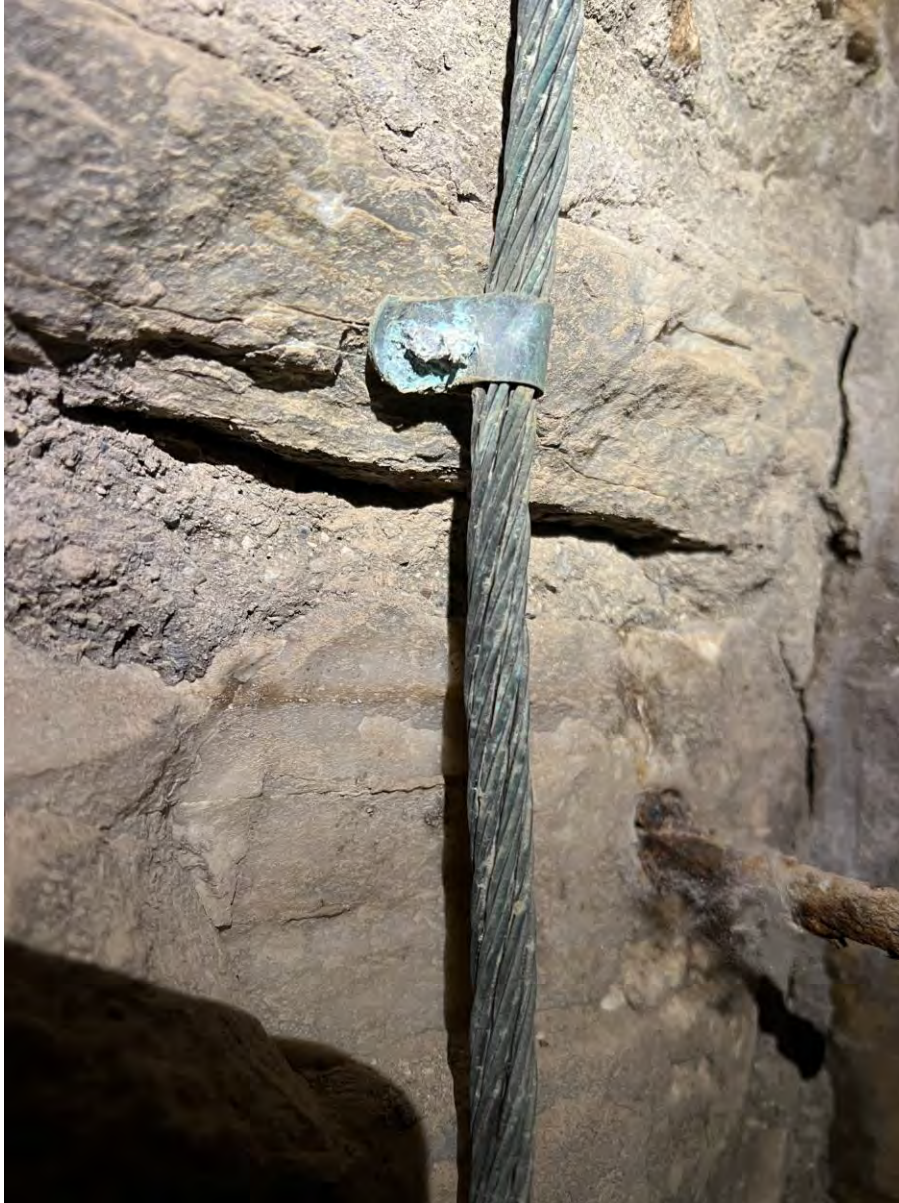
Image 7. As the conductors travel through the monument the condition of the fasteners gets progressively worse. Towards the lower half of the tower many of the fasteners are mostly corroded and are only loosely holding to the inside wall of the tower. This report recommends addressing the moisture issues in the tower then replacing all, or at least the bottom half of the conductor fasteners in the tower.

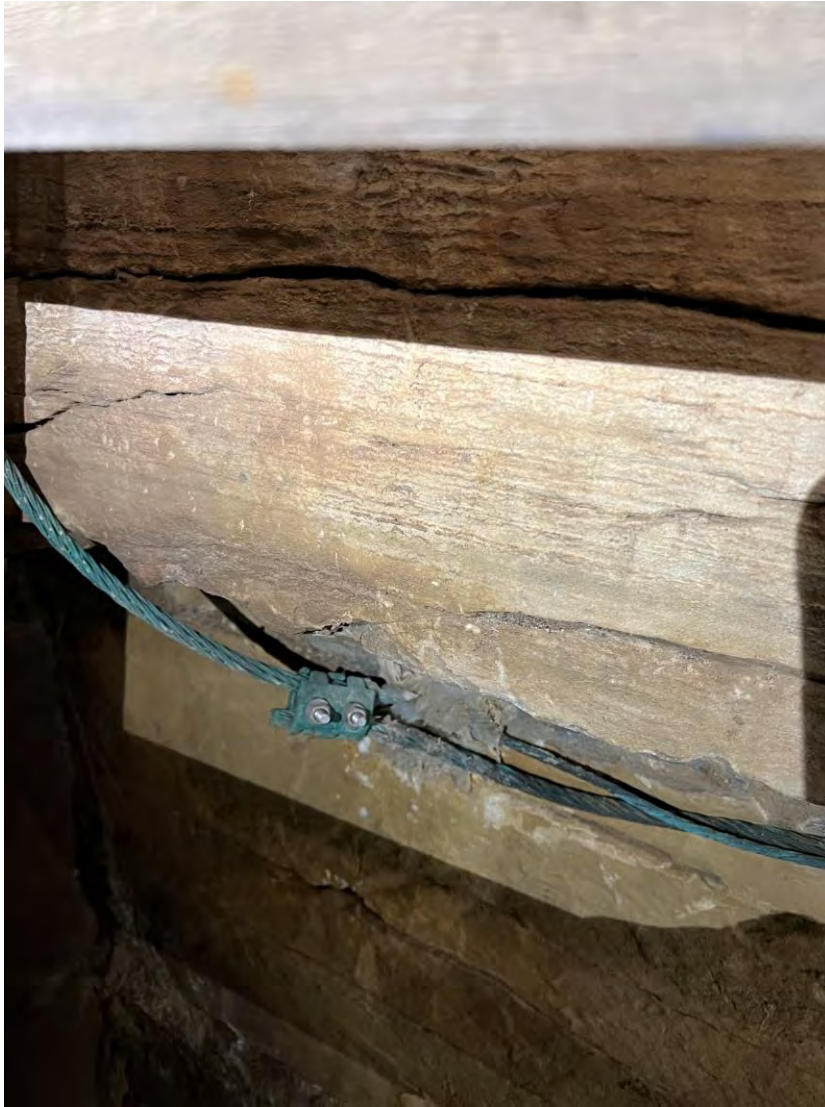
Image 8. The two conductors that travel from the top of the tower to the base exit the structure below grade as in this picture. The condition of the grounding on the exterior is unknown at this point and this report recommends further investigation in the form of excavation around the exterior to determine the condition of the grounding. Also, this report recommends investigating and collecting any as built or plan drawings from the lightning protection system installation if they are available.

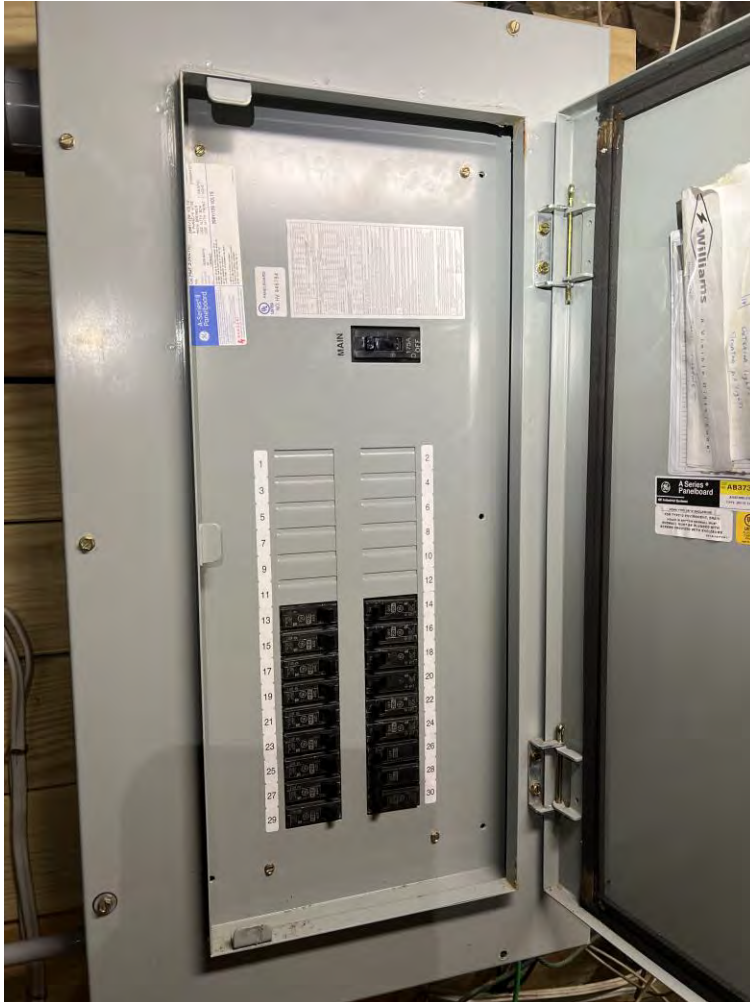
Image 9. There is no surge protection on the main electrical service panel in the monument. Surge protection is required for a complete lightning protection system on all incoming power and communication lines.

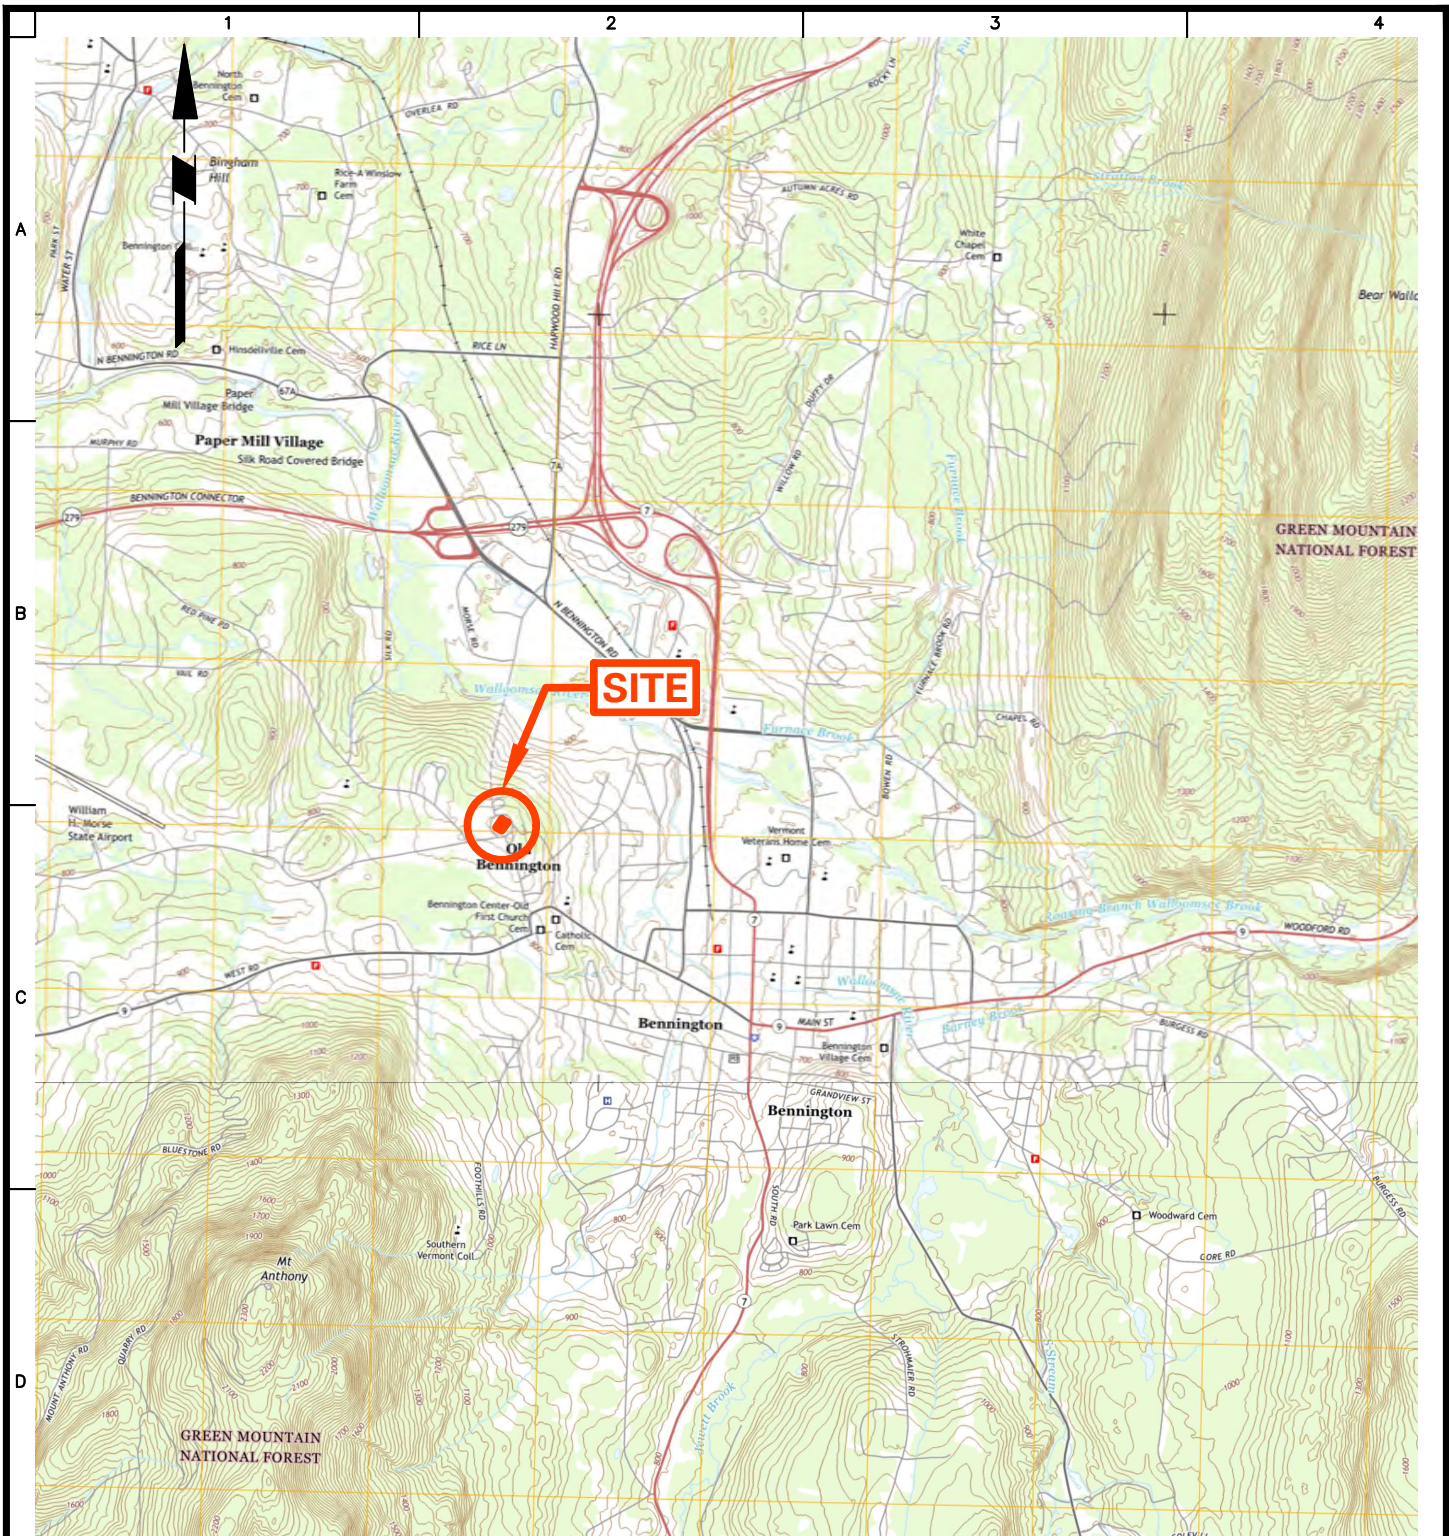
NOTE: ELEVATIONS ARE REFERENCED TO THE NORTH AMERICAN VERTICAL DATUM OF 1988 (NAVD 88).
SOURCE: "BENNINGTON, AND POWNAL QUADRANGLE MAP, VERMONT-BENNINGTON CO. 7.5-MINUTE SERIES", U.S. GEOLOGICAL SURVEY, 2011

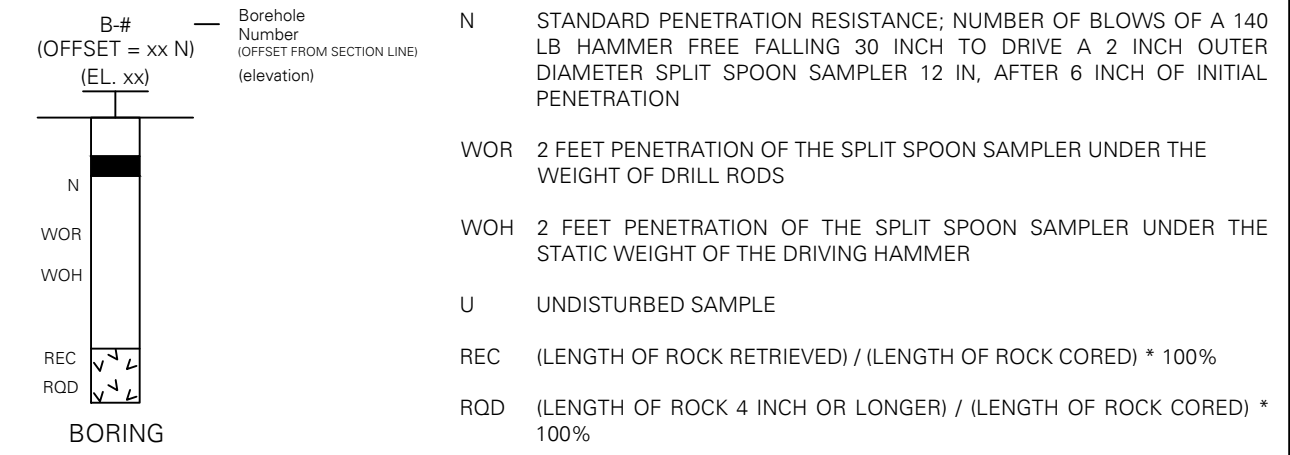
BORING FENCE KEY DIAGRAM AND LITHOLOGY NOTES:

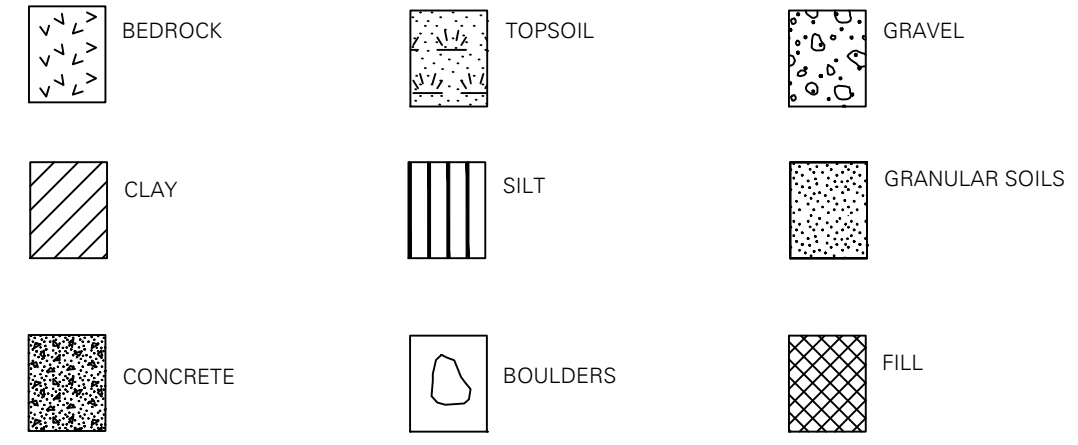
WARNING: IT IS A VIOLATION OF THE NYS EDUCATION LAW ARTICLE 145 FOR ANY PERSON, UNLESS HE IS ACTING UNDER THE DIRECTION OF A LICENSED PROFESSIONAL ENGINEER, LAND SURVEYOR OR GEOLOGIST, TO ALTER THIS ITEM IN ANY WAY.

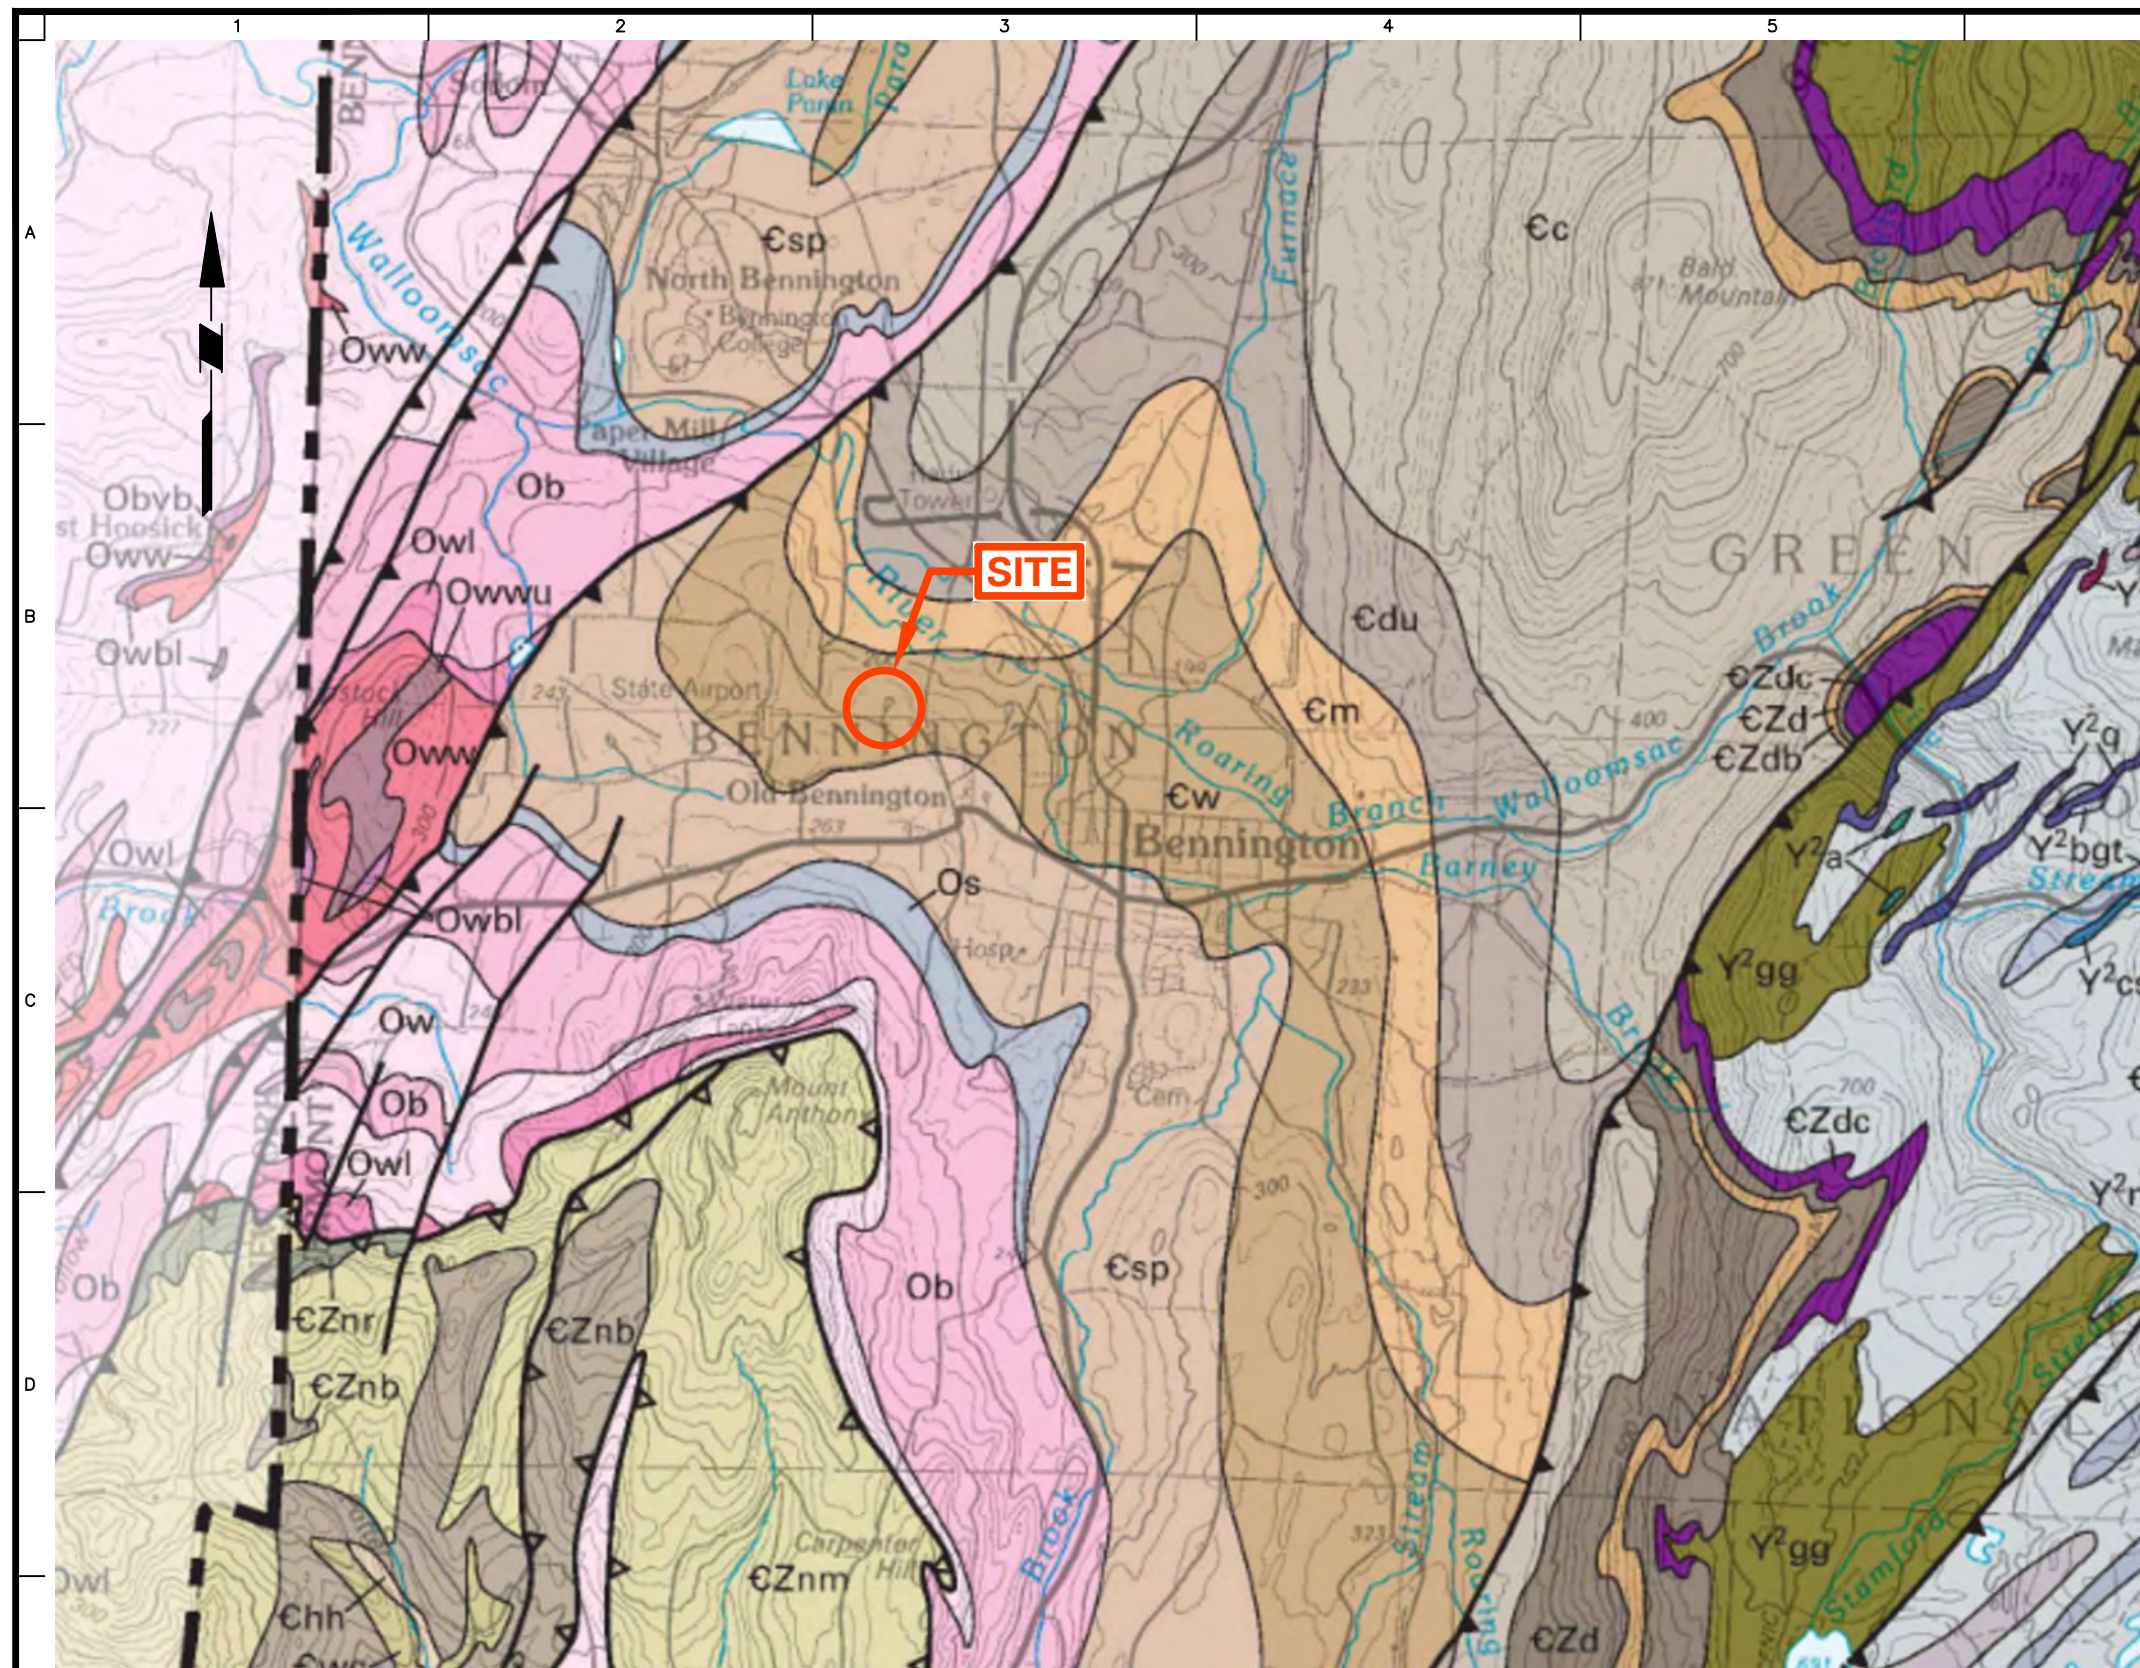
- Ocu** Cutting Dolostone (Lower Ordovician)—Gray, thinly bedded dolomitic sandstone, grading upward into dolomitic limestone or mottled dolomitic marble. In southern Vermont east of the Taconic Range, unit is not recognized and may appear as sandy zones within rocks mapped as the Shelburne Marble

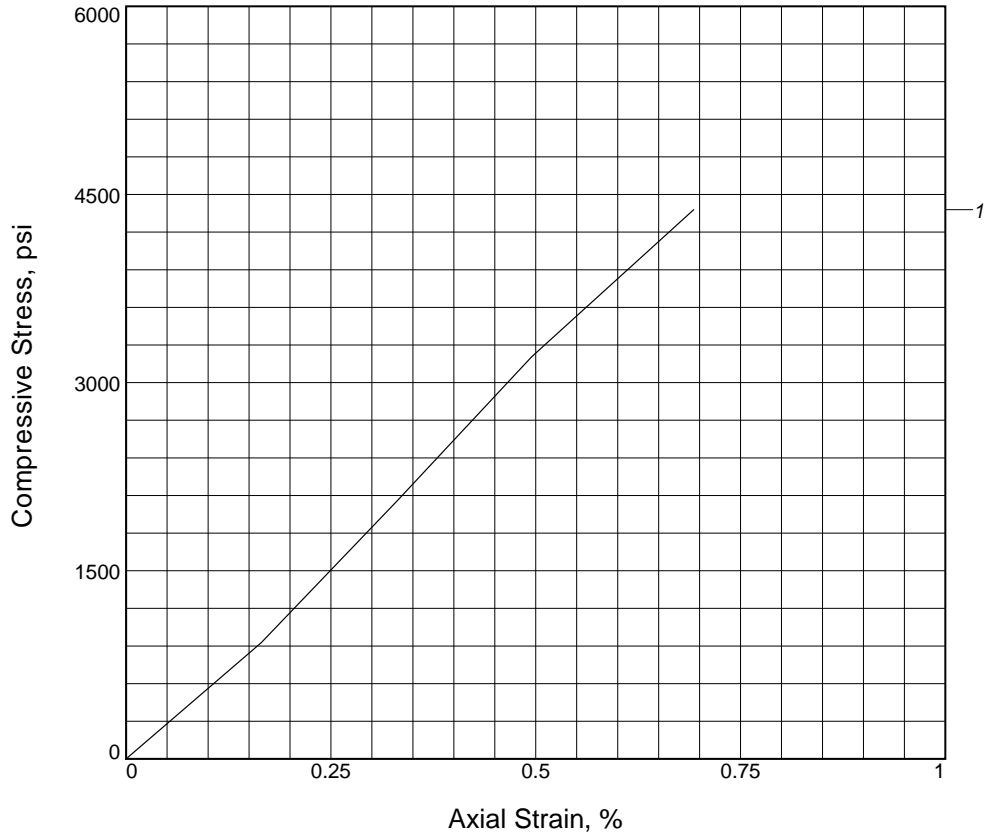
Sample No.	1		
Unconfined strength, psi	4379.24		
Undrained shear strength, psi	2189.62		
Failure strain, %	0.7		
Strain rate, in./min.	0.050		
Water content, %	N/A		
Wet density, pcf	174.5		
Dry density, pcf	N/A		
Saturation, %	N/A		
Void ratio	N/A		
Specimen diameter, in.	2.50		
Specimen height, in.	6.06		
Height/diameter ratio	2.43

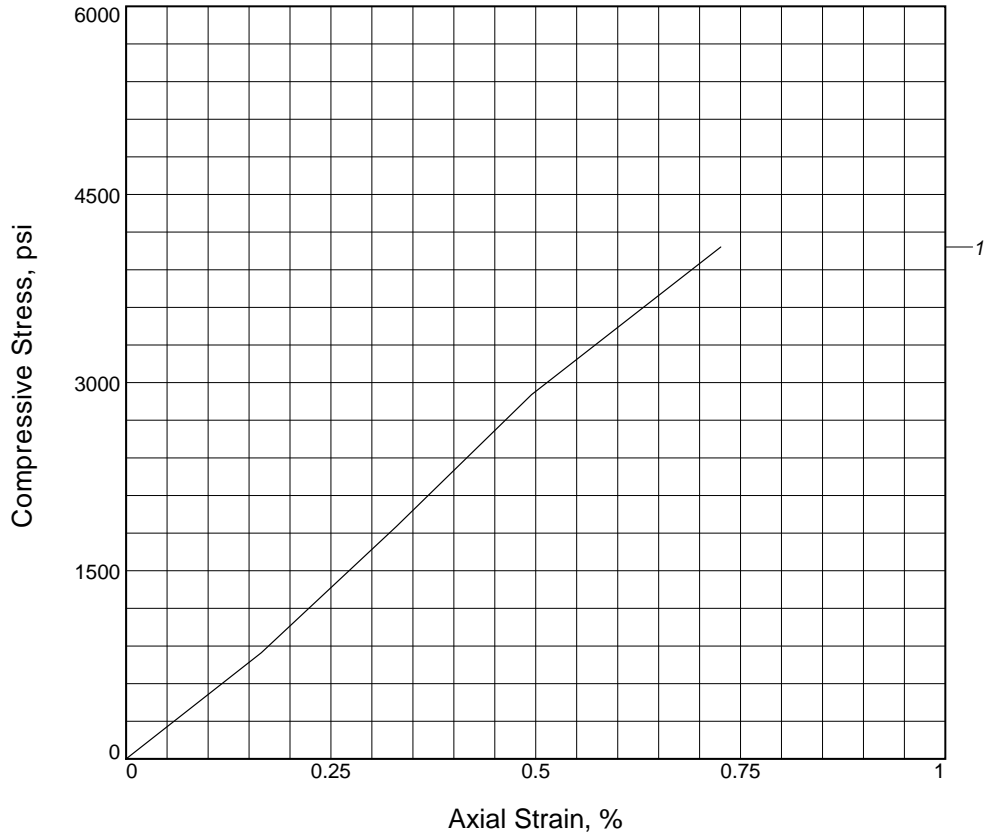
Sample No.	1		
Unconfined strength, psi	4081.33		
Undrained shear strength, psi	2040.66		
Failure strain, %	0.7		
Strain rate, in./min.	0.050		
Water content, %	N/A		
Wet density, pcf	174.5		
Dry density, pcf	N/A		
Saturation, %	N/A		
Void ratio	N/A		
Specimen diameter, in.	2.50		
Specimen height, in.	6.06		
Height/diameter ratio	2.43
