STATE OF VERMONT Division for Historic Preservation VERMONT ARCHITECTURAL RESOURCE INVENTORY Individual Property Survey Form	SURVEY NUMBER: 263 St. Paul (Assigned by VDHP)
	Listed in State Register <input checked="" type="checkbox"/> 1993 Eligible for State Register Yes <input type="checkbox"/> -or- No <input checked="" type="checkbox"/> Date: October 30, 2024 SHPO LVT
	PRESENT FORMAL NAME:
	ORIGINAL FORMAL NAME:
COUNTY: Chittenden	PRESENT USE: Residential dwelling
TOWN: Burlington	ORIGINAL USE: Residential dwelling
PHYSICAL ADDRESS: 263 Saint Paul St	ARCHITECT/ENGINEER:
COMMON NAME:	BUILDER/CONTRACTOR:
PROPERTY TYPE: Residential	DATE BUILT: c. 1899
OWNER: Robert Rich / 263 St Paul LLC MAILING ADDRESS: 9 Duchess Ave, So Burlington, VT 05401	
	PHYSICAL CONDITION OF STRUCTURE: Good <input type="checkbox"/> Fair <input checked="" type="checkbox"/> Poor <input type="checkbox"/>
	STYLE:
GENERAL DESCRIPTION: Structural System: 1. <u>Foundation:</u> Stone <input checked="" type="checkbox"/> Brick <input type="checkbox"/> Concrete <input type="checkbox"/> Concrete Block <input type="checkbox"/> 2. <u>Wall Structure</u> a. Wood Frame: Post & Beam <input type="checkbox"/> Plank <input type="

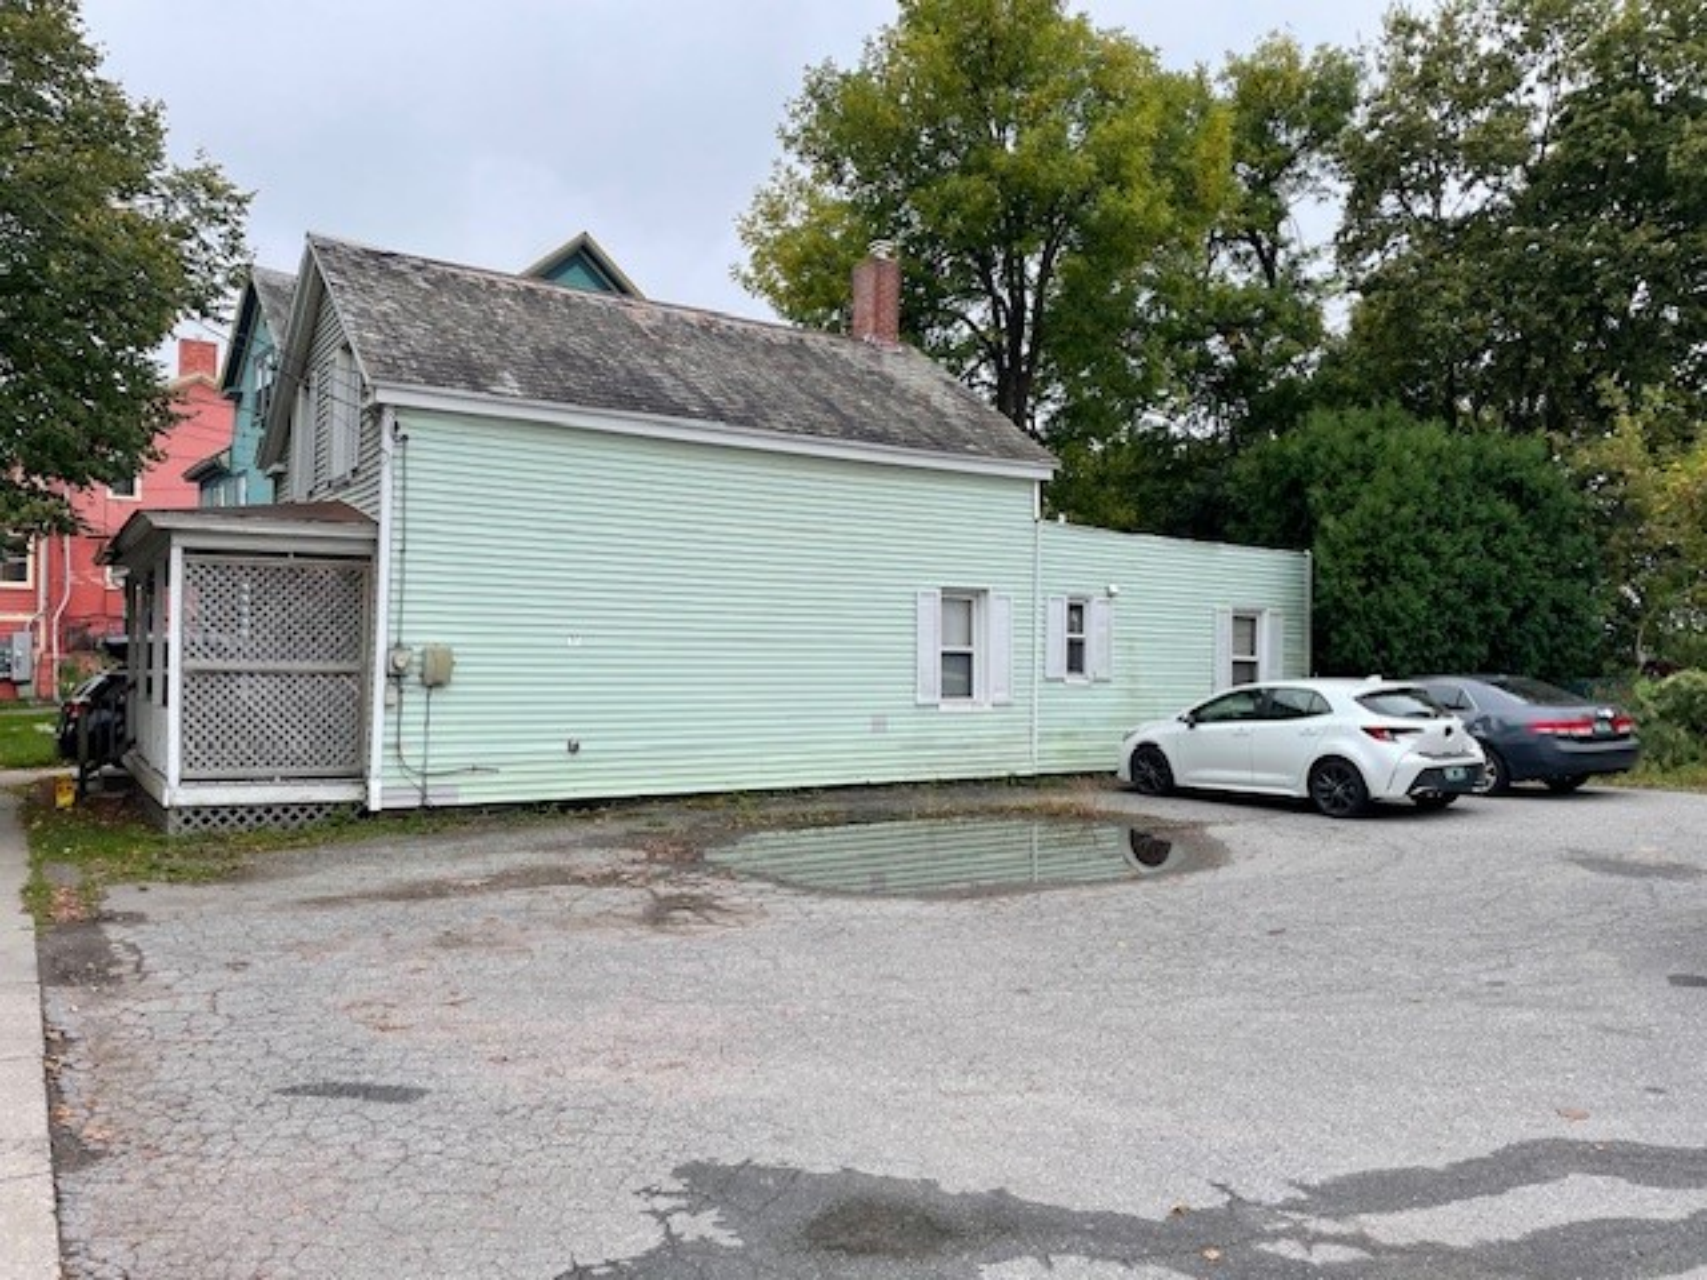
Reconstructed interior chimney

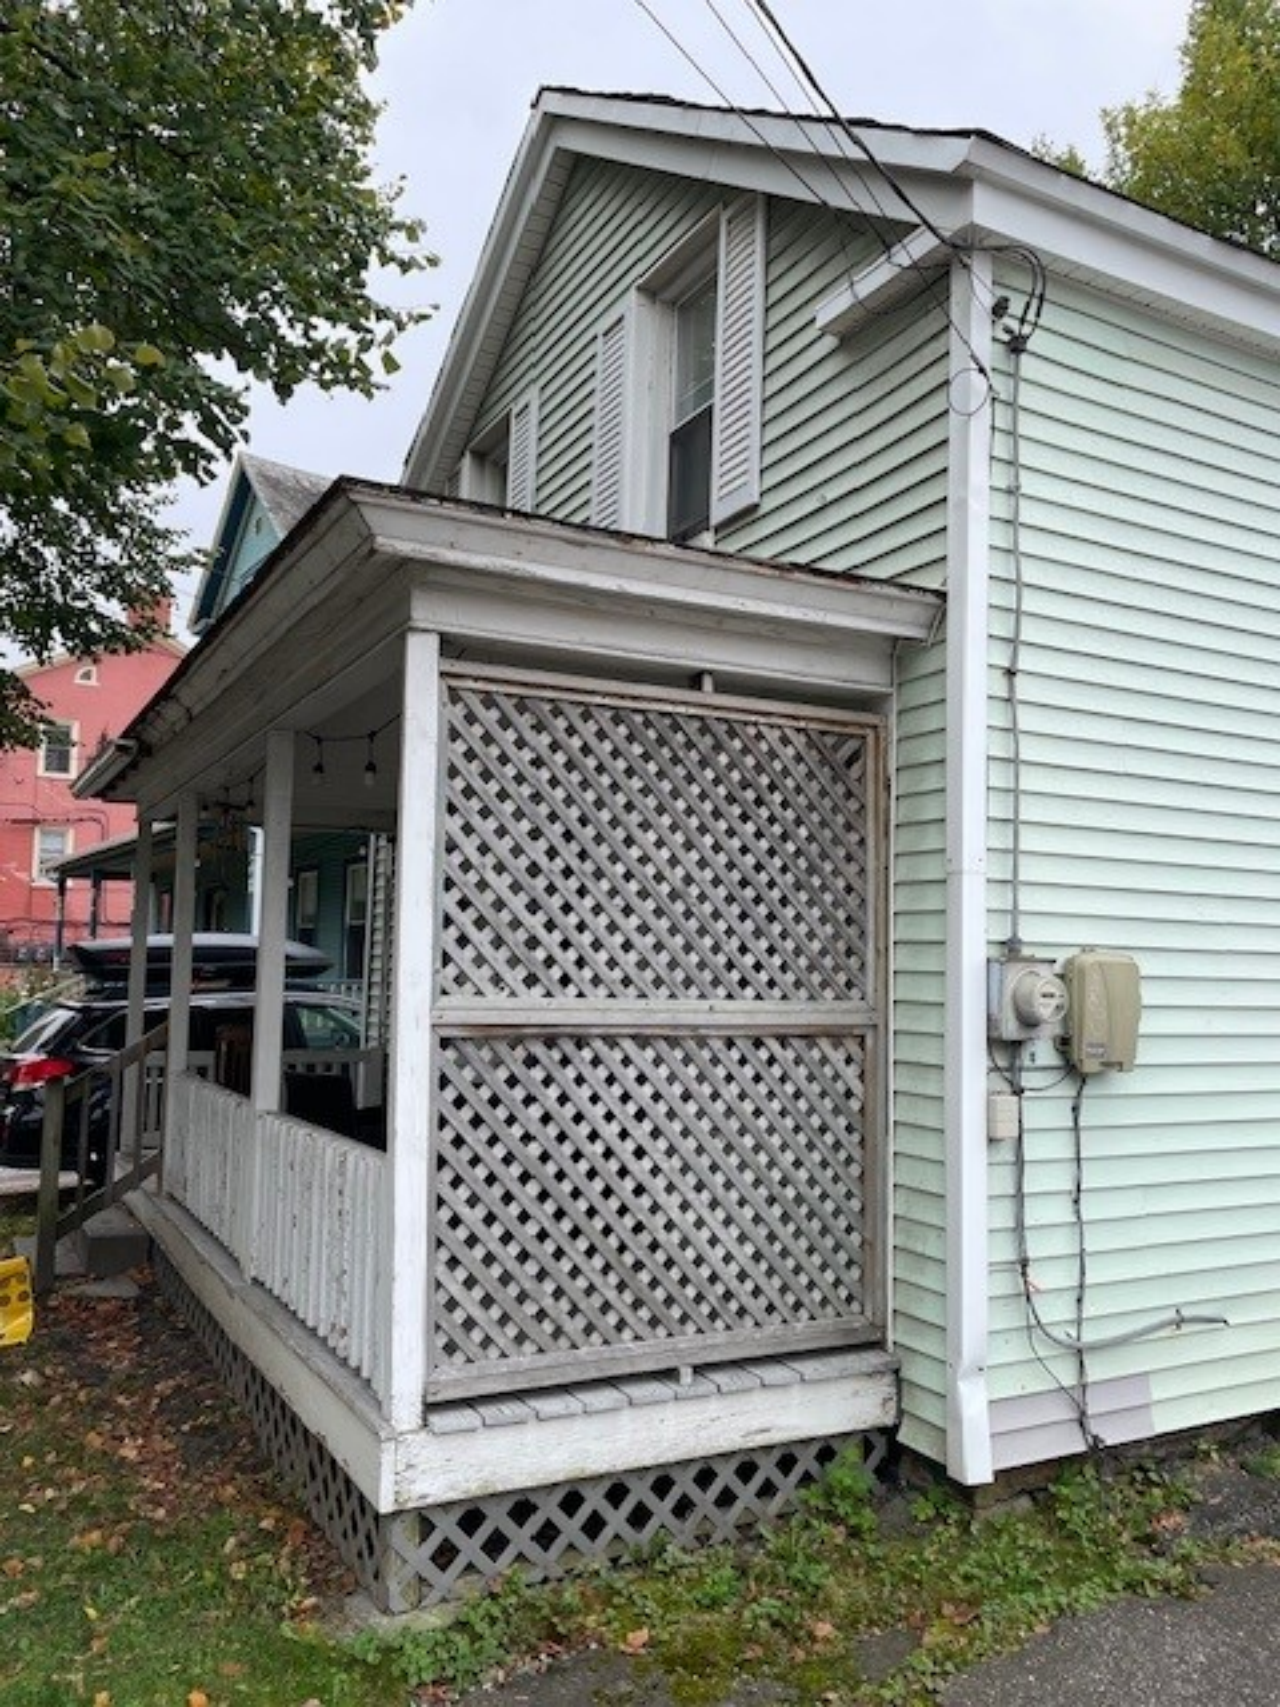
Eaves and returns covered in vinyl siding

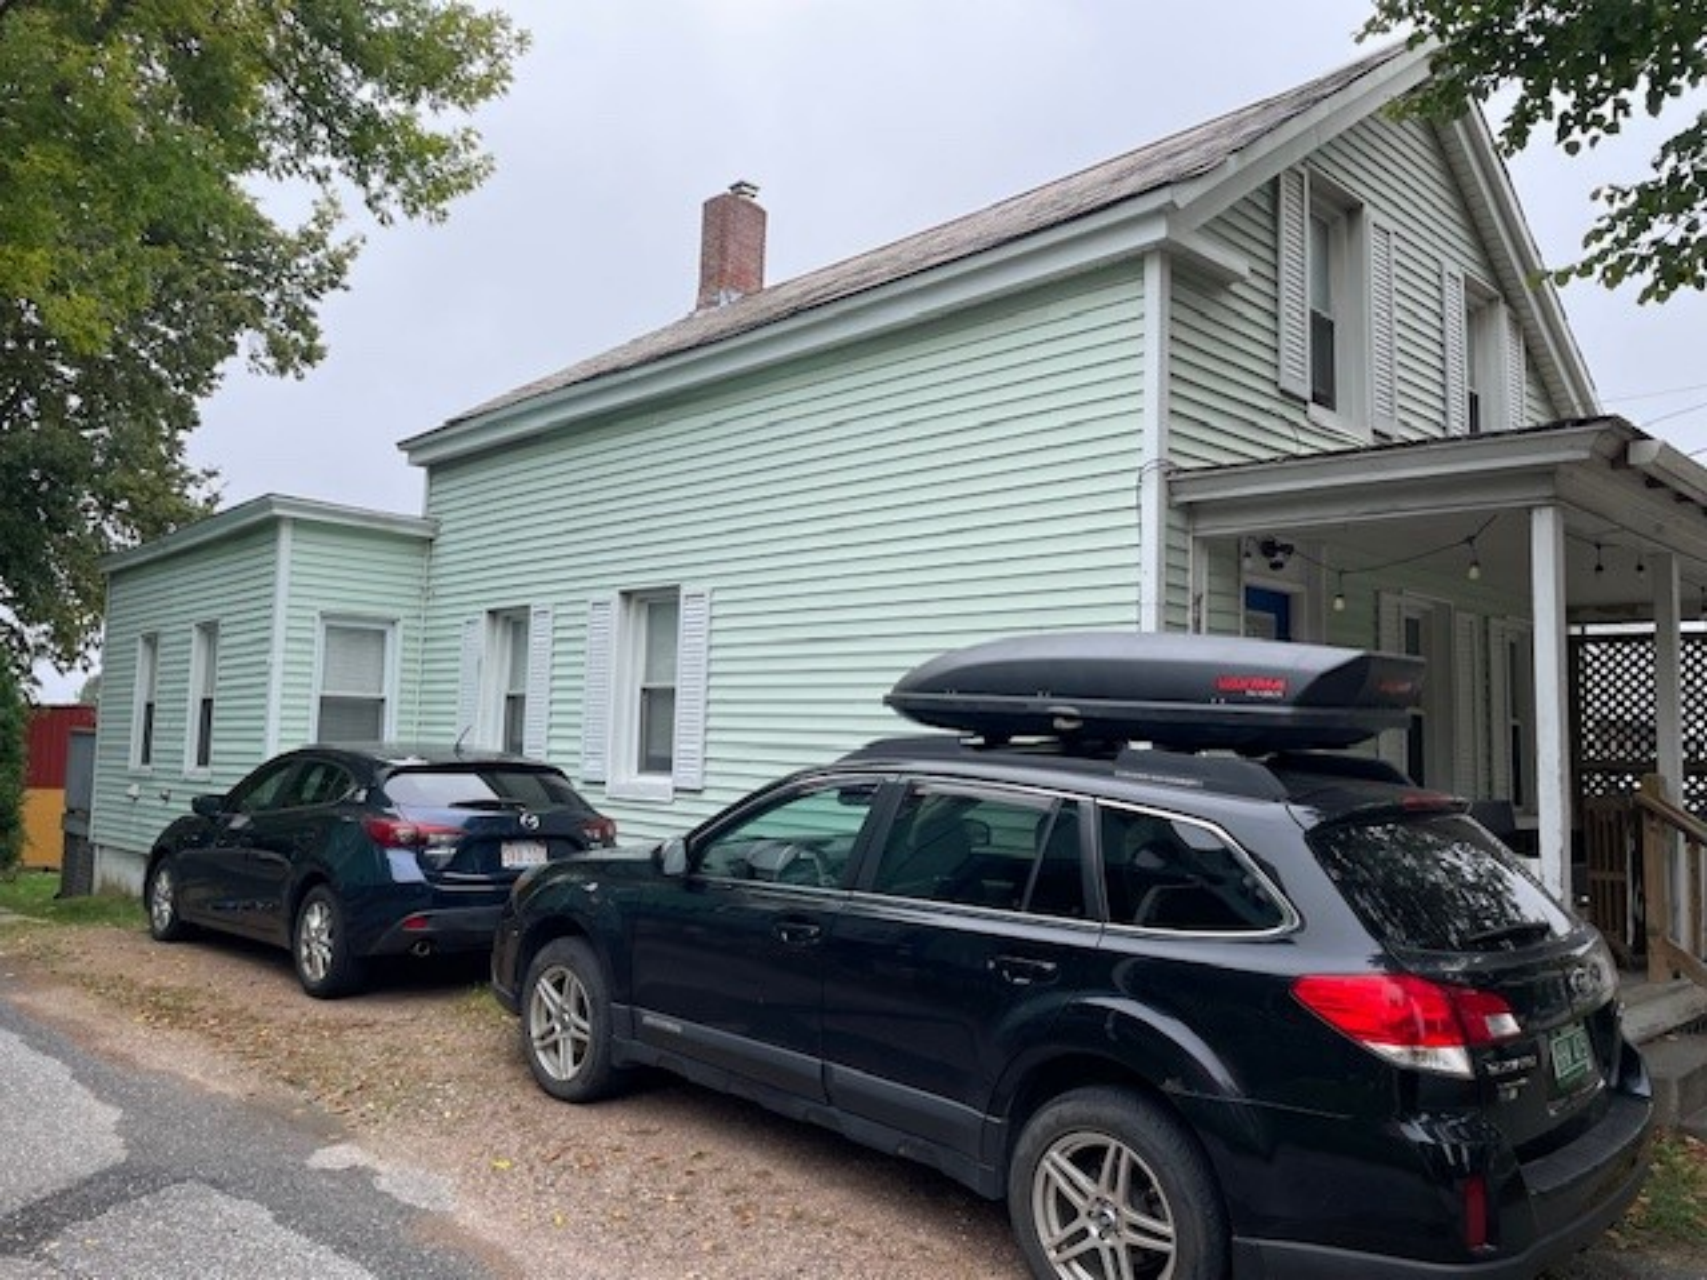
Windows and doors replaced, fanlight over main entry covered or infilled; fake shutters

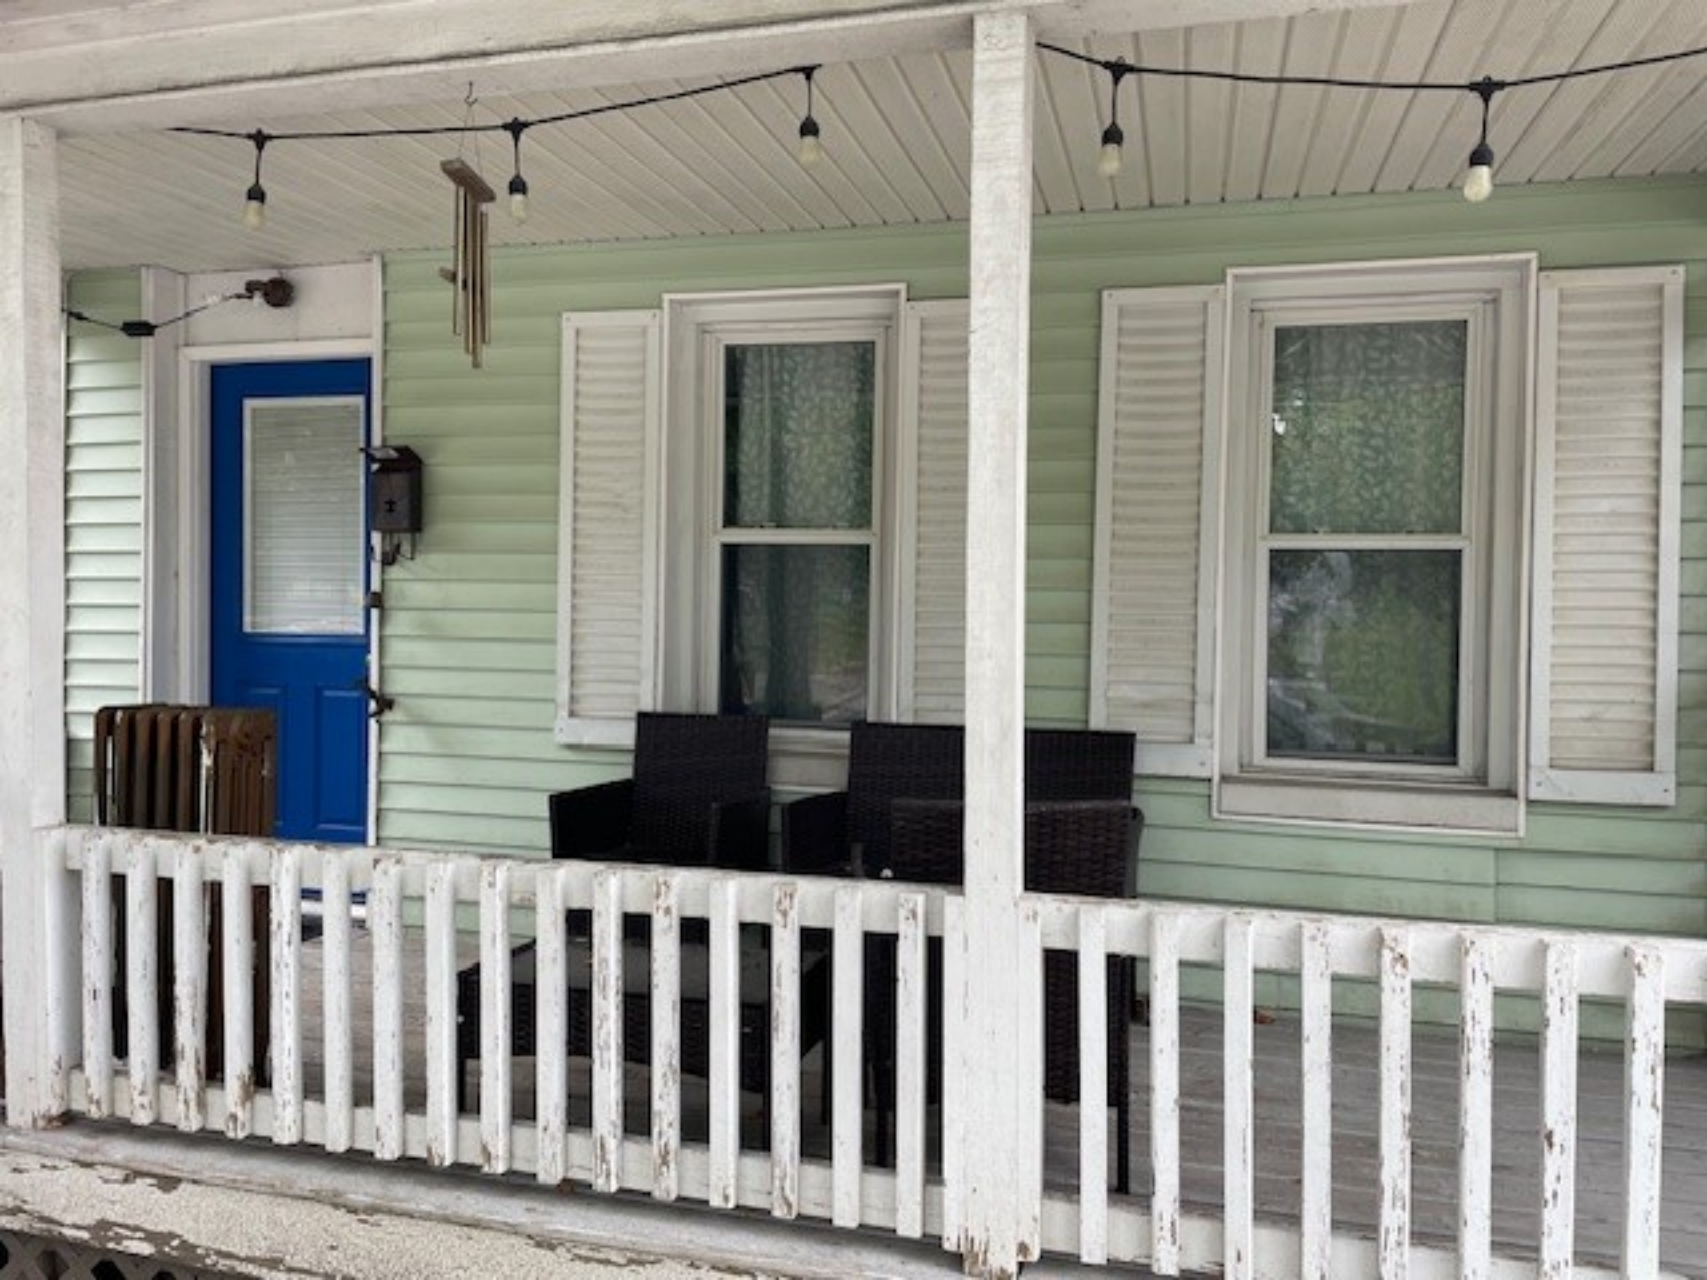
Reconstructed front porch with square posts replacing turned posts noted in 1977 HSSS
