**Unitarian Property
Burlington, VT**

**Capital Needs Assessment
June 2, 2016**

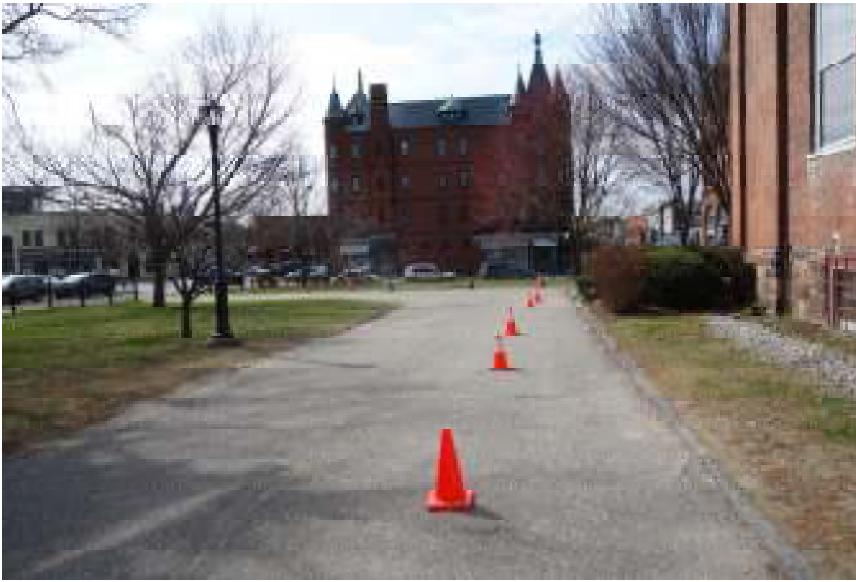
The asphalt paved areas are in fair to good condition. Potholes have developed, particularly where the asphalt and gravel meet and in the parking around 30 and 34 Elmwood. The 30 Elmwood parking is being expanded onto areas intended to be lawn that are now packed earth. You should consider working with these tenants to either expand the available parking or limit parking to approved areas.

There is also damage to the curbs along the circular drive. These are redstone blocks that have settled over the decades to the point where they no longer serve their purpose. My understanding is the blocks are actually quite tall and could be reset at a higher level and again be effective. This is a

The paving dates from 2000. The pavement has an expected life of 25 years and is 16 years old. Patching and sealing cracks can extend this life a few years in the areas in better condition. The area near Elmwood will need repaving in year 2. The balance is budgeted for better curbs, modest widening and repaving in year 7.

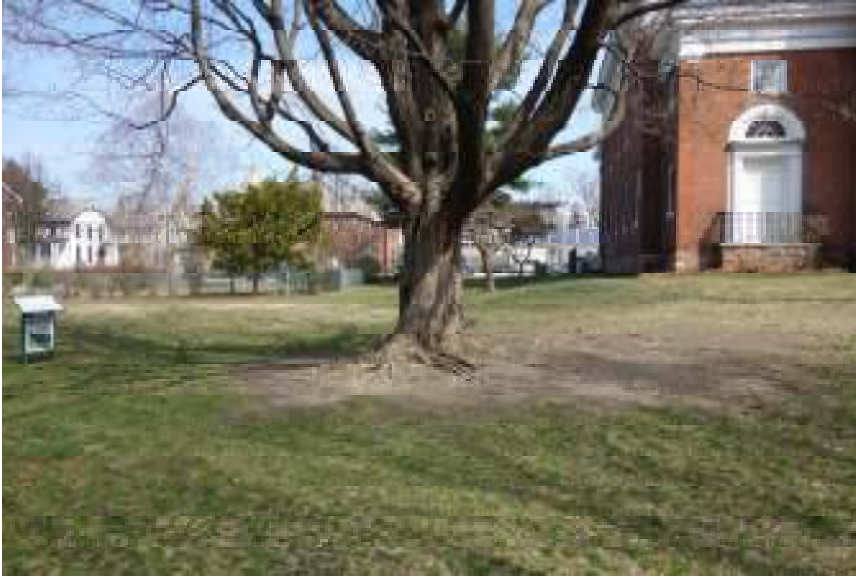
The other buildings have less pronounced drip line drainage problems, but there are still low areas next to the Clarke St. building. The solution is similar.

The storm drain should be cleaned out in year 1. The areas at the drip lines should be regraded and the drainage improved in year 1. The overall drainage, especially at the parking areas should be addressed in the paving and parking project in year 7.

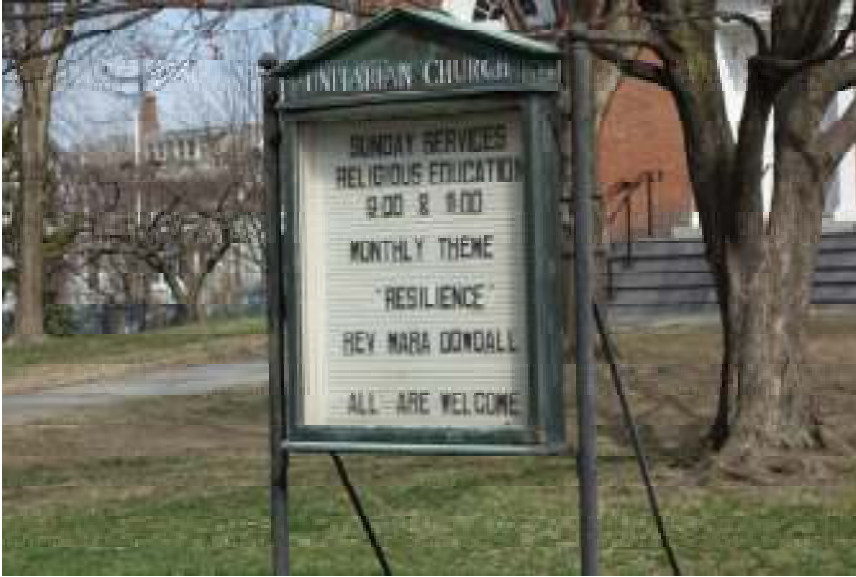
There are two glass fronted display cases on the front lawn. One on the right is metal and the one on the left is wood. Both have some damage from normal wear and tear and should be repaired. This includes resoldering the bottom of the metal case and

repairing the wood and painting the wood case. This is budgeted in year 1 and repeats in year 11.

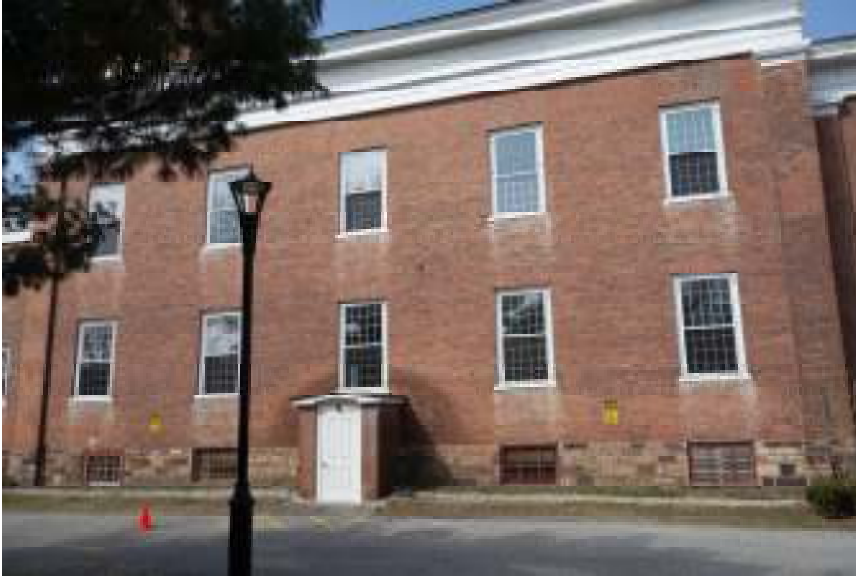
30 Elmwood Ave. – This brick building is in good condition. The brick has some small defects that should be repaired and the wood trim is generally in good condition. There is some minor rot at the north side eaves.

Painting the trim is budgeted in years 5, 12 and 19. A round of repairs is included in each repainting. The current brick problems are more maintenance than a capital expense. A full round of repointing the brick is budgeted in year 13. This will be 40 years since the renovation of the building.

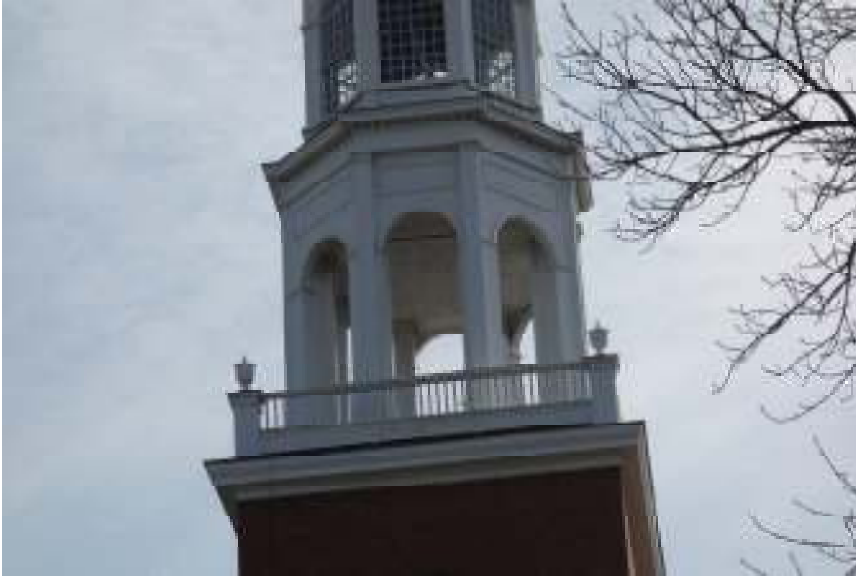
Meetinghouse – The building has a brick exterior with painted wood trim. The brick is generally in good condition. The original building has some mortar deterioration and should be monitored. The decay may accelerate and require repointing during the report

period. There is less significant damage to the mortar in the 1868 addition and no damage in the 1994 building. A round of repointing is budgeted in year 11.

The trim was painted in 2007 except for the front façade, which was repainted in 2014, and is due. You should anticipate painting the building every 7 years and there will be some trim repairs and caulking with each round of painting. This is budgeted in years 2, 9 and 16.

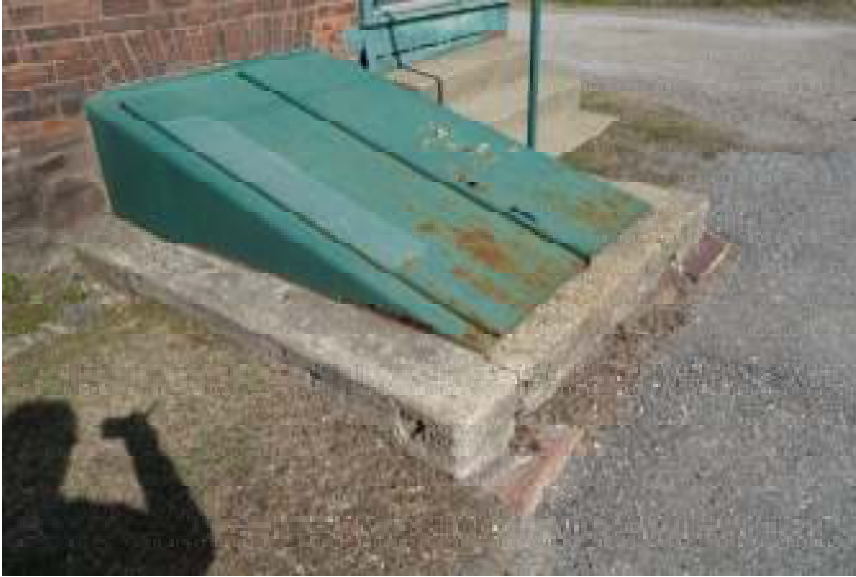
The storm door is budgeted for replacement in year 9. The Bilco door has extensive rust and has begun to deteriorate. It should be scraped and painted with rust resistant paint in year 1. Its life is limited due to the rust and replacement is budgeted in year 9.

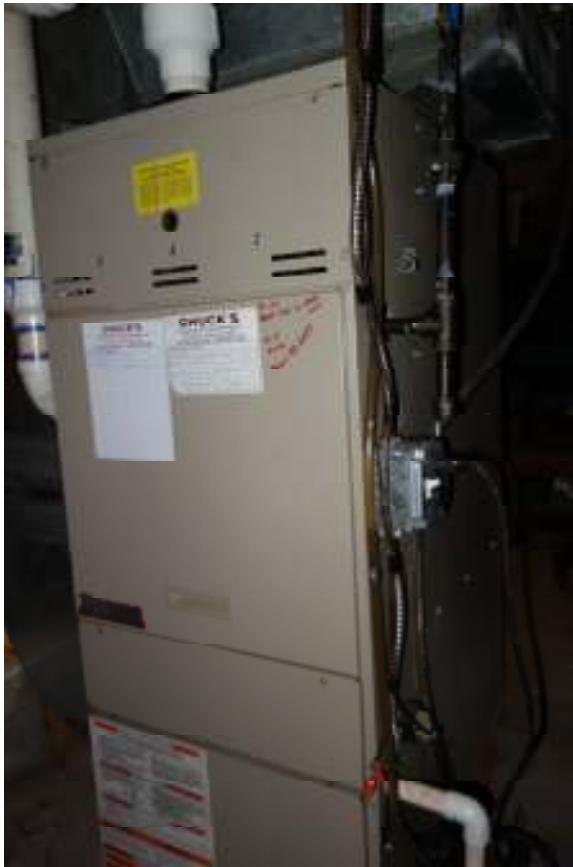
27 Clarke St. – This building has a natural gas hot air condensing furnace (above). It appears to be almost 20 years old. It is an efficient model and no problems were reported. It may require extensive repairs soon to prolong its life. This is budgeted in year 1 and replacement is budgeted in year 11. There is a gas hot water heater. Its age is approximately 14 years. It is budgeted for replacement in years 1 and 16.
