Southgate Steeplejacks

STEEPLE INSPECTION UNITARIAN CHURCH BURLINGTON VT. May 2014

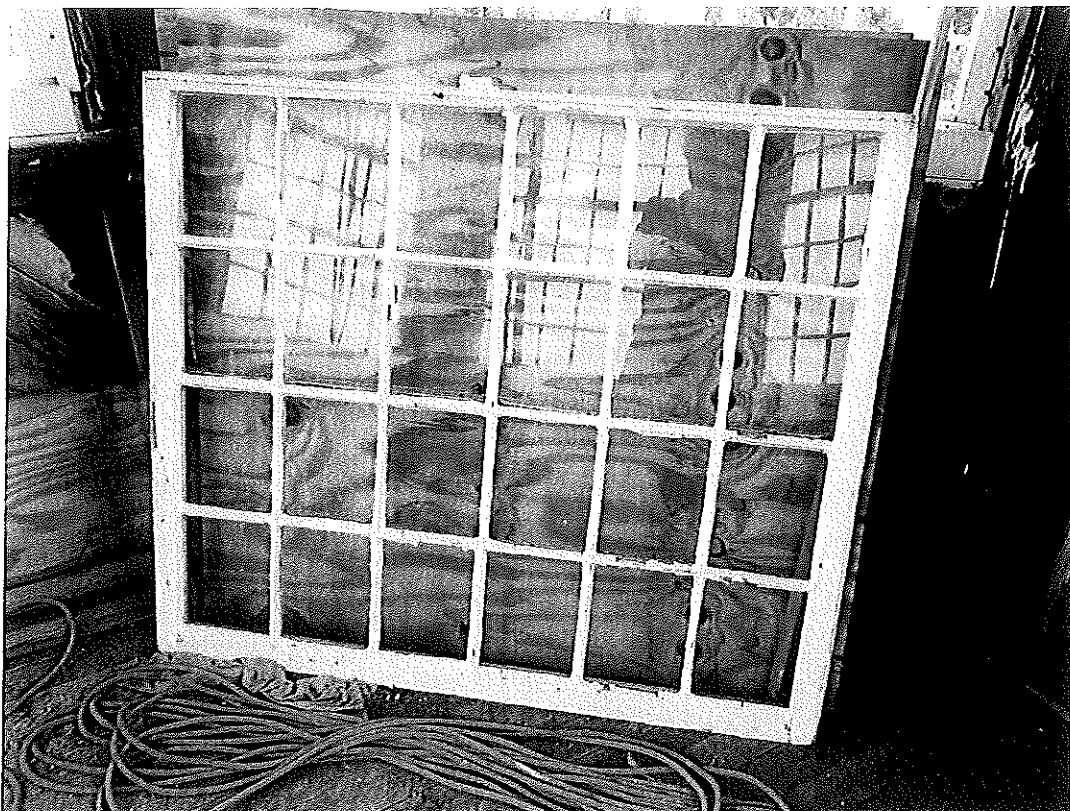
Shows window is pretty beat. I wish I had more up close pic of windows. But they need serious care soon

The windows need to be removed to a shop, all glass removed, all paint stripped, total re-priming, re-glazing, top-coating. I do not know if code will require safety glass. I think it will not if the sash are repaired, but will if replaced. You could consider making each sash new out of one piece of tempered glass with applied wood or plastic to mimic the current look. This would result in a smooth interior surface. We have done this with good result in the past and it might cost less than restoring the old sash

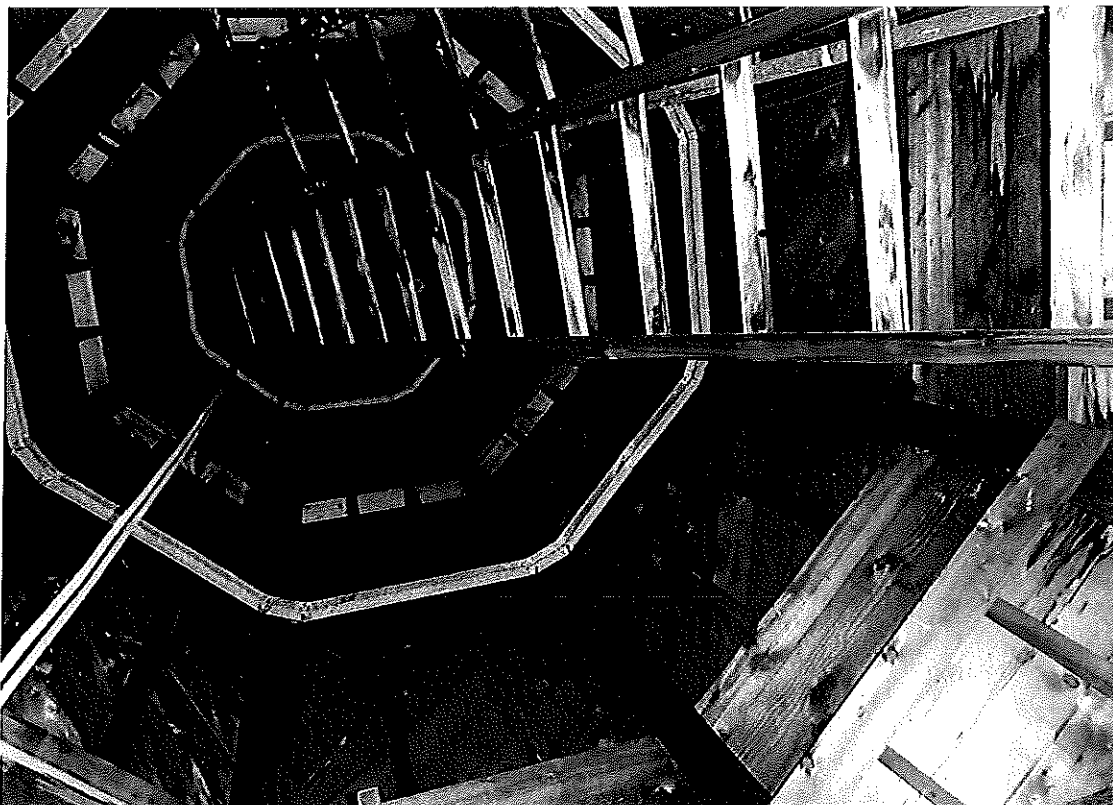
This home made ladder is AWFUL and a new one should be made

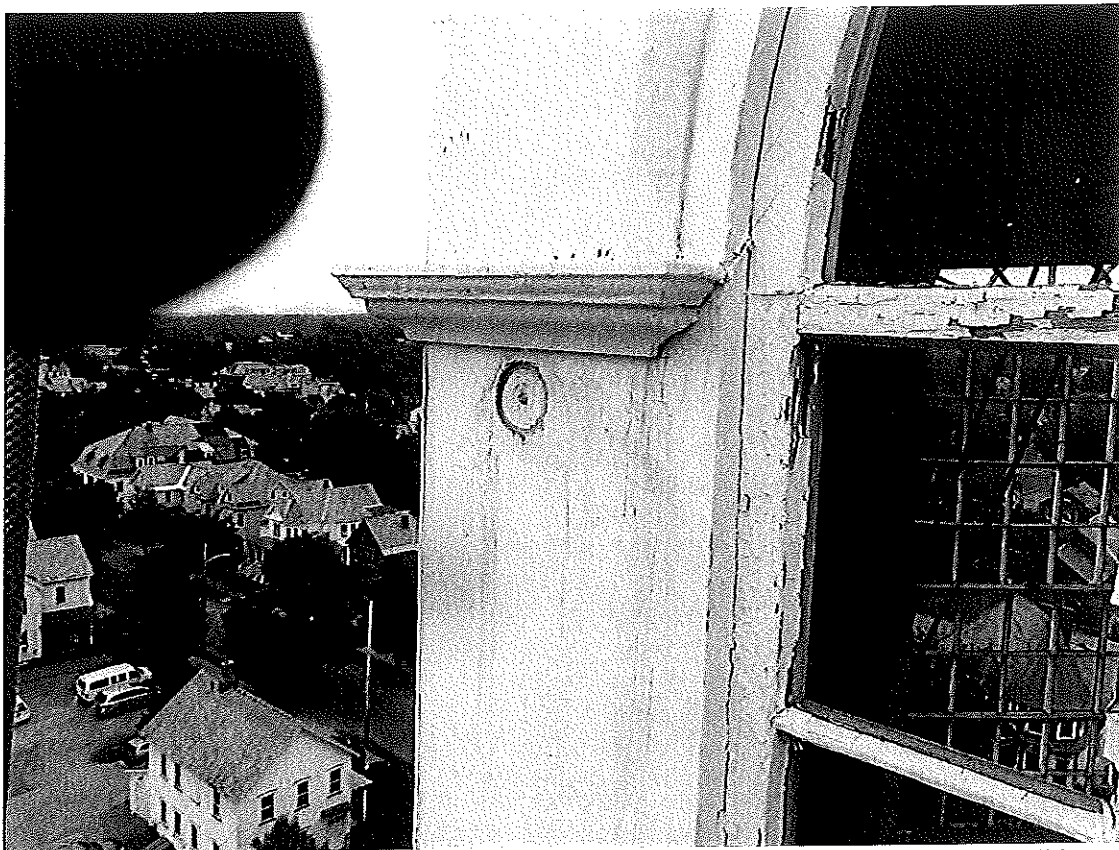
Shows the stains from the water running behind plinth. Another spot where the regular caulking maintenance will be needed if woodwork is to be kept.

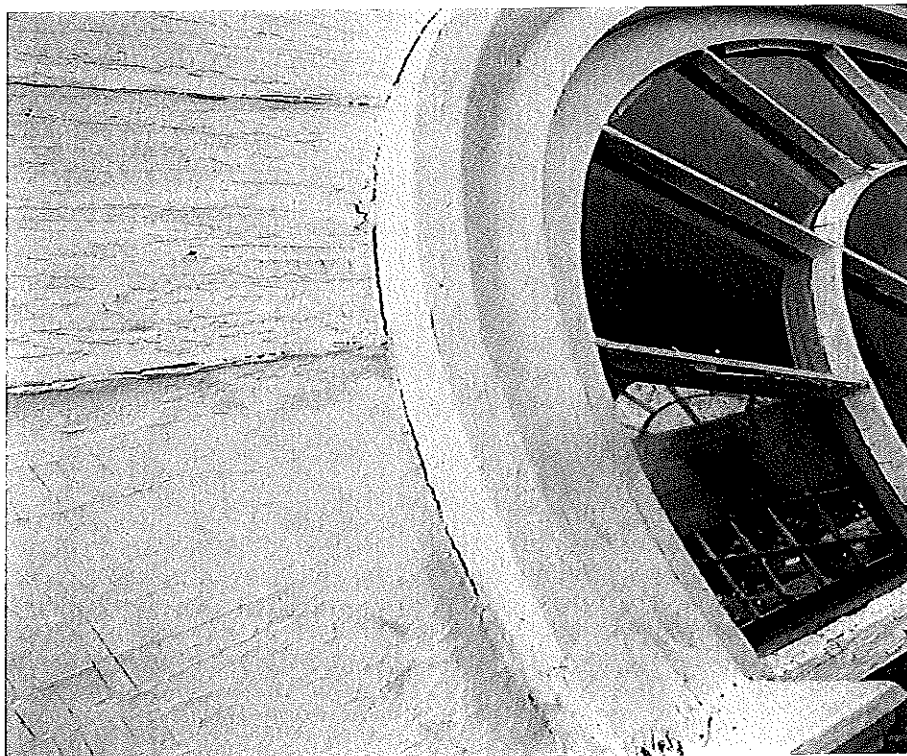
More places where water runs behind. Also shows window needs work. Wish I took more window pics, they're beat.
