**Diagnostic Report  
For The Brick School Museum**

Town of Georgia  
47 Town Common Rd. No.  
Georgia, Vermont 05568

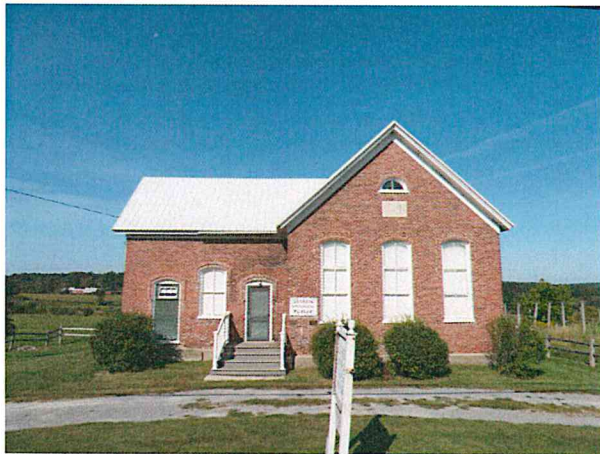
Exterior View of Museum

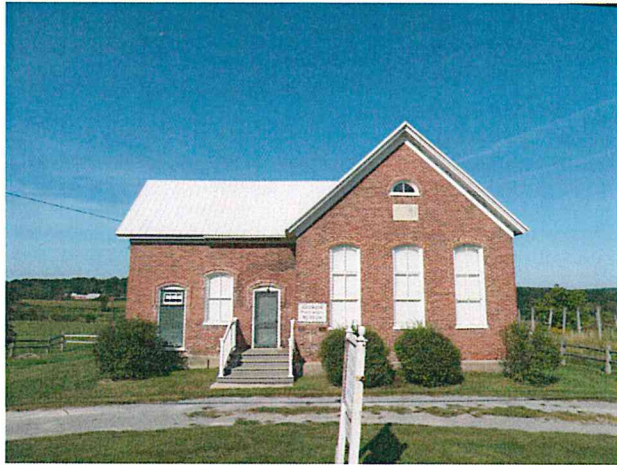
The existing Brick School Museum is a one and a half story brick veneer building with exterior and interior wood framed walls, floor and roof. It sits on its original stone foundation. At some point, the stone foundation was covered with a concrete facing. Its roof is a pre-finished corrugated metal roof that is not original. There is an existing brick chimney on the west side of the building that was added at a later time.

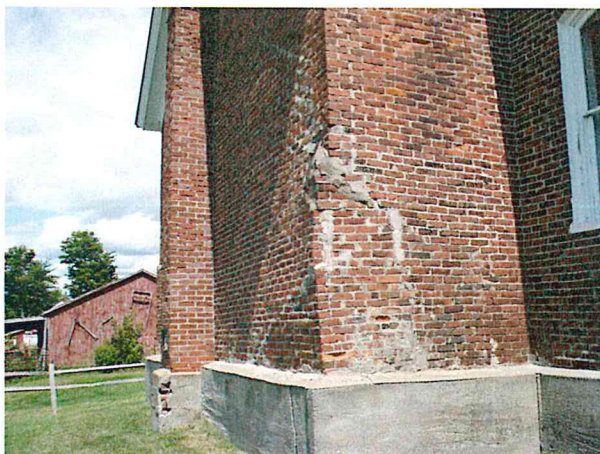
View of Brick Veneer in Poor Condition

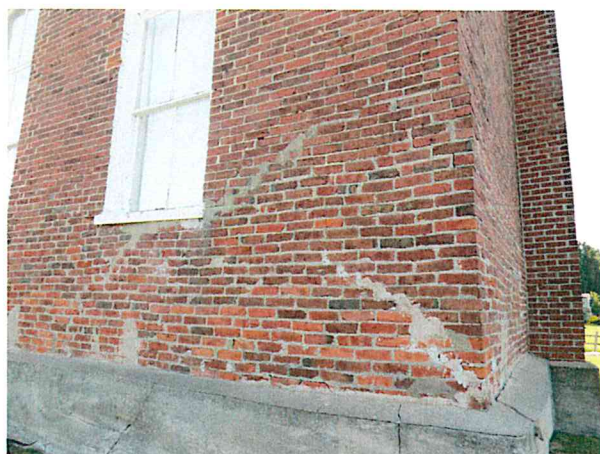
View of Brick Veneer in Poor Condition

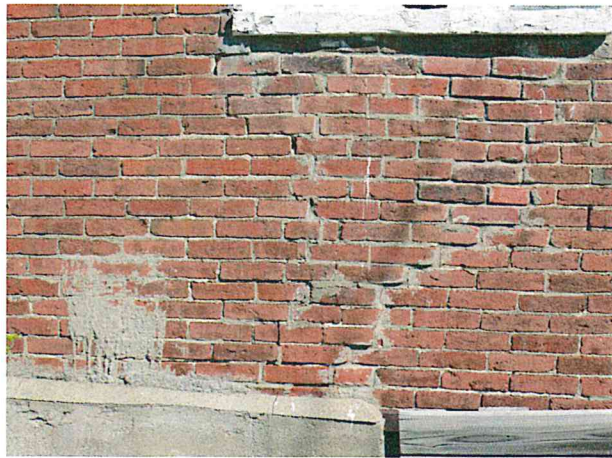
View of Brick Veneer in Poor Condition

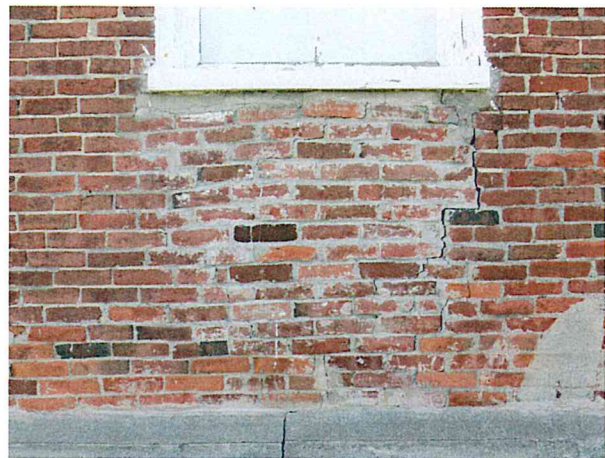
View of Brick Veneer in Poor Condition

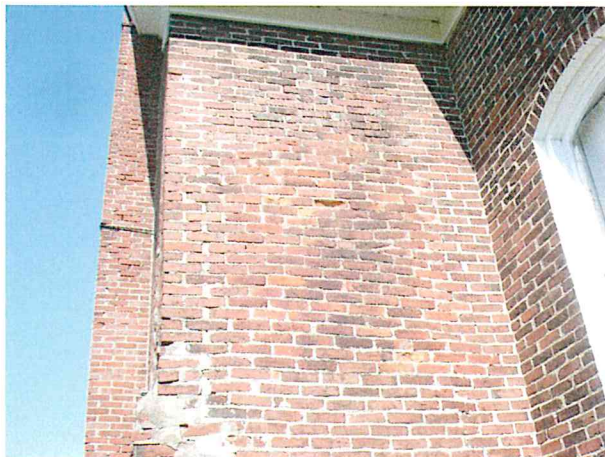
View of Brick Infill at Former Opening

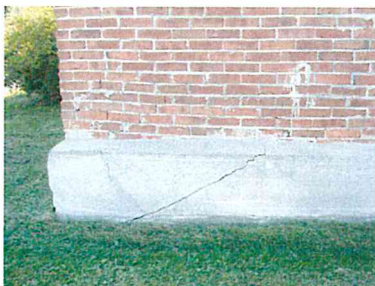
View of Existing Concrete Facing

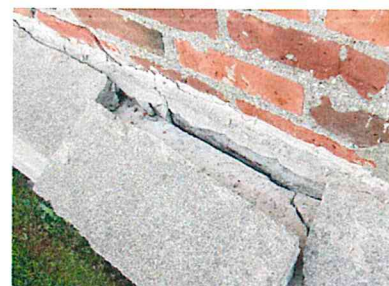
View of Sloped Top Concrete Facing

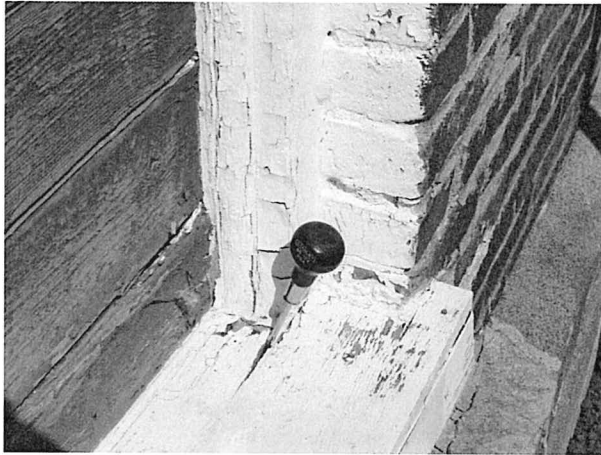
View of Failed Joint at Sill

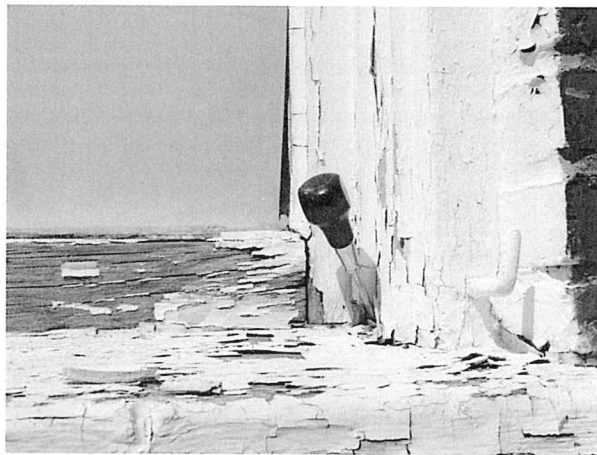
View of Failed Joint Where Sill Meets Window Frame

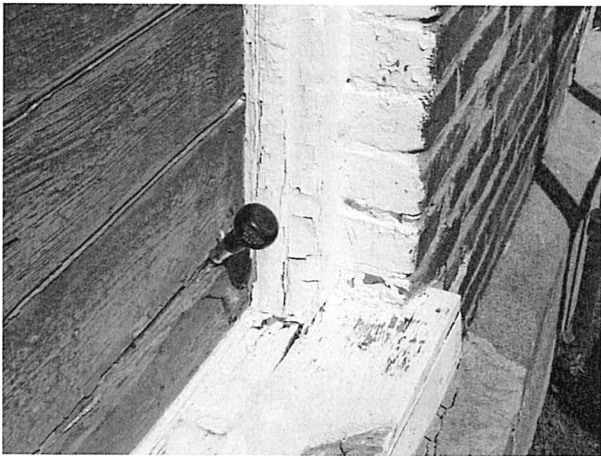
View of Failed Joint at Infill Siding

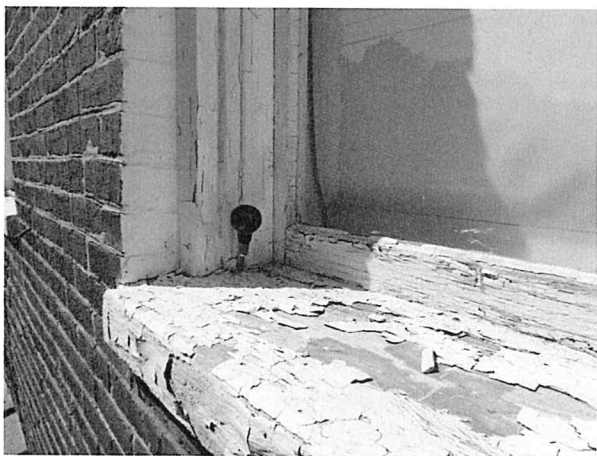
View Existing Sill that has rotted at Window Frame

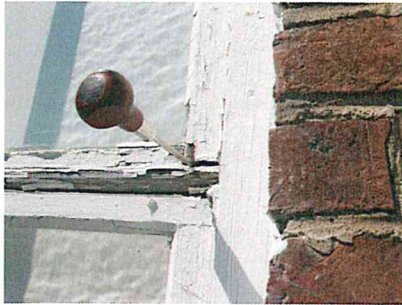
View of Failed Window Joint

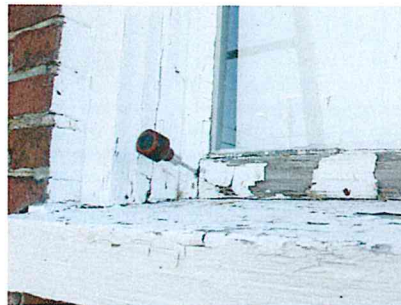
View of Failed Window Joint

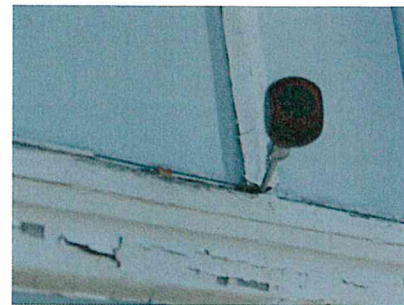
View of Failed Joint at Muntin Bar

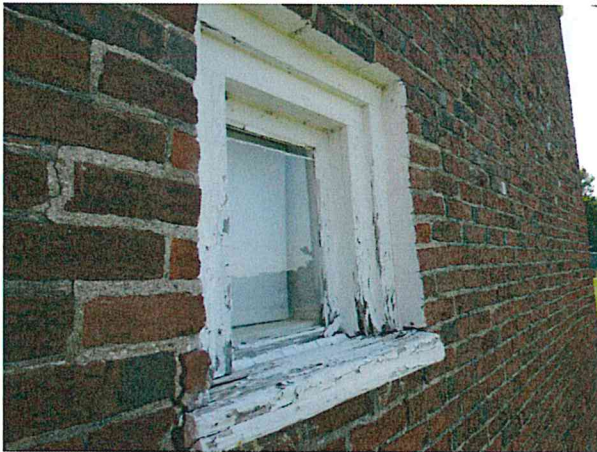
View of Existing Window to be Replaced

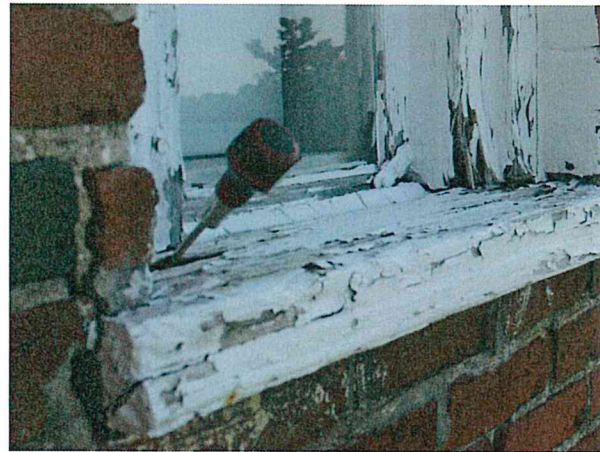
Close up View of Damaged Window to be replaced

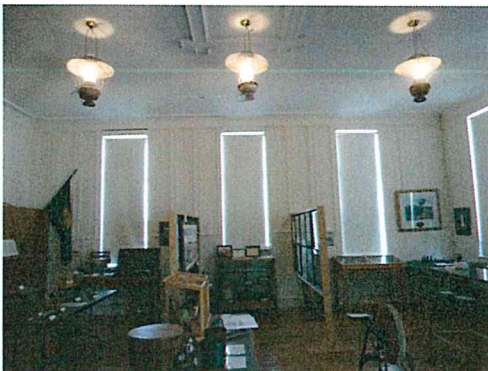
View of Former Classroom

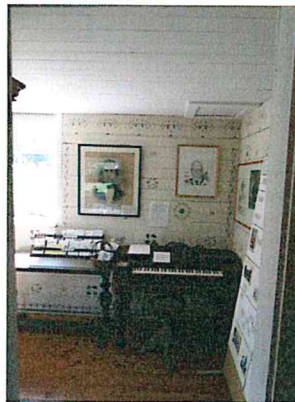
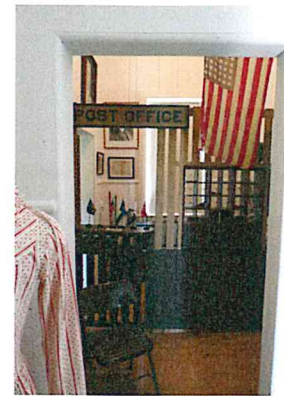
View of Other Interior Spaces
