September 4, 2016

**The Holland Historical Society**

**Holland, Vermont**

**A Preservation Trust of Vermont  
Technical Assistance Survey**

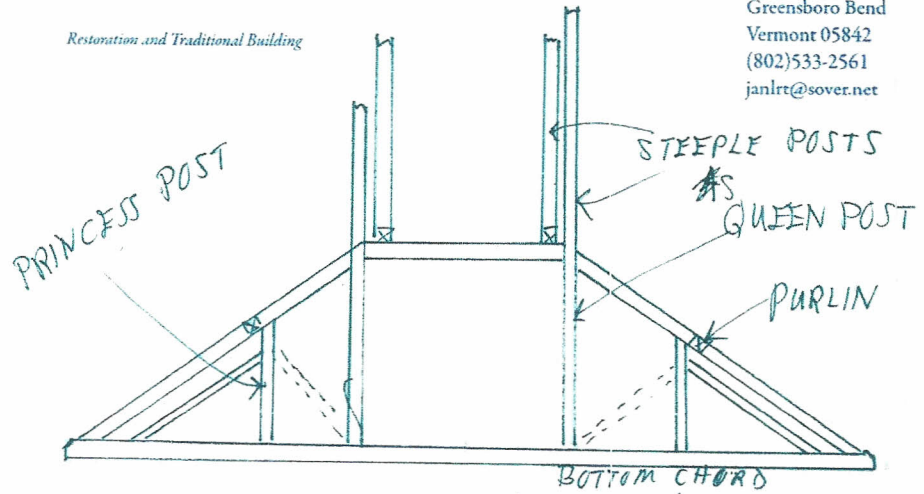
Queen Post at Steeple

- 2. Framing:** The floor framing appears very good. The wall framing is concealed. The roof frame suffered extensive leakage in the past but damage was restricted largely to the boarding, some of which has been replaced. The exception is the southwest corner of the roof frame, below the steeple, where water and impact have caused 2 broken small rafters, one missing diagonal brace, and some rot to the purlin. When roofing work is done this section should be opened, the 8x9 purlin replaced if necessary and new, larger common rafters, such as 4 x 6 with the 6 inches tall, installed, as well as inserting a diagonal brace where one is missing, perhaps by cutting a lap for one end or using a free tenon on one end of the brace.

Another action to strengthen the roof frame around the steeple would be to add braces running from the bottom chord near the queenposts to a point near the top of the princess posts (see Fig. 1). These original princess posts were meant to work supporting the principal rafters and holding up the bottom chord, but due to a design error, the lack of this second brace, they are mostly dead weight.
