Pawlet Town Hall Ceiling Restoration Assessment

9/13/16

S·A·fishburn inc.

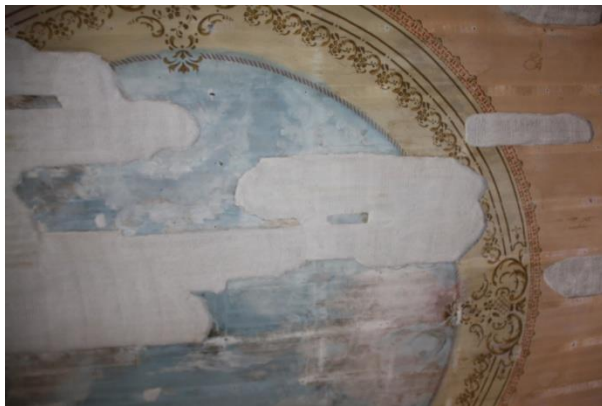
After re-attaching the plaster to the lath and removing the furring strips Mike applied a scratch coat of plaster in all areas of missing plaster. It appears that he also filled some of the nail holes where there was damage but not tight nail holes. The estimate that Mike submitted indicates that the scratch coat is a lime based plaster. The coat looked sufficiently “scratched” to create a good mechanical bond with subsequent layers of plaster. Prior to starting

In the process of re-adhering plaster to lath it can either be pushed tight to the lath while the adhesive cures or be left as is and the space between the plaster and lath filled with adhesives. It appears that in this instance the plaster was left as is and the space filled with adhesives. This impacts filling the voids (areas where there was plaster loss) in that the depth of the voids are inconsistent with some areas requiring a brown coat and finish coat while others only have enough depth for a finish coat.

work the type of plaster used for the scratch coat should be confirmed in order to guide the choice for the remaining plaster composition.

Given that the patching plaster is wet when applied great care will need to be taken when filling the plaster voids in order to limit damage to the decorative painted finishes. The finish plaster surface in the voids will need to be kept just below the finish ceiling level in order to conserve the painted finishes. The patching plaster will have to be applied carefully within the edges of the voids. Any water and plaster that gets onto the distemper paint will wash it away. The slightly recessed patched areas will provide a clear demarcation between original plaster and restored plaster.

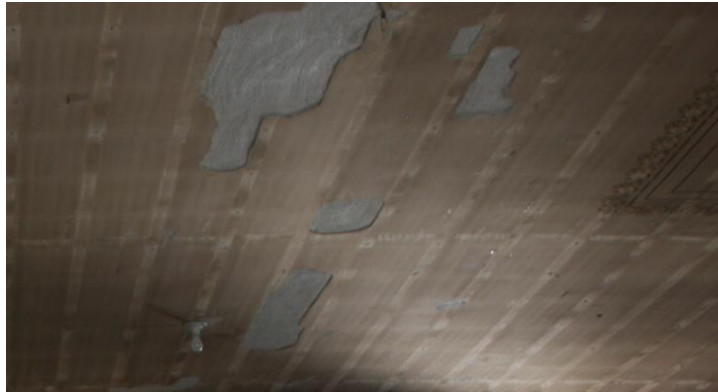
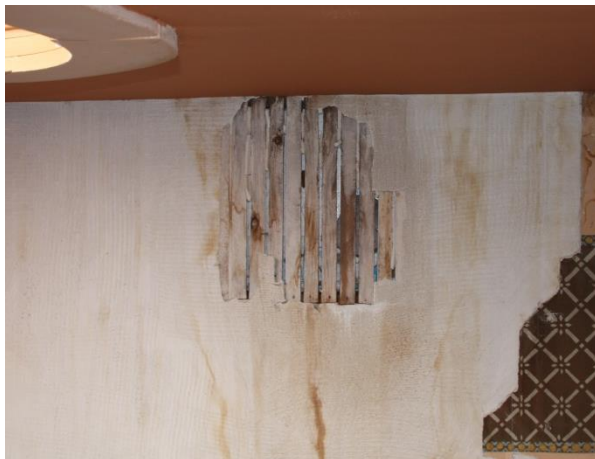
There are two areas where roof leaks damaged the ceiling after Mike completed his work. Some of the scratch coat plaster over a window on the front elevation failed as a result of the water damage. There appears to be some hard board insulation that was installed above the lathe where the plaster failed. This is not consistent with the ceiling re-insulation work as the insulation was blown-in cellulose. It is suspected that a piece of foil-faced hard board insulation was installed during the repair of the roof leak. It

may impact the replacement of the scratch coat if it is laid tight to the back of the lathe. It will minimize the ability to push the plaster through the gaps in the lathe which is necessary to create the keys.

The scratch coat in the affected area over the emergency exit door is still in place but will have to be inspected for structural stability before applying plaster over it. If it is found to be unstable it will need to be removed and a new scratch coat applied. The surrounding plaster at both leak sites will need to be assessed for structural stability and removed or re-attached if found failing. The roof has been repaired so that it no longer leaks.

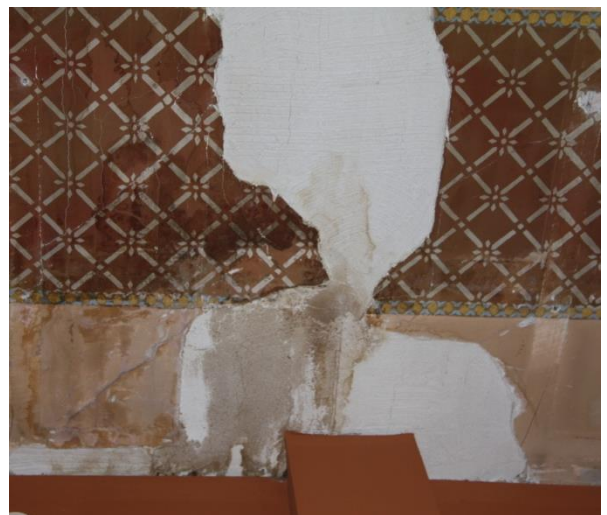
There is a gap along the edges of the ceiling where the blue board on the walls meets the ceiling. That gap varies from ¼” to up to 1” or more. While finishing the plaster repairs to the ceiling this gap at the juncture of the walls to ceiling should be filled flush with the blue board. When the blue board is skim coated the skim coat can run right to the ceiling. For smaller gaps plaster may be all that is required to fill the space but in the largest gaps either a backer material or metal lathe may be required to bridge the space and limit the amount of plaster required to fill the void.

Once the voids have been filled with the appropriate plaster matching the existing plaster the ceiling will be ready for the preservation and restoration of the decorative finishes. If the patching plaster is lime-base the plaster will need to cure for 60 days at a minimum of 50 degrees Fahrenheit prior to painting.

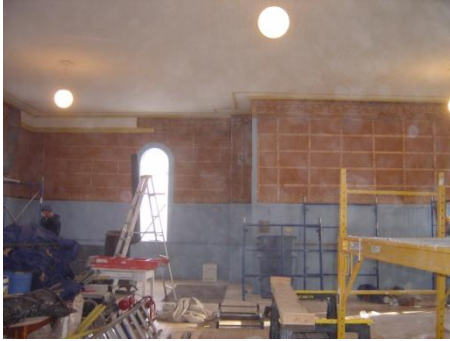
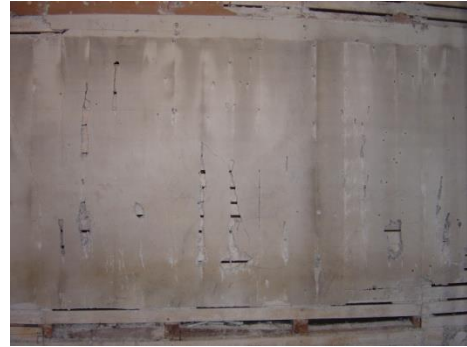
The walls were sheathed with blueboard with the expectation that they would be finished with skim coat (or veneer) plaster. The seams were quickly taped

and mudded. It is believed that the seams were sealed with paper tape but unknown whether light weight joint compound or a Durabond setting type joint compound was used. The specifications for blueboard include sealing the joints with paper tape and Durabond setting type joint compound. The paper tape has a much higher sheer strength and generally will not stretch when the building is stressed where fiberglass mesh tape will creating cracks at the seams. Durabond setting type joint compound, once set, will not soften up in the presence of water where light weight joint compound will making Durabond a better match for skim coat work. The seams were simply taped and mudded but they were not leveled out with multiple layers of joint compound for a flush finish.

In either case the walls were primed with a dark orange primer when it was realized that the skim coat work was not in the budget. Blueboard is manufactured specifically to receive skim coat plaster. The paper on the board is several layers thick to withstand the water present in the plaster when applied and the paper has chemicals in it that create a mechanical bond with the gypsum based skim coat plasters. The paint on the board has effectively sealed the face of the blue board prohibiting a mechanical bond between the plaster and the face of the board.

Blue board with skim coat plaster was specified in the restoration to recreate as close as possible the hard, smooth finish of a traditionally plastered wall. In order to skim coat over the painted surface a plaster bonding adhesive (PBA) will have to be applied to the wall surface creating a bond between the paint and the plaster. The strength of the plaster to wall bond will be completely dependent upon the strength of the paint to the blue board. Before any skim coat is applied two tests should be completed. The first will be to test the bond between the paint and the blueboard. A series of lines should be cut into the paint creating a small ¼” grid. Apply a piece of Gorilla tape to the paint and remove it. If there is failure it needs to be between the paper and core of the blueboard rather than between the paint and the paper face of the board. If the paint peels off leaving the paper surface intact the painted surface will not be suitable for plastering over.

It might be prudent to then conduct a small plaster test area and repeat the above test with the plaster/paint/board combination. Again if there is failure and it occurs between the paper surface and plaster core of the blueboard skim coating the walls using a PBA is a viable option.

If skim coat plastering the walls is not a viable option they could be skimmed over with light weight joint compound creating a smoother surface than the paper finish of the board but not the hard polished surface of skim coat plaster.

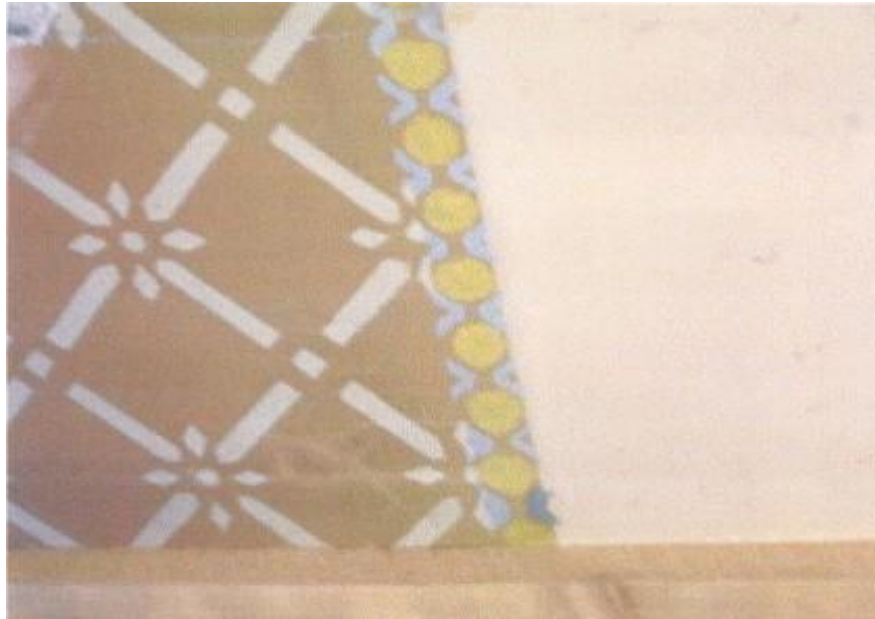
1880's stencil pattern with later terminating border pattern with blue color of border over top (in part) of peach color

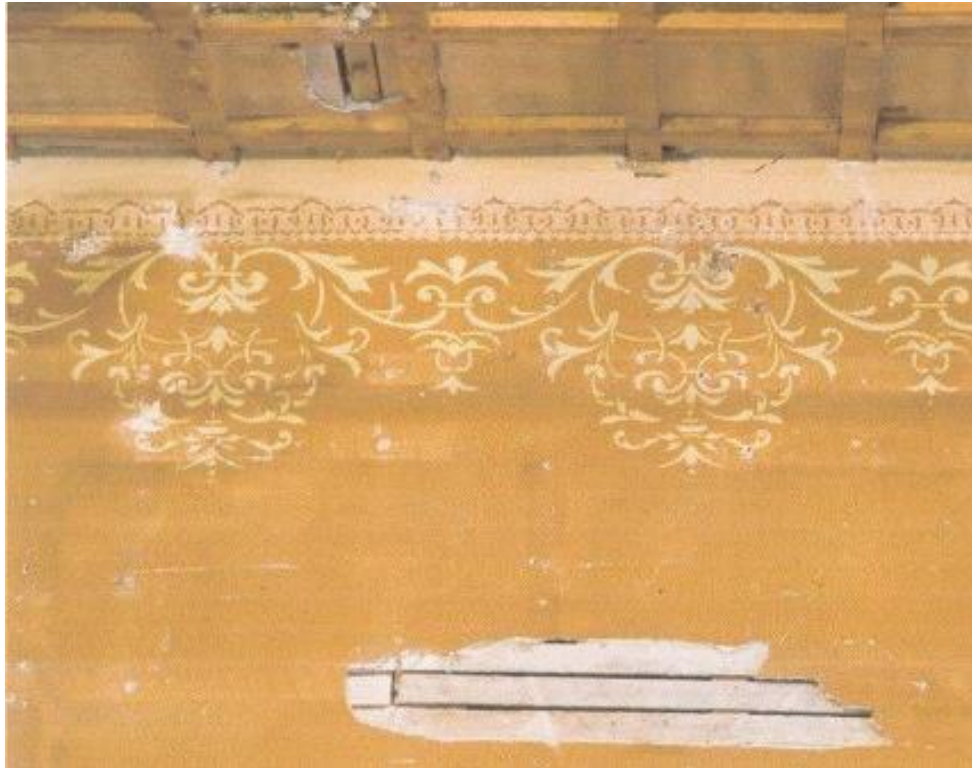
Crown Stencil — cream on burnt orange color

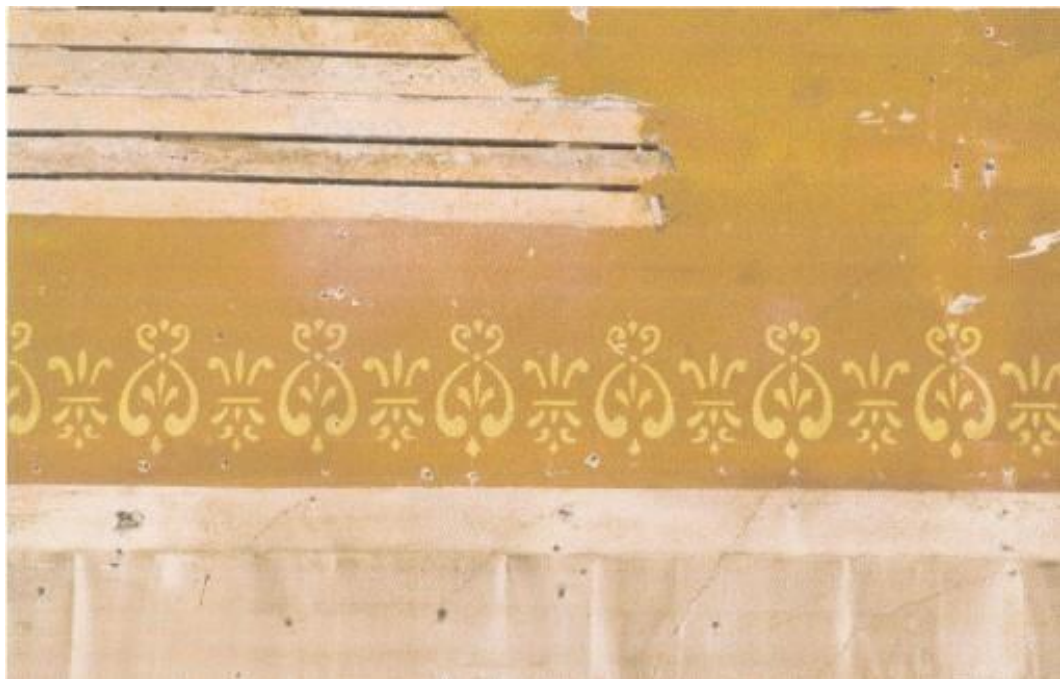
Waist stencil or stencil above dado

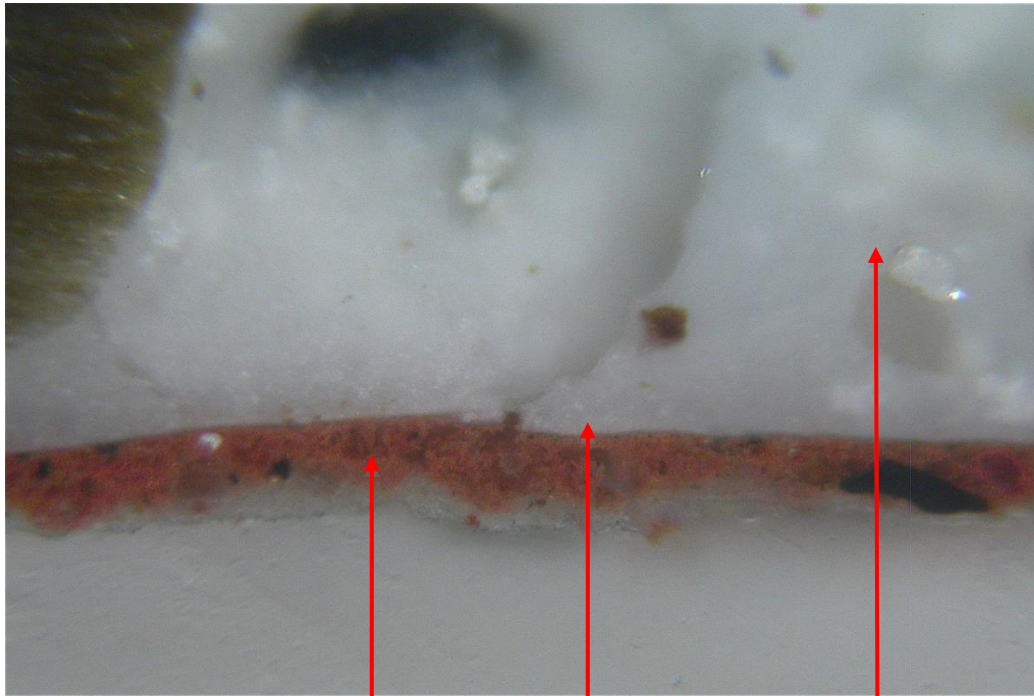
Photomicrograph of sample PTH-200-1. Red ground with off-white lattice stencil

Red ground – There was no reaction to Sodium sulfide (Na₂S) indicating there was no lead present. It was a water-soluble finish that had an even, thin application but appeared to have a very high pigment to vehicle ratio. The coating was very fragile with poor adhesion, demonstrated by easy removal with gently rolling a cleaning sponge, cotton swap, or gently brushing with a bristle, chip brush. The coating had a matte finish.

Off-white stenciled pattern – The stencil appeared to have a slight pinkish coloration. There was no reaction to Sodium sulfide (Na₂S) indicating there was no lead present. It was a water-soluble finish, thicker than the red ground coating with uneven thickness and evidence of bubbles. This coating was less fragile than the red coating, although gently brushing in certain areas resulted in pulling the underlying red coating away along with the off-white stencil coating.

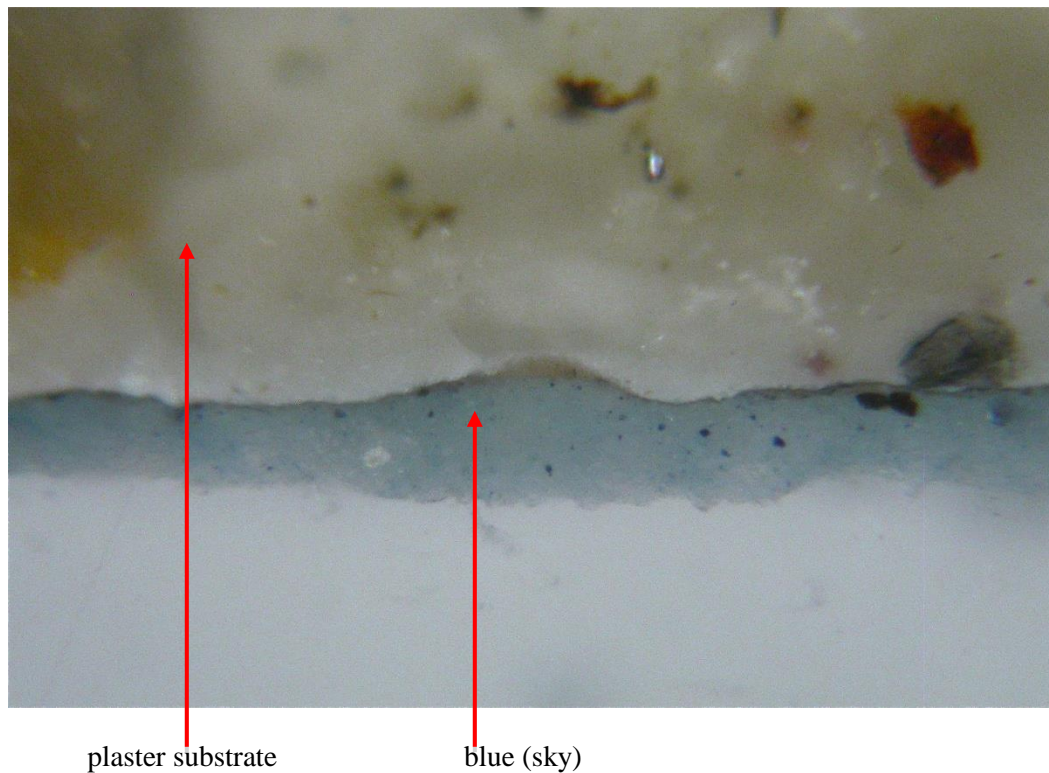
Photomicrograph of sample PTH-200-2 with blue sky

Blue - There was no reaction to Sodium sulfide (Na₂S) indicating there was no lead present. It was a water-soluble finish that appeared to have been applied free hand. The coating was fragile and easily removed by gently rolling a cleaning sponge. Brushing with a bristle, chip brush also left brush marks. The coating was thin and had a matte finish.

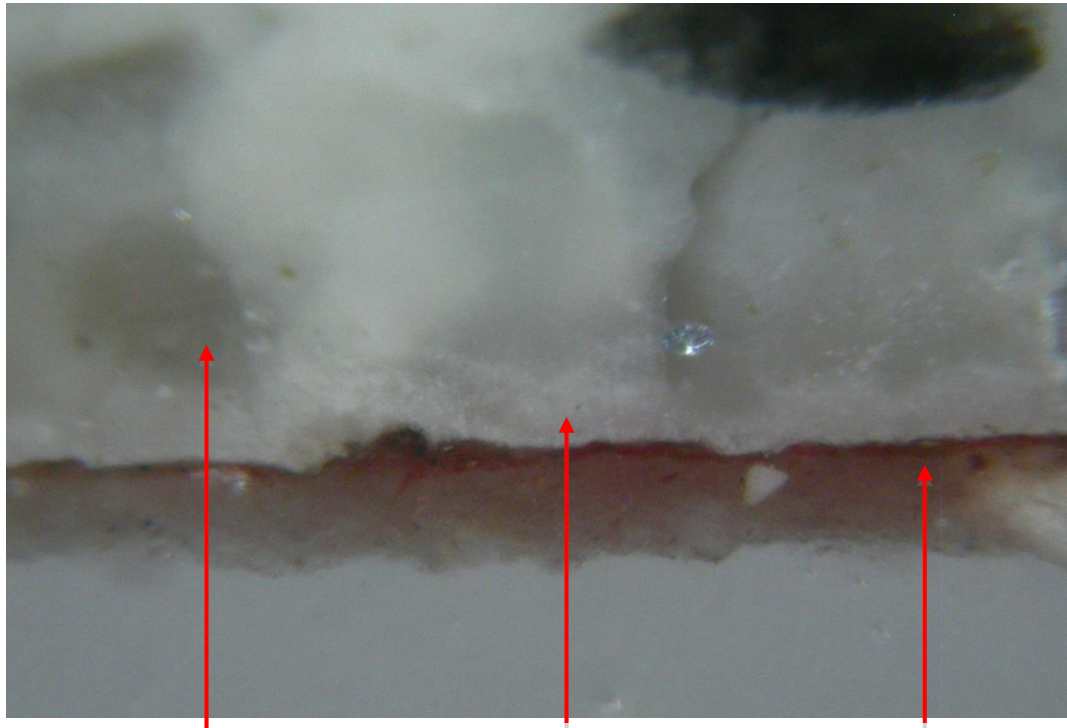
Photomicrograph of sample PTH-200-2 with red stencil pattern

Red stenciled border pattern - There was no reaction to Sodium sulfide (Na₂S) indicating there was no lead present. It was a water-soluble finish with a thick application consistent with stenciled application, although the coating was fragile, with even gentle brushing removing material and leaving brush marks.

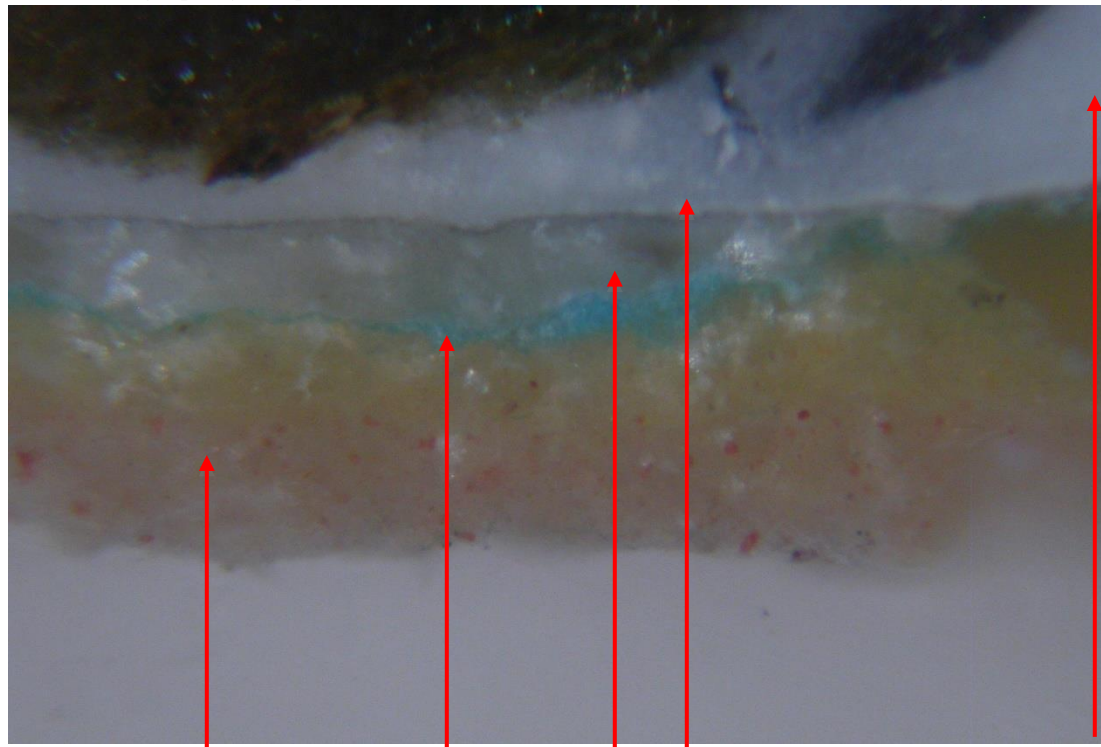
Photomicrograph of sample PTH-200-3. Peach colored ground with underlying layers.

Microscopic examination of the sample revealed additional coatings or remnants of coatings under the peach ground (see photomicrograph below) suggesting a possible earlier finish campaign. A yellow ocher ground coating (with more yellow and less red than the peach ground) was directly under the peach coating but stopped just short of the brown red ground of the border stencil. Under this yellow ocher were remnants of blue and white.
