Douglas G. Hayward Masterslater & Coppersmith Inc.

Contract for Services

PROJECT DESCRIPTION

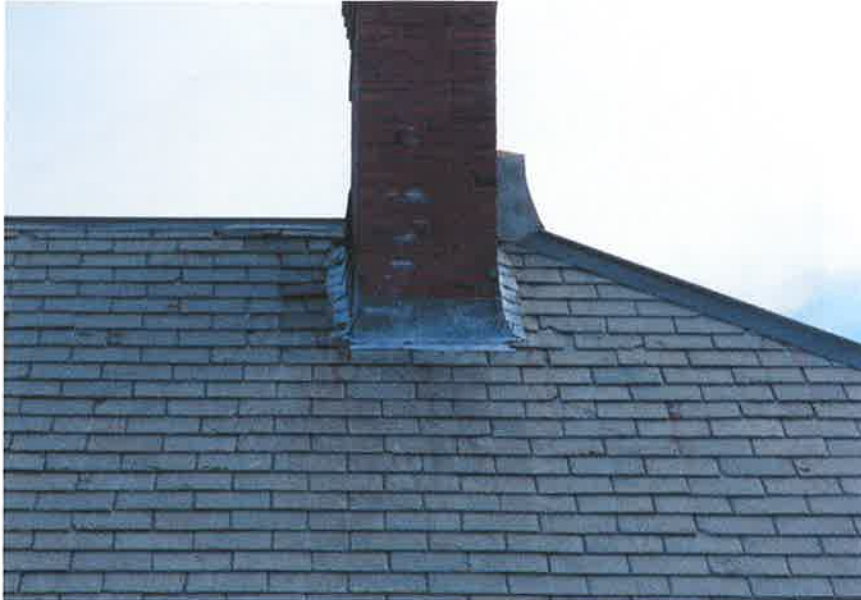
The chimney seen in this photo is incorrectly flashed and the pan above the chimney is a rotted piece of steel. There isn't any flashing in the roof and the chimney leaks.

The lead looks to be in good condition and I believe it can be reused.

The slates will need to be removed around both chimneys to allow the decking to be repaired, replaced. With the decking repaired the surface will be sealed with Grace Ice & Water Shield. The new slates and flashing will be installed to finish the repairs. If the lead needs to be replaced for whatever reason it will not be covered under this contract and will have an additional cost. There will be no brick repairs under this contract. If there are any repairs needed there will be an additional cost.

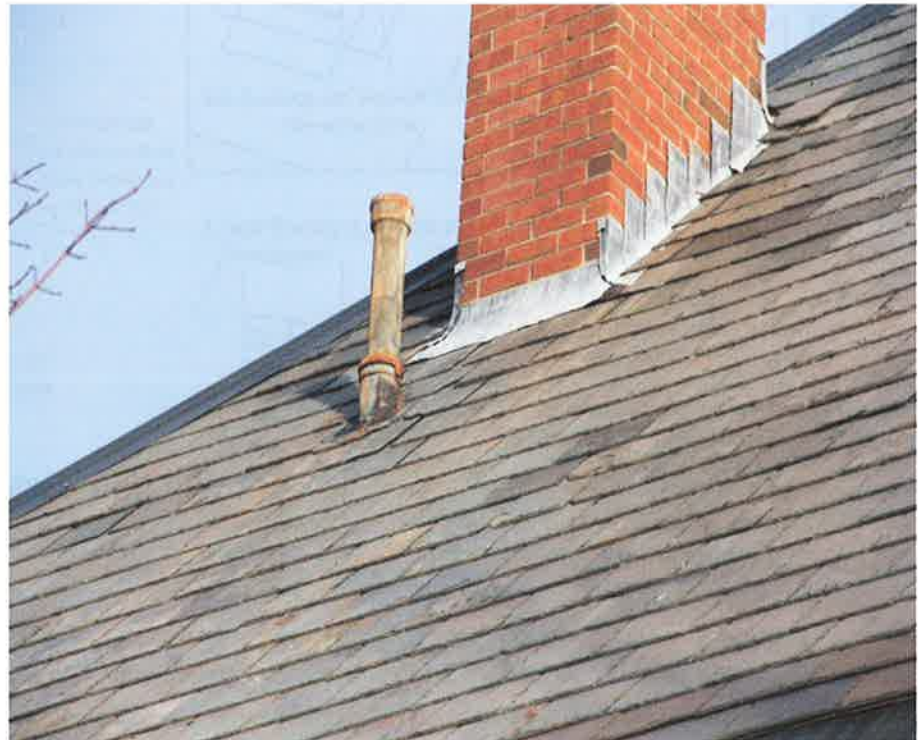
The chimney in this photo also has a small cricket above it that is all rotted and needs to be replaced. The lead was woven into the slates, this is incorrect. There isn't any flashing in the roof. The lead is in good condition.

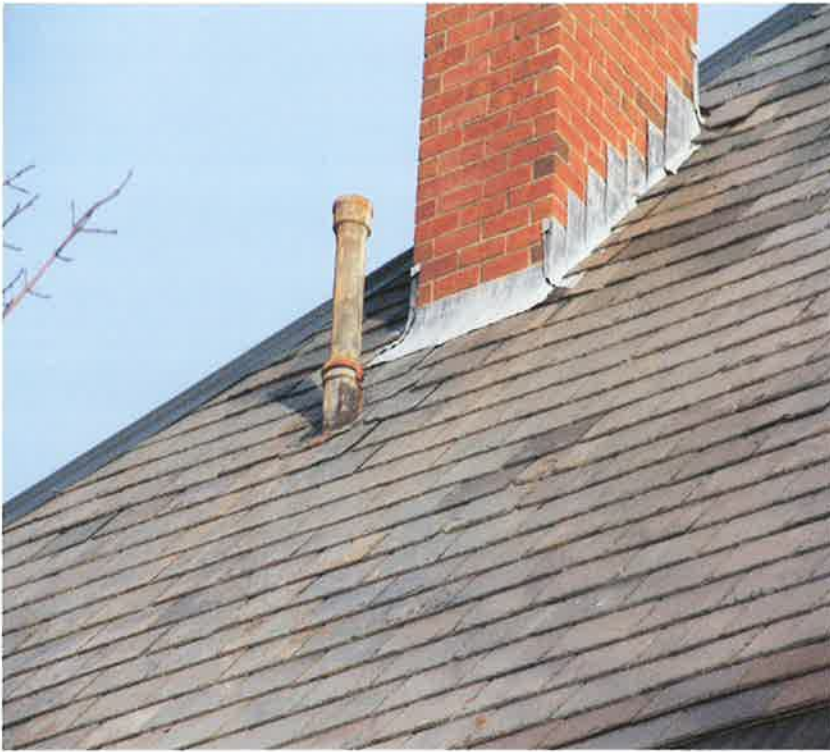
The vent pipe in the photo has an old lead boot on it that has been covered in tar and still leaks.

I will remove the lead boot and install a copper stack to cover the pipe and stop the leak.
