**First Congregational Church**

**Inspection Report**

October 30, 2105  
First Congregational Church  
School Street,  
Shoreham, Vermont

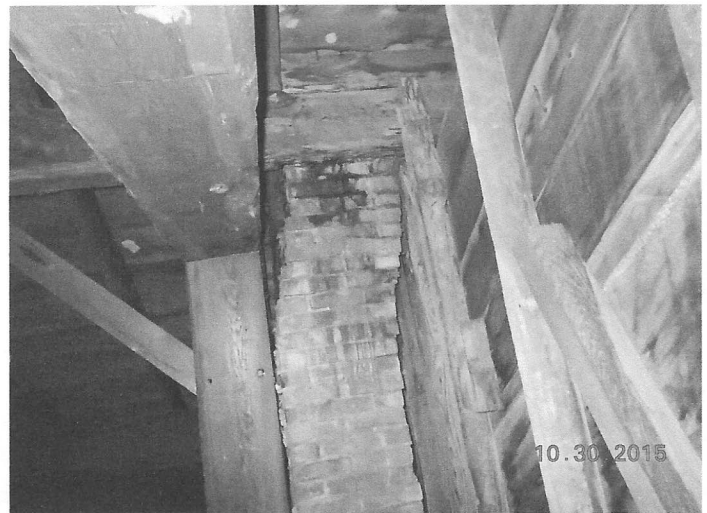
The chimney flashing on the southwest chimney has been damaged and needs replacement or repair. The attic portion of the chimney shows water and creosote stains as is shown in the image to the right.

Attic conditions: I inspected all of the attic that I could safely access. The undersides of the roof sheathing boards were all dry and showed no signs of chronic leaking or decay except for minor decay and staining near the southwest chimney.

The mortar joints at the top of the southwest chimney are due for repointing as are areas of the east basement wall. (Most of the basement walls are not visible.) The chimney flashing should be repaired at the same time.

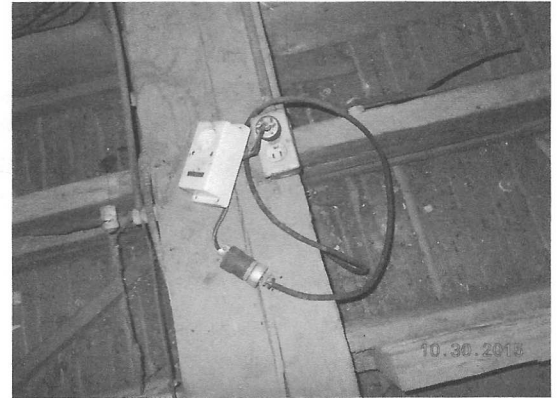
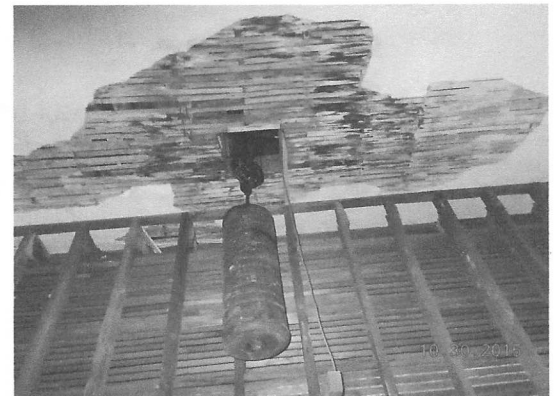
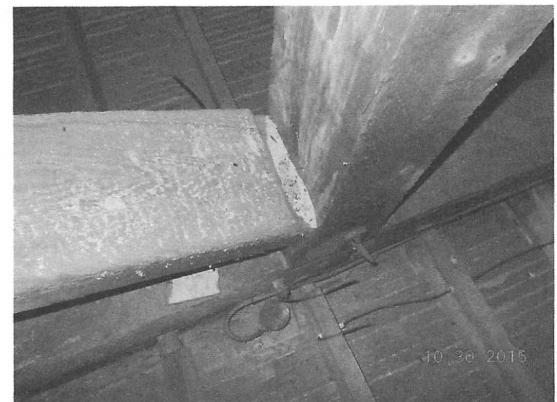
There was some frass, the debris left by wood-eating insects such as carpenter ants or powder post beetles, in a few areas, but I did not see any current activity. So there is no way to be sure when in the past the frass was deposited. I suggest cleaning up the debris where found and monitoring the area annually for insect activity. If activity is located in the future, the area could be treated with a borate solution which will both has both insecticidal and fungicidal properties. Another option would be do consult an exterminator.

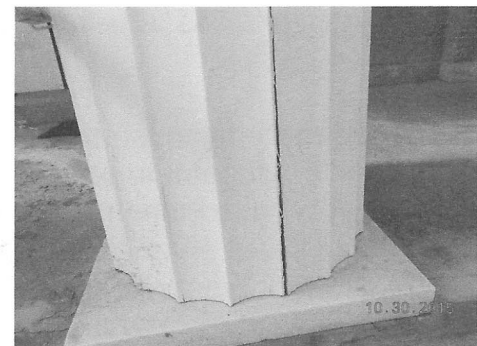
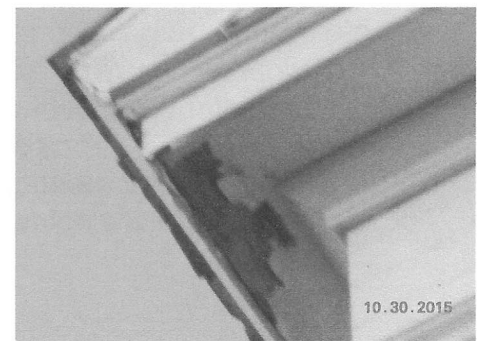
The cracks in the entry columns should be repaired and caulked.

There is a damaged area of eaves at the northwest corner of the roof.

All four of the above maintenance or repair items could be mostly effectively and safely accomplished with the use of a lift. Areas not currently visible from the ground such as the north roof, base of the clock tower and the northwest chimney should be inspected as well when a lift is available.
