Re: Property Condition Assessment
Tri Park Cooperative
Brattleboro, VT

Property Condition Report

Ms. Nancy Brosz
President
Tri Park Cooperative
Brattleboro, VT

September 15, 2014

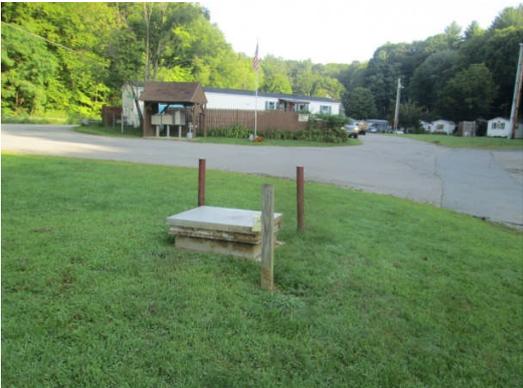
Water meter pit

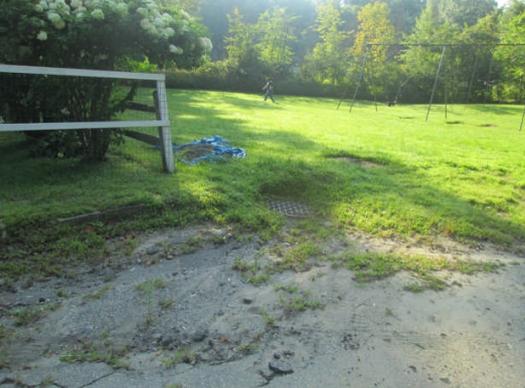
The south side catch basin and associated drainage pit often gets full following rain events and backs up into the street within the cul-de-sac. A new larger capacity drainage pit or leach field is recommended for this catch basin.

area of catch basins, cul-de-sac

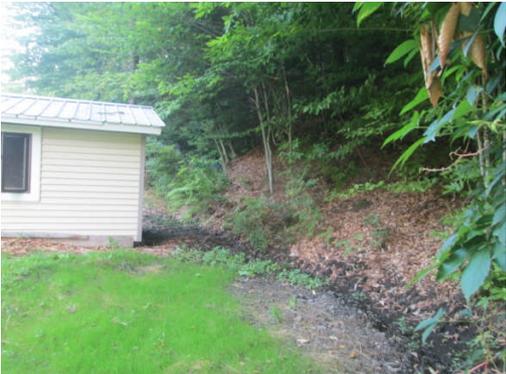
The drainage swale at the Eastern side of the property at the bottom of the hill has an improperly sized drainpipe leading into the wetlands area. The drainpipe often gets clogged with silt and dirt and cannot accommodate large amounts of water. The drainage swale is an earth swale and is overgrown with vegetation. A larger diameter drainage pipe is recommended for stormwater swale drainage discharge. We also recommend maintaining drainage swale to prevent water backups at the south Eastern side of the property. Table 3-3 illustrates the storm water drainage system within Tri Park.

Drainage swale base of hill

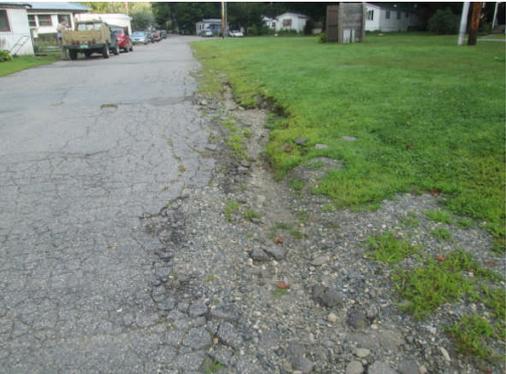
Storm water drainage for Black Mountain is generally fair to poor. Storm water from Road drainage fails to properly be directed to the South Eastern section of the property. The improper road drainage is causing deterioration of the road surface. Improved and new subsurface drainage with approximately 4-5 catch basins and subsurface drainage is recommended at the middle section of the property following eventual sewer system replacement and road paving. A site engineer is recommended for proper design and locations.

improper road drainage, wash out 1

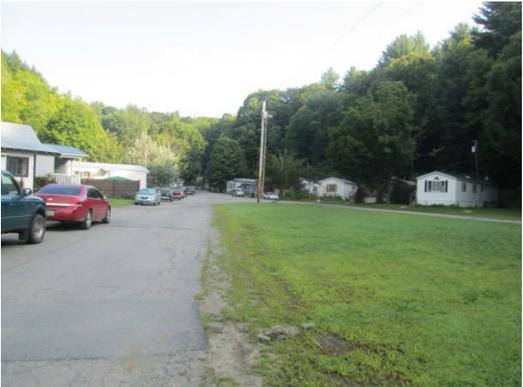
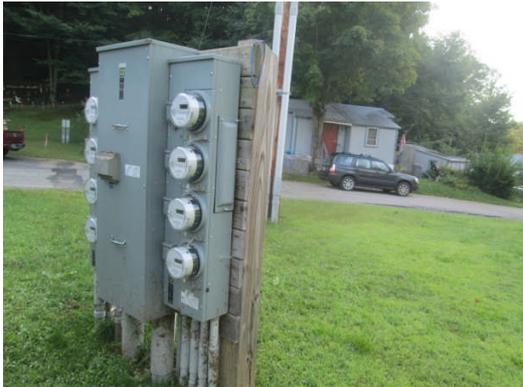
Updated electric

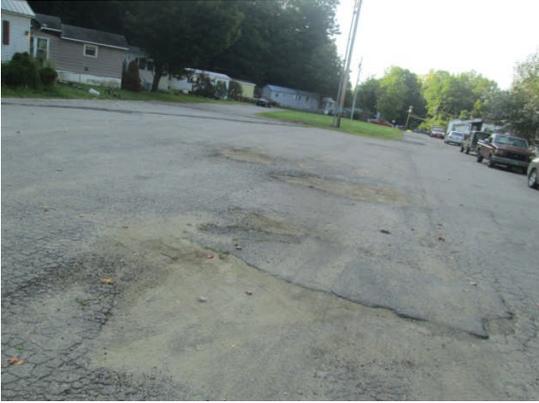
Deteriorated road surface

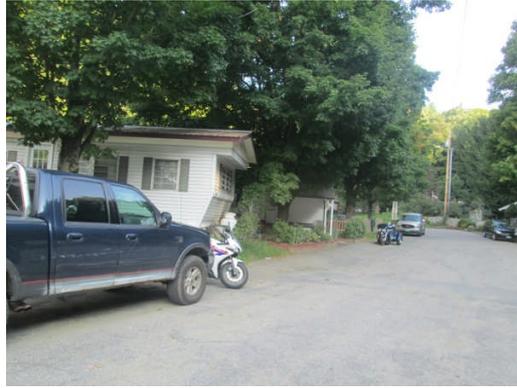
overhanging trees

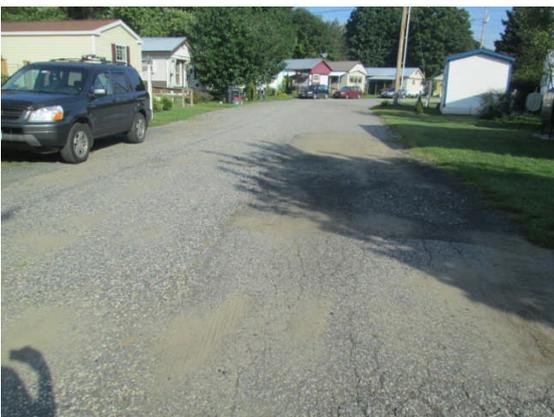
The overall condition of the roads within the Glen Park community is fair compared to similar properties inspected by our firm. Asphalt surfaces of the roads have moderate to significant cracking and deterioration. Several potholes and repairs were observed in the roads. Most roads observed have proper crowns and grading with adequate sub base.

Deteriorated asphalt

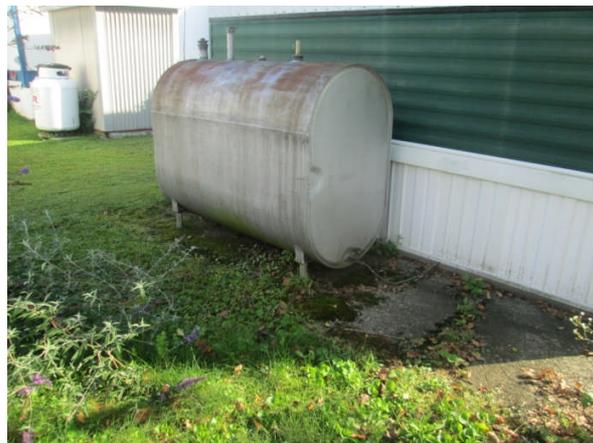
Oil tanks observed in Glen Park and Black Mountain were generally in fair condition. Some moderate corrosion was observed on tanks and several tanks were not properly supported on pads.

corrosion on tank, fair condition

All oil tanks on the property should be evaluated by an oil supply technician and environmental professional with any necessary repairs or replacement as needed to reduce the potential for any future leaks and contamination. The Tri Park should implement periodic inspections of all oil storage tanks. Further evaluation of any previous environmental conditions should be further evaluated by a qualified environmental professional for the entire property.

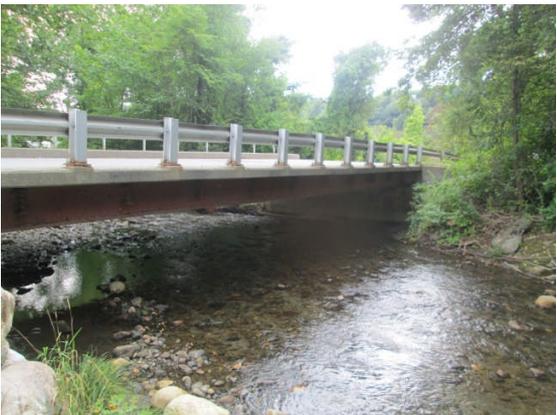
Halladay Brook Bridge

Our inspection of the bridge #1 indicated structural steel beams and abutments generally in good condition. We observed several minor potholes on the bridge deck which should be repaired. We also observed the hand rail on the sidewalk of the bridge to be too short, bent and damaged, and openings too wide, especially for children. We recommend the bridge deck potholes be repaired and repair sidewalk handrail.

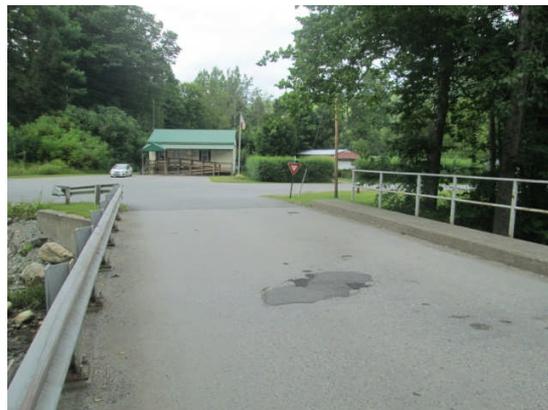
Whetstone Brook Bridge

Our inspection of bridge #2 indicated significant surface corrosion to steel beams and improperly sized fascia beams. The lack of pedestrian sidewalk is also a safety hazard. Since the report recommended replacement within a few years, approximately five years ago, we recommend replacement of this bridge within the next 2 to 3 years.

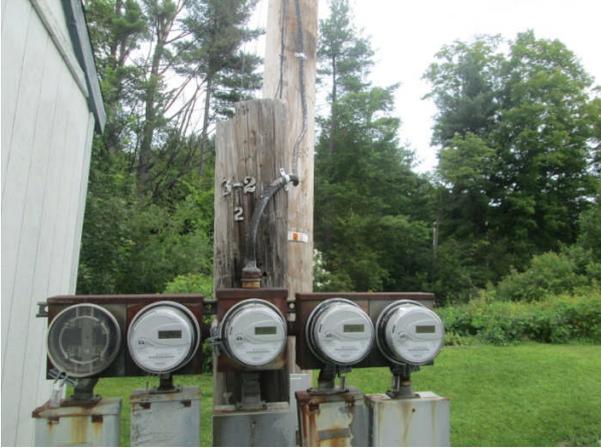
The overall condition of the electric service in the Mountain Home park is fair. However, numerous safety hazards associated with exposed wires, frayed wires, improperly secured and supported panels, inadequate service, and antiquated equipment are present. Approximately 70% of the electric service has been updated and in good condition and the remainder in poor condition with approx. 82 electric services in poor condition. It is our understanding Green Mountain power does not allow Tri Park to repair service wires and meter panels which are connected to utility poles. Complete updated service is required by the power company with meter bank electrical panels with underground lateral services from the polls to the meter panels if repairs or replacement are needed. An electrical meter assessment report from Tri Park for Mountain Home was also reviewed to determine service conditions. Table 3-4 illustrates all poorly rated electrical disconnect meter panels and shutoffs within the Mountain Home community. These listed electrical services are in poor condition with antiquated equipment and potential safety hazards. The listed equipment is typically at the end of its useful life and updated services are recommended soon.

Antiquated electrical

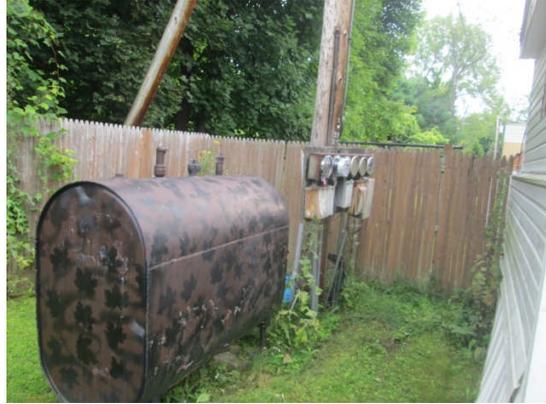
marginal corrosion on tank

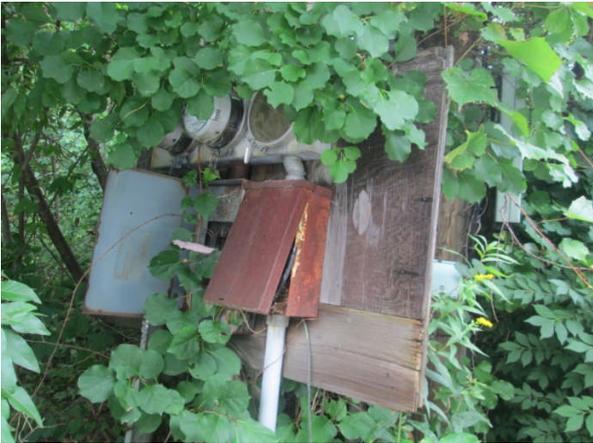
Unsafe electrical

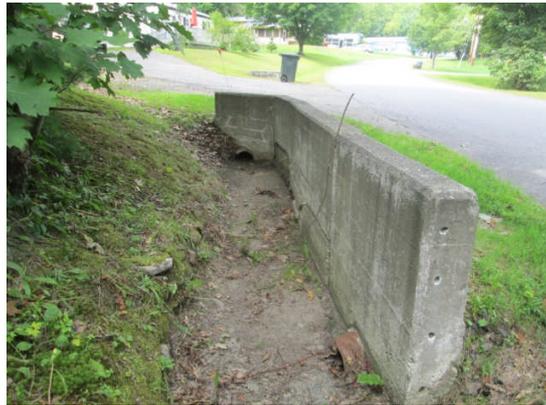
Numerous catch basins observed along with numerous drainage pipes and drainage swales had excessive silt, dirt, and debris buildup. Deferred maintenance with cleaning catch basins and drainage pipes was observed. This dirt buildup within drainage pipes results in overflowed pipes, puddling, and standing water following or during heavy rain events. We highly recommend cleaning all catch basins and all drainage pipes throughout the entire property to improve storm water drainage. Catch basins and drainage pipes should be kept free and clear and maintained for proper storm water collection and discharge.

blocked drainage pipe

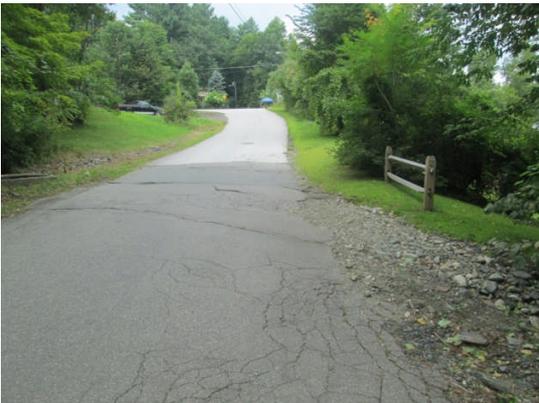
The overall condition of storm water drainage within the Mountain Home Property is fair. Several areas of improper drainage were identified within the property. However, one moderate to significant area of improper drainage is located near the North Central sections of Valley Road, north in the area of reservoir road, and northern area of Windward Drive. We understand this area near Valley Road can become troublesome following heavy rain events. Improper drainage is a result of steep slopes, inadequate pipe sizes and discharge areas of drainage from areas west and north of Windward Drive. Drainage improvements are recommended on Windward Drive and Reservoir Road to improve drainage conditions. Several catch basin structures on Windward Road are recommended along with chimney structures for elevation changes between Winwood Road and reservoir road, and between reservoir road and Valley Road. Drainage pipe is recommended to direct water to the eastern side wetlands and brook. A site contractor/engineer is recommended for design and construction of the system.

Areas of improper drainage
