**Tyler Bridge Road Culvert**

**TH#9**

## **Existing Condition of Culvert**

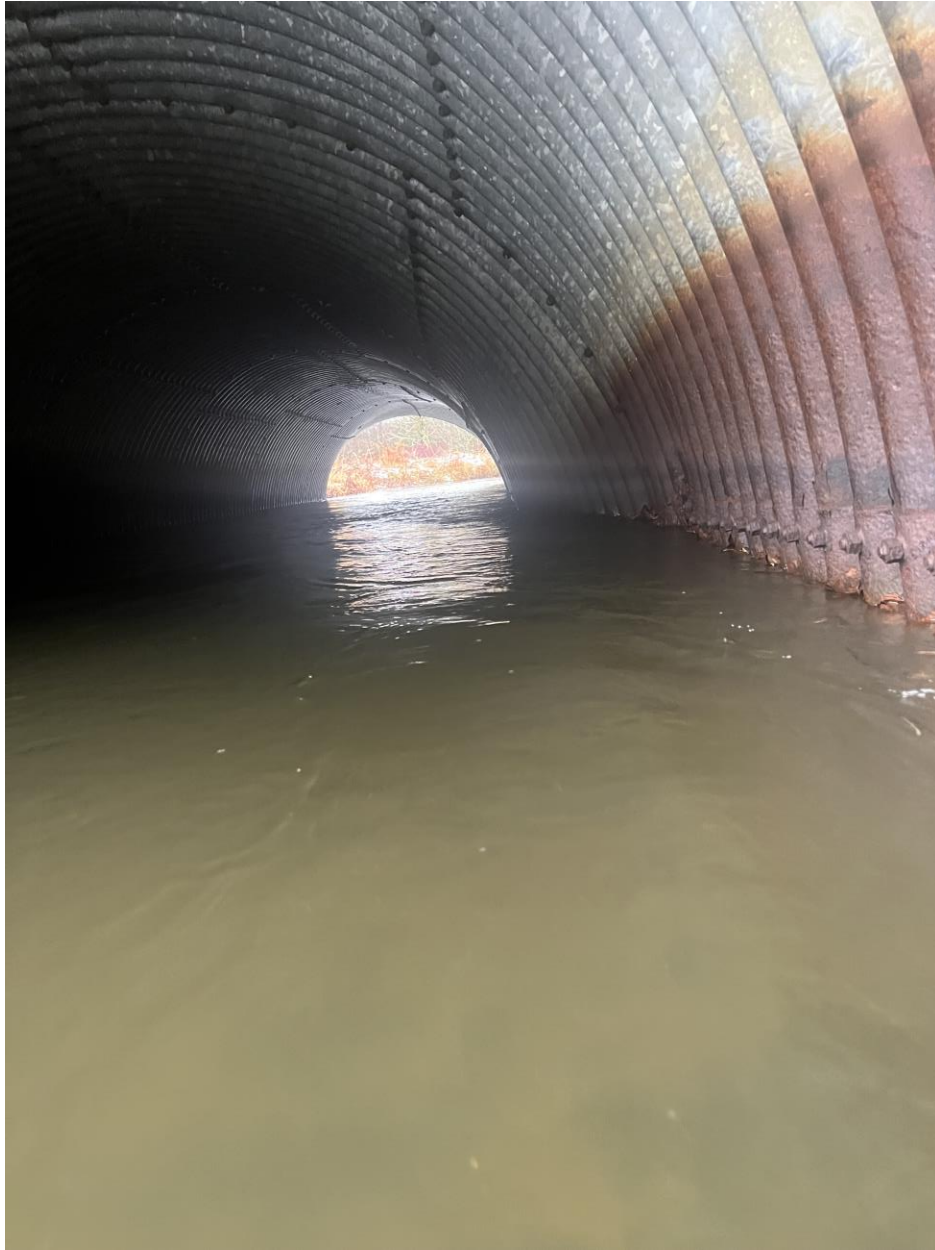
The Tyler Bridge Road (TH#9) culvert, located roughly 1500 feet north of States' Prison Hollow Road intersection's condition is poor, as you can see from Photo #1. The culvert has severe abrasion along the sides, specifically the north side, appoxamently thirty feet in, where the culvert is not physically connected part way through. The bottom half seems to have squished out further than the top half, creating a void in this span of the culvert. The culvert span is roughly seventy feet long. After work that the town had performed, there still creates a minor void at the inlet of the pipe, off the shoulder out of travel portions which is maintainable and safe.

(1) Photo shows the collapsed version of pipe on the inside from the inlet.

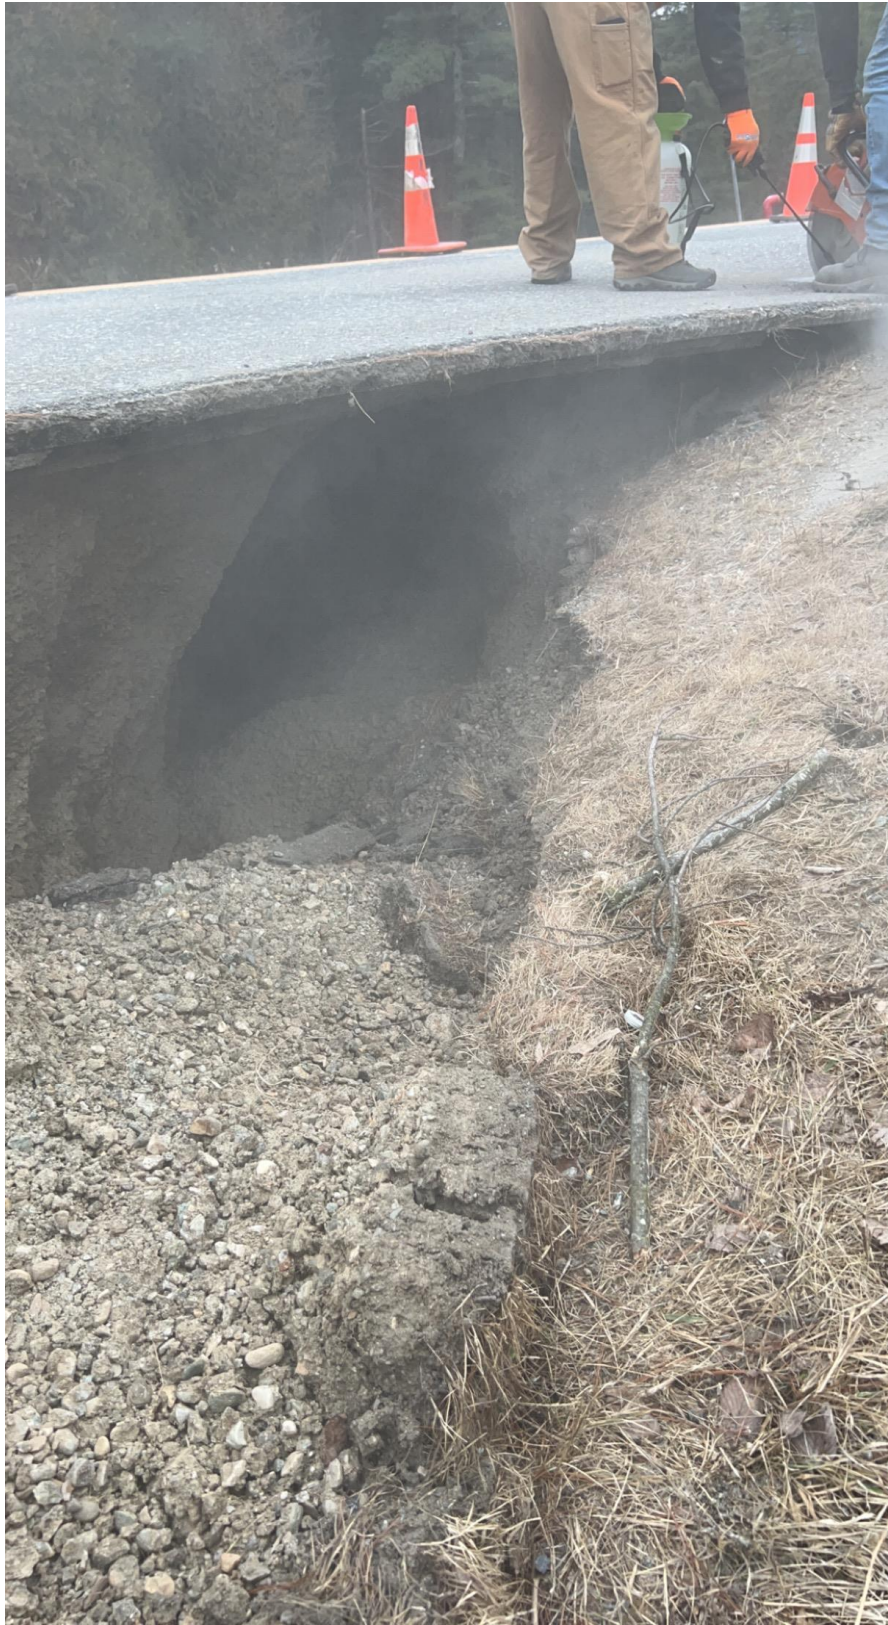
(2) Photo shows the January 9<sup>th</sup> collapse.

The town has taken action for proactive and reactive due to safety concerns. On January 9<sup>th</sup>, the west lane of Tyler Bridge Road had collapsed, creating a minor void in the road. The town cut this section of asphalt, dug down to the culvert, and inspected. After inspection, the town lined the culvert with road fabric, added 4-6" stone, and backfilled with gravel compacting every three to four inches.

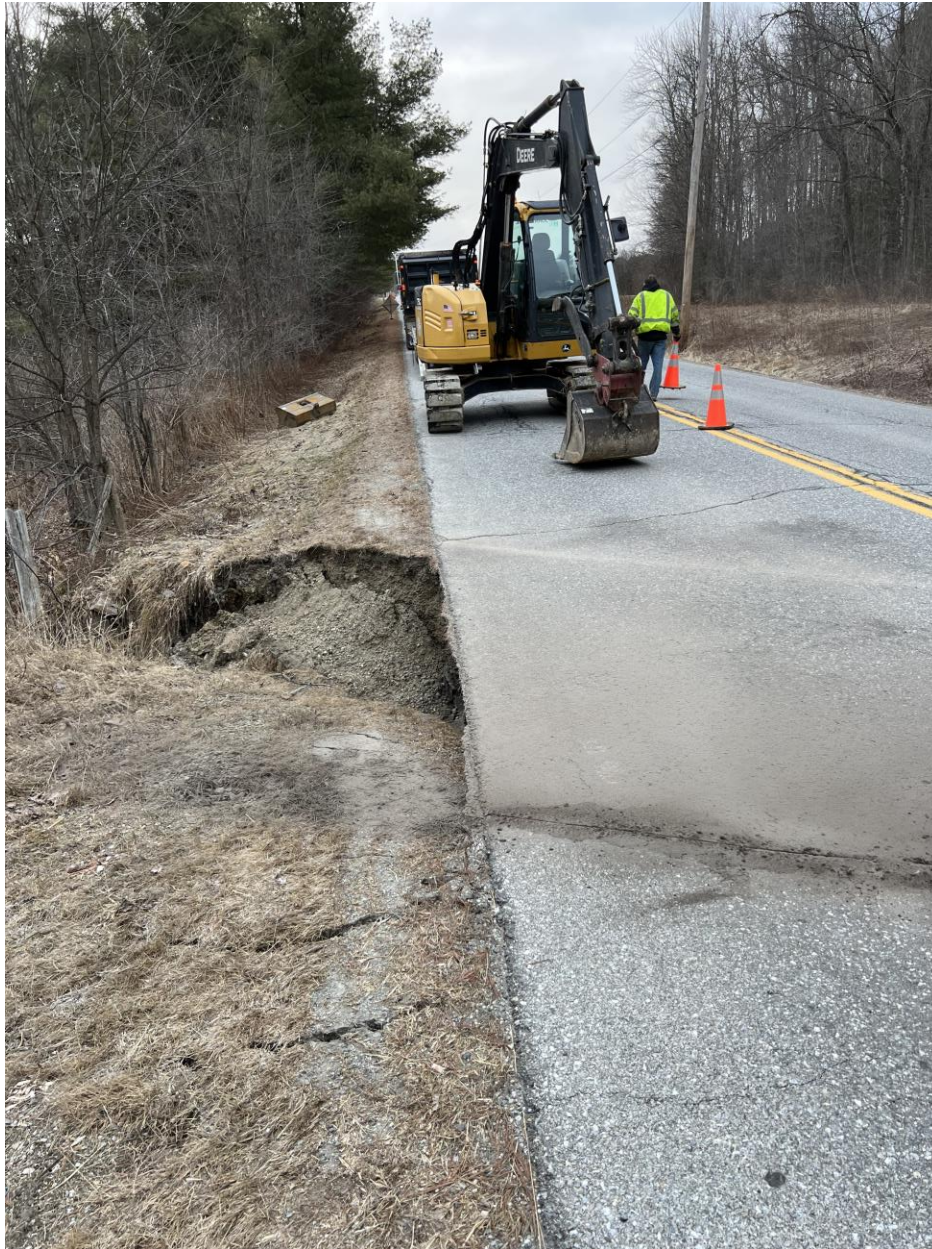
(3) Another view of the January 9<sup>th</sup> collapse

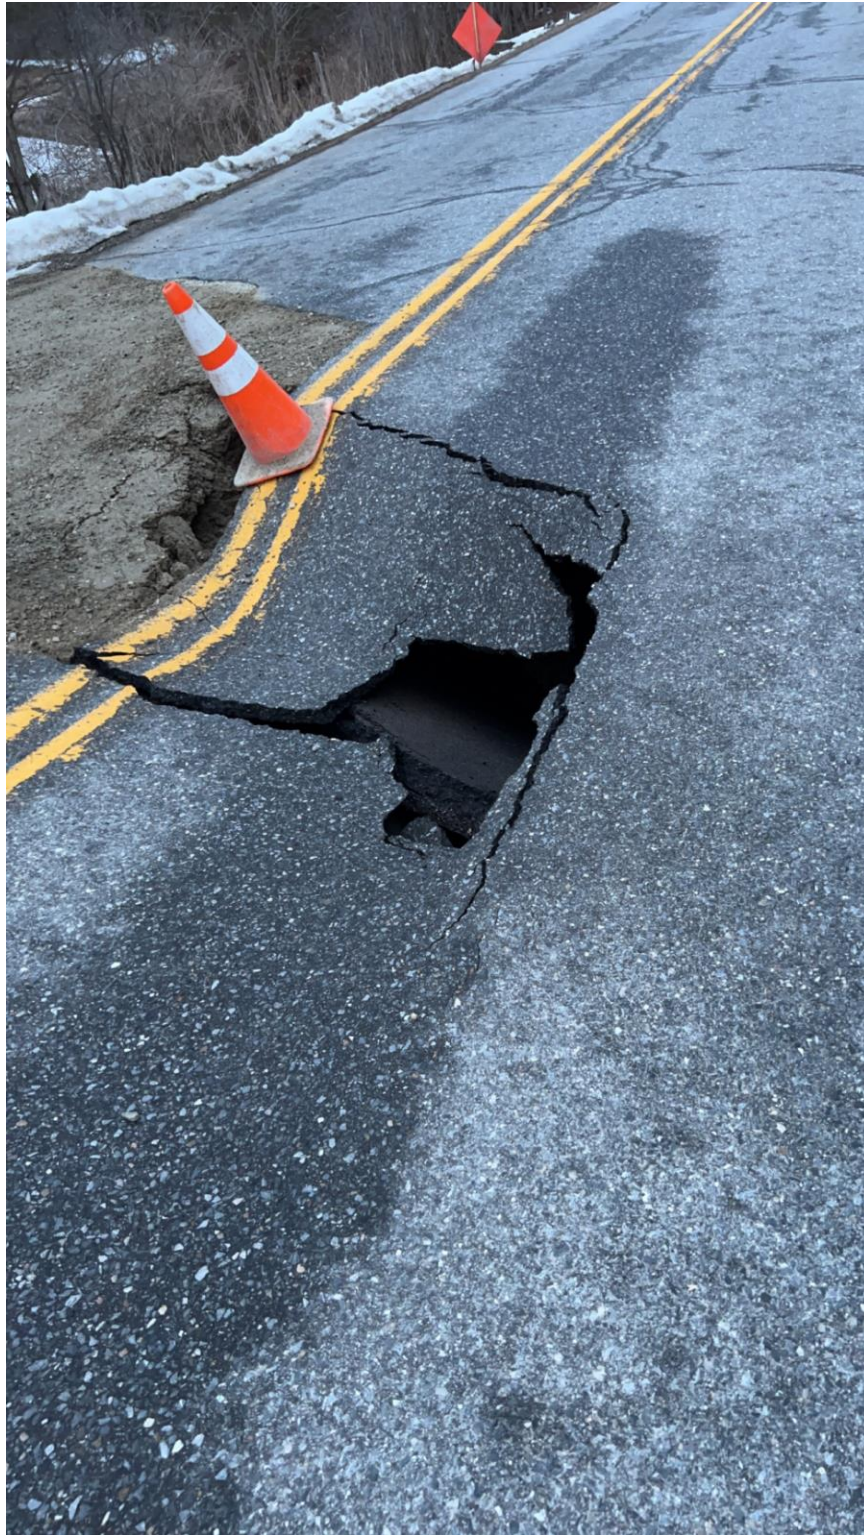
(4) Photo of the March 23<sup>rd</sup> collapse

On March 23<sup>rd</sup>, the east side of the road had collapsed near the center of the road. The town shut the road down until the next day, where work was performed. Cutting out what was left of the east side of the road; we dug the entirety of the road portion of the culvert up. After diligent inspection, we came to the conclusion that the lower half of the culvert had collapsed and expanded, meaning the top half was inside, thus creating a void and sinkholes. We lined the entirety of the culvert with road fabric, backfilled with 4-6" stone, then backfilled with gravel, compacting every three to four inches.

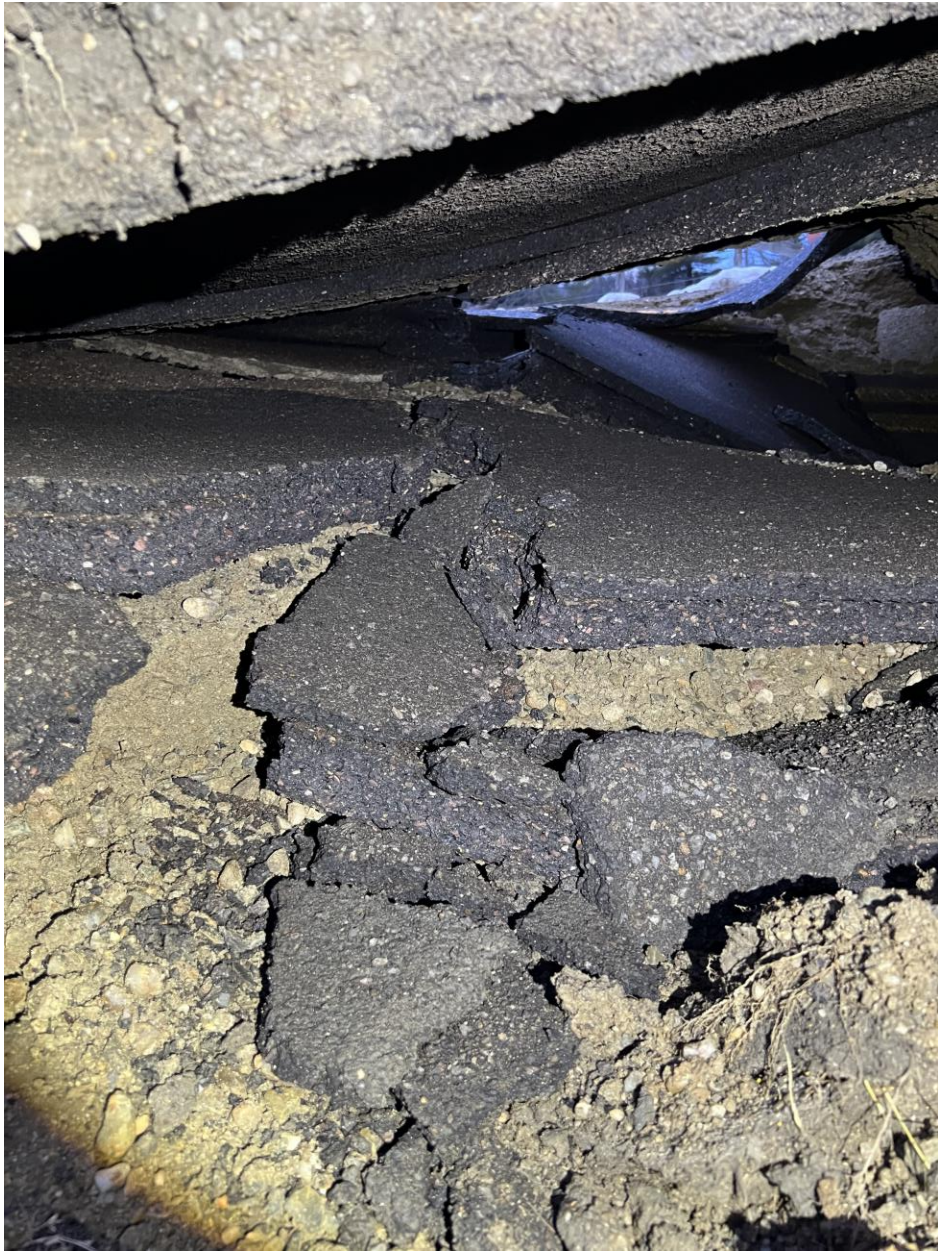
(5) Inside of the March 23<sup>rd</sup> collapse
