Vermont Better Roads Grant Program

CATEGORY B/C/D

Road Name: **Handy Road** TH #: **14** Structure # (if applicable): # **25**

TOWN OF HUNTINGTON, VERMONT CULVERT INSPECTION FORM

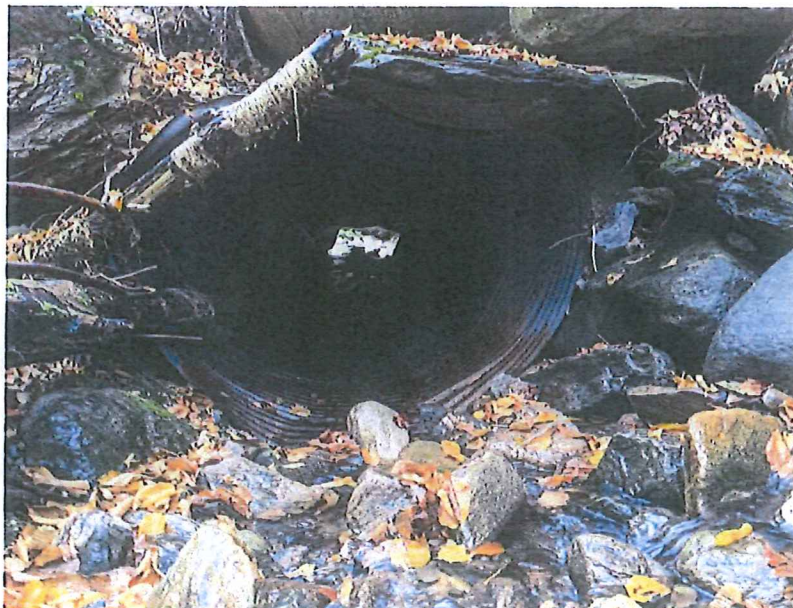
Photo 2 (25)
Inlet Elevation
Significant Culvert Damage/Debris Build-Up

Culvert 25 was the most critical finding from a hydraulic capacity standpoint. The culvert is approximately a six-foot diameter buried Corrugated Metal Pipe (CMP), approximately ten feet below Handy Road. The culvert exhibits signs of initial failure, with numerous locations of interior deformation along the culvert length. This results in a reduced hydraulic opening, creating an increased chance of debris accumulation within the CMP and developing a dam effect which could seriously affect Handy Road.

- 1 Recommend replacement. Major culvert damage.
- 2 Increase hydraulic opening on future structure.
- 3
- 4
- 5
- 6
- 7
- 8
- 9
- 10

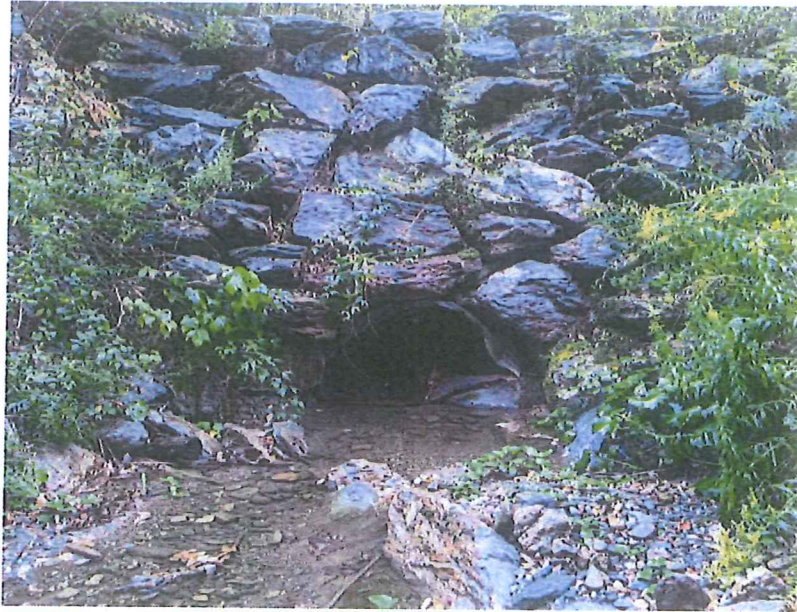
Photo 3 (25)
Outlet Elevation
Severe Culvert Failure (1/2)

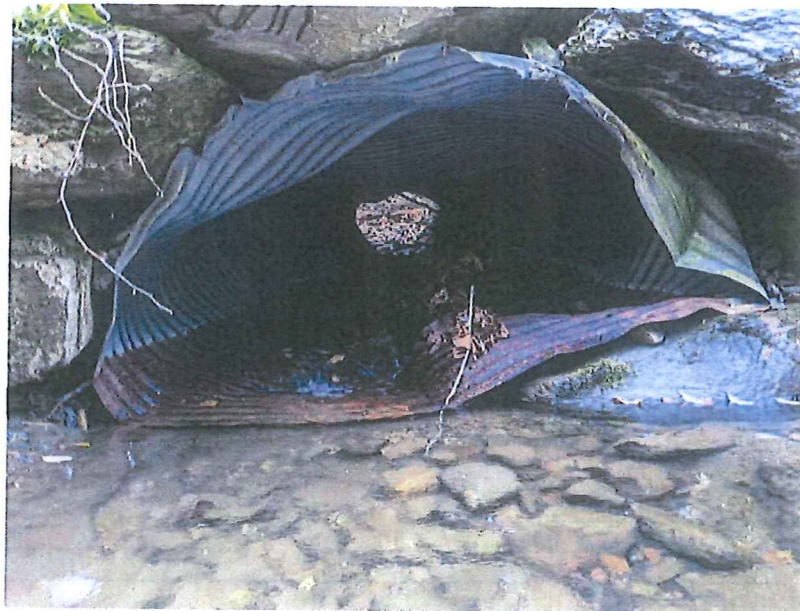
Photo 4 (25)
Outlet Elevation
Severe Culvert Failure (2/2)

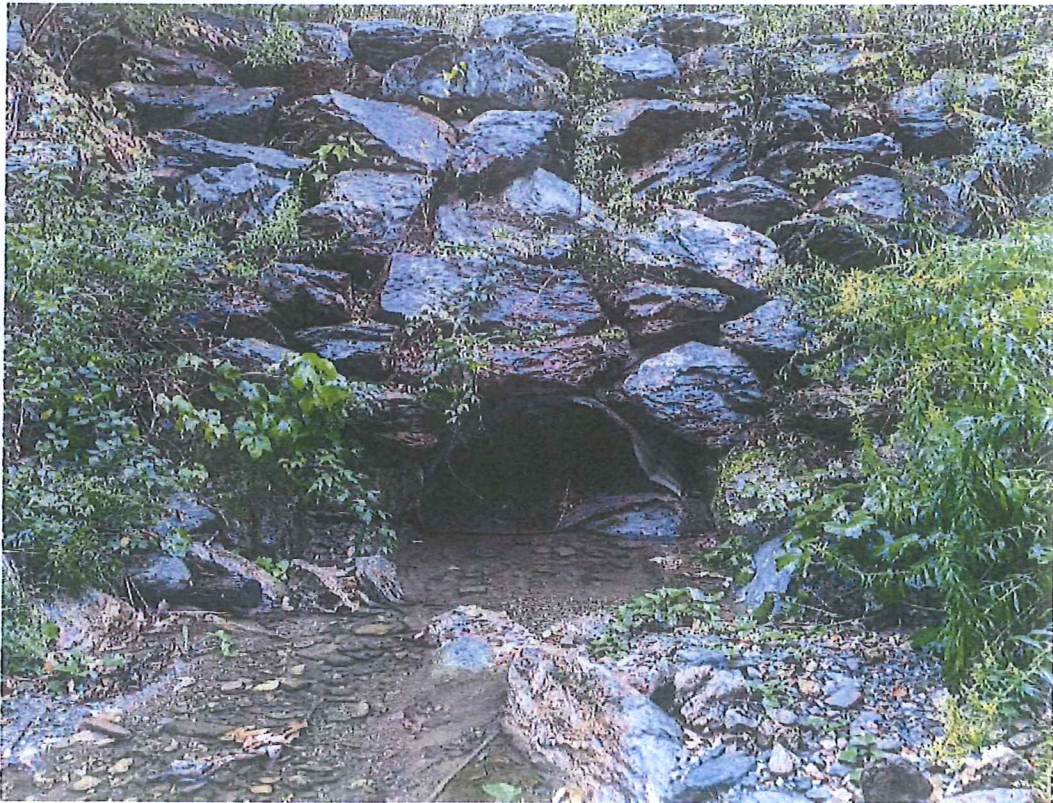
*Figure 3: Culvert 25 - View of Crushed CMP Outlet
(Handy Hill Road 0.26 Miles North of The Intersection with Bert White Road)*

Please describe the project and how it will create a positive water quality benefit (ex. Reshape 500’ of ditch and line with 12 inch minus stone, to prevent sediment from entering the Lamoille River at the bottom of the hill):
 The project will be to replace the existing damaged and undersized 6’ culvert with a 12’ steel culvert in order to reestablish better water flow and eliminate erosion.
