**To:** Logan Perron, District 7 PM  
**From:** Callie Ewald, P.E., Geotechnical Engineer  
**Date:** December 22<sup>nd</sup>, 2023  
**Subject:** St. Johnsbury – VT 2 MM 7.0 Slope Instability

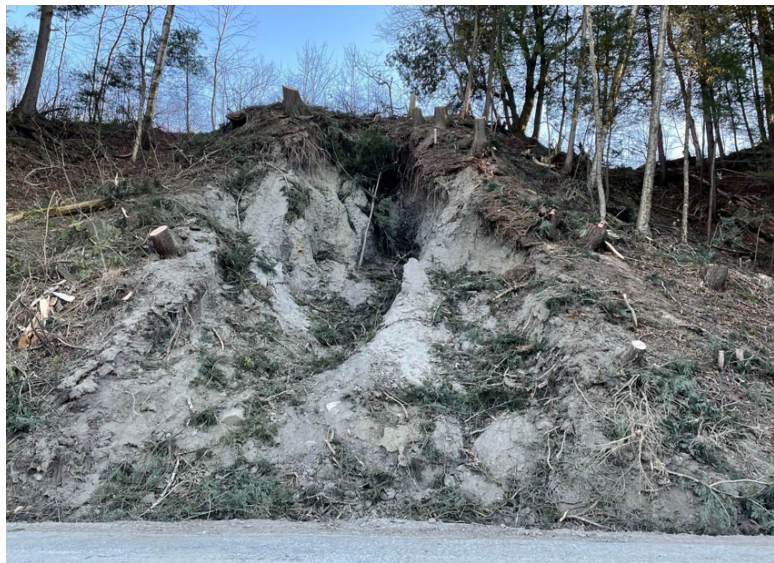
The slope appears to be approximately 50 feet in height and about 60 feet in width at the ditch line as shown in Figure 1. The apparent mechanism of failure is gully erosion, where the soil is eroded by large water flows. This particular site was likely a combination of gully erosion and saturated overburden soils sliding on the harder glacial till material beneath it. An incised narrow channel can be seen in the upper half of the slope. Several factors contribute to a slopes susceptibility to gully erosion, including topography, land use, soil types, and surface run-off velocity and volume. Several of these factors were identified and are discussed herein.

**Figure 1.** Slope looking South, gully erosion characteristics present in upper half of slope

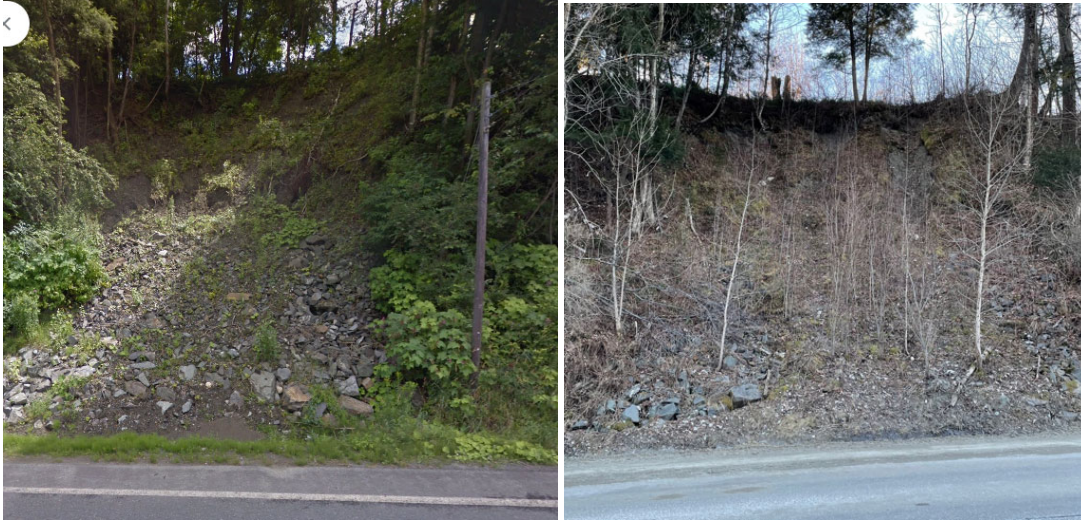
A review of historical google street views show that this general vicinity has been experiencing similar distress dating back approximately 10 years. Figure 2 below shows an area directly east of this current slide which exhibited a slope failure before the summer of 2014. It appears a surficial slide occurred removing the slope of heavy vegetation and stone fill was placed on the lower half to provide some erosion control and confinement to the exposed soils. A few other gully type features and drainages can be seen along this stretch of slope adjacent to Route 2.

**Figure 2. July 2014 Google Street View (left) December 2023 Photo (right)**

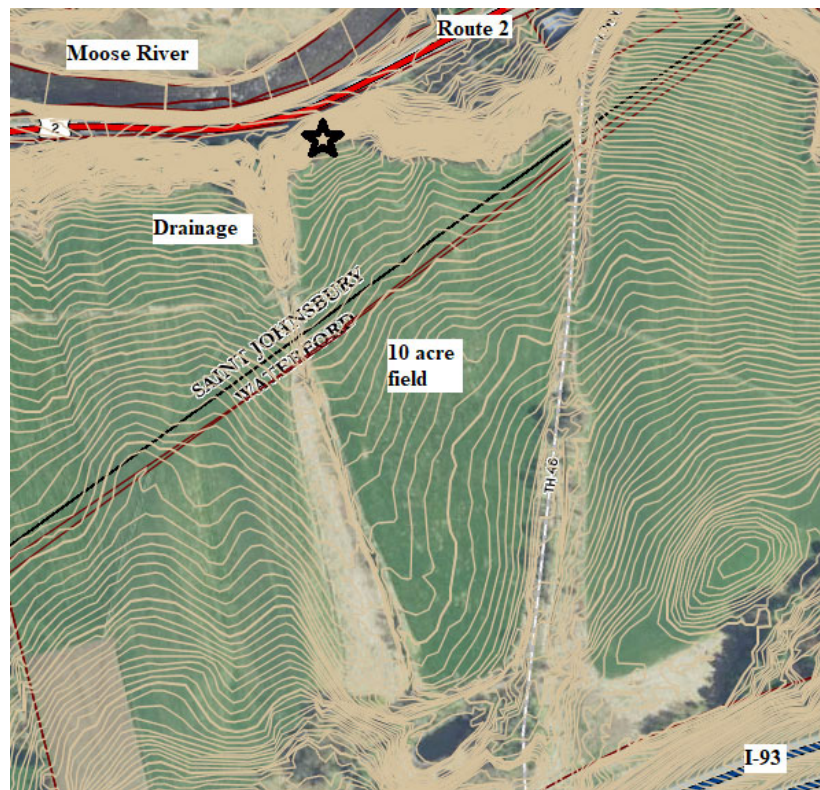
The exposed soils in the failure area appear to consist of a hard glacial till, composed of various grain sizes of sands, clays/silts, and cobbles intermixed. This aligns with the 1970 surficial map that shows the area as Till. The topography of the area is illustrated in Figure 3 below. There is an approximately 10 acre grass field on top of the slope with the grade of the field sloping toward the northwest, directly above the slide area. Upon inspection of the crest of slope and field, remnants of sediment transported and left from large water flows could be seen in the grass just inside the grassy field from the crest of slope (Figure 4). It is apparent that during the heavy rain event, the saturated soils were not able to absorb excess water, and the water was likely funneled toward the low point of the field and onto the slope in a concentrated manner.

**Figure 3. Plan view showing large field, star denotes failure area**

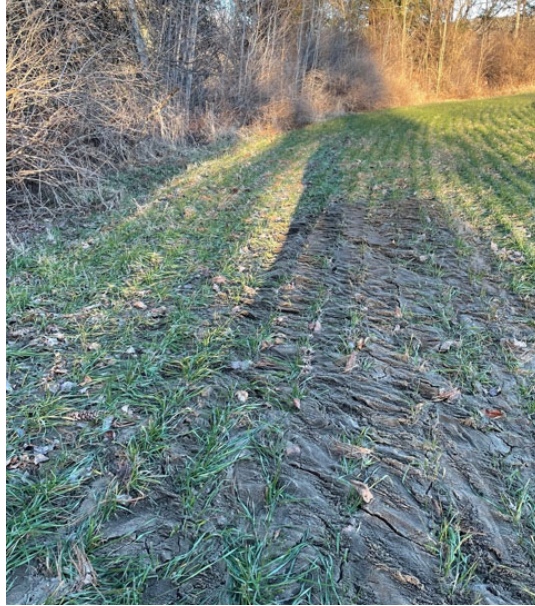
**Figure 4.** Looking east, note sediment deposited during heavy rain

It is our opinion that based on the failure mechanism and the soils present on site, the existing slope is temporarily stable. Rain events will continue to erode the soil and undermine the root/vegetation mat, but the trees have been removed and any sloughing should be managed by the ditch. In terms of a more permanent solution to this site, we recommend that a hydraulics/hydrology analysis be conducted to understand the surface run-off that this slope is experiencing and strategies to disperse the water. Any solution here should involve diverting the flow of water to a more stabilized drainage pathway and away from the erosion prone gullies.

Once the water run-off issue is dealt with, the existing slope simply requires standard stabilization strategies. The slope will require a survey and a couple borings and/or hand sampling to develop an appropriate mitigation which will likely utilize re-grading and some stone fill and vegetative erosion control techniques to re-establish the slope and promote vegetation. There appears to be some real estate to grade the slope appropriately in this area but the survey will help to understand feasible alternatives.
