STATE OF VERMONT  
AGENCY OF TRANSPORTATION

**Scoping Report**

**Weathersfield STP 0146(16)  
VT ROUTE 131, BRIDGE 15 over MILL BROOK**

March 2, 2016

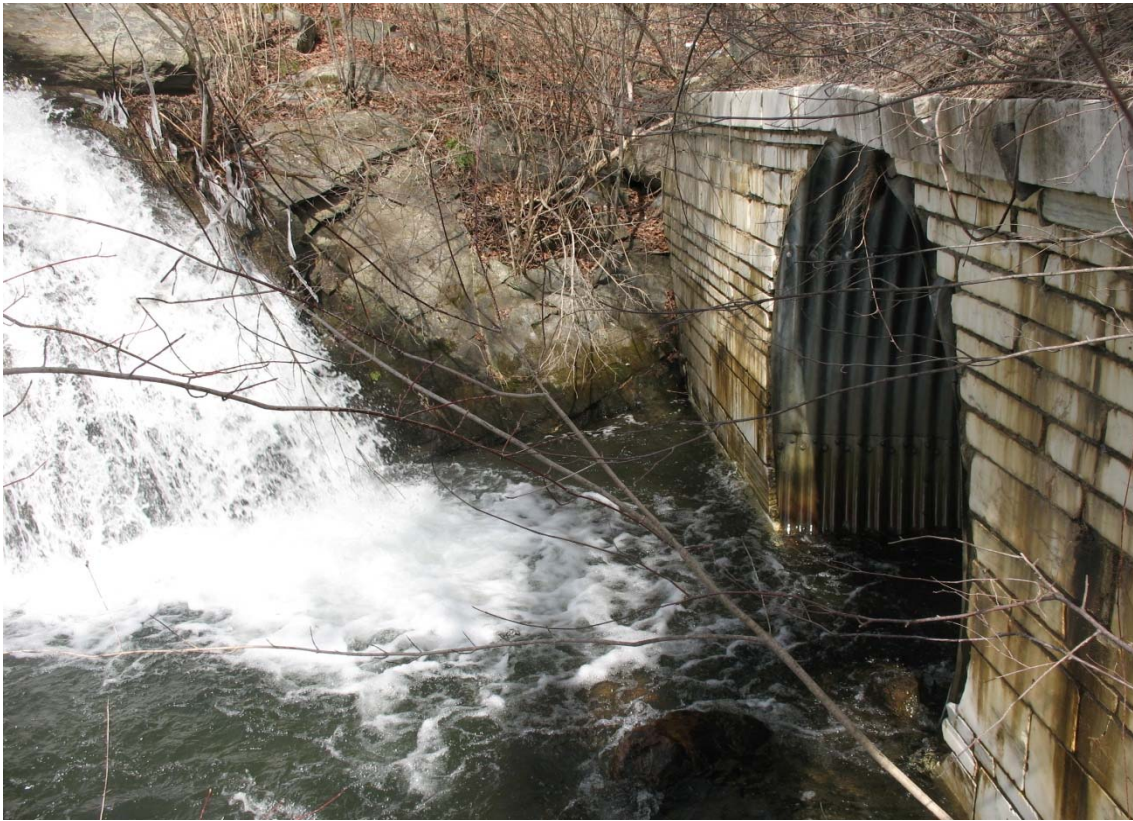
Inlet

The existing structure is an 11.0' CMPP, providing 95 sq. ft. of waterway area. It was built in 1959. This pipe is in fair condition with bolt-line cracking. The pipe has a laid up stone headwall on the inlet. There are some large ledge falls just upstream of the structure, with a pool area between the base of the falls and the inlet of the pipe. There is about a 4' drop into a large scour pool at the outlet. Thus the structure does not provide AOP.

For a repair, we recommend a 10.0' corrugated interior liner with a beveled inlet. This size liner would provide 78.5 sq. ft. of waterway area. It would be adequate hydraulically and there would be no roadway overtopping up to Q100. Headwater elevations would increase and AOP would not be provided. Due to the presence of the waterfalls upstream, that may be acceptable at this site. Assuming the invert of the liner is 0.5' higher than the existing pipe invert, this pipe would result in a Q50 headwater elevation of 790.9'. This liner will require Stone Fill, Type IV protection at the outlet. The stone should extend at least 15' downstream from the outlet.

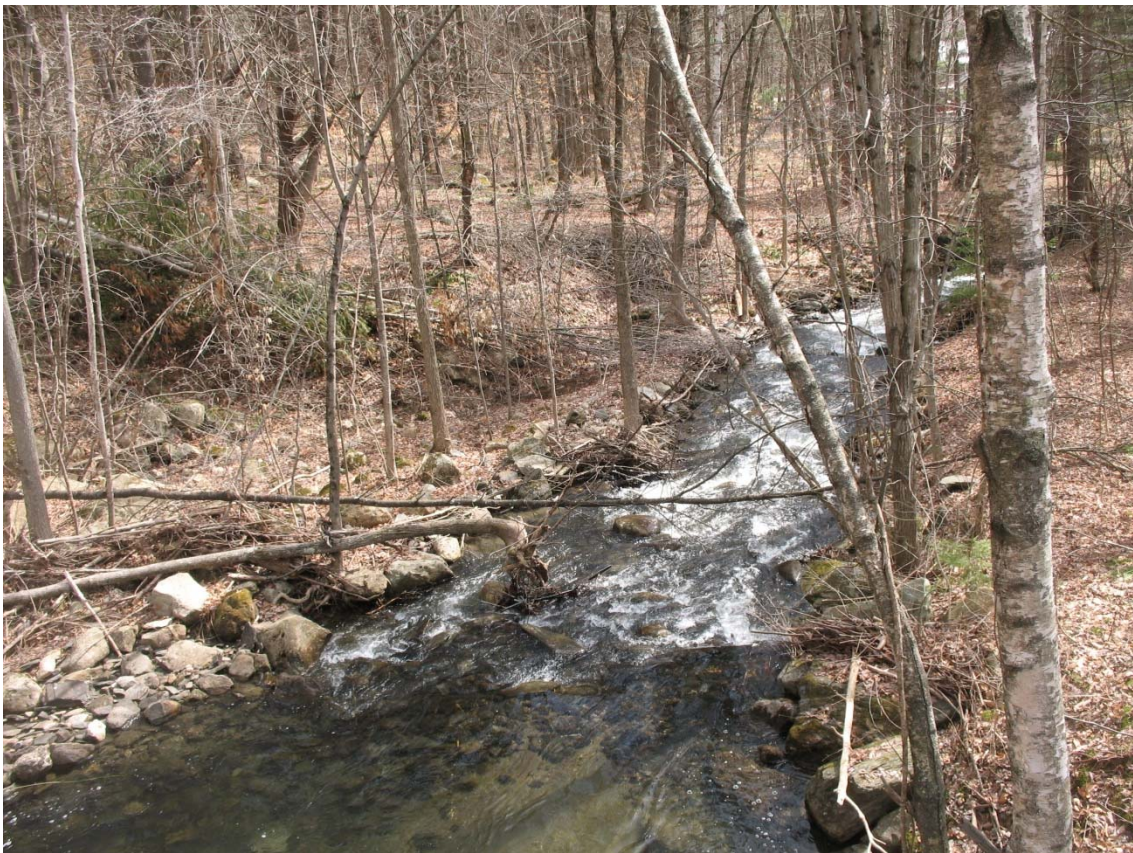
Looking downstream from on the end of the pipe

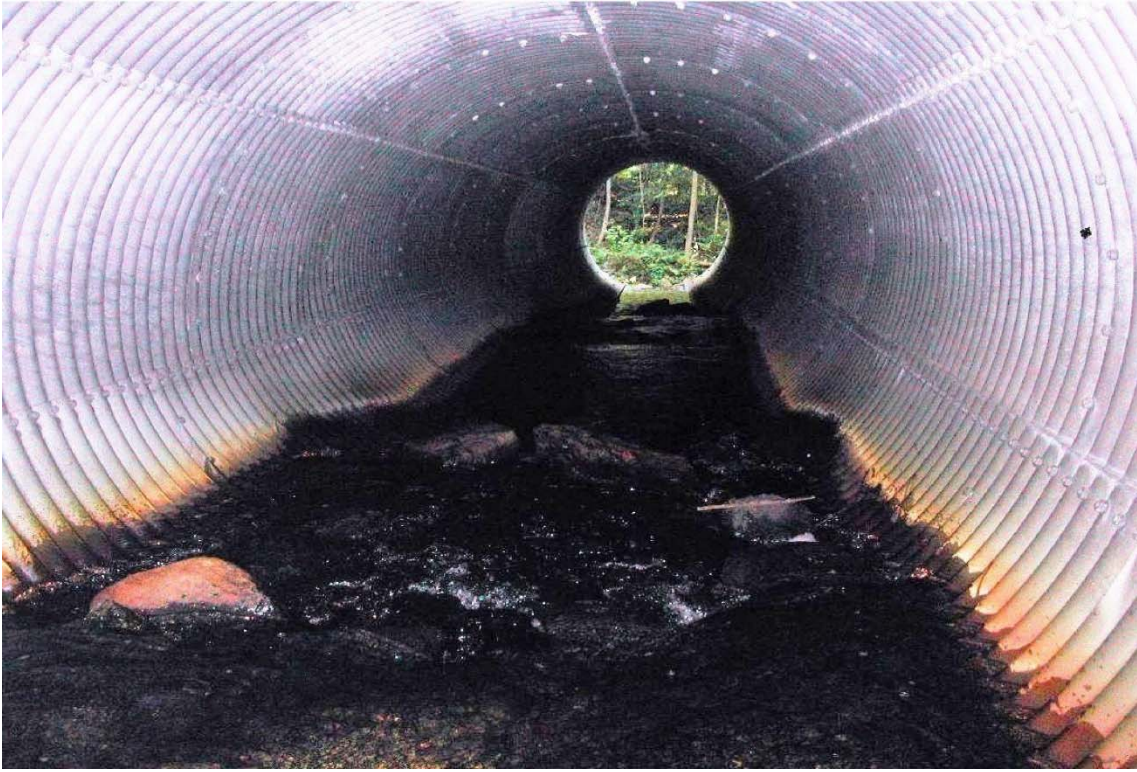
12/10/2013 – Pipe is in fair condition with some distortion and bolt line cracking from displacement. A number of loose bolts indicate poor construction and installation technique which likely has led to shape distress as well. Continue to monitor quinquennially. MJ/JS

Interior View

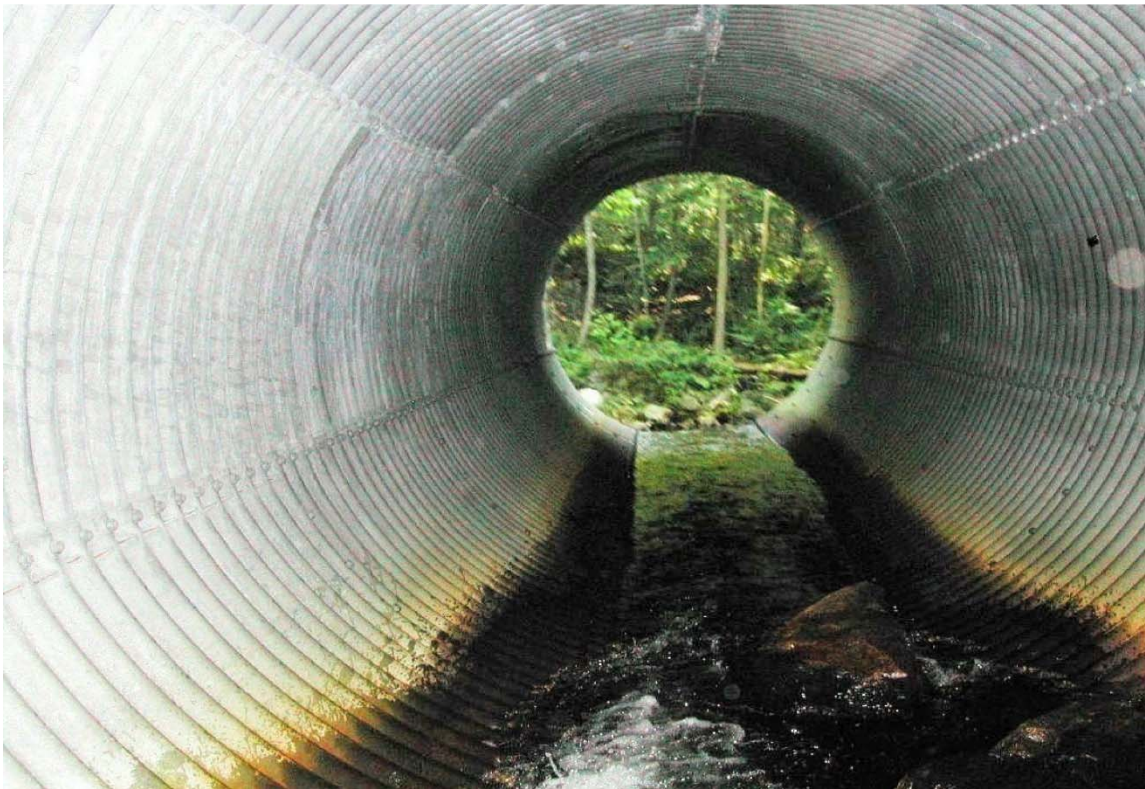
Interior View
