STATE OF VERMONT  
AGENCY OF TRANSPORTATION

**Scoping Report**

**Norwich IM 091-2(89)**  
**I-91 Bridges 48 N&S over VT Route 10A**

January 30, 2020

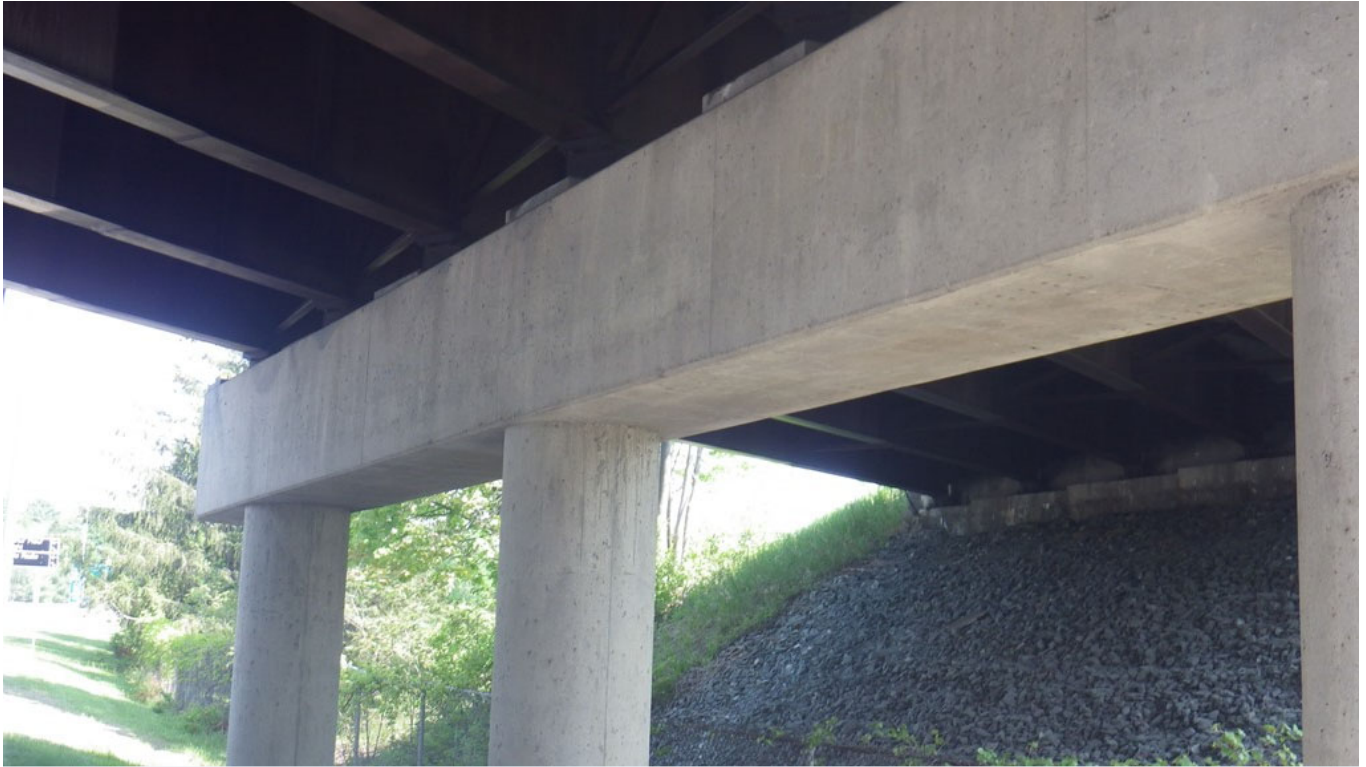
- *Piers:* The piers are in fairly good condition with only minor distresses. There is some fine map cracking in the pier cap ends with light staining.

Picture 1: Typical pier condition

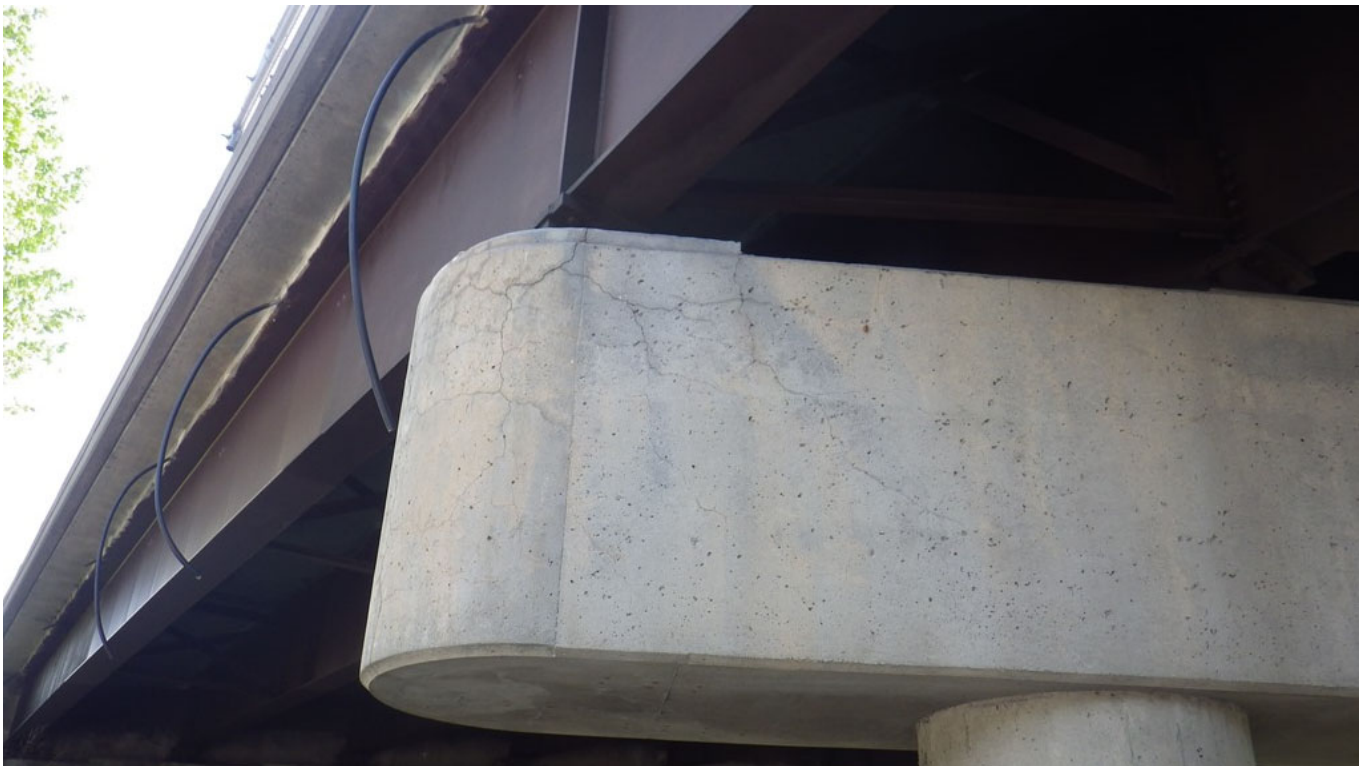
Picture 2: Cracking at pier cap nose

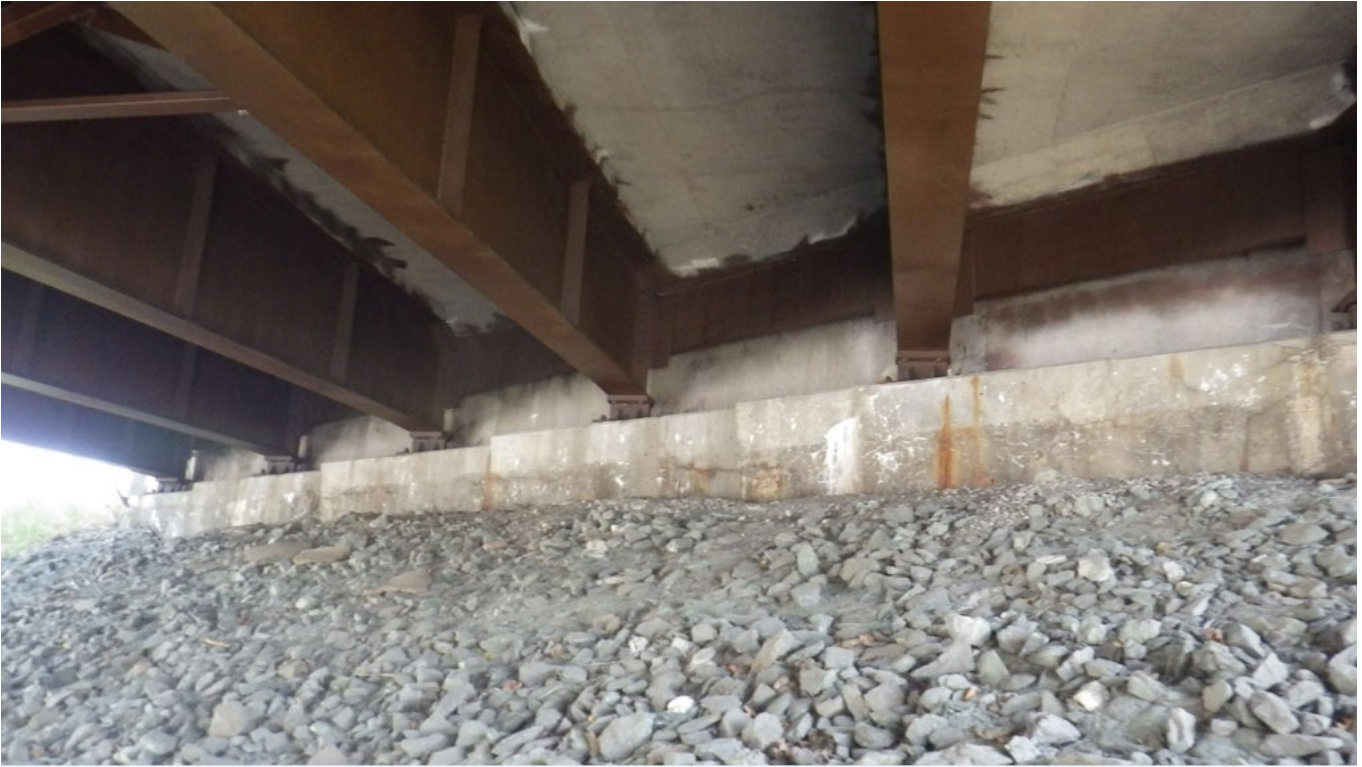
Picture 3: Abutment Condition

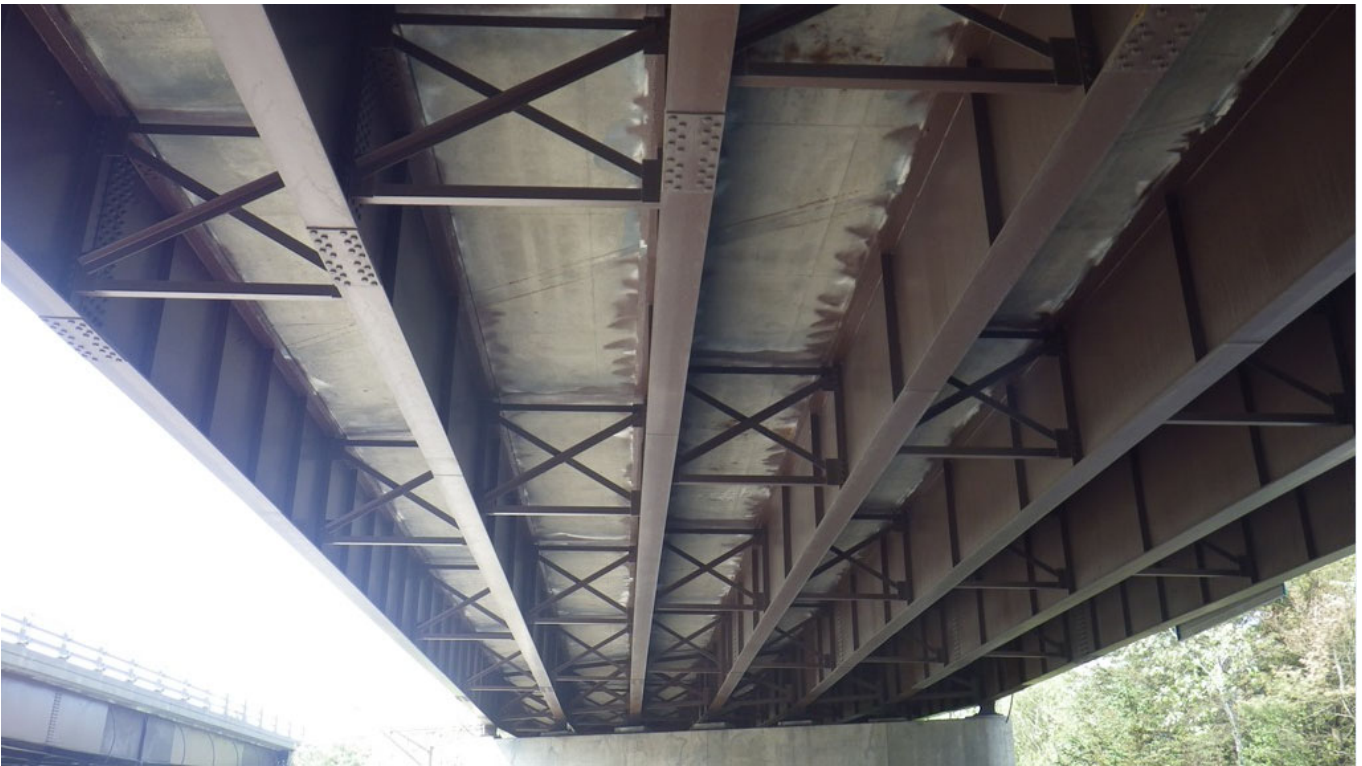
Picture 4: Deck and Superstructure

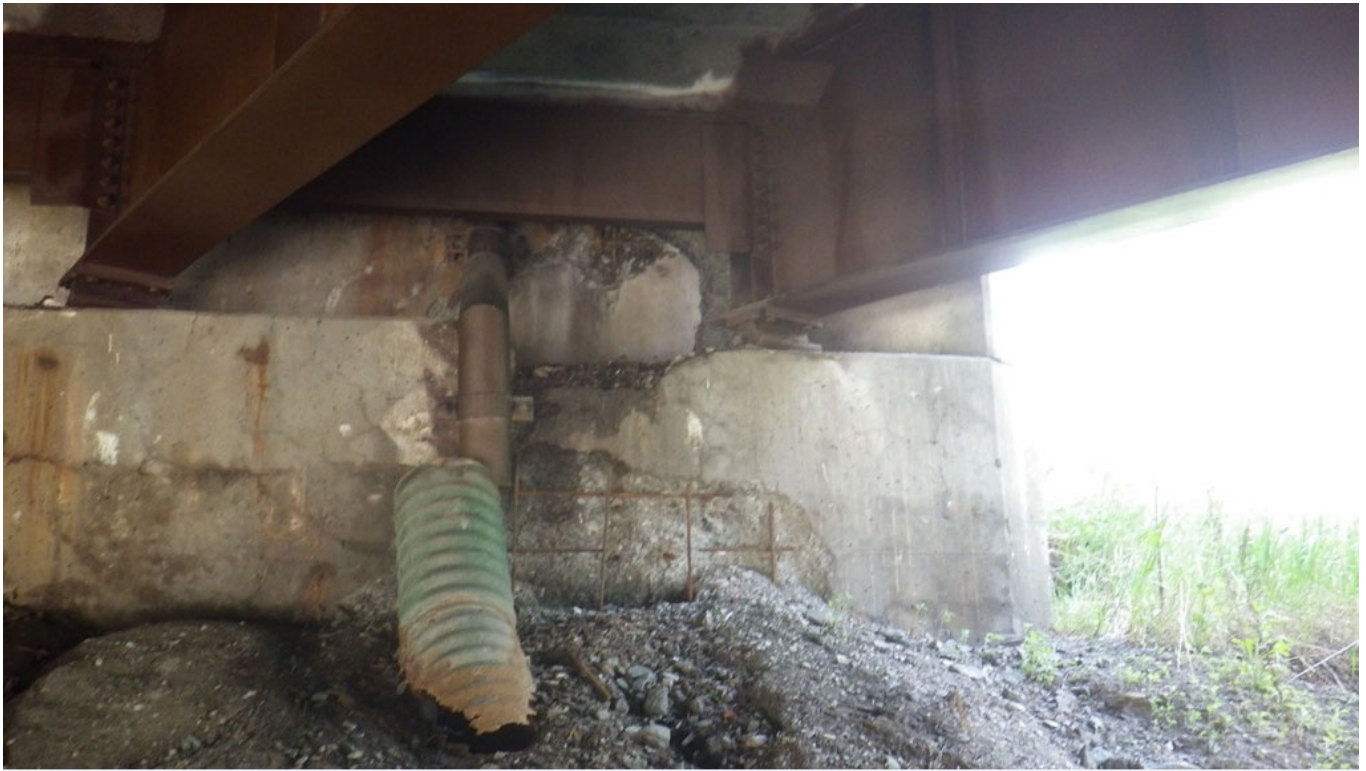
- *Abutment Stems:* The abutment stems have heavy deterioration with map cracking throughout with scattered areas of rust staining and light efflorescence throughout. The ends of the abutments have large areas of spalling that have undermined the bearings, exposing swedge bolts, and caused some minor settlement. The spalling extends down into the stems in areas. Spalling in the west end of abutment 1 on bridge 48S will soon penetrate to the backfill.

Picture 5: Abutment Deterioration

- The superstructures would be shored at each of the abutments. The bridge seats and stems at the abutments would be cut down, and new stems and bridge seats would be poured on the existing footings supported on piles. The wingwalls have a significant amount of map cracking. The wingwalls should be repaired along with the stem and bridge seats. The superstructure would then be placed back on new bearings.

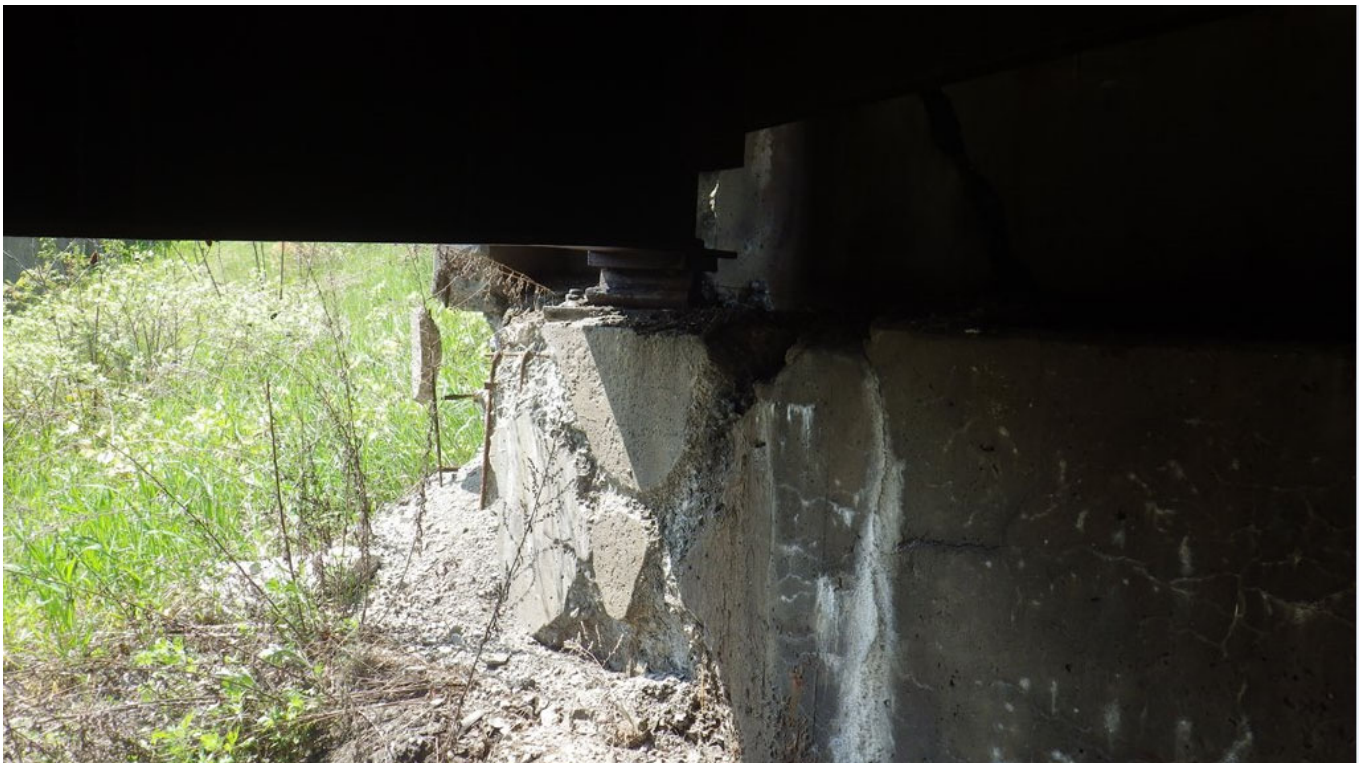
Picture 6: Abutment Deterioration

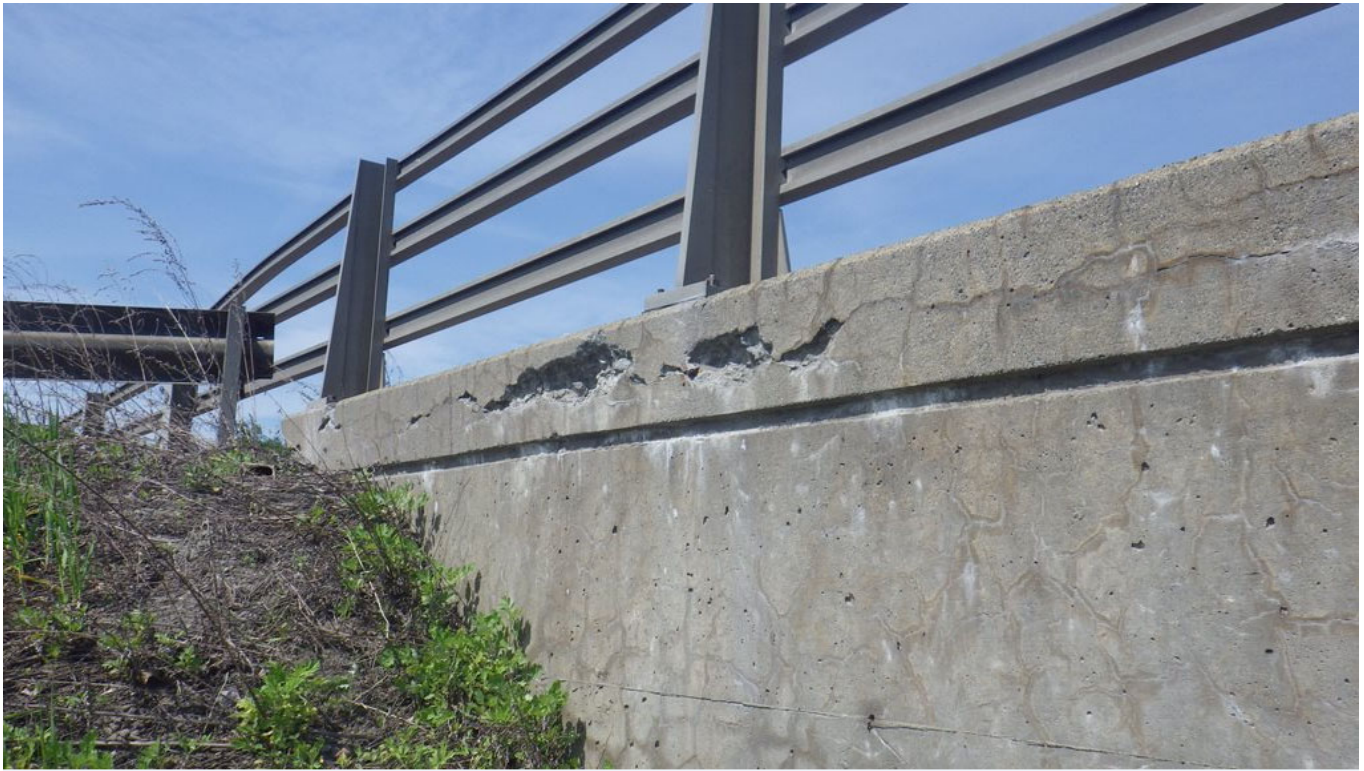
- *Wingwalls:* The wingwalls are in fair condition, with map cracking throughout and light staining. There are areas of spalling with surrounding delaminations along the joints.

Picture 7: Wingwall cracking and curb deterioration

- The concrete curbs behind the granite facing have a significant amount of map cracking with some spalled areas with exposed reinforcing. The bridge fascias would be removed, and new fascias, curbing, and railing would be constructed.

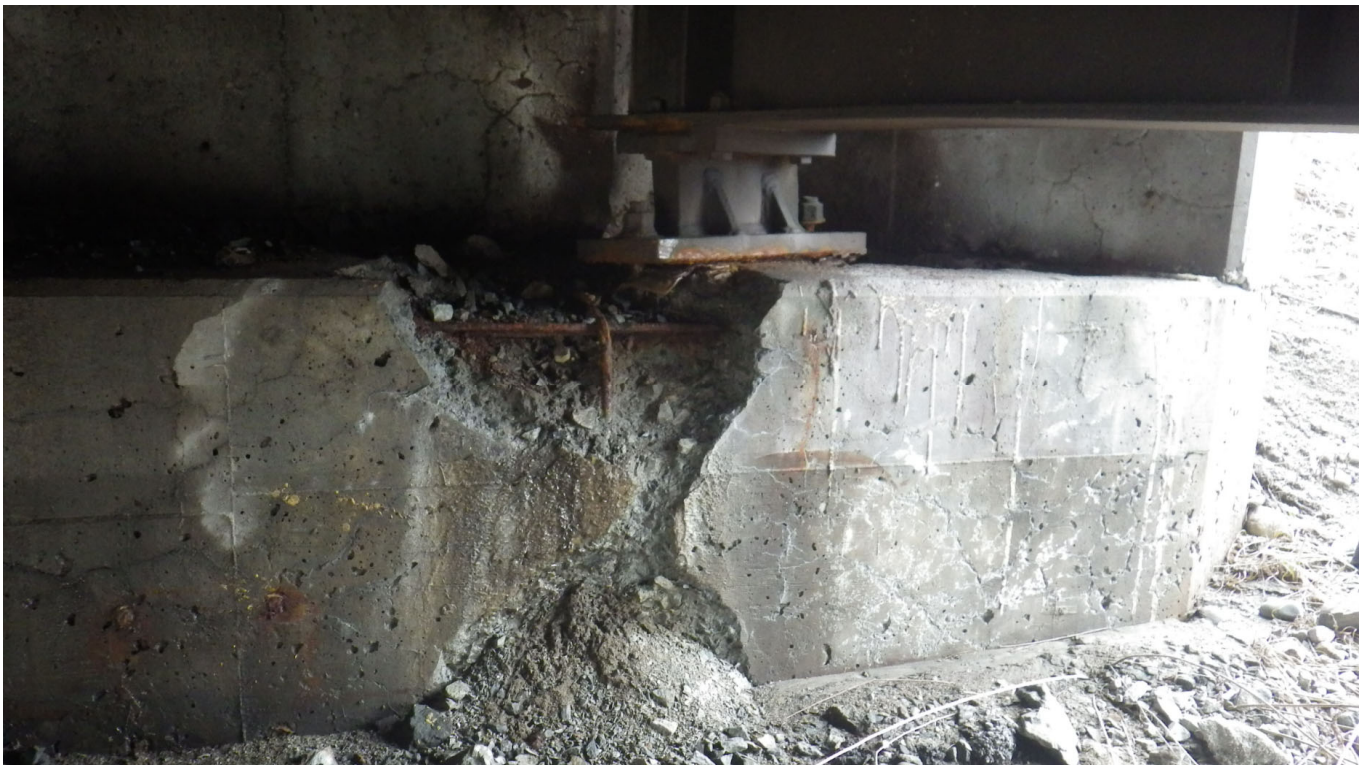
5/25/2018 – The abutment ends have significant spalling in the bridge seats undermining the fascia beam bearings. The undermining of the abutment 2 bearings has caused some minor settlement. Saturation continues due to the open curb joints above. This structure should be considered for a

Picture 8: Abutment deterioration at bearing location

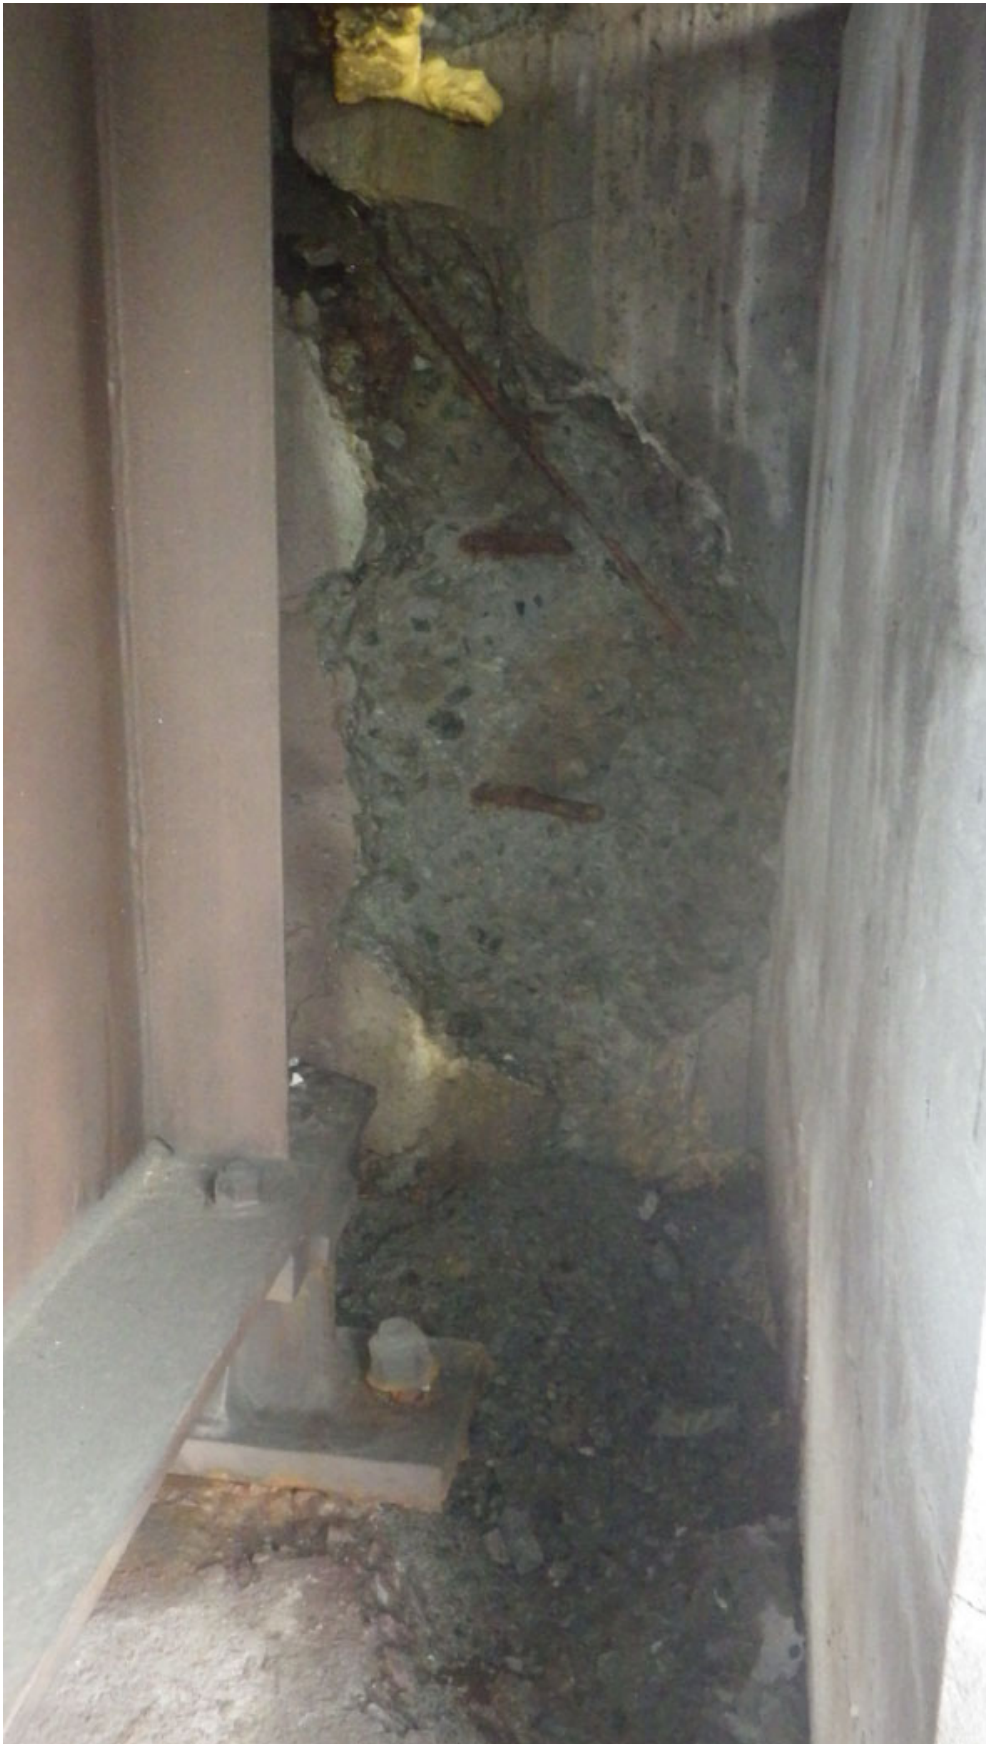
1. Bridges 48 N&S are structurally deficient with substructure ratings of 4, poor.
  - *Reinforced Concrete Backwalls:* The backwalls have map cracking throughout and scattered areas of light efflorescence and rust staining.

Picture 9: Poor backwall condition

- The backwalls are failing. New backwalls should be poured.
- The northern bridge joints (finger joints) are in poor condition and have significantly contributed to the poor rating of the substructure due to water and salt leaking on to the abutments. In order to protect any new substructure elements, the finger joints would require replacement. The existing finger joints would be removed, and new joints would be constructed. The deck has spalling in the surrounding areas of the joints with heavy scaling and exposed reinforcing steel. The joint replacement would include removal of the concrete surrounding the joints and pouring new concrete around the joints.

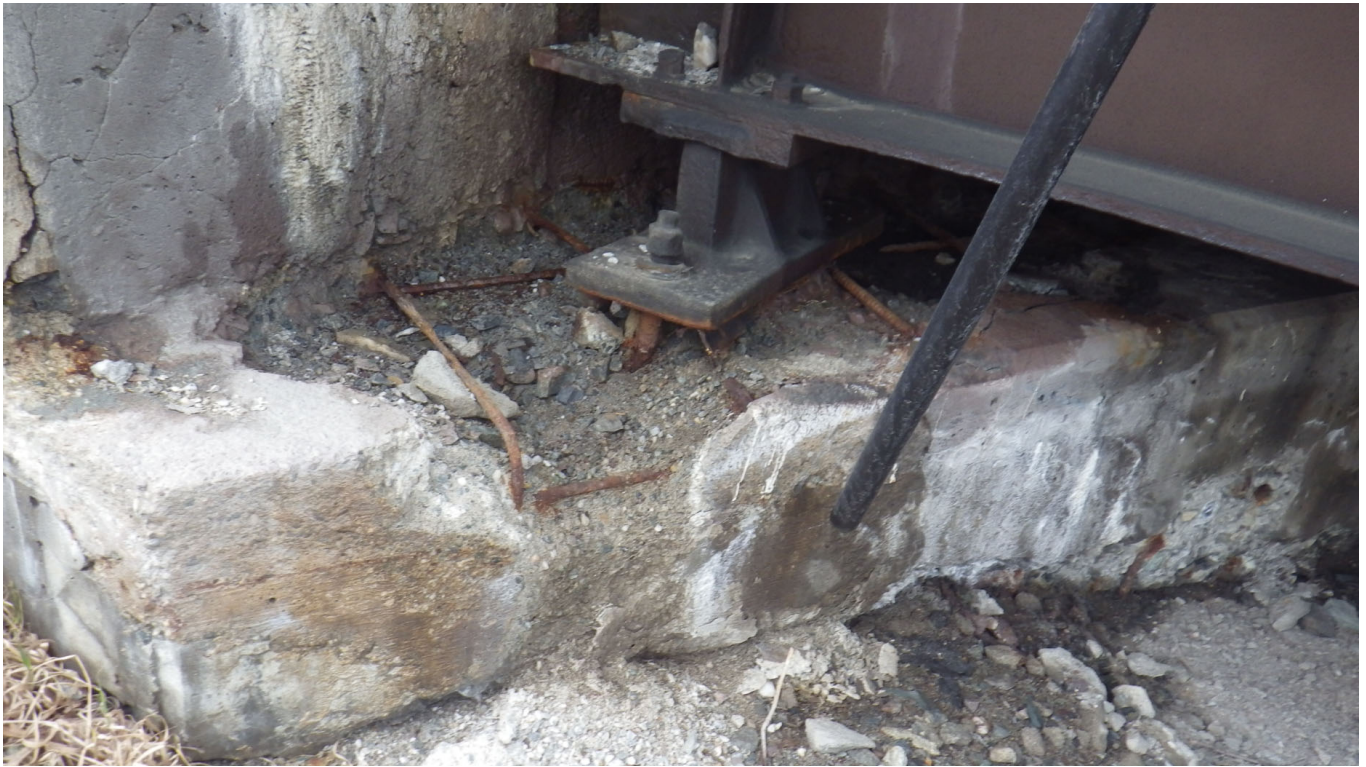
Picture 10: Abutment deterioration at bearing location

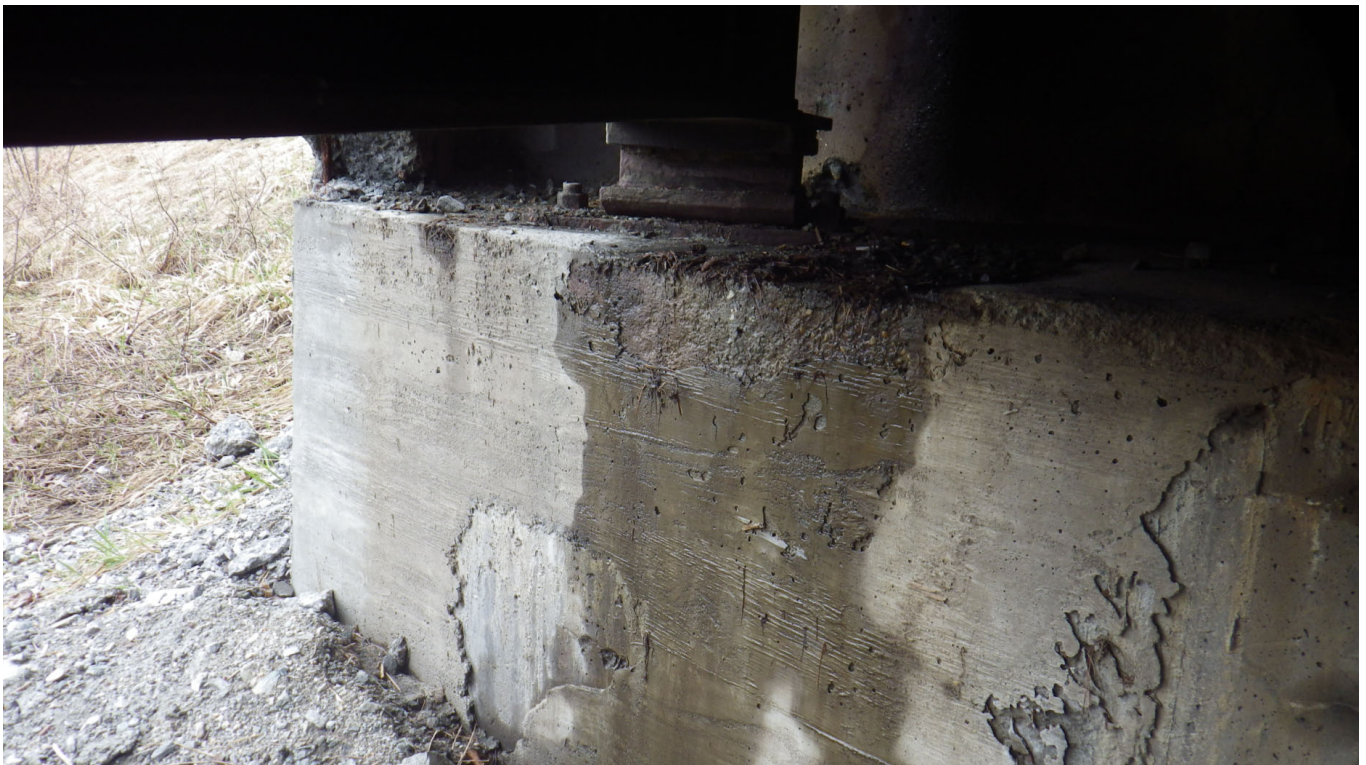
4/18/2019 – The failed drainage systems of the joints and spalled out curb ends allows for the saturation and deterioration of the abutments. Spalling continues in the backwalls and bridge seat of abutment 2 w/ heavy scaling and exposed reinforcing. The fascia beam bearings of abutment 2 have minimal supporting concrete and settlement will occur. Corrective repairs are needed.  
~JW/MC

Picture 11: Water infiltration on abutment

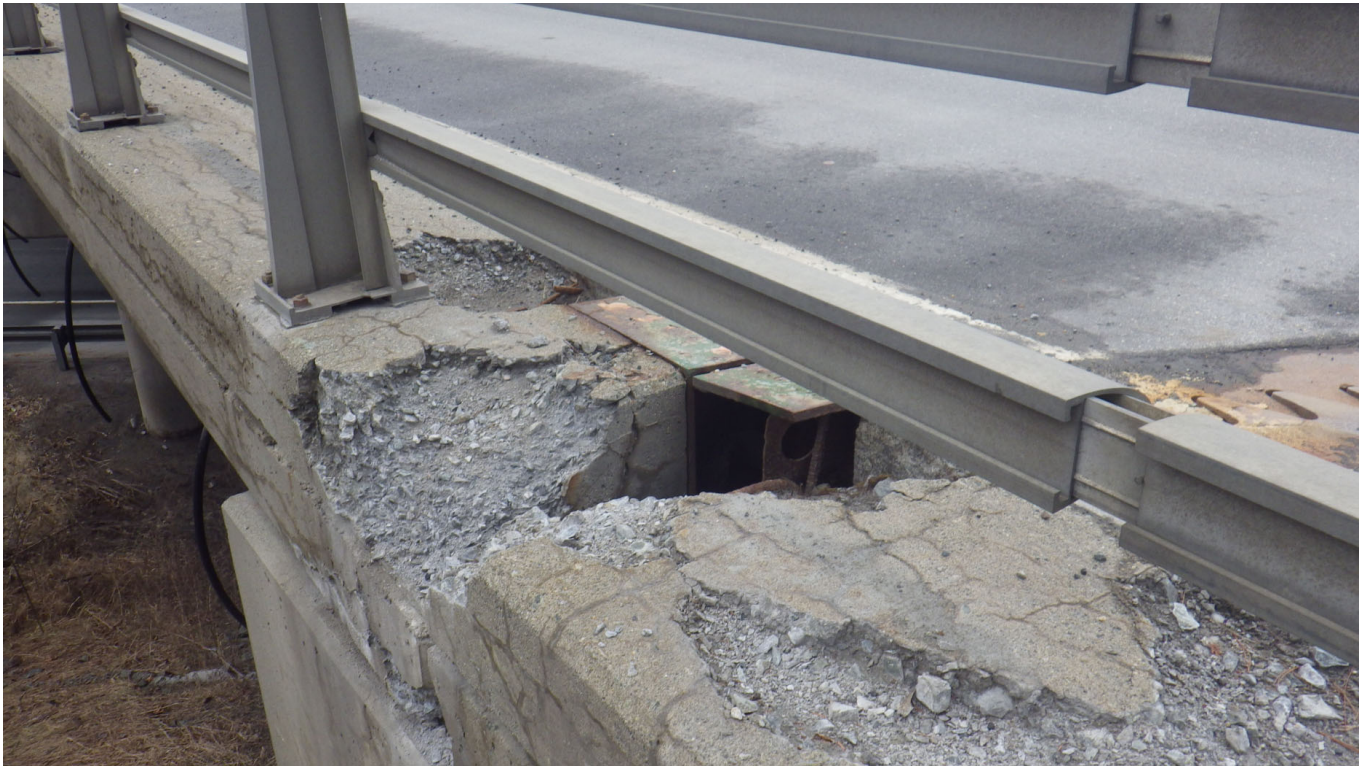
2. While the decks on bridge 48N and 48S are rated as good and satisfactory respectively, they have minor maintenance needs.
  - *Curbs:* The existing concrete curbs with granite facing on both bridges have map cracking throughout w/ scattered small spalls and patched areas. The ends have large spalled areas w/ scaling and exposed reinforcing.

Picture 12: Curb cracking and deterioration

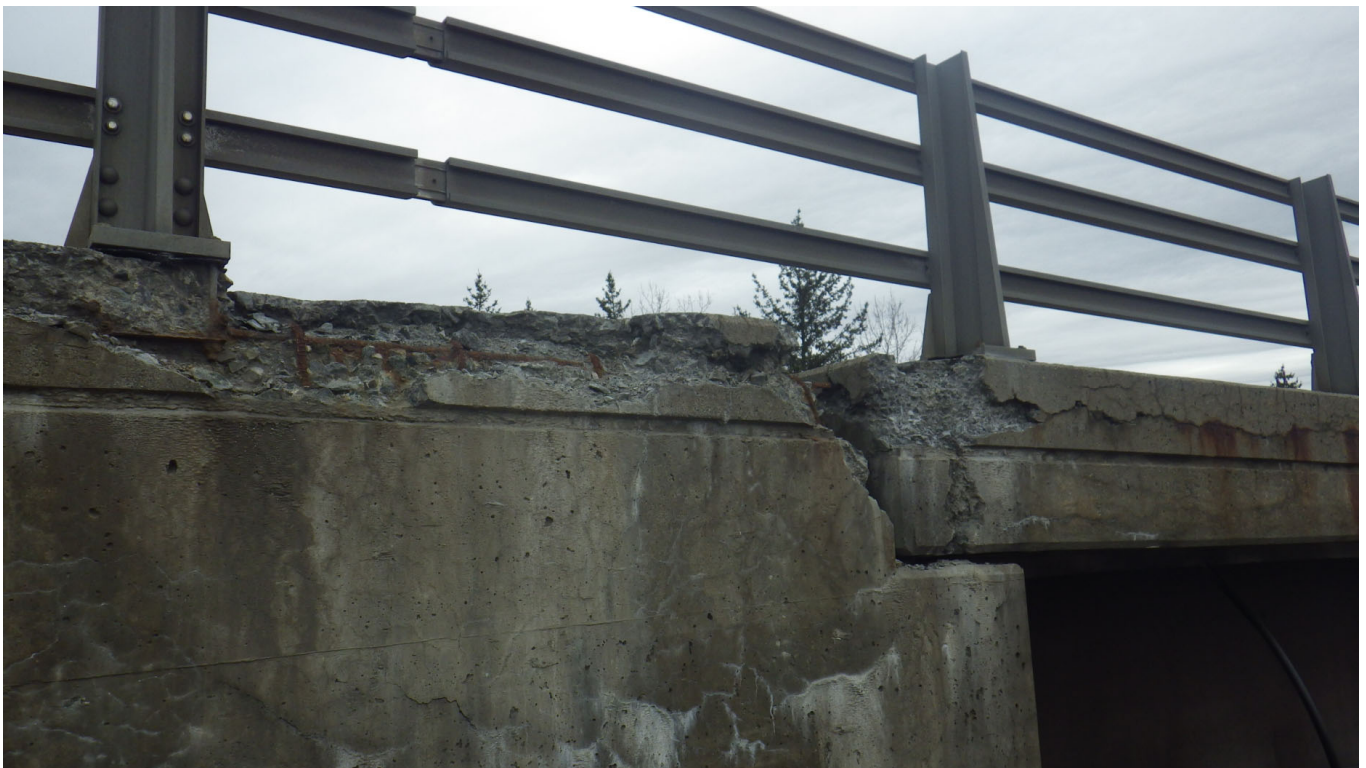
Picture 13: Curb Deterioration (note cracking and efflorescence on wingwall)

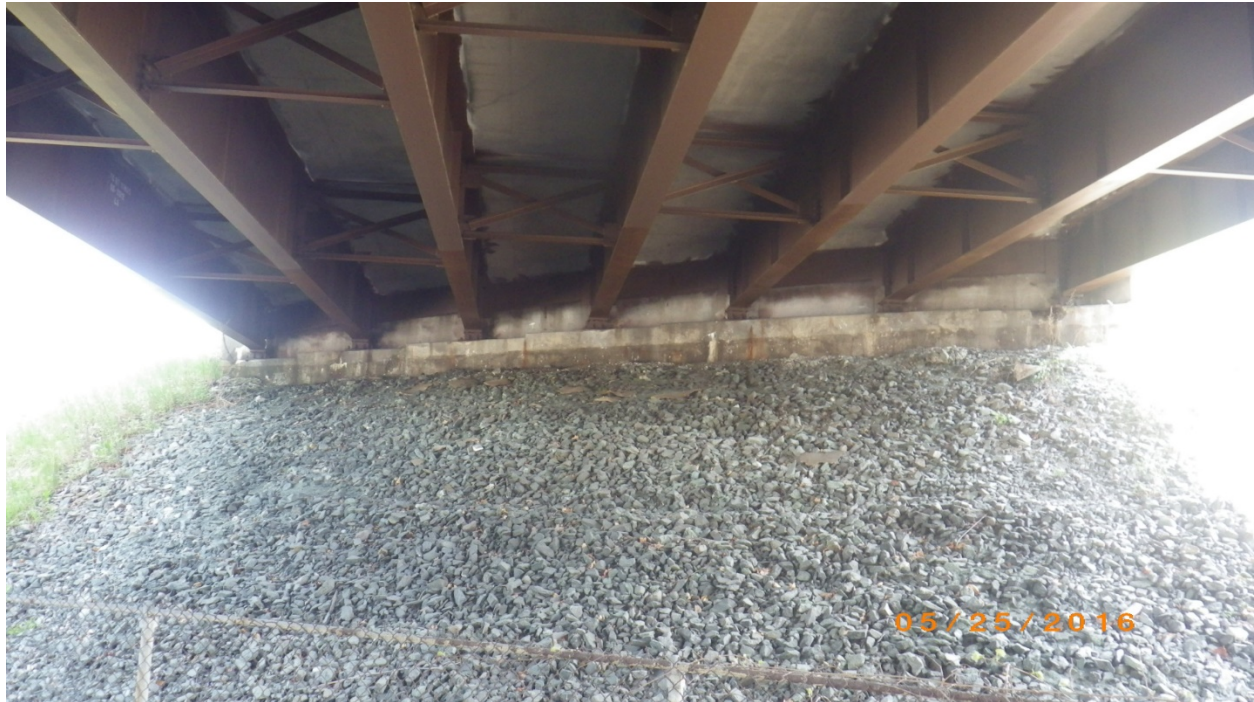
**Figure 3.1:** *Stone fill armoring at bridge abutment. [Inspection photo dated 2016]*
