**STATE OF VERMONT  
AGENCY OF TRANSPORTATION**

**Scoping Report**

**Castleton BRF 015-2(10)**

**VT ROUTE 30, BRIDGE #93 OVER THE  
CLARENDON & PITTSFORD RAILROAD**

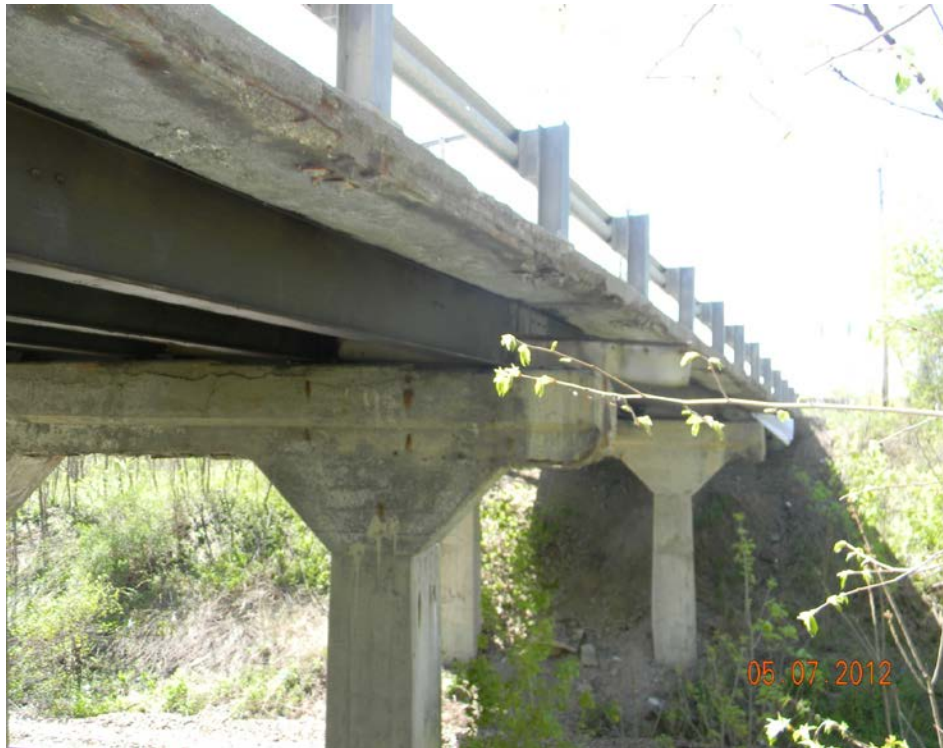
- The latest inspection report lists the structure as “structurally deficient”.
- The deck and superstructure are in fair to poor condition. Multiple holes have been patched in the deck previously and there is concern that full depth holes will open in the deck at any time.
- The existing deck geometry is substandard.
- The current curb to curb width is 25.5 ft., which is substandard.
- The existing sight distance and “K” values are substandard due to the vertical geometry of the approaches.
- The bridge rails are steel beam on steel posts. The latest Inspection Report indicates that the existing bridge rails do not meet current standards. This report also has the following ratings:

East side of bridge looking north – Deteriorating Deck Overhang

This alternative allows for all bridge elements to be replaced. The new deck should be wider than the existing to meet standards. New TL-2 bridge rails are recommended, and consideration should be given to a bare deck surface to economize on depth of section. A new bridge would have a single span of approximately 65 ft., and would be founded on integral abutments if bedrock conditions allow. If pile installation is not feasible, then geosynthetic-reinforced soil

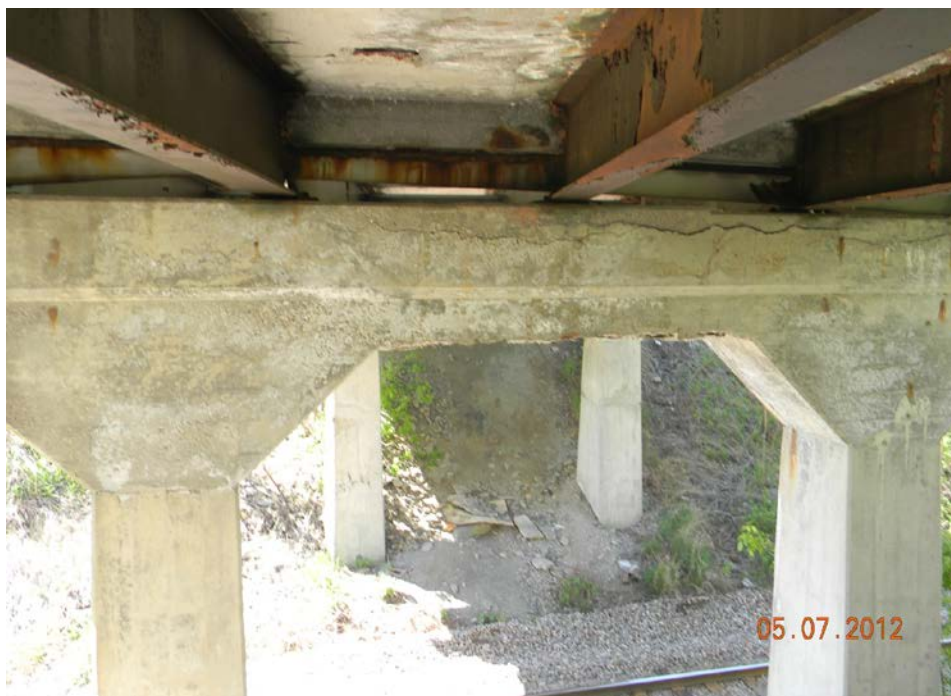
“5/18/2011. Fair to poor condition deck continues to deteriorate along top and soffit. Steel continues to deteriorate and substructure continues to deteriorate. Structure needs major recon or full replacement in near future. Deck has potential full depth holes at anytime. MK PH”

Underside of bridge looking north – Deteriorating Superstructure

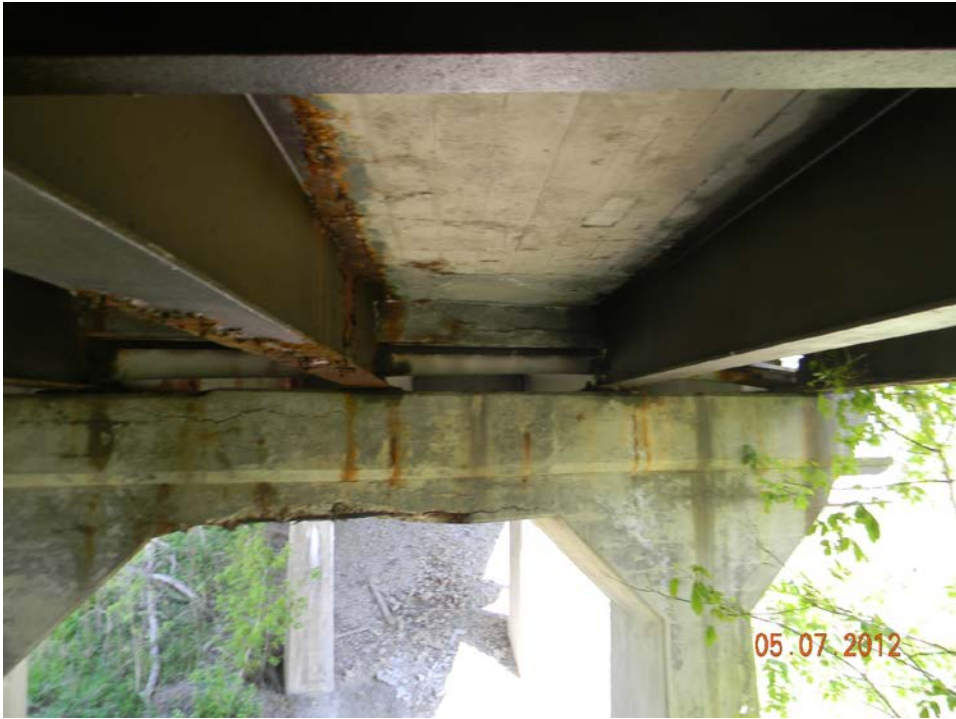
Underside of bridge looking north

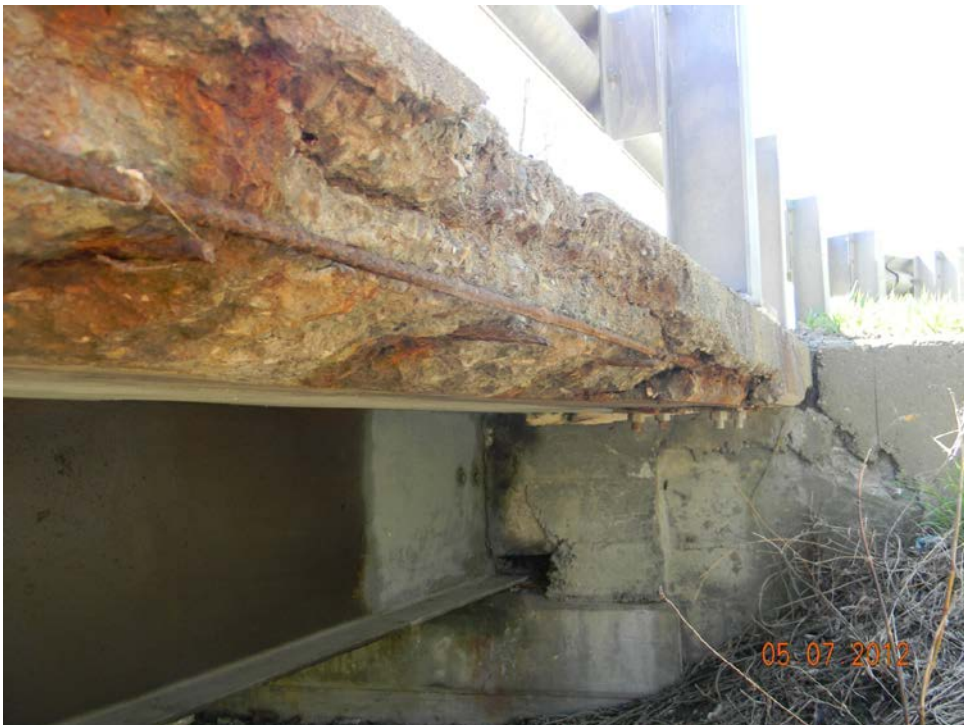
Close-up, west side of bridge deck looking south

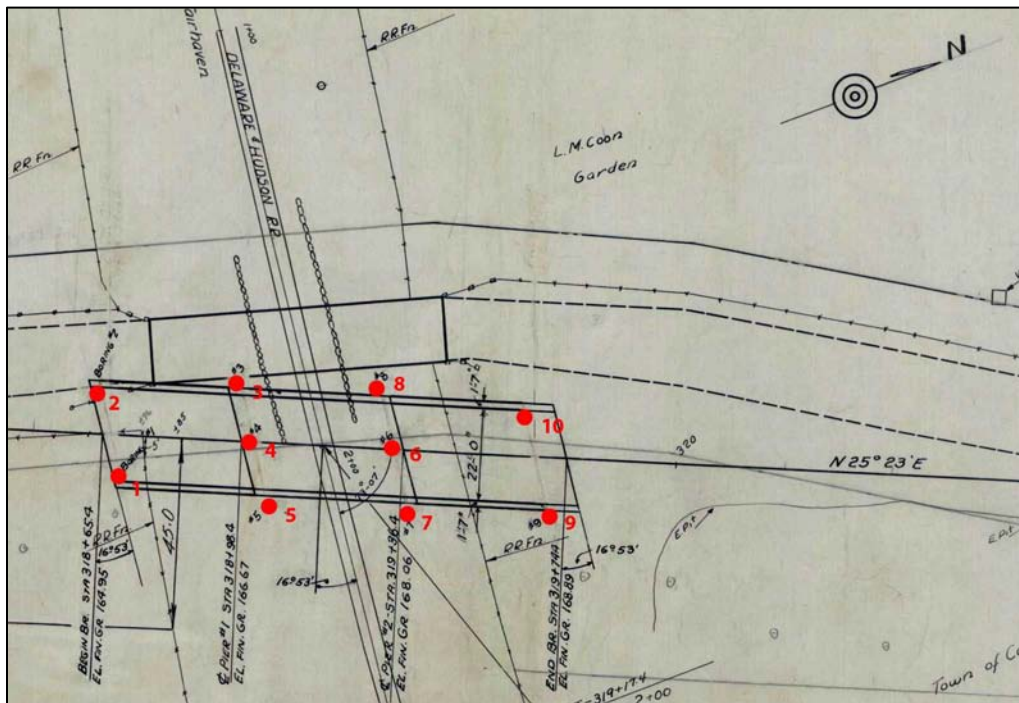
As-built plans show that there were ten borings drilled in 1939 in preparation for the design of the current bridge (Figures 3 and 4). These borings show that the area of the bridge is underlain by sandy loam, sand and gravel and clay. Bedrock was not encountered to depths of approximately elevation 140 feet.

Figure 3 Part of 1938 plan set showing location of borings.

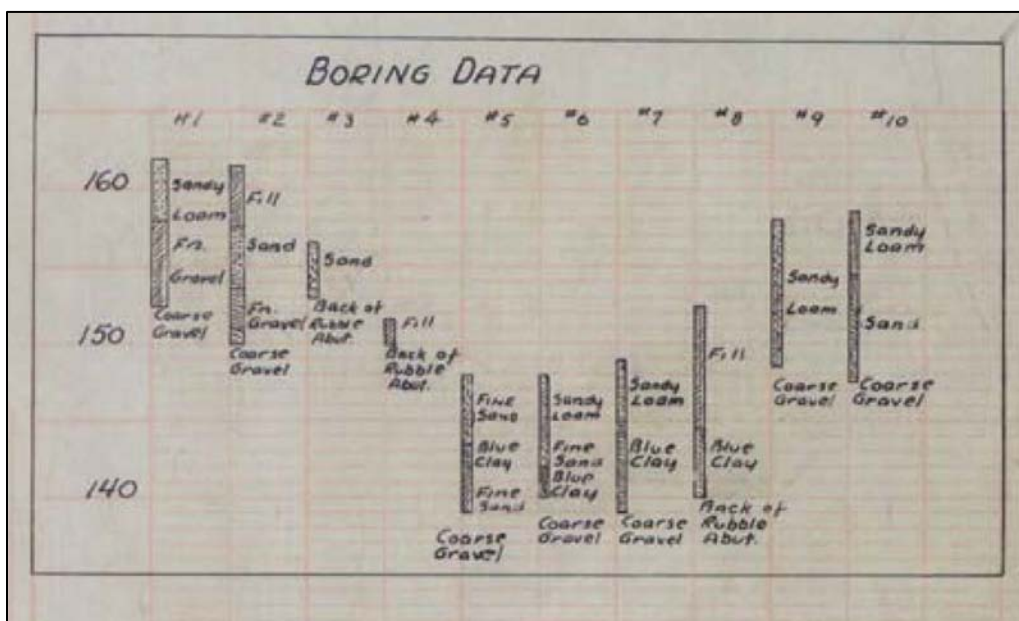
Figure 4 Borings from 1939 As-Built plans.

Since the depth to top of bedrock may be relatively shallow in the area of Bridge 93, we recommend that four borings be conducted (two at each abutment). Borings should extend into bedrock.

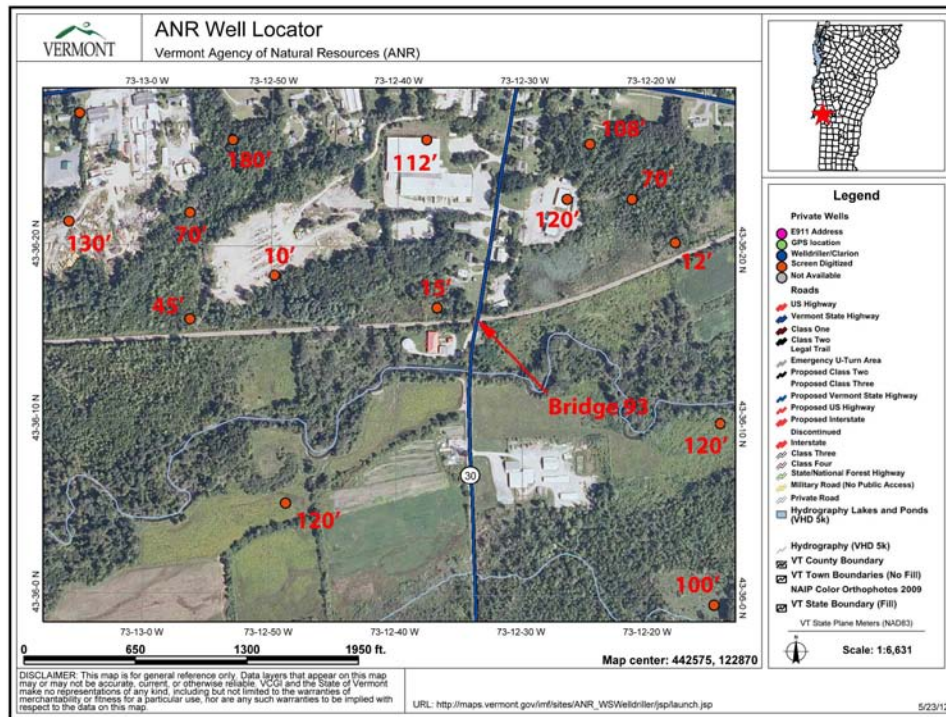
bedrock within the project area is at depths ranging from 12 to 180 feet below ground surface. The closest water well located approximately 225 feet west northwest of the bridge reported top of bedrock to be at 15 feet. Based on the distribution of depth to bedrock depths in the area, the depth to top of bedrock is quite variable and it appears that there is a bedrock high trending east-west through the area of the bridge. The closest well to the project reports fine sand from ground surface to 15 feet. These sands reportedly overly green and purple colored slate (bedrock).

Figure 5 Private water wells in vicinity of Bridge 93. Depth to bedrock is noted.

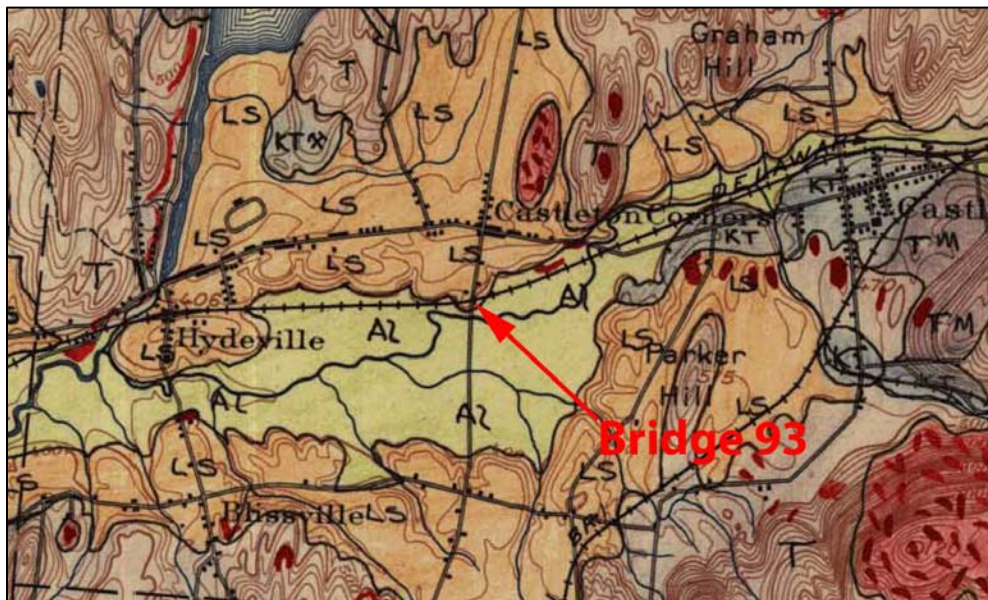
Surficial mapping conducted for the 1970 Surficial Geologic Map of Vermont indicates that the subject area is underlain by glacial sand deposits. Recent alluvial sands and gravels overly the glacial deposits within the Castleton River floodplain. A portion of the original surficial geology field mapping is presented as Figure 4.

Figure 6 Surficial geologic map showing distribution of soil. AL=Alluvium, LS= Glacial Lake Sand, T= Glacial Till.

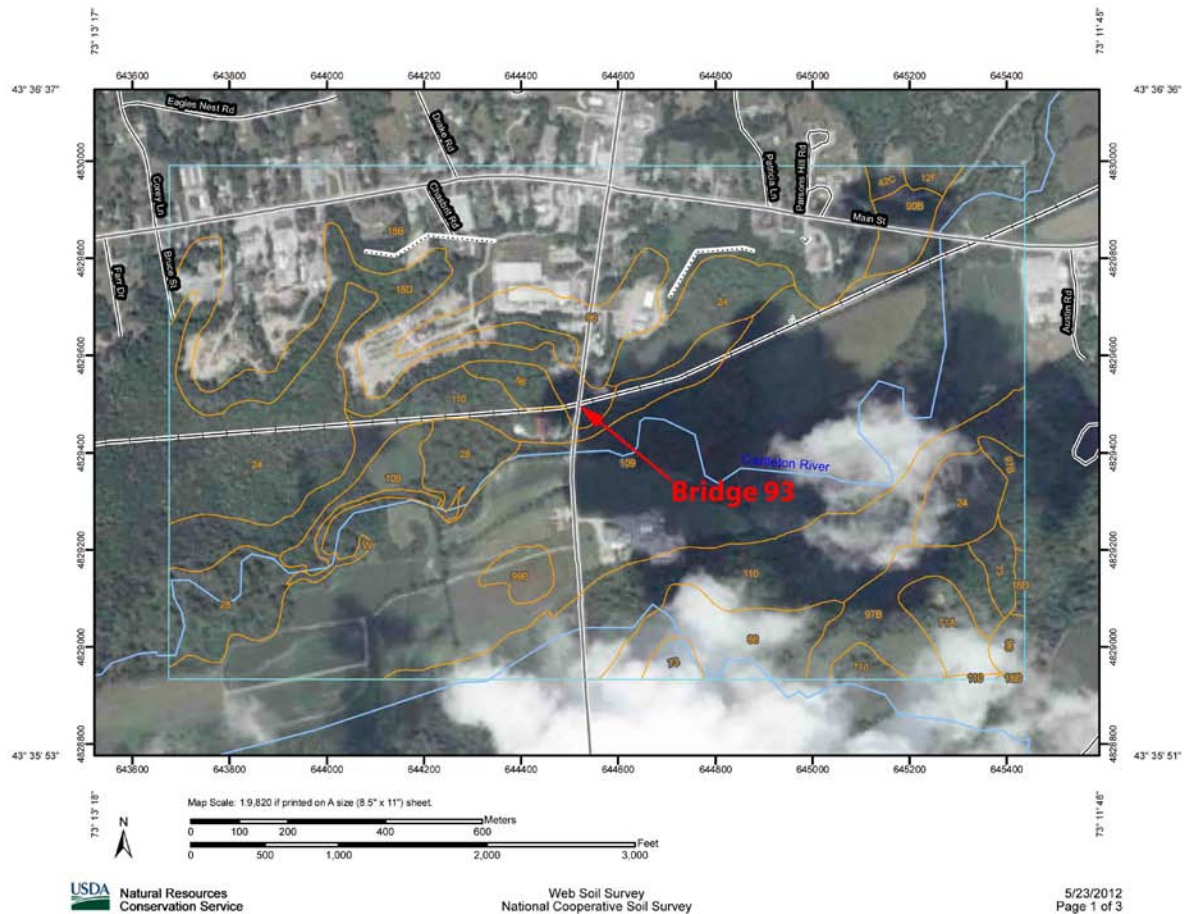
USDA Natural Resources Conservation soil survey records indicate that surficial soils in the area of the bridge consist of Sandy glaciofluvial deposits of the Windsor Loamy Sand complex. Figure 5 shows the portion of the USDA NRCS soil map.

Figure 7 USDA NRC Soil; Survey map showing distribution of soil complexes in the vicinity of Bridge 93.
