STATE OF VERMONT
AGENCY OF TRANSPORTATION

Scoping Report

Andover BHF 016-1(29)

VT ROUTE 11, BRIDGE 41 OVER MIDDLE BRANCH OF WILLIAMS RIVER

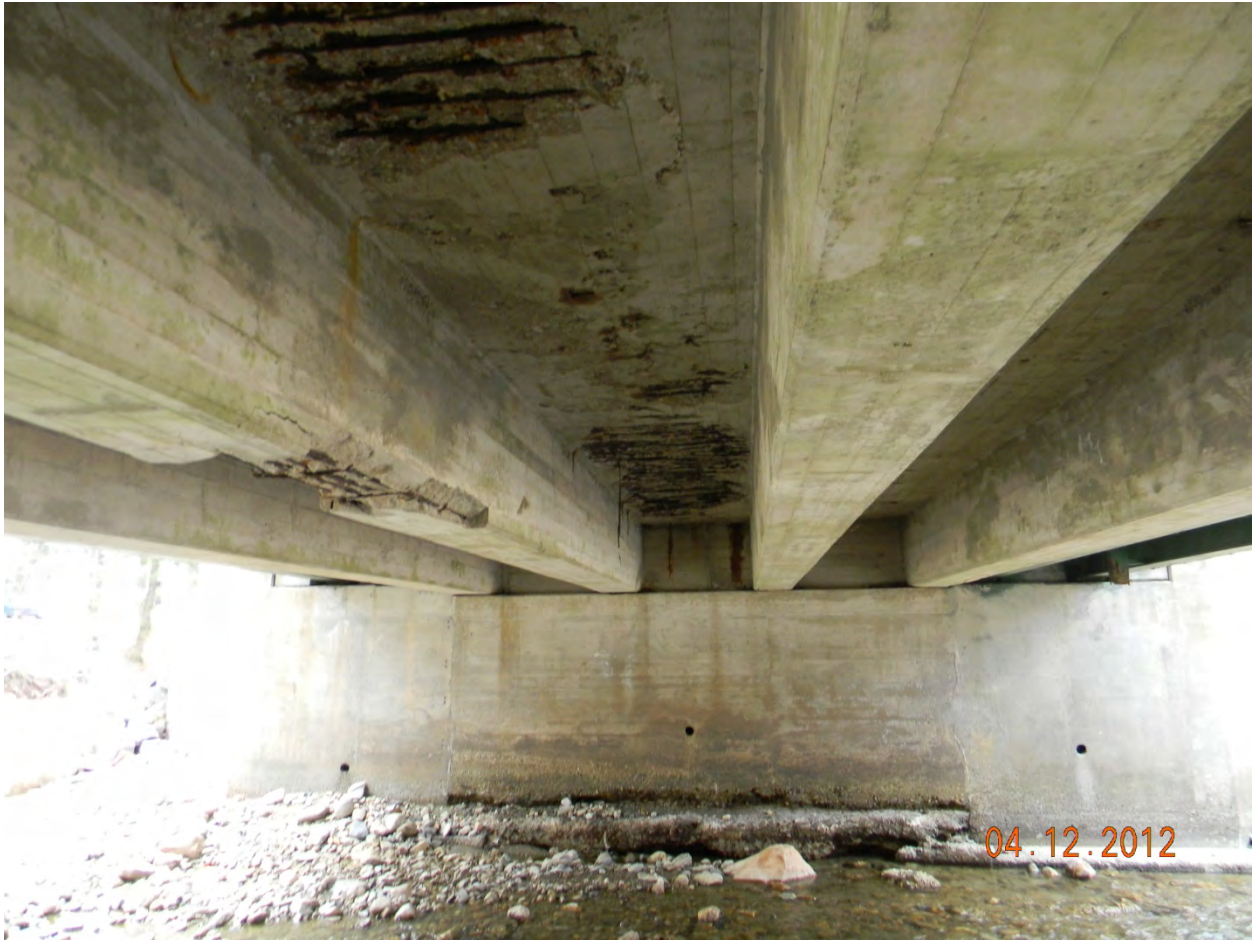
04/07/2011 – Deck continues to deteriorate and full depth holes could occur at any time. Tee beams 4 & 5 continue to deteriorate. Abutments are in satisfactory condition. There is some scour along abutment 1 exposing the footing. ~DCP/FRE

West Abutment (Note Deck/T-Beam Deterioration)

- Undermining along the eastern abutment should be filled in, and measures should be taken to protect against future undermining.
- Repair of minor spalling along the water line.

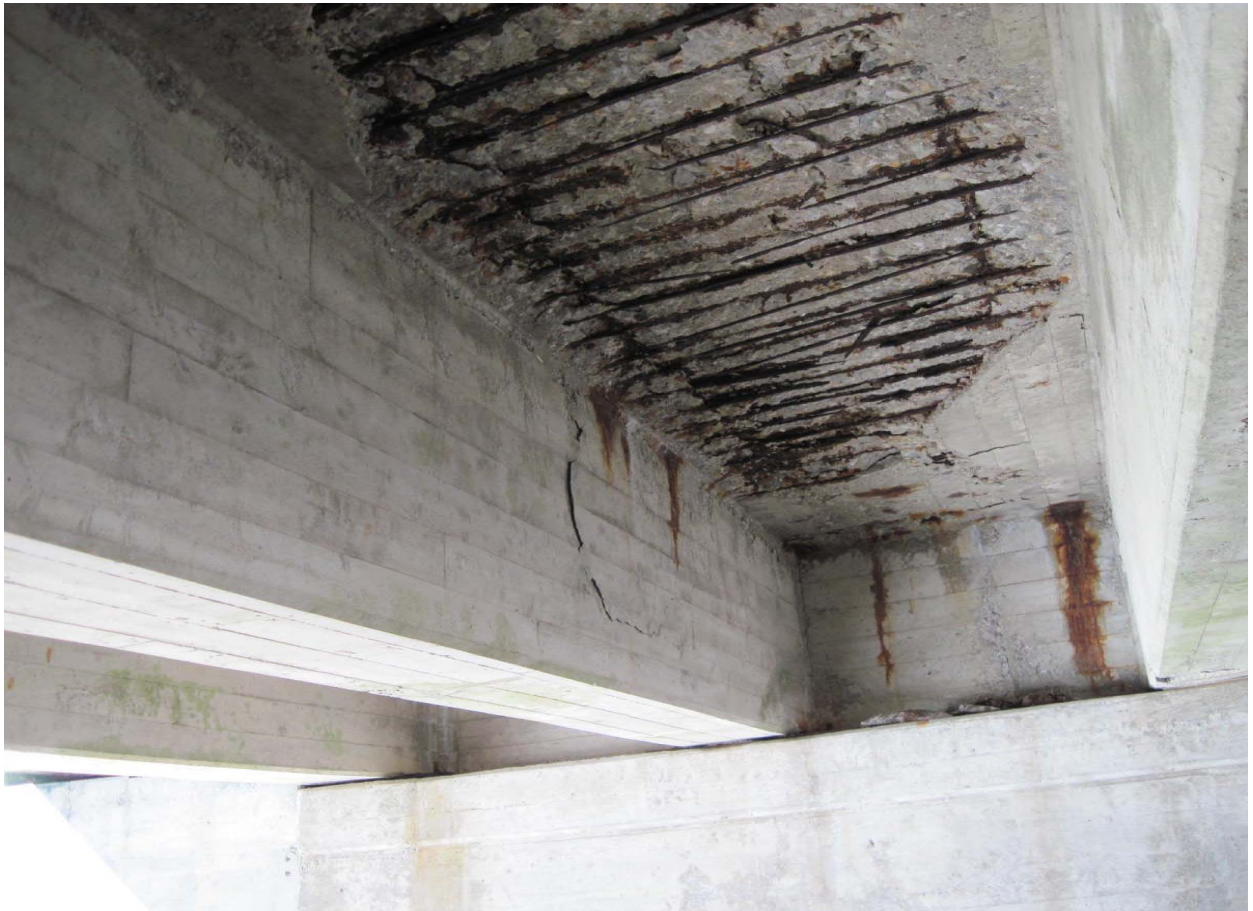
1. The deck slab is in poor condition, and at risk for full depth holes.
2. There is a scour issue along the eastern abutment's upstream wingwall. Also, the east abutment's stem has a significant amount of undermining.

Exposed Reinforcing Steel in Deck

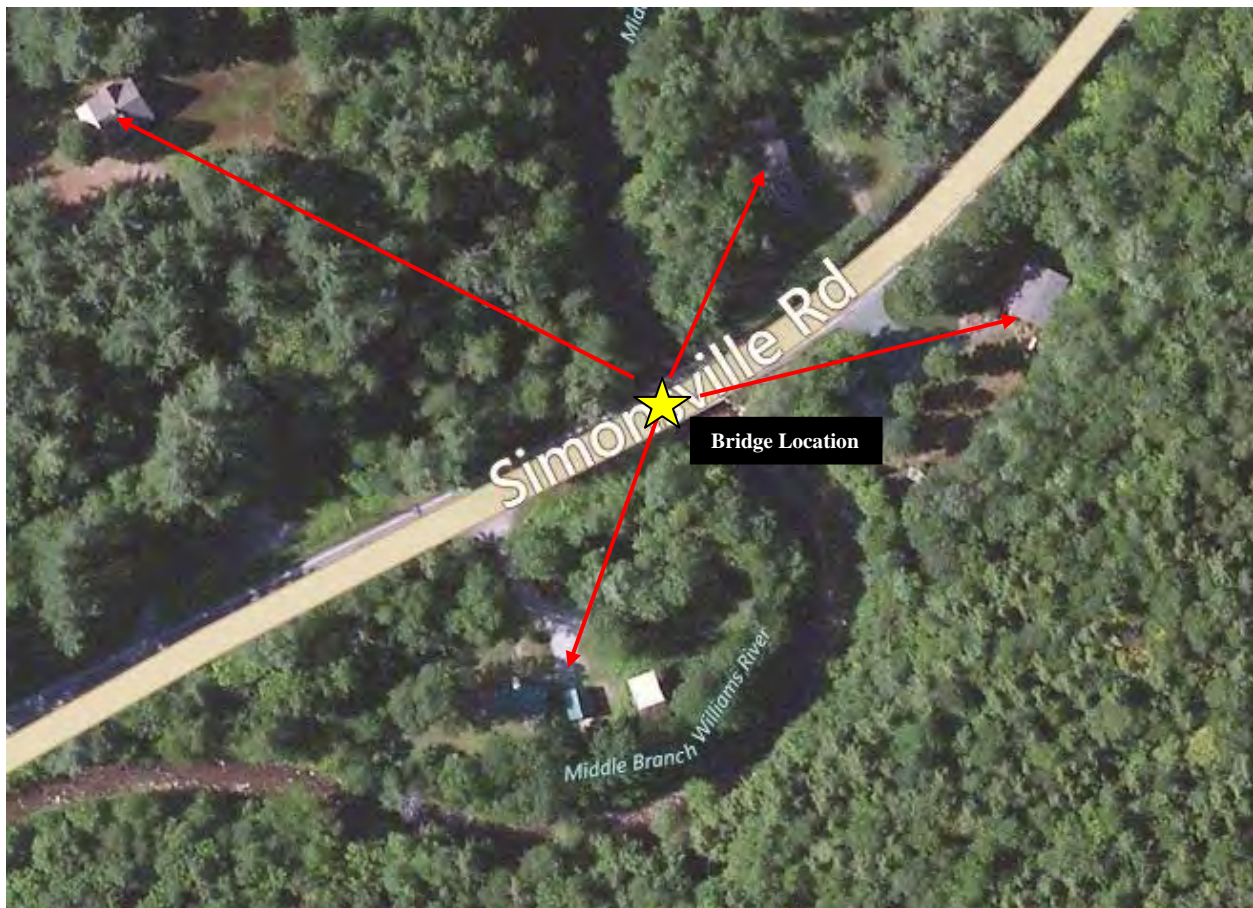
Overhead power crosses the road before the bridge approach and runs along the south side of the road, which in combination with a power pole in the southwest corner, may interfere with the borings. Numerous cobbles and some small boulders were prevalent in the streambed and along the banks, which may also impede boring and construction operations. Several residential houses were noted in close proximity to the bridge, which will need consideration during the design and construction phases. These are seen in Figure 3.

Figure 3. Proximity of residential houses to project location.
