Town: 26 - BRATTLEBORO

| IDENTIFICATION | |
|---|---|
| (8) Structure Number | 200010005413022 |
| (6) Features Intersected | WHETSTONE BROOK |
| (7) Facility Carried | VT 00009 ML |

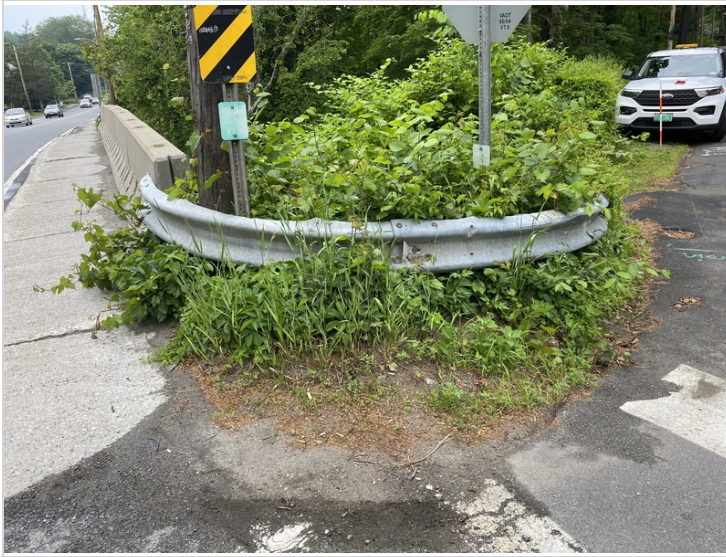
Northeast Transition

Reinforced concrete jersey barrier bridge rail transitions into single galvanized steel beam rail on all four (4) corners. Post spacing is original with no additional posts and rail is original.

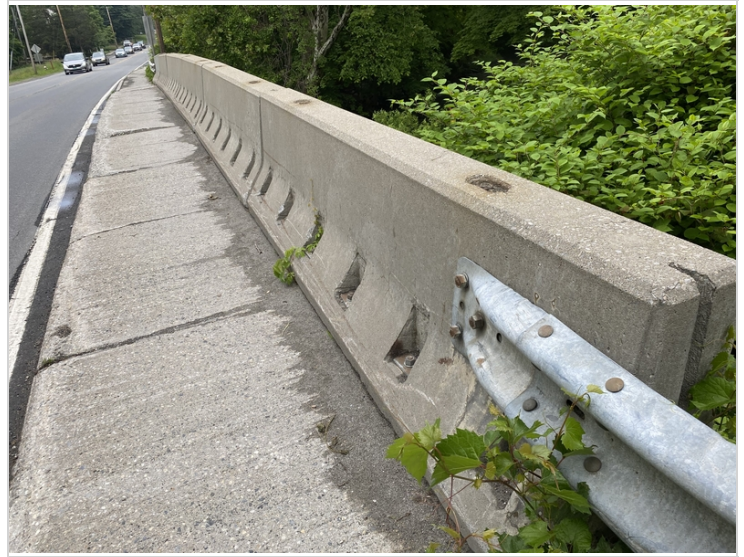
Upstream Rail

Reinforced concrete jersey barriers are present both upstream and downstream in good condition.

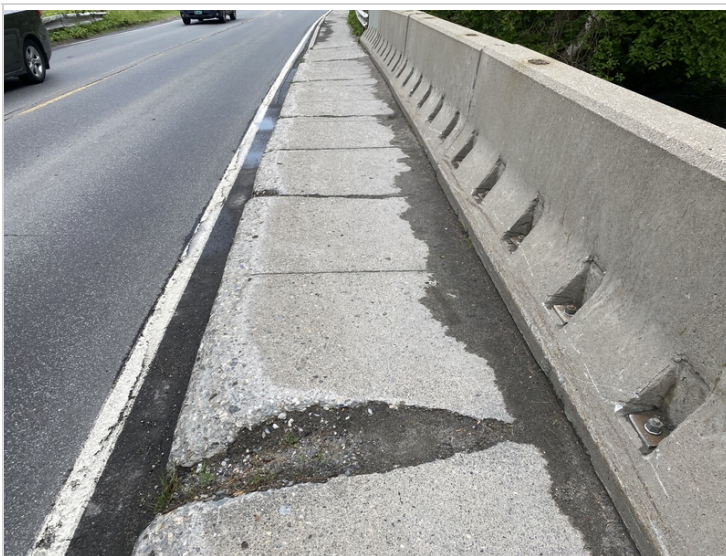
Sidewalk from Eastern End

Concrete sidewalk is present along the upstream side only being in fair condition having areas of minor to moderate concrete scaling and abrasion. Asphalt patches are present where scaling is heaviest. Heavy breakup is present along the abutment #1 end (Western side) with minor settlement.

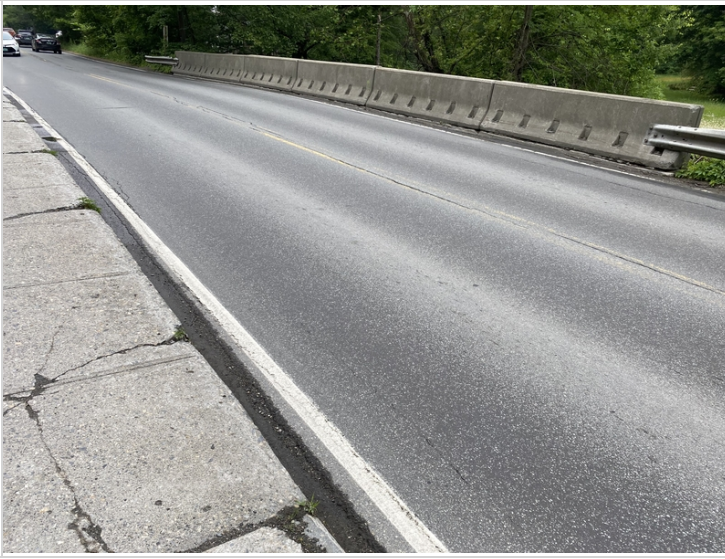
Wearing Surface over Structure

Asphalt over structure was recently paved in good condition.

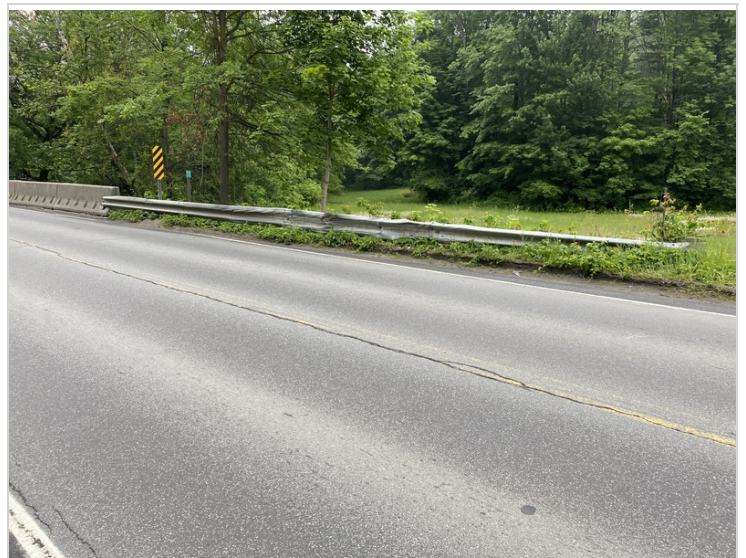
Southwest Approach Rail

Galvanized steel beam rail is in fairly good condition having some minor scrapes and dents along the face of rail along the downstream side.

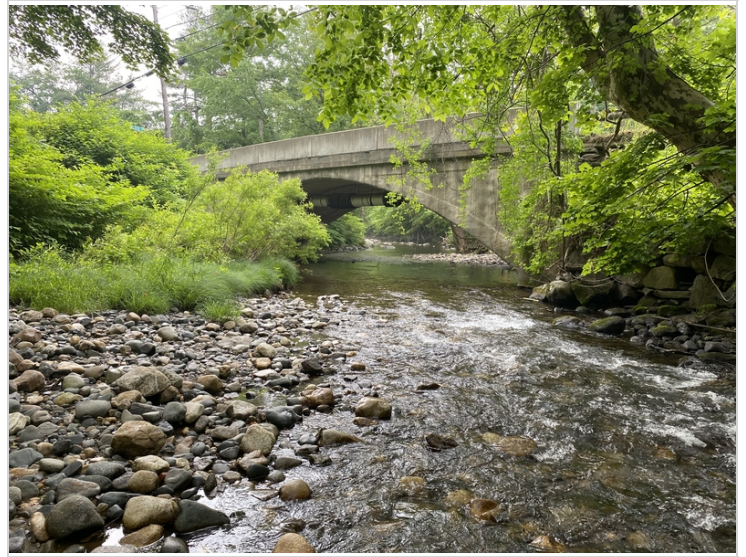
Upstream Elevation

Reinforced concrete arch is in satisfactory condition having minor wearing along the lower portions of both ends. Both the upstream and downstream fascia's have shotcrete present with minor cracking with saturation and efflorescence leakage present along the lower portions. Downstream edge along the abutment #1 side (western end) has a small area of spalling that has exposed the steel reinforcing along the lower portions.
