**STATE OF VERMONT
AGENCY OF TRANSPORTATION**

**Scoping Report
FOR
Burke BO 1447(31)**

**TOWN HIGHWAY 31, BRIDGE 35 OVER THE WEST BRANCH OF
PASSUMPSIC RIVER**

March 9, 2018

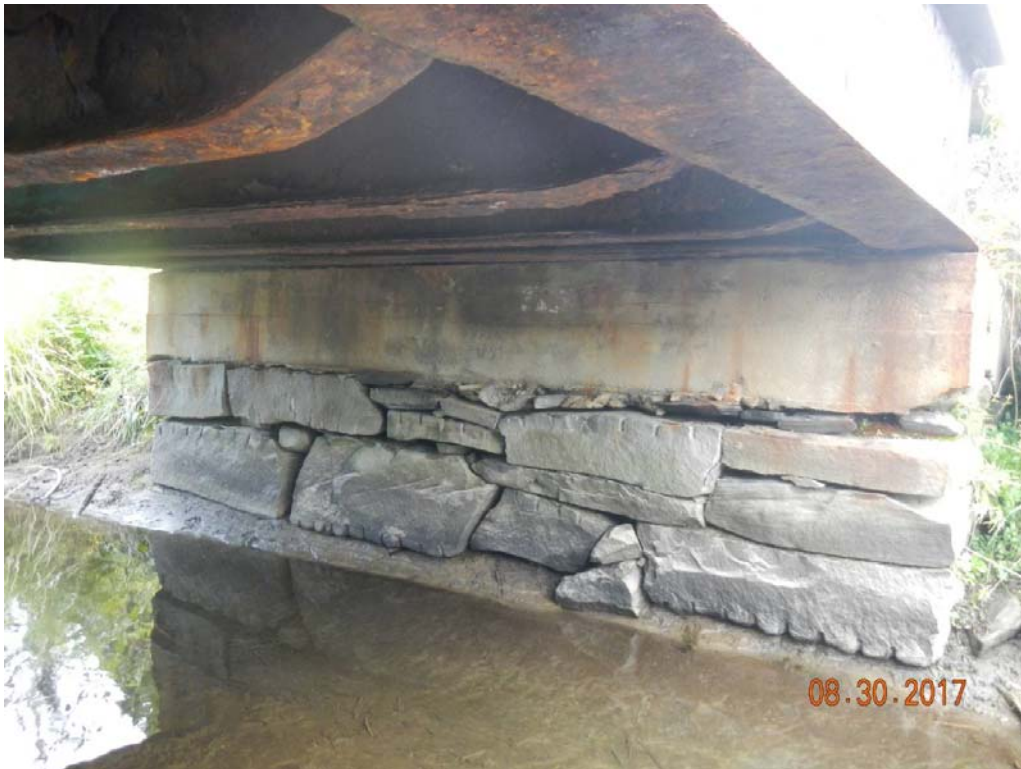
Eastern abutment

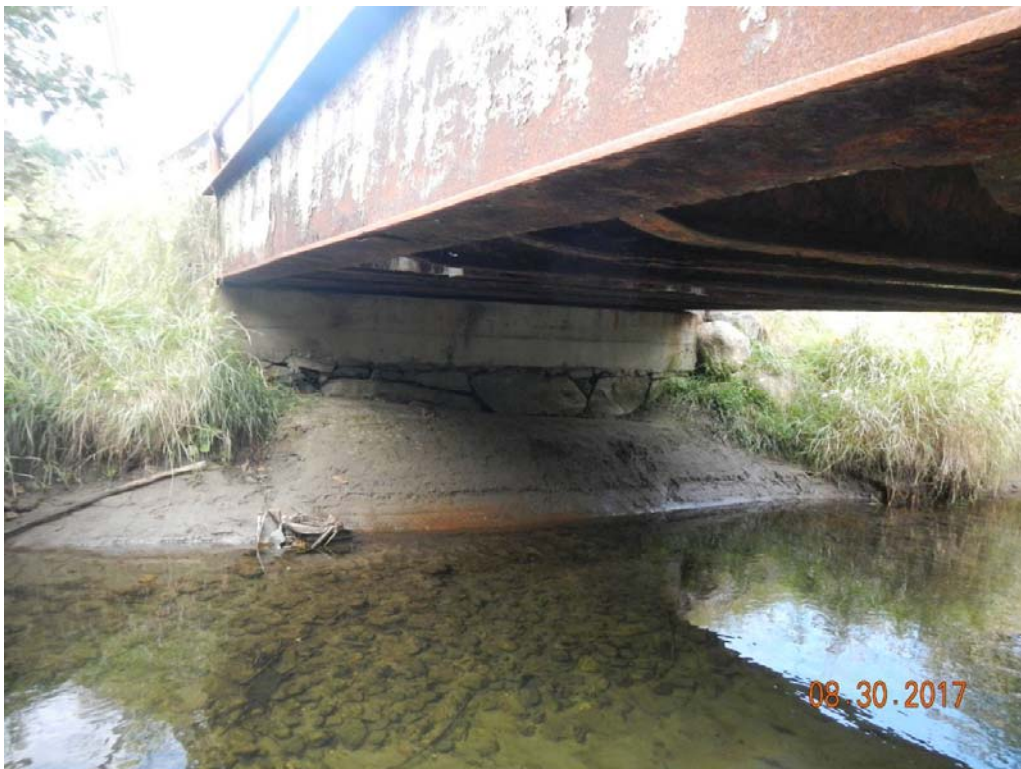
Western abutment

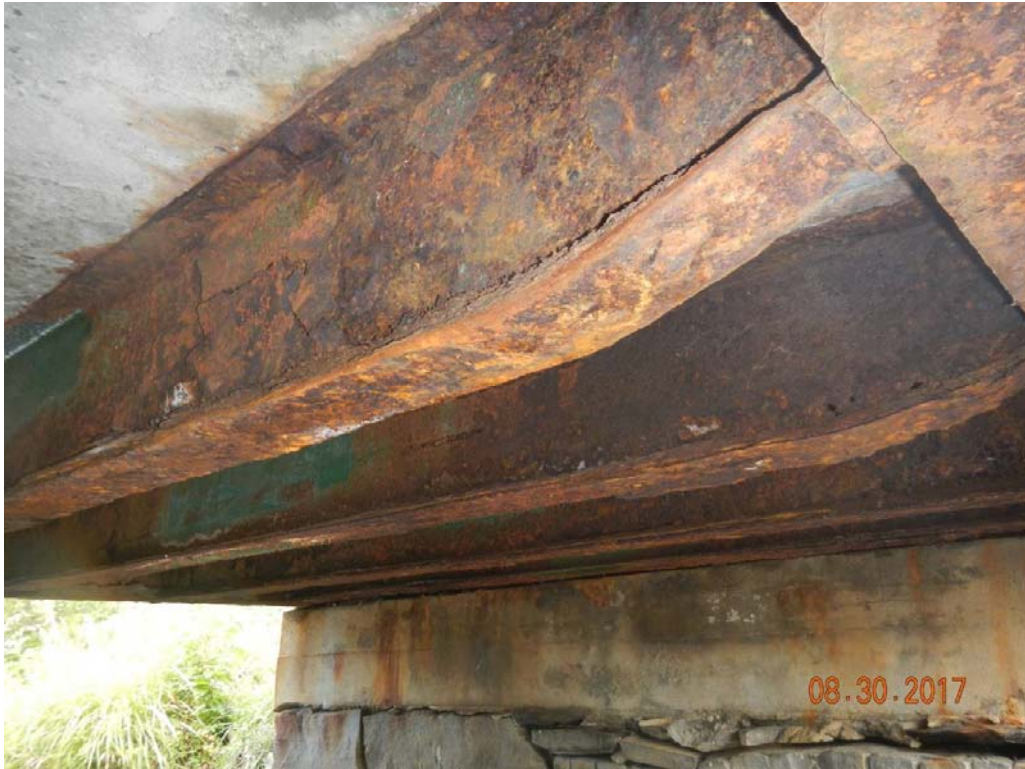
07/11/13 – Structure was closed due to deterioration and overloading. Numerous floorbeams are crushed and connectors sheared off. ~MJK/SP

Existing failed superstructure

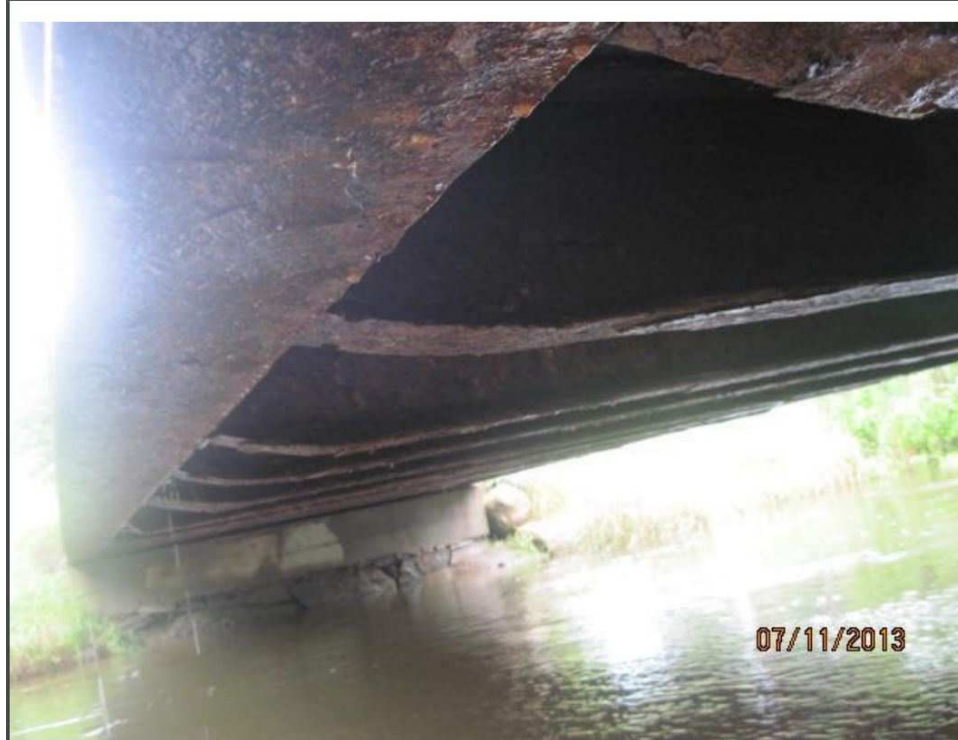
An inspection team visited the bridge in September of 2014 and September of 2016 but no inspections were performed as the structure was closed to all traffic. The bridge was closed to all traffic following an inspection in July of 2013 due to crushed floor beams and sheared connectors, as seen in Figures 3-5 below. It was noted in the inspection from September of 2012 that the structure was in need of full replacement due to rapidly progressing deterioration.

Figure 3. Floor beams noted as crushed in the July 2013 inspection report

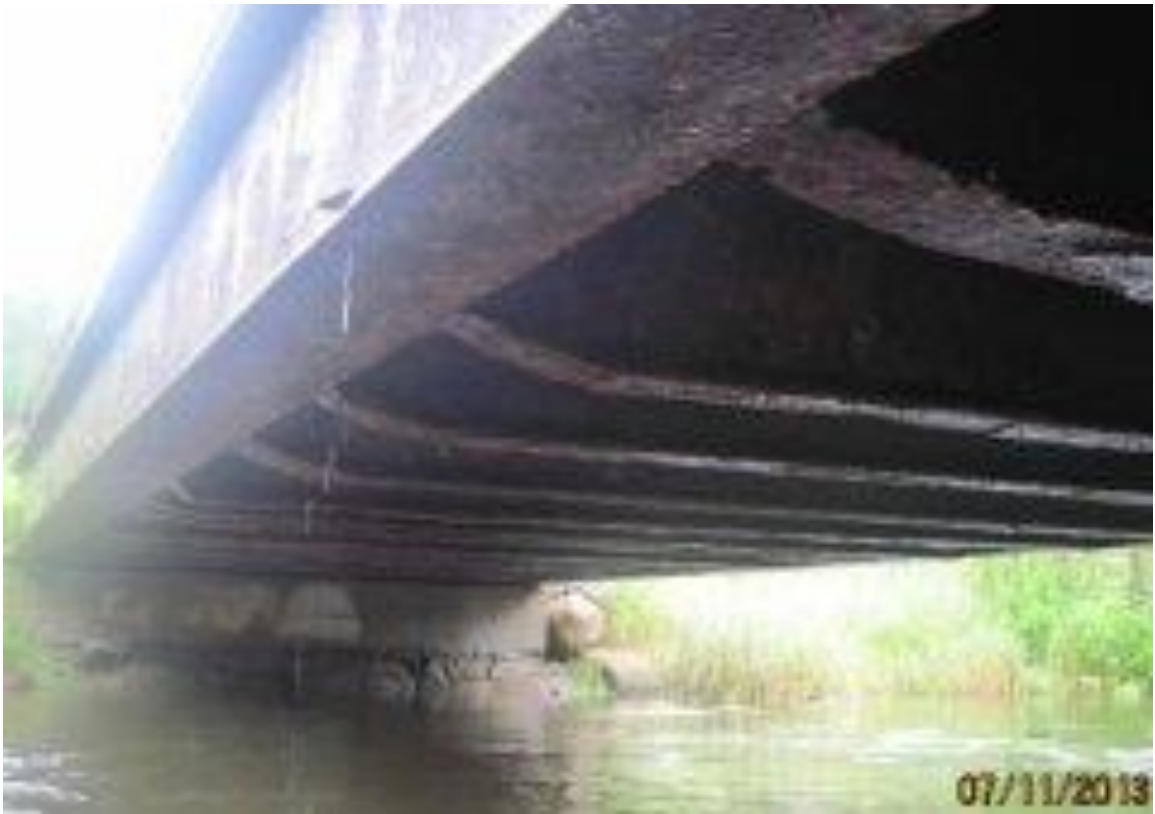
Bridge No. 35; Note extensive rust.
