**STATE OF VERMONT  
AGENCY OF TRANSPORTATION**

**Scoping Report  
FOR  
Danby BF 0130(4)**

**FAS ROUTE 130 (TH 1), BRIDGE 7 OVER MILL BROOK**

March 8, 2022

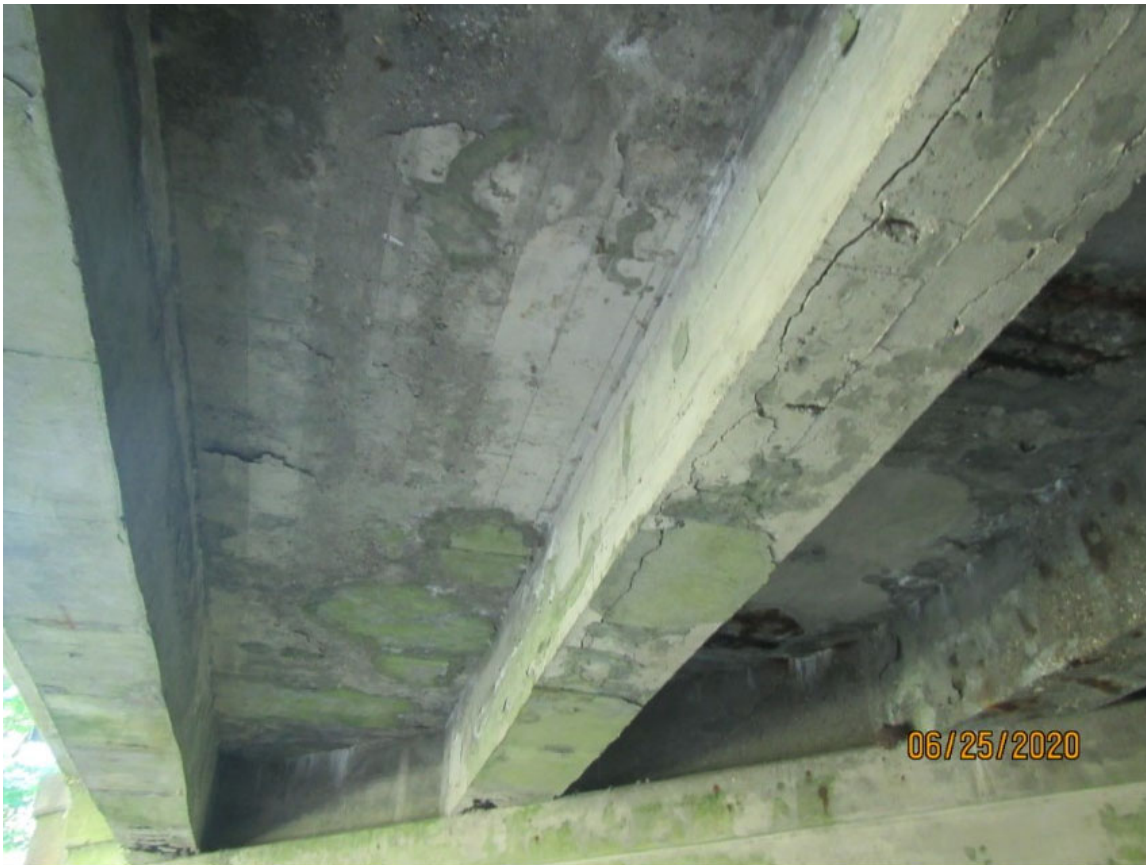
1. The existing concrete T-beams are in satisfactory condition; however, they have patched areas throughout, small pop outs and areas of spalling with exposed reinforcing in the beam ends. Beams 1 & 2 have moderate to heavy saturation with scattered rust staining, small delaminations and areas of spalling with exposed reinforcing. Beam 3 has wide lineal cracking along the base and scattered small delaminations throughout.

Picture 9: T-beam deterioration

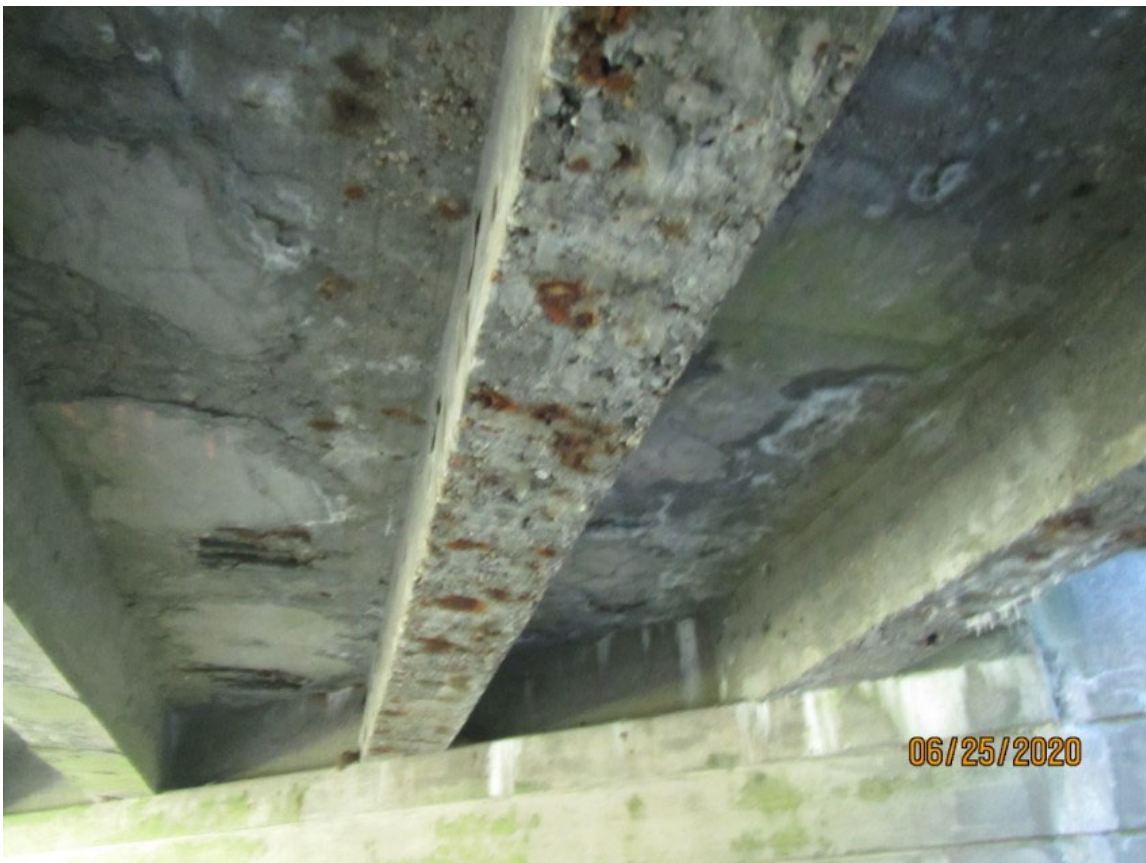
Picture 10: T-beam deterioration

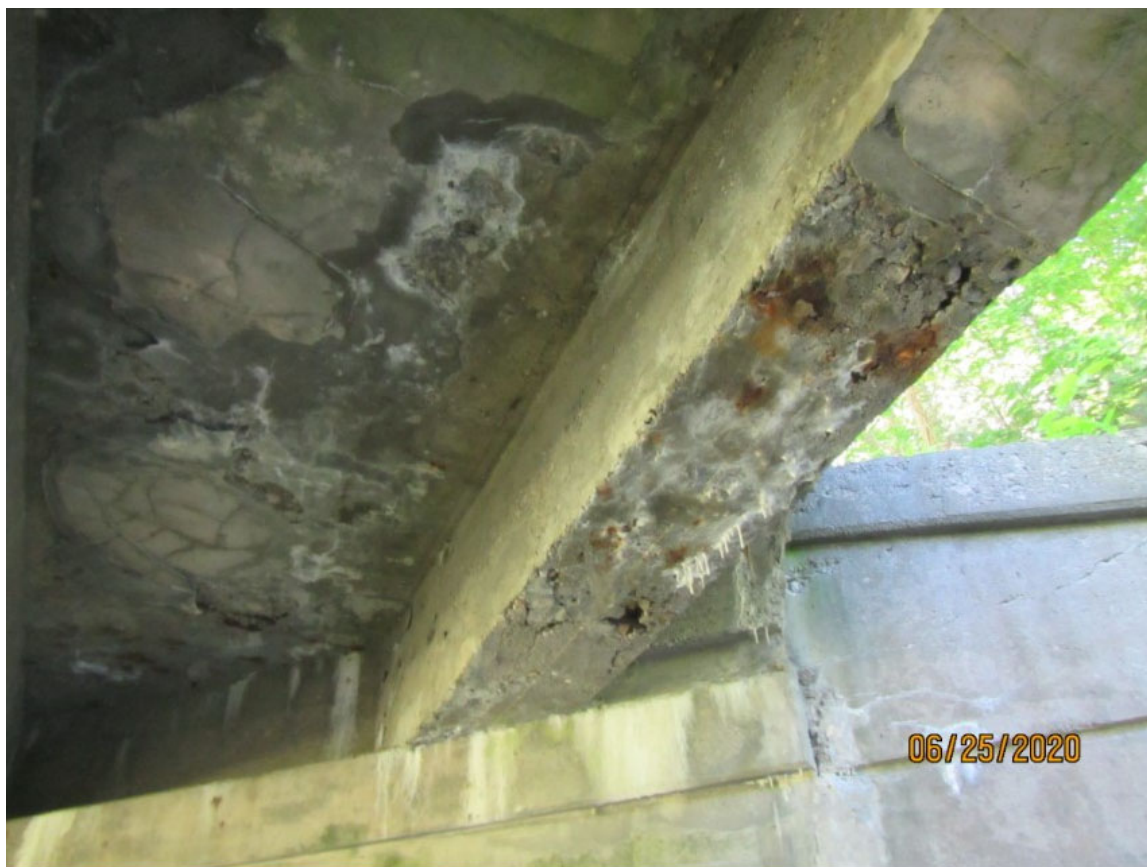
Picture 11: T-beam deterioration

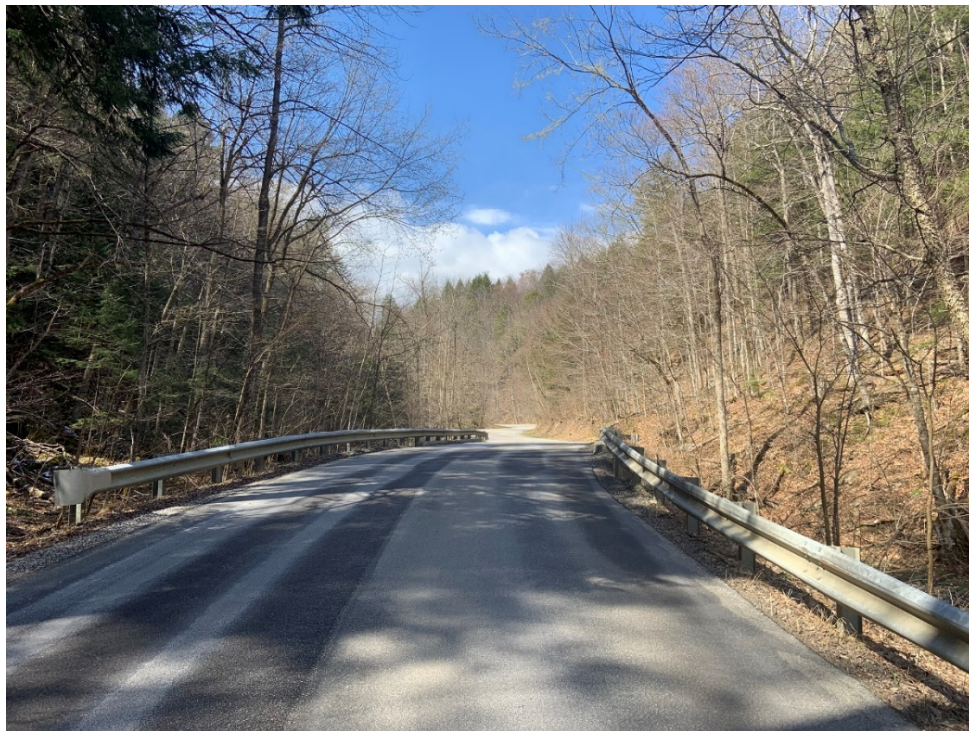
**Figure 3.1:** Looking west along Route FAS 0130, note no overhead utilities present near the bridge.

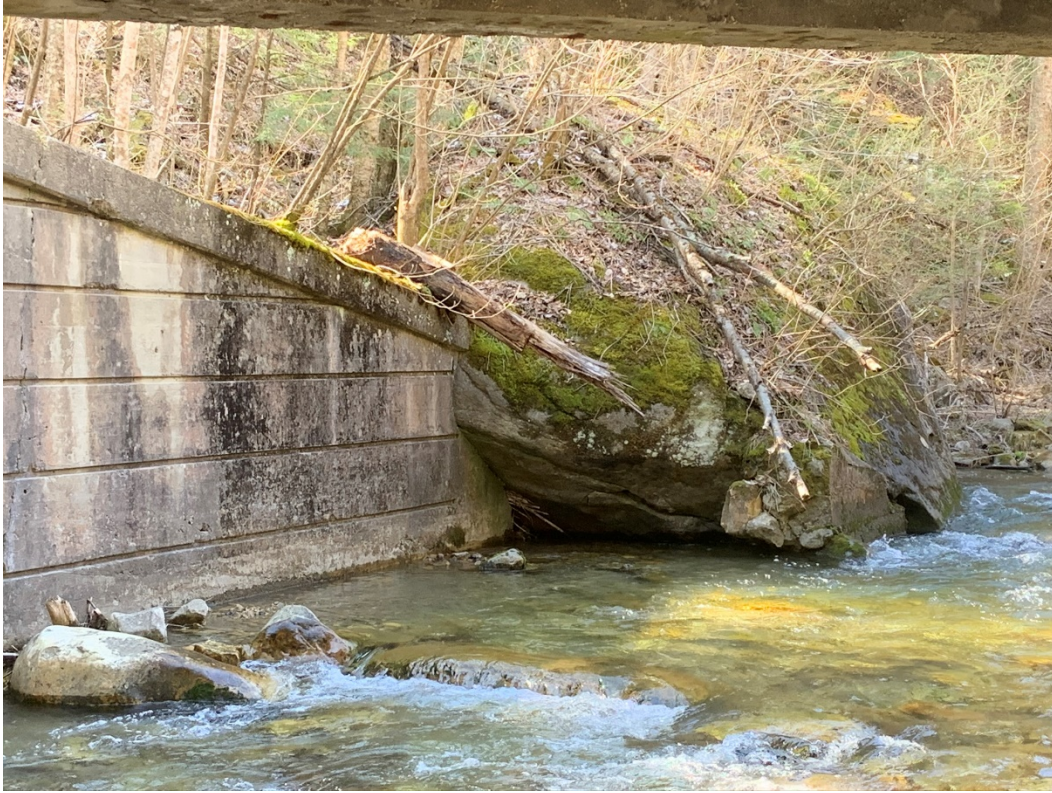
**Figure 3.2:** *Facing eastern upstream wingwall, note wingwall cast around large boulder present.*

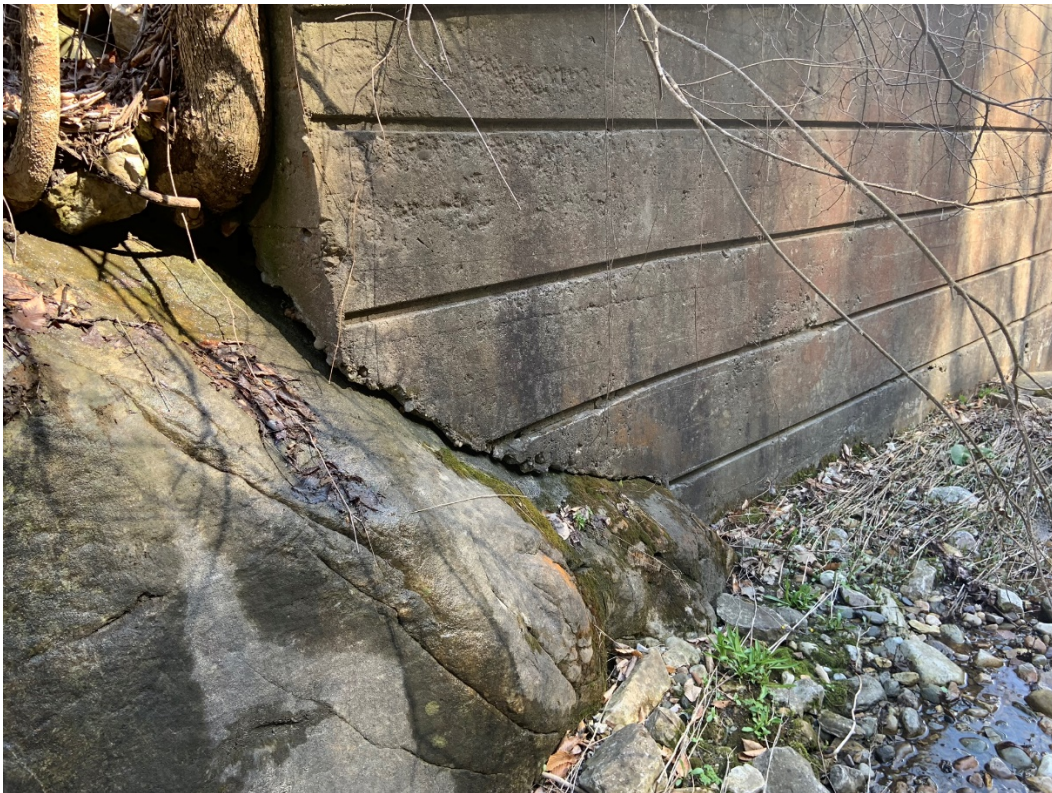
**Figure 3.3:** *Western upstream wingwall of bridge, note wingwall cast around large boulder present.*

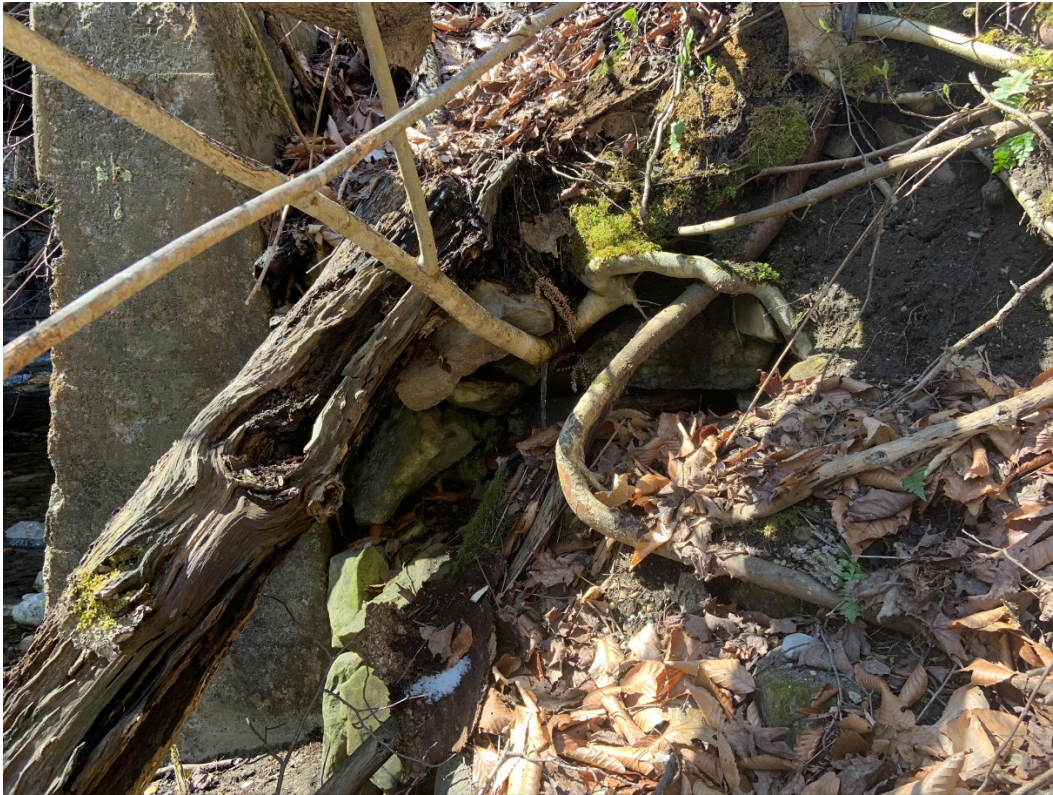
**Figure 3.4** *Western downstream wingwall of bridge, note voids present within cobble and sand backfill.*

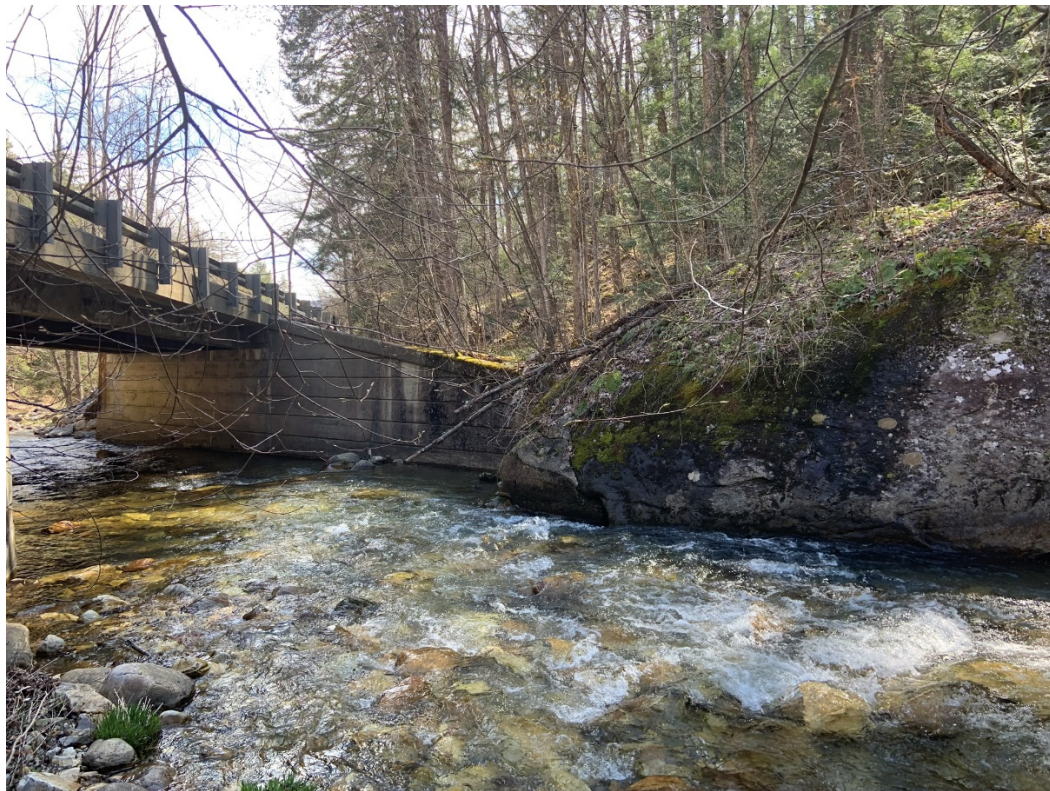
**Figure 3.5:** *Large boulder present upstream of bridge, note presence of cobbles and boulders in streambed.*
