STATE OF VERMONT AGENCY OF TRANSPORTATION

Scoping Report

Huntington BO 1445(38) Town Highway 22, BRIDGE 32 over Brush Brook

January 14, 2019

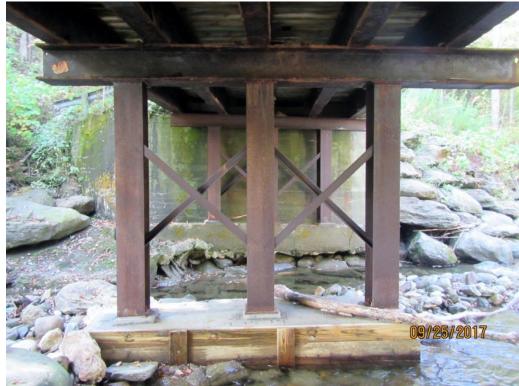
The substructure is rated 5 (fair). Scour has occurred at the base of both abutments, but particularly at the east abutment. There are also cracks in both abutments. These deficiencies can be rehabilitated, but it is felt that the abutments, if rehabilitated, would give approximately 30 more years of service.

Picture 5: Temporary Mid-Span Support – Note undermining at far abutment

Rehabilitation of the existing substructures would include preparation of the concrete substructure surfaces for a new seal coat, and filling cracks with a cementitious or epoxy sealer to limit water entry. Scour protection measures would be required by adding stable material to the voids around and under the substructures, and minor erosion control work would be needed to stabilize and protect the stream banks in the project area. The bridge seats would have to be rehabilitated by removing the top 6"-8" of concrete and adding new grout or concrete. New bearings would be required.

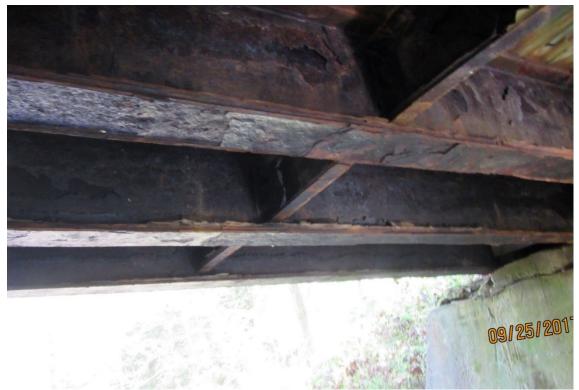
The superstructure, referring to the rolled steel beams, is rated 5 ("fair"). Depending on the nature of the deterioration, it is sometimes appropriate to rehabilitate existing steel sections by removing all rust and recoating the surfaces. Sometimes it is appropriate to add steel plates in areas where deterioration is more advanced. In the case of Bridge 32, some of the steel beams are suffering from extreme section loss, particularly near the ends, to the point where it is not possible to add steel plates and expect them to act in composite action with the beams. In fact, work has been done to add support to the beams on one end in order to relocate the bearing points to a more intact area of the beams. The bearings on the other end are in very rough shape. For this reason, rehabilitation of the superstructure is not recommended and will not be considered further in this report.

Picture 6: Significant Corrosion of Beams
