STATE OF VERMONT
AGENCY OF TRANSPORTATION

Scoping Report

Ludlow Village BO 1443(52)

Town Highway 324, Mill St., BRIDGE 57 Over Black River

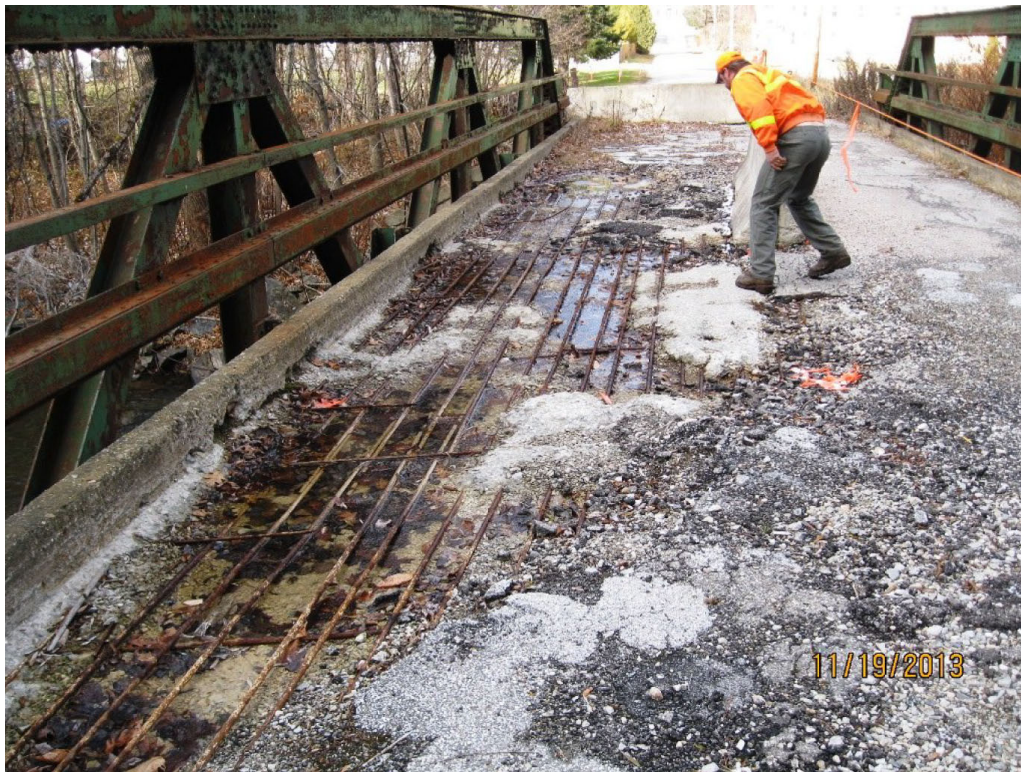
2. The deck is in serious condition with large sections of spalling with exposed reinforcing steel on both the top and underside of the deck.
3. The substructures are in poor condition. The backwalls have many cracks with leaks throughout. The bridge seats are spalling on the ends. Additionally, the abutment stems have cracks with leakage throughout as well as some areas of deep spalling.

Picture 5: Exposed Reinforcing Steel on Deck

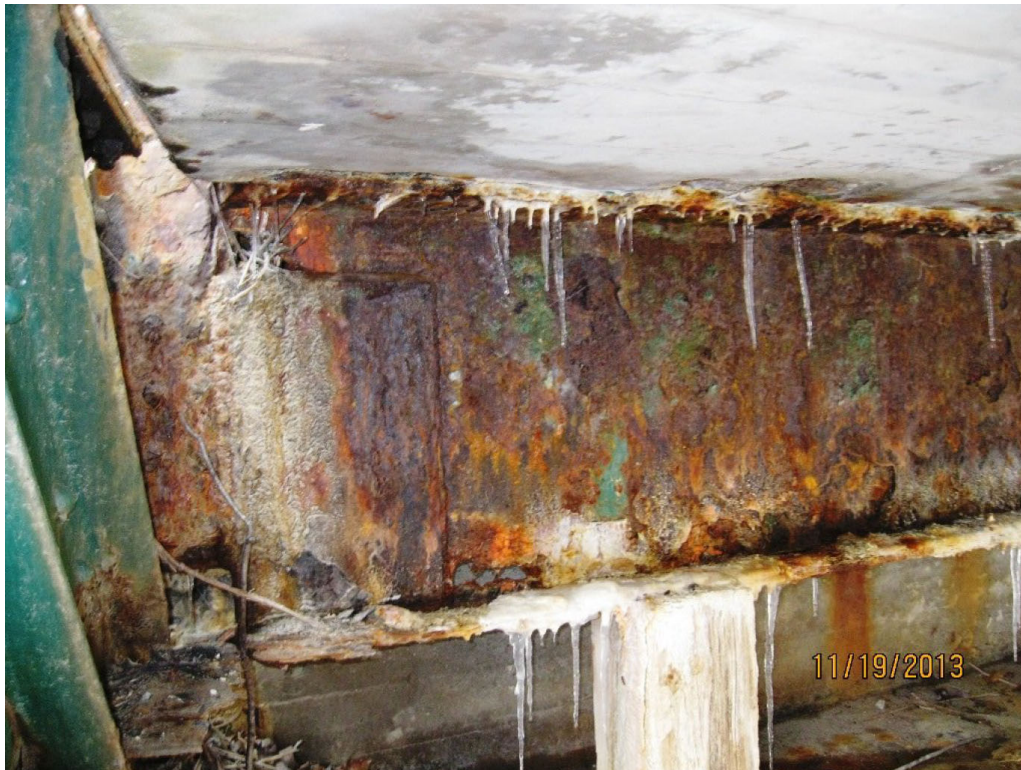
1. Bridge 57 is considered Structurally Deficient and was closed to vehicular traffic on October 10th, 2007 due to the amount of section loss in the gusset plate connections and floorbeams.

Picture 6: Deteriorated Floorbeam

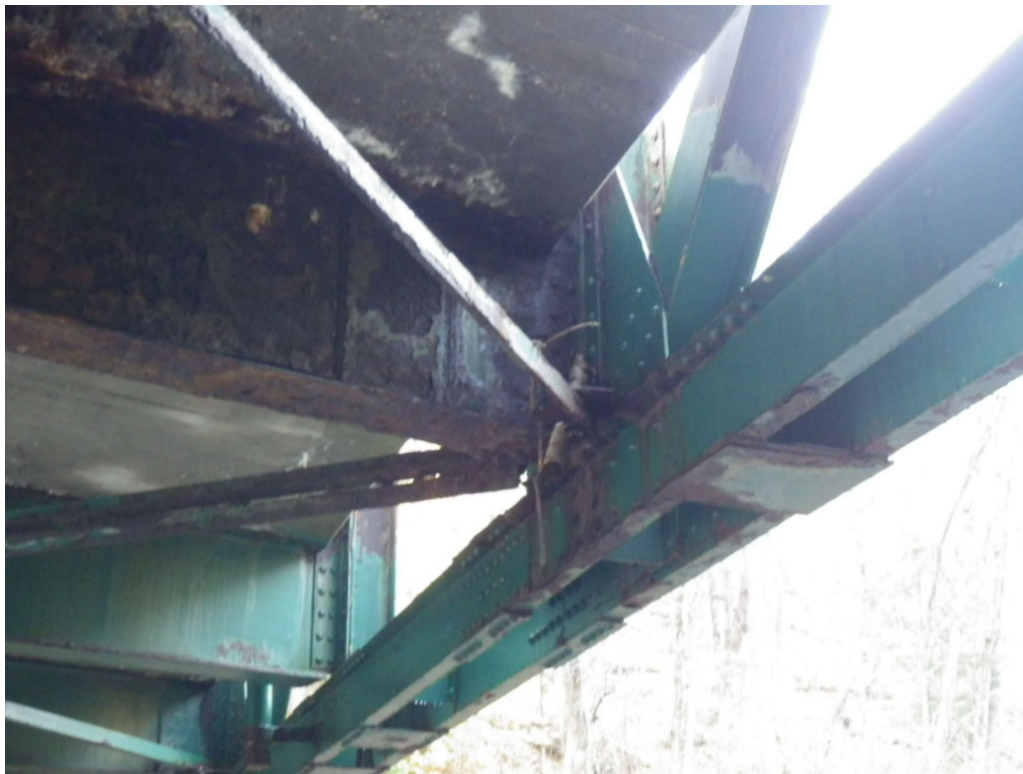
Picture 11: Deteriorated Floorbeam

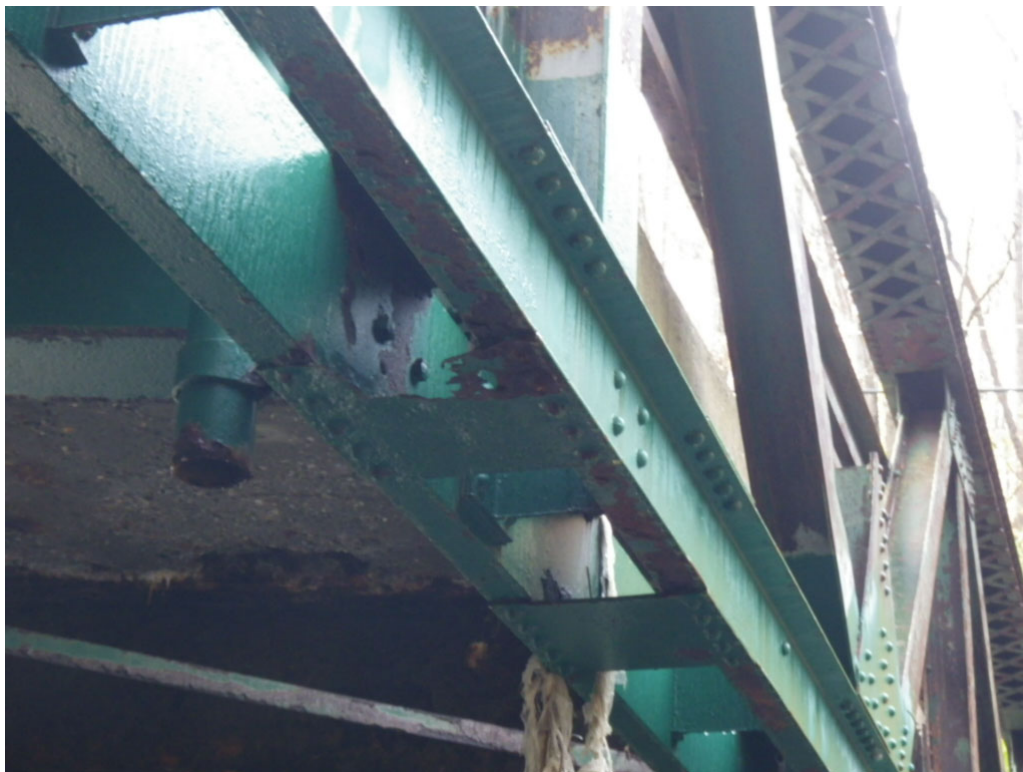
Picture 12: Section Loss at Gusset Plate

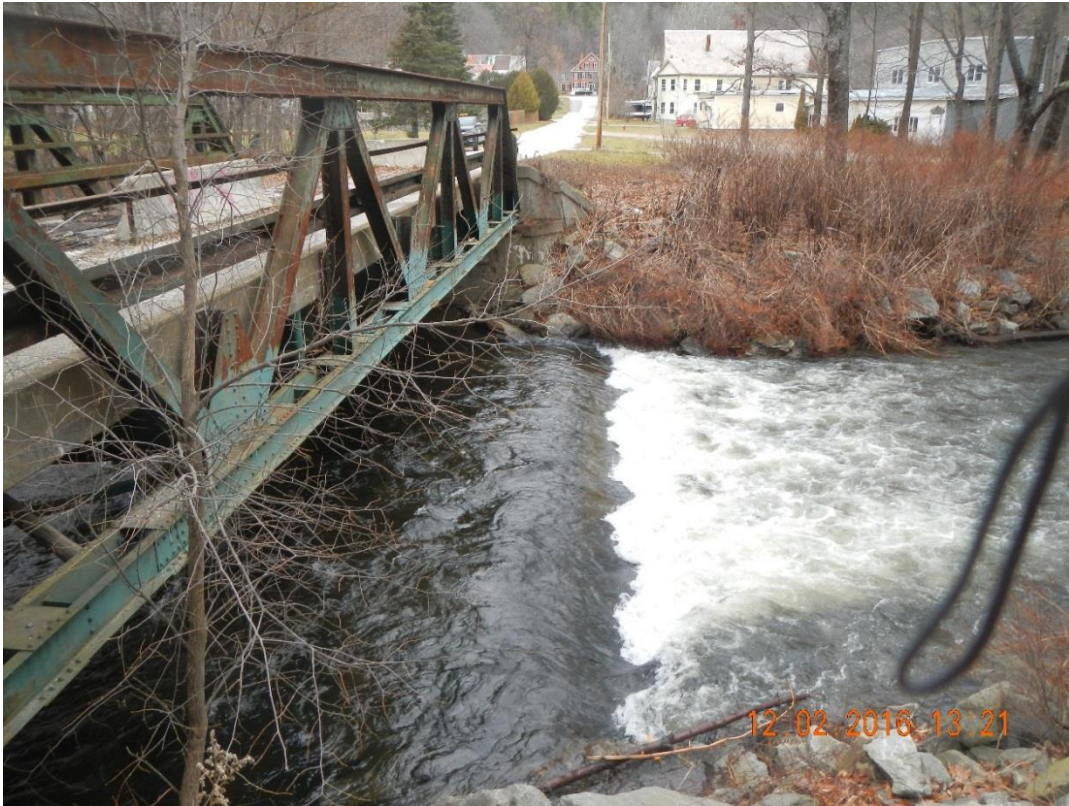
Figure 3: *Cobbles and boulders within river and on river banks on downstream side. Also visible is possible weir within river.*

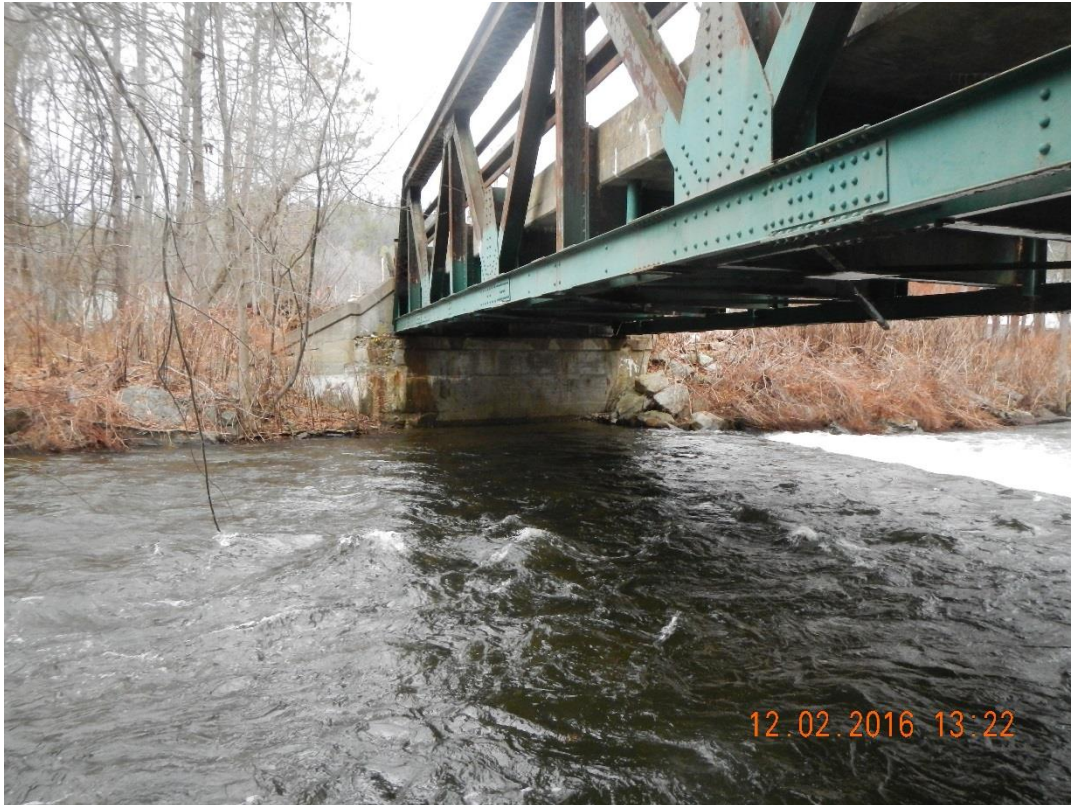
As shown in Section 3.0 of this report, the bridge abutments were rated as being in poor condition. During the site visit spalling and cracking of the concrete abutments was visible, as seen in Figures 5 and 6, however there was no apparent scour at either abutment.

Figure 5: *Northern abutment; note visible cracking and spalling of concrete.*

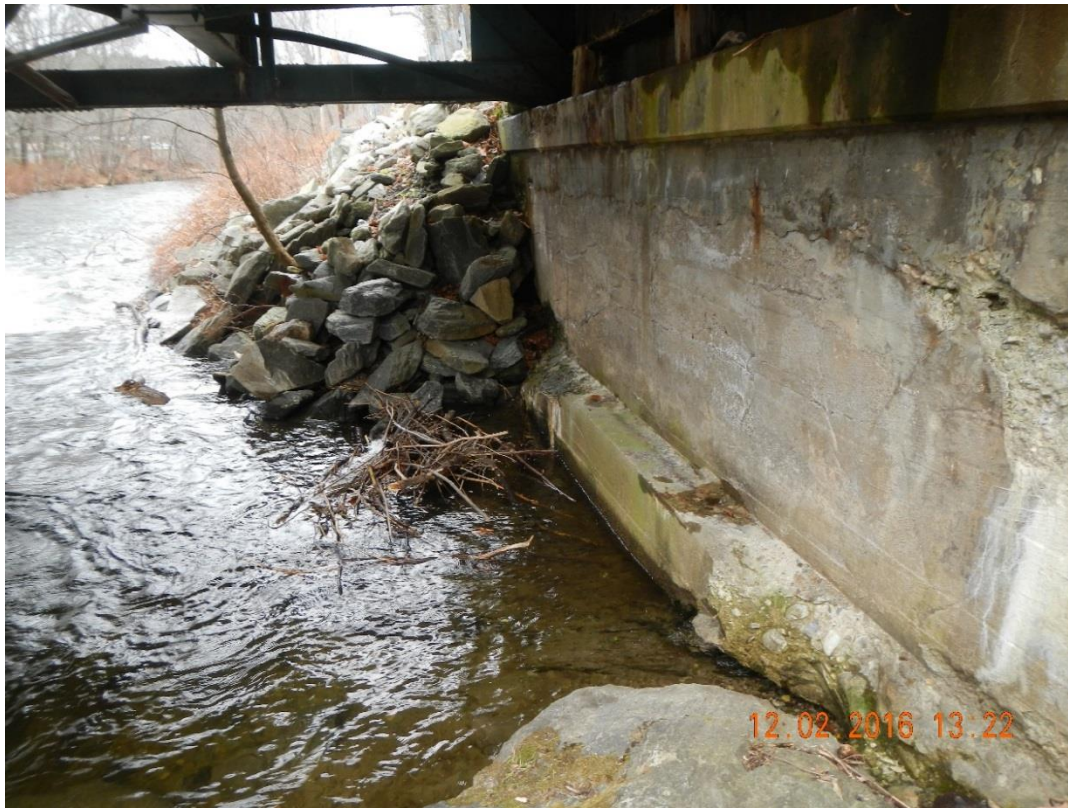
Figure 6: *Southern abutment; note visible cracking and spalling of concrete.*
