**STATE OF VERMONT  
AGENCY OF TRANSPORTATION**

**Scoping Report**

**Johnson BF 0248(7)  
VT ROUTE 100C, BRIDGE 4 over UNNAMED BROOK**

December 4, 2015

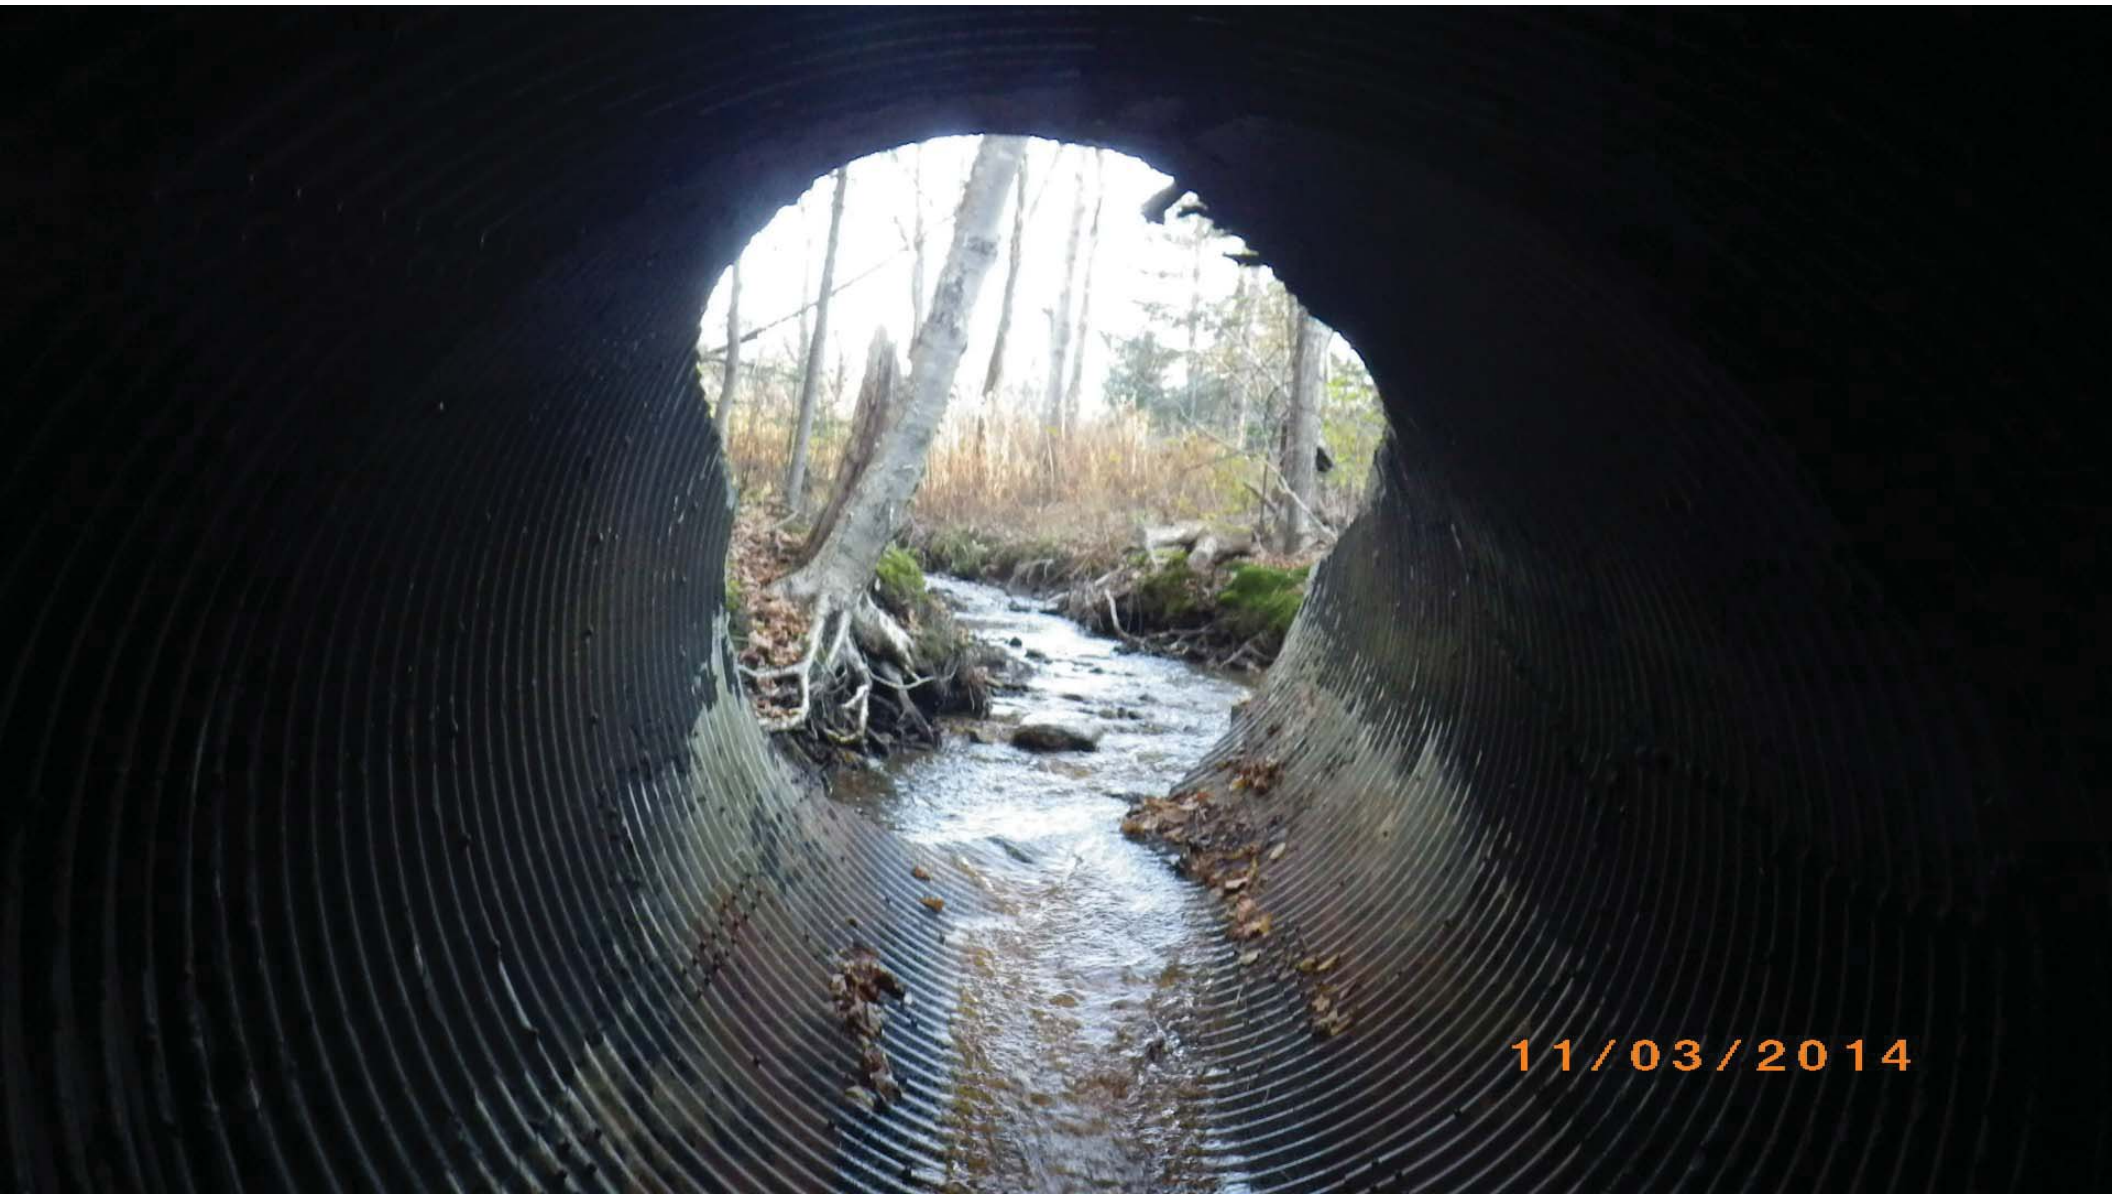
11/03/2014

11/3/14 This culvert needs to be replaced. There are two large sink holes in the downstream embankment, one about 10' deep. The barrel of the pipe is squashed about 8" towards the outlet end. The Downstream end of the pipe is riddled with holes ranging from 1" to 6" in size. The holes are allowing the stream to wash away the fines around the pipe causing sink holes, squashing, and undermine the pipe. (CM sent) JM JW

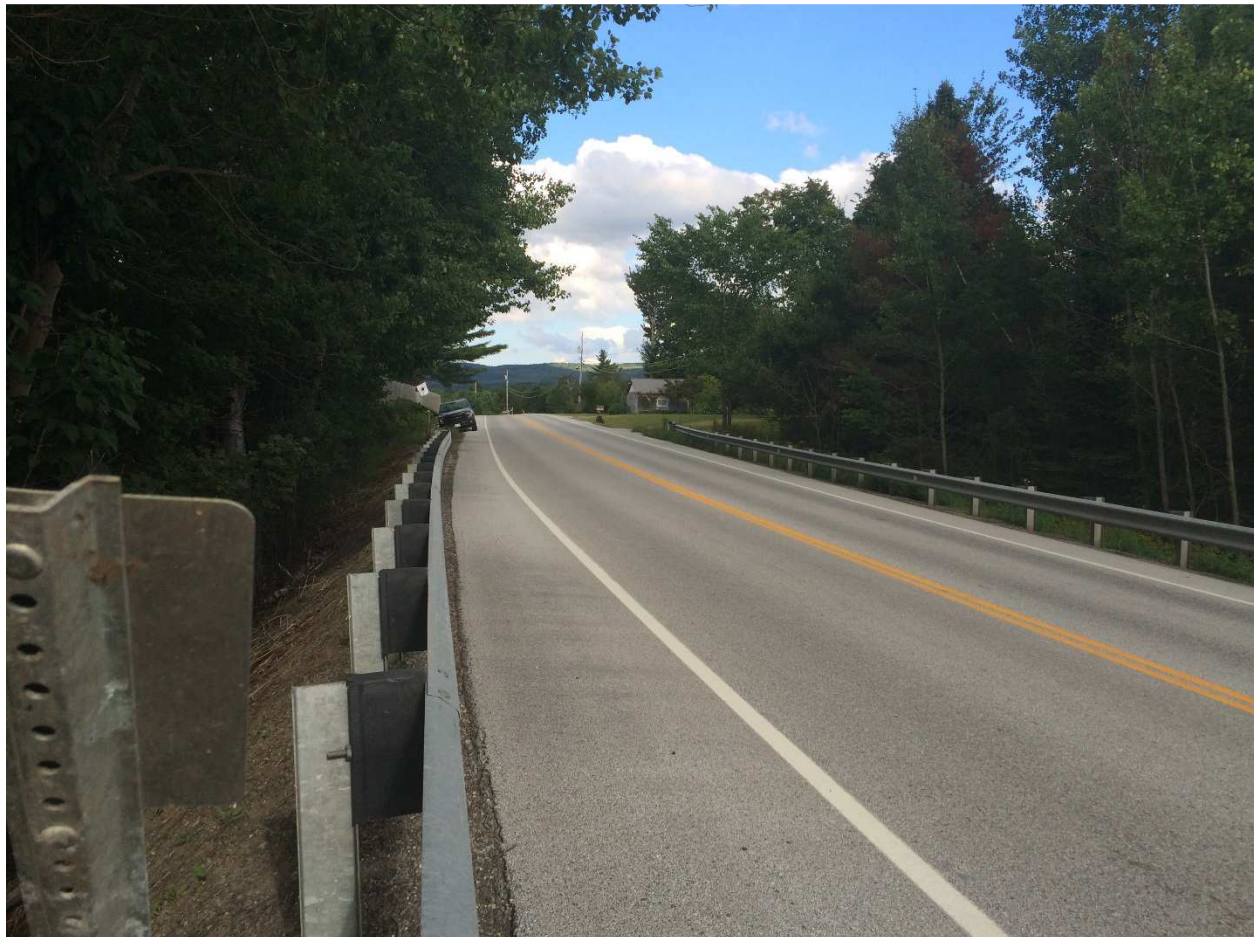
**Figure 2:** View Above Culvert Looking Northeast

A preliminary site visit was conducted on August 20, 2015 to determine possible obstructions inhibiting boring operations and to make any other pertinent observations about the project. Sight distance seemed to be the only complication for borings as there were no overhead power lines near the culvert. As shown in Figure 2 and Figure 3.

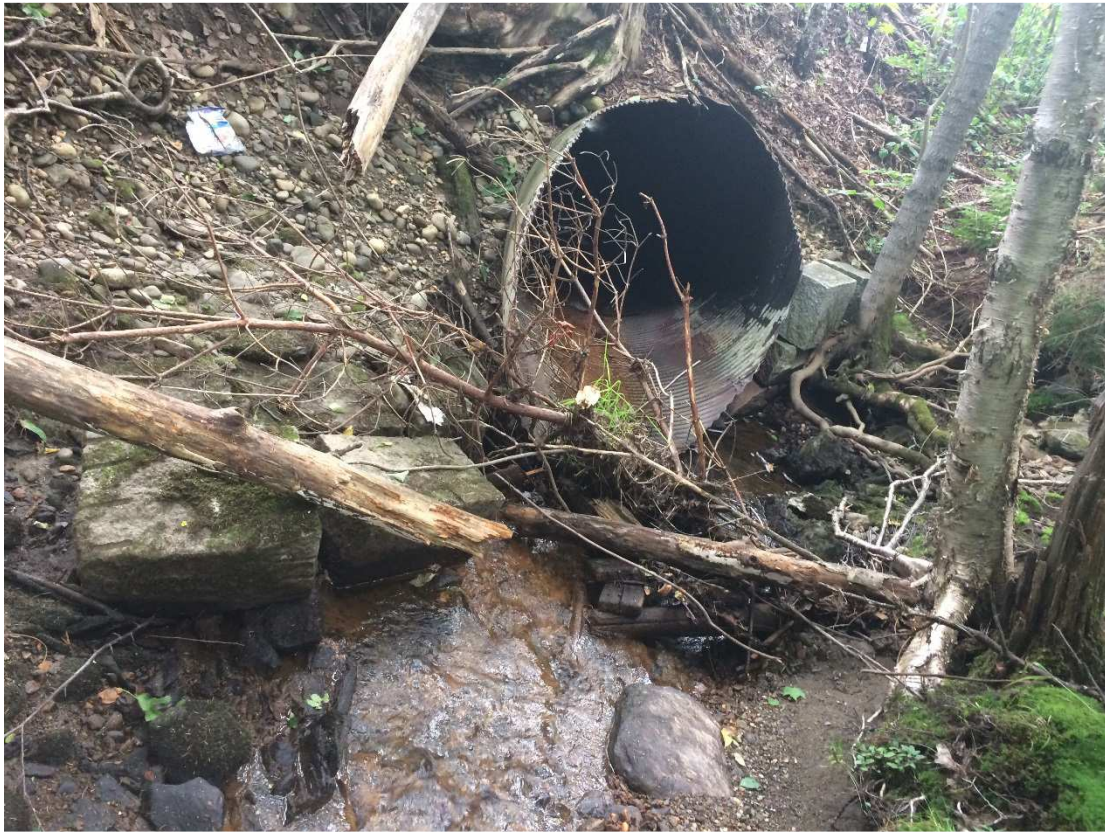
**Figure 4:** Inlet of Culvert

The inlet of the existing culvert was in unsatisfactory condition, as seen in Figure 4. The water seems to be undermining the culvert as stone blocks were the only attempt as scour prevention. It can be seen in Figure 5 that there is very little flow of water that is exiting. There were many holes seen that would allow water to leak out, along with the possible piping effects throughout. Bedrock was visible at the downstream side of the culvert. The soils at the surface were determined to be loamy sandy gravels with cobbles.

Based on the site visit, the existing culvert appears to be in unsatisfactory condition. For this reason, a replacement of the culvert should be considered. If this is not the preferred option, possible foundation alternatives for a bridge replacement include the following:
