**STATE OF VERMONT
AGENCY OF TRANSPORTATION**

Scoping Report

Leicester BO 1445(37)

Old Jerusalem Road, TH 12, BRIDGE 4 over LEICESTER RIVER

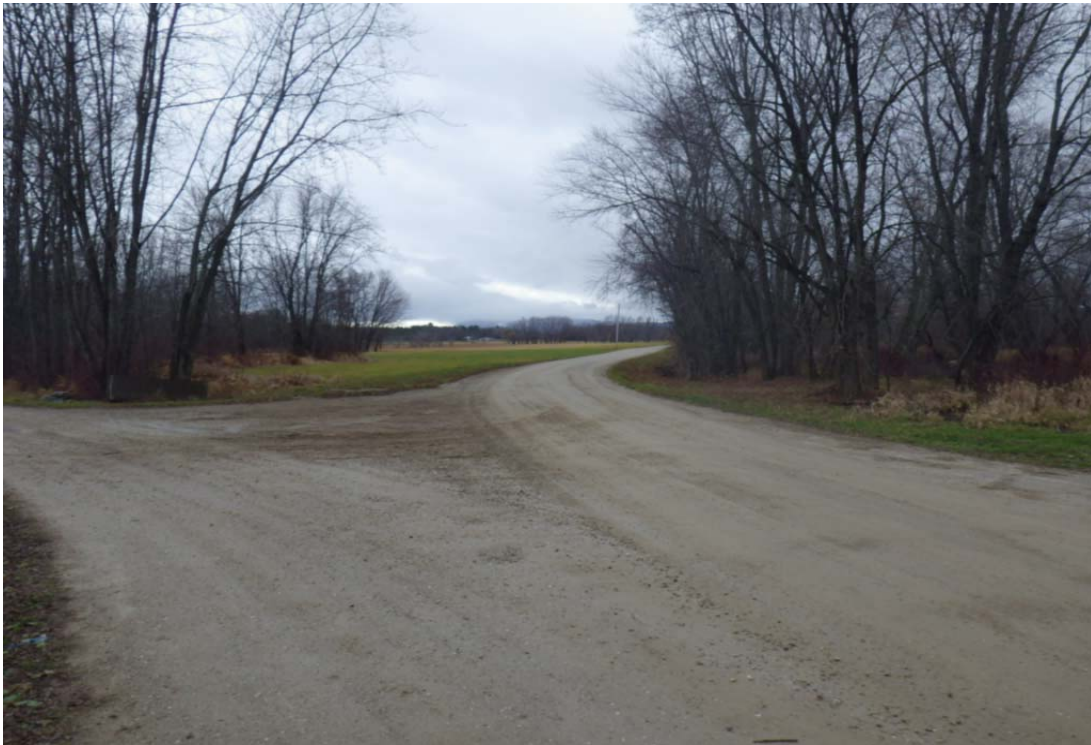
TH 12 looking south

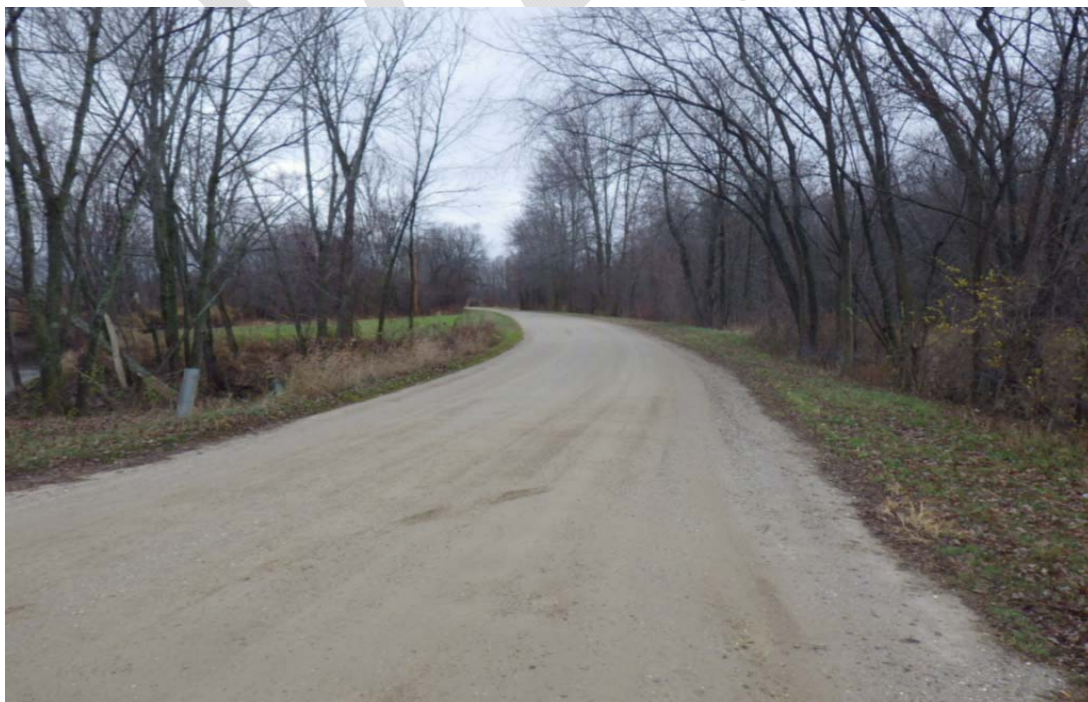
TH 12 looking north

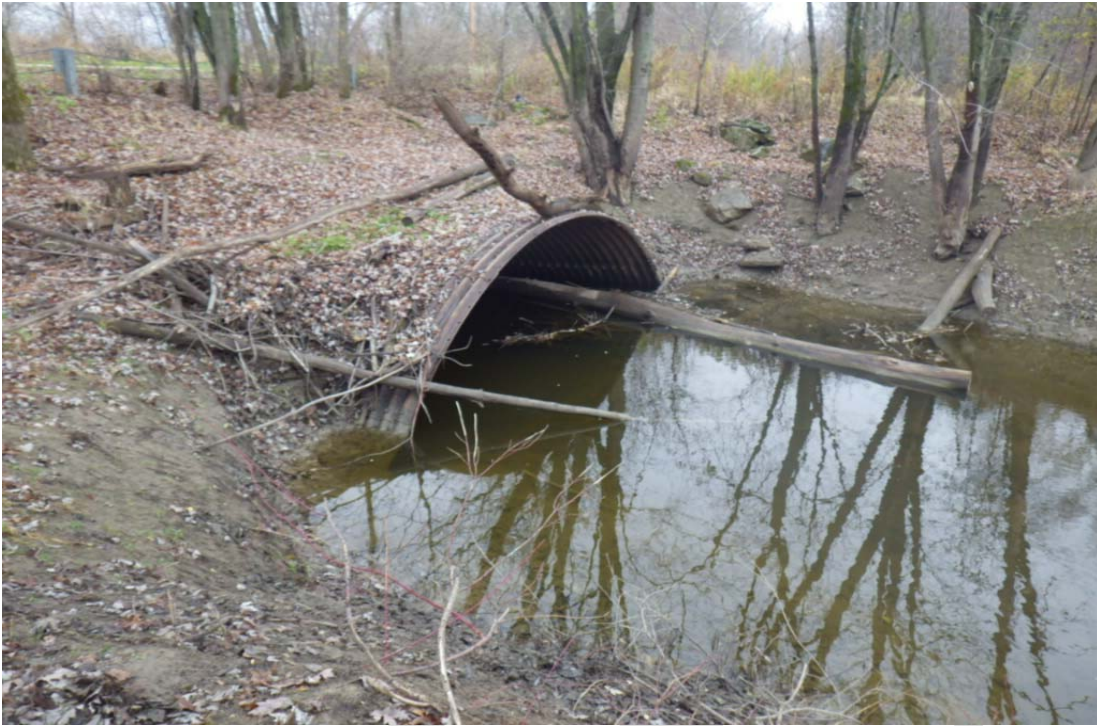
Culvert Inlet

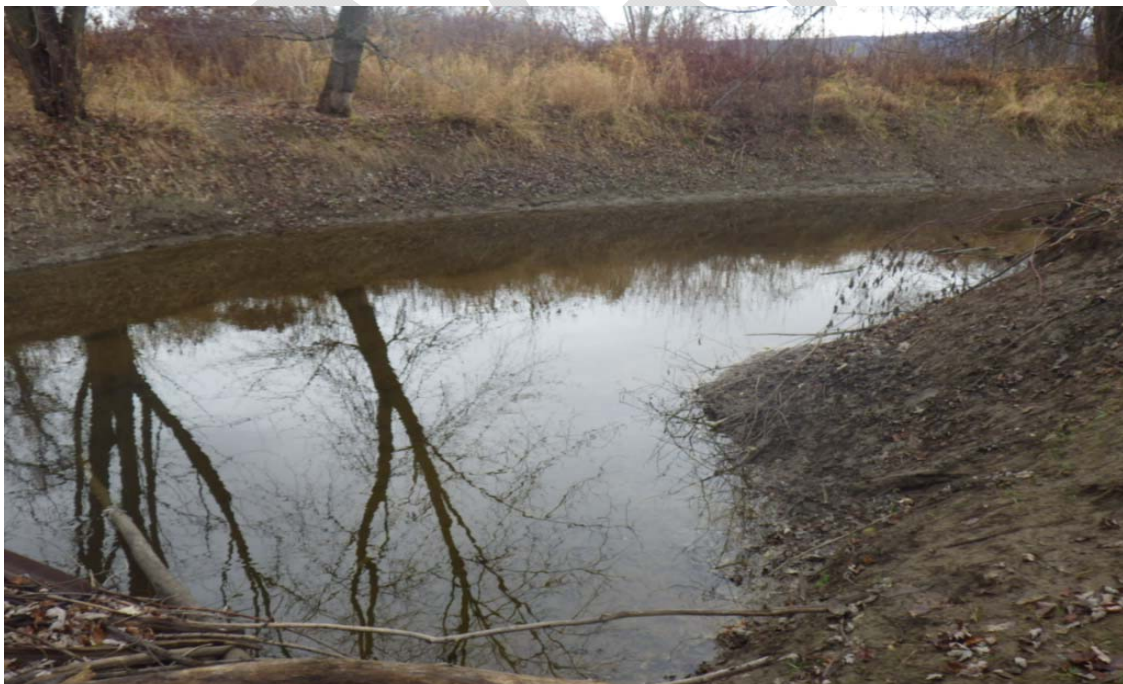
Looking Upstream

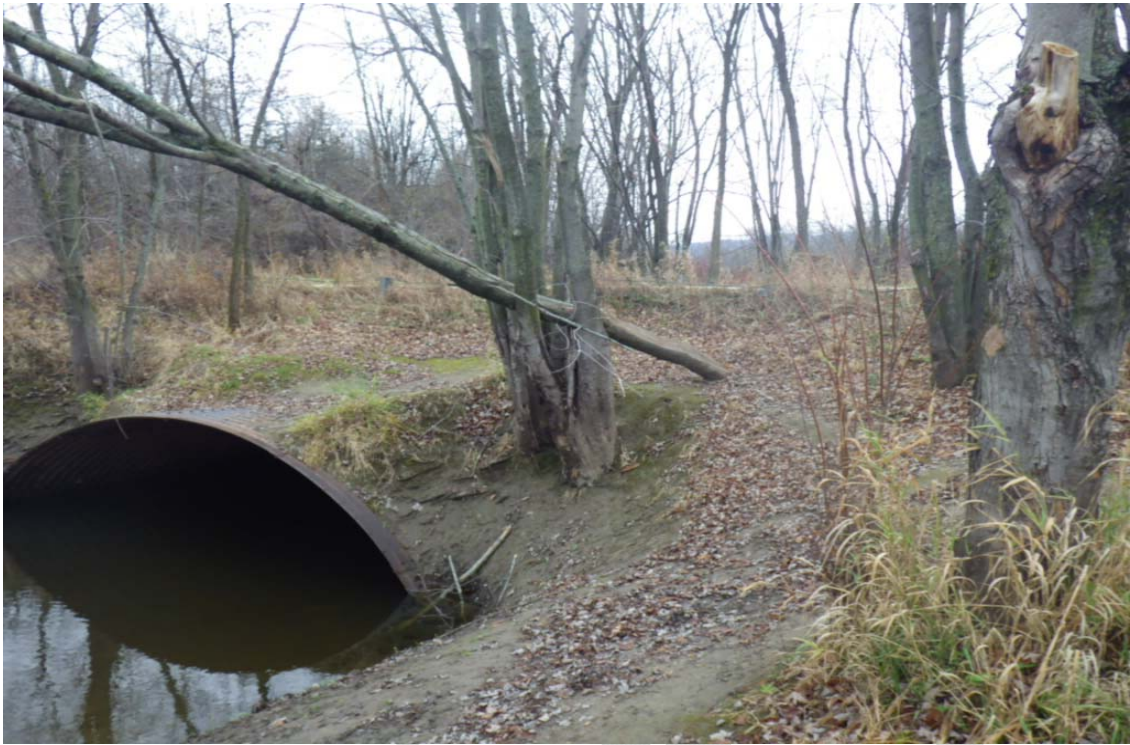
Culvert Outlet

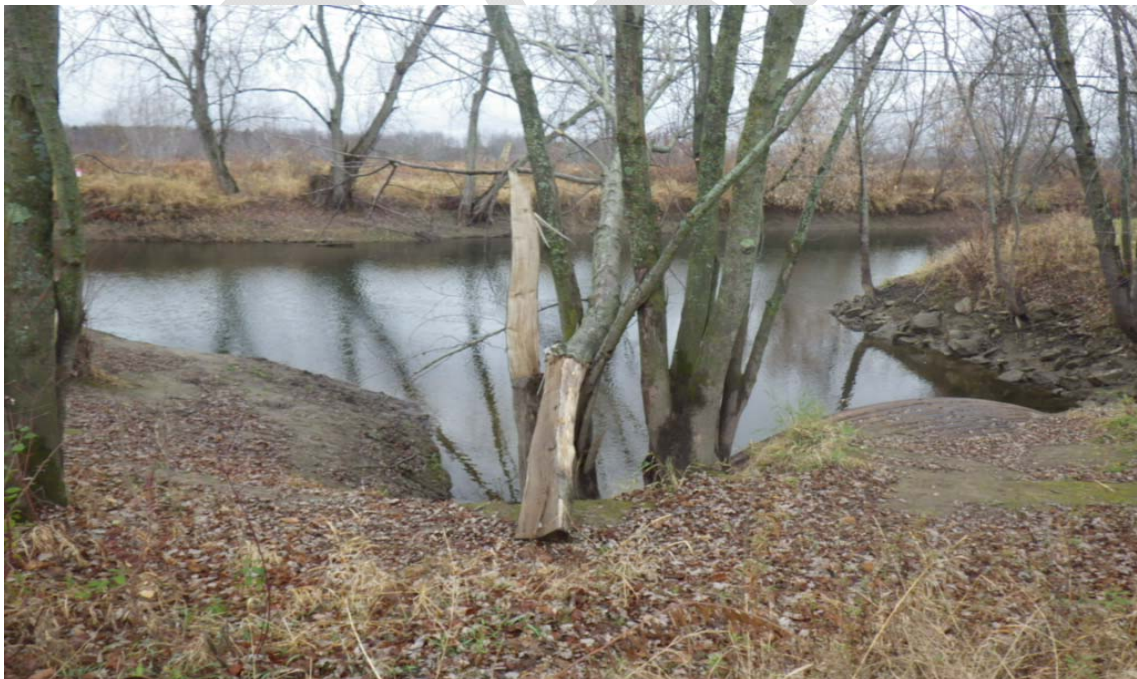
Looking Downstream

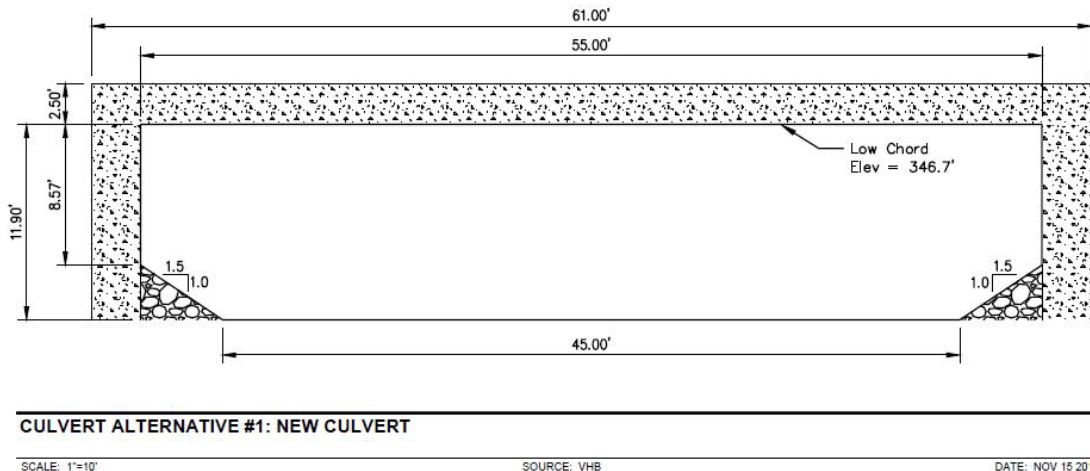
Culvert Alternative 1 – 55-ft Span

Culvert alternative 1 is a single span bridge, 55-ft wide and 10.2-ft tall. This design assumes a trapezoidal channel geometry with 1.5:1-ft channel side slopes forming natural channel banks through the crossing. No changes to the roadway width or profile is proposed. Culvert alternative 1 has the largest hydraulic opening of all the alternatives with 637.8-sqft and a low chord of 346.7-ft. This alternative maintains 5.2-ft of freeboard and meets the VTrans hydraulic requirement to pass the Q25 flow with 1.0-ft of freeboard. This option also spans the BFW of 40-ft. During the Q₁₀₀ storm event, the water surface elevations decrease around the culvert by 1.0-ft, as compared to existing conditions, to an elevation of 342.7-ft.

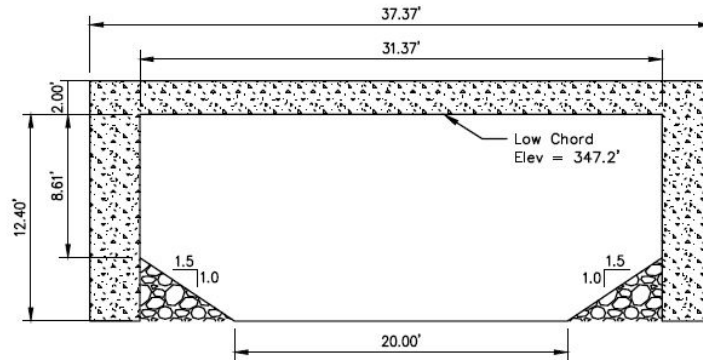
CULVERT ALTERNATIVE #2: REUSE EXISTING SLAB, NEW CULVERT

This alternative reuses the existing concrete slab located above the center of the existing culvert and replaces the existing culvert with a new open bottom structure, 31.4-ft wide and 10.7-ft tall. Like Alternative 1, this design assumes a trapezoidal channel geometry with 1.5:1 channel side slopes within the culvert area. No changes to the roadway width or profile is proposed. Alternative two has a hydraulic opening of approx. 367.4-sqft with a low chord elevation 347.2-ft. This alternative has 5.1-ft of freeboard and meets the VTrans hydraulic requirement to pass the Q25 flow with 1.0-ft of freeboard. This option does not spans the BFW of 40-ft. In the Q₁₀₀ storm event, the water surface elevations decrease around the culvert by 0.2-ft, as compared to existing conditions, to an elevation of 343.5-ft.

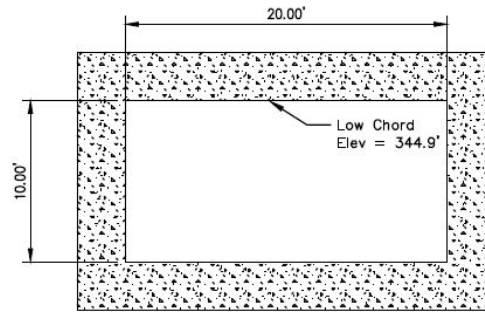
CULVERT ALTERNATIVE #3: BOX CULVERT

Culvert alternative 3 is a new precast concrete box culvert measuring 20-ft wide by 10-ft tall. VHB assumed the culvert to be slightly embedded but without any channel side slopes within the culvert. Culvert three, presumably the cheapest option, has the smallest hydraulic opening with 200-sqft with a low chord of 344.9-ft. This option has 2.1-ft of freeboard and meets the VTrans hydraulic requirement to pass the Q₂₅ flow with 1.0-ft of freeboard. This option does not spans the BFW of 40-ft. In the Q₁₀₀ storm event, the water surface elevations increase around the culvert by 0.5-ft, as compared to existing conditions, to 344.2-ft.
