**STATE OF VERMONT  
AGENCY OF TRANSPORTATION**

**Scoping Report  
FOR  
Bristol BF 021-1(33)**

**VT Route 116, BRIDGE 12 OVER BALDWIN CREEK**

February 24, 2015

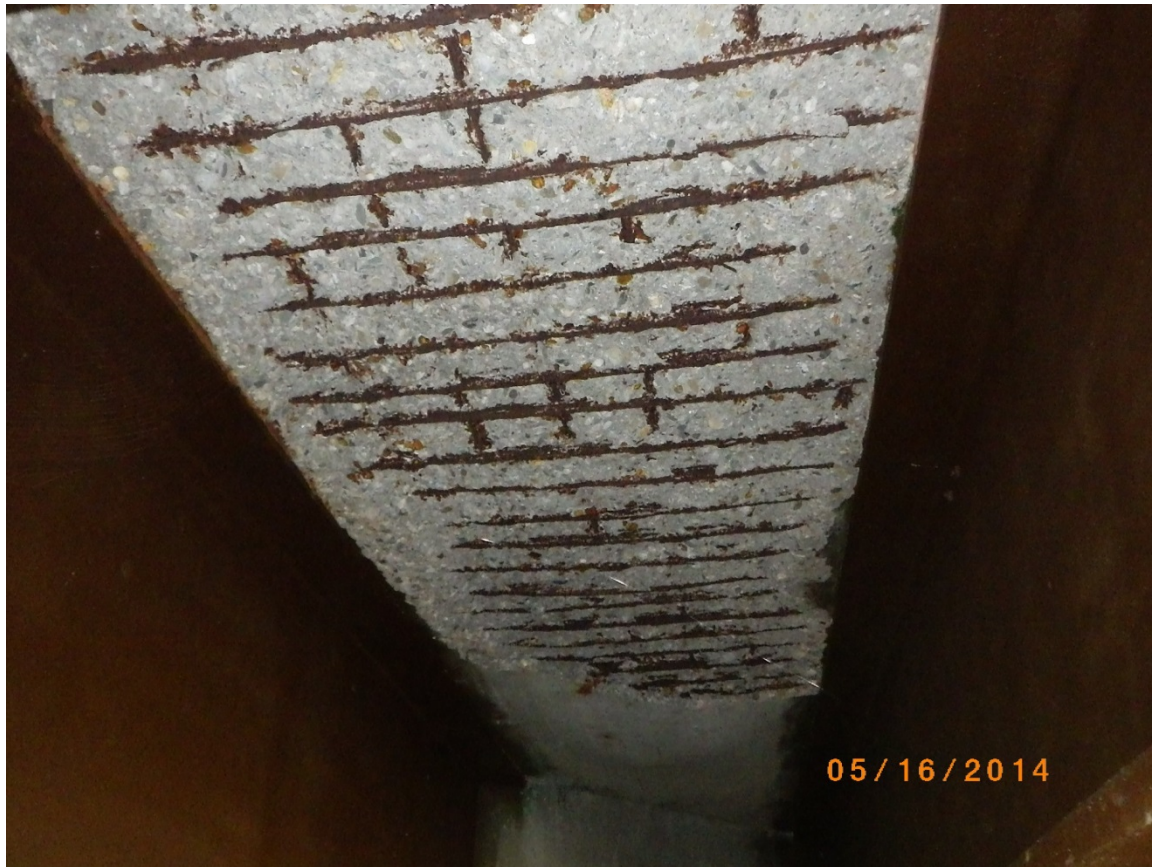
1. Bridge 12 is Structurally Deficient.
2. The existing concrete deck is in poor condition. There have been pop-outs in the past, and future deck pop-outs are possible at any time. Many of the deck bays continue to deteriorate, with large areas of delaminations and fully exposed reinforcing steel. The shoulders on the bridge are too narrow, and the bridge railing is substandard.
3. The existing bridge is too narrow for the roadway classification and traffic volumes.
4. The roadway is not banked sufficiently for the horizontal curve present.
5. The existing bridge railing is not crash tested. The concrete bridge railing posts are deteriorated with exposed reinforcing steel throughout.

Exposed reinforcing steel on underside of deck

This alternative would involve removing the existing deck in its entirety and placing a new deck on the existing steel beams. The advantage to performing a complete deck replacement over patching in this situation is that the lifespan of all new concrete would be much greater than patching. There is some rust and exposed rebar on the abutments at the bridge seats. These areas would be cleaned and repaired as necessary. Additionally there would be repairs as follows:

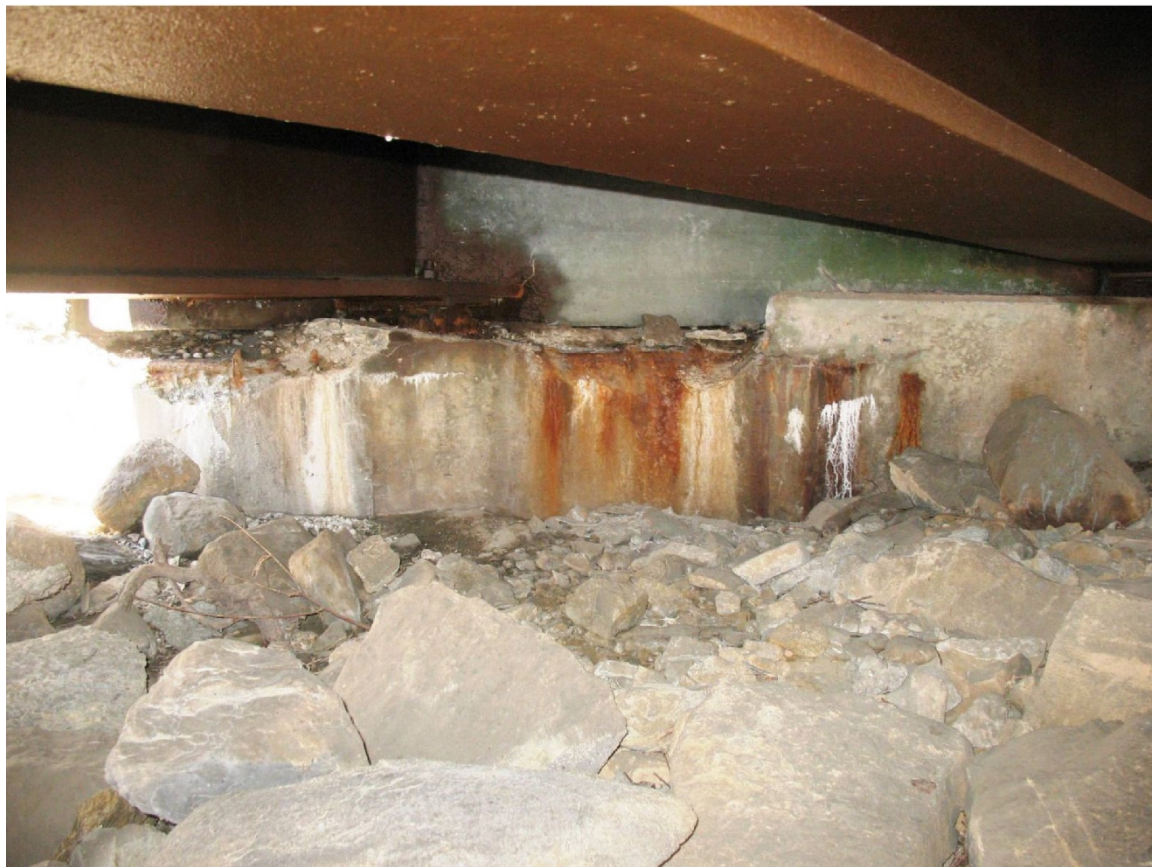
- There is chloride attack along the abutment at the bridge seats as evident by spalling concrete and efflorescence. This is due to leaky bridge joints. This can be mitigated with concrete repair of the bridge seats, and new bridge joints.
- The existing concrete and steel beam bridge rail would be replaced in its entirety with a new railing.

Bridge Seat Deterioration

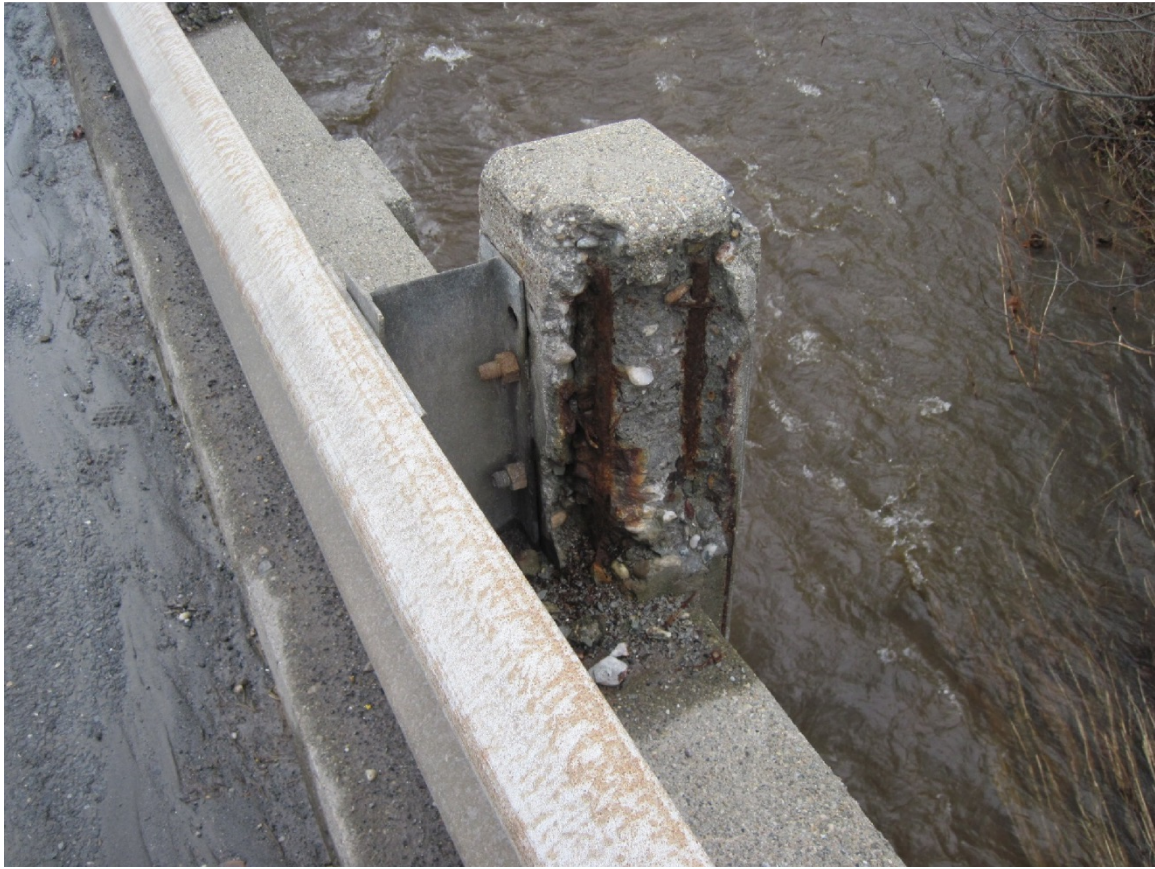
Bridge Railing Deterioration

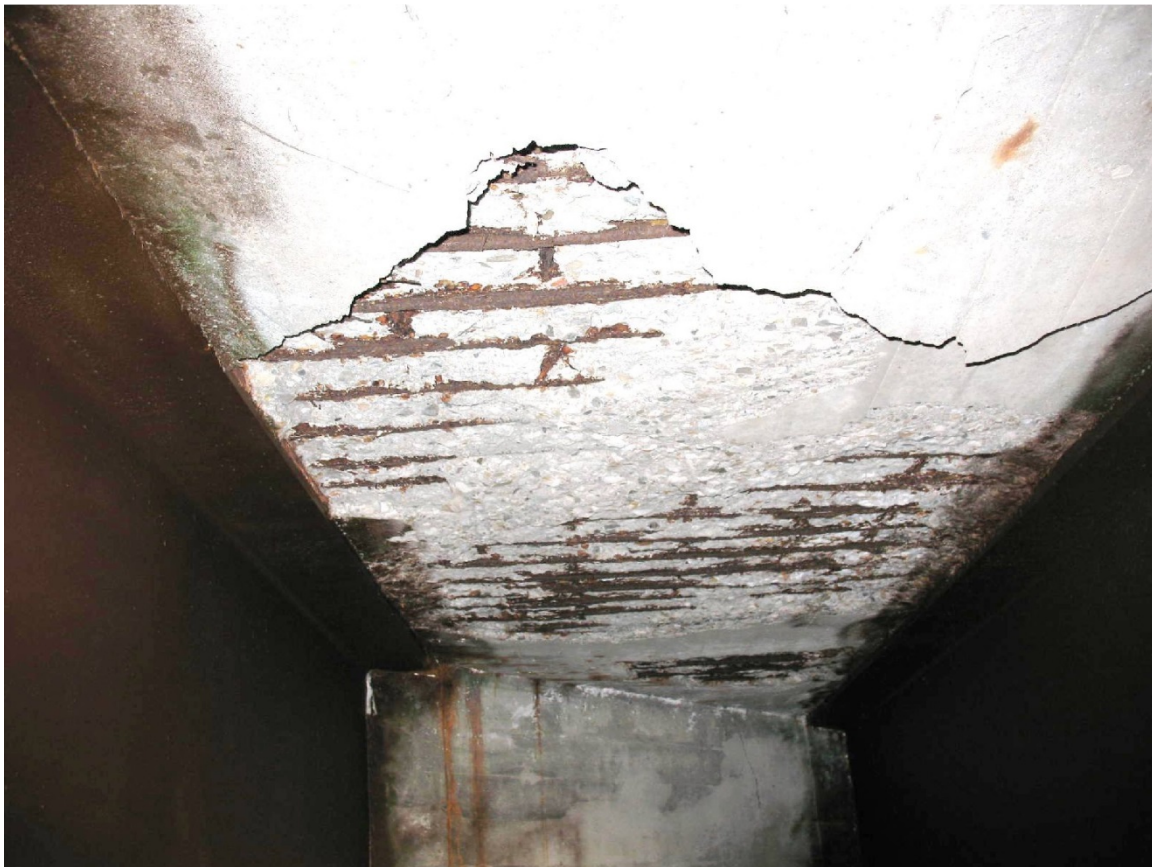
Bridge 12 is considered structurally deficient, due to the poor deck rating. Many of the deck bays continue to deteriorate, with large areas of delaminations and fully exposed reinforcing steel. The shoulders on the bridge are too narrow, and the bridge railing is substandard.

Spalling concrete and Exposed Reinforcing steel on underside of deck
