**STATE OF VERMONT
AGENCY OF TRANSPORTATION**

Scoping Report

**Londonderry BF 016-1(33)
VT ROUTE 11, BRIDGE 24 over UNNAMED BROOK**

April 2, 2015

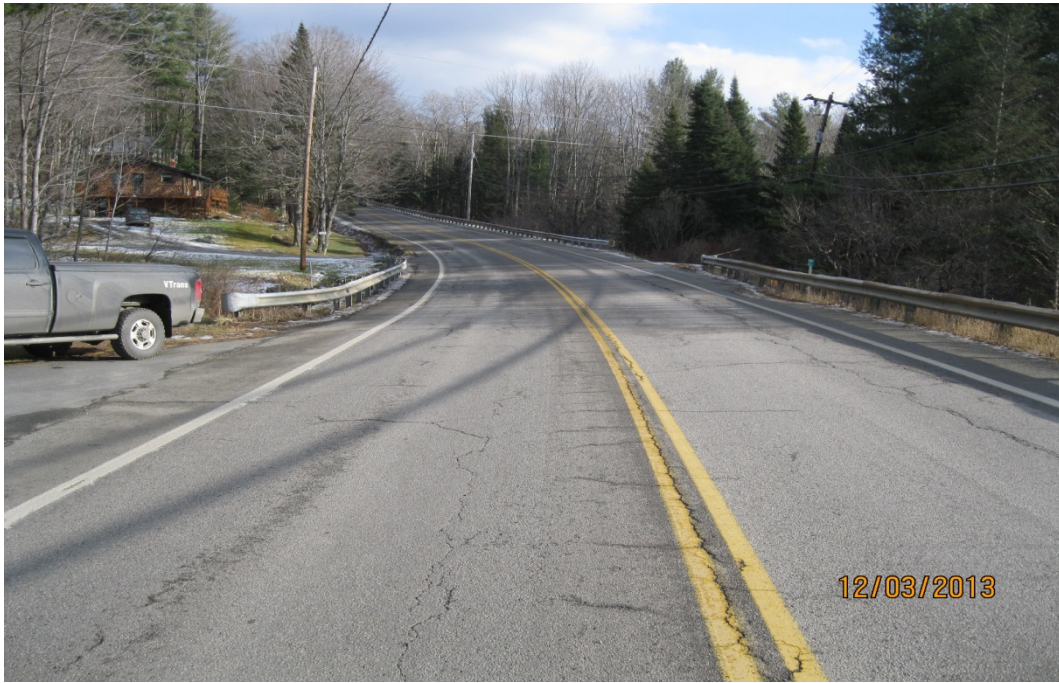
VT Route 11, Looking East

¹The Bridge Inspection Report indicates that a 32' approach roadway width. From the photos, it doesn't look like there are 4' shoulders.

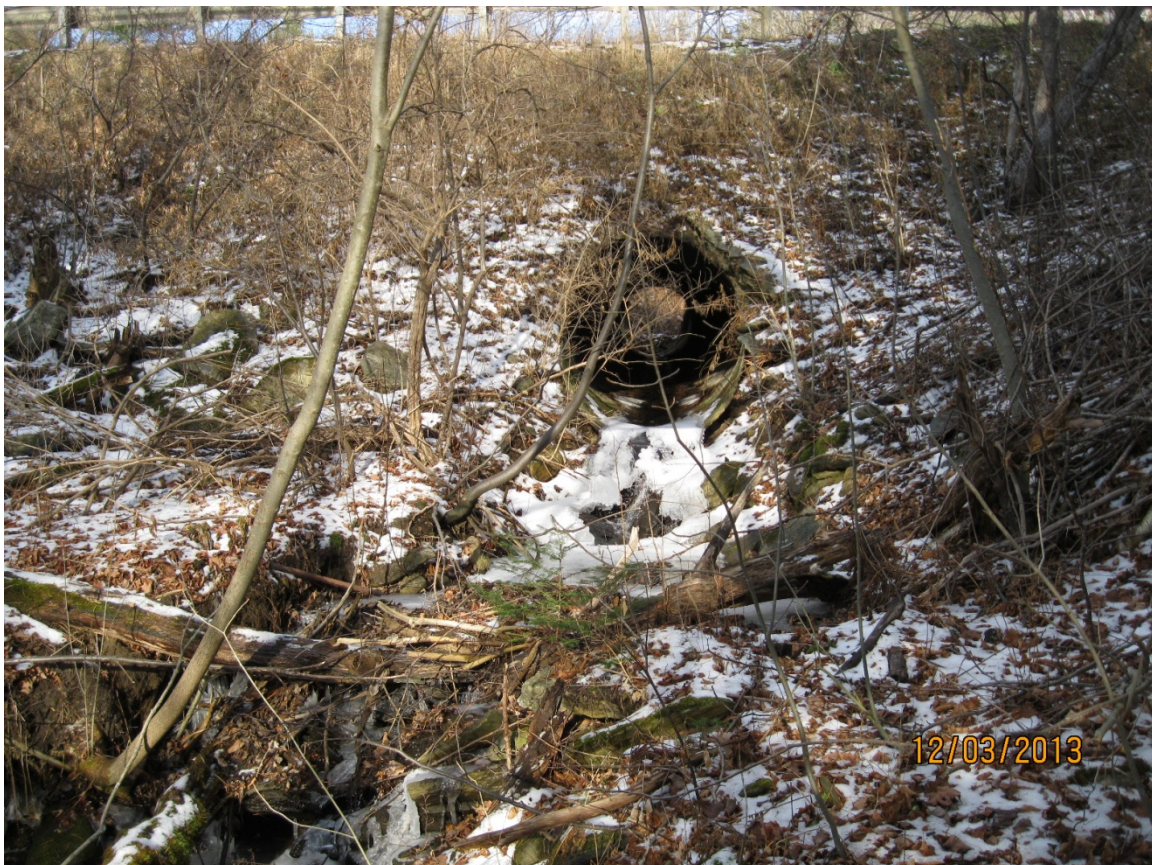
Figure 3 Photograph of culvert outfall.

The existing structure is a 6.0' CMP with mitered ends. It provides 28.3 sq. ft. of waterway area. It was built in 1948. The pipe is in serious condition with holes through the invert and sides. There is about a 3' drop over rocks at the outlet.

If a new box is installed, we recommend it have full headwalls at the inlet and outlet. The headwalls should extend at least four feet below the channel bottom, or to ledge, to act as cutoff walls and prevent undermining.

Additional large stone fill may be required at the structures outlet, due to the anticipated high outlet velocities. We will make recommendations for stone fill when we do Final Hydraulics.
