Pittsford BF 019-3(59) US Route 7 over Furnace Brook

EXISTING BRIDGE DEFICIENCIES

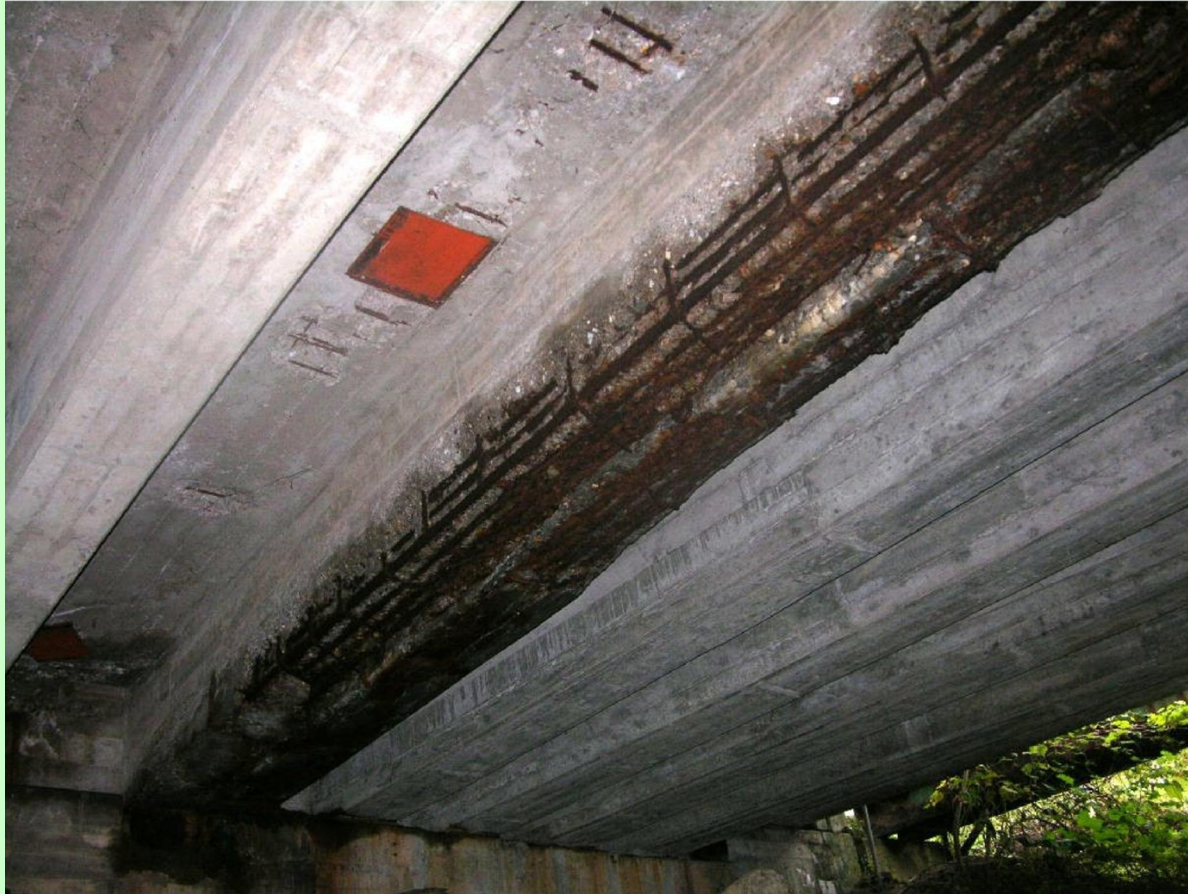
Beam and Deck Deterioration

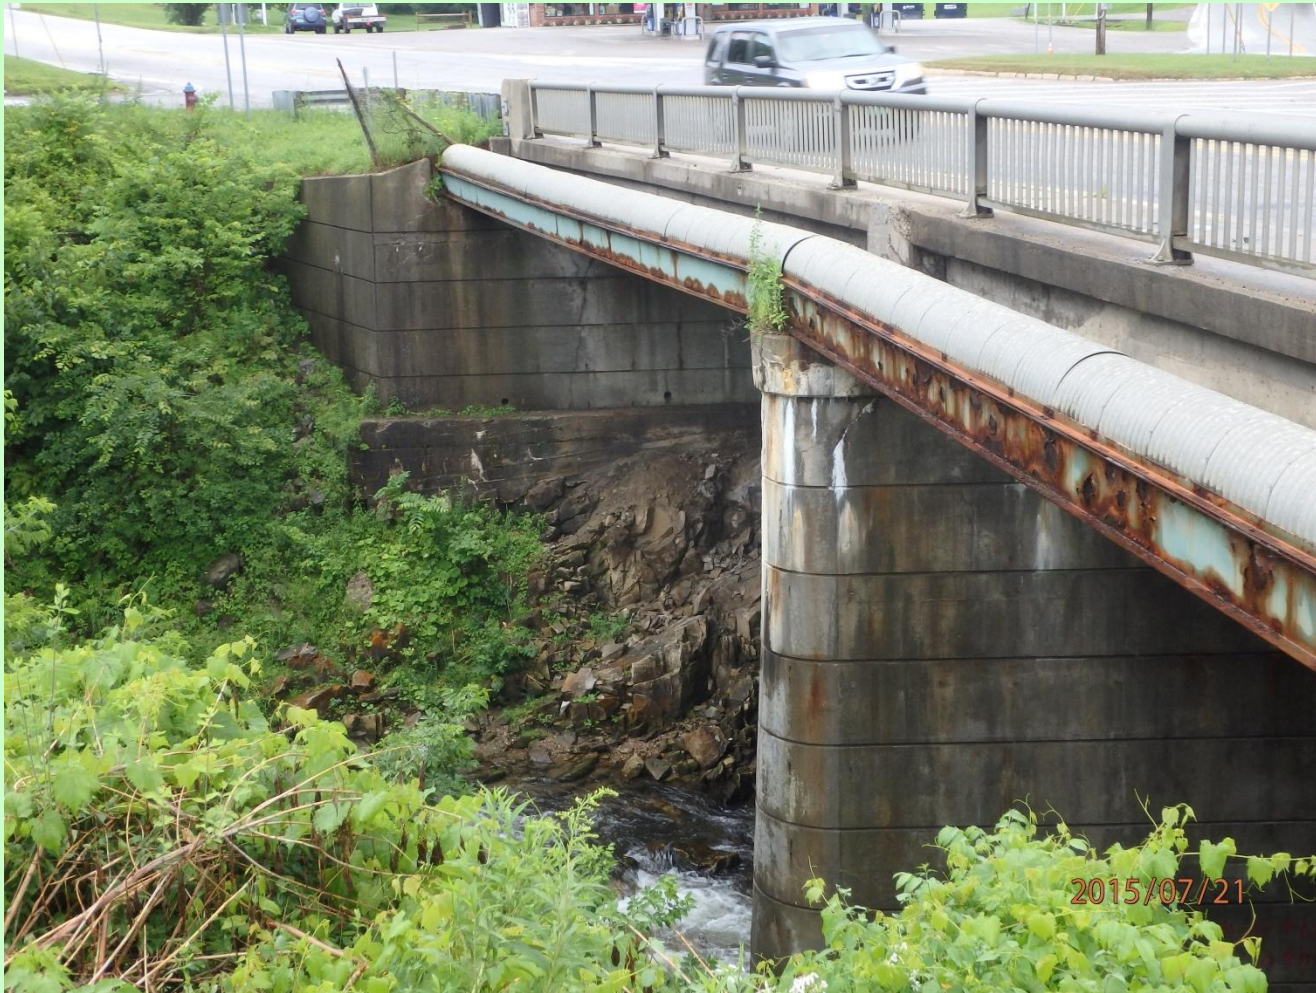
Pier deterioration

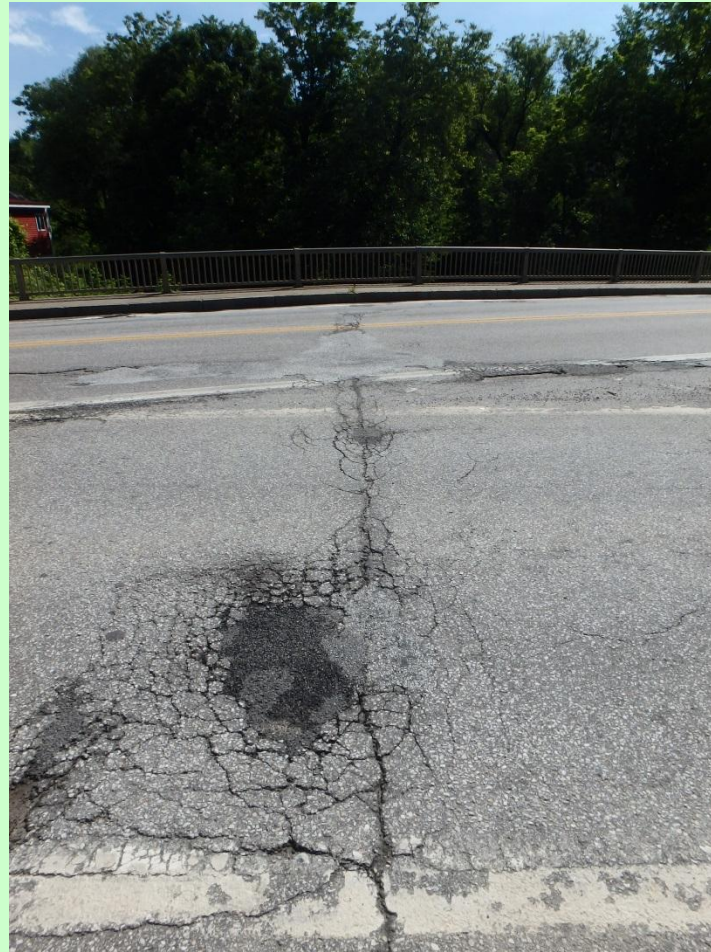
Pavement and Joint Deterioration
