**STATE OF VERMONT  
AGENCY OF TRANSPORTATION**

**Scoping Report**

**Orleans Village BF 0310(7)  
VT ROUTE 58 (TH 1), Bridge 10 over the Barton River**

February 23, 2015

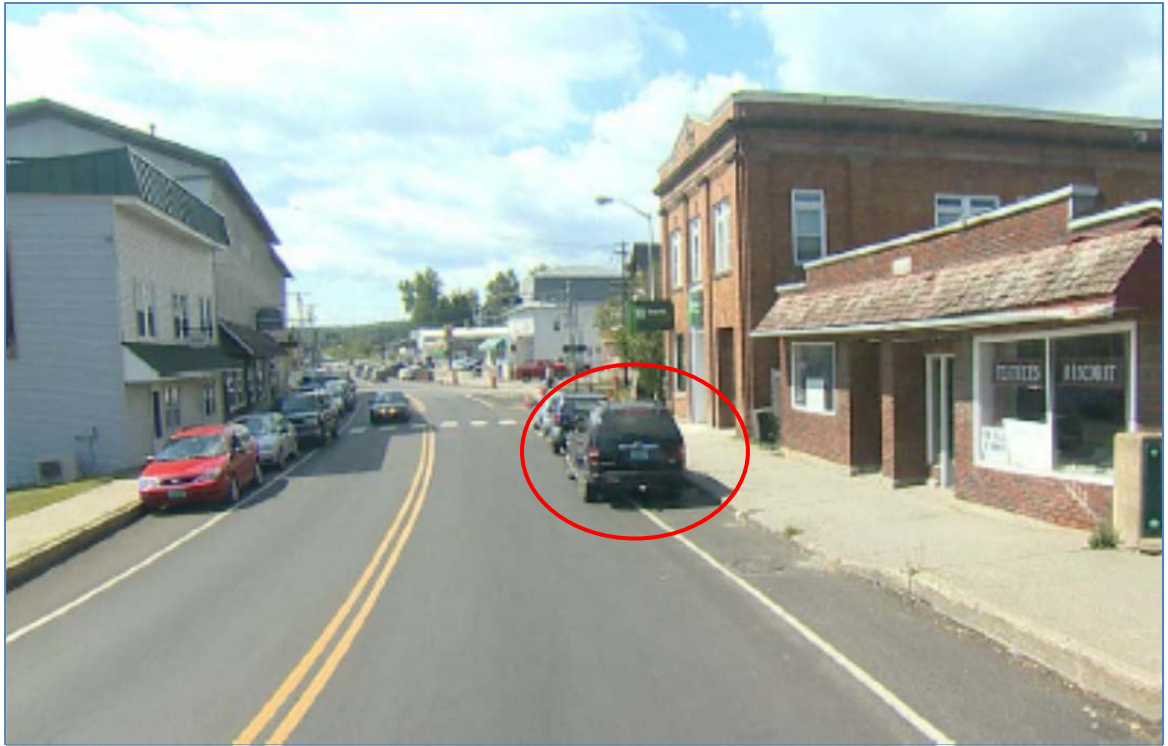
- There is an issue with on-street parking in front of the North Country Federal Credit Union. The shoulder width is not large enough to accommodate a vehicle. Parked vehicles are either encroaching in the road or they are parked with the right wheels up on the sidewalk, thus interfering with pedestrians. Where parked vehicles are encroaching in the road is where westbound traffic is just coming off of the bridge.

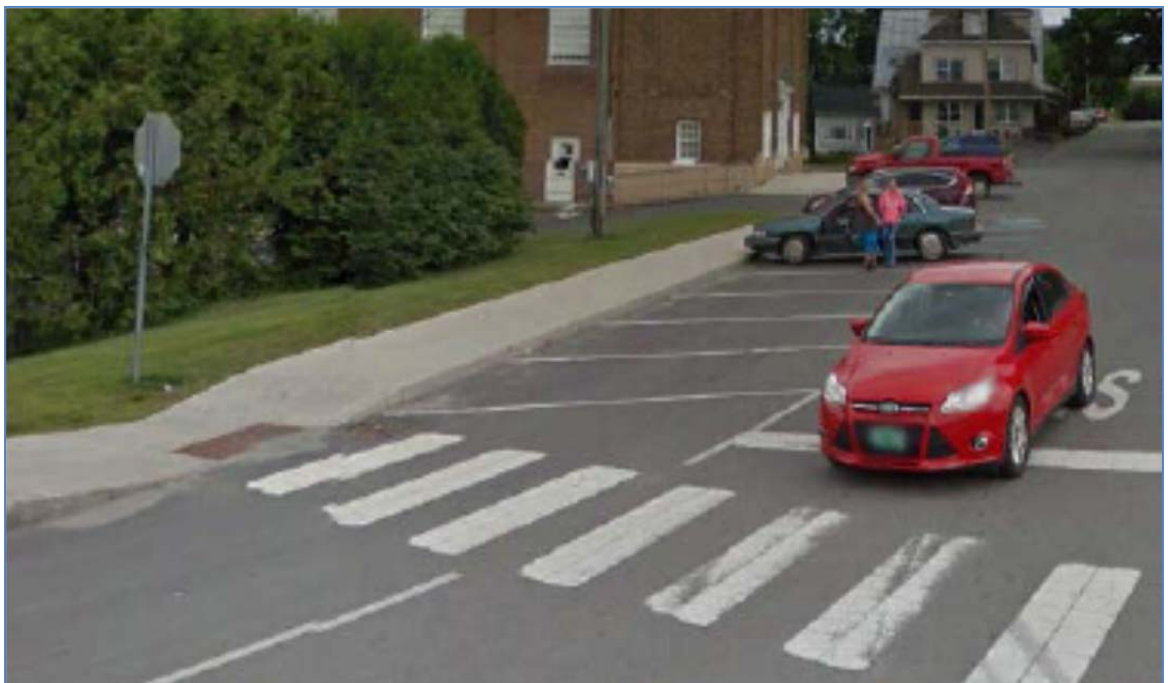
- There should not be a parking space next to the crosswalk on Maple Street. There should be at least 20 feet of free space. Additionally, the stop bar should be 4 feet behind the crosswalk.

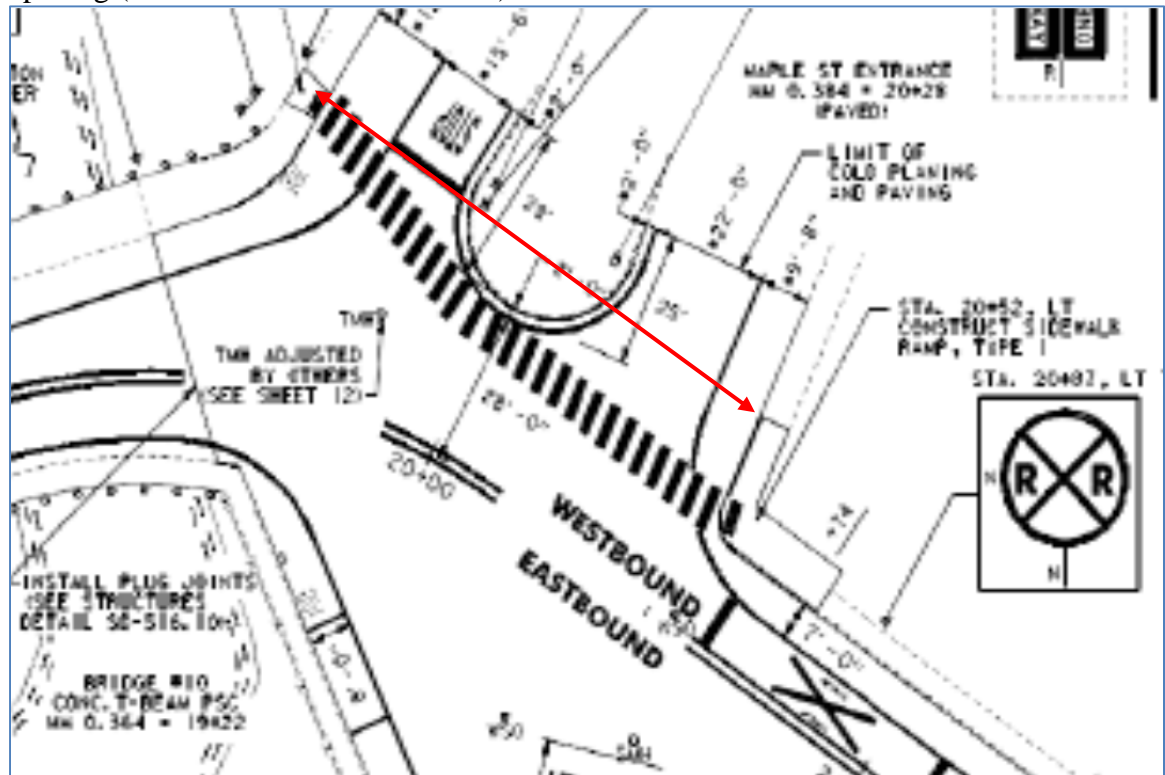
- The crosswalk on the east side is close to westbound traffic. Under the current scheme, it would be safer to make the crosswalk go through the park by creating a cut through opening (treated as if it were a median).

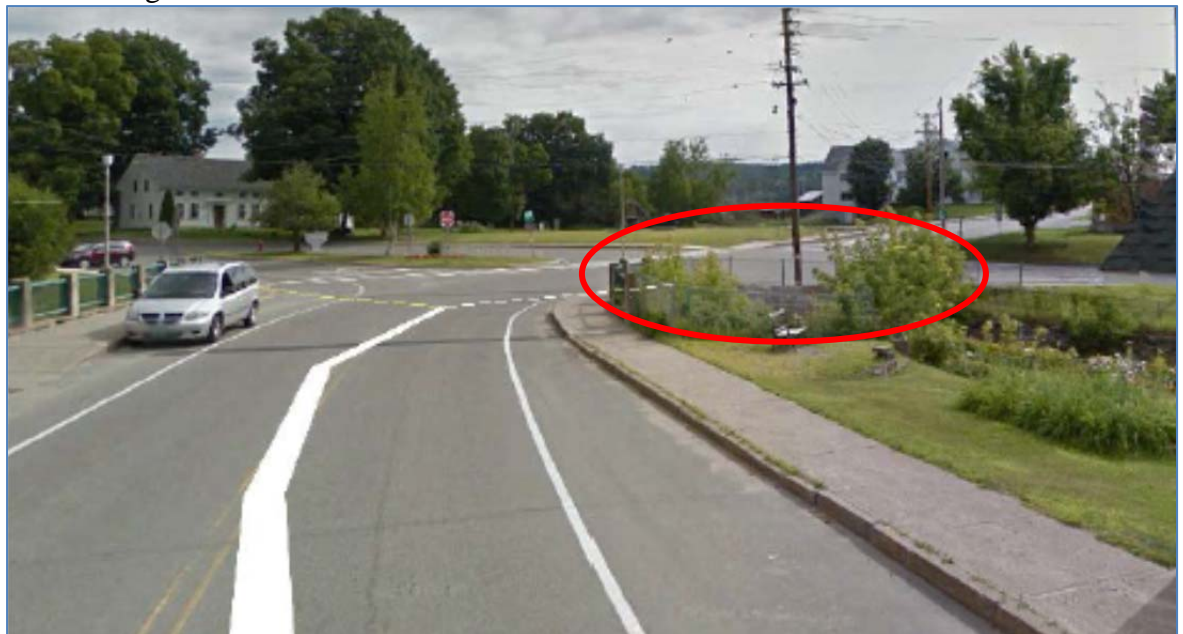
- The top bar of the chain link fence is unsafe. Additionally, the trees should be kept low to maintain sight distance.

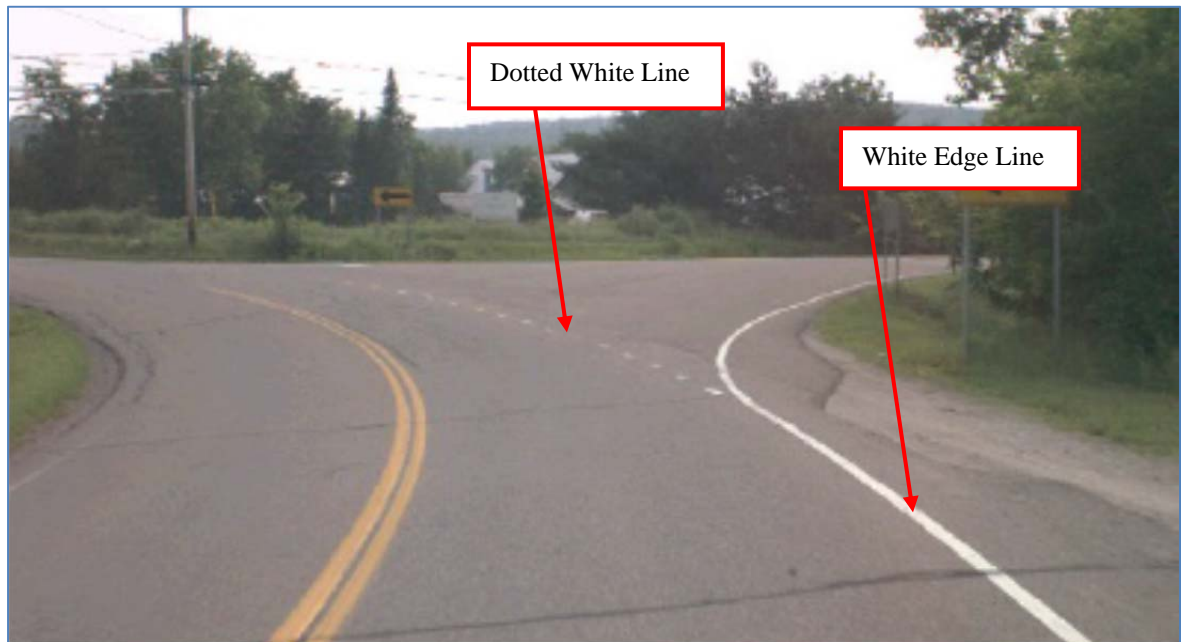
- To help guide westbound traffic around the curve, a dotted white line could be installed. See below for an example. The current location of the crosswalk may interfere.

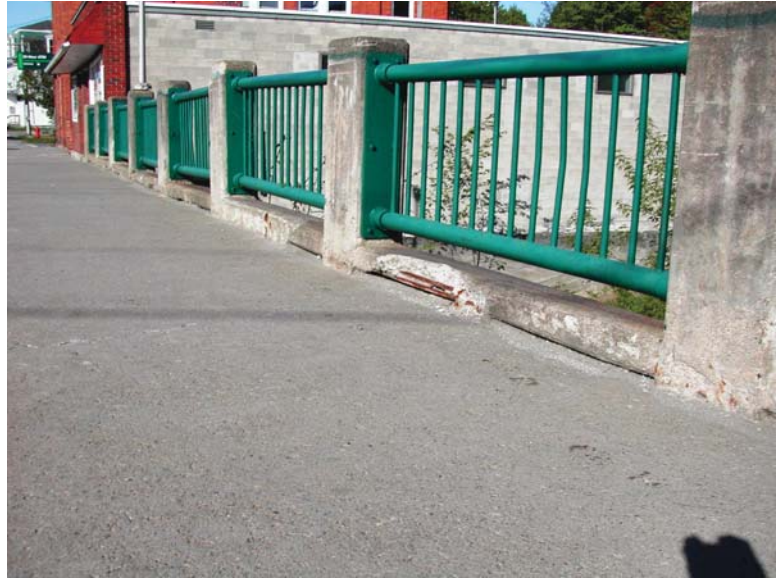
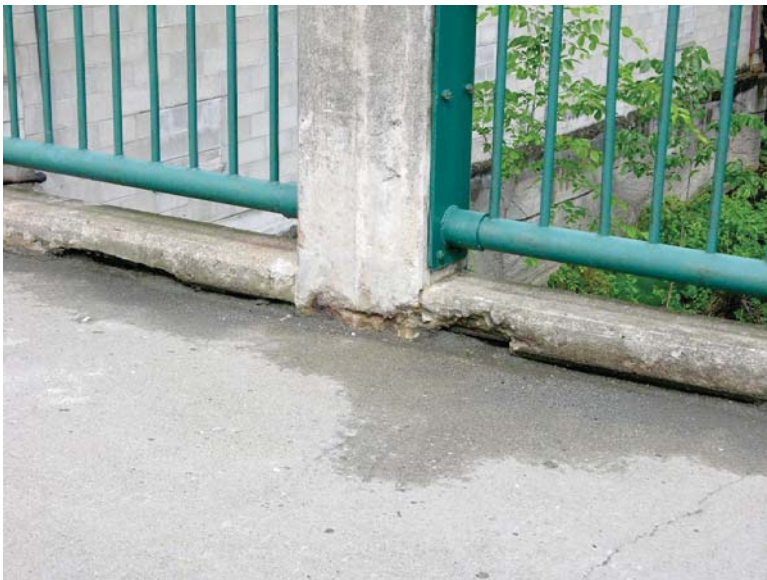
Bridge Rail Deterioration

The existing rail has not been tested to current crash testing criteria per NCHRP 350 TL-2 criteria and as such its use is not approved by the Federal Highway Administration (FHWA) in this location. As part of a deck replacement the existing rail would be replaced by a FHWA approved rail system.

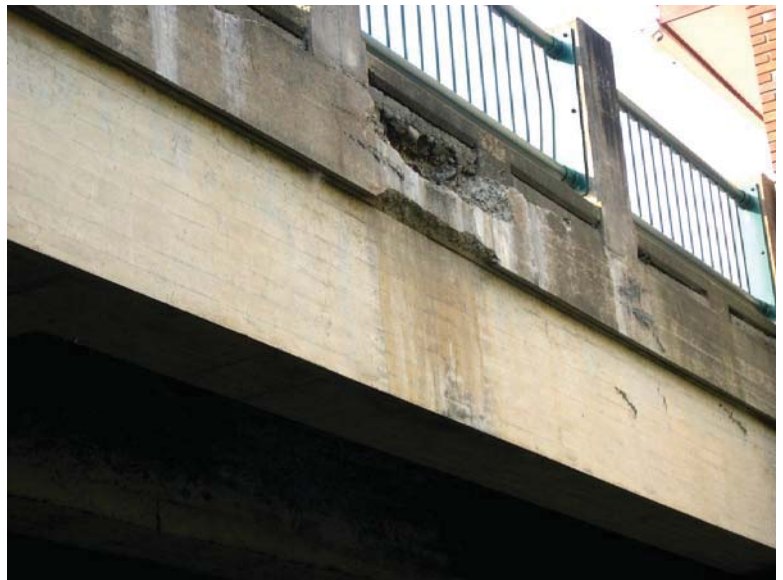
Deterioration of Northern Fascia

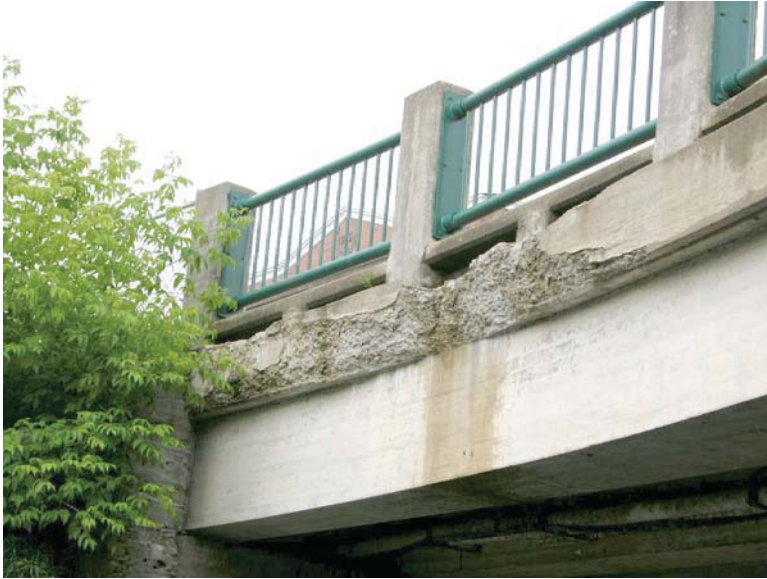
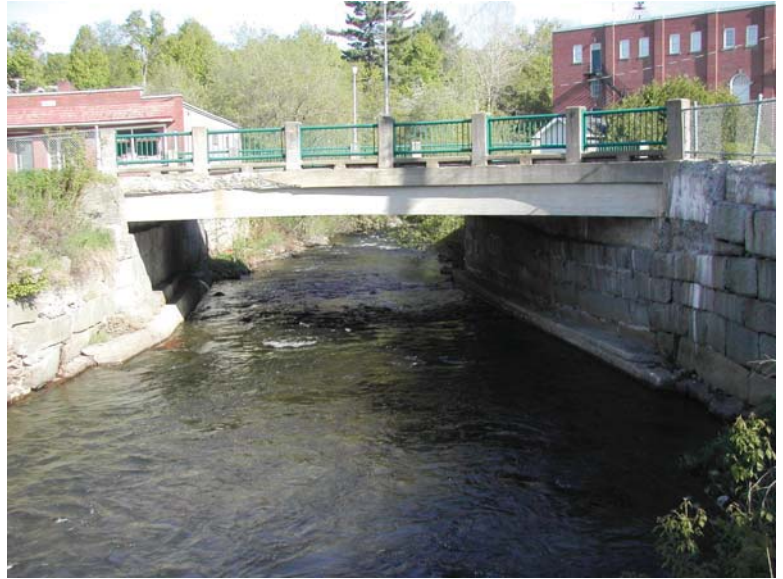
Deterioration of Southern Fascia

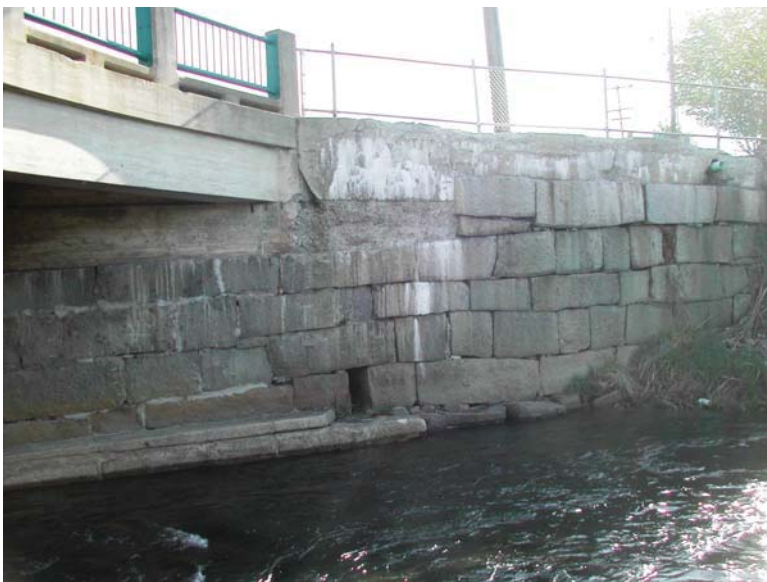
Existing Laid up Stone Abutment  
and Substandard Approach Rail

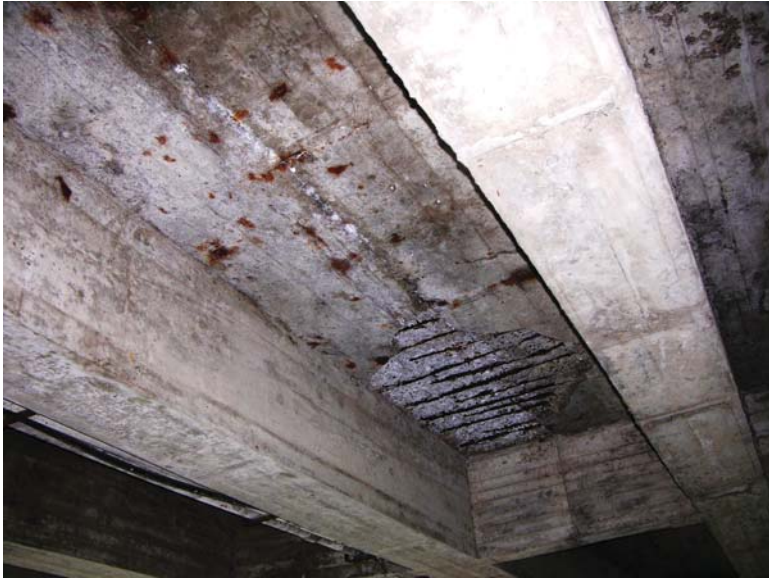
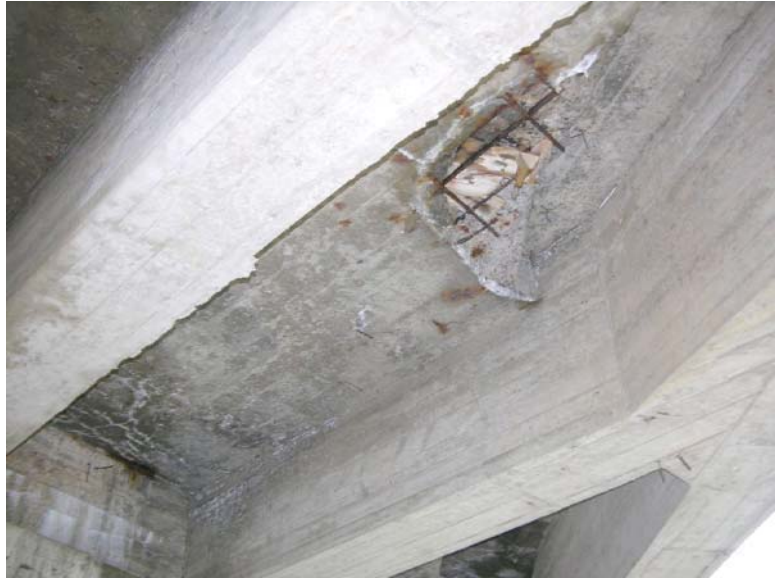
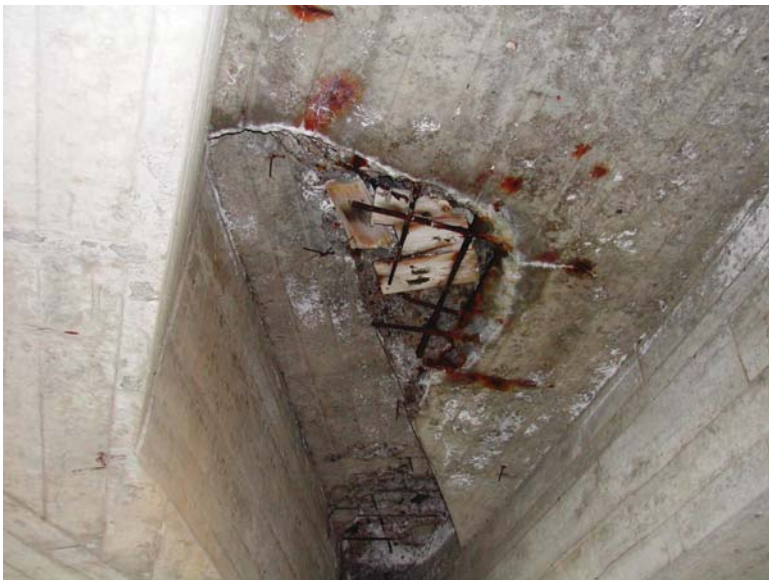
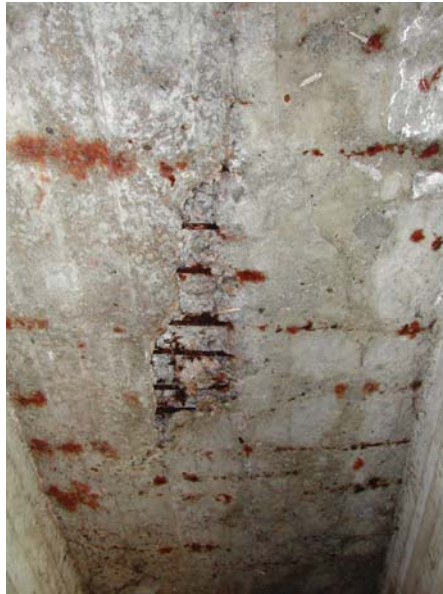
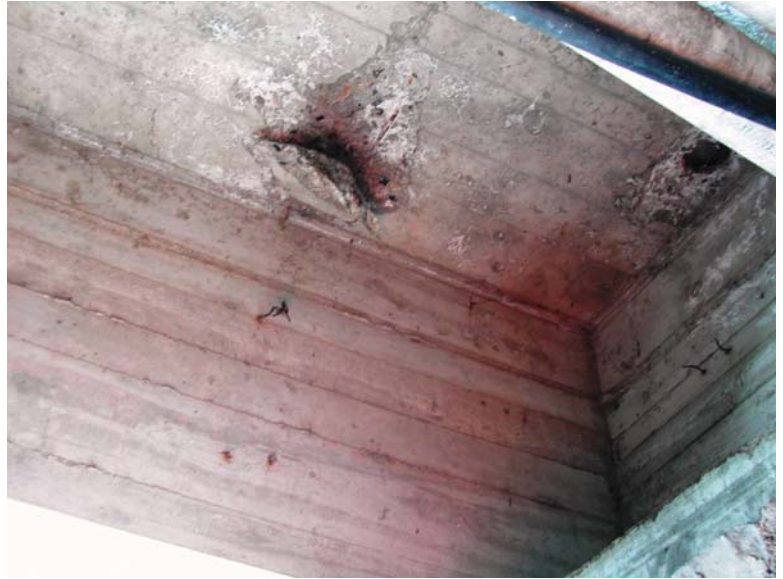
5/24/2011 - Structure should have a full deck replacement in the near future. ~FRE/DCP

05/19/2009 - Deck is generally poor with localized areas of advanced deterioration. Consider 5" thick reinforced concrete overlay or additional full depth bay replacement. Prestressed slab or box units would also be desirable. Even with the ailing deck, the superstructure and substructure still have many years of service life remaining. - MJ/DS

Spalling of Existing Bridge Deck

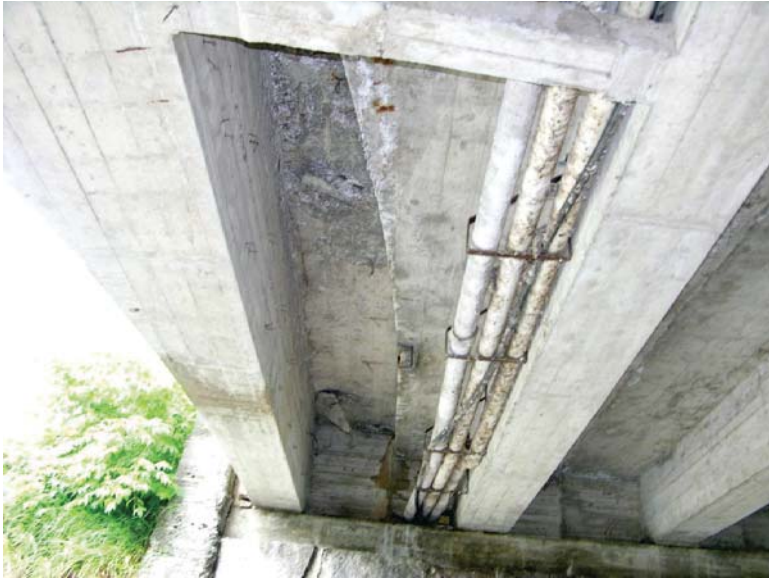
Communication Lines under Existing Bridge Deck

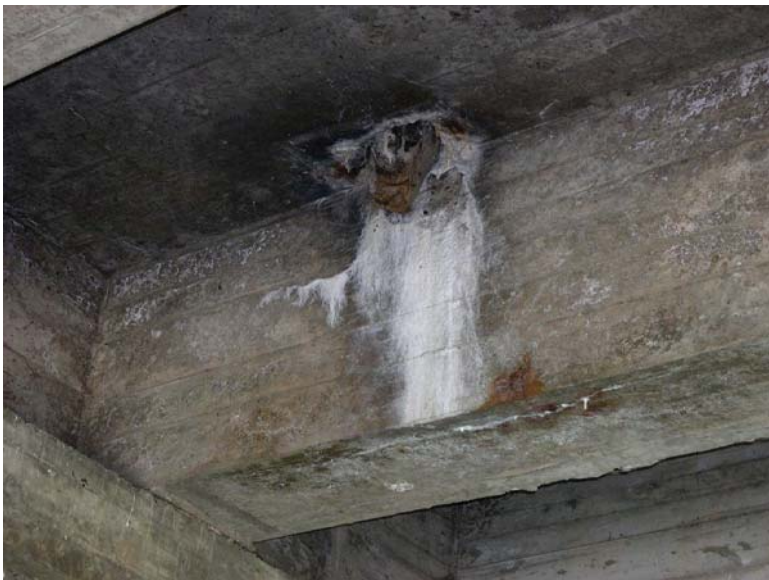
Efflorescence of Existing Bridge Deck and Beams

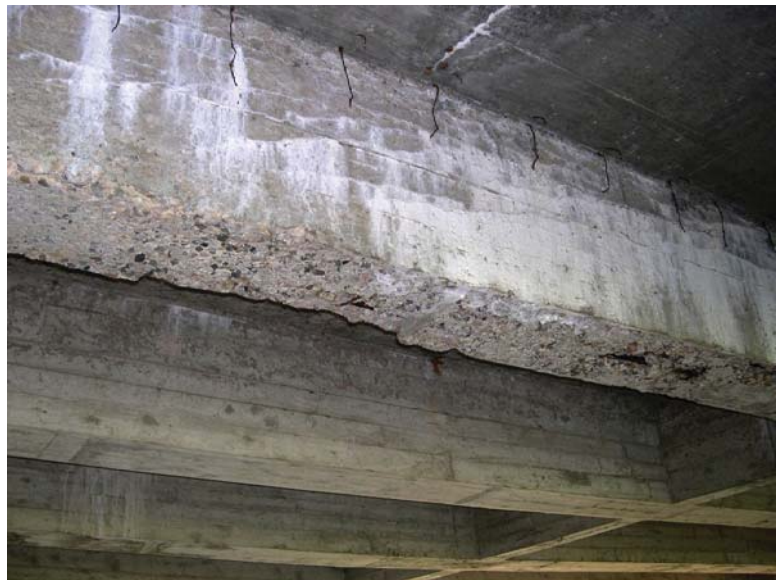
Efflorescence of Existing Bridge Beams

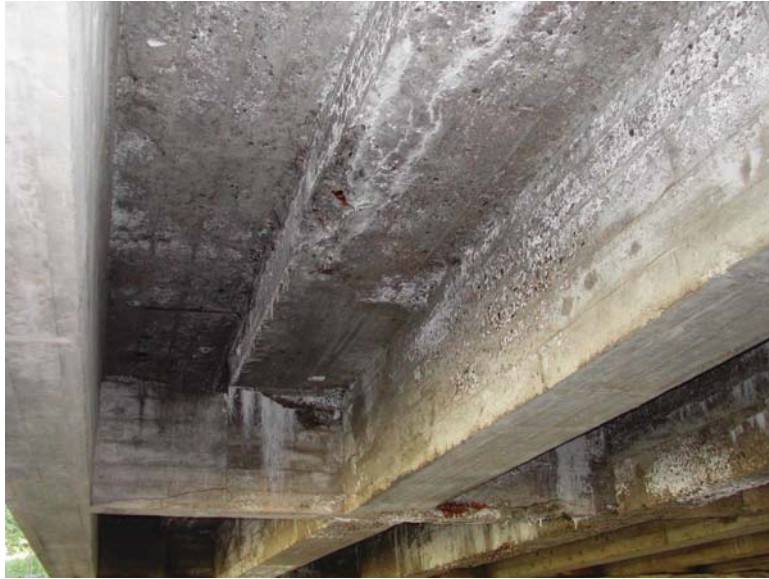
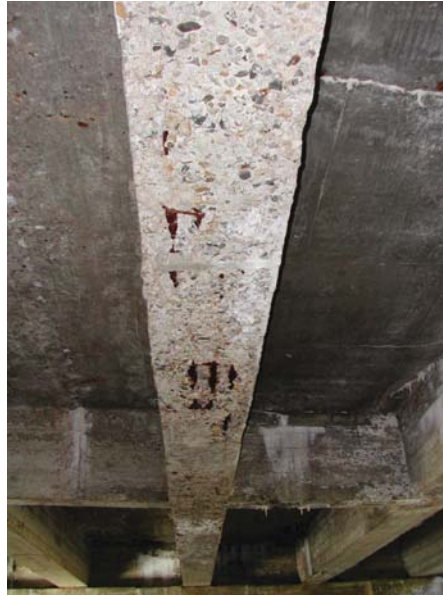
Spalling of Existing Bridge Beams

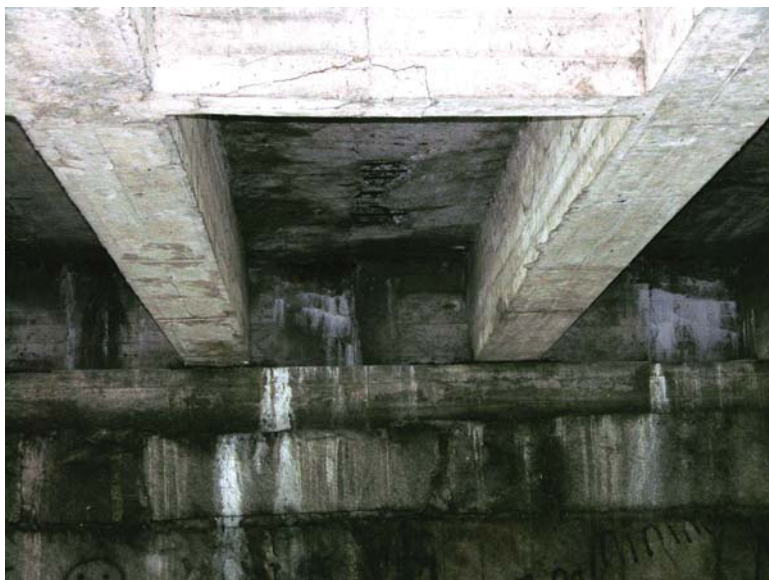
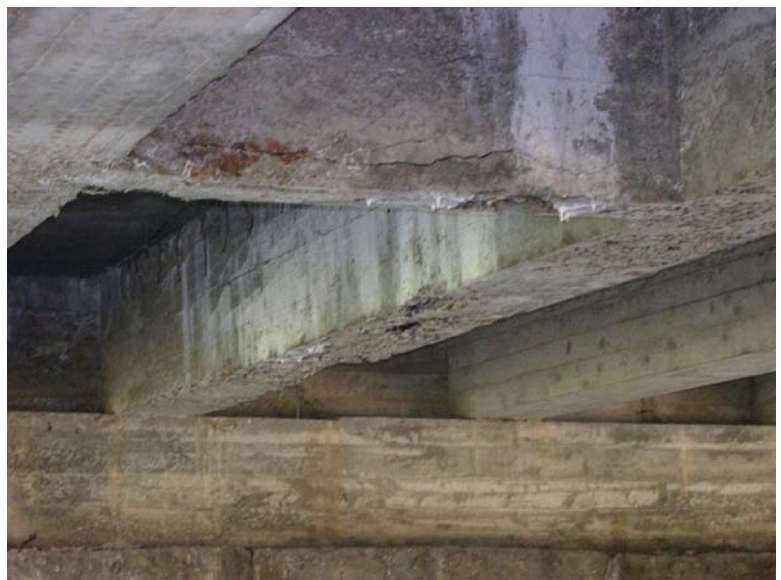
Cracking of Existing Diaphragms

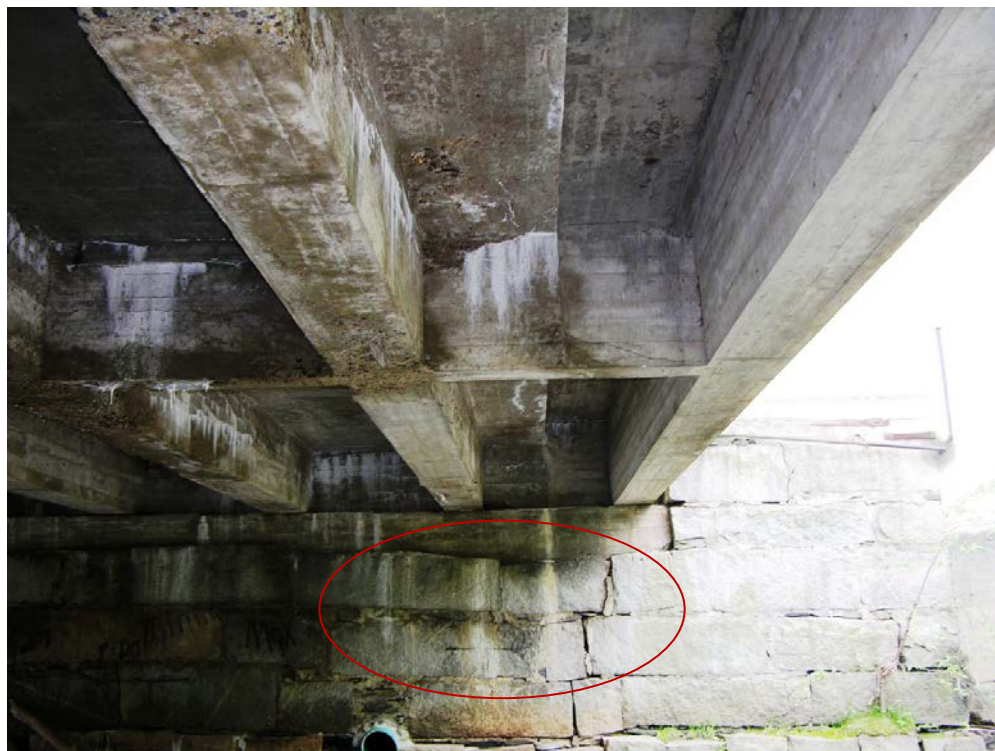
Based on the latest bridge inspection photos from May 2011, it appears that part of the stone wall on the southern abutment has cracked and settled, as seen in Figure 2.

**Figure 2.** Broken Stone under Southern Abutment

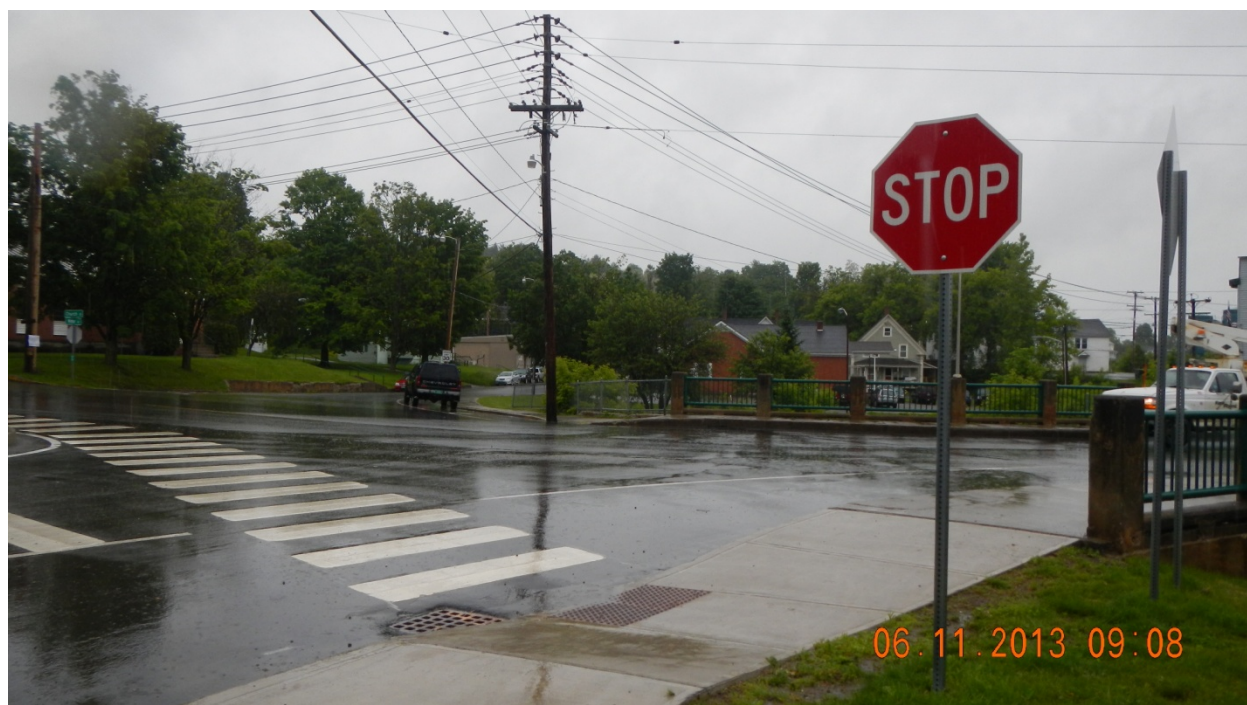
A preliminary site visit was conducted on June 11<sup>th</sup>, 2013 to determine possible obstructions inhibiting boring operations and other site information pertaining to various construction considerations. Information from this visit indicated power lines located with close proximity to the bridge, as seen in Figure 3.

**Figure 3.** Power Lines Located Close to Bridge

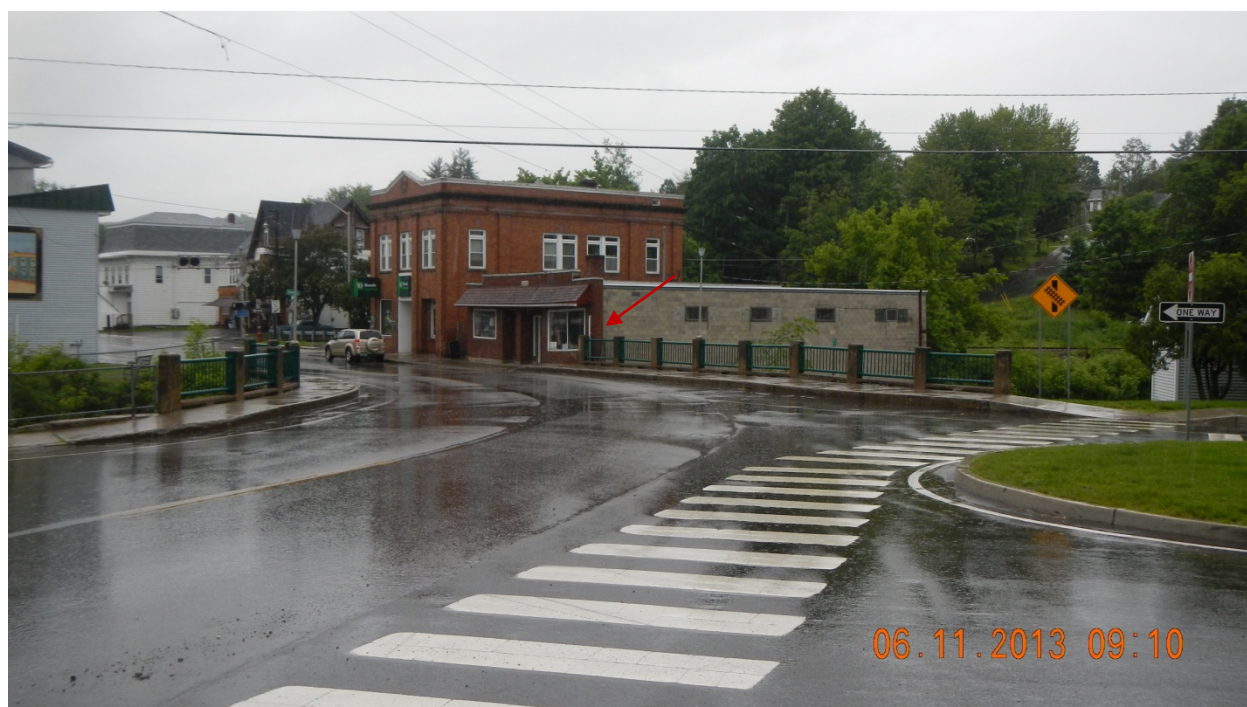
In addition to power lines, the subject bridge is surrounded by buildings along the southern abutment, and has very little access from the southwestern corner, as seen in Figure 4.

**Figure 4.** Surrounding Buildings along Southwest Corner of Bridge

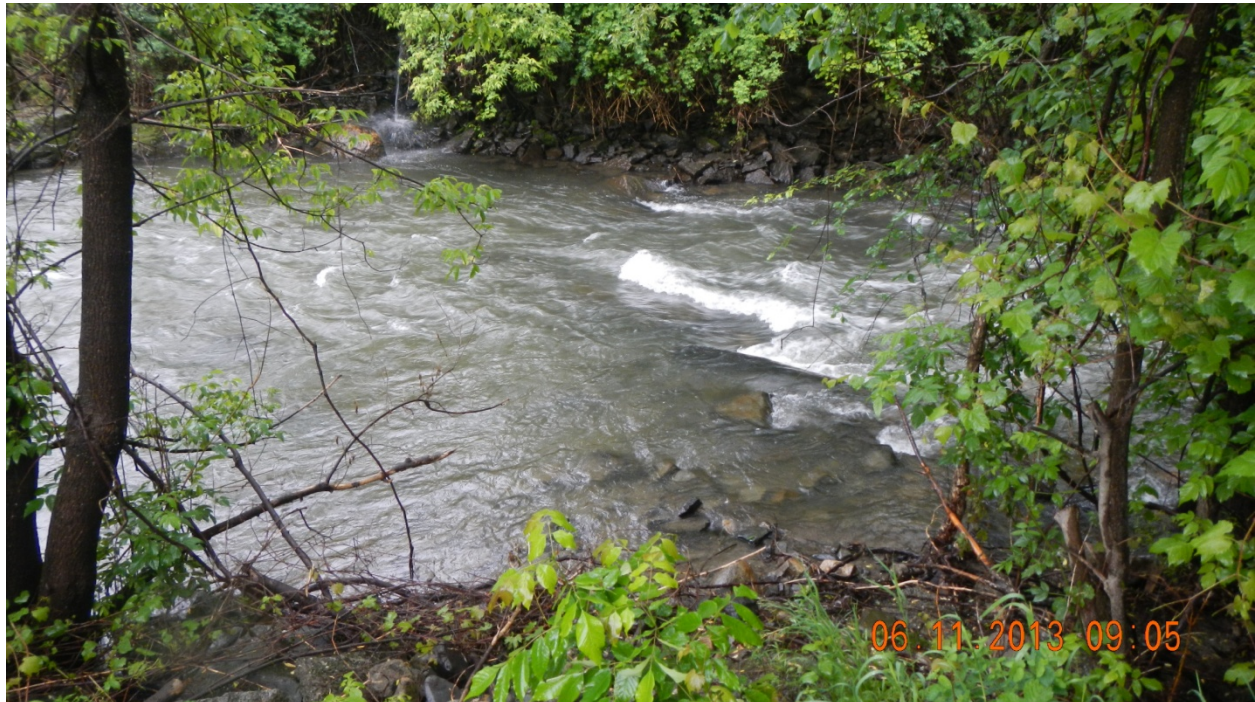
No visible bedrock outcrops were seen in the area; however, boulders and cobbles were evident throughout the stream bed, as seen in Figure 5.

**Figure 5. Boulders and Cobbles Evident in Stream Bed**
