STATE OF VERMONT  
AGENCY OF TRANSPORTATION

Scoping Report

FOR  
Sharon IM 089-1(64)

Interstate Route 89, Bridges 17 N/S over the White River

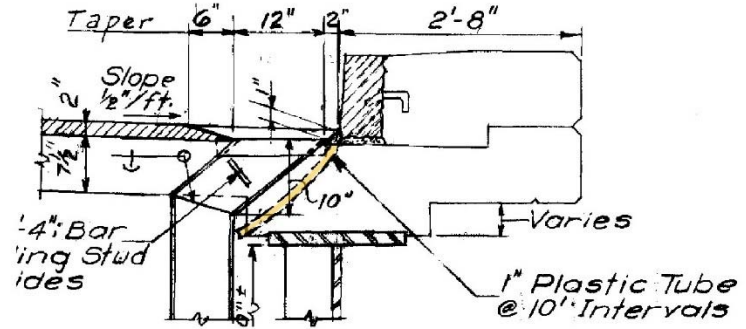
Figure 1: Detail of Drip Tubes from Record Drawings

There are 1" diameter plastic drip tubes through the deck at 10-ft spacing along each curbline (Figure 1). These tubes drain water that permeates through the wearing surface directly onto the lower lateral steel bracing, causing significant deterioration (Figure 2). All of the drip tubes should be cleaned and either filled with grout or extended below the steel. If they are filled with grout, new deck drains can

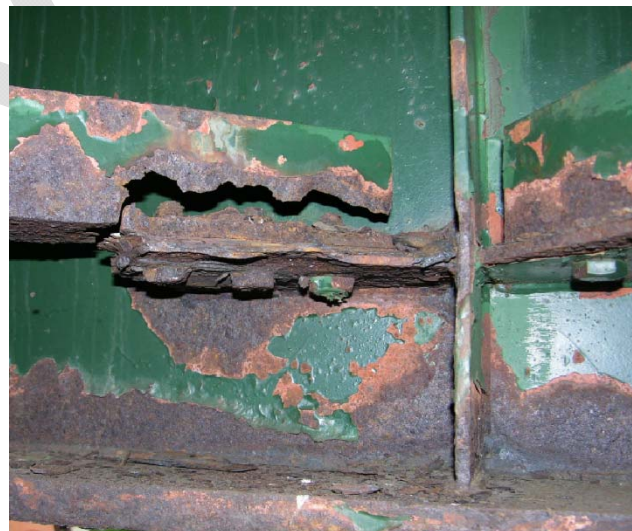
Figure 2: Lateral Bracing Deterioration below Drip Tubes

The drip tubes in the deck are draining water directly onto the lower lateral wind bracing, causing severe section loss. The deteriorated gusset plates and bracing angles should be removed and replaced in kind in every location with a drip bar directly above. For the purposes of this report, it is assumed that half of the angles in each exterior bay will require replacement. These repairs are included in the Deck Patching and Deck Replacement alternatives. During the next design phase, when the extent and locations of deterioration is known, the structure can be evaluated for a condition with the deteriorated angles removed and not replaced, to potentially avoid unnecessary repairs.

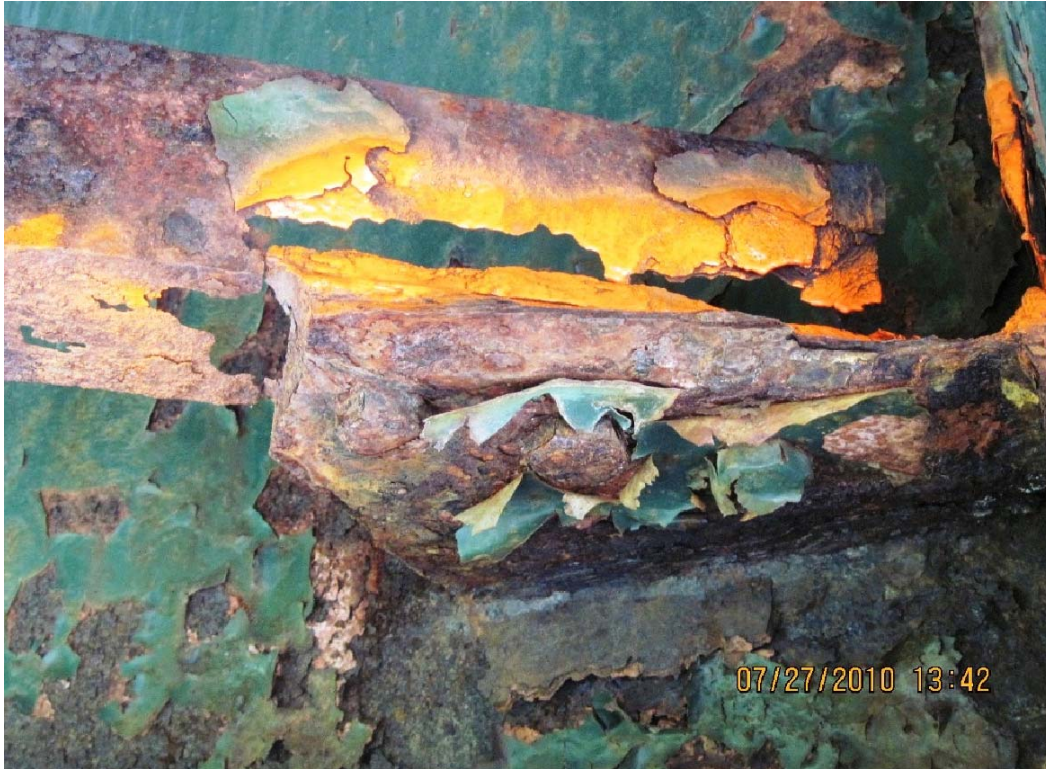
Lateral Bracing Angle Deterioration below Deck Drip Tube (Bridge 17N shown)

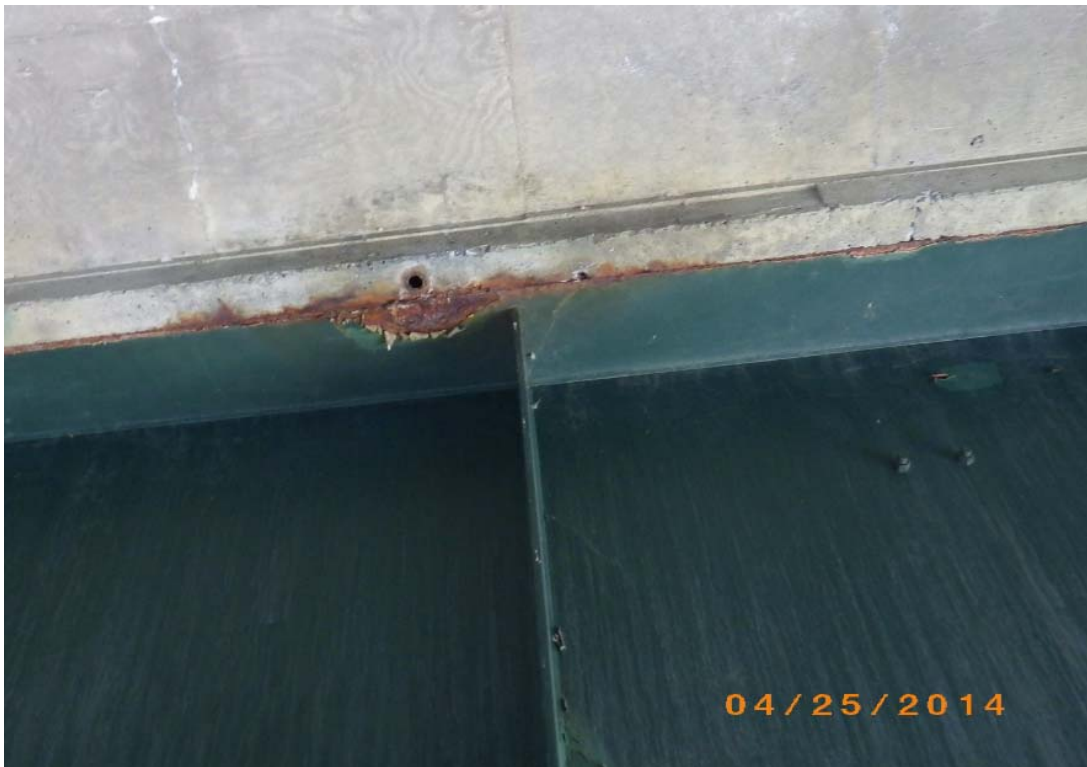
Typical Deck Drip Tube

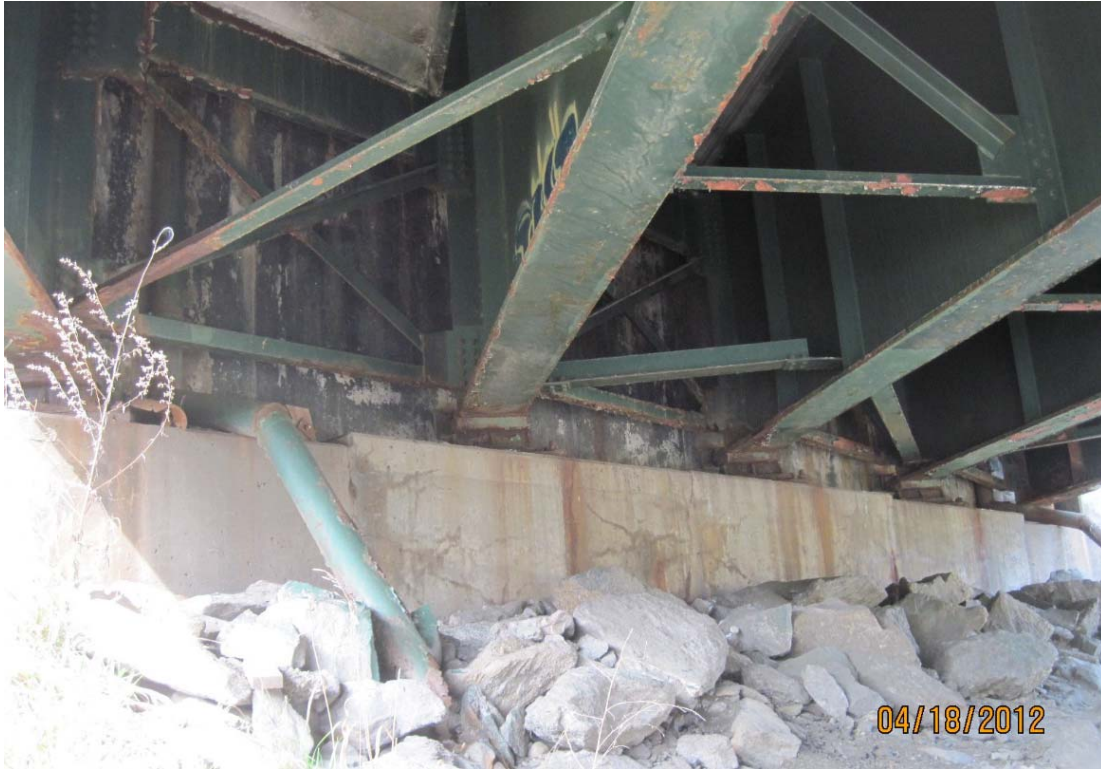
The substructures are in fair (northbound) and satisfactory (southbound) condition. Based on field observations, it is likely that this assessment is due to the condition of the backwalls. As previously discussed, the finger joints are leaking, resulting in significant staining and spalling on the front

Condition of Abutment and Backwall (Bridge 17N shown)

faces of the backwall. When the finger joints are replaced, the deteriorated concrete will be removed and replaced, which will include a significant portion of the backwall. It is anticipated that after sounding the surfaces of the remaining substructure units, only minor repairs will be required. Each rehabilitation alternative includes a nominal quantity of shallow concrete patch repairs and pressure injection of cracks.

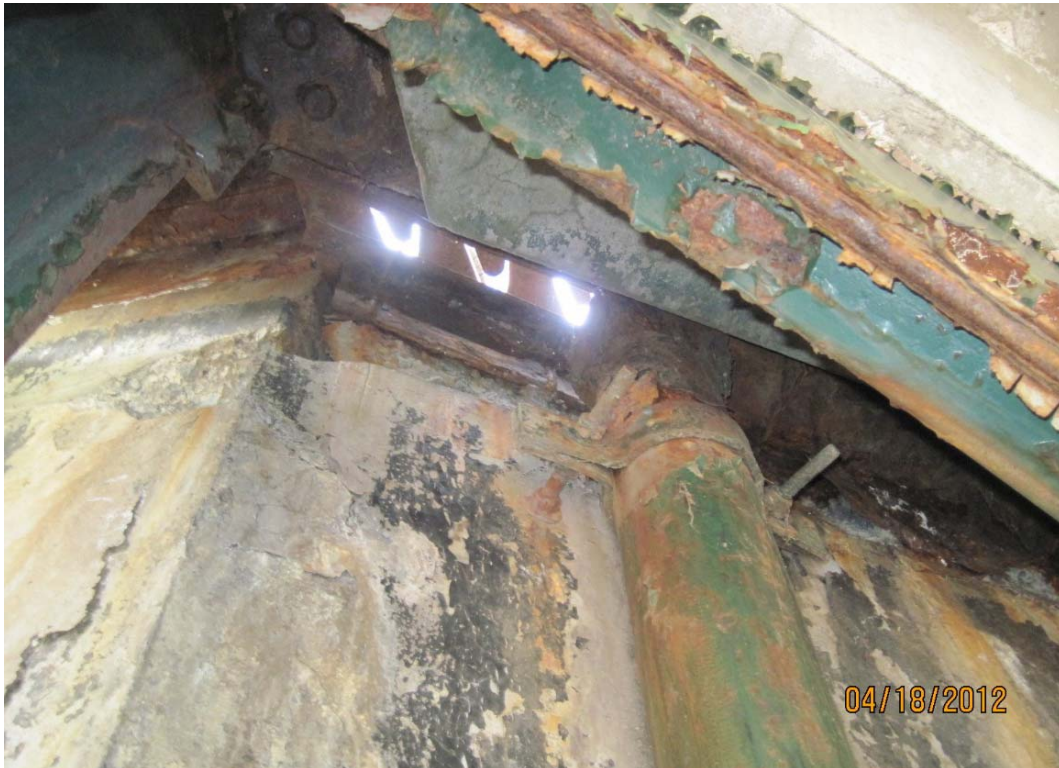
The steel expansion finger joints at each abutment are leaking and vertically misaligned; they should be replaced as part of every rehabilitation alternative. The calculated range of thermal movement under a 150-degree temperature differential is 4.84". This is outside of the typical range of movement accommodated by the Fingerplate Vermont Joints, however it is possible that the finger configuration could be designed for this expansion. During the next design phase, products such as Emseal Bridge Expansion Joint System (BEJS), a product with which MassDOT has had recent success, will be investigated to find an appropriate system for this range of movement.

Exposed Finger Joint (Bridge 17N shown)

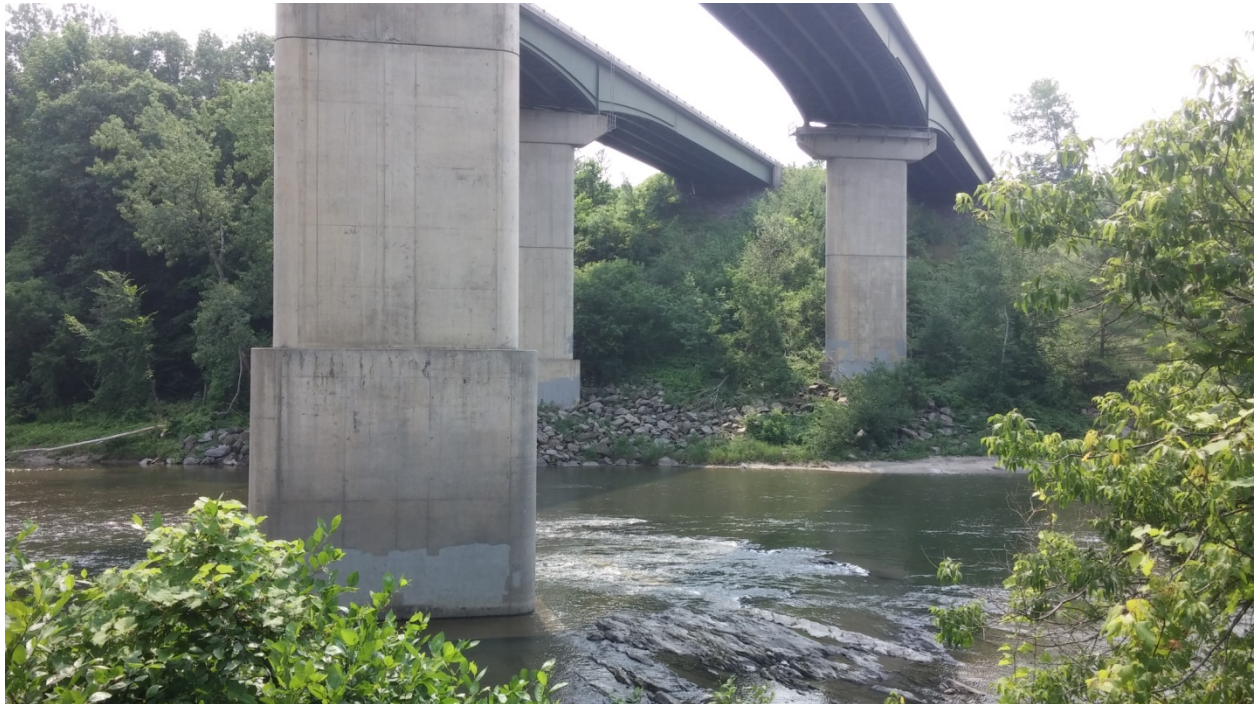
**Figure 3: Bedrock in the River**

During the site visit, exposed bedrock was observed in the river. The bedrock can be seen in Figure 3. According to record plans from previous construction, the existing piers are founded directly on bedrock. No visible bedrock was seen in the areas of the abutments during the site visit. If deep foundations are contemplated for the abutments, additional borings advanced to bedrock may be required.
