**STATE OF VERMONT  
AGENCY OF TRANSPORTATION**

**Scoping Report**

**Woodford BF 010-1(52)  
VT ROUTE 9, BRIDGE 18 over UNNAMED BROOK**

February 26, 2016

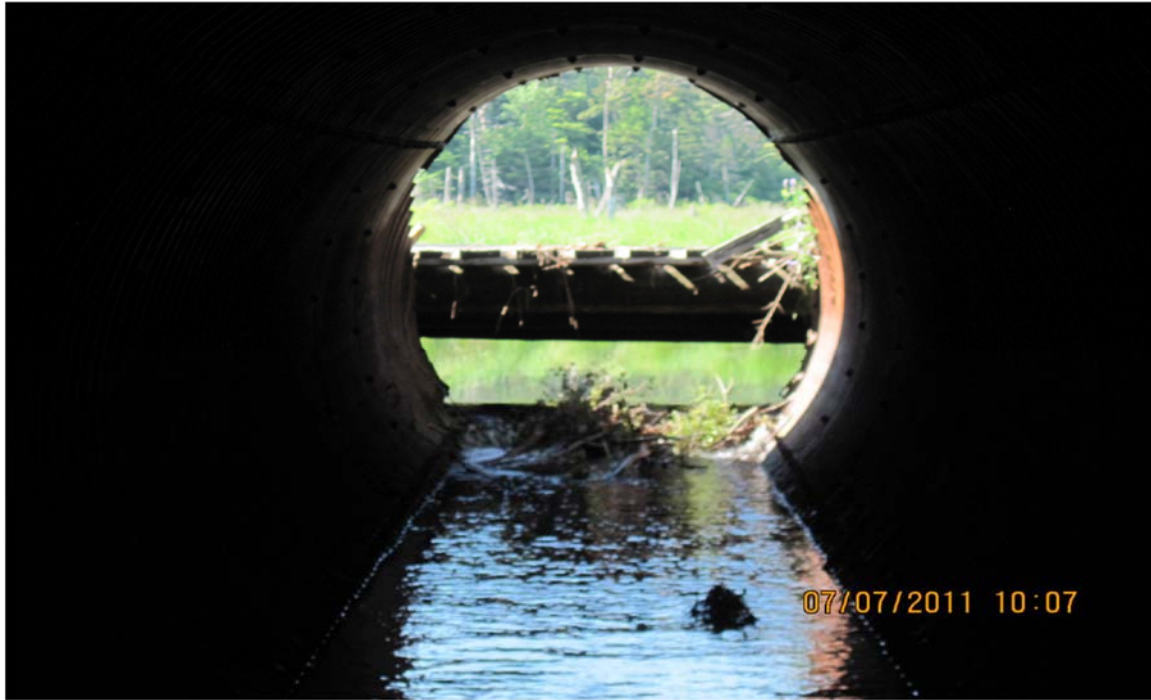
Interior of Pipe Looking at Snowmobile Bridge

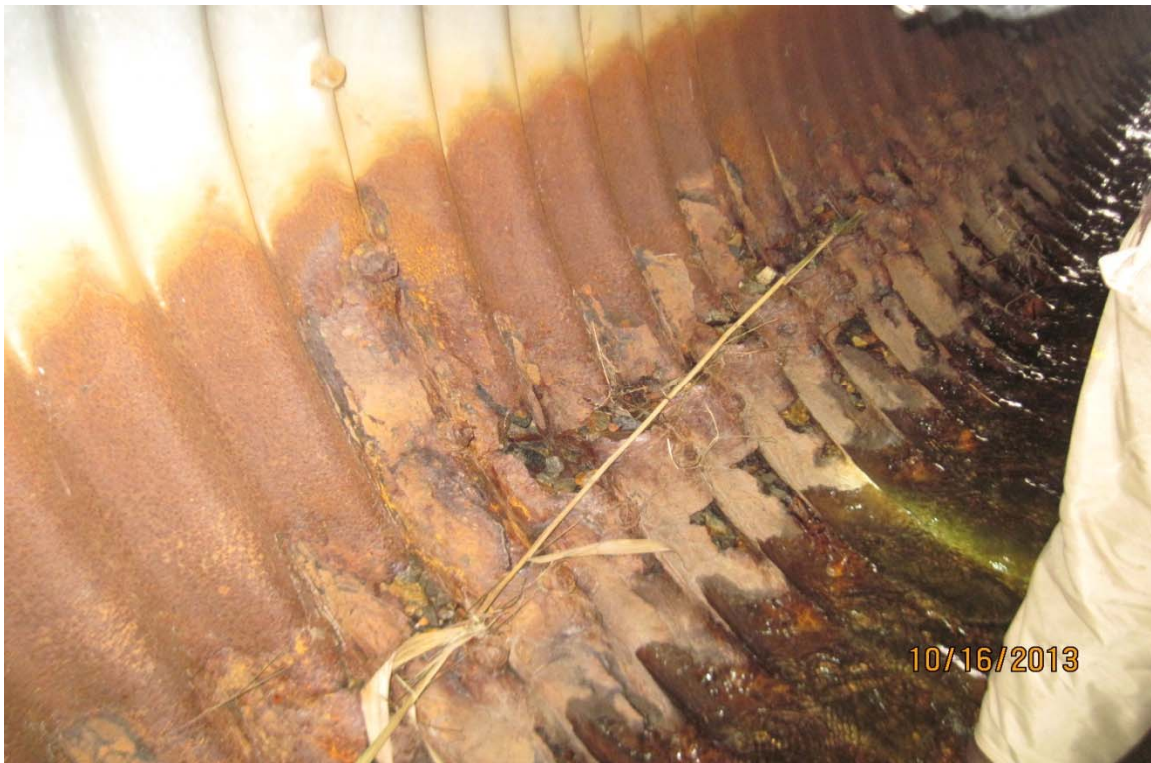
Interior of Pipe

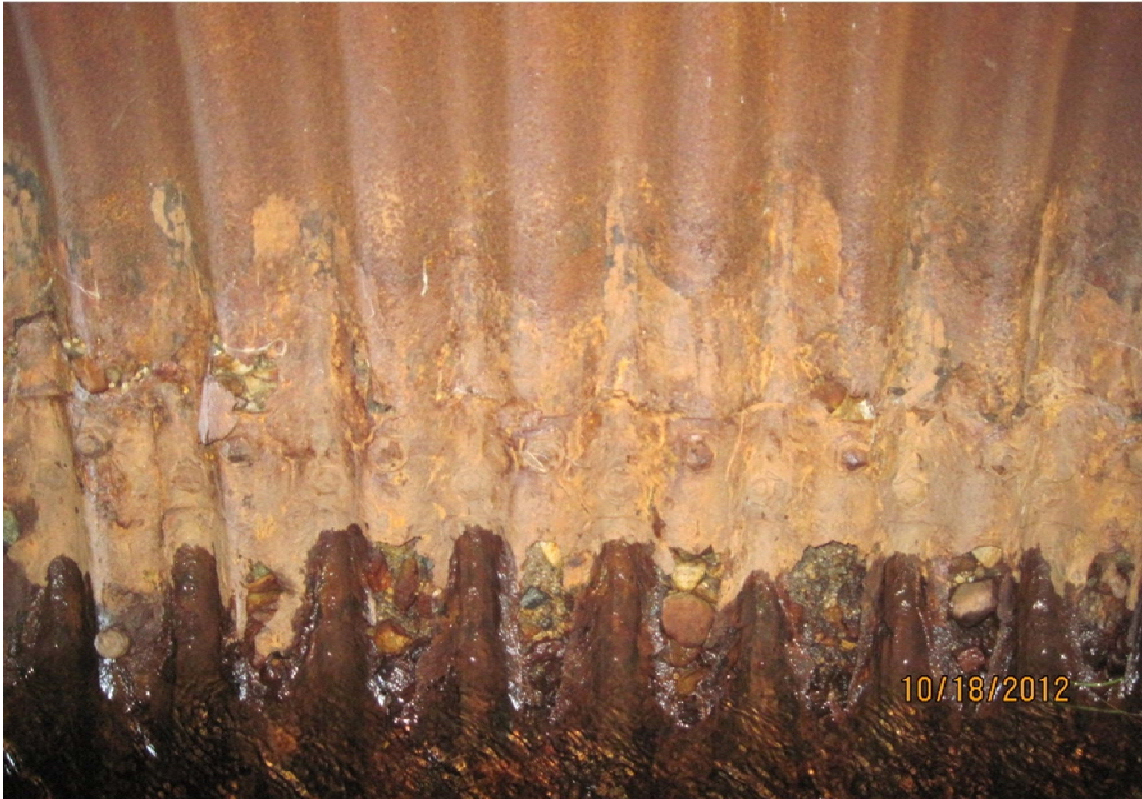
Interior of Pipe

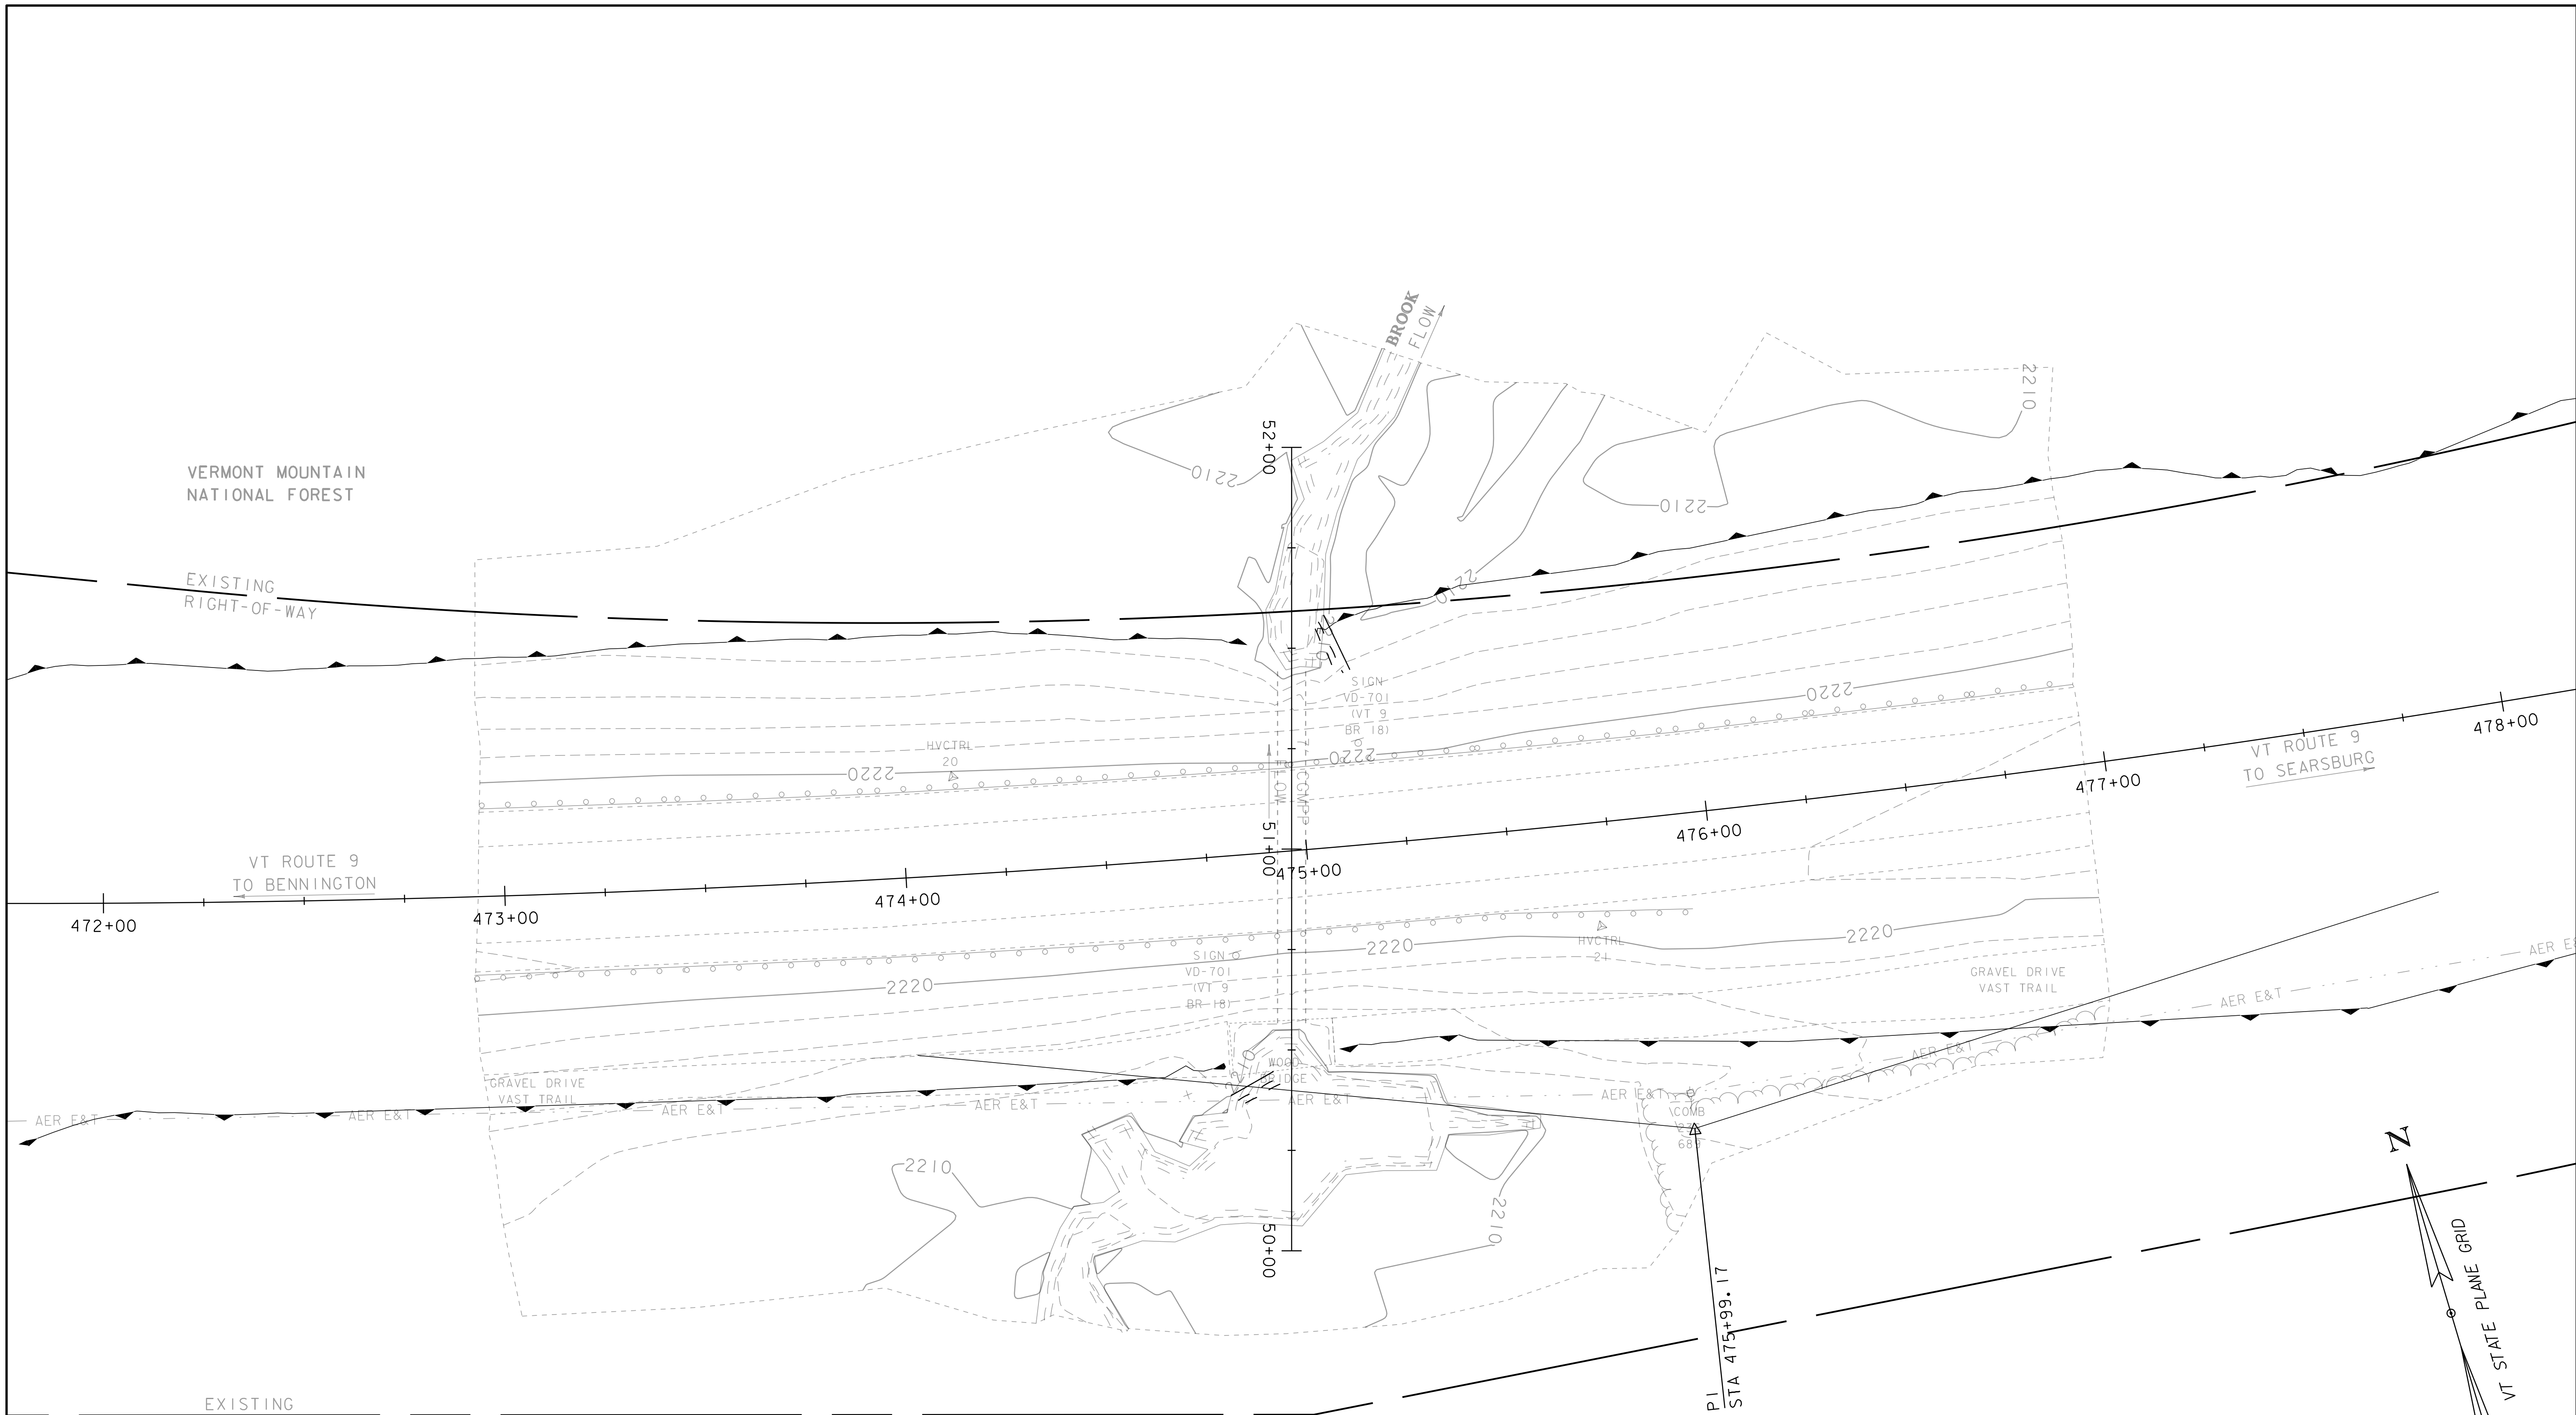
**EXISTING CONDITIONS**

EXISTING 7' CGMPP  
 92' LONG, BUILT 1919  
 RECONSTRUCTED 1965  
 6' AVERAGE COVER  
 38 SQFT WATERWAY AREA
