**STATE OF VERMONT
AGENCY OF TRANSPORTATION**

Scoping Report

**Springfield BF 0134(43)
VT ROUTE 11, BRIDGE 57 over UNNAMED BROOK**

October 13, 2017

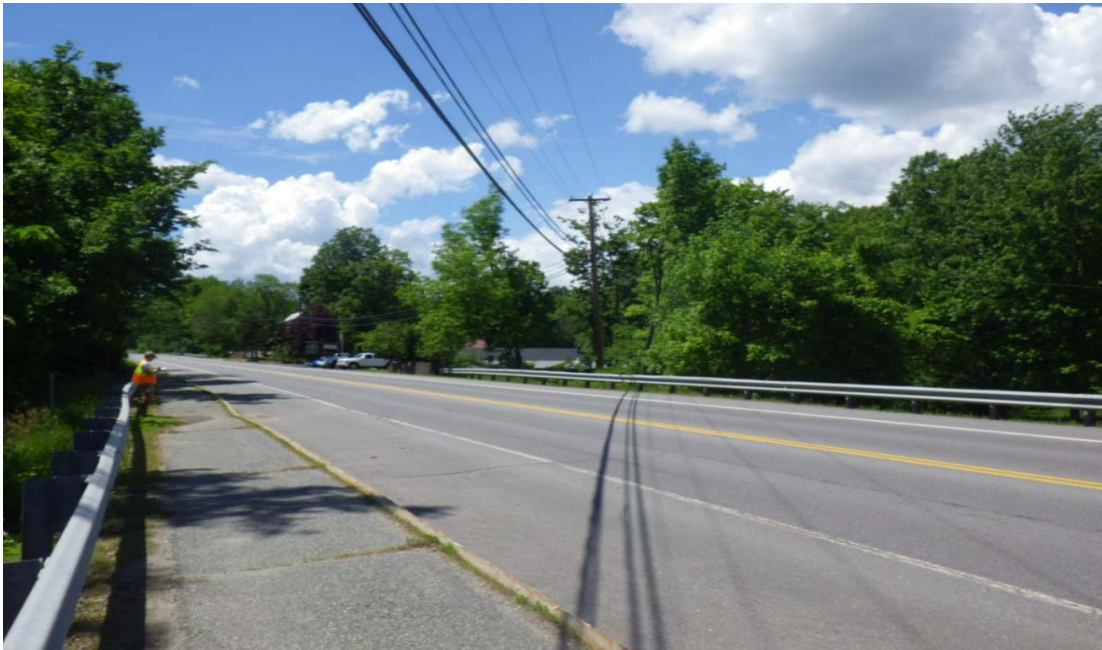
VT 11 looking west

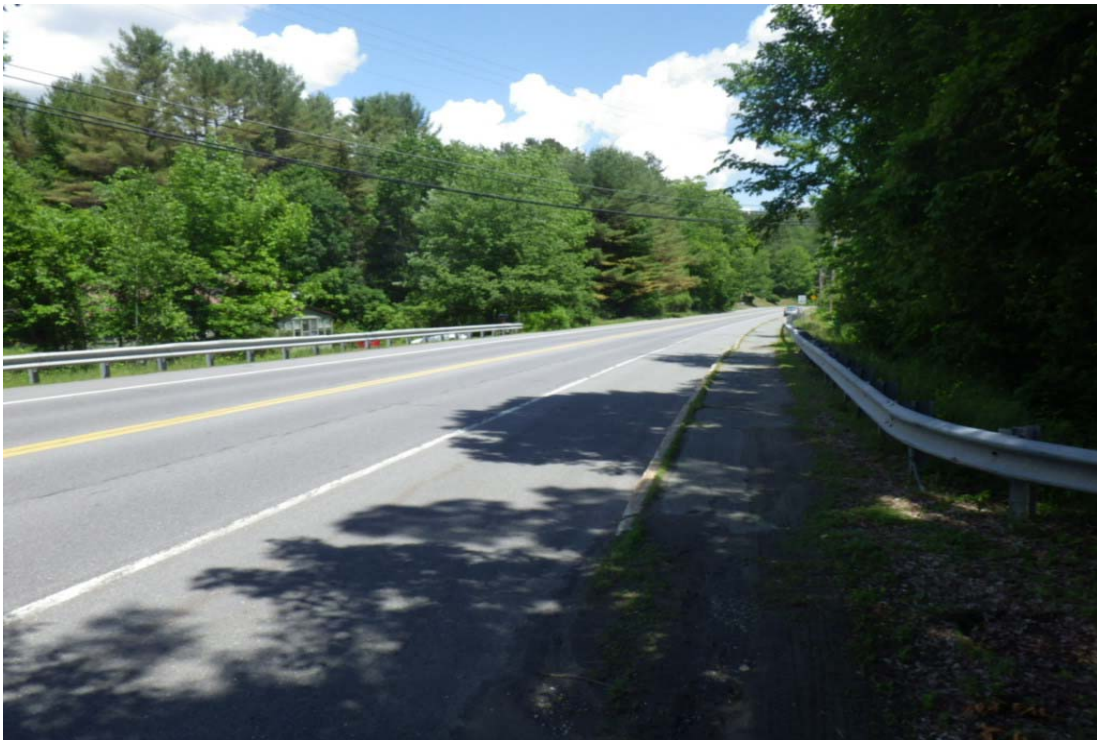
VT 11 looking east

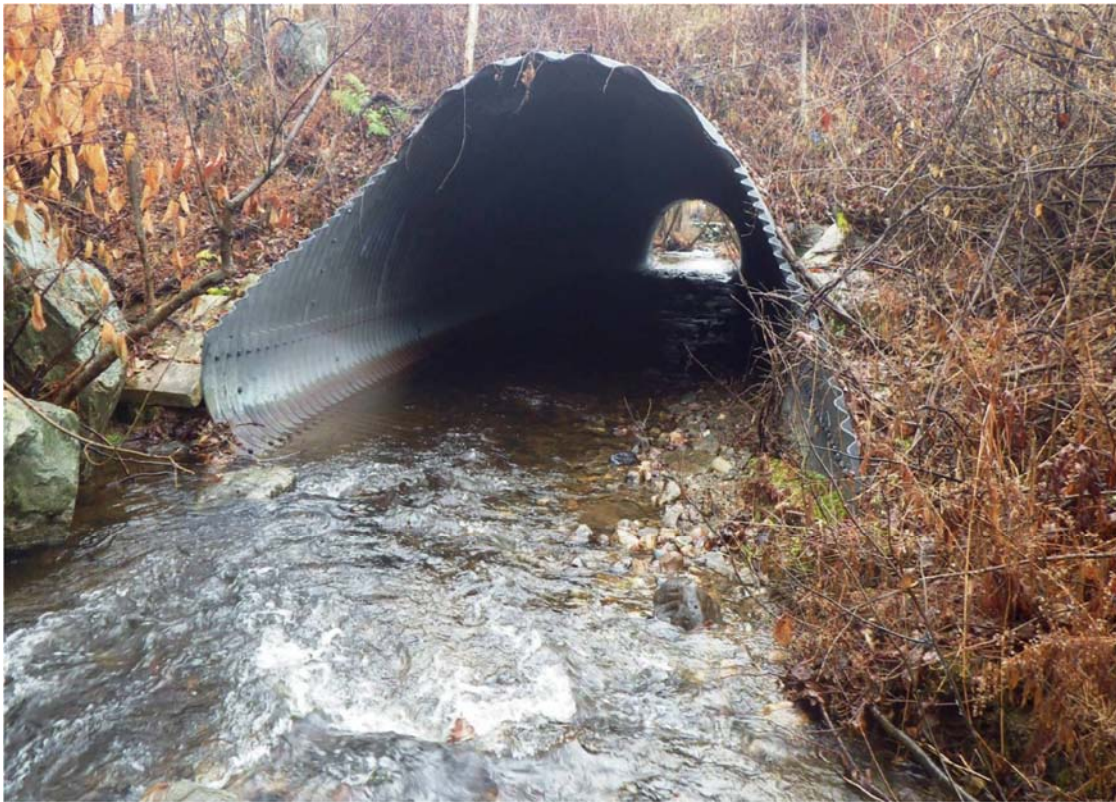
Culvert Inlet

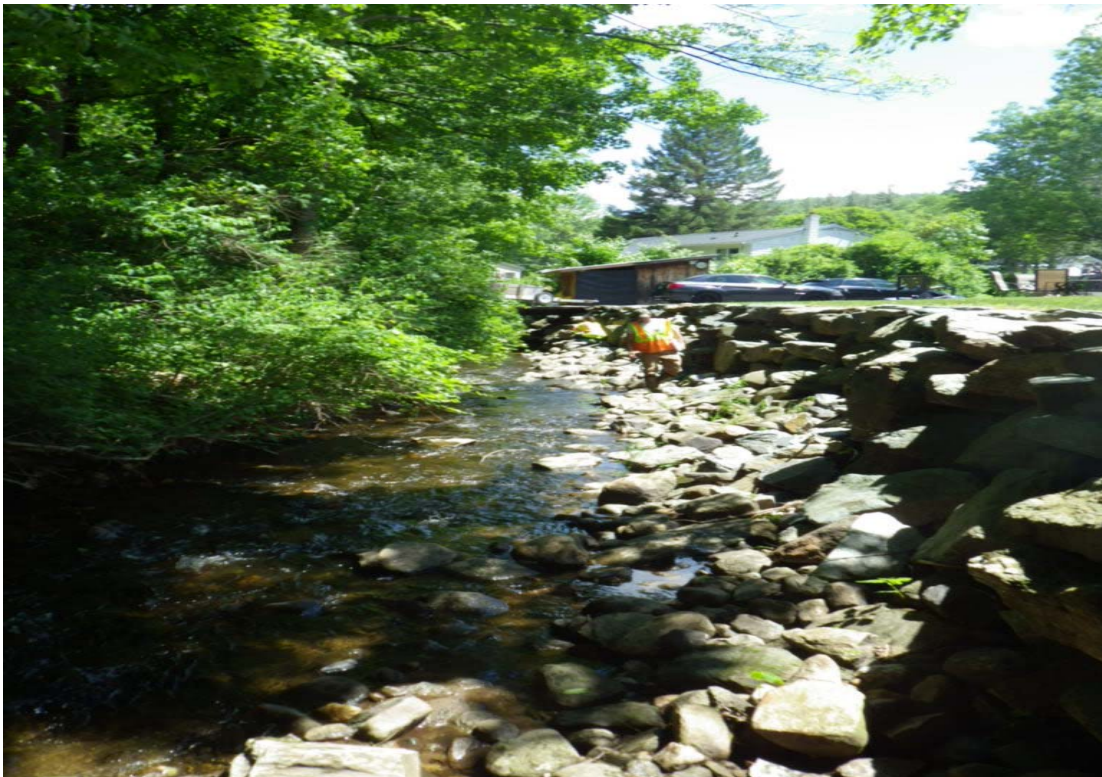
Looking Downstream

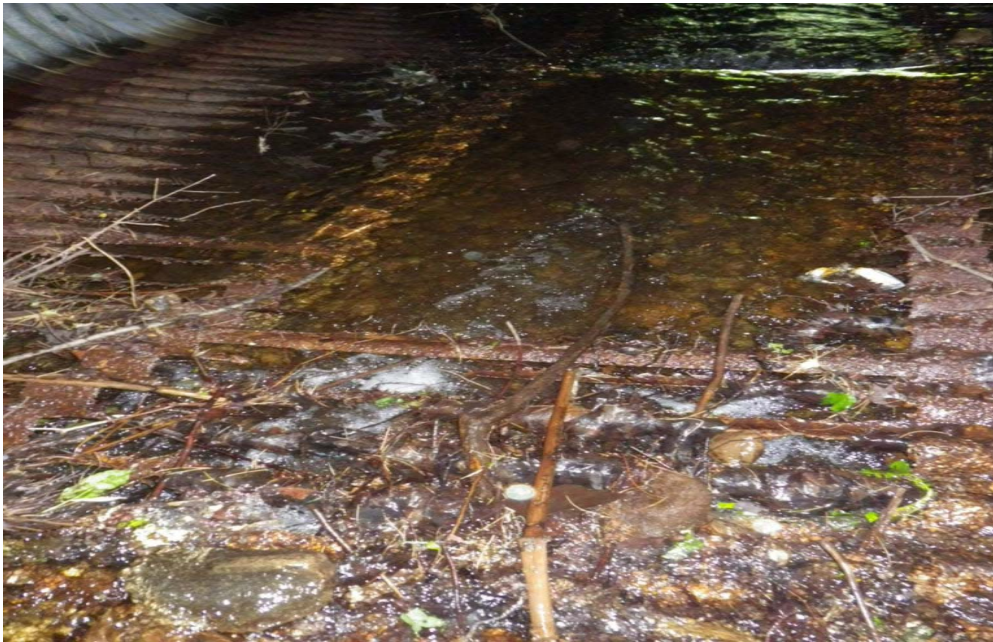
1. This culvert has a rating of 2 "Critical" and is showing significant corrosion and section loss at the invert. There are perforations throughout.
2. The roadway above the culvert is showing signs of distress and settlement.
3. The existing culvert meets Hydraulic Standards, but constricts the channel.
4. There are no known roadway geometric deficiencies.

The condition of the galvanized metal above the ordinary water line in the culvert is very good, suggesting that there is significant service life remaining in that portion of the pipe. Below the water line, the corrosion is severe. There are different types of invert repair that can be utilized on corrugated steel pipe. The following were considered:

Missing invert

Alternative 2a is recommended; new buried structure constructed in phases with traffic maintained on a temporary on-site detour provided one lane in each direction. A precast or cast in place structure could be used, however if precast, portions of cast in place should be considered for the joint between phases.

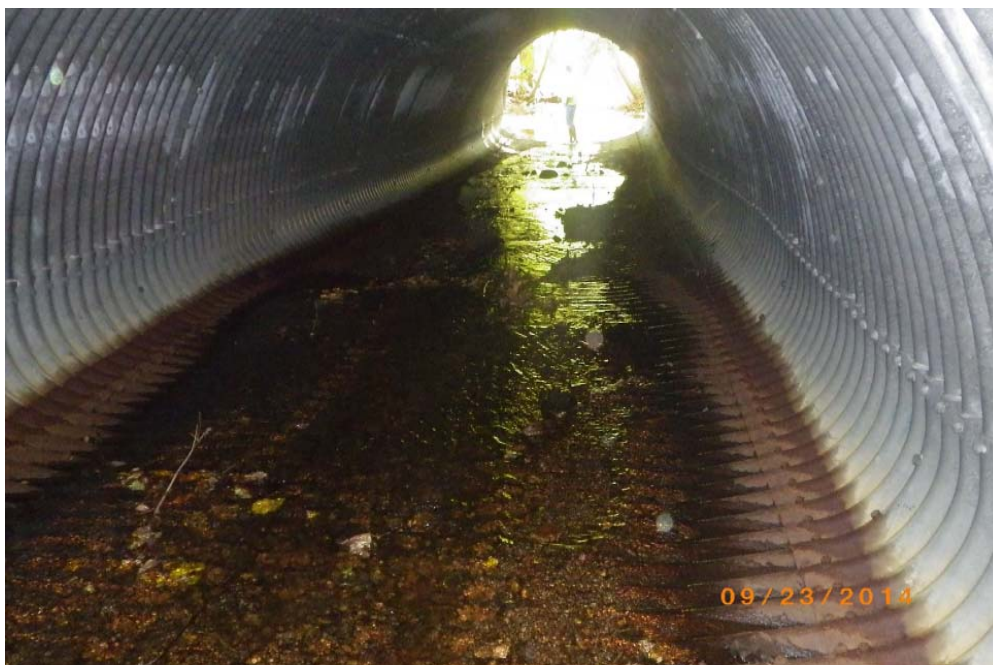
Condition of Pipe above waterline
