**STATE OF VERMONT
AGENCY OF TRANSPORTATION**

Scoping Report

Springfield BF 0134(45)

VT ROUTE 11, BRIDGE 60 over UNNAMED BROOK

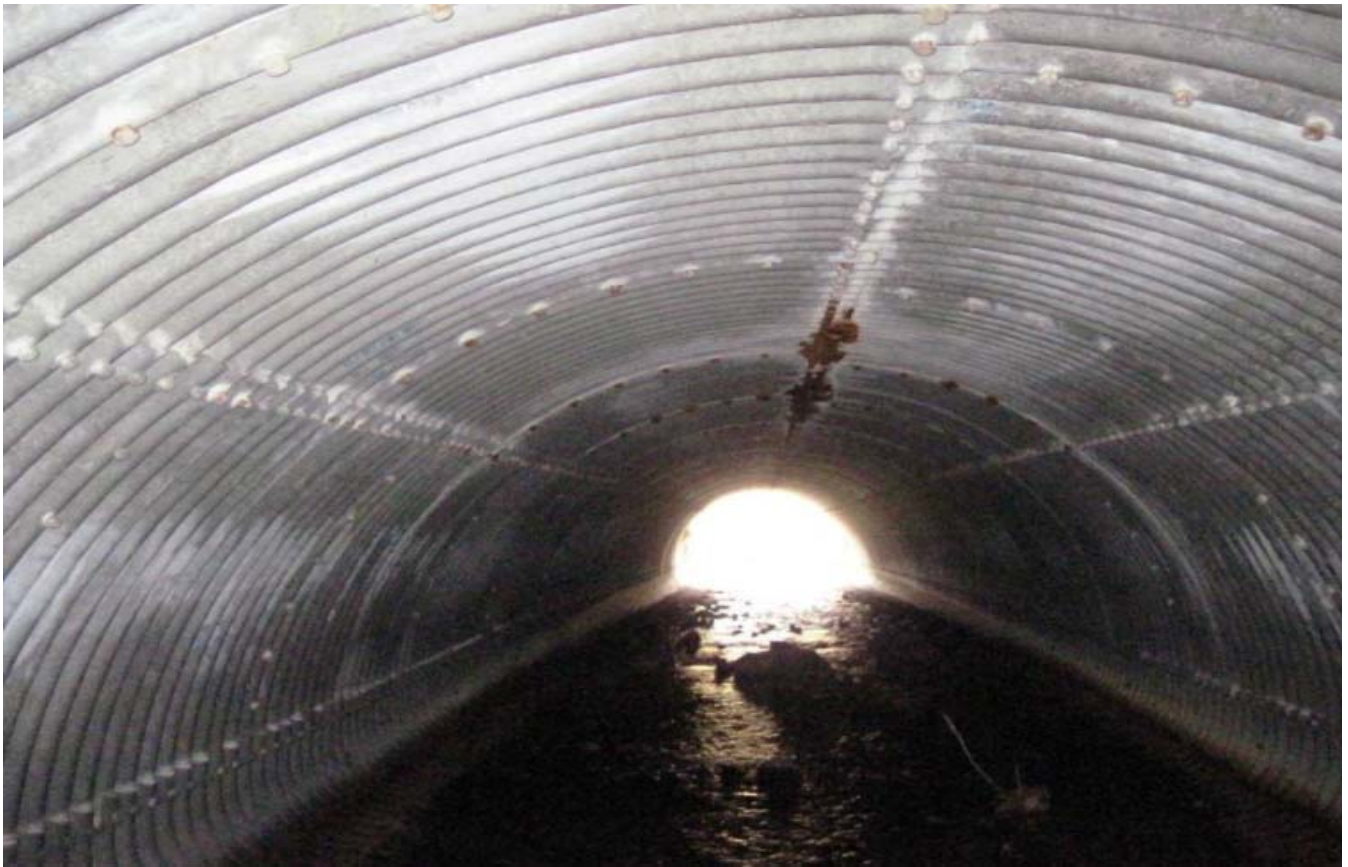
Pipe Interior

The condition of the galvanized metal above the ordinary water line in the culvert is fairly good. There is some corrosion evident along bolt lines and seams, but it does not appear that the pipe is settling significantly. There are different types of invert repair that can be utilized on corrugated steel pipe. The following were considered:

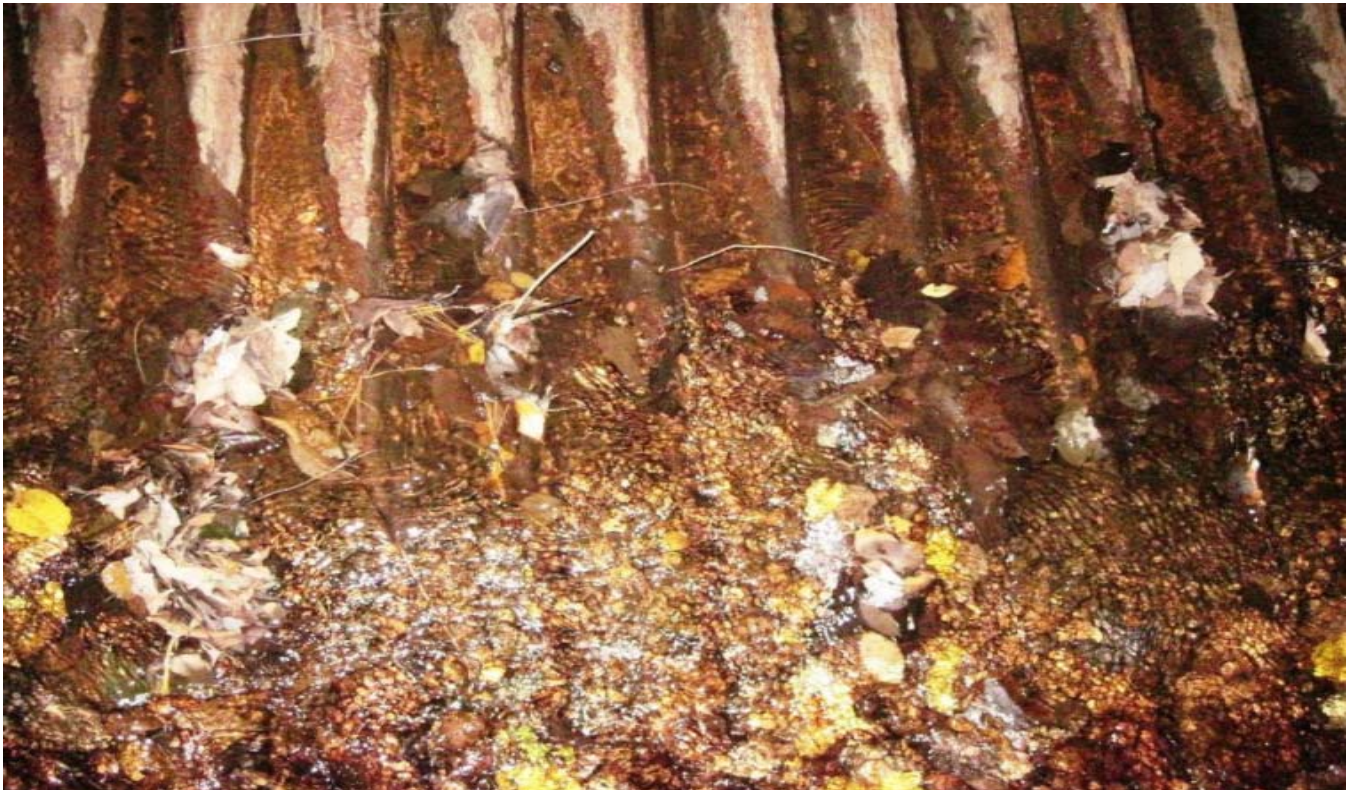
1. This culvert has a rating of 3 “Serious” and has significant corrosion and section loss, particularly in the invert area. Piping is occurring.
2. The existing culvert does not meet Bank Full Width (BFW) Standards.
3. VT 11 is slightly substandard in banking in the project area.

Deteriorated Invert

11/08/2016 - ** Culvert has severe corrosion of invert, along with piping occurring. Pipe has potential for significant distortion/sink hole formation and needs replacement. ~ MJ/AC

04/22/2016 - Special inspection to monitor distress. ** Extensive invert deterioration with large holes, especially at midlength with a 4' square hole and 16" drop where piping is occurring. Culvert needs extensive invert repair or full pipe replacement soon. ~ MJ/SP

Alternative 2a is recommended; replace the existing culvert with a new buried structure in phases.
