STATE OF VERMONT  
AGENCY OF TRANSPORTATION  
**Scoping Report**

FOR  
**Addison BF 0172(9)**  
**VT ROUTE 125, BRIDGE 1 over WARDS CREEK**

Revised March 26, 2017

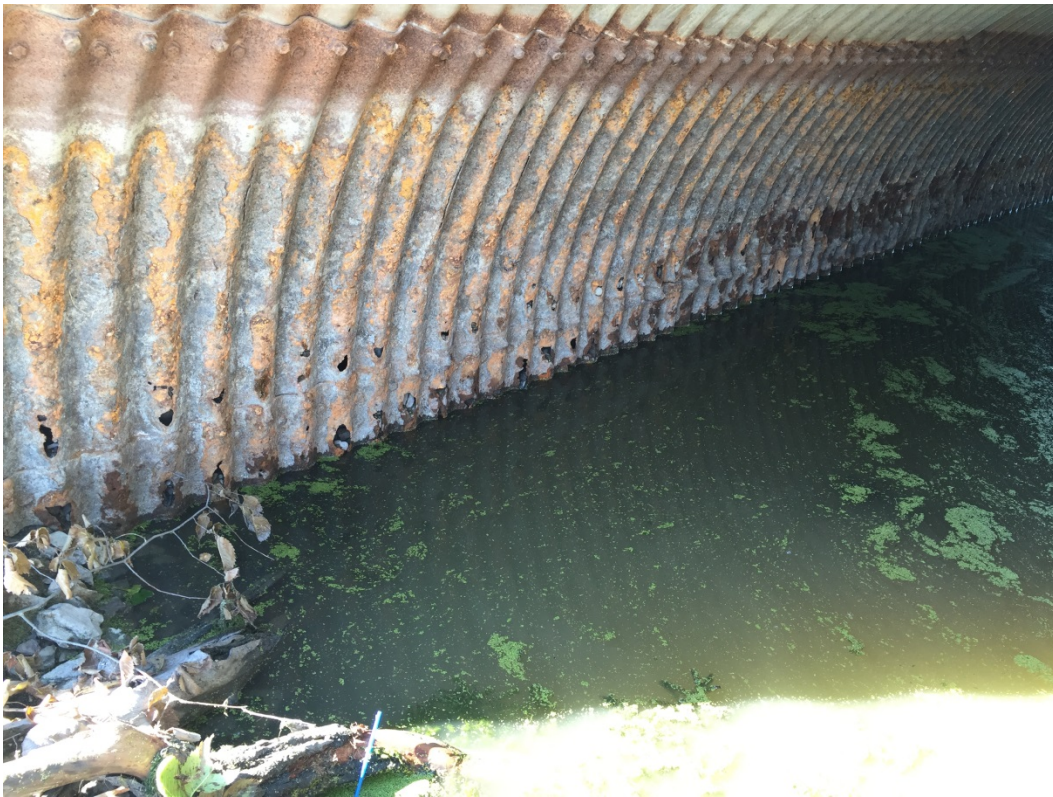
Typical Culvert Deterioration at Waterline

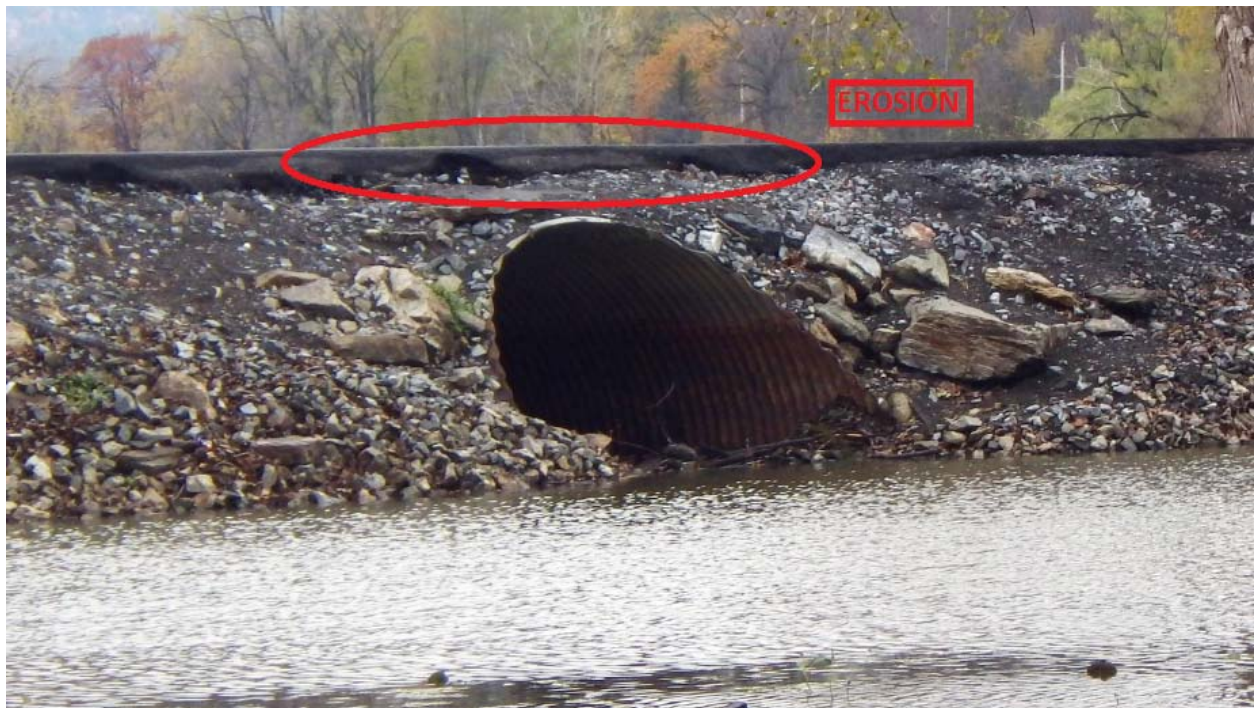
**Figure 2:** Erosion on the Bank above the Inlet

Based on the latest bridge inspection report from October 2014, the culvert is in serious condition and will need to be replaced soon. From the inspection, it was indicated that the material over the pipe has eroded and needs to be repaired as shown in Figure 2. It was also recommended that a guardrail be installed.

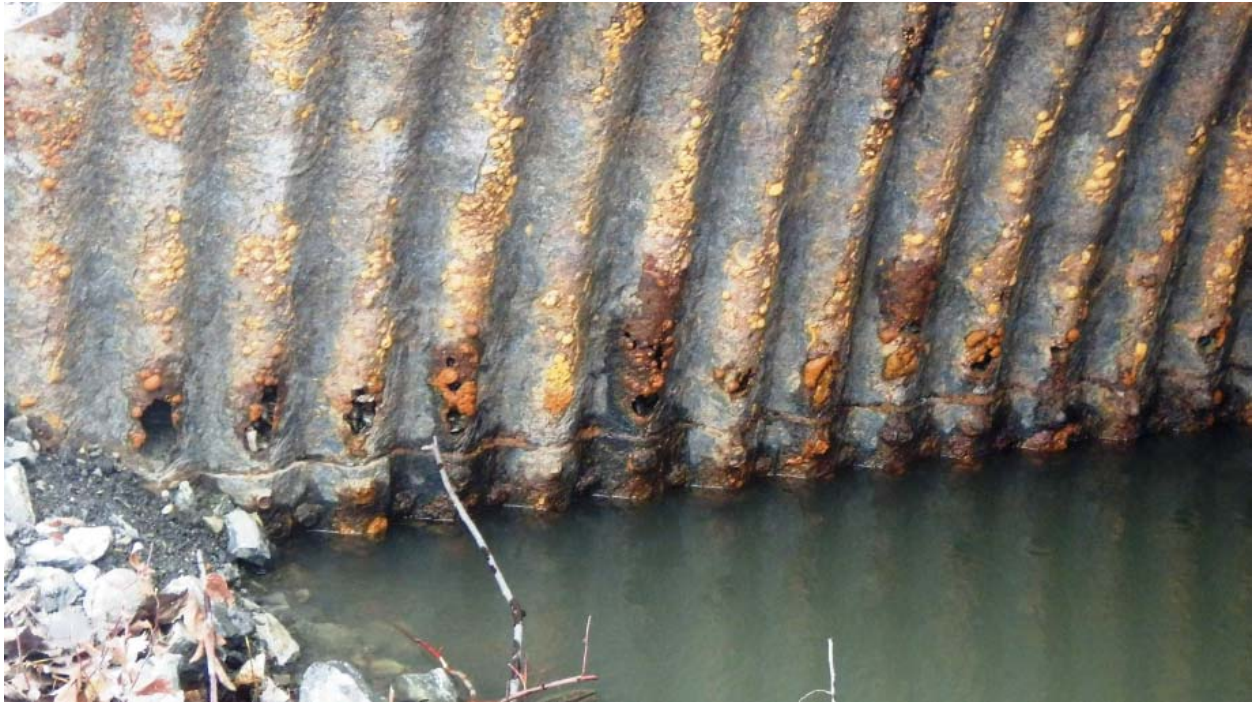
**Figure 3:** Inlet Corrosion

Steel Culvert Corrosion Indicator: 3 PERFORATIONS > 2"  
INLET/OUTLET ONLY

The inspection also indicated that there were perforations greater than 2 inches, due to corrosion, at the inlet and outlet as shown in Figure 3.

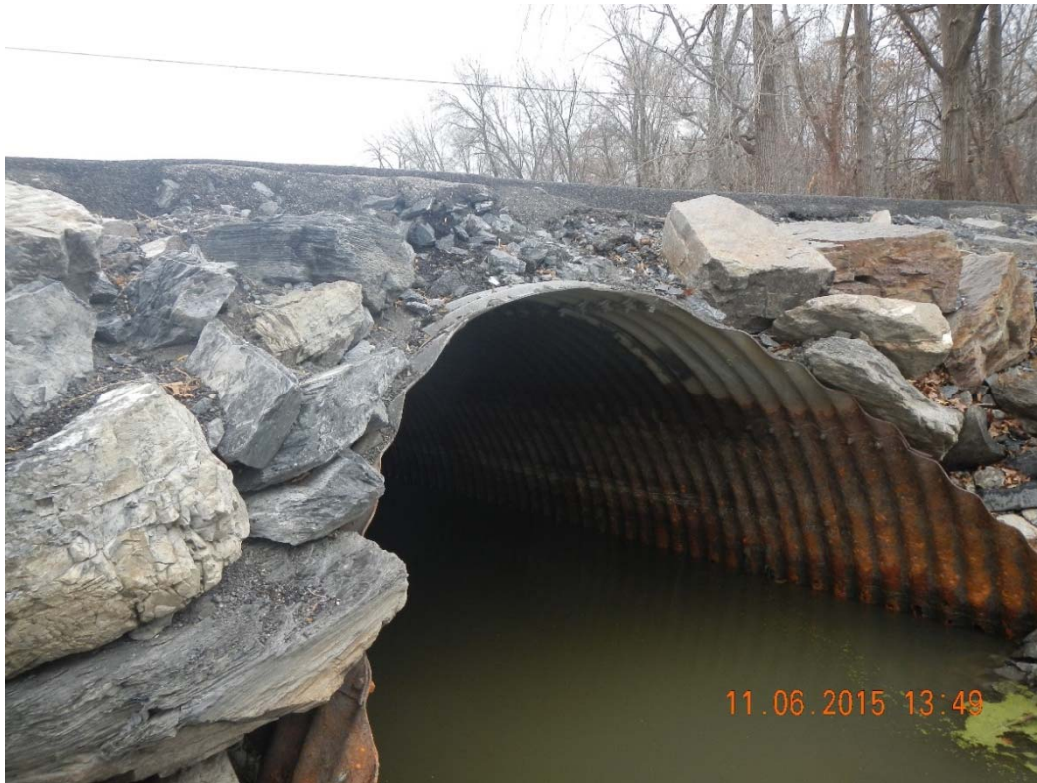
**Figure 5:** Large Stone Surrounding Culvert Outlet and Erosion above the Culvert

No visible bedrock was seen in the vicinity of the project during the site visit. Large stacked stone was used as make-shift wing walls to build up the roadway embankment on either side of the pipe. This stone exists around both the inlet and the outlet of the culvert. Smaller stone was used on top of the culvert inlet and outlet and appeared to exhibit erosion as seen in Figures 5 and 6.

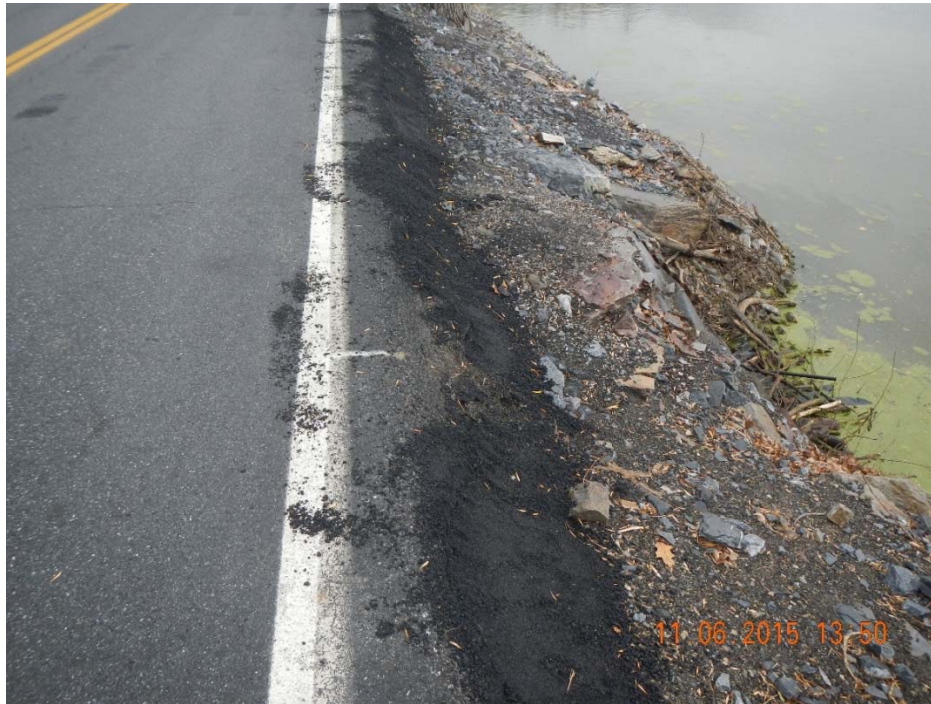
**Figure 7:** Shoulder Rehab for Erosion Located above the Culvert Inlet

The shoulder of the roadway above the inlet of the culvert appeared to have been rehabilitated recently as seen in Figure 7. It is expected that as the smaller stone and gravel erodes here, it leaves the pavement undermined causing the shoulder support to severely decrease.
