**STATE OF VERMONT
AGENCY OF TRANSPORTATION**

Scoping Report

**Springfield BF 0134(49)
TH-1 (Chester Road), BRIDGE 61 over UNNAMED BROOK**

October 13, 2017

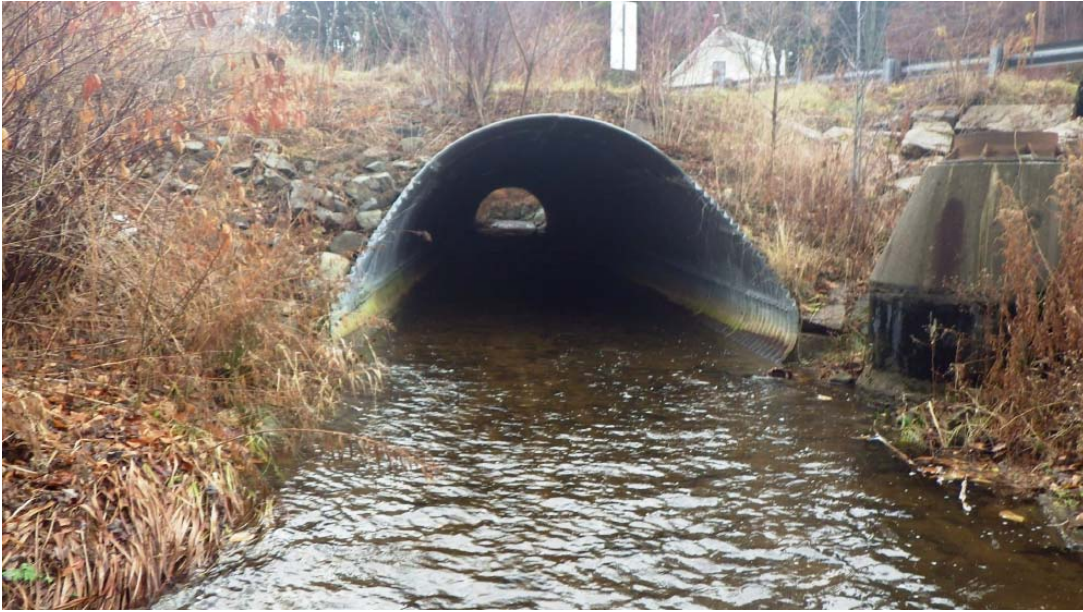
Culvert Outfall

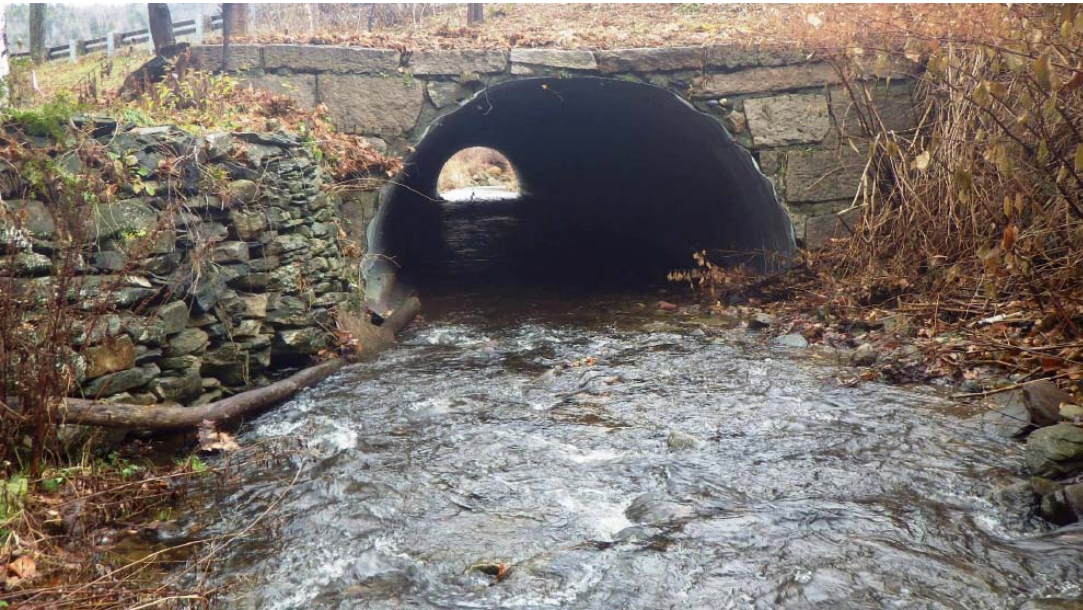
Culvert Inlet

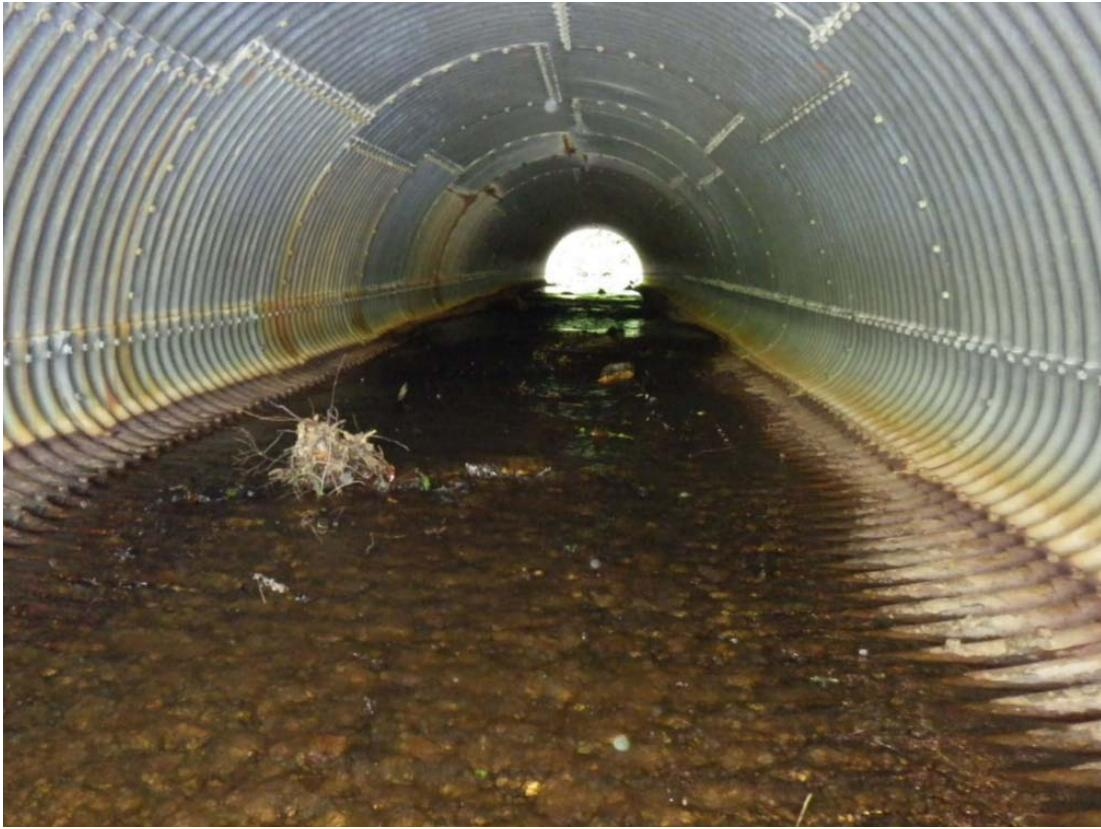
*"11/08/2016 - ** Culvert has severe corrosion of invert, along with piping occurring. Pipe has potential for significant distortion/sink hole formation and needs replacement. ~ MJ/AC"*

*"4/22/2016 – Special inspection to monitor distress. Invert poor and ~ 6" drop at 2/3rds from the inlet at ~ 140', where large invert holes have formed and plate ribs are torn away. **Culvert needs extensive invert repair or replacement in the near future. ~ MJ/SP"*

Culvert Interior

Alternative 2b is recommended; replace the culvert in phases with a new buried structure, while maintaining two-way traffic on VT 11 with periodic minor delays.

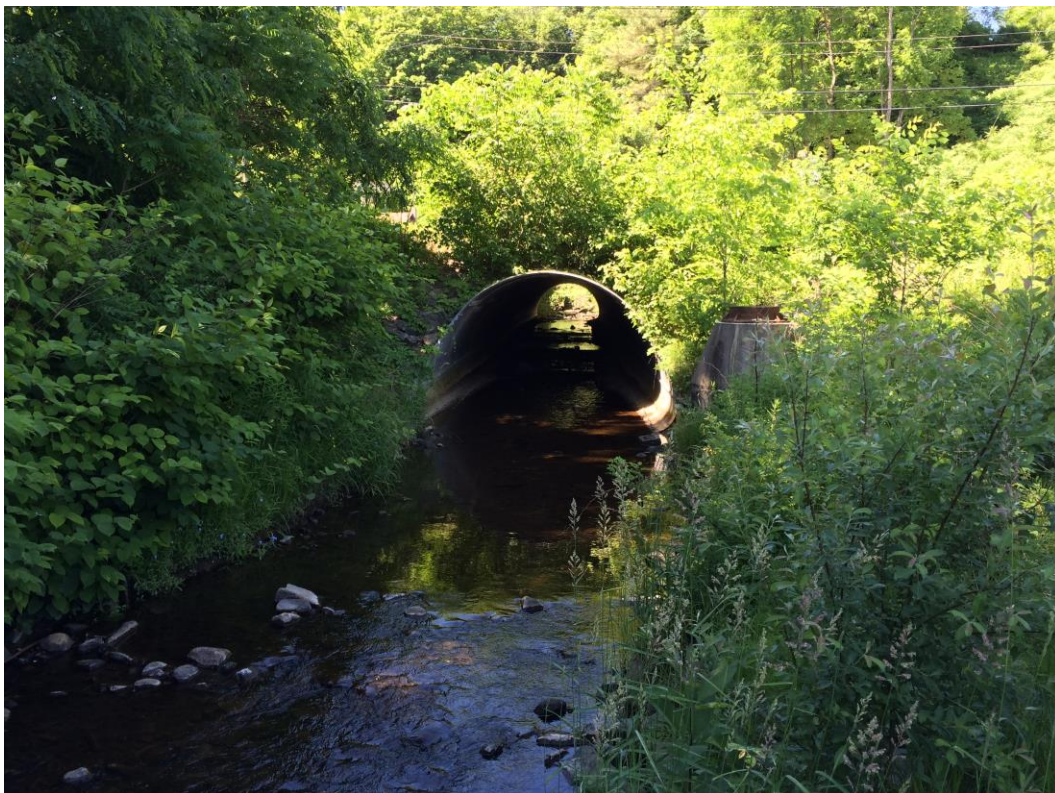
Figure 2. Bridge 61 inlet, looking north.
