**STATE OF VERMONT
AGENCY OF TRANSPORTATION**

Scoping Report

**Chester BF 0134(50)
VT ROUTE 11, BRIDGE 51 over UNNAMED BROOK**

October 13, 2017

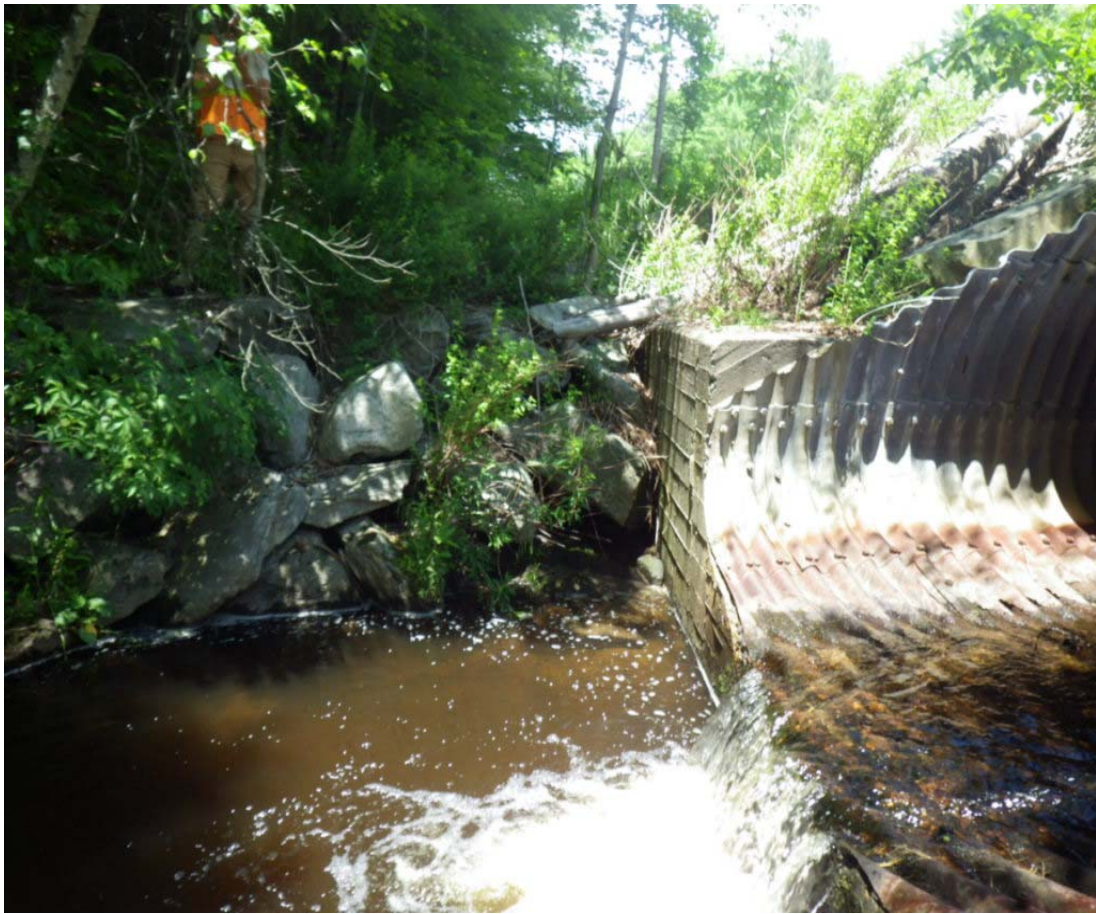
10/26/2010 – "Poor condition – pipe continues to deteriorate and needs repair or replacement soon. Heavy tree debris at outlet and needs to be removed as deep scouring is occurring along cradle. Inlet needs to be cleaned also." ~MK/RF"

Culvert outlet

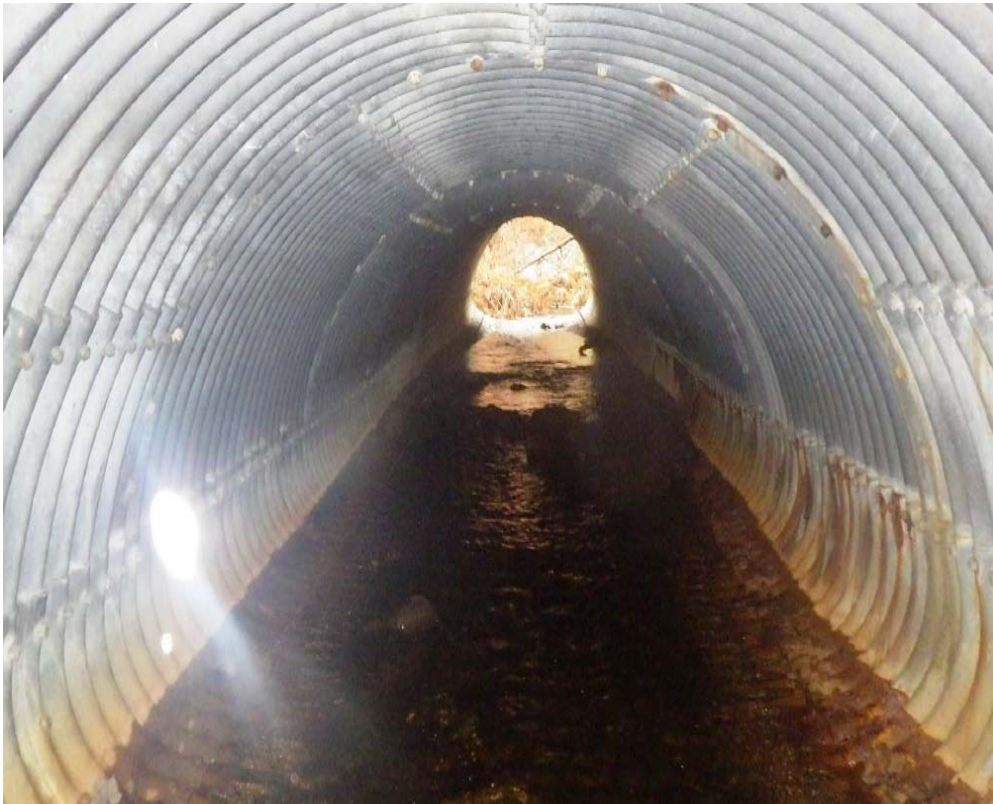
*"11/08/2016 - * Culvert has heavy corrosion along the invert, and needs replacement. During highwater flow rates, the pipe has the potential for drastic distortion. Could pour invert now to save, though pipe is settling, and has distorted to some degree. ~ MJ/AC"*

"04/22/2016 - Special inspection to monitor distress. Pipe has high potential for progressive deformation due to extensive invert deterioration. Slight dip noted along western side of roadway. Culvert needs extensive invert repair or full pipe replacement soon. ~ MJ/SP"

Culvert Interior

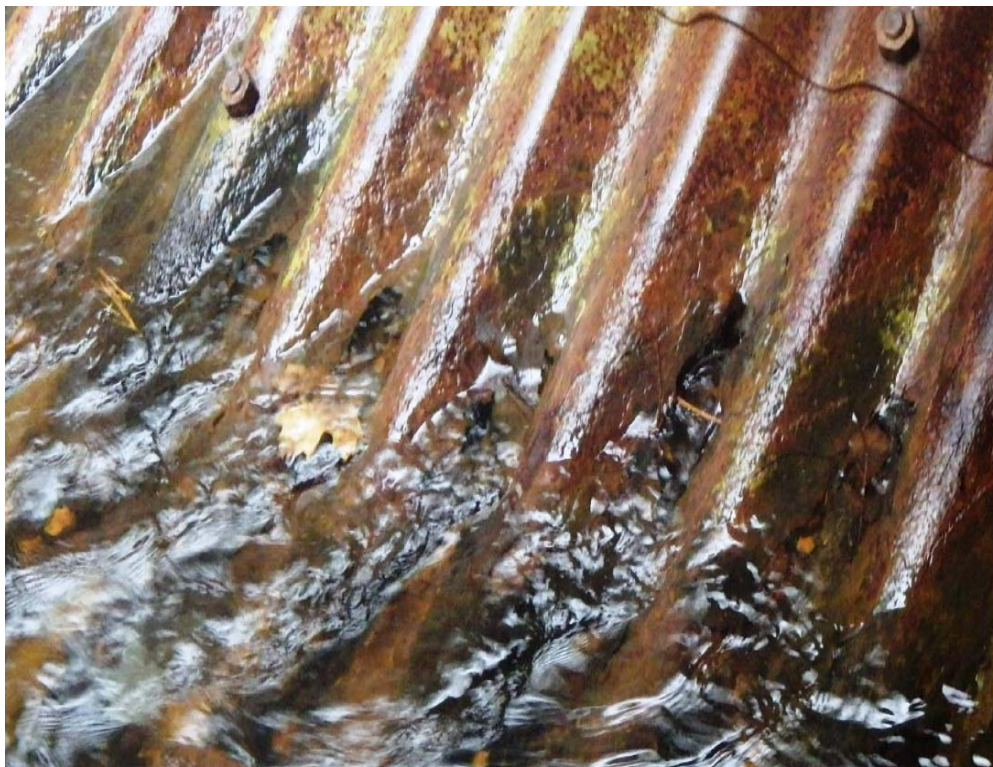
1. This culvert has a rating of 3 "Serious" and is suffering significant corrosion and section loss at the invert. Bolt line cracking and perforations exist throughout.
2. The existing culvert meets the Hydraulic Standard but not the Bank Full Width. The culvert is located in Zone A of a Flood Insurance Study.
3. There are no known roadway geometric deficiencies.

"12/3/2015 Culvert is in poor condition due to the boltline cracking and the rusting of the invert. Culvert should be evaluated for a possible concrete invert in the near future. Scour hole on the outlet should be filled. ~ FRE/TJB"

Corrosion and Perforations

Since the culvert is rated as being in serious condition, it is reasonable to assume that a replacement structure is needed. Additionally, the culvert does not meet bank full width requirements, further warranting a full replacement.

The new culvert will be a 14-foot x 8-foot precast concrete box culvert, as per the VTrans Hydraulic Section's recommendation. The new precast box will have bed retention sills, to allow for a natural channel bottom to form, accommodating aquatic organism passage. Since the precast culvert will have a closed bottom, it will be protected from scour. In order to satisfy the AOP needs, the culvert invert should be buried 3-feet and stone should be placed along the length of the channel bottom through the culvert, resulting in a 5-foot high waterway opening. The new culvert should have headwalls that extend four feet below the channel bottom at the inlet and the outlet to prevent undermining. This structure will have no roadway overtopping below the Q₁₀₀ storm event.
