**STATE OF VERMONT
AGENCY OF TRANSPORTATION**

**Scoping Report
FOR
Springfield BM19201**

VT Route 106, Bridge 4 over Unnamed Brook

January 31, 2023

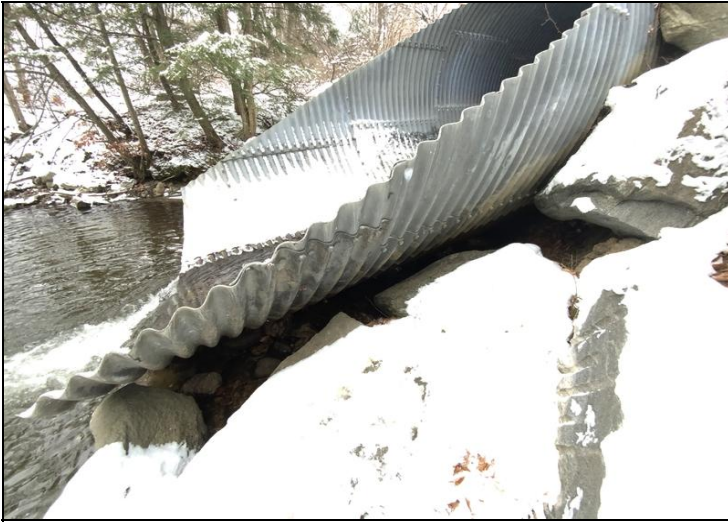
Outlet

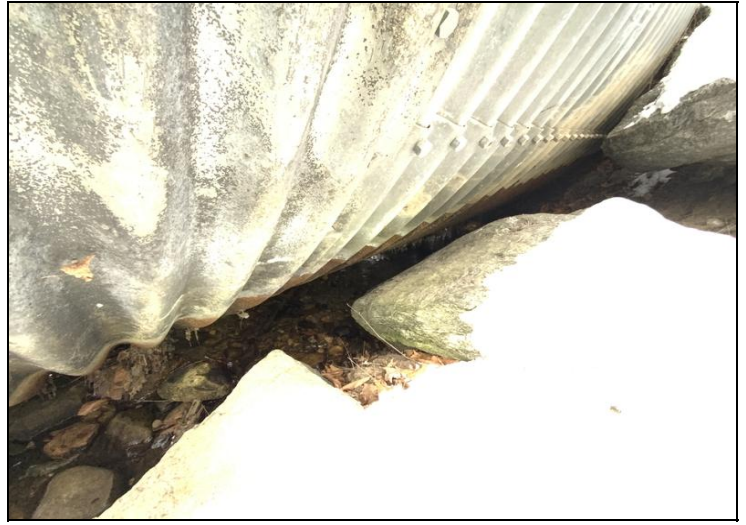
Outlet

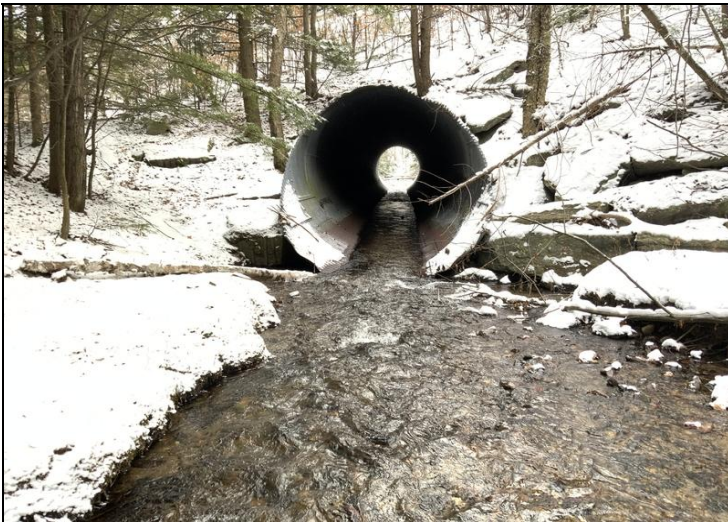
Inlet

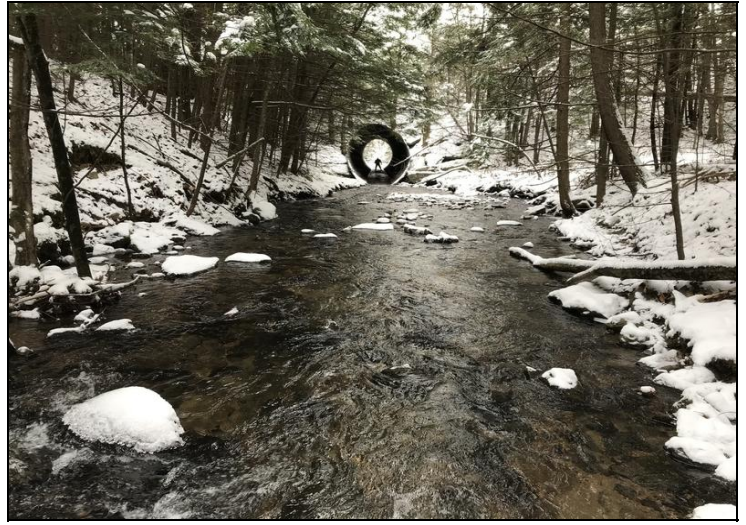
Upstream channel

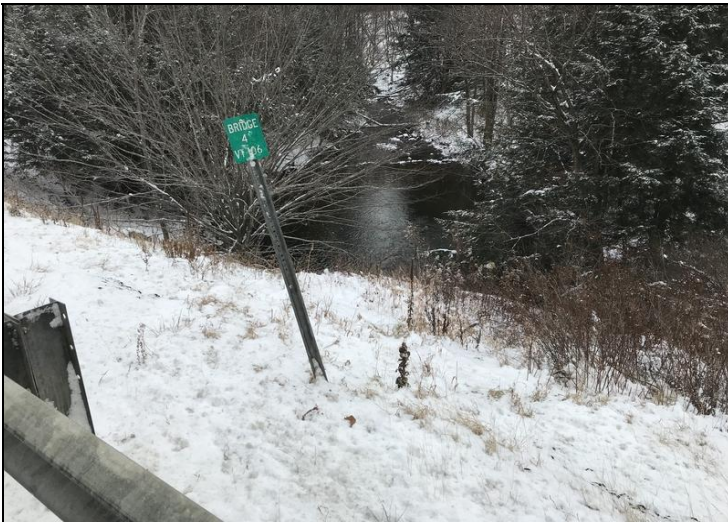
Downstream
