**STATE OF VERMONT
AGENCY OF TRANSPORTATION**

**Scoping Report
FOR
Irasburg STP DECK(50)**

Vermont Route 14, Bridge 124 over Black River

October 19, 2020

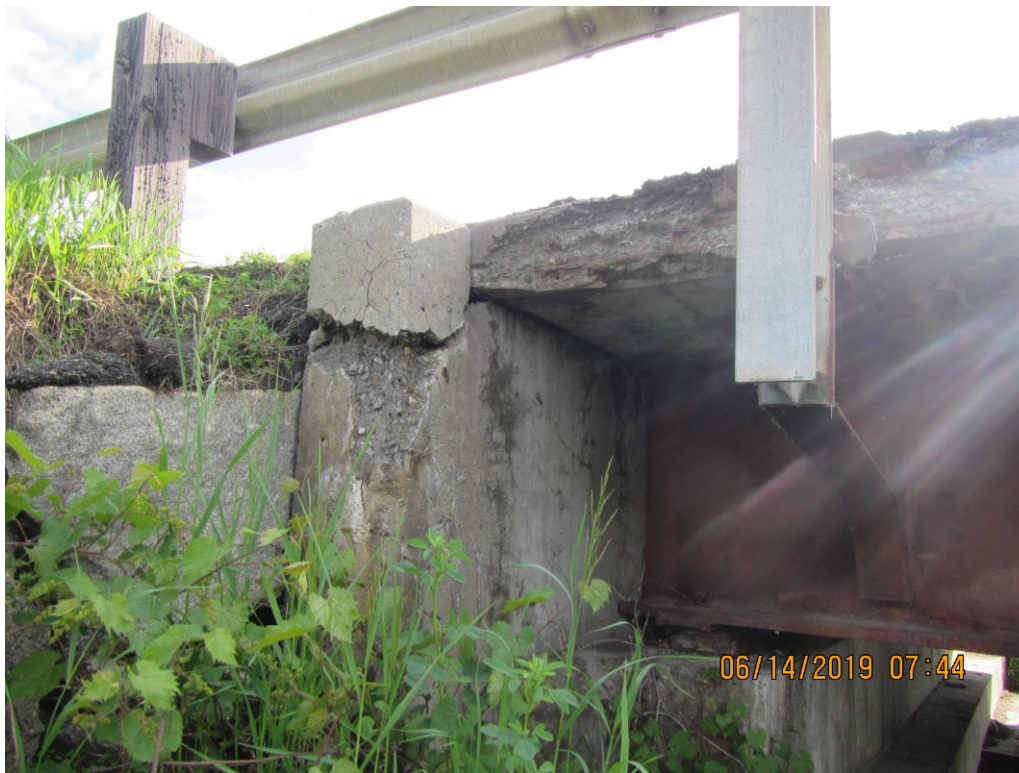
Picture 3: Fascia deterioration at backwall

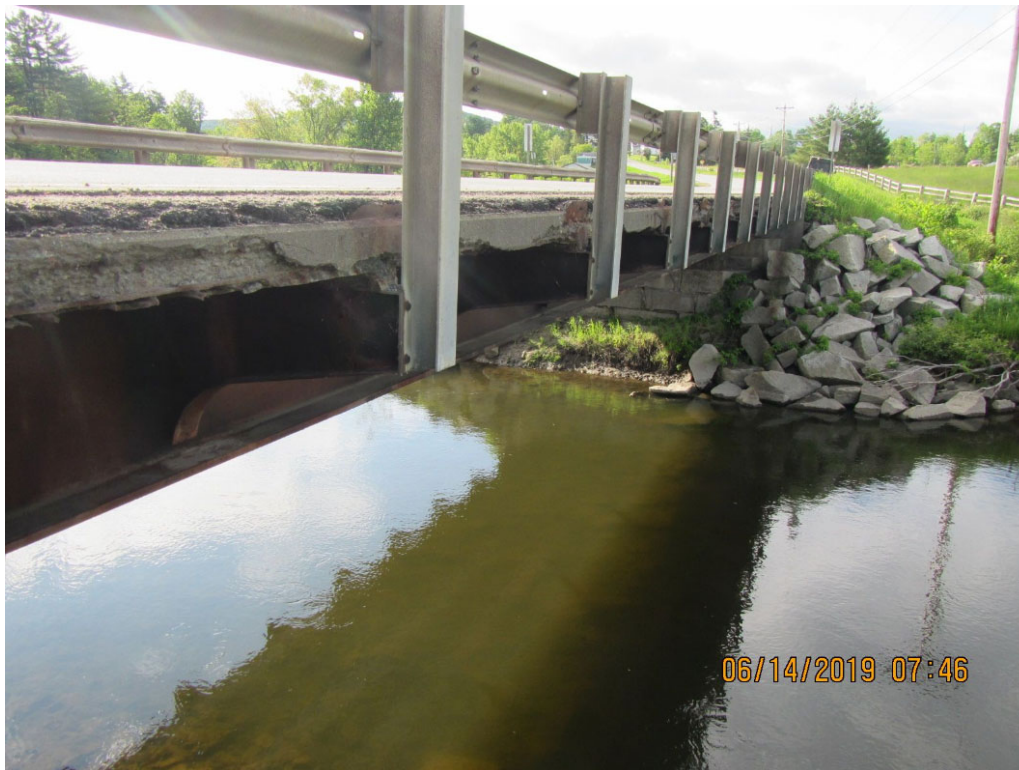
6/2/2017 – Structure is in fair to good condition. Deck could use some repairs and pavement pot holes should be patched. Spalling in the fascia on the upstream side should be repaired. ~FRE/JAS

Picture 4: Upstream Fascia

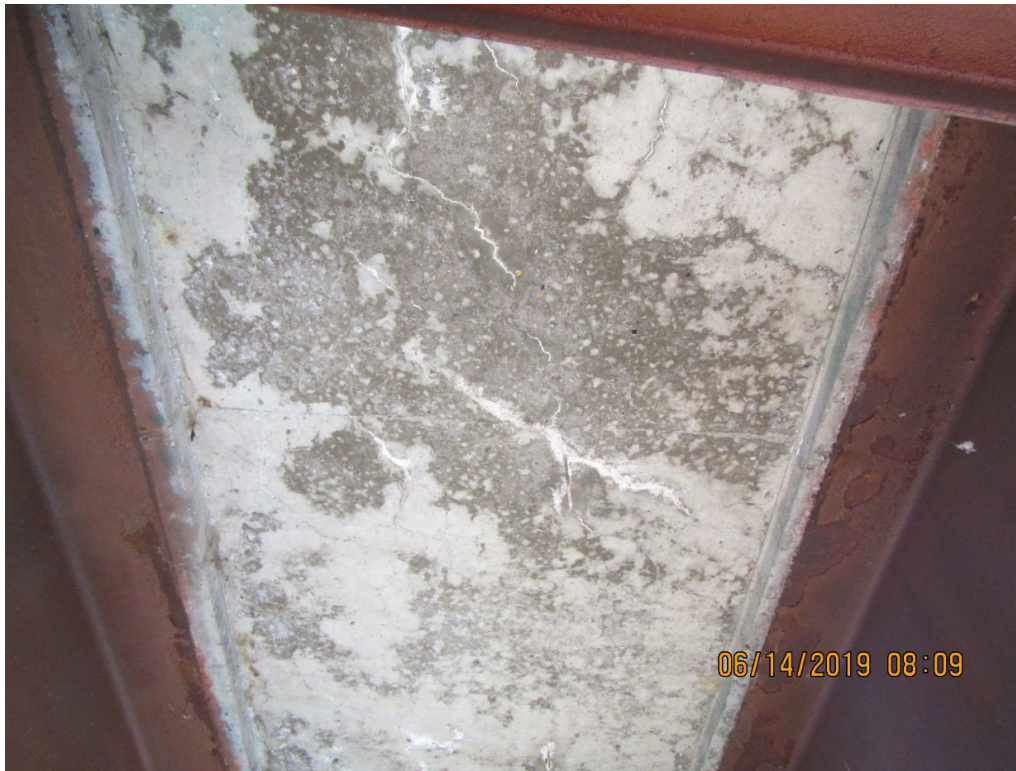
1. The reinforced concrete deck is in fair condition. There are multiple correlating areas where depressions have formed along the top of the deck and delaminated areas are present in the soffit with efflorescence leakage and saturation. Minor map cracking and saturation is present in various areas around the deck. Additionally, the membrane has been compromised in a few locations. Both the upstream and downstream fascias are in poor condition with spalling and delaminations along the entire length. Spalling has exposed longitudinal and transverse bars with rust scaling and are starting to thin.
2. The bridge is narrow.

Picture 7: Saturation and cracking in deck

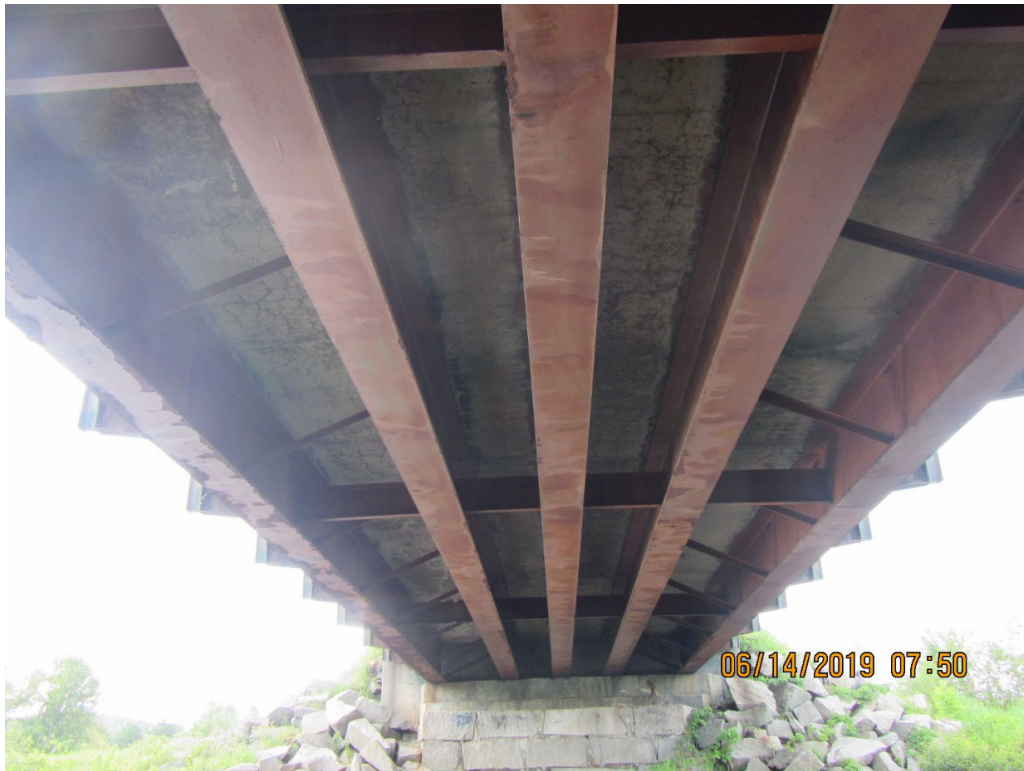
Picture 9: Underside of deck

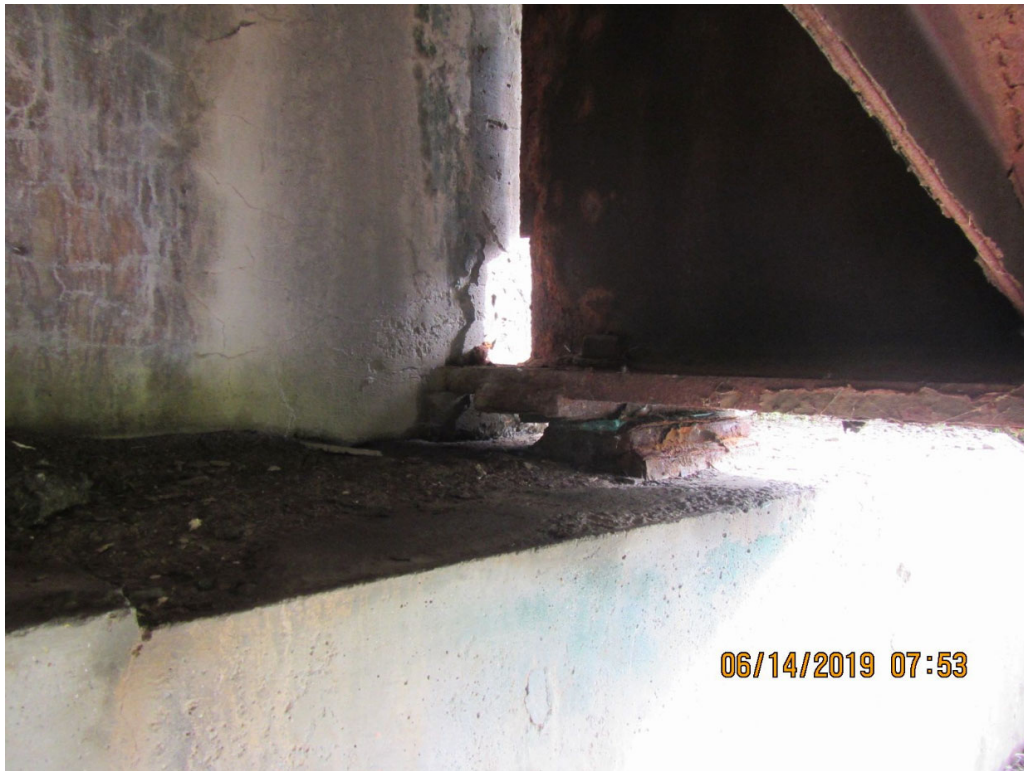
Picture 11: Section loss at beam end

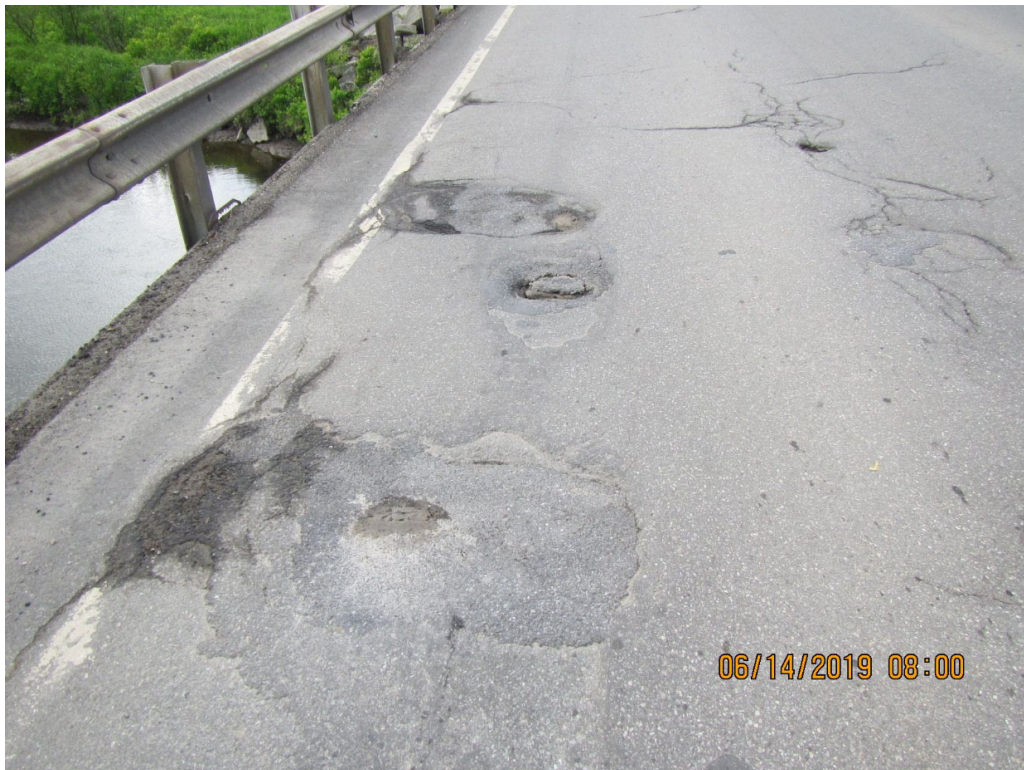
Picture 12: Potholes in wearing surface

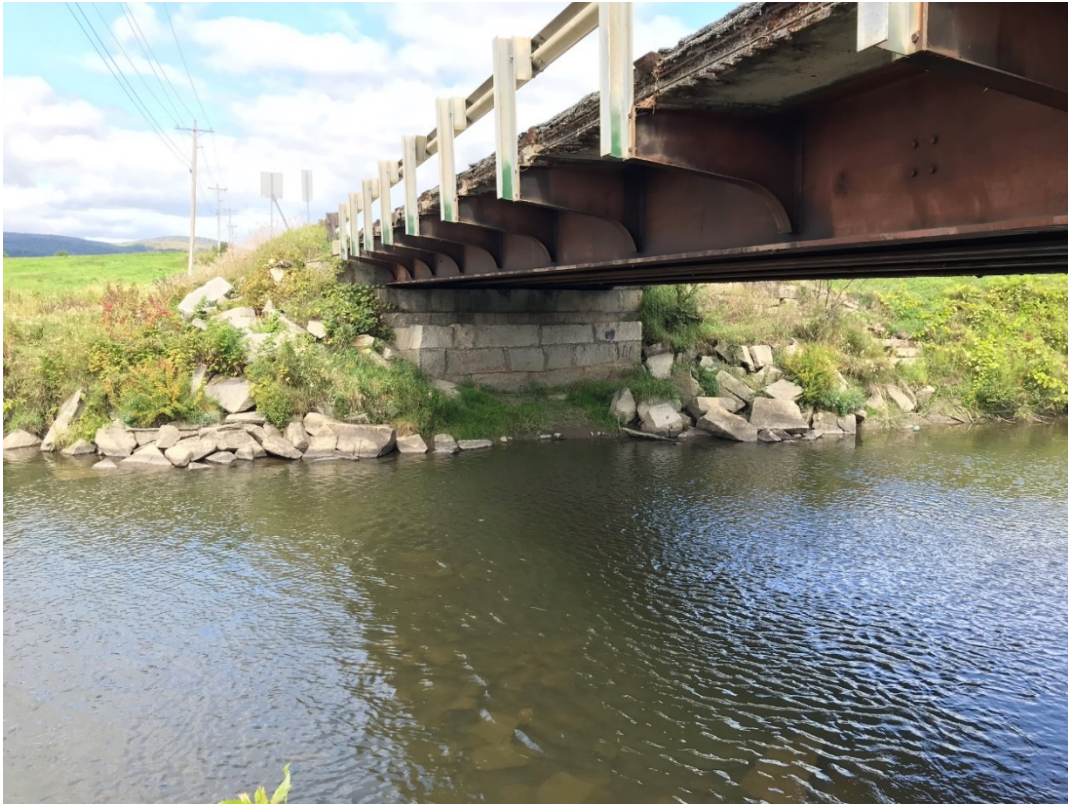
Figure 3.1: Facing northern abutment; note stacked stone facing and rip rap on adjacent embankments.

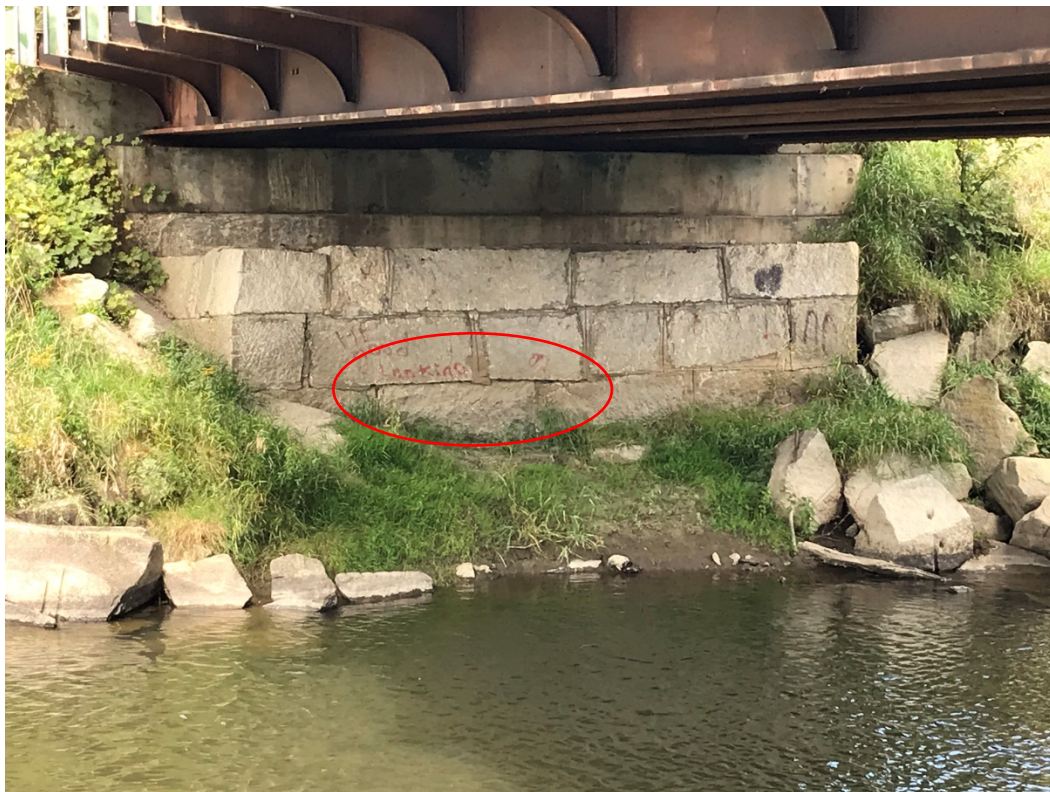
Figure 3.2: Facing northern abutment; note stacked stone facing and lack of mortar at some block connections (highlighted).

If a deck replacement is selected as the preferred alternative, we recommend that repointing of the mortared block connections within the stacked stone facing of the abutments is included as part of the project. We also recommend that scour protection meeting current Agency requirements be designed and added in front of the abutments. Addressing these issues during the deck replacement project should help to ensure the abutments perform as expected during the design life of the replacement deck.

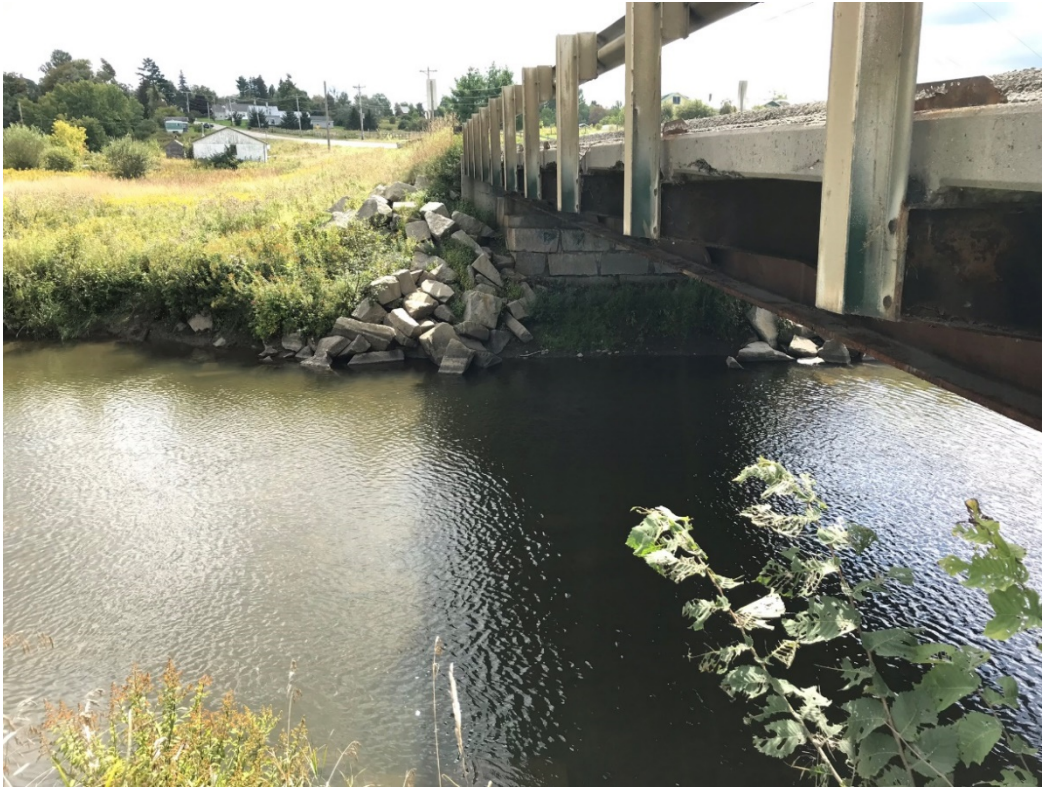
Figure 3.3: *Facing southern abutment; note stacked stone facing and rip rap on adjacent embankments.*

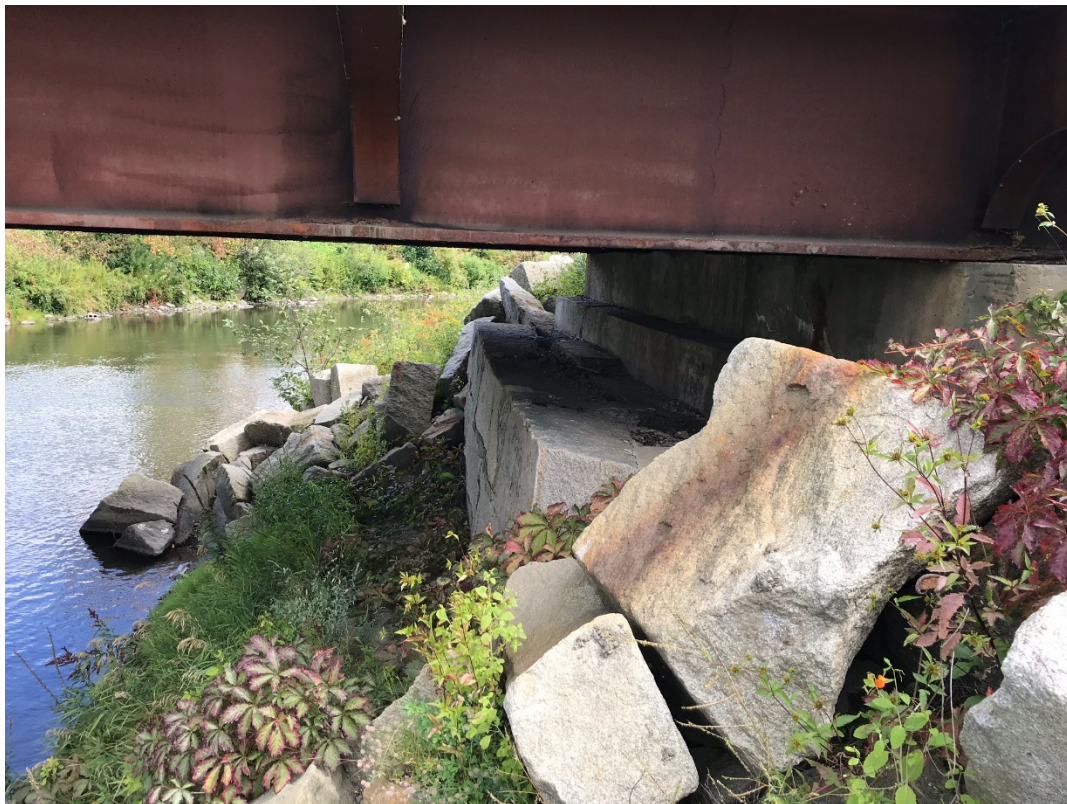
Figure 3.4: *Facing southern abutment; note stacked stone facing and rip rap on adjacent embankments.*
