Scoping Study

Jamaica BO 1442(42) Depot Street Truss Town Highway 19 Bridge 32 over West River

Prepared for:
Vermont Agency of Transportation

May 2021

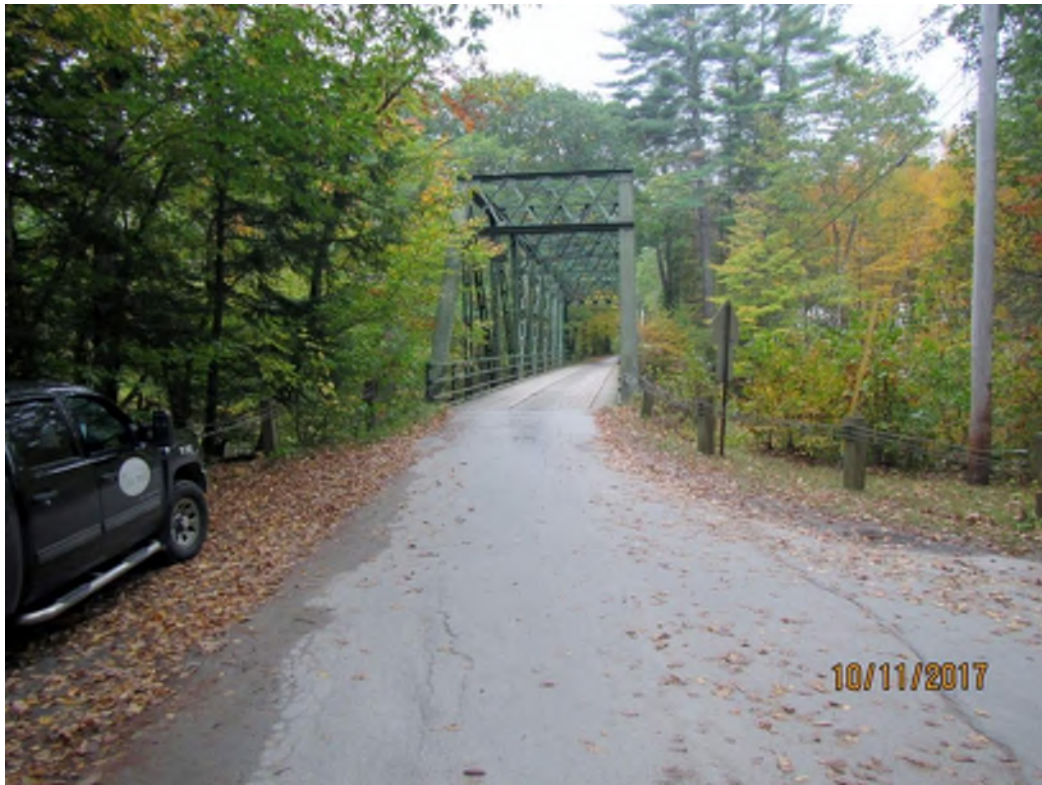
Overhead utilities are present running parallel to the upstream face of the bridge, as seen in Figure 3.1. We do not anticipate that these overhead utilities will restrict boring operations, however, a minimum safe distance from the drilling equipment will be required to be maintained during drilling operations. Bridge No. 32 has a weight capacity of 8 tons, as noted in Figure 3.7, this may impact our ability to access the eastern side of the bridge for boring explorations due to the weight of our drilling equipment.

Figure 3.1 *Looking west at bridge; note overhead utilities on the upstream face of the bridge. [Inspection photo dated 2017].*

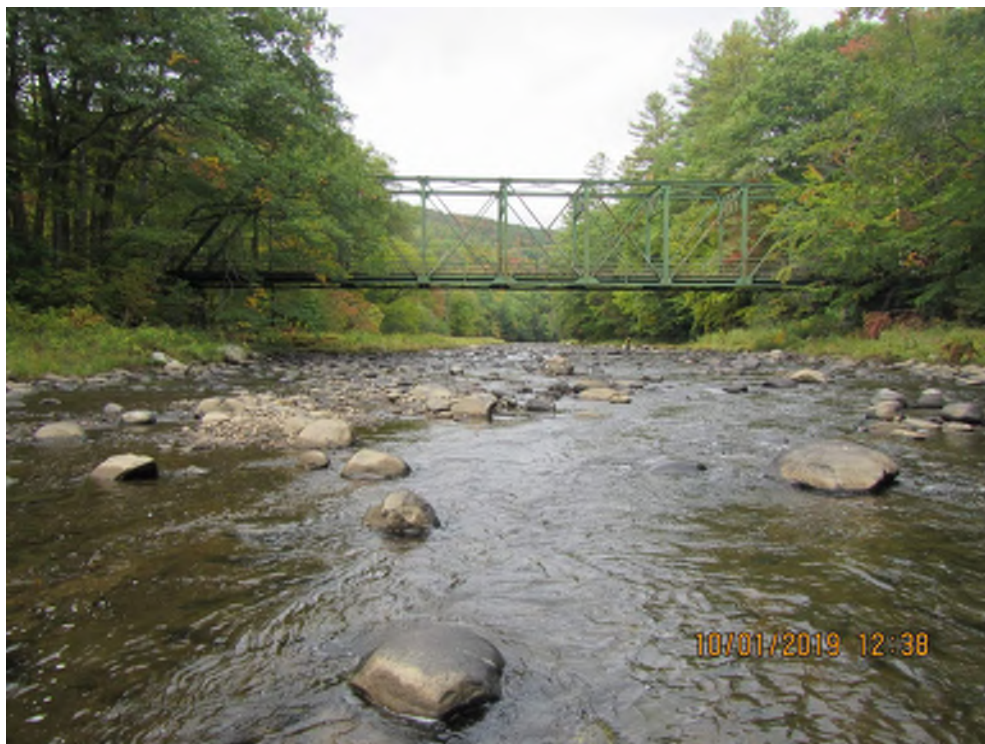
Figure 3.2 *Looking upstream at bridge; note cobbles and boulders located in riverbed. [Inspection photo dated 2019].*

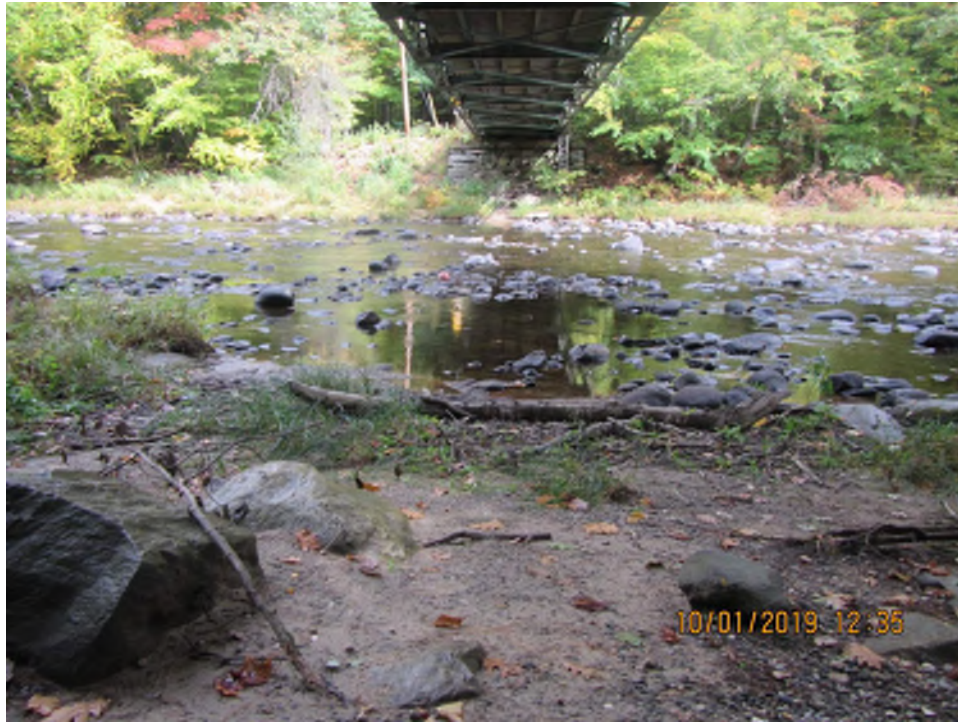
Figure 3.3 *Underneath the western abutment looking across the West River; note boulders along riverbed and along bank. [Inspection photo dated 2019]*

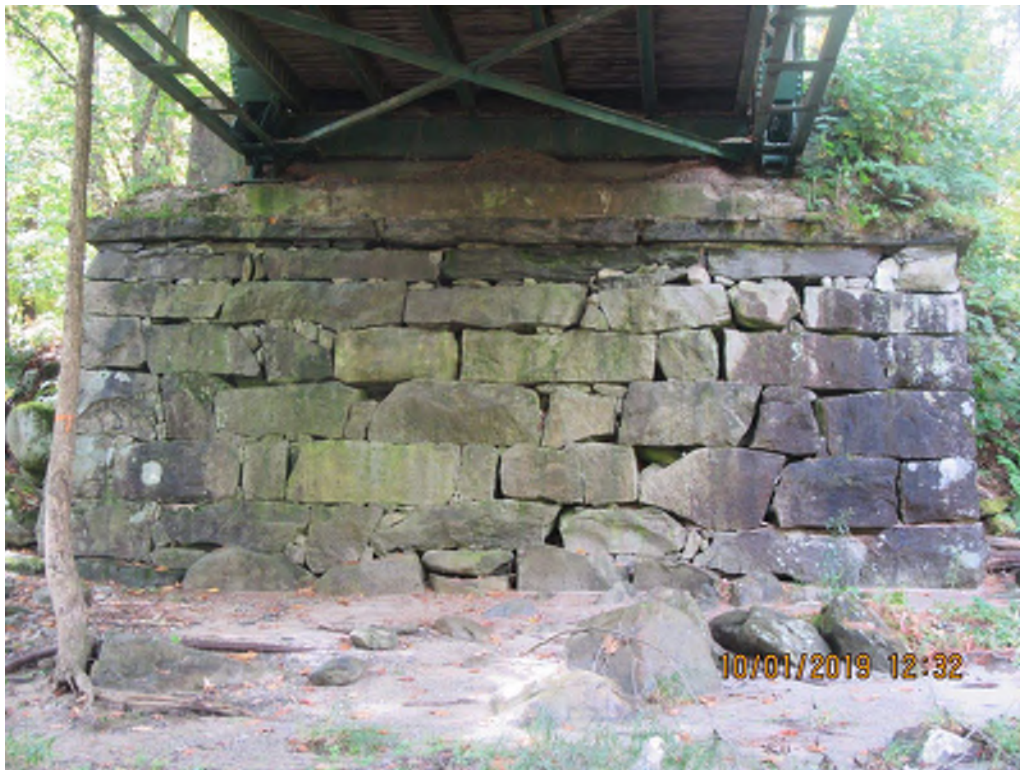
Figure 3.4 *Abutment of the western approach of the bridge. [Inspection photo dated 2019]*

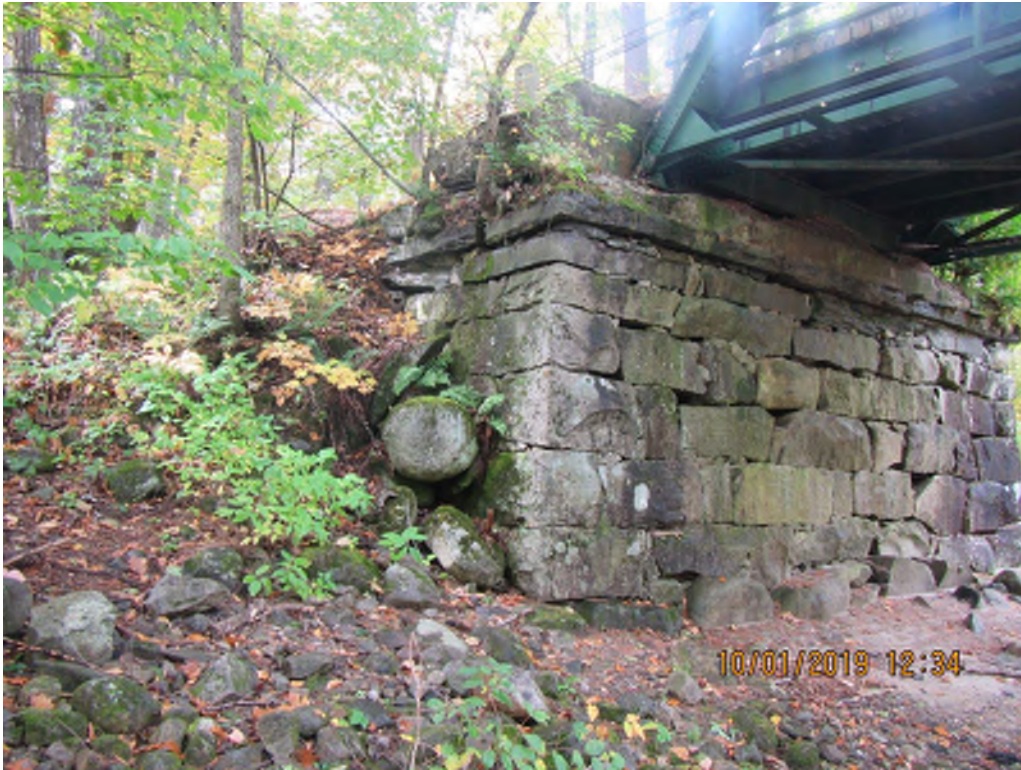
Figure 3.5 *Abutment of the western approach of the bridge; note boulders. [Inspection photo dated 2019]*

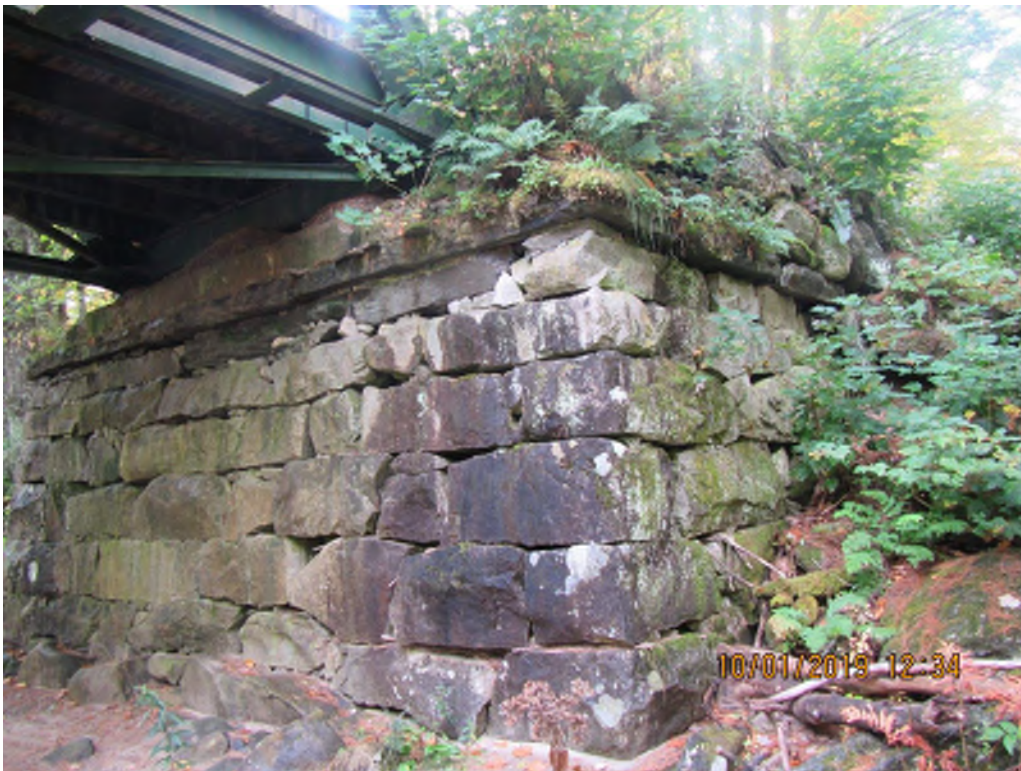
Figure 3.6 *Abutment of the western approach of the bridge; note boulders. [Inspection photo dated 2019]*

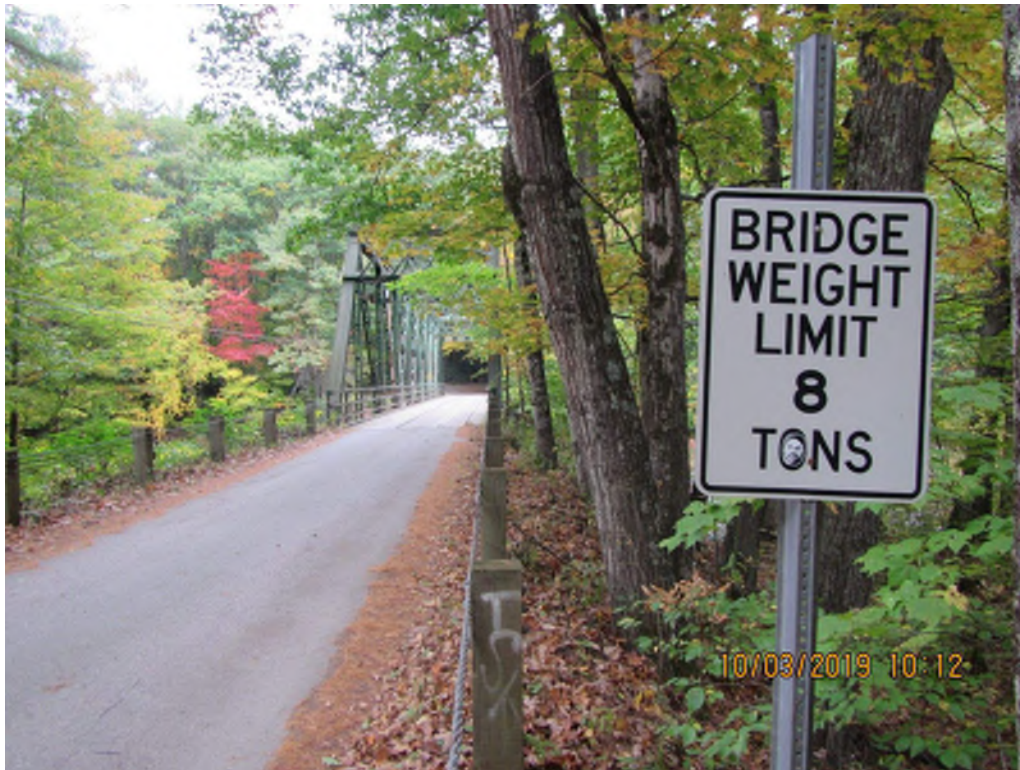
Figure 3.7 Posted sign designating the weight limit of Bridge No. 32. [Inspection photo dated 2019]

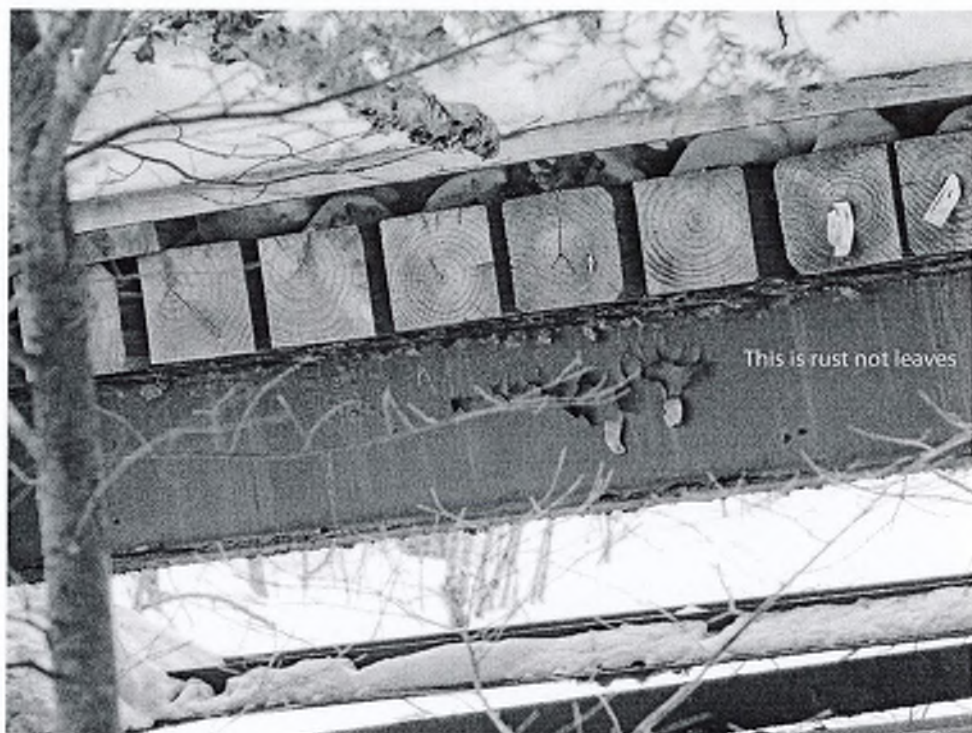
While the bridge is on the VTrans candidate Capitalization Program, I'm told that this could take 5-10 years. Though I am not an engineer, I don't think it will last that long. I am enclosing photographs to show that the supporting I-beams have rusted severely. The construction of the bridge is steel I-beams supporting pressure-treated 4x4s covered by pressure-treated 2x12 decking. The top flanges of the I-beams seem to have completely rusted away. This is confirmed in the enclosed Army Corps report. The bottom flanges of the I-beams also seem to be severely rusted.

This is a view of the underside of the bridge, lateral view. Please note that the orange-ish material underneath the 4X4s is rust, not leaves.

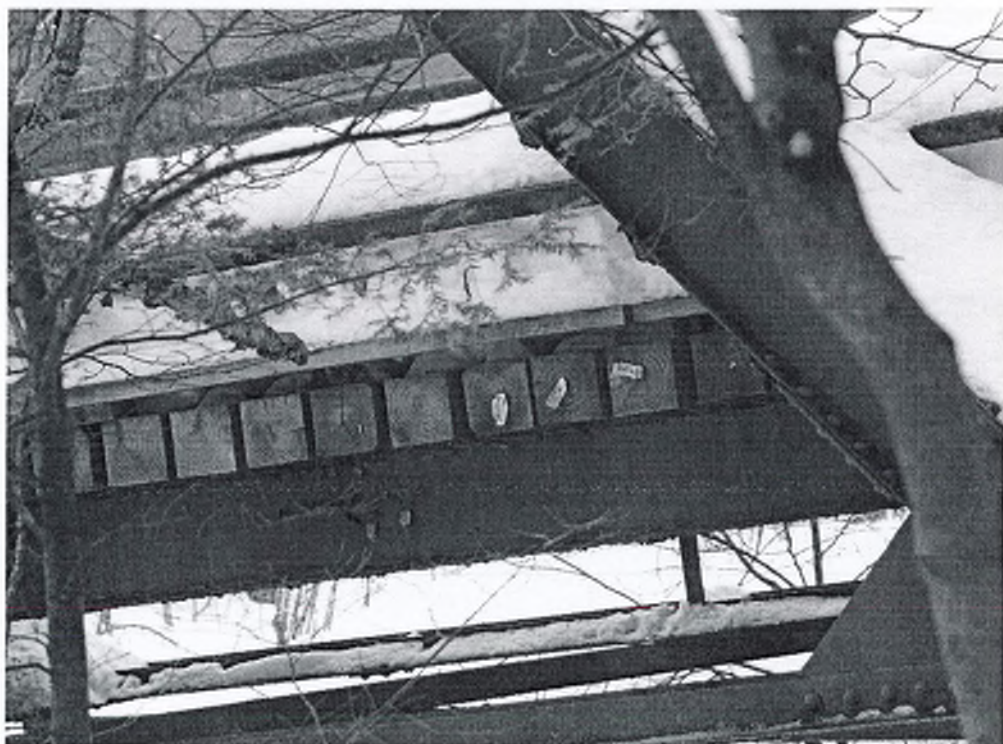
This is a more overall view

Also the abutment stones are loose

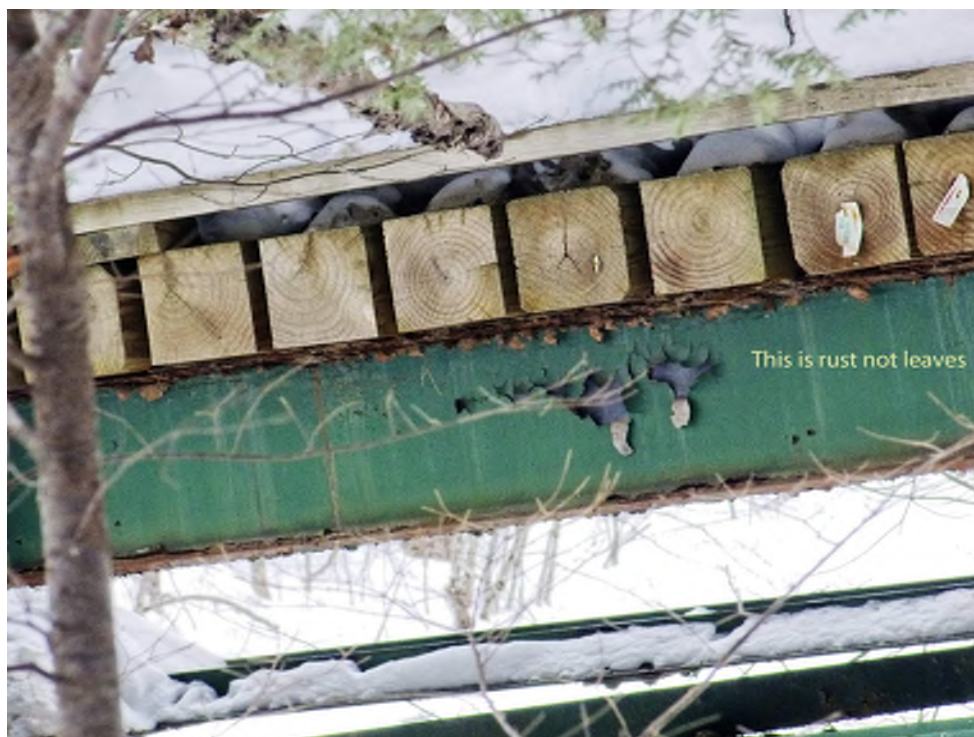
While the bridge is on the VTrans candidate Capitalization Program, I'm told that this could take 2-5 years. Though I am not an engineer I don't think this will last that long. I am enclosing photographs to show that the supporting I-beams have rusted severely. The construction of the bridge is steel I beams supporting pressure treated 4x4s covered by pressure treated 2x12 decking. The tops of the the I-beams seem to have completely rusted away. The underside of the IBeams are also severely rusted.

This is a view of the underside of the bridge, lateral view.

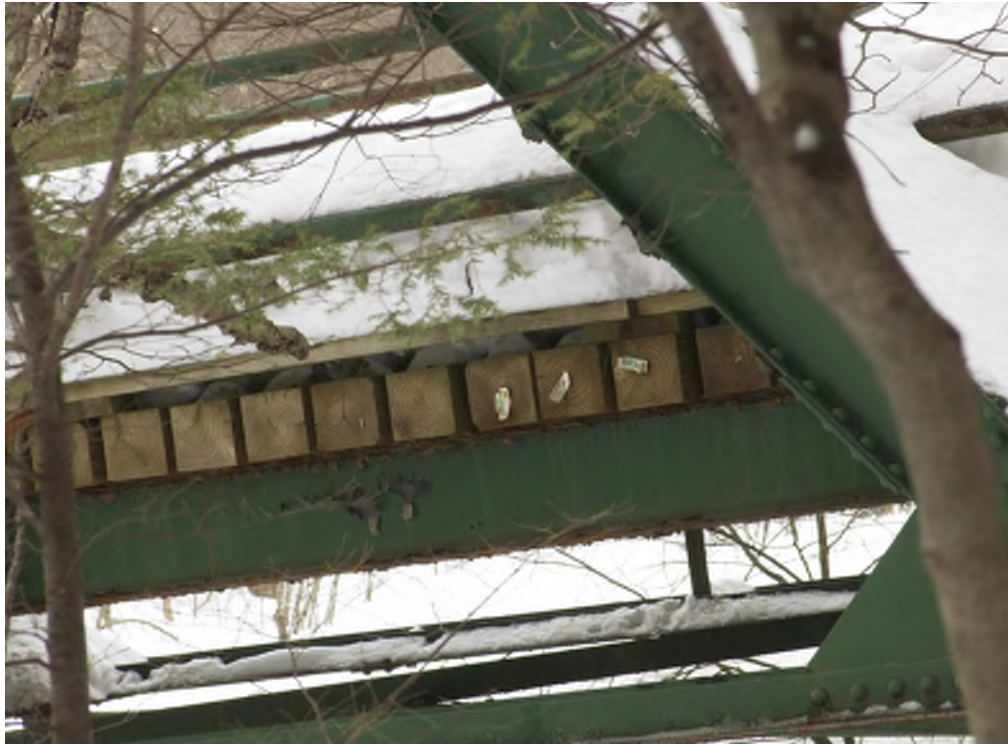
This is a more overall view

Also the abutments stones are loose

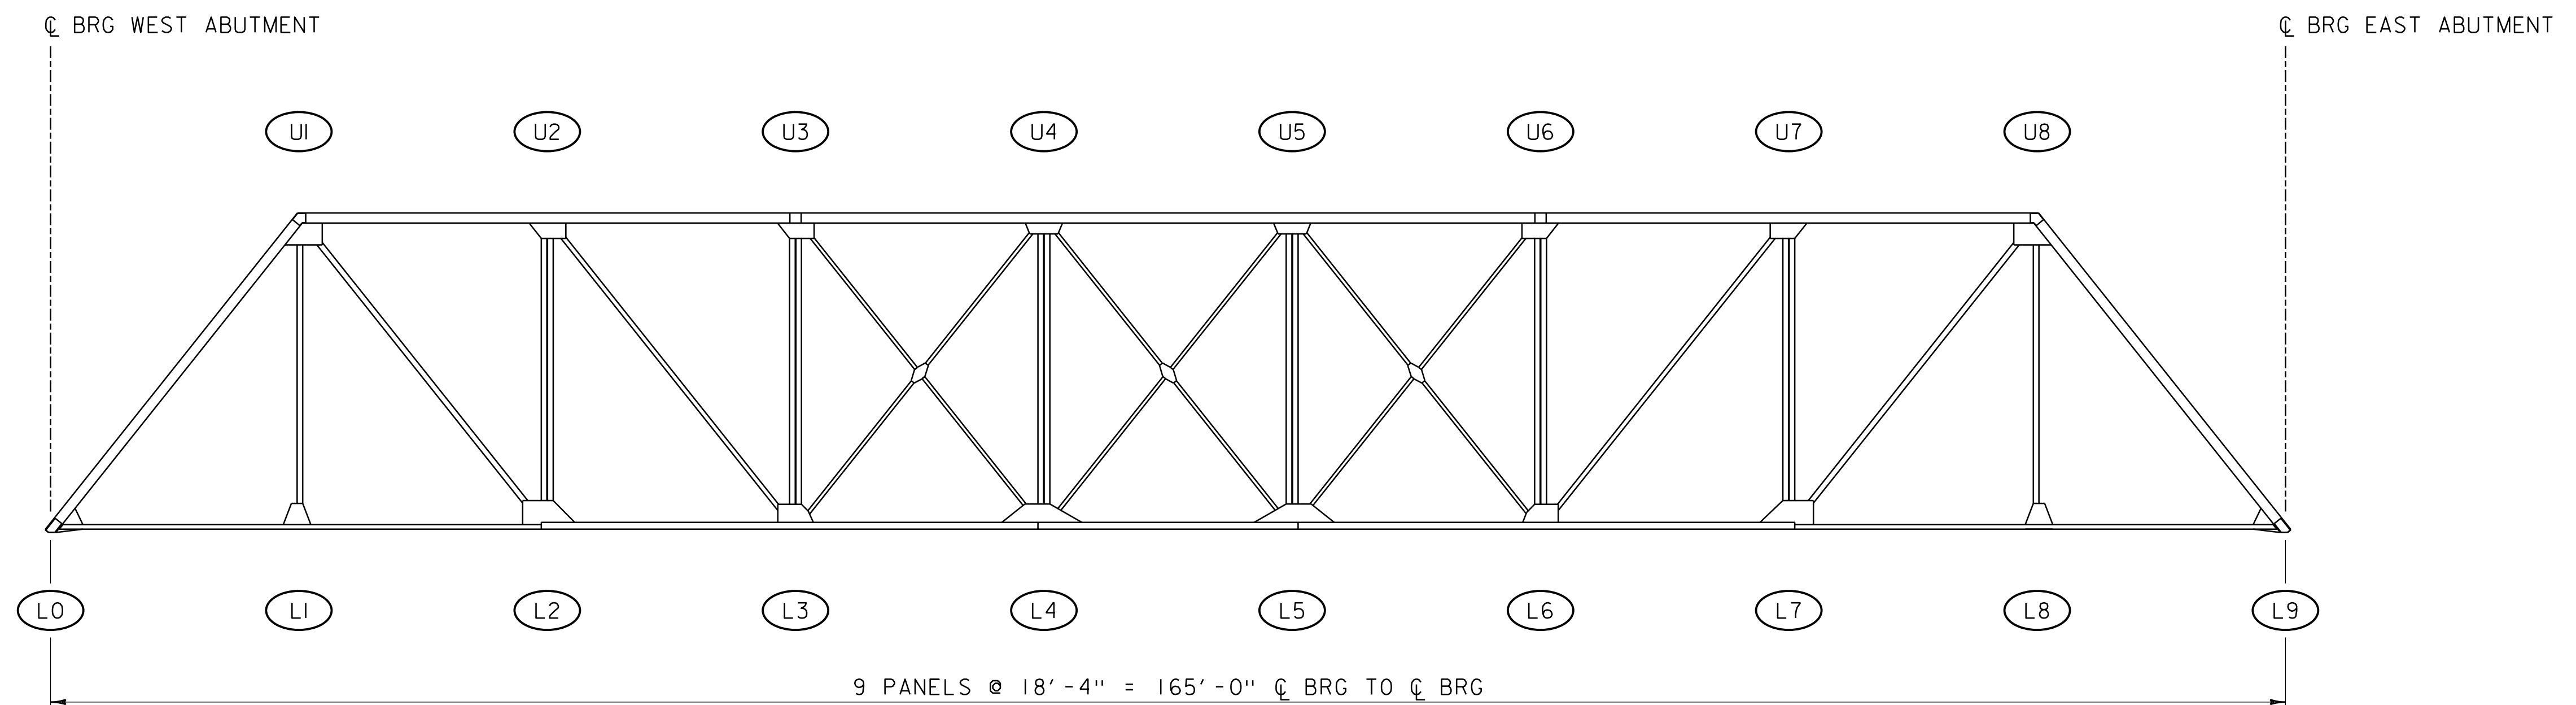
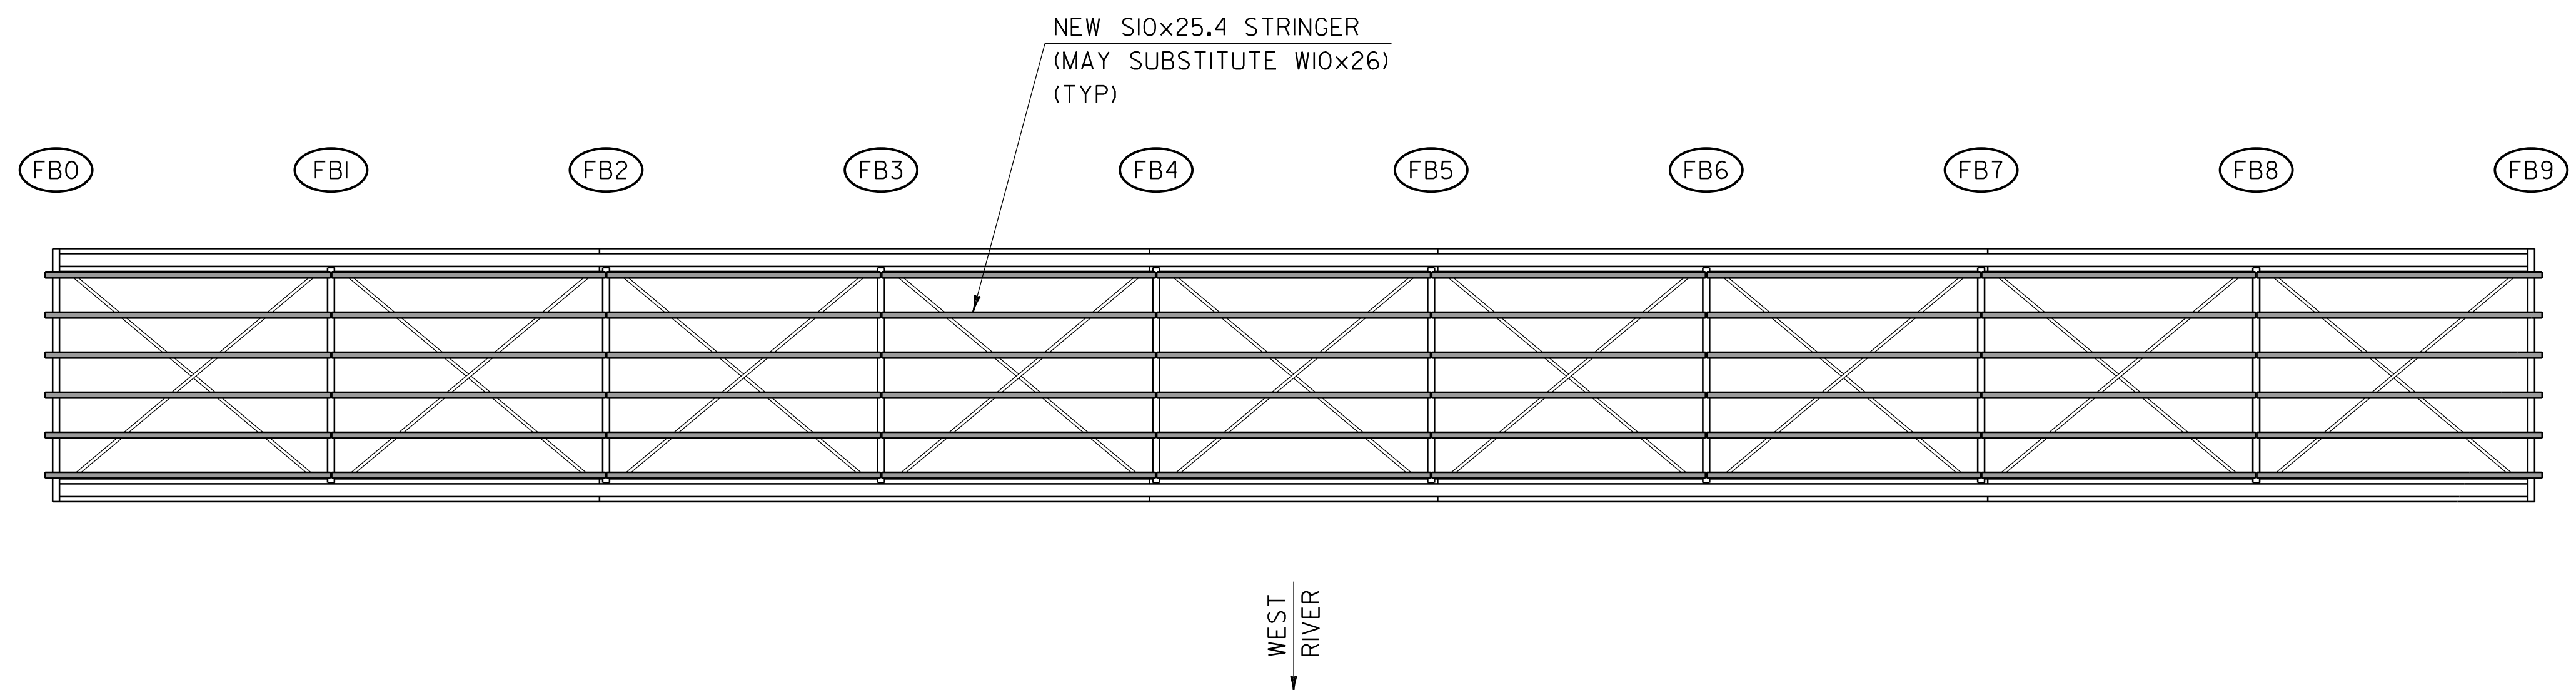
TRUSS ELEVATION
SCALE: 1/8" = 1'-0"

PROJECT NAME: JAMAICA	
PROJECT NUMBER: BO 1442(42)	
FILE NAME: z19j226sup2.dgn	PLOT DATE: 1/29/2021
PROJECT LEADER: L.STONE	DRAWN BY: P.DUSTIN
DESIGNED BY: B.SCHORN	CHECKED BY: R.WOOD
TRUSS H8 LIVE LOADING	SHEET 5 OF 10

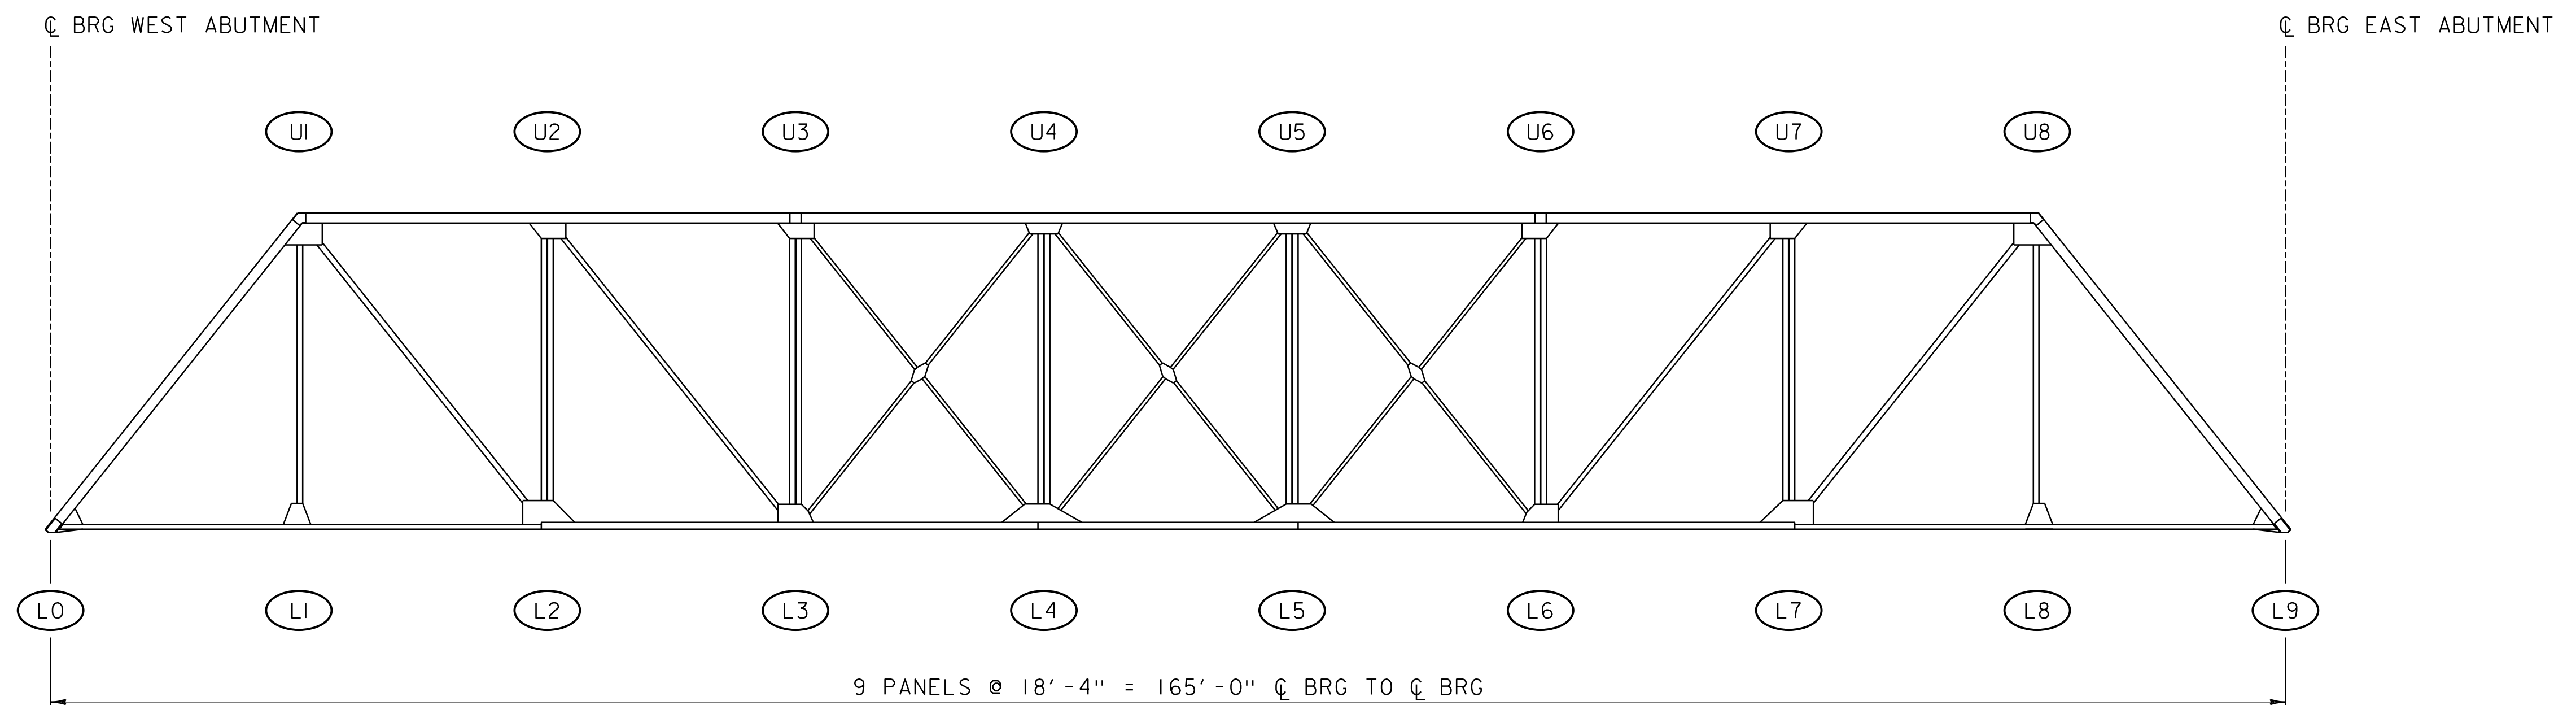
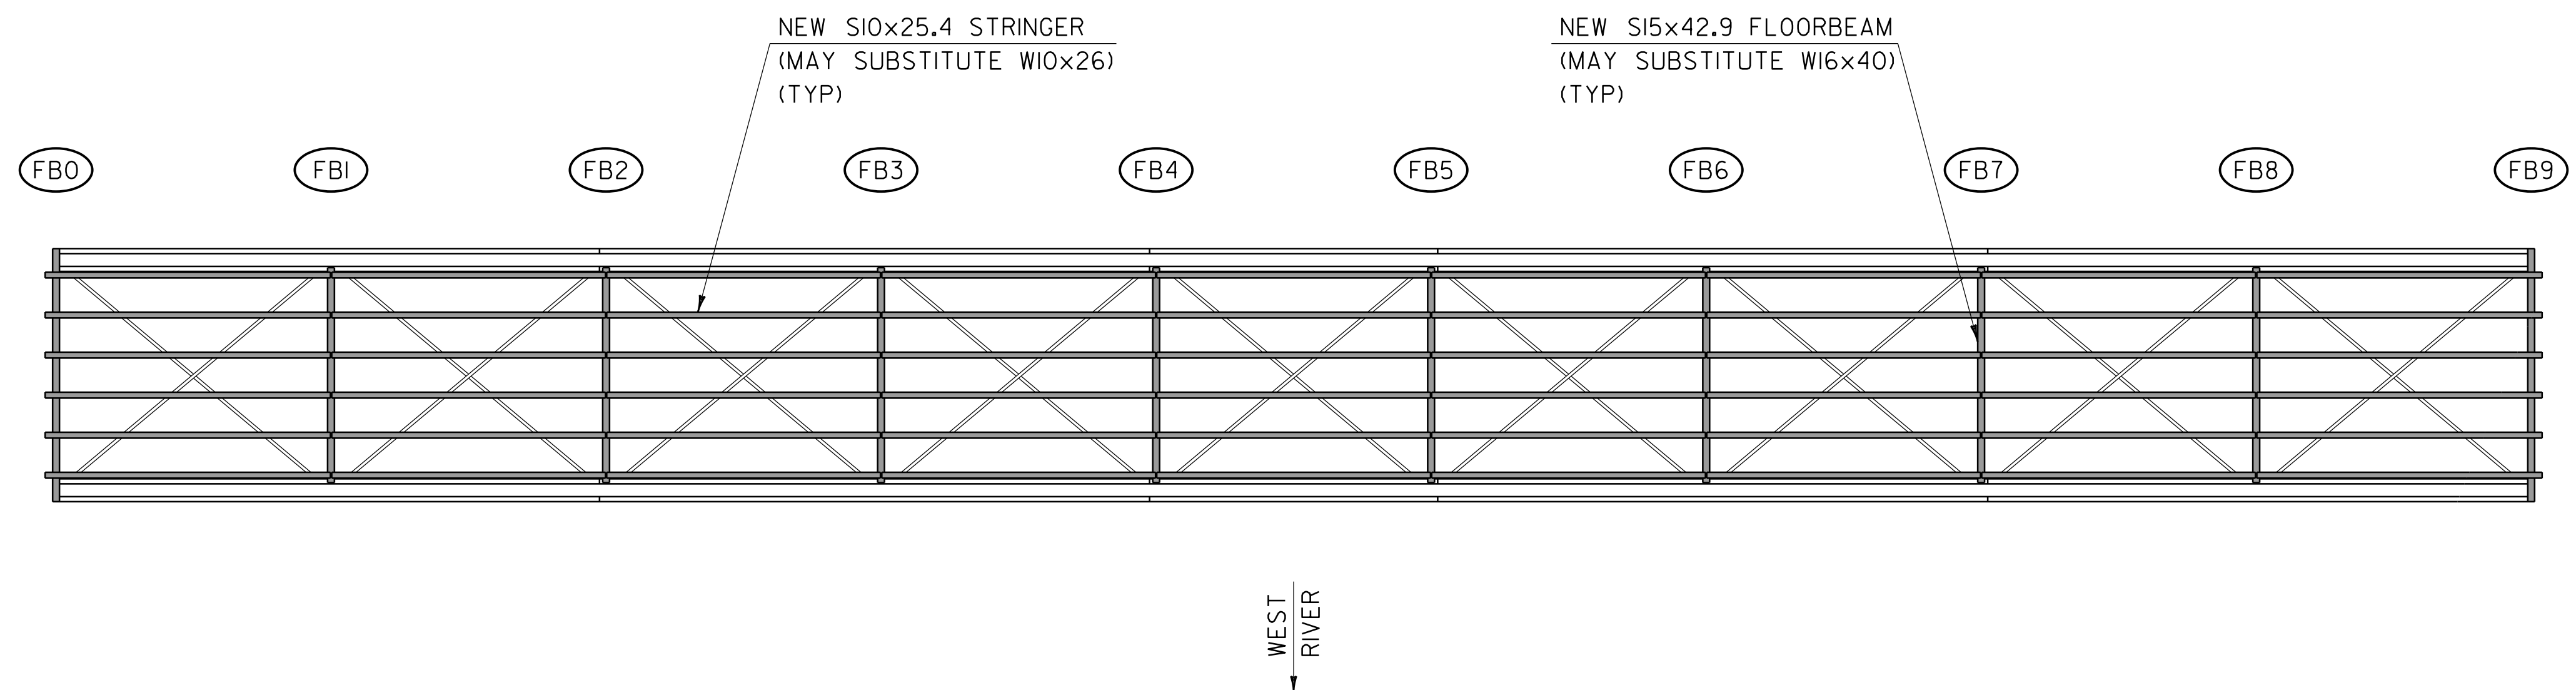
TRUSS ELEVATION
SCALE: 1/8" = 1'-0"

PROJECT NAME: JAMAICA	
PROJECT NUMBER: BO 1442(42)	
FILE NAME: z19j226sup2.dgn	PLOT DATE: 1/29/2021
PROJECT LEADER: L.STONE	DRAWN BY: P.DUSTIN
DESIGNED BY: B.SCHORN	CHECKED BY: R.WOOD
TRUSS H15 LIVE LOADING	SHEET 6 OF 10
