Scoping Report

Clarendon BO 1443(55)
Kingsley Covered Bridge
Town Highway 39
Bridge 28 over Mill River

Prepared for:
Vermont Agency of Transportation

Hoyle, Tanner
& Associates, Inc.
www.hoyletanner.com
January 2021

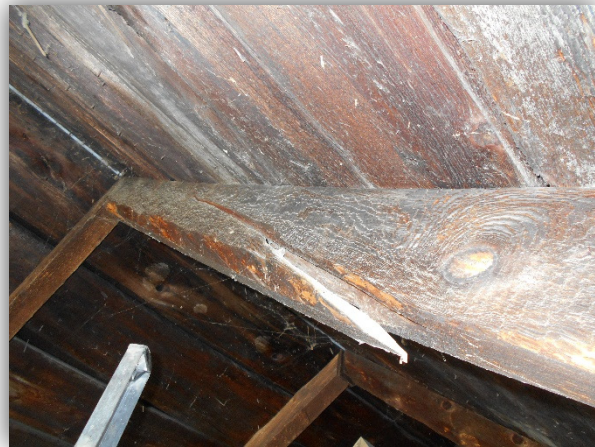
Typical Broken Roof Rafter

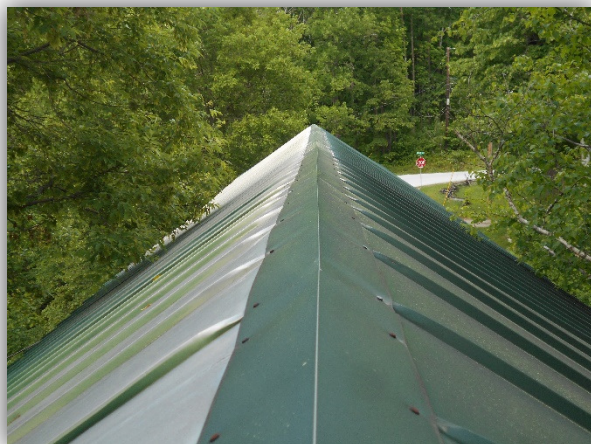
Nailed Ridge Cap
Metal Roof Paint Failure – Left Side

- The majority of the existing metal roof exhibits areas of rust staining, paint blistering and fading.
- The metal roof ridge cap is attached to the roof boards with nails and screws over rubber gaskets and it is not mechanically field-seamed or watertight.
- The roof boards and rafters exhibit through splits, breaks, rot and insect damage. It is estimated that 20% of the roof boards and 19% of the roof rafters will require replacement due to condition.
- The siding boards at each end of the bridge exhibit areas of rot due to poor air circulation and moisture retention from the overgrown trees and vegetation. The rest of the siding is in good condition; however, removal and replacement will likely be required due to provide access for the extensive truss member replacements.

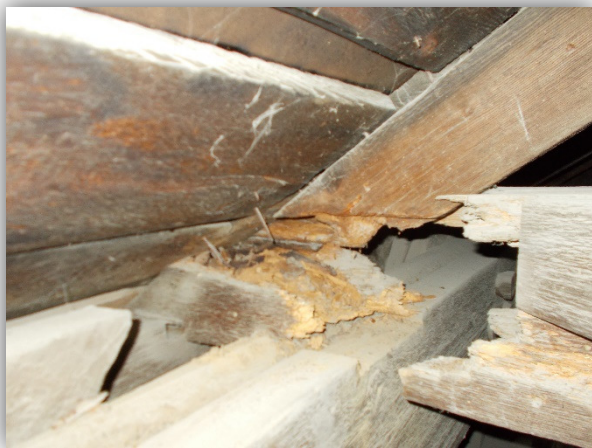
Heavy Rot at Cross Beam
Node 10/11 West End

- Three cross beams and three upper lateral braces exhibit twisting, rot and splits. Several other cross beams are not bearing on chord 1 members and a large gap of up to 1 ½" exist at some locations.
- Added knee braces have large overcuts at the upper bolted connection, which are weakening their capacity.
- Seven knee braces have been previously damaged from oversized vehicles and are not well connected to the cross beams or truss members.

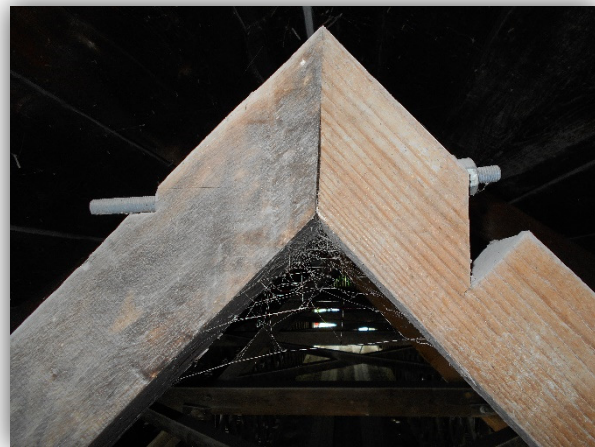
Typical Broken Roof Rafter

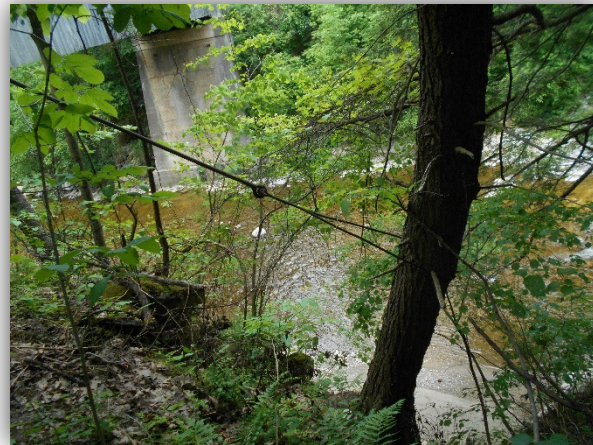
- Guy rods are not well anchored and most of them are connected to trees.
- The majority of the upper lateral braces are loose and do not have wedges or means of tightening them.

Typical Guy Rod Tied to a Tree

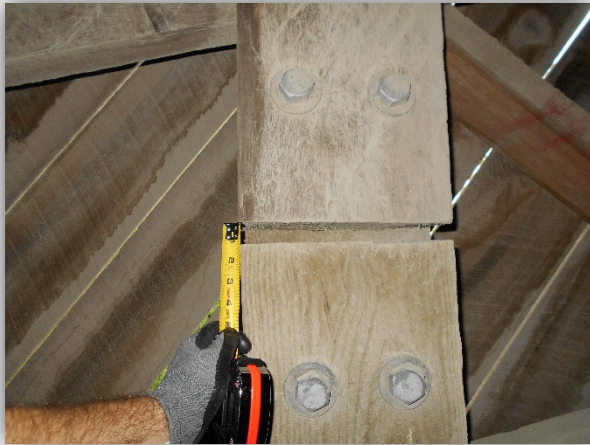
Typical Gap at Spliced Lattice Members

- The majority of the lower lattice members were cut-off and spliced with remaining portions of the old lattice with fish plates and 1" diameter through bolts during the 1987 rehabilitation. Many of the tension lattice have splice gaps up to 1¼" and through bolts are deformed, indicating overstressing of such connections.
- Many lattice members are broken, rotted and exhibit through splits and insect damage. Refer to Appendix E sheets 8 and 9 for deteriorated lattice members that were identified in need of replacement due to condition.

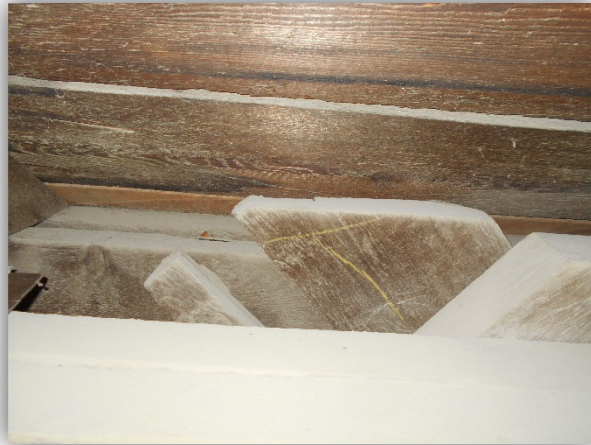
Split Lattice Member

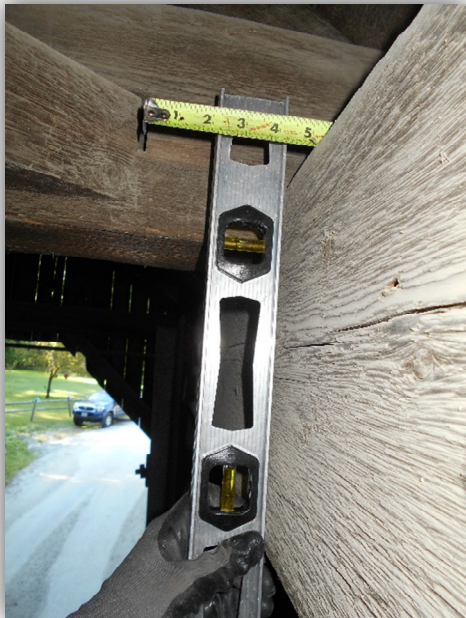
Out of Plumb Chord 1
South End of West Truss

- The south end of the west (downstream) truss is out of plumb due to extensive rot of the bearing blocks over the south abutment. The upper chord was measured to be out of plane by $\frac{3}{4}$ " over its height of 12".
- The butt joints on the lower chord have gaps up to $\frac{3}{8}$ " wide, indicate some crushing of the wood at the existing through bolts.
- The lower chord galvanized through bolts installed during the 1987 rehabilitation exhibit various levels of rusting and minor section losses on the steel washers.
- There is evidence of powderpost beetle activity at top chord members at the southern end of the bridge. Trees at the southern end of the bridge have overgrown and are directly over the bridge roof, promoting insect infestation of the bridge.

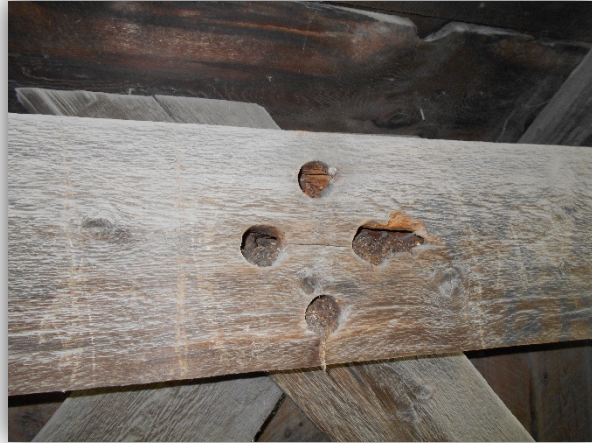
- The upper chords exhibit extensive rot and insect damage. Carpenter ants were observed on the upper chord members. Refer to Appendix E sheets 8 and 9 for deteriorated chord members that were identified in need of replacement due to condition. Chord 4, Ply A near midspan is not deteriorated in these drawings,

Typical Rot at Top Chord

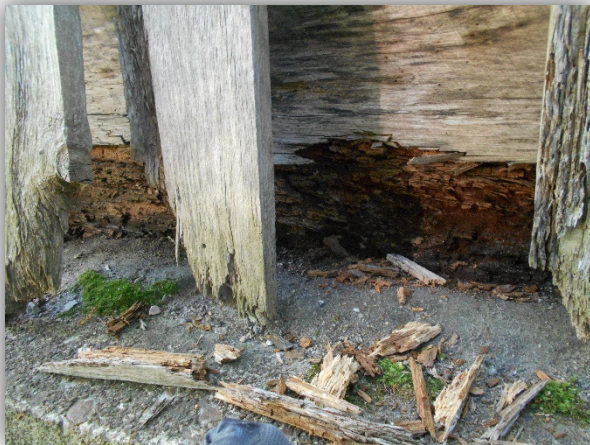
- The wooden bearing blocks are decaying at each end of the bridge.
- At the southwest end of the bridge the bearing blocks exhibit extensive rot which has caused the truss bearing to settle approximately 2½".
- The bearing blocks are not strategically positioned to reduce the truss clear span and do not fully support the truss lower chord over the entire concrete beam seat.

Bearing Block Rot
South End West Truss

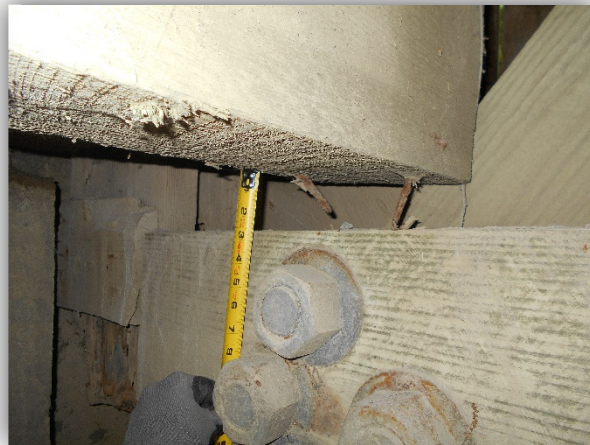
Floor Beam to Chord 4 ½" Gap Due to Bearing
Block Extensive Rot – South End West Truss

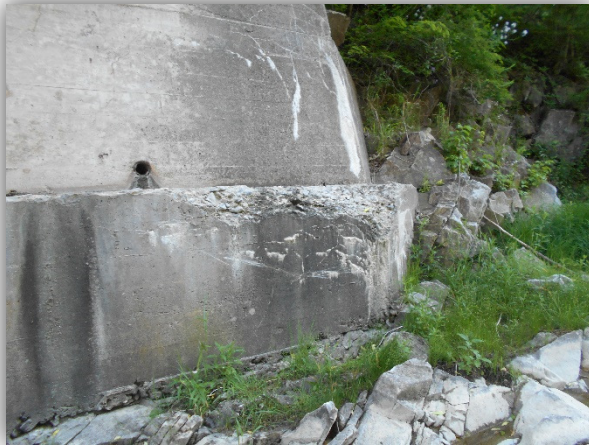
- Both abutments exhibit some areas of concrete spalling, delamination, efflorescence staining, vertical, horizontal and map cracking.
- At the spalled areas the concrete was observed to contain round river stones with no fractured faces, which significantly reduces the concrete strength and durability.
- The footing of Wingwall No. 1 (southwest) has started to undermine due to erosion from stormwater drainage at that quadrant.

Abutment No.2 (North) Footing Spalling and Efflorescence Staining

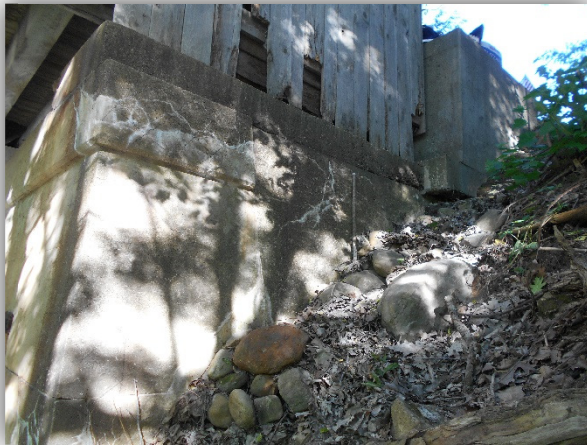
Wingwall No.1 (Southwest) Undermining

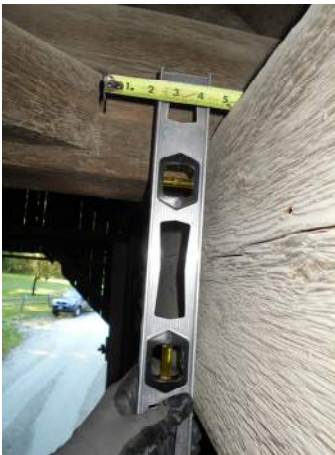
Out of Plumb, Splits, Breaks, Rot, Insect Damage

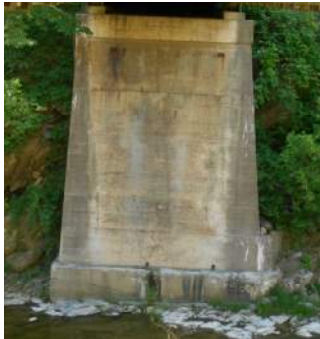
Concrete
Cracks,
Spalling,
Delamination

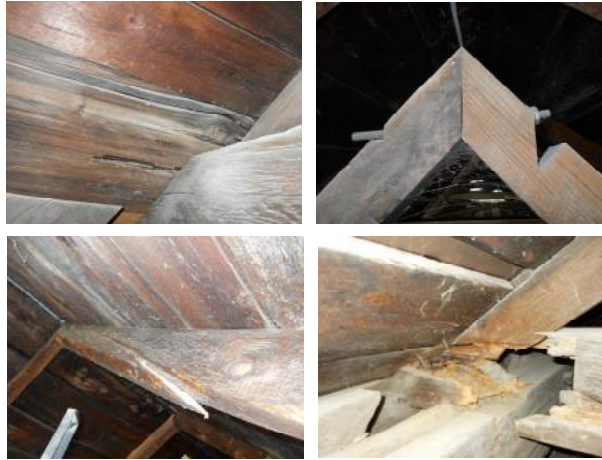
Splits, Breaks,
Rot,
Overcuts,
Insect
Damage

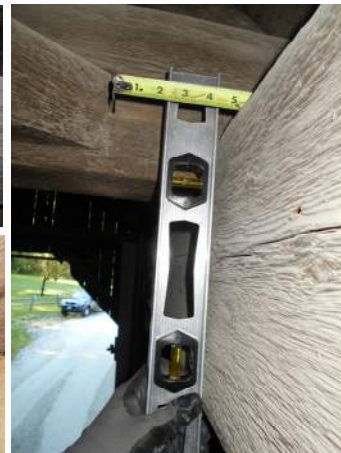
Out of Plumb,
Splits, Breaks,
Rot, Insect
Damage

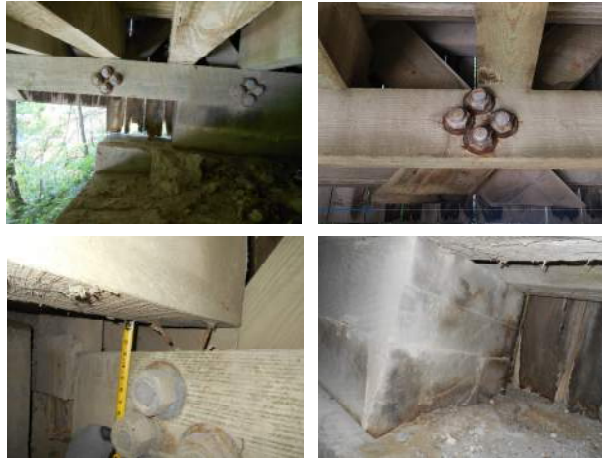
Bedding
Timbers
Rotted,
Settling of
Trusses,
Rusting of
Bolts

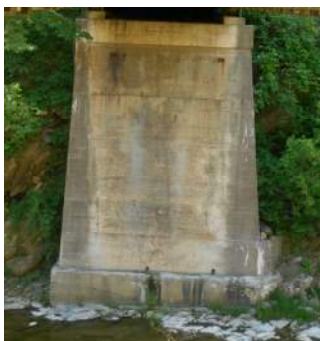
Concrete
Cracks,
Spalling,
Delamination,
Efflorescence
Staining
