KINGSLEY COVERED BRIDGE

CLARENDON BO 1443(55)
TH 39, BRIDGE NO. 28 OVER MILL RIVER

ALTERNATIVES PRESENTATION

MARCH 22, 2021

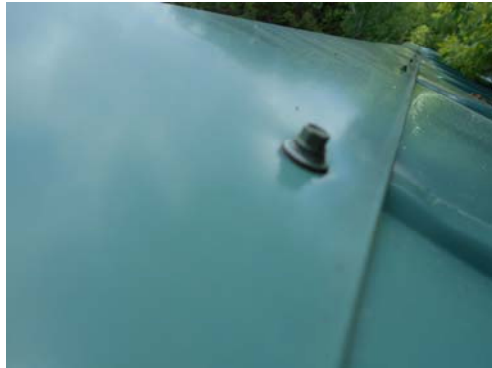
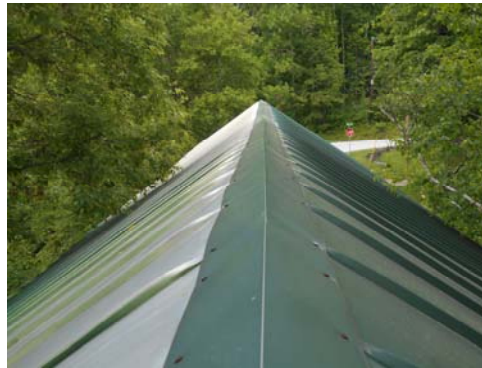
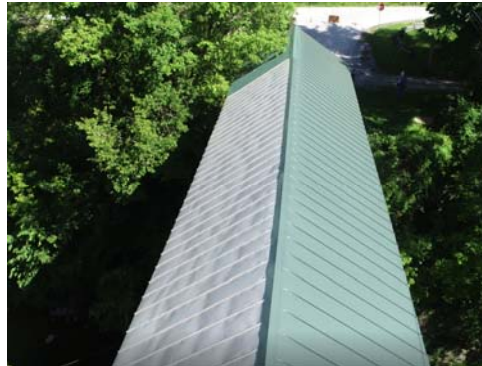
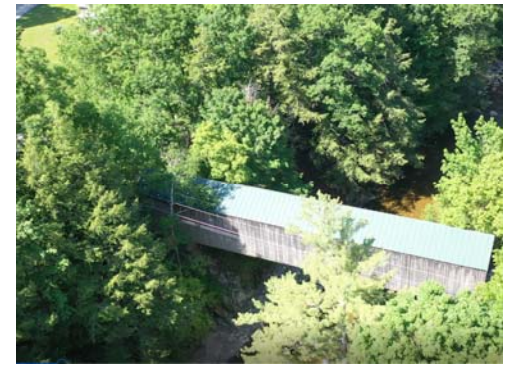
INSPECTION FINDINGS: METAL ROOF

Paint Blistering,
Fading, Ridge
Cap Attached
with Nails &
Screws, Trees
Overgrown

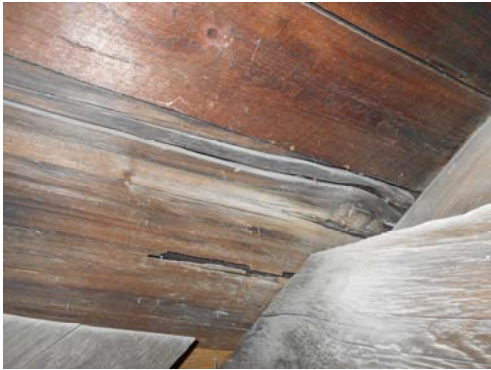
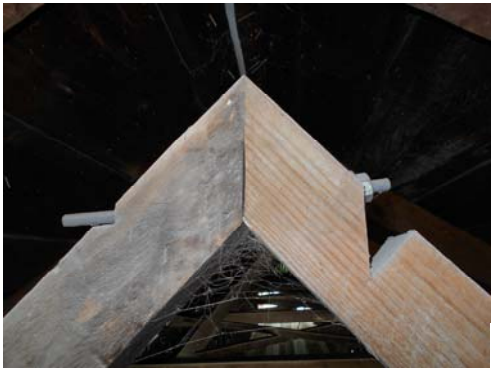
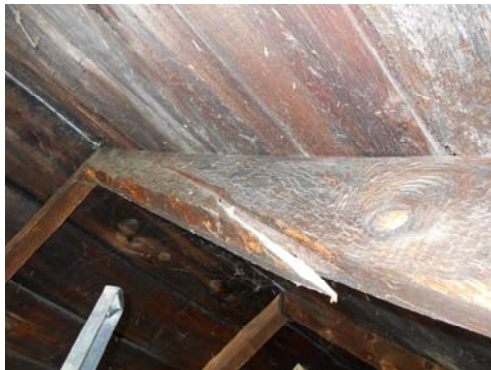
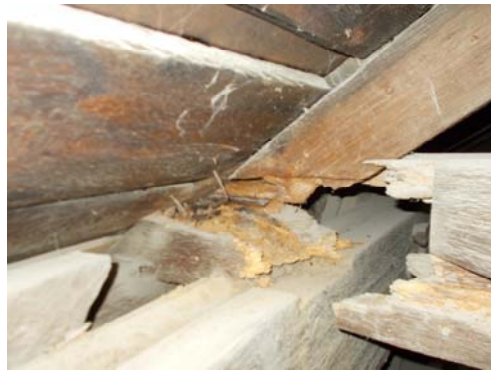
INSPECTION FINDINGS: ROOF MEMBERS

Splits, Breaks,
Rot,
Overcuts,
Insect
Damage

- New Standing Seam Metal Roof
- Rafters are 3"x5" or 4"x5" Eastern Spruce
- Roof Boards are 1" thick Eastern Hemlock
- 20% Replacement of Existing Roof Boards
- 12 Rafters (19%) to be Replaced due to Condition
- 5 Rafters to be Epoxy Repaired

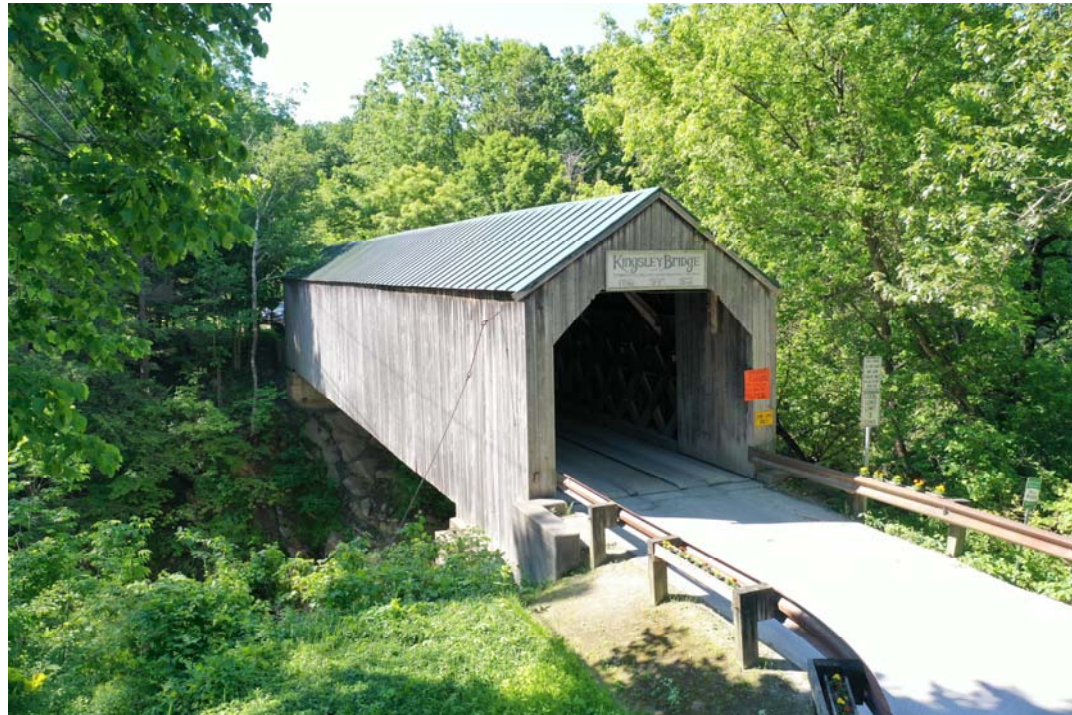
INSPECTION FINDINGS: BRACING MEMBERS

Guy wires
not well
anchored

- Existing Lateral Bracing not Adequate to allow removal of guy wiring.
- Strengthen Crossbeam to Chord connection or
- Add Additional Lateral Bracing Below the Crossbeam

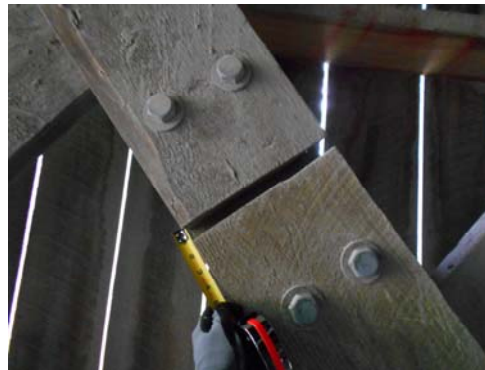
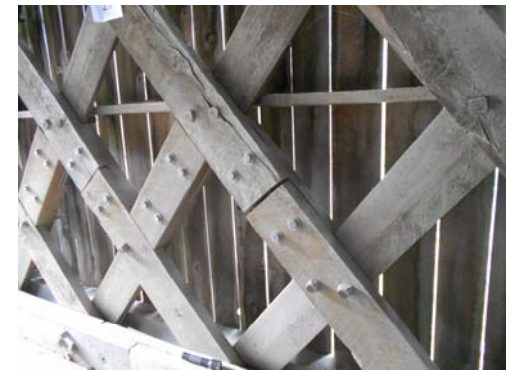
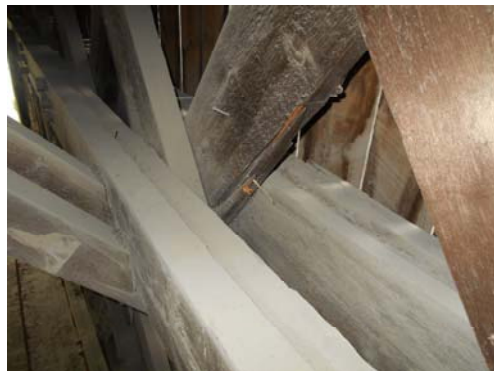
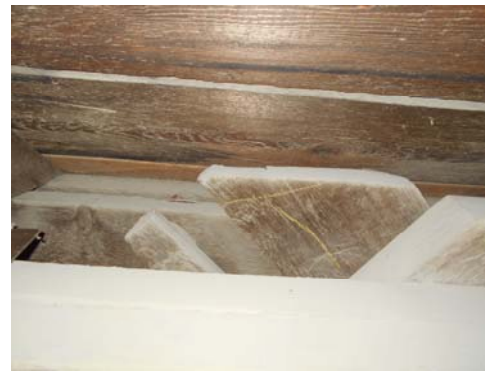
INSPECTION FINDINGS: LATTICE MEMBERS

Large Gaps at
Previous
Splices, Splits,
Breaks, Rot,
Insect
Damage

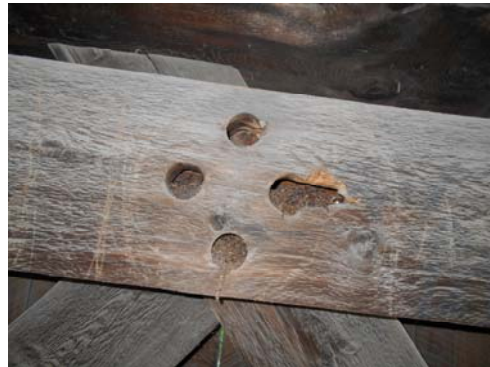
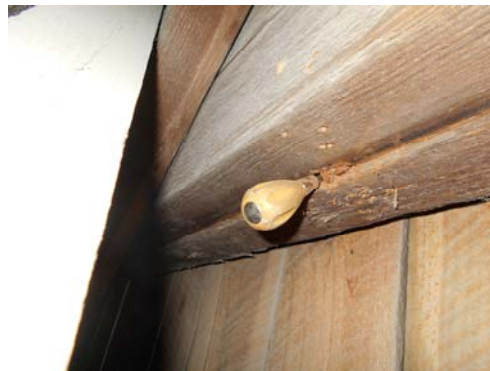
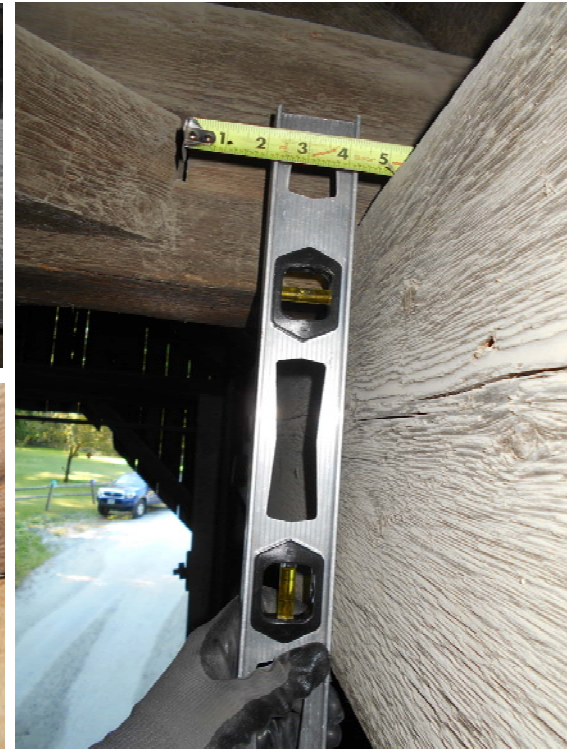
INSPECTION FINDINGS: TOP CHORD MEMBERS

Out of Plumb,
Splits, Breaks,
Rot, Insect
Damage

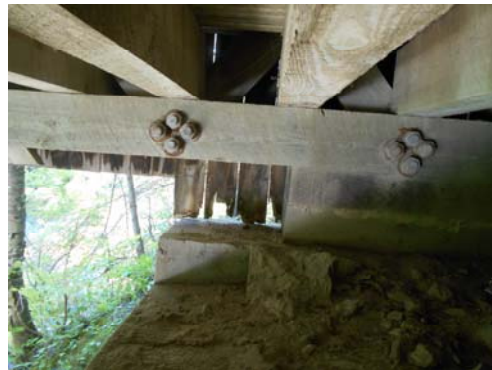
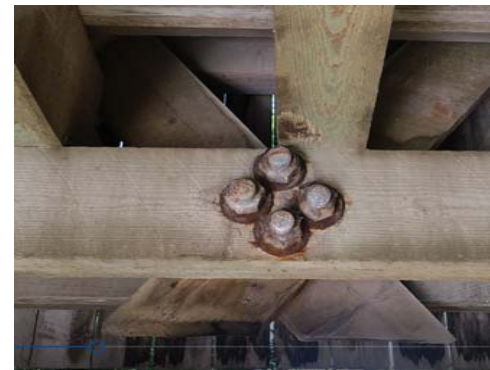
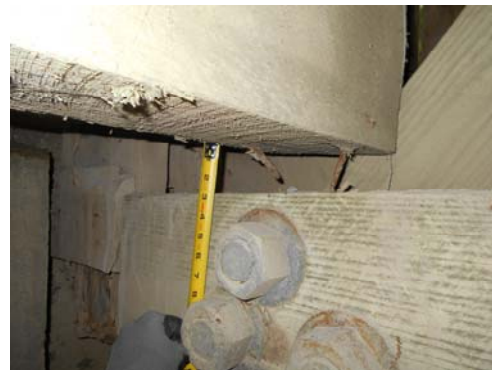
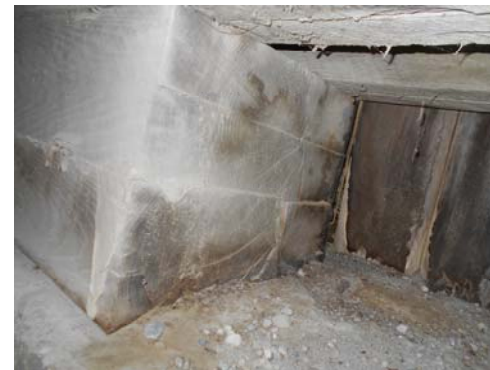
INSPECTION FINDINGS: BOTTOM CHORD MEMBERS

Bedding
Timbers
Rotted,
Settling of
Trusses,
Rusting of
Bolts

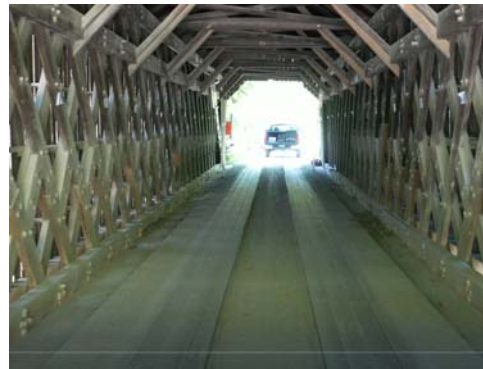
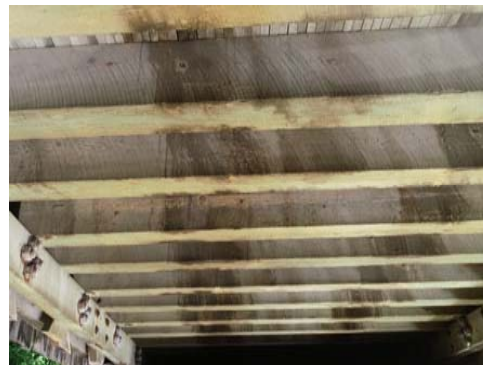
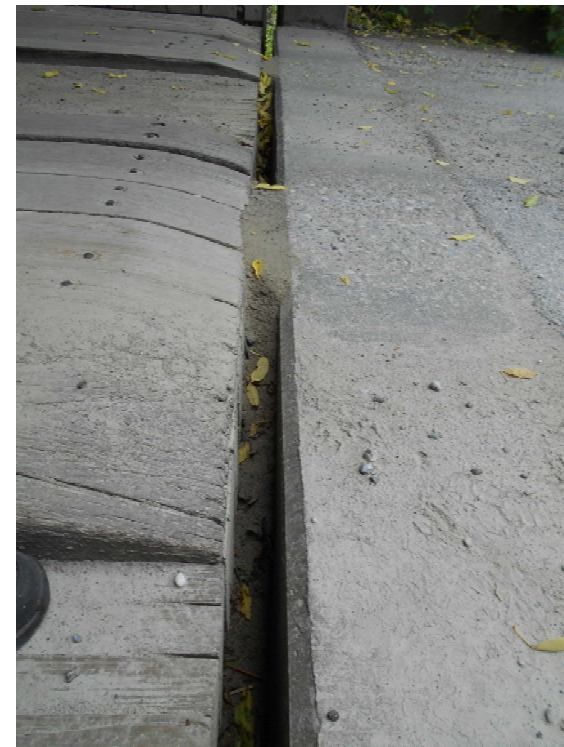
INSPECTION FINDINGS: FLOOR MEMBERS

Runners Trap
Debris,
Ramps Each
End

- Floor Members Include 8”x14” Floorbeams, 2”x6” Nail Laminated Deck and 3” thick Runner Boards
- Floorbeams are Southern Pine and Decking is Eastern Spruce
- Nail Laminated Deck Adequate for H20
- Floorbeams Adequate for H15
- Replace Runner Boards with full width Runners
- No Floorbeam/Deck Replacement or Repair Required for H3, H12 or H15

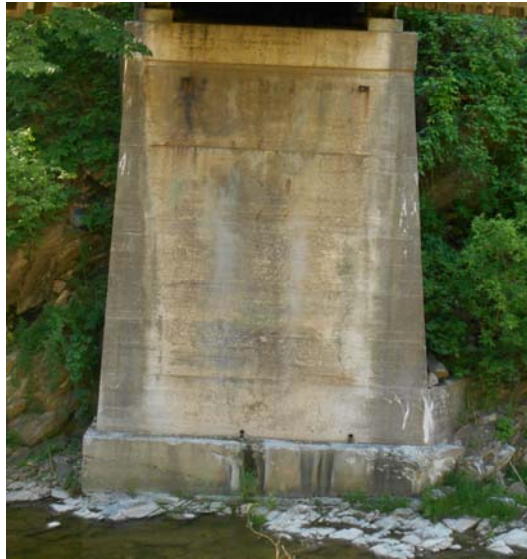
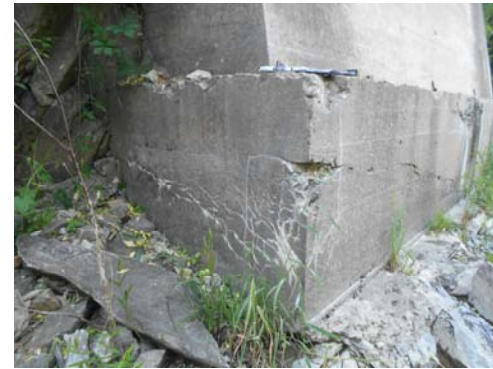
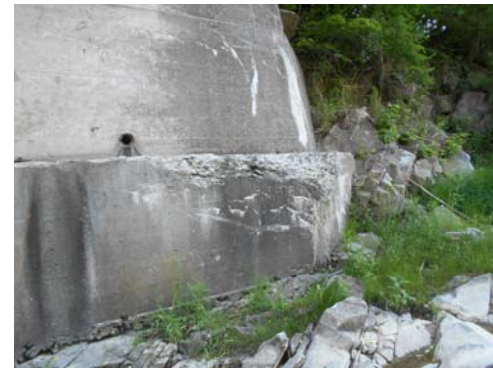
INSPECTION FINDINGS: SUBSTRUCTURE

Concrete
Cracks,
Spalling,
Delamination,
Efflorescence
Staining

- Concrete Repair / Crack Sealing
- Stain And Seal Concrete
